Report for
29 High Street, Hallaton, Leicestershire

The Medieval Peasant House in Midland England

HAL-A: 29 HIGH STREET, HALLATON, LEICESTERSHIRE

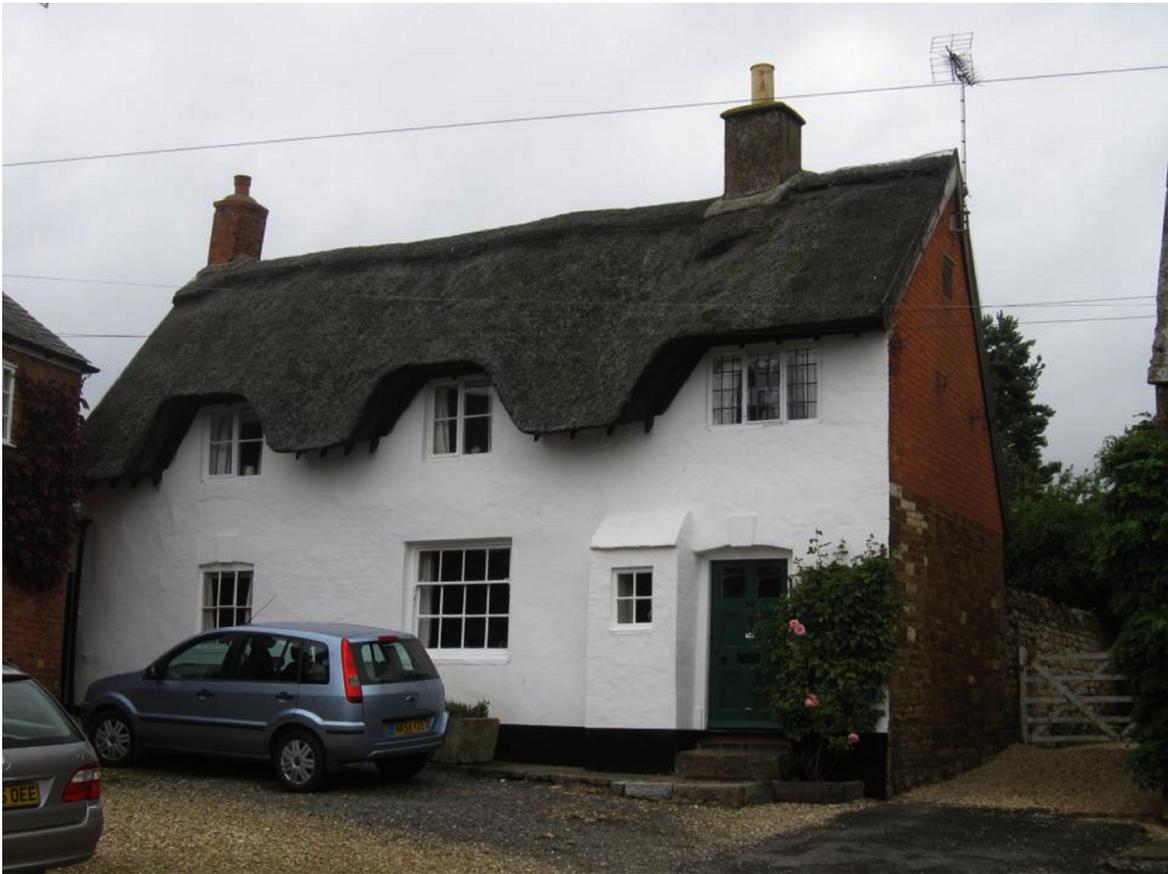
Fig. 1. View from south (Photo: N. Hill)

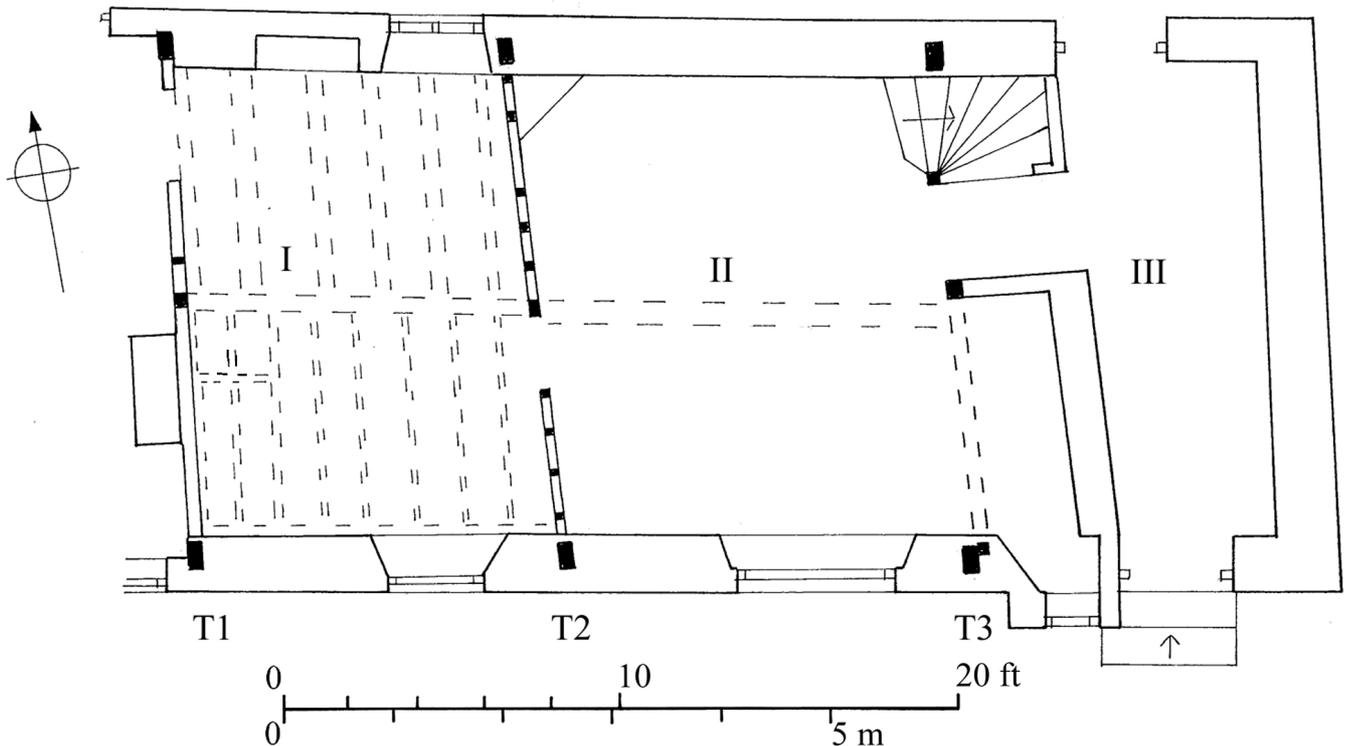
Fig. 2. Plan, showing truss and bay numbering.

PHASE 1: 29 High Street Hallaton is a cruck house now of three bays, aligned parallel to the village street, retaining three cruck trusses. The external walls were of mud on a stone plinth and the house is still thatched. The central cruck has given a felling date range of 1465-83. The cruck spurs are unusual, being dovetailed in section and pushed into corresponding dovetail trenches in the cruck blades. Detailed analysis indicates that the building may be more complex than it appears. Multiple pegging of many joints and a strange pattern of smoke-blackening suggest that the building was re-planned, perhaps in the mid-sixteenth century. Thereafter, the house had a central open hall (bay II) with a timber chimneystack, a floored bay (I) to the west with a chamber over a parlour, and a short service end to the east (III), including a cross passage. A further bay at the west is likely since truss T1 lacks a stone plinth, as would be expected if it had been part of an external wall.

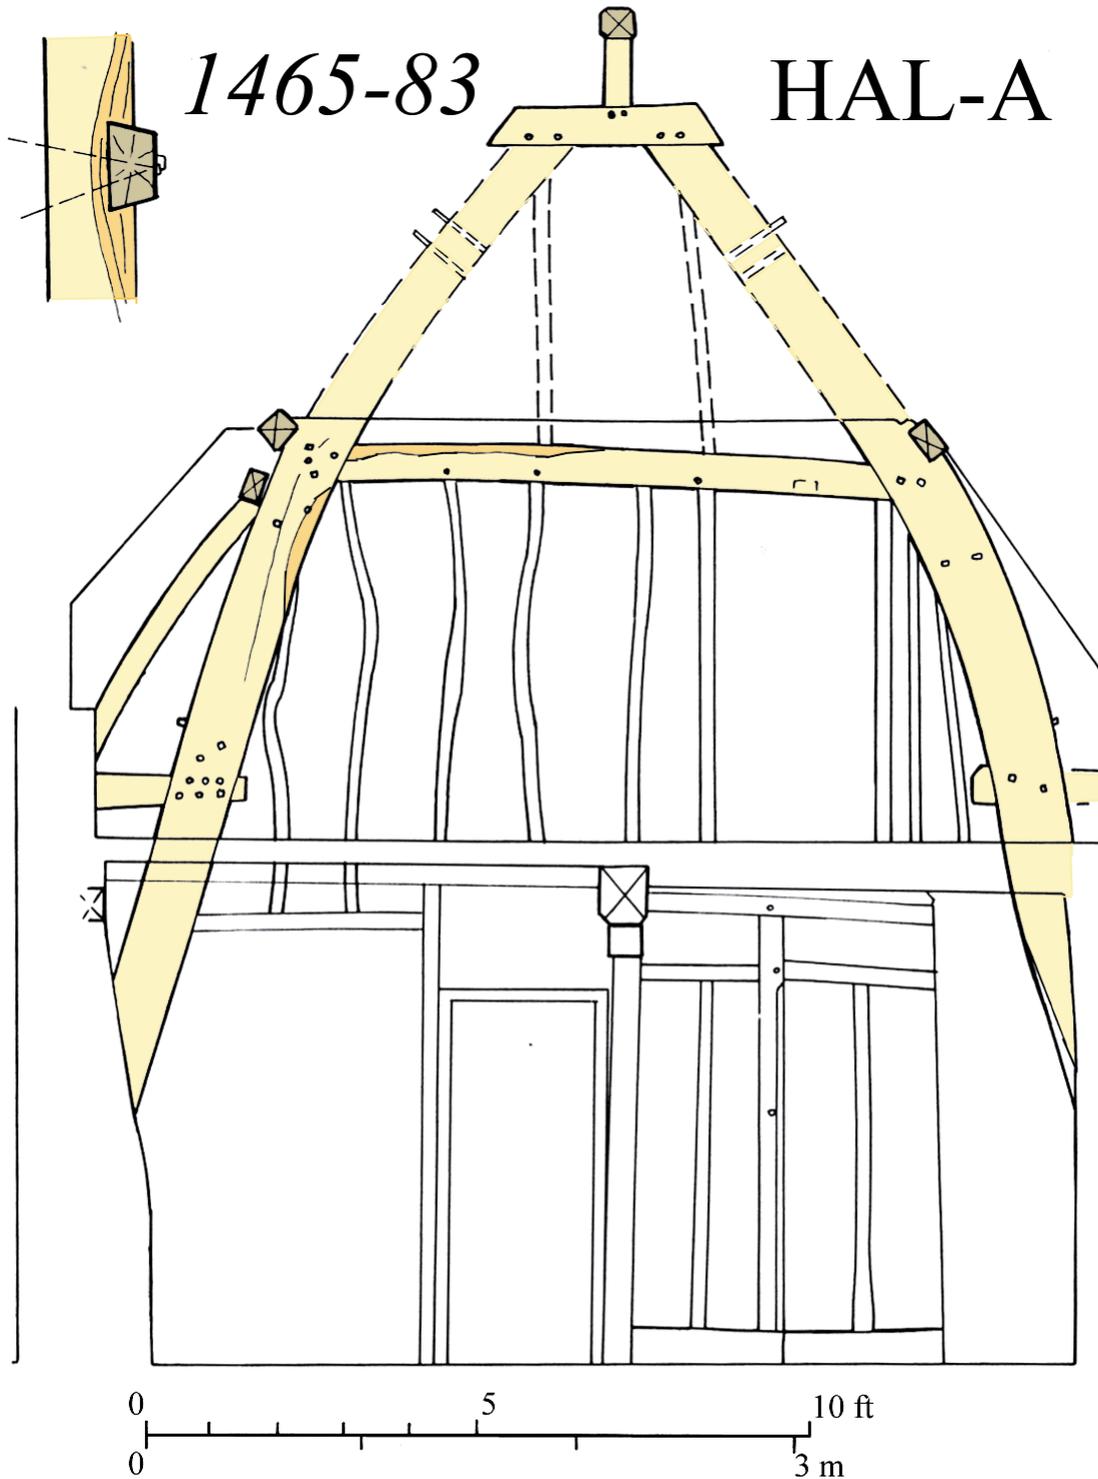
Fig. 3. Section of truss T2 from east. Inset: face view of cruck spur dovetail.

PHASE 1: Both trusses T1 and T2 have an apex with a short saddle and king-post, supporting a square-set ridge (type F1). However, truss T3 towards the east has a plain saddle apex (type C), which is the normal local form. The cruck blades have gently curving profiles and trusses T1 and T3 are irregular and of rather slight scantling. The F1 apex type, where the blades stop short of the apex, may have been the result of difficulty of obtaining suitable timber for the more normal C-apex. The north blade of truss T1 is visible almost to ground level, and it seems likely that all the original blades extended down to the ground. In truss T2, the blades measure 12 x 6 in, and appear to be halved from the same tree.

All three trusses have lapped collars, which extended past the cruck blades to support the purlins. The collar of truss T3 is probably of re-used timber. It seems there were no tiebeams, though the visible evidence at truss T1 is not conclusive. Instead, all three trusses had cruck spurs, set a little above the current first floor level. In the one instance where the spur joint is fully visible, it takes an unusual form, being slid into a long dovetailed trench in the side of the blade with two skew pegs (Figs. 3-4). On the north side of truss T3, the outer end of one cruck spur is visible, with a through-peg which fixed the wallplate down onto the spur. The square-set ridge runs along all three bays of the building, with splayed scarf joints at each truss. The purlins are largely concealed, but may survive towards the west. Pegs for removed windbraces are present on the back of the blades above the spurs and pairs of long pegs passing through the top of the blades of T2 and T3 (Fig. 3) may have supported longitudinal framing for a louvre, although they might have been for downward wind-braces.

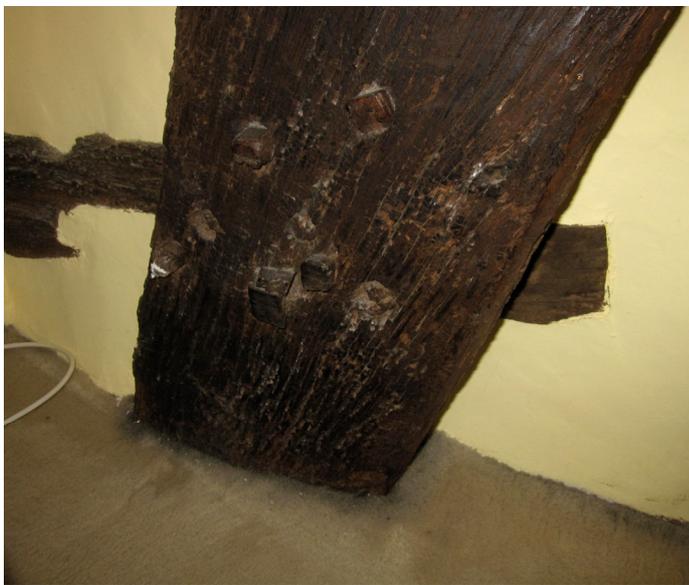
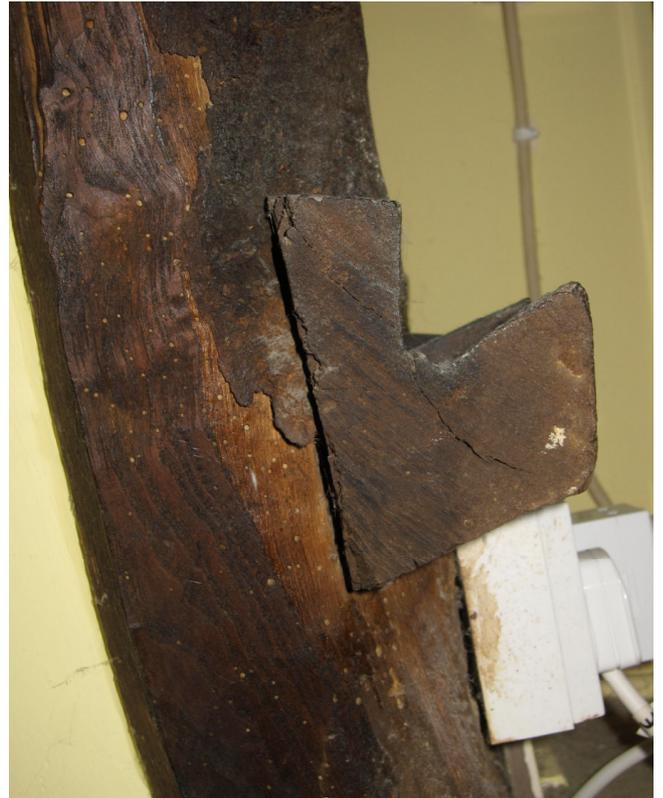
Fig. 4. (a) Multiple pegging of spur to truss T2. (b) Dovetailed cruck spur to T3 (photos: N. Hill).

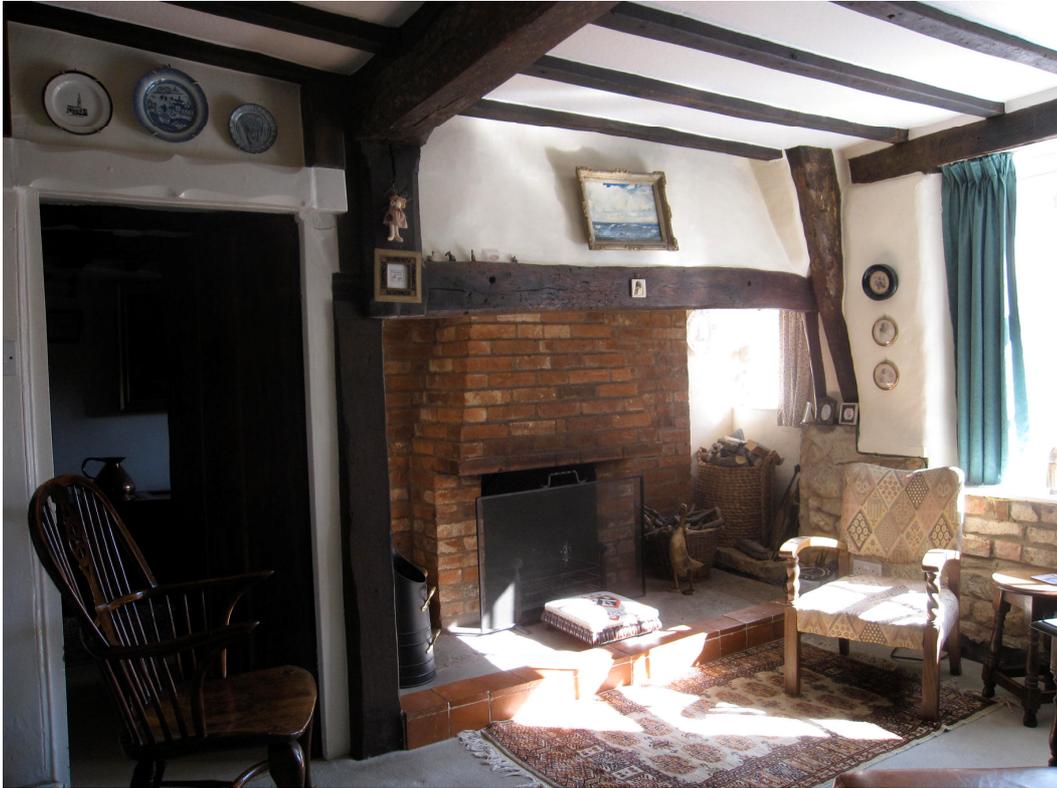
Fig. 5. Foot of truss T3 with inserted timber fireplace and ceiling (photo: N. Hill)

LATER PHASES: Bay I has early floor joists carried on an axial beam, with a trimmer for a ladder stair, passing through either the larger southern or smaller central opening. Bay III contains a well-preserved timber-framed fireplace with framed stack above. Framing remains in T2 for a doorframe between bays I and II, with the southern doorpost and the door head surviving. The doorpost has a chamfer up it,

The inserted hall floor is carried on an axial beam with scroll stops and joists with soffit tenons; the east end is supported on a chamfered stub post rising from the lintel of the timber-framed fireplace (Fig. 5). The west end of the beam is attached to the end of the axial beam of bay I, itself carried by the central post of the T2 infill.
