Report for
**4 Main Street, Long Whatton, Leicestershire ,
Leicestershire**

The Medieval Peasant House in Midland England

LWH-A: 4 MAIN STREET, LONG WHATTON, LEICESTERSHIRE

Survey Date: 4 April 1991

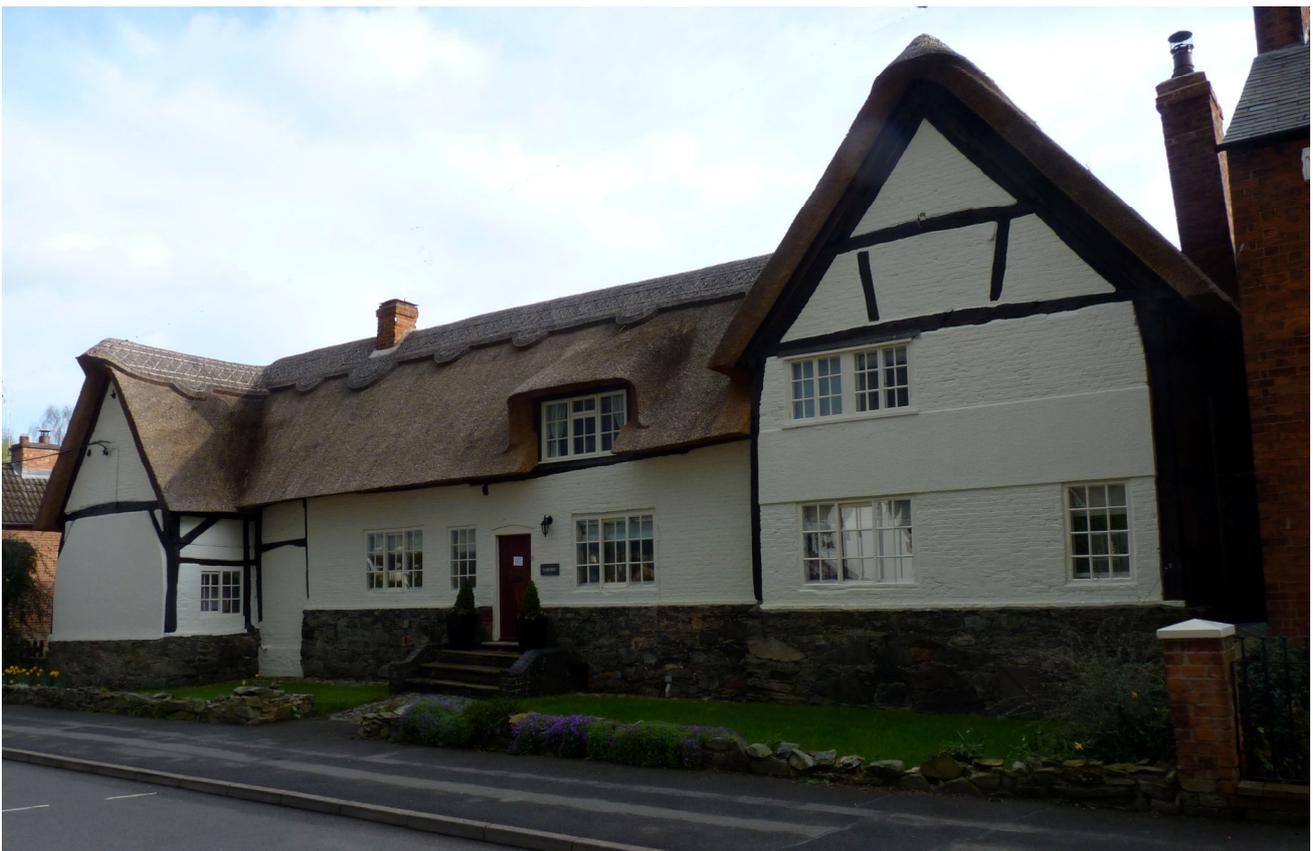
Fig. 1. View from the north

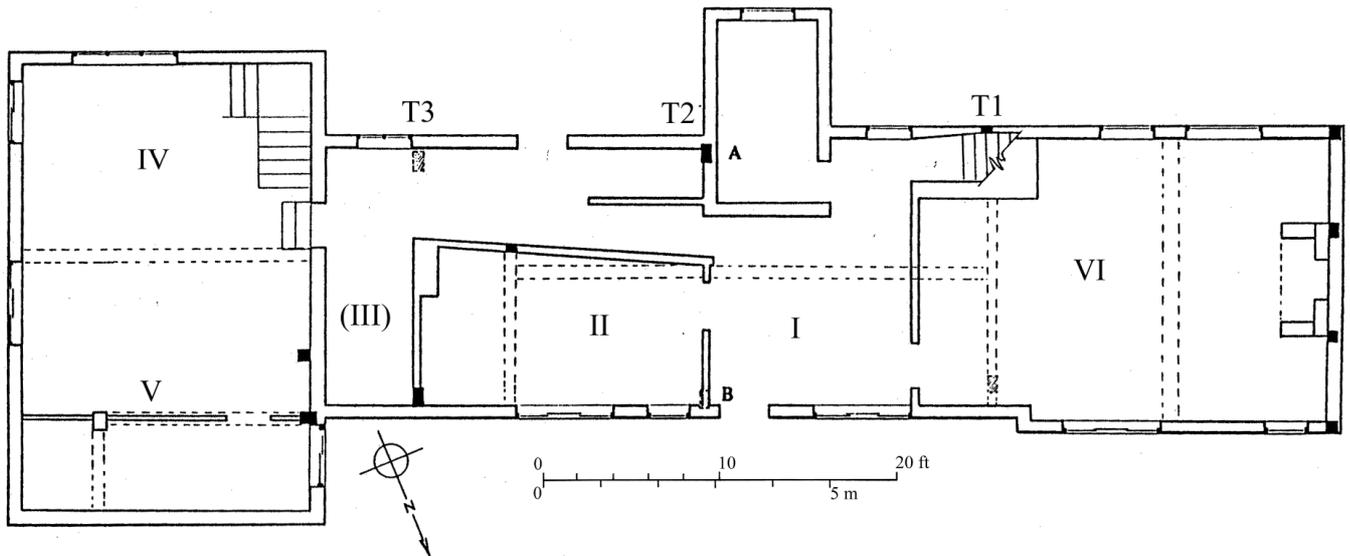
Fig. 2. Plan, showing truss and bay numbering.

PHASE 1: No. 4, Main Street, (formerly the Boot Inn) is a substantial thatched house now comprising a core of two and a half cruck bays facing north and running parallel to the road (nominally east-west), with a two bay cross-wing at the east end, and a single bay wing at the west. When built, the original cruck house probably had three bays. Bay III was partially replaced by the cross-wing at the eastern end and is evidenced only by the purlins which continue through to the east of truss T3. No smoke blackening visible in bays I or II, but some residual soot blackening can be seen around truss T3, although this most likely came from the adjacent smoke hood which appears to be original. The small scantling of the joists suggests that there were no first floors initially. All three cruck trusses have saddle apexes (type 'C'). Timbers in the cruck part of the house have a felling date range of 1558-1562.

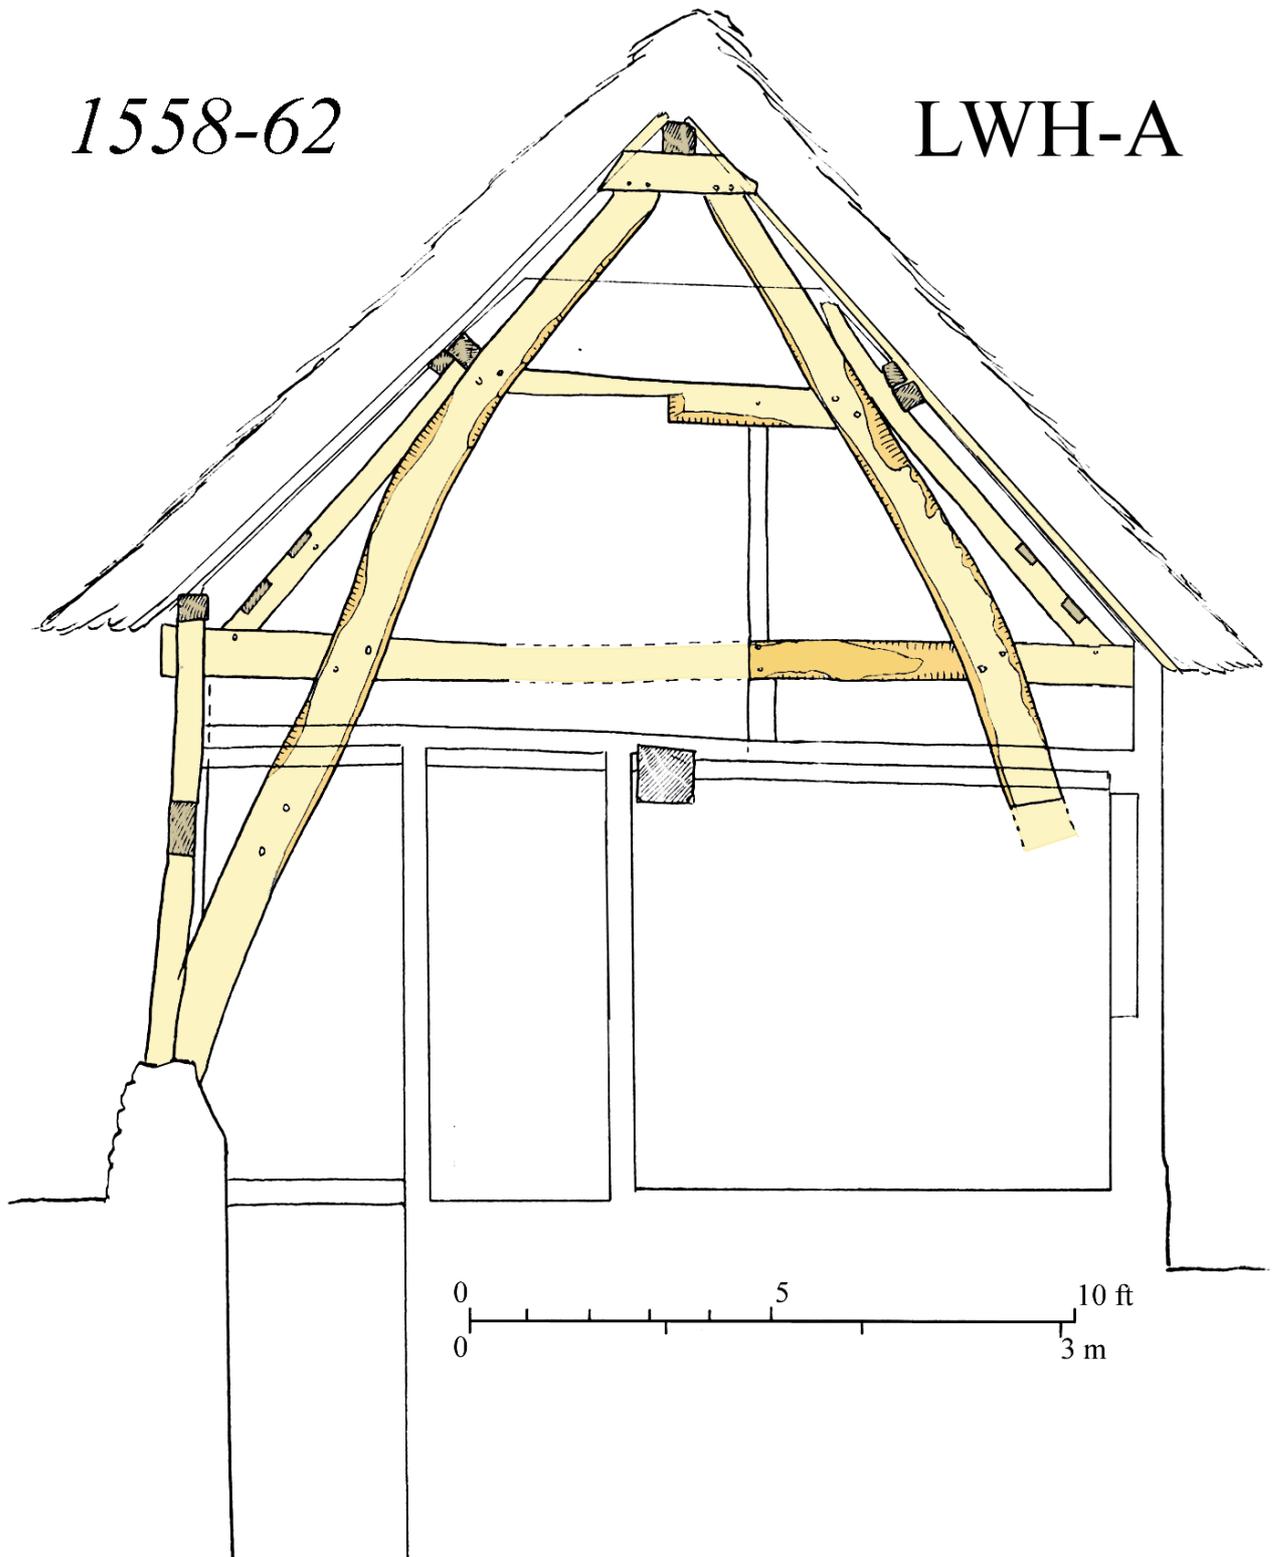
PHASE 1: Truss T2 comprises two slightly curved cruck blades joined at the top by a saddle which supports the ridge beam (7 by 6½in). The blades measure 11 x 9in at the bottom and may have been cut from the same tree, although insufficient of the face sides of the crucks is visible to verify this. The inside edges are finished with an inch-wide chamfer continuing to the saddle. It has a collar and a tiebeam. The latter continues out to support the wall-plates and is in turn supported by the cruck studs. The purlins (5-9 by 5-6in) are trenched into a packing piece on the front side, while at the back they are

Fig. 3. Section of Truss T2.

pegged to the back of the purlin and supported below by the packing piece. Wind-braces, all since removed, lapped over and were trenched into the backs of the packing pieces. The face side of the truss faces west. The feet of the crucks probably sat on the side sill-beams which in turn rested on a stone foundation plinth. The tiebeam has been severed for a doorway which was later moved further to the rear. The front cruck has apparently been either cut back or removed altogether below first floor level.

Trusses T1 and T3 appear to be basically the same as truss T2, except that truss T1 does not have packing pieces, the wind-braces and purlins being trenched directly into the back of the blades. Both these trusses apparently have paired blades, cut from the same tree. Truss T3 is also chamfered on the east side, adding to the evidence for a third bay. The rear cruck of T1 is cut off just above collar level and is supported on what may be a section of collar or tiebeam laid on the flat, the stave groove being visible on the east face. The front cruck of this truss is also severed roughly at tiebeam level and is supported on a transverse beam of similar section to the axial beam in bay VI. The rear cruck of T3 is also cut off at first floor level. Assembly marks are present on the face side of the front crucks around the tiebeam joint in the form of a 'cc' gouged into T2, and 'ccc' into T3. A 'square' mark was also noted on this cruck above the tie, adjacent to the 'ccc' mark. The pegs in truss T3 were driven from the west, rather than from the east, as would have been expected if it had been an outside wall. These pegs give a notable example of skew-pegging (Fig. 4).

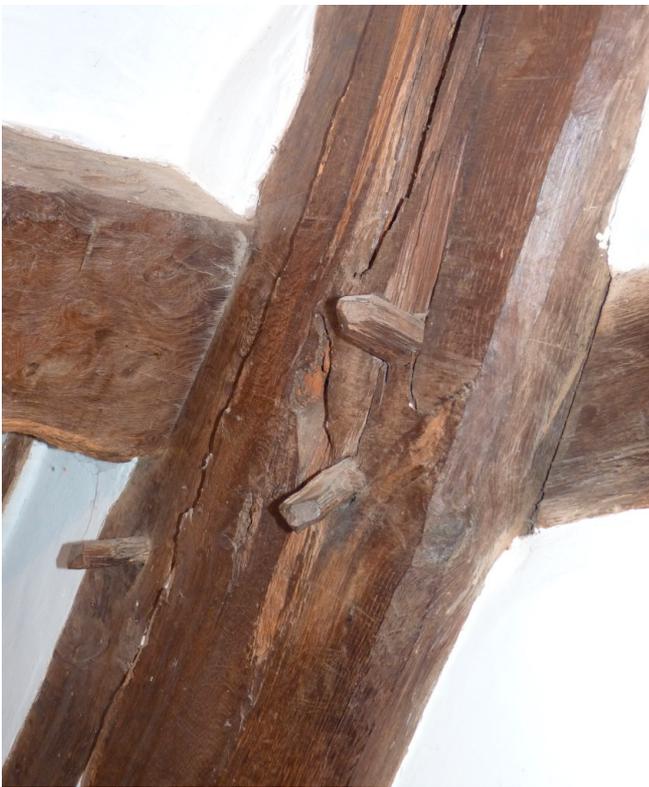
Fig. 4. Skew-pegging in truss T3, viewed from the east.
