Report for  
**72 High Street, Syston, Leicestershire**

The Medieval Peasant House in Midland England

## SYS-A: 72 HIGH STREET, SYSTON, LEICESTERSHIRE

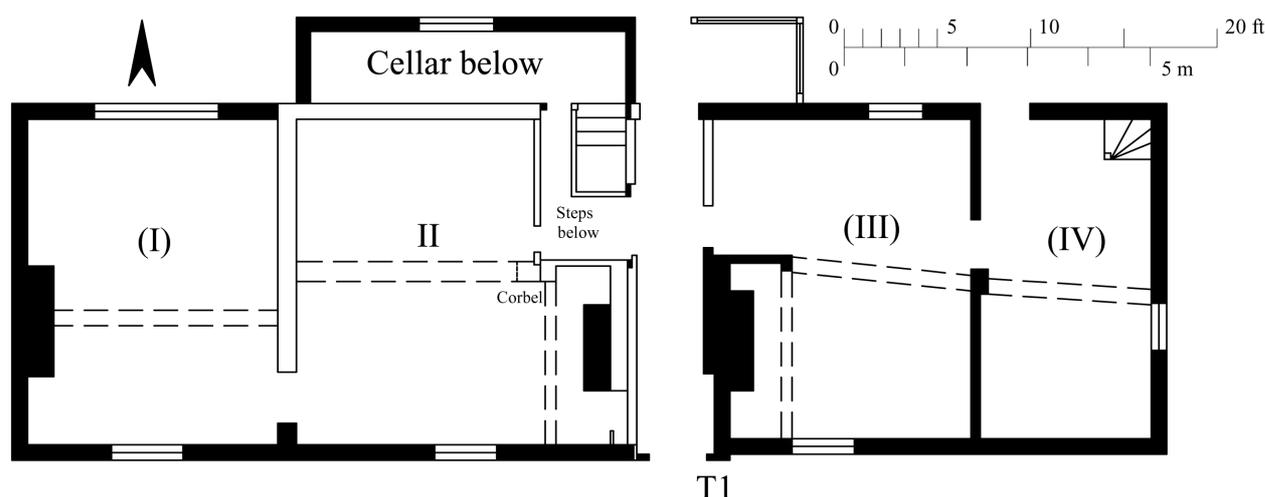
Fig. 2. Plan, showing truss and bay numbering.

The house has a standard three-room and passage plan, but only the cruck truss beside the passage (formerly with saddle apex) is definitely medieval (probably later fifteenth/early sixteenth century by analogy with dated examples). Bay II was presumably the original open hall; it retains an inserted ceiling beam and chimney, probably of the seventeenth century. At this period a rear lean-to was added, over a stone cellar. Bays I and III are later (or totally rebuilt), as is the extra service bay (IV). The house is thatched and the pebble-dashed exterior walls appear to be of brick, apart from the stone rear lean-to.

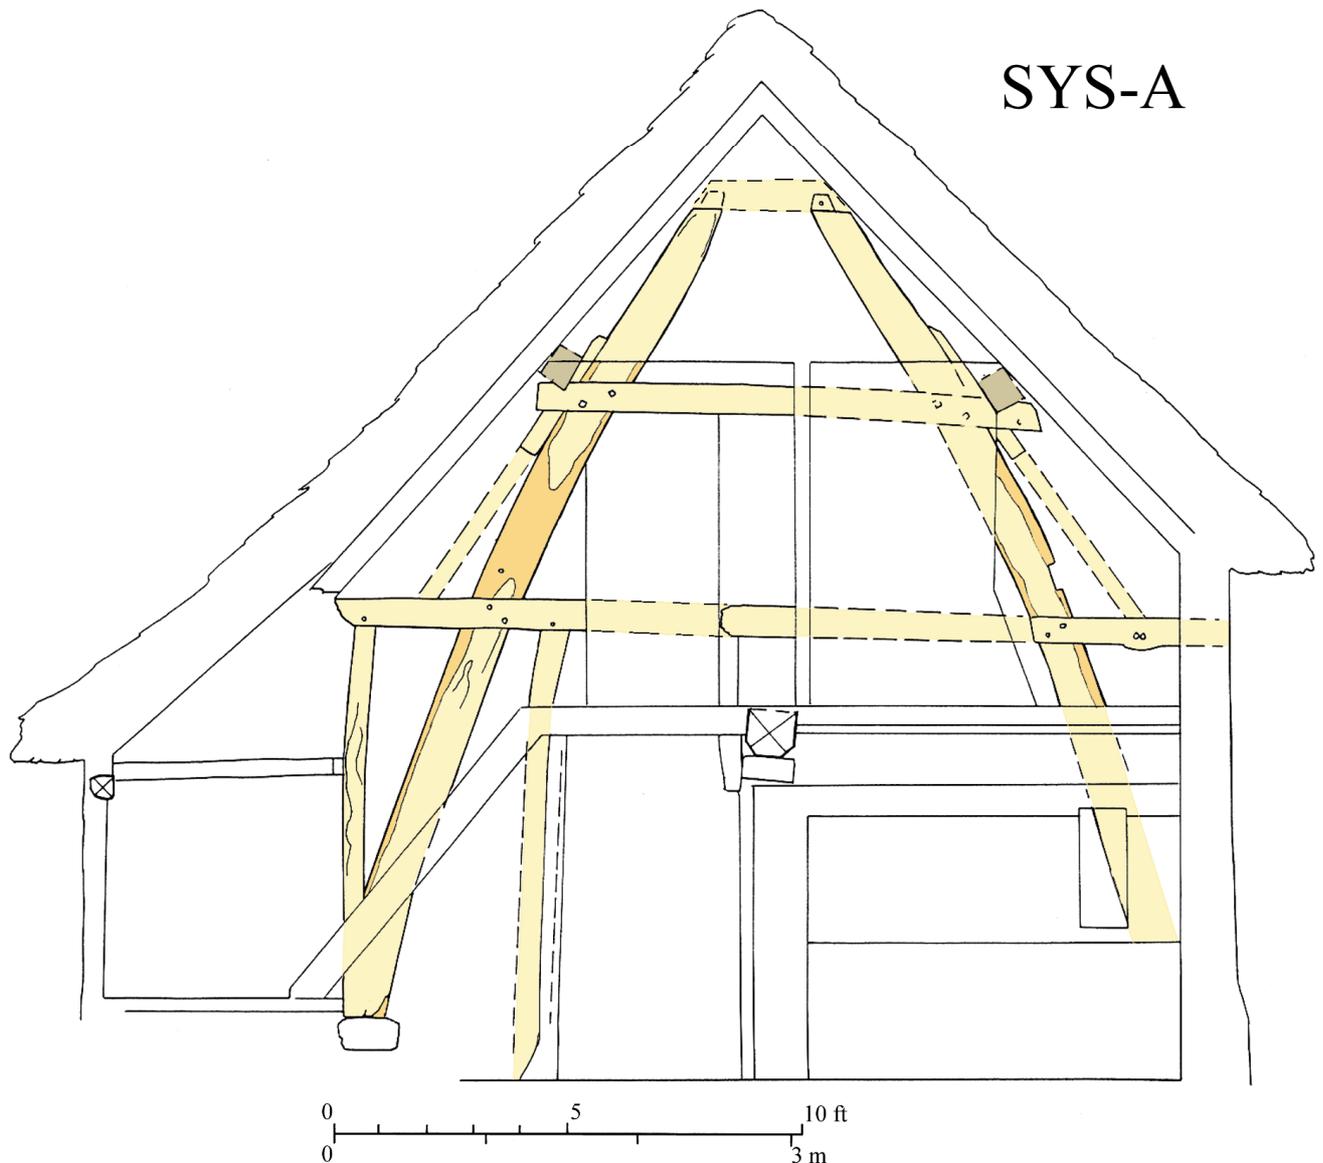
Fig. 3. Section of truss T2 from west.

**PHASE 1:** The cruck truss has large halved blades (11in by 6in) with a slight even curve; their outer surfaces are very irregular. The tiebeam is at eaves level, with two studs remaining below it, as well as the northern cruck stud. The soffit of the N blade also has stave holes for infill. The purlins have been removed, as has most of both packing pieces and the windbraces, which were set in trenches on the backs of the cruck blades; a double trench on the N blade confirms that the roof formerly continued into bay III. The apex was recently burnt off, but one tenon remains for a saddle. This probably carried the ridge piece directly (C-apex), but it might have had a small supporting post (i.e. an F1 apex). Wall studs survive on either side of the front (S) door, with a pegged lintel; these are probably part of the original building.
