Report for
**Golden Cottage, 280 Forest Road, Woodhouse,
Leicestershire**

Site Code: WOE-A

The Medieval Peasant House in Midland England

WOE-A: GOLDEN COTTAGE, 280 FOREST ROAD, WOODHOUSE,
LEICESTERSHIRE

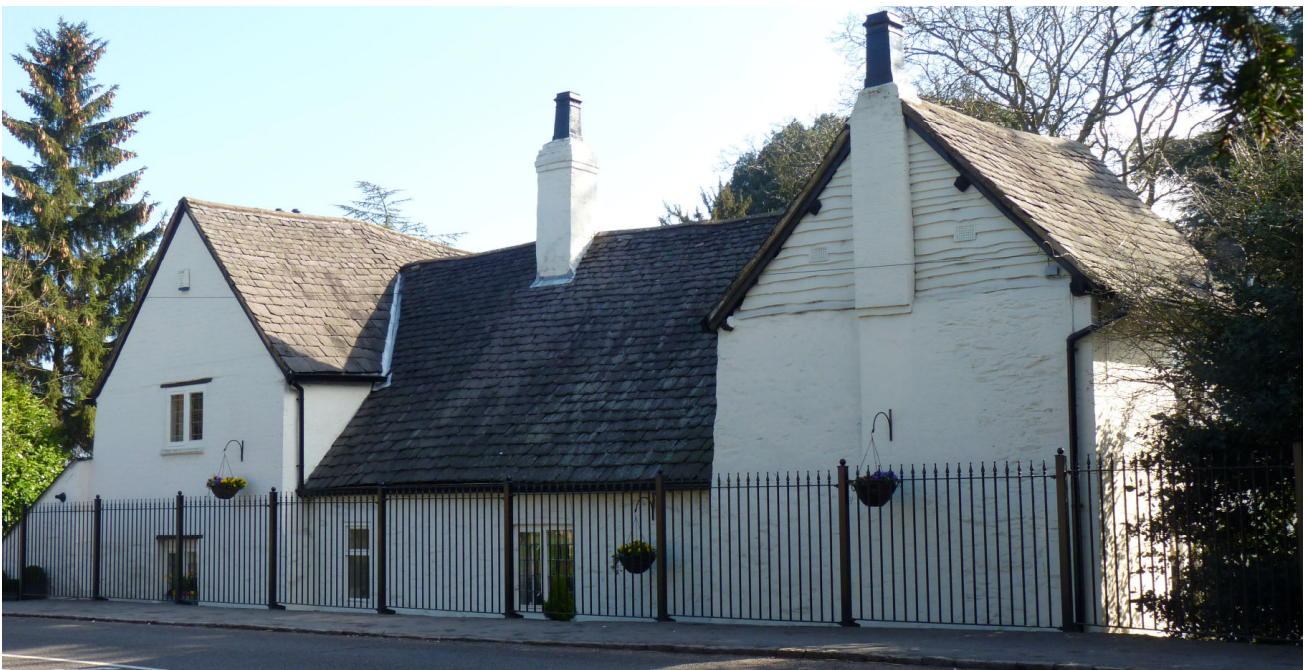
Fig. 1. View from the west

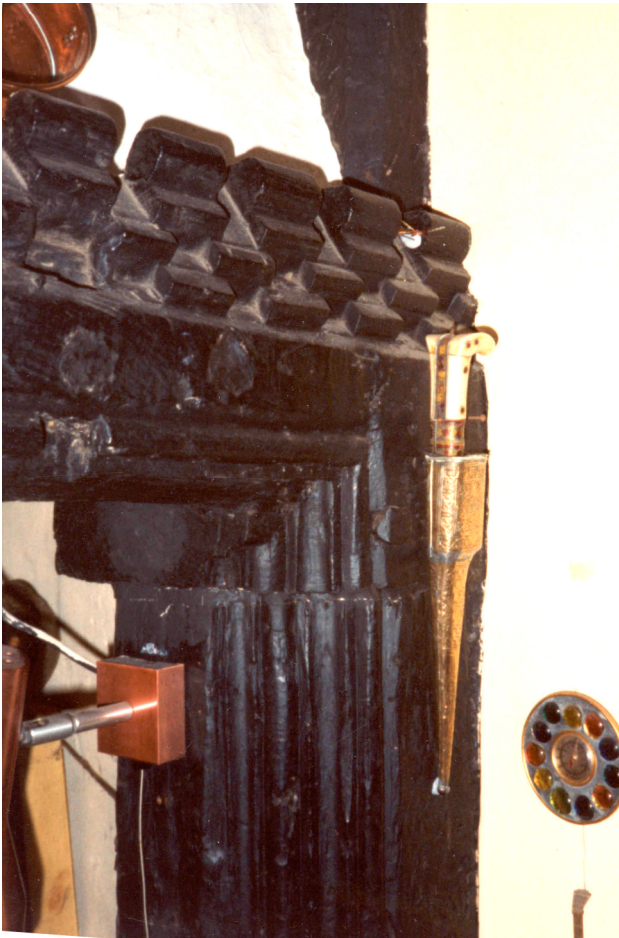
Fig. 4. Decoration of the inserted fireplace in bay II

PHASE 2: An early sixteenth century date is suggested for the insertion of the hall fireplace; this has a finely moulded jamb and battlemented bressemer carrying a smoke hood. It probably pre-dates the flooring of the hall.

PHASE 2: The fireplace in the Hall is remarkably elaborate, with a cranked mantel beam decorated with a triple row of battlementing above a series of roll mouldings. The right hand jamb continues the mouldings down and is jointed with a masons mitre, although the left hand end appears unfinished, ending only in a rough chamfer stop. This must date from around 1500. Above the mantel beam is the remains of a smoke hood which survives up to first-floor ceiling level.
