Report and Documentary History for
**The Cottage, Aston Street, Aston Tirrold,
Oxfordshire**

The Medieval Peasant House in Midland England

AST-A: THE COTTAGE, ASTON STREET, ASTON TIRROLD, OXFORDSHIRE

Survey date: 1990 - 1993

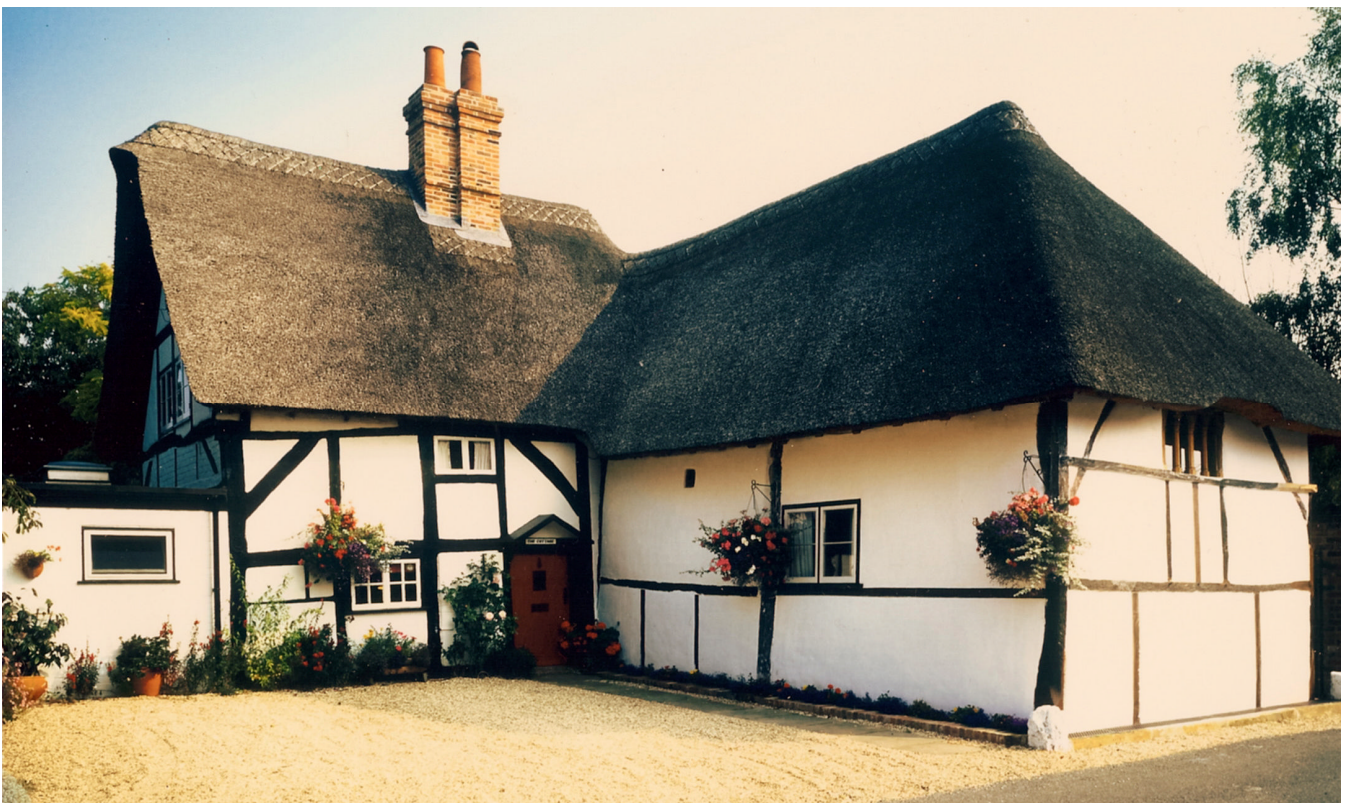
Fig. 1. View of the house in 1993, after restoration (Photo: English Heritage)

The Cottage, Aston Tirrold (Fig. 1-2) is a multi-phase building consisting of a chamber block (bays I-II) dated by dendrochronology with felling dates from 1282 to 1286 (indicating construction probably in

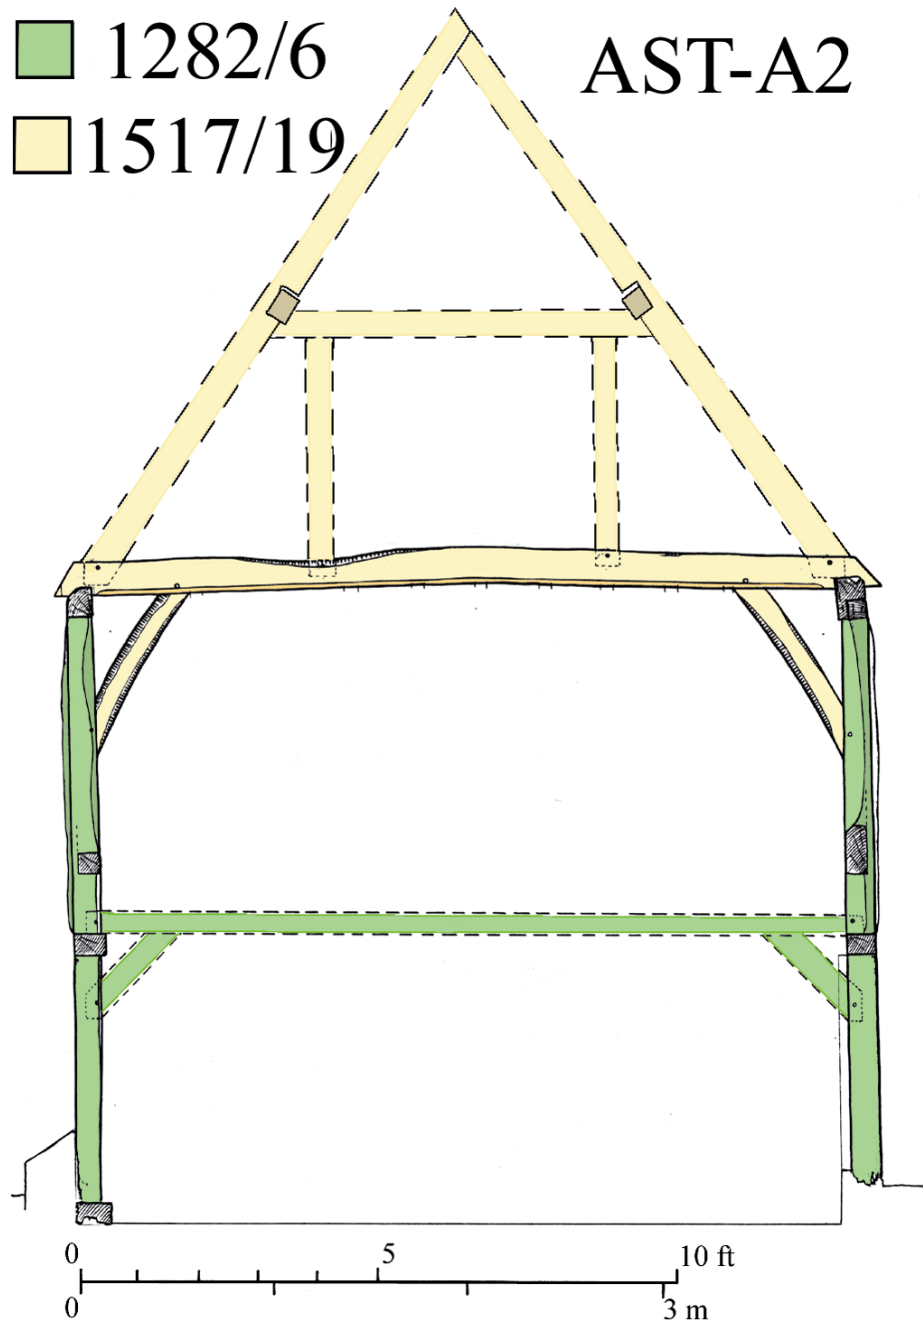
Fig. 3. Section of truss T2. The approximate profile of the destroyed later roof timbers is dashed.

The chamber block is of two bays with large wall panels (Figs. 3-4). In plan, the west end is at a slight angle to the side walls, with the north side about a foot shorter than the south. It seems likely that the block was built square-on to an existing hall, and extended to the front of the toft, which was not quite perpendicular to the side walls. The block was entered by a door at the east end in the position of the present doorway. Immediately inside, a staircase rose to the north, on the site of the present stair. The ground floor would have been little more than an undercroft, as the floor level (established by excavation) was only five feet below the level of the joists. Upstairs would have served as a chamber or solar and it was lit principally by a four-light window at the west end (Figs. 4-5), with one small 'wind-eye' on the north side just off centre of the panel to the north of the staircase (Fig. 6). There may have been other window openings of this type in the side walls, but the only other surviving original large panels are in the east end.

The original first floor joists ran transversely and were lodged on the storey girts. They were occasionally pegged on, but many simply rested in place. Half-lapped dovetails for two stair trimmers can be seen in the eastern storey girt.⁴ The trimmers have been removed but one joist remains *in situ* under the present stair landing and, indeed, the staircase still occupies its original position. This sole remaining joist measures 3 by 8in and was probably thinner than the others, as it only carried the landing; it is raised on a packing block and the whole is surrounded by what appears to be undisturbed thirteenth century daub. The other joists probably measured 4 to 4½in high by 8 to 9in wide, as evidenced by the storey girts at the ends and the mortices for the central beam. This was fixed and braced into the centre posts (Fig. 3).

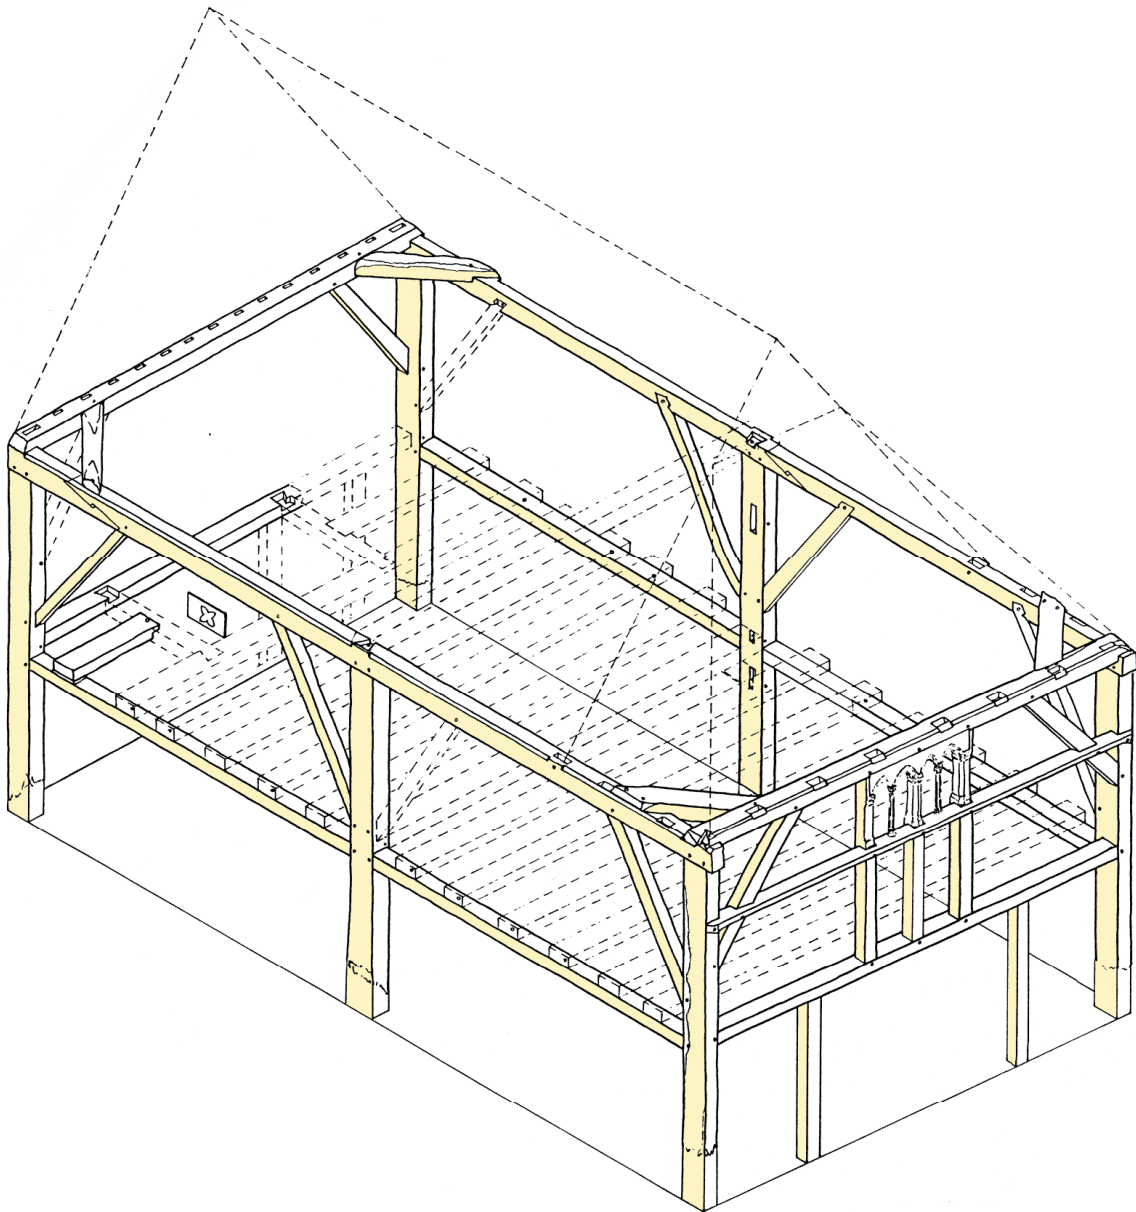
Fig. 4. Isometric view of the chamber block

In the west end wall, evidence for an elaborate and sophisticated mullioned window was discovered behind the reveals of the nineteenth-century window (Fig. 4). The sill and jambs survived, with remains of moulded capitals on each jamb and a rebate for a face-fixed plank headboard, which was also rebated into the tiebeam. Mortices remained in the tiebeam and sill for a central king mullion as well as intermediate 'colonnets', all of which presumably were octagonal and decorated to match the jambs. A chamfered window sill runs across the whole end wall, with run-out chamfer stops just before the curved ends. The 7¼in diameter of the small quatrefoil on the north side provides a module which fits the framework of the west window. The headboard is 1 module wide by 5 across, while below the imposts, the window is 2½ modules high by 5 wide. The spacing between each of the four lights is 1 module and the cusping as restored is geometrically derived from this. This window has been reconstructed at the suggestion of the owners to a design by David Brock and Paul Woodfield of English Heritage. Whilst the elements described above had reasonably clear evidence for their restoration, the cusping of the headboard as well as the bases are conjectural, based on the few remaining examples of thirteenth century windows (principally in stone). Thus, the window as reconstructed may not correspond precisely to the original, but is important none-the-less in that it shows that houses, even of such modest size as this, could have sophisticated fenestration. When lime-washed, as it probably would originally have been, the capitals, with the plank headboard and the projecting sill would have echoed stone construction. By contrast, the small quatrefoil 'windeye' has far-reaching implications, in that many smaller houses which were apparently without much fenestration, may have had similar openings incorporated into their daub infill, leaving no evidence if the panels were replaced.

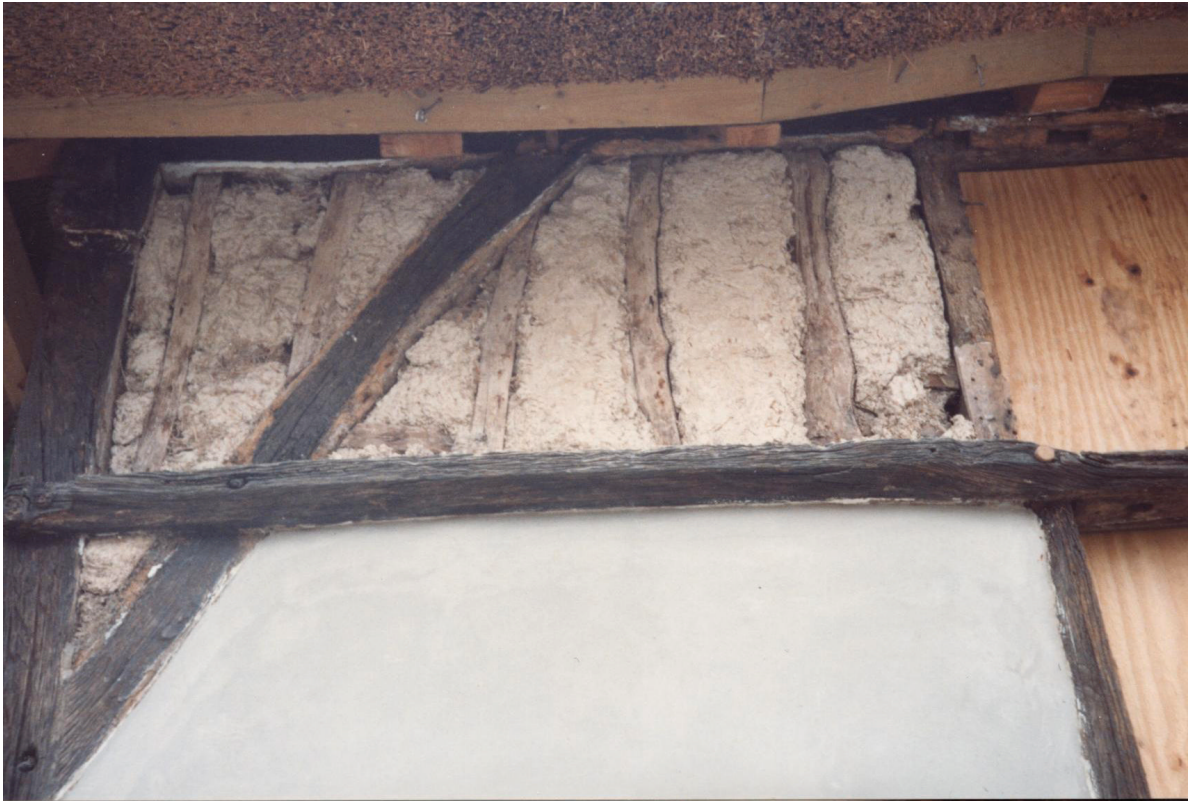
Fig. 5. Gable end framing, viewed upwards under the eaves.

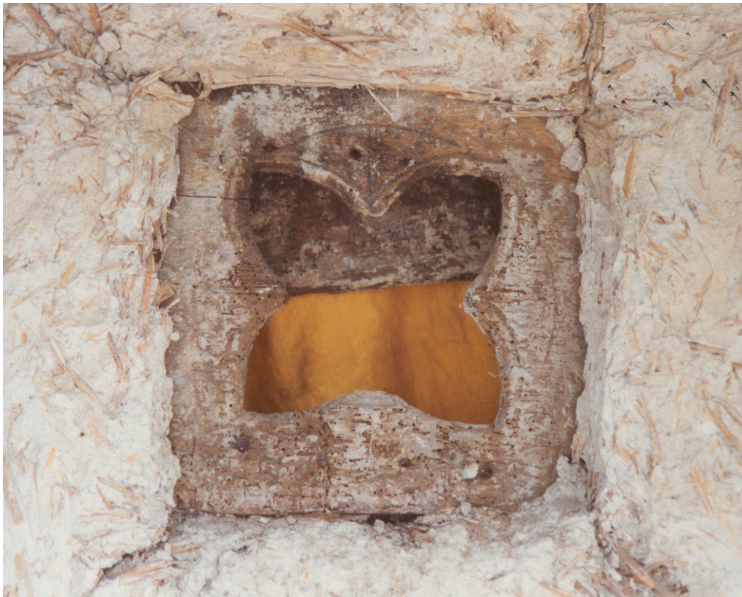
Fig. 6. 'Wind-eye' in the north wall of the chamber block.

revealed. The removal of this infill revealed a small quatrefoil 'wind-eye' cut out of a solid ½in thick plank of oak (Fig. 6). This measured 9in high by 15in wide, and was nailed to the outside of the vertical staves. Externally, riven oak laths were nailed around the plank, and the lime/chalk daub was applied to a thickness of 4in, forming a slightly bevelled reveal measuring approximately 8½in square. Centred within this was a pointed quatrefoil opening set in a 7¼in diameter circle which, together with the horizontal and vertical setting-out axes, had been scribed into the external face of the plank. The arris of the opening was finished with a fine 5/16in hollow with a quirk similar to the setting out lines, while internally the opening has a plain ¼in flat chamfer. Equally remarkably, the major portion of the original internal harr-hung shutter survives *in situ*, pivoting on wooden ears or pintles let into sockets in the inside of the staves and retained by a small cleat of riven oak lath, the latter with bevelled edges nailed top and bottom to the staves. This flap originally covered the whole of the inside of the opening and when opened would have been hooked or tied to the underside of the wall plate.

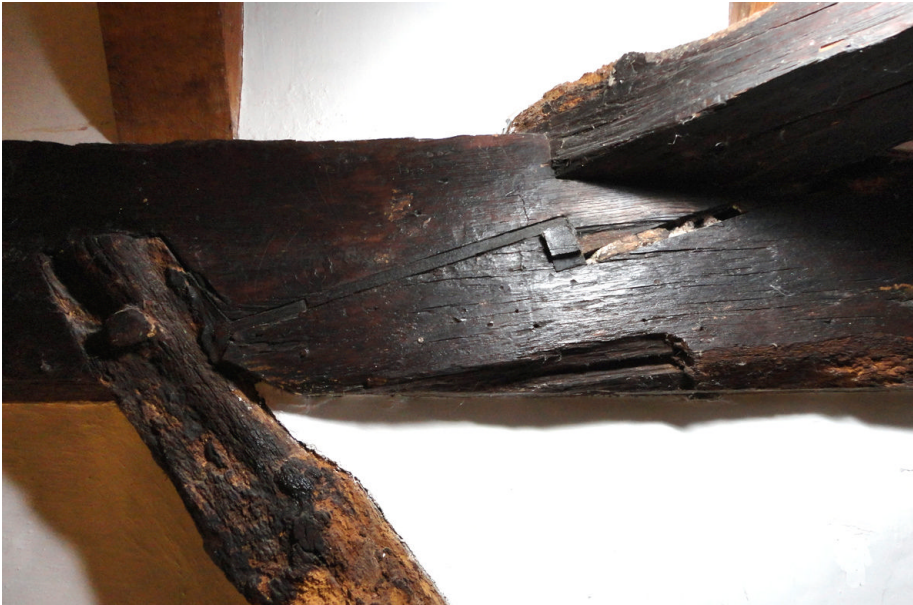
Fig. 7. Wall plate scarf in the chamber block.

PHASE I CARPENTRY: A combination of advanced and archaic carpentry features was used in the thirteenth century structure. The wall posts are totally unjowled and without upstands. The wall braces, mostly straight, are joined to the wall plates with notch-laps having ‘refined’ entry profiles on the inside along the north and south longitudinal walls and externally on the east (Fig. 7). However, the bases of all the braces and the wall-plate ends at the west are tenoned, indicating more care and consideration in the appearance of the structure there. The tiebeams have secret half-dovetails with single pegs. Dragon ties at the corners are tenoned into the tiebeams and jointed with half-dovetails into the wall plates. The only scarf joints in the building are in the wall plates. Adjacent to the centre post, the south wall plate has a tabled scarf with an undersquinted abutment to the top side only, face pegged with a transverse key (Fig. 7). The north wall plate scarf has undersquinted abutments both top and bottom. On the south wall plate, the bottom abutment was omitted, clearly because that wall plate is only 6in high compared to 8in to the north. A delightful subtlety is shown in the positioning of the northern scarf joint; it is placed at the east end of the wall plate just to the east of the last brace, so that the lower undersquinted abutment also forms the notch in the lap joint to the wall brace. The storey girts are 6 by 4in, laid flat, and (apart from the infill panels) are supported only by tenons at each end into the main posts; surprisingly, this optimistic approach has remained reasonably intact.

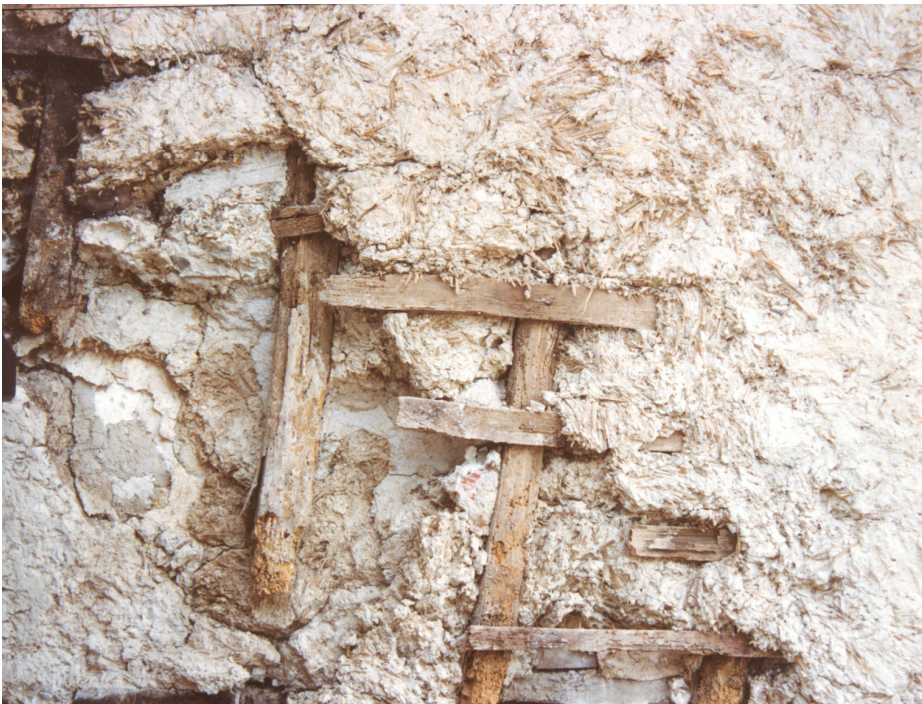
Fig. 8. Original stave and daub infill.

Although no original infill panels survive below the storey girt, several of the upper ones remain. The two panels on either side of the west window are primary and intact, as is the large panel at the east end. This panel has only been damaged by the insertion of the doorway (presumably in 1620) leading into the upper part of the chamber block adjacent to the south-east corner post (which had been replaced during the reconstruction of the hall in 1519). The panel in the eastern half of the north elevation also survives intact, including the ‘wind-eye’ described below. These primary panels comprise riven oak staves with riven oak laths *nailed* onto the outer face of the staves at 3 to 4in centres (Fig. 8). A chalk/lime daub mixed with chopped straw was applied on this framework, finishing flush with the inside face of the staves and with the outer surface of the wall, covering the laths externally by about an inch. Overall, the panels average about 2½ - 3in thick. The only main variation is that the west end panels had the laths nailed on the inside instead of the outside. Externally, the panels may have been finished with a lime-rich lime/hair finish coat, whereas internally the panels had a fine silty/sandy coat over the daub.

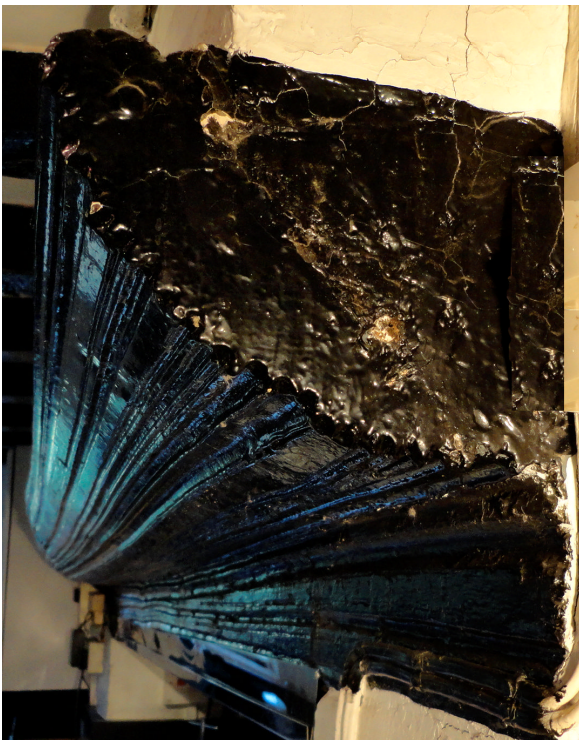
Fig. 9. Mantel beam in bay IV (probably from the 1517/19 range).

kitchen.³ The elaborately moulded mantel beam now reset in bay IV (Fig. 9) may have originally related to a smokehood in this bay.

At some date between 1519 and 1620, the open hearth in this bay was apparently superseded by a smoke hood, and the very decorative mantel beam (Fig. 9) (now reset in bay IV) was probably associated with this hood; its mouldings resemble those on beams dated to the later sixteenth century.⁸

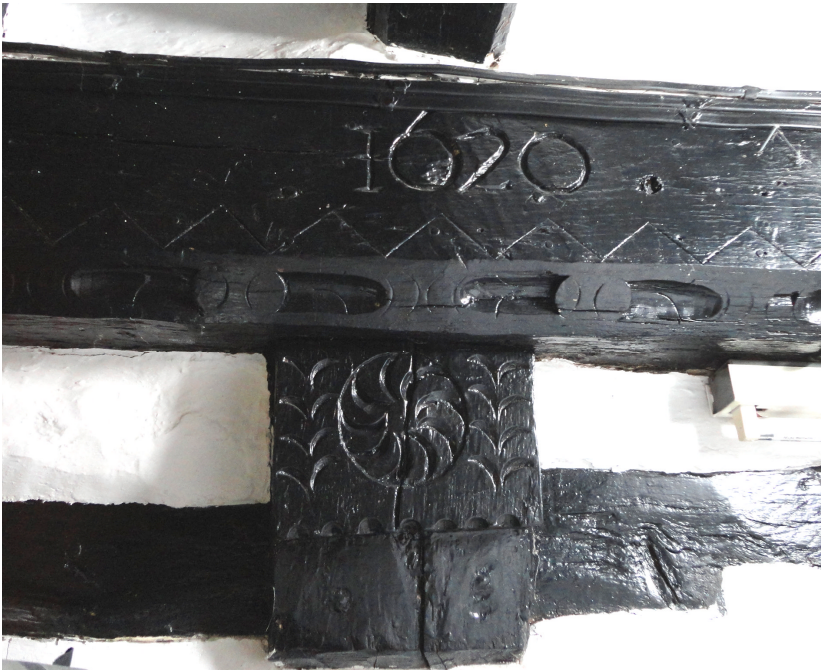
Fig. 10. Beam and bracket in the 1620 block.

1286), an early sixteenth century box-framed hall (bay III), with felling dates from spring 1517 to winter 1518/9, and a seventeenth century wing (bays IV-V) probably of about 1620, the date inscribed on the inserted floor in the hall (Fig. 10).¹

A floor was inserted in 1620 in bay III. The ceiling beam and applied half-beams are decorated to a very high standard, with ovolo moulding on the transverse beam accompanied by chiselled zigzag patterns and scalloped carvings with ornate floral brackets (Fig. 10). The transverse beam has clear evidence for a smokehood with a corner post and stave holes. The eastern half beam stops at the line of the smokehood, with the incised 1620 date centred in the remaining section. The smokehood was subsequently replaced by the existing brick chimney stack which also serves the north wing, and the mantel beam which is presumed to have been associated with it was reset in bay IV, as the lintel of the new chimney.
