Report for  
**Kingsholm, East Hagbourne, Oxfordshire**

The Medieval Peasant House in Midland England

DID-B: KINGSHOLM, EAST HAGBOURNE, OXFORDSHIRE

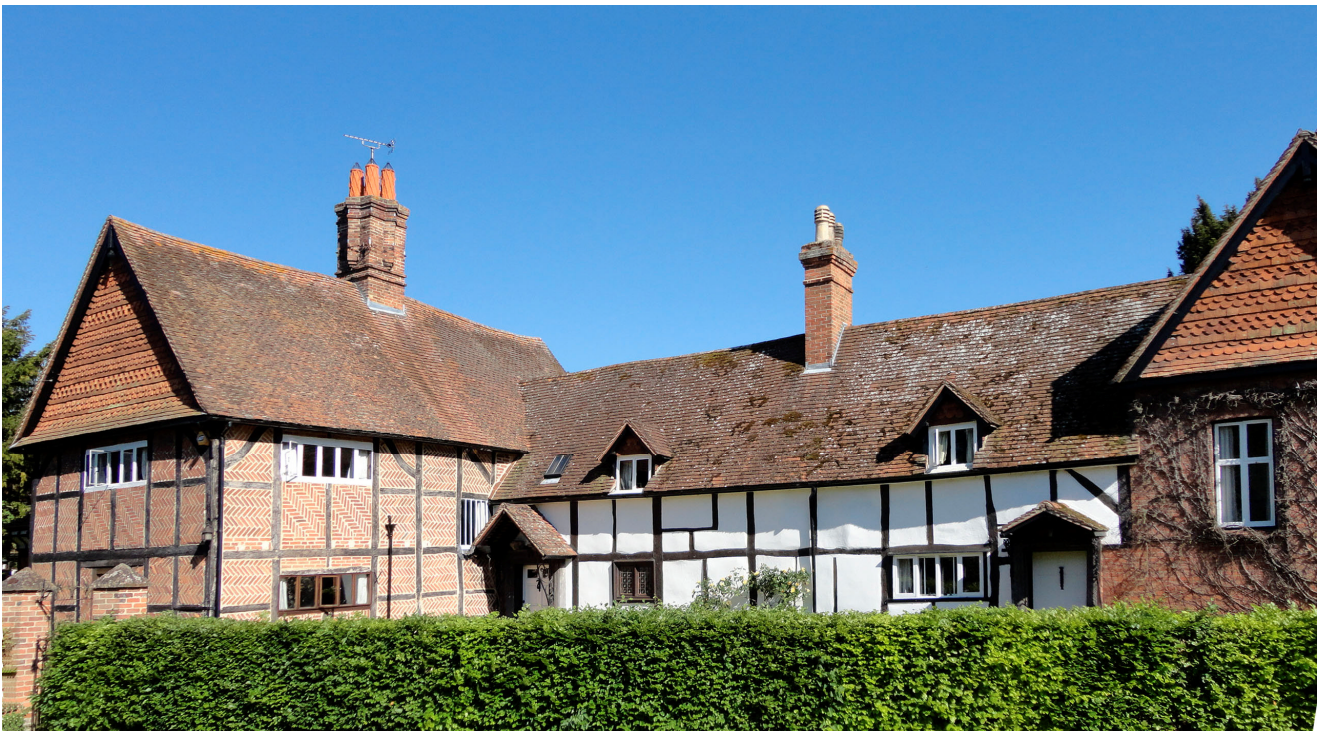
Fig. 1. View of the house from the north.

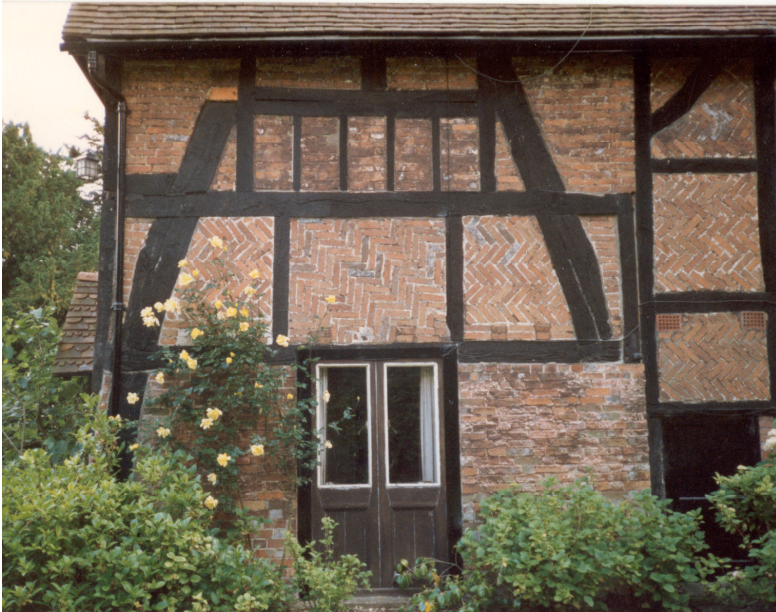
Fig. 2. View from the east, showing cruck T1 incorporated into the later wing.

chimney/smoke bay in bay IV. Only cruck truss T1 is visible from ground to apex. However it is clear that all the trusses have type 'W' apexes, the blades terminating just above the collar, with only common rafters above.

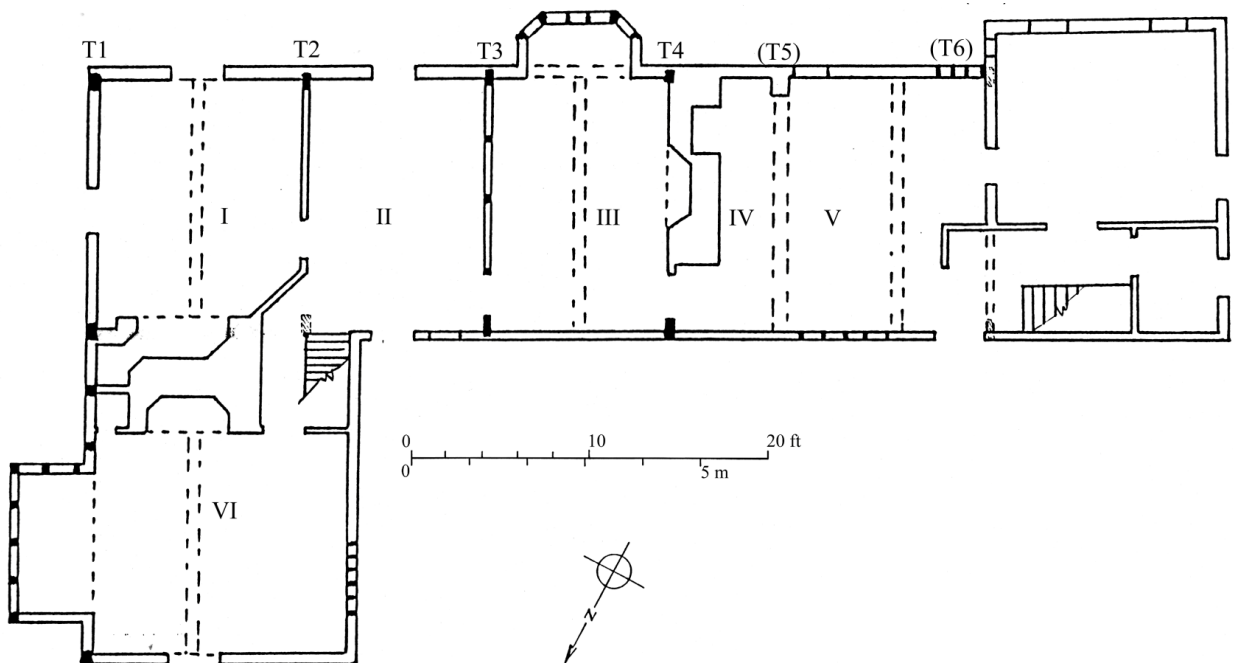
Fig. 3. Plan, showing truss and bay numbering.

was probably of five bays, although evidence for the fifth is somewhat inconclusive and it would make the house unusually long. Bay II appears to have been an open hall, an interesting feature considering the late date of the house. This use is clearly evidenced by the heavily soot-blackening on the rafters and the wattle-and-daub panel in the apex of truss T3; this bay also has evidence for the presence of a louvre.

The rafters in bay III are clean, and although the rafters are missing altogether in bay I, the eastern side of truss 2 is equally clean, indicating the hall did not extend beyond bay II. Bays I and III were probably floored over initially; the bay III joists are probably original, running from truss to truss where they lodge on the lower tiebeams. No cruck timbers are now visible in truss T5, though they have been recorded there; a final cruck would have been lost in the nineteenth century rebuilding of that end. Whether original or added in the later 16th century, bay V can be interpreted as a kitchen, served by a

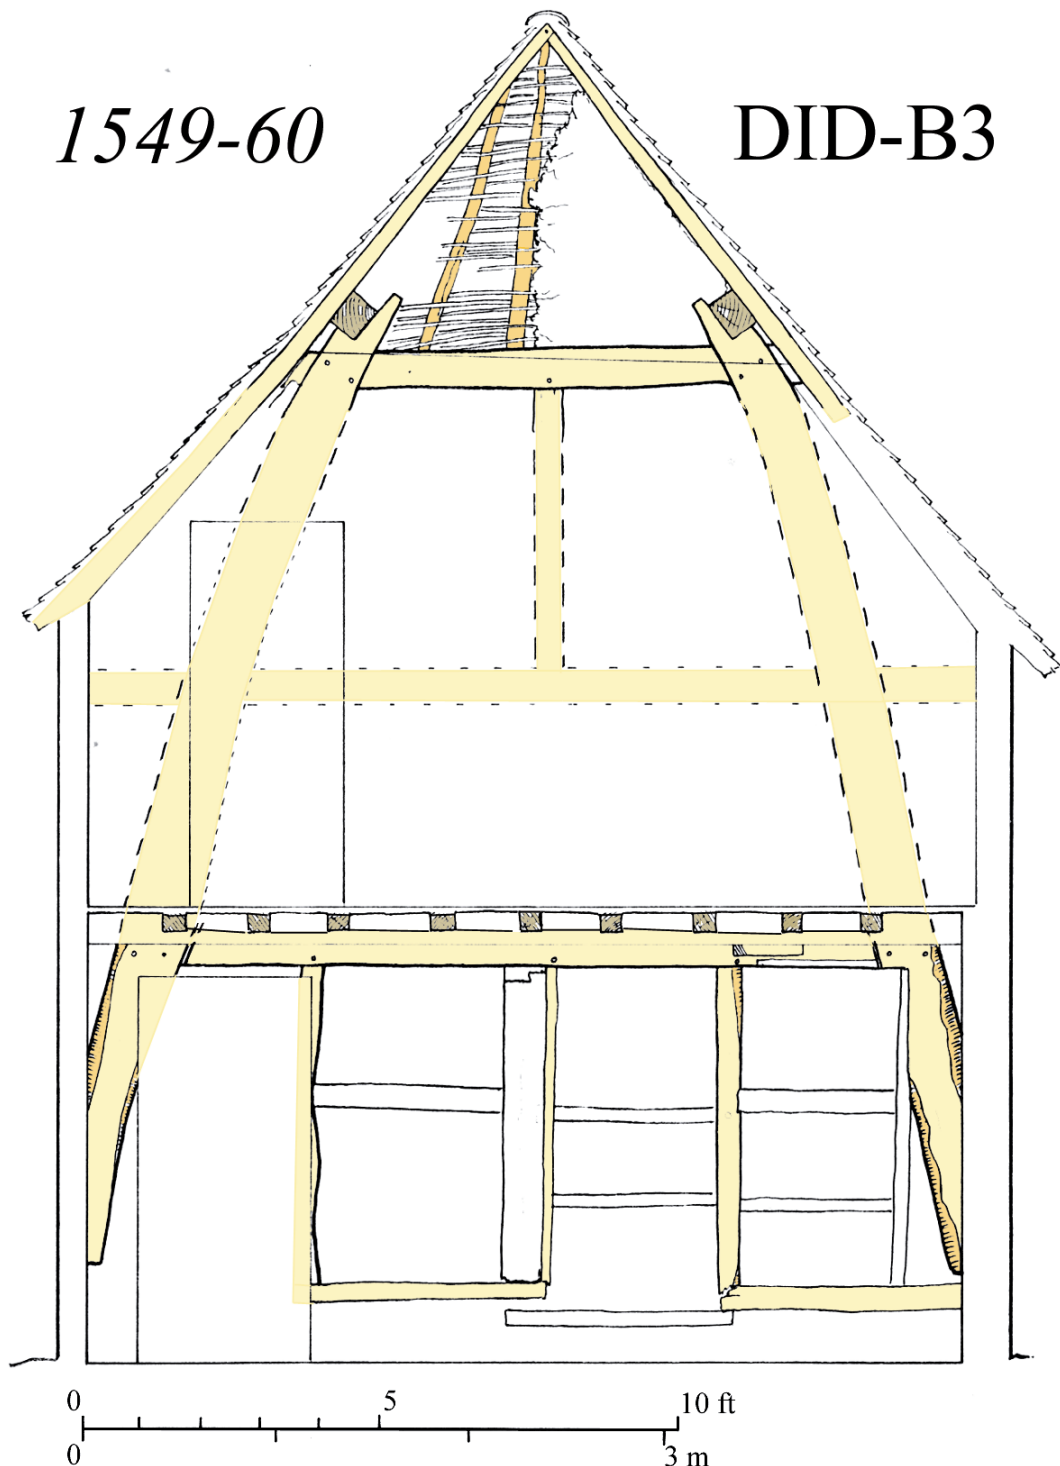
Fig. 4(a). Section of truss T3.

PHASE 1: CRUCK RANGE: Externally, the walls of this part of the house consist of large-panel timber-framing infilled with brickwork, most of it in herringbone pattern and all of it probably replacing wattle and daub. Internally, the cruck trusses all have type 'W' apexes. They all measure about 13 by 6-7in, reducing to about 9 by 5in at collar level. The internal framing of the trusses vary somewhat. Trusses T1, T4 and possibly T3 and T5, all have upper and lower tiebeams, but truss T2 has an upper and lower collar with cruck spurs to engage the cruck studs. The centre portions of trusses T3 and T5 are not clearly visible, however the Ascough survey shows their features. Immediately below the collars, all the trusses have single struts. Trusses T1 and T4 have two struts between the two tiebeams, but truss T2 has evidence for three (also possibly T5). Truss T3 has three studs below the lower tiebeam, but T4 had only two.

The lower sections of the internal wall frames have largely been replaced by brick nogging with bonding timbers, although several wattle and daub panels remain. The only one above collar level is in truss T3. This is heavily soot encrusted on the side facing bay II. In bay II, three pegs protrude through the rafters a foot down from the ridge; these probably indicate the position of a smoke louvre. The floor joists in bay III measure 5in high by 4 to 6in broad, the wider ones tending to be of elm.

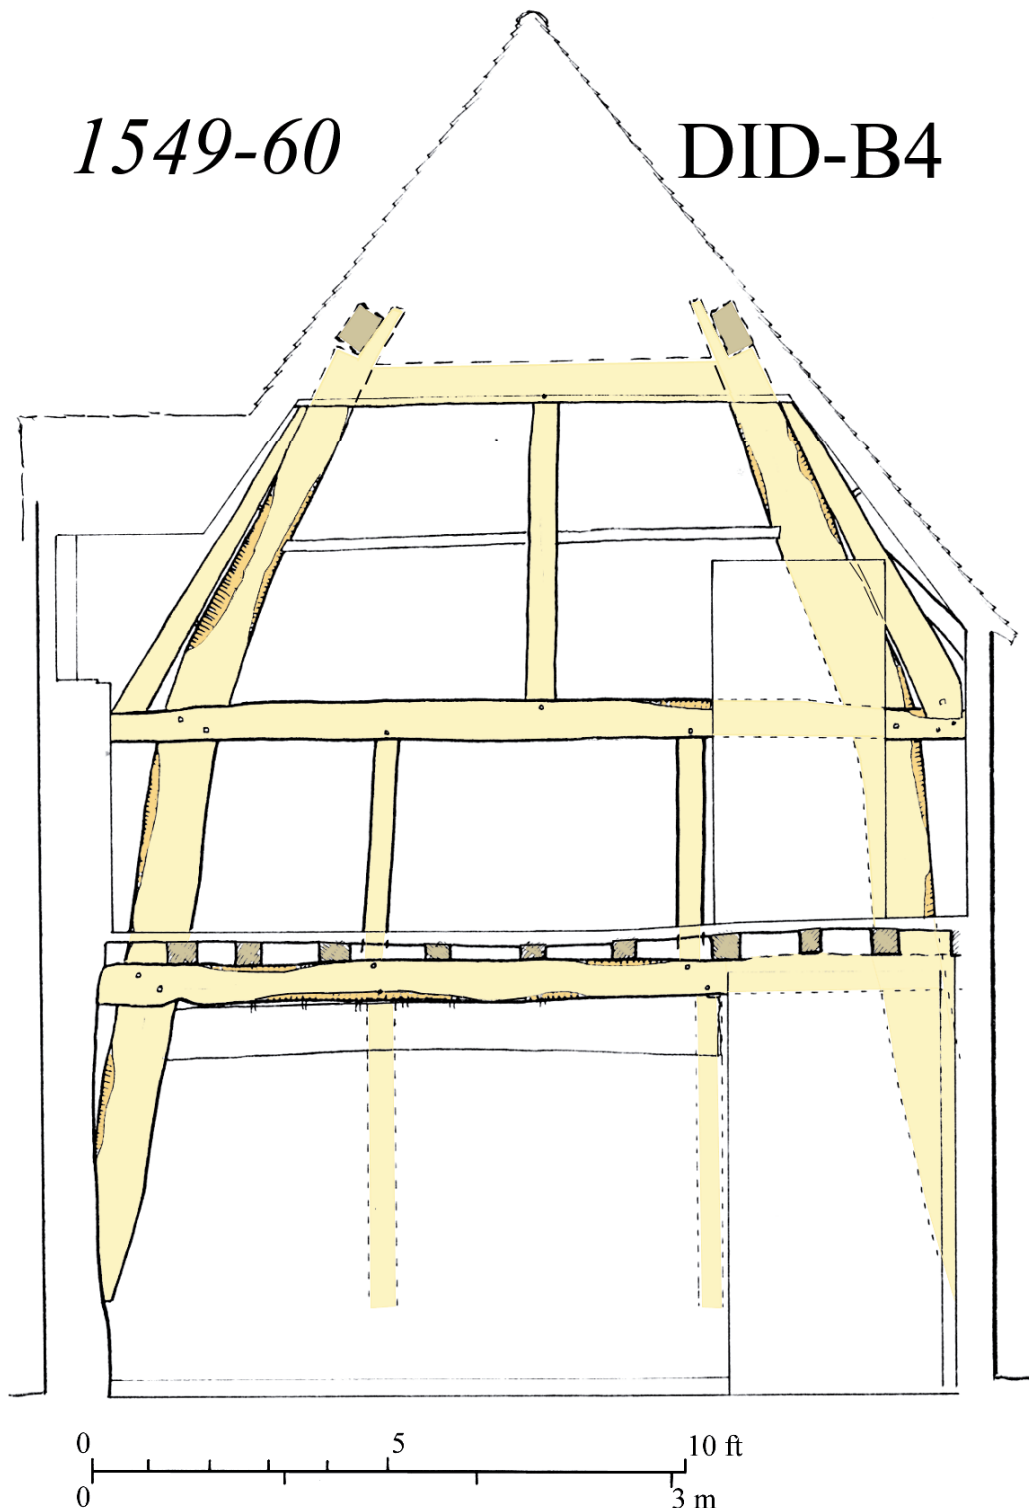
Fig. 4(b). Section of truss T4.
