Report for
**Old Forge, Church Street, East Hendred,
Oxfordshire**

Site Code: EAH-A

The Medieval Peasant House in Midland England

EAH-A: OLD FORGE, CHURCH STREET, EAST HENDRED, OXFORDSHIRE

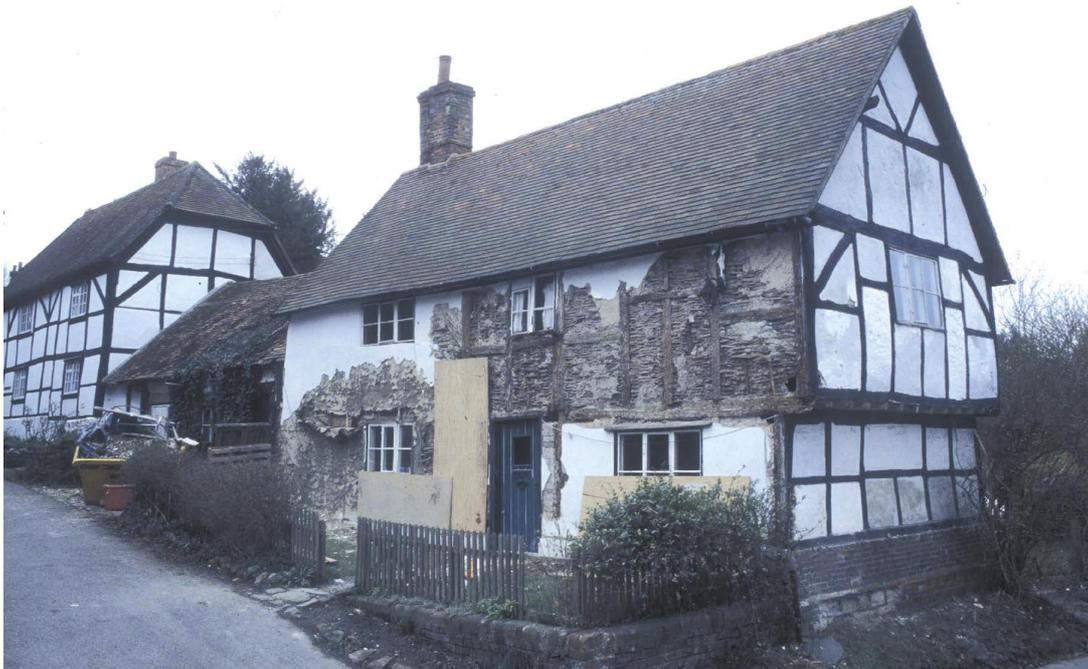
Fig. 1. View of the group of houses in 2001.

Hillside is the nearest, the Old Forge is in the centre with Forge Cottage beyond (photo: David Clark)

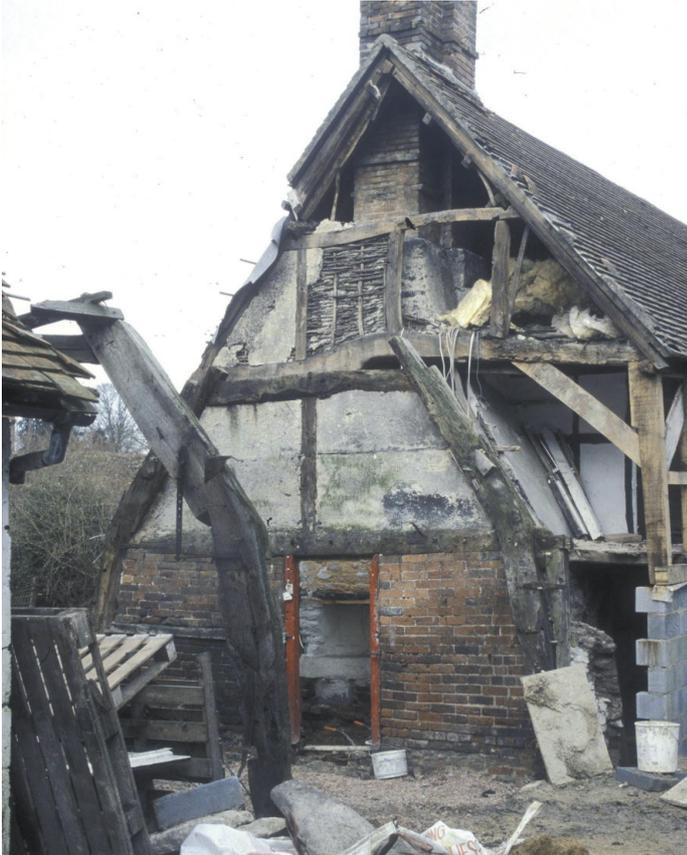
Fig. 2. The Old Forge during rebuilding in 2001, showing the cruck trusses (photo David Clark)

PHASE 1: The Old Forge is the remnant of a cruck house originally of at least two bays, but now of one bay only. Although it might appear that The Old Forge is a later infill between two sixteenth/ seventeenth century timber framed houses, it is in fact earlier and the intimate connection with the later buildings must be the result of alternate rebuilding. Only the southern two cruck frames exist, the third truss (and any further trusses) along with the second bay having been demolished during the building of Hillside Cottage. It is fairly clear that the cruck structure did not extend further south than T1, from the weathered surface of the south face of this truss. The northern face of truss T2 is smoke blackened, indicating the presence of an open hearth beyond it. The crucks have type 'W' apices, terminating at the (removed) purlins. The cruck blades have given felling dates of 1553 and 1556, indicating construction soon after then; this supersedes the early to mid-fourteenth century date suggested by Fletcher (1968) on stylistic

PHASE 1: The blades of truss T1 (measuring 11 x 5½in) continue a short distance above the collar and are notched for purlins, since removed. The crucks were also joined by a tiebeam (5½in high), only the western end of which is left. The slightly cambered collar is tenoned into the blades rather than having half-lapped barefaced dovetails (the more usual joint form). The tiebeam has a half lap, but without a tapered dovetail. Truss T2 is similar, except that its tiebeam seems to be a later insertion. This continues past the eastern cruck blade as a spur. The space between the collar and the tie is infilled with wattle and daub and this and the tiebeam are probably contemporary with the construction of Hillside Cottage. There appears to have been a small window in the west wall immediately to the north of T1; the rail there is only visible on one cruck and is considerably lower than the wall-plate.

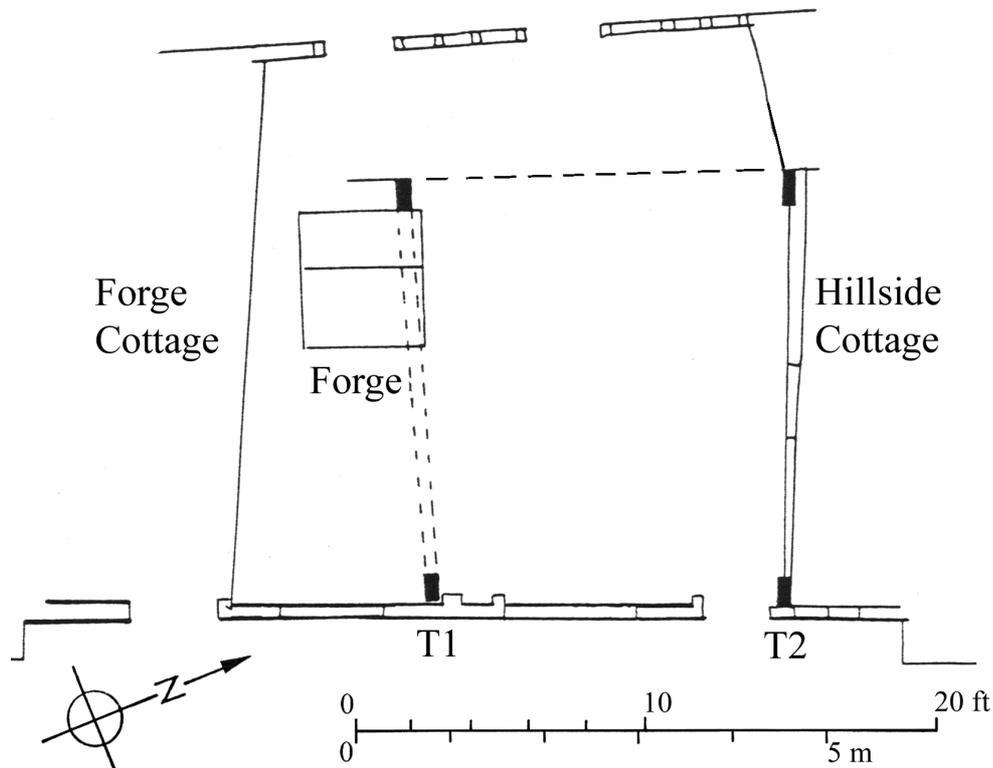
Fig. 3. Plan, showing truss numbering (from Steane (1985)).

Hillside is a three-unit complex running north-south, facing Church Street with the two northernmost sections nearest the church being in one occupation. The oldest section is the centre part, known as the Old Forge, lodged between Forge Cottage to the south and Hillside Cottage to the north. Most of this report is based on a field investigation by John Steane (Steane, 1985).

PHASE 2: The northern block (Hillside) is a two-storey box-framed structure of three unequal bays terminating in a gable-end jetty on Church Street. The largest bay, to the south adjacent to the cruck range, is 16ft long, of which the southern 5ft has been divided off by a storey post and higher floor level. Evidence of door posts in both front and back wall frames at this end of the bay suggest it formed a cross passage. Later, a massive chimneystack was inserted here, converting it to a lobby entry. At the rear of the wall frame, a small window was cut into the wall brace. Tree-ring dating on the very few timbers from this block suitable for dating produced felling date ranges of 1497-1517, 1538-52 and 1521-50. However, these dates appear too early for the surviving structure, for which framing and carpentry details suggest a seventeenth-century date, and it seems likely that the dated timbers were reused, perhaps from the replaced part of the cruck house.

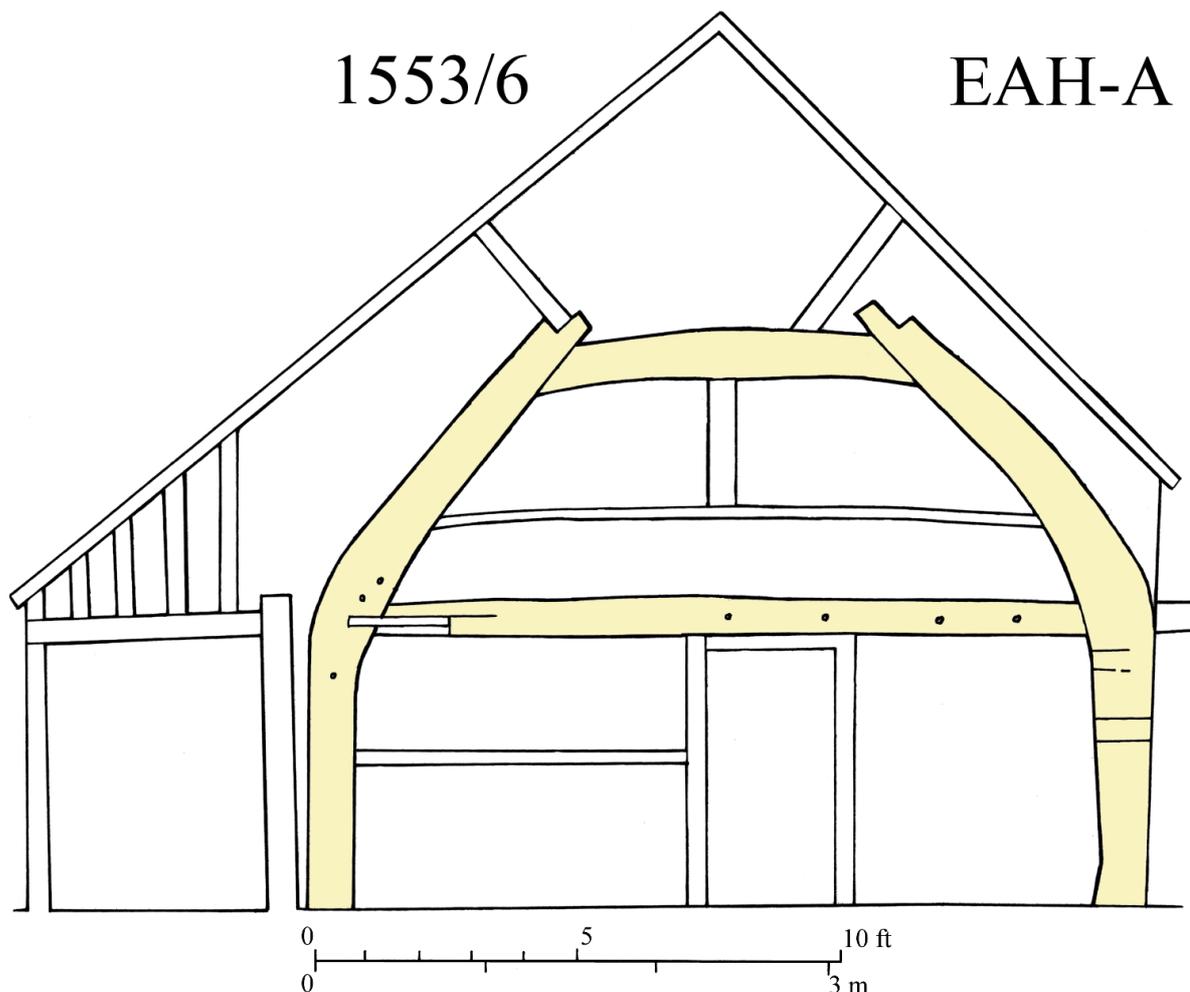
Fig. 4. Section of truss T2 (redrawn from Steane (1985)).

Sample Code	Sample Location	Total Rings	Sapwood Rings	FMR Date	LHR Date	LMR Date	Date Cat
EAH-A01	Cruck blade truss T2 west side	132	05	1390	1516	1521	3d
EAH-A02	Cruck blade truss T2 east side	127	HS	1379	1505	1505	3d
EAH-A03	Cruck blade truss T1 west side	80	21	1475	1533	1554	
EAH-A04	Cruck blade truss T1 east side	60	23	1495	1531	1554	
EAH-A05	Cruck blade truss T2 west side	178	34¼C	1375	1518	1552	
EAH-A06	Cruck blade truss T1 west side	68	19¼C	1488	1536	1555
