Report for
**Holywell Cottage, Wellshead Lane, Harwell,
Oxfordshire**

Site Code: HAR-F

The Medieval Peasant House in Midland England

HAR-F: HOLYWELL COTTAGE, WELLSHEAD LANE, HARWELL,
OXFORDSHIRE

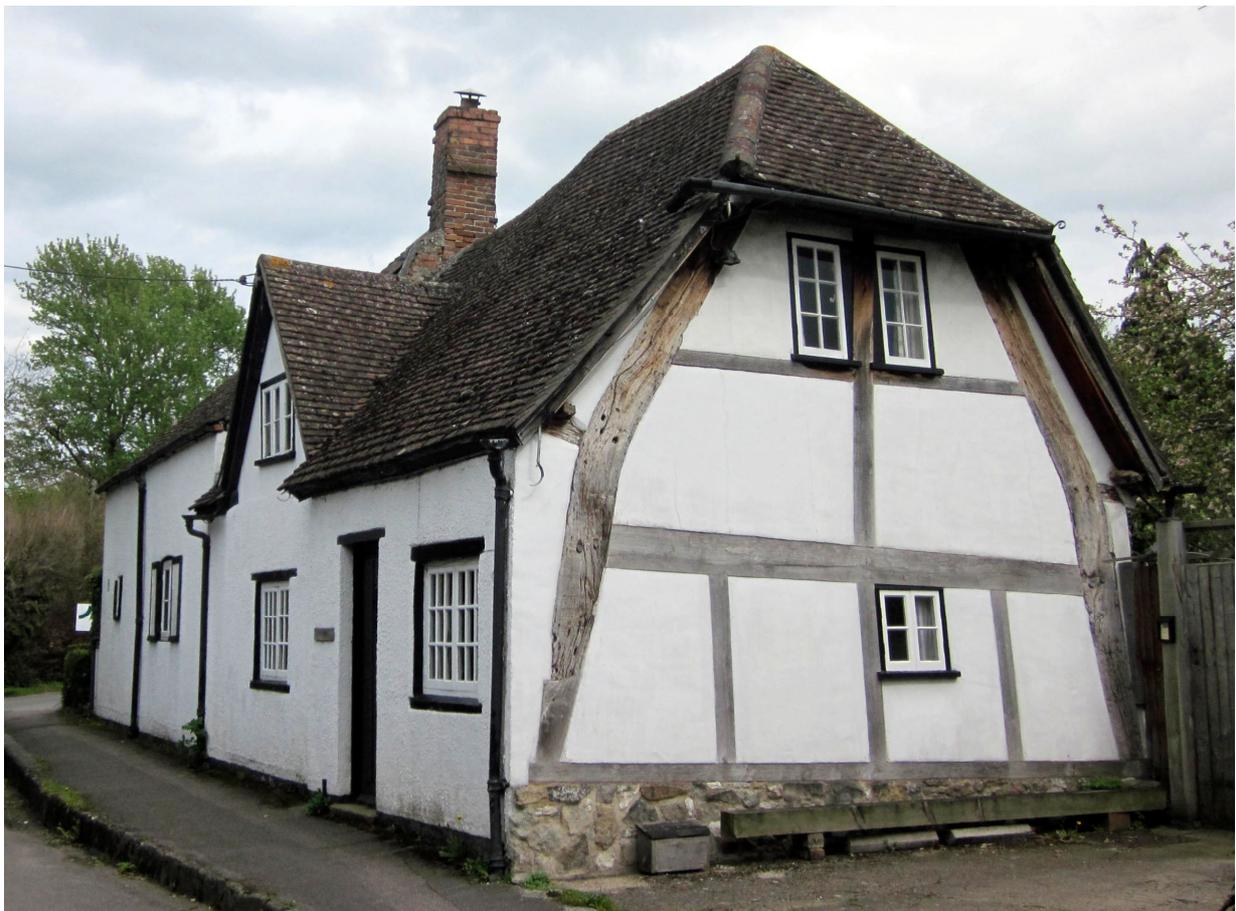
Fig. 1. View of the house from the north-west (Photo: D. Clark)

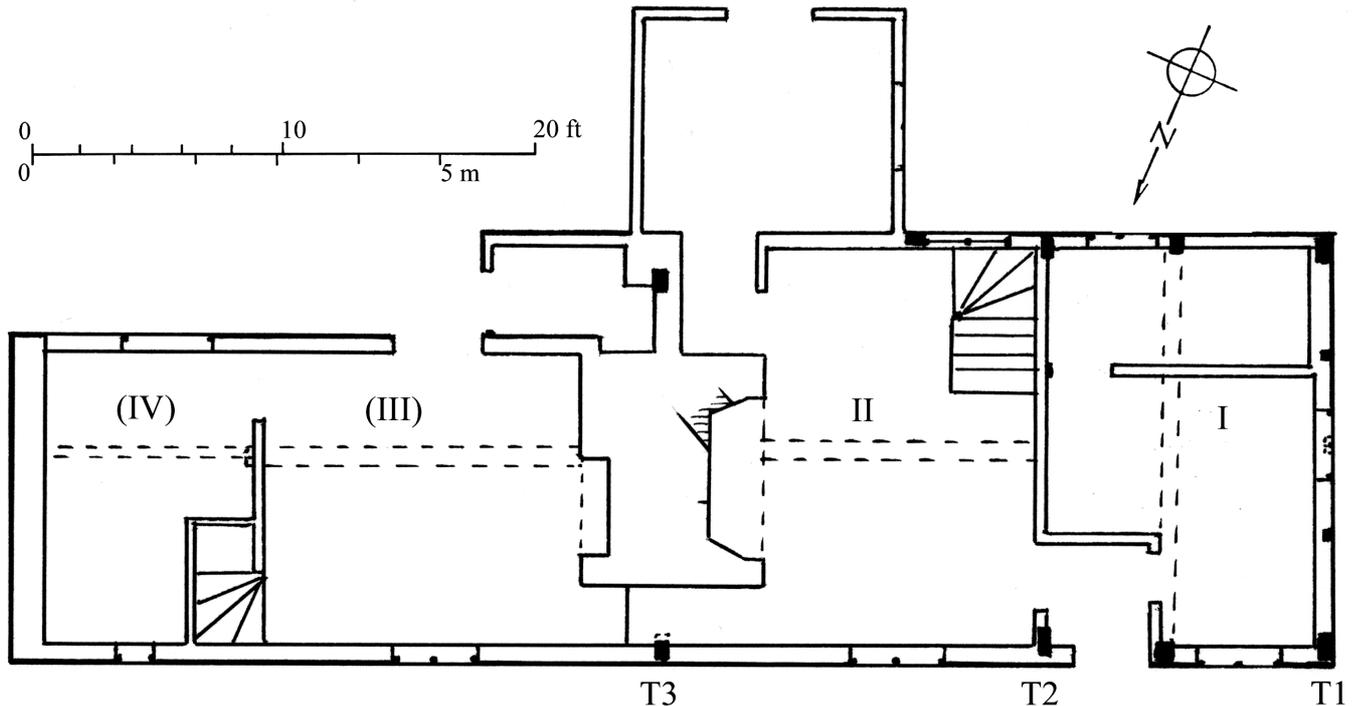
Fig. 2. Plan, showing truss and bay numbering.

CRUCK PHASES 1-2: Holywell Cottage is a cruck building now of four bays, aligned parallel to the road, roughly east-west. The sequence of building and alterations is complex and not altogether understood. It is likely that the first phase encompassed bays II and III and possibly IV. The weathered western face of truss T2 and the crude joints of the purlins there indicate that the original house ended here. Truss T2 has a 'W1' apex, with truncated blades and a king-post on the collar. There is evidence of smoke blackening in the roof space of bay II and on the eastern side of the cruck in bay III where some of the original roof survives in the outhouse. The weathering on T2 indicates that this phase must be at least 50 years earlier than phase 2, so a mid-fifteenth century date is indicated.

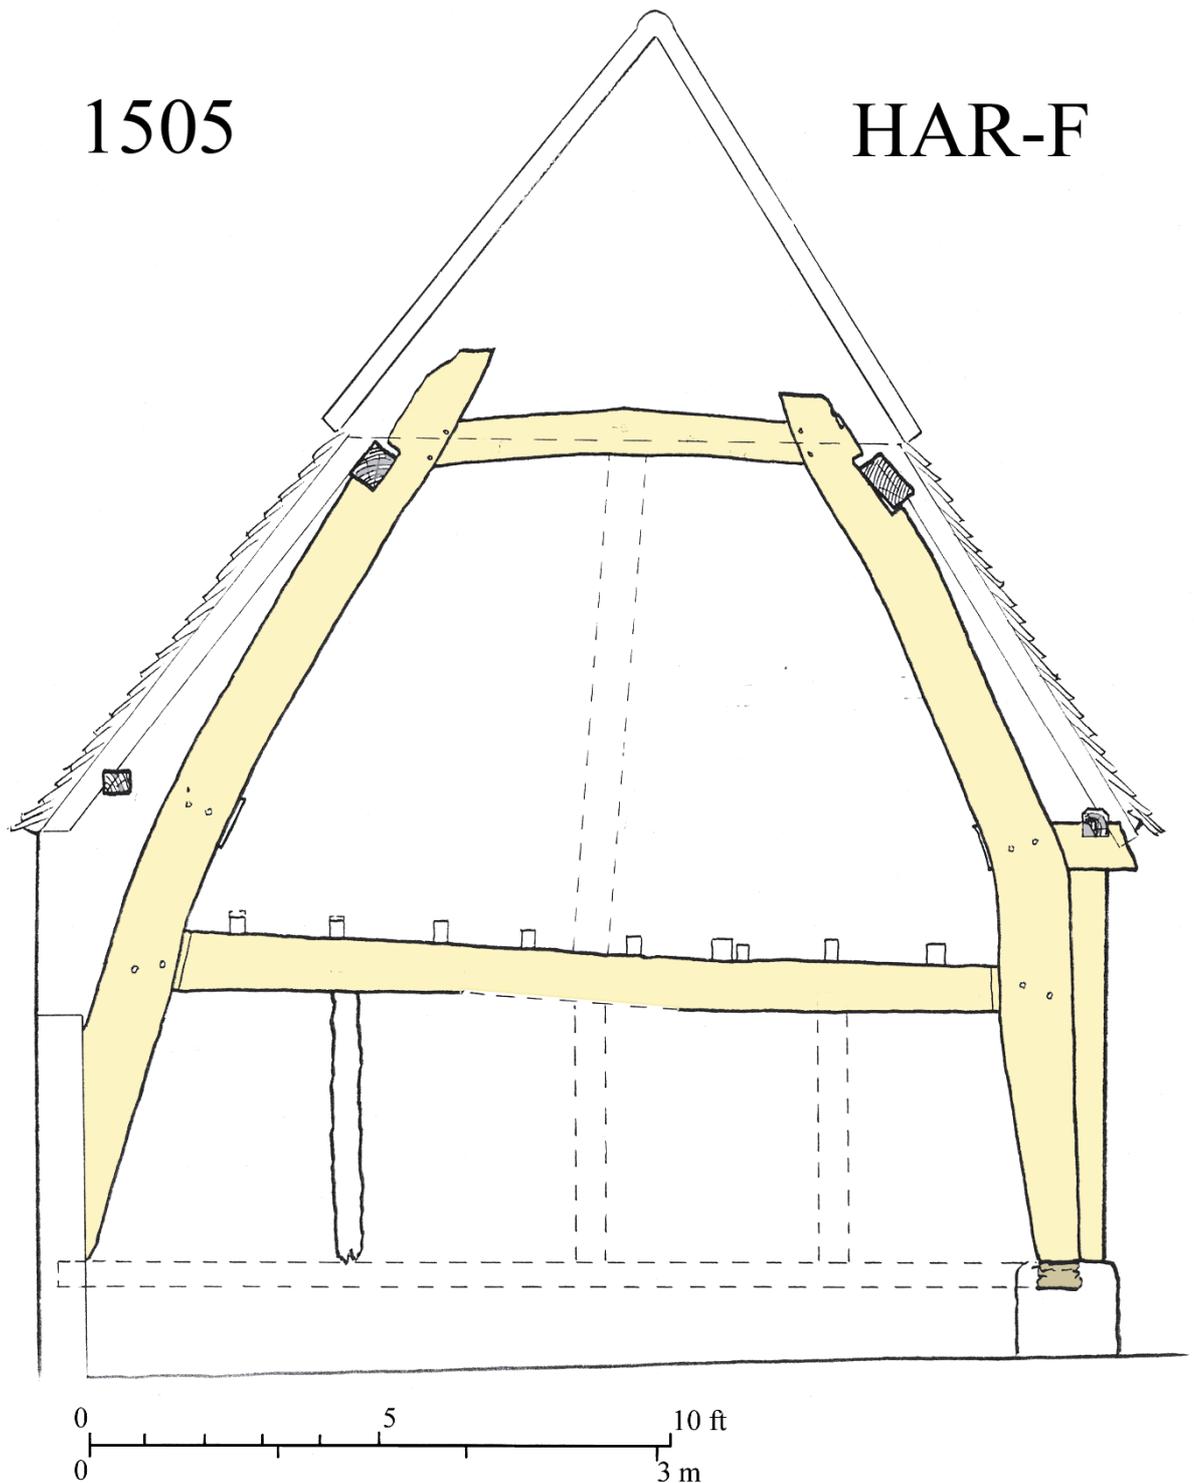
Fig. 3. Section of truss T1.

PHASE 2: BAY I: This now consists of only bay I and cruck truss T1 which forms the half-hipped western end of the cottage. The truss is similar to T2 though lacking a king-post (now a type 'V' apex, formerly type 'W'). The crucks are boxed heart, yet have been trimmed surprisingly thin, only 4½in thick by 12in wide. The tiebeam of elm measures 6 by 12in diminishing to 9in at the rear; it has fragments of three studs below it. The underside of the collar contains a large central unpegged mortice for a 7in stud, and another smaller (4in) mortice also without a peg set 5½in to the right of the first. A series of stave holes seem to relate to the larger rather than the smaller mortice. Which, if any, of the lower studs are primary is uncertain.

The purlins are both of elm and measure 11 x 5½in; at T2, they are lodged above the bay II purlins. The 5in square wall plates are of elm, and still survive although the front infill panels have been replaced in brick. The plates are supported by elm cruck spurs; the rear spur rests on the surviving cruck stud which stands close to the back of the blade and extends down to the sill. The south plate protrudes approx. 6in beyond the cruck stud and a stave hole is evident in this projection. This indicates the former presence of another bay. Internally, the floor in bay I is supported on a 9in by 9in transverse beam roughly chamfered, with joists measuring 3½ by 4in.

The roof of bay I is half-hipped. The ridge was supported by a yoke at the hip end although this has since slipped away leaving the ridge hanging from the rafters. At the other end it is supported on the western end of the ridge from bay II. The roof timbers in this bay are all heavily smoke blackened.

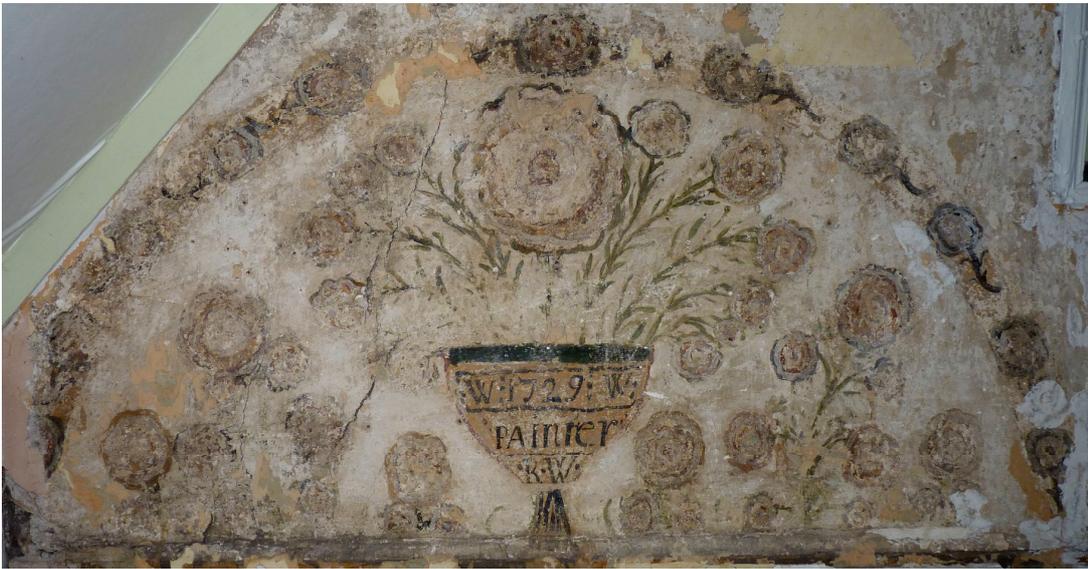
Fig. 4. Wall-painting in bay II.

LATER PHASES: Probably during the late eighteenth century bays III and IV were radically rebuilt, being reduced in width by four feet at the rear (apart from a small section surviving in an outhouse adjacent to truss T3). A wall painting dated to 1729 survives on the central chimney-breast.

This upstairs room retains an early cupboard in the chimney stack and a door to the rear which probably led to a now vanished staircase over the original bread oven. The upstairs chimney-breast is decorated with a wall-painting showing a vase of roses (Fig. 4). The inscription on the vase reads: W 1729 W / Painter / RW.
