Report for  
**Mill farm, Mapledurham, Oxfordshire**

*Site Code: MDM-A*

The Medieval Peasant House in Midland England

**MDM-A: MILL FARM, MAPLEDURHAM, OXFORDSHIRE**

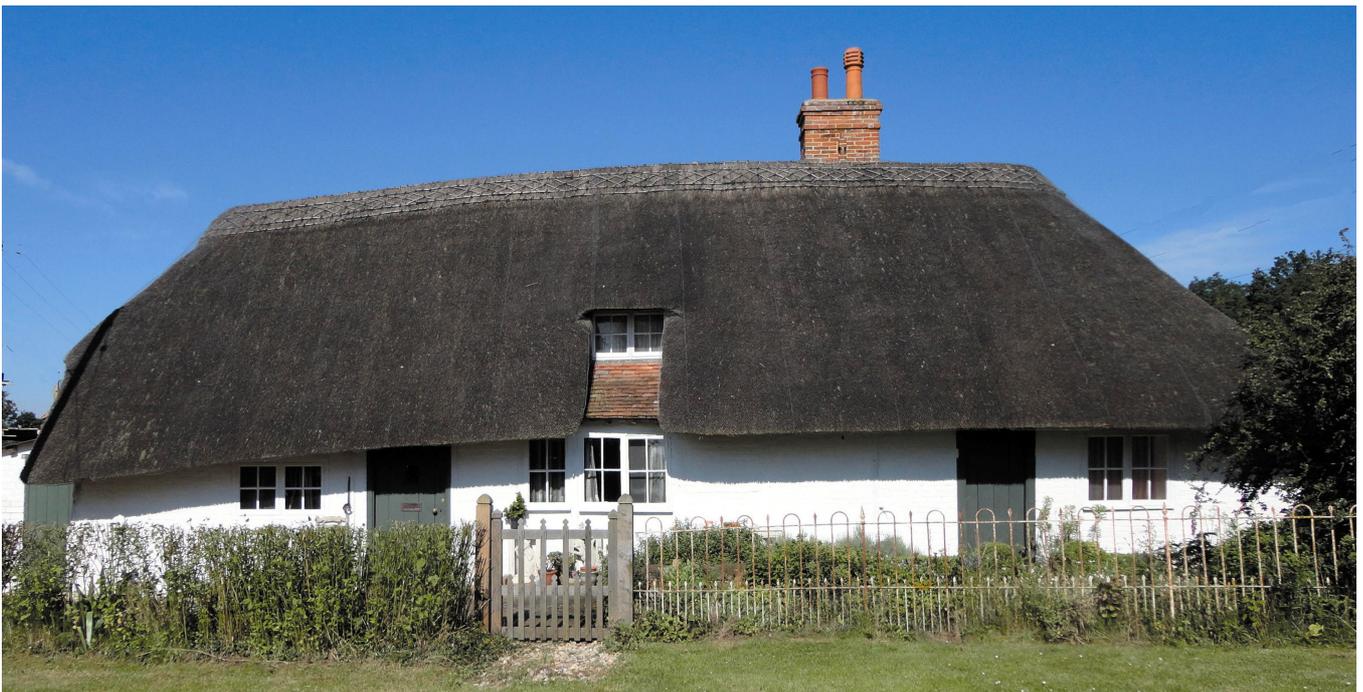
Fig. 1. View of the house from the east.

PHASE 1: Mill Farm stands on an isolated site, facing east (Fig. 1, 11). The house is of three bays, although as built it had an additional lean-to half-bay at the south end (partitioned off in 1445/6 and later removed). Samples from trusses T2 and T3, plus the roof structure, have been tree-ring dated to 1335. As well as this early date, the house is of particular interest due to its mainly unaltered state. The original house was fully single-storeyed, the two southernmost bays (bays I and II) being the open hall, bay III (north) the chamber and the removed bay 0 a small service space (not divided from the hall). The chamber was partitioned off from the open hall by truss T3, a closed truss. It is not possible to determine the original door position, but the house now has external doors into bay III just north of T3 and bay I just south of T2. Both these doors were probably in position by the eighteenth century. The drawing of the house in 1587 (Fig. 11) shows a door towards the southern end of the house, in either bay 0 or bay I.

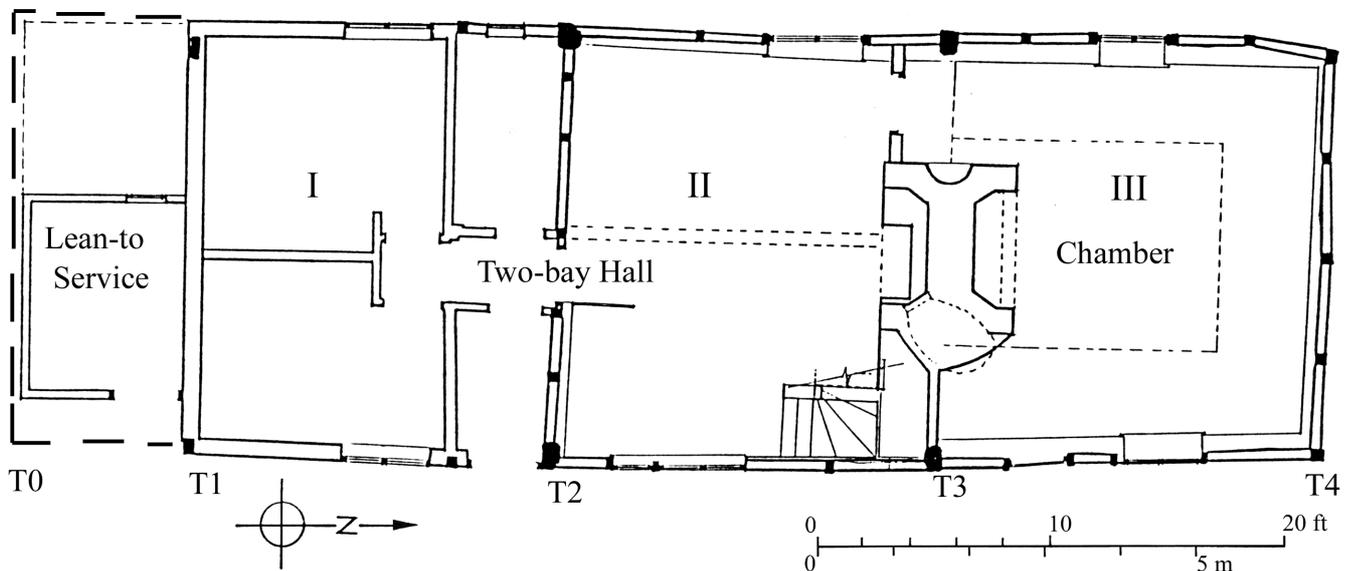
Fig. 2. Plan, showing truss and bay numbering.

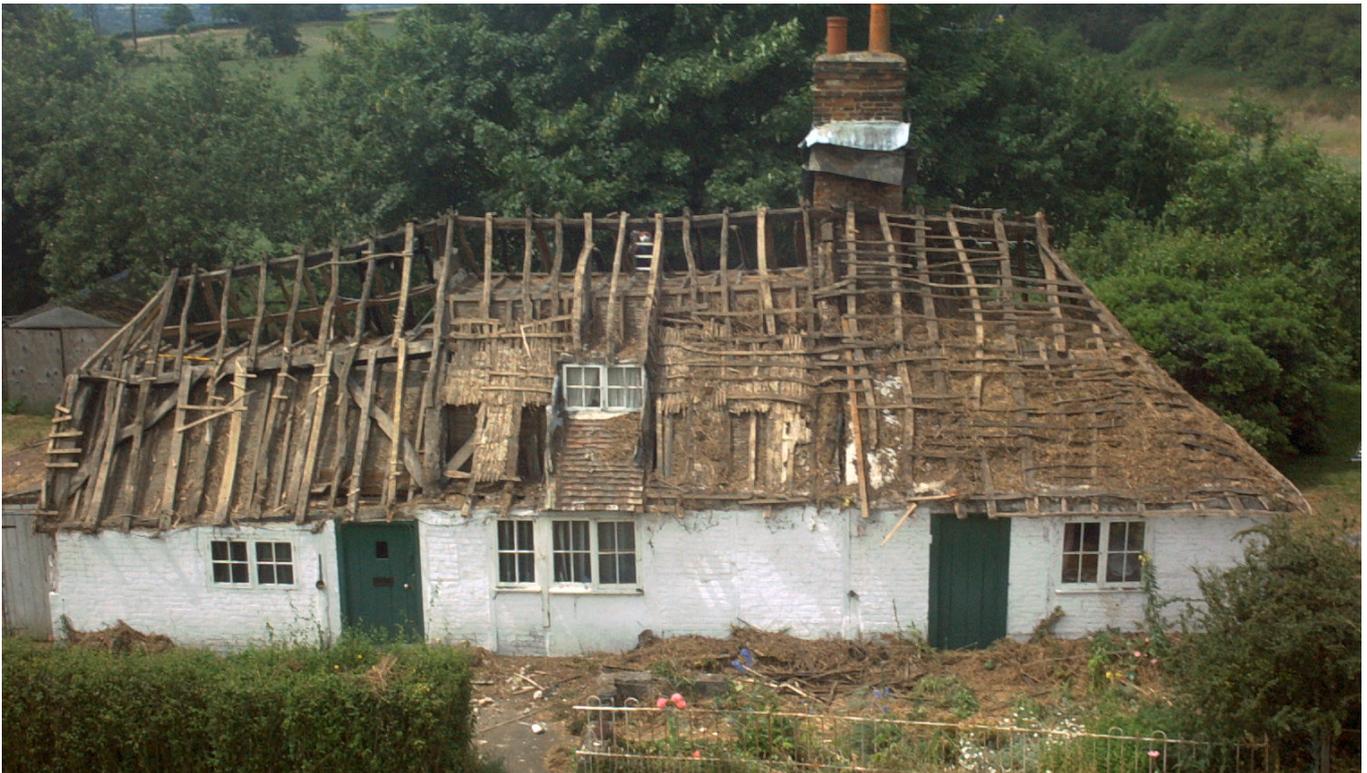
Fig. 3. View of Mill Farm during re-thatching in 2004.

Most of the primary roof structure survives intact (Fig. 3). The ridge is 5in square in section, with the top inch being chamfered to give a seating to the rafters. It is in three lengths, with face-pegged splayed scarfs immediately to the north of trusses T2 and T3. These joints, combined with a similar scarf in the front wall plate immediately north of T2, indicate that the order of erection was from south to north. The purlins are of substantial section, averaging about 6 by 8in. They are lodged on the backs of the crucks, either on packing pieces or housed into the backs of the blades. A notable exception is that the purlins are butt-jointed (with bare faced soffit tenons) into the eastern blade of T2. Windbraces are still in place on the east side of bay I. They are ogee in shape, measuring 6 x 3in, and have notched lap joints into the top of the purlins (Fig. 7). The windbraces on the western side of the bay have been removed, as have those in bay III, if they ever existed. The purlins and rafters in bay II are plastered, concealing any windbraces which might exist.

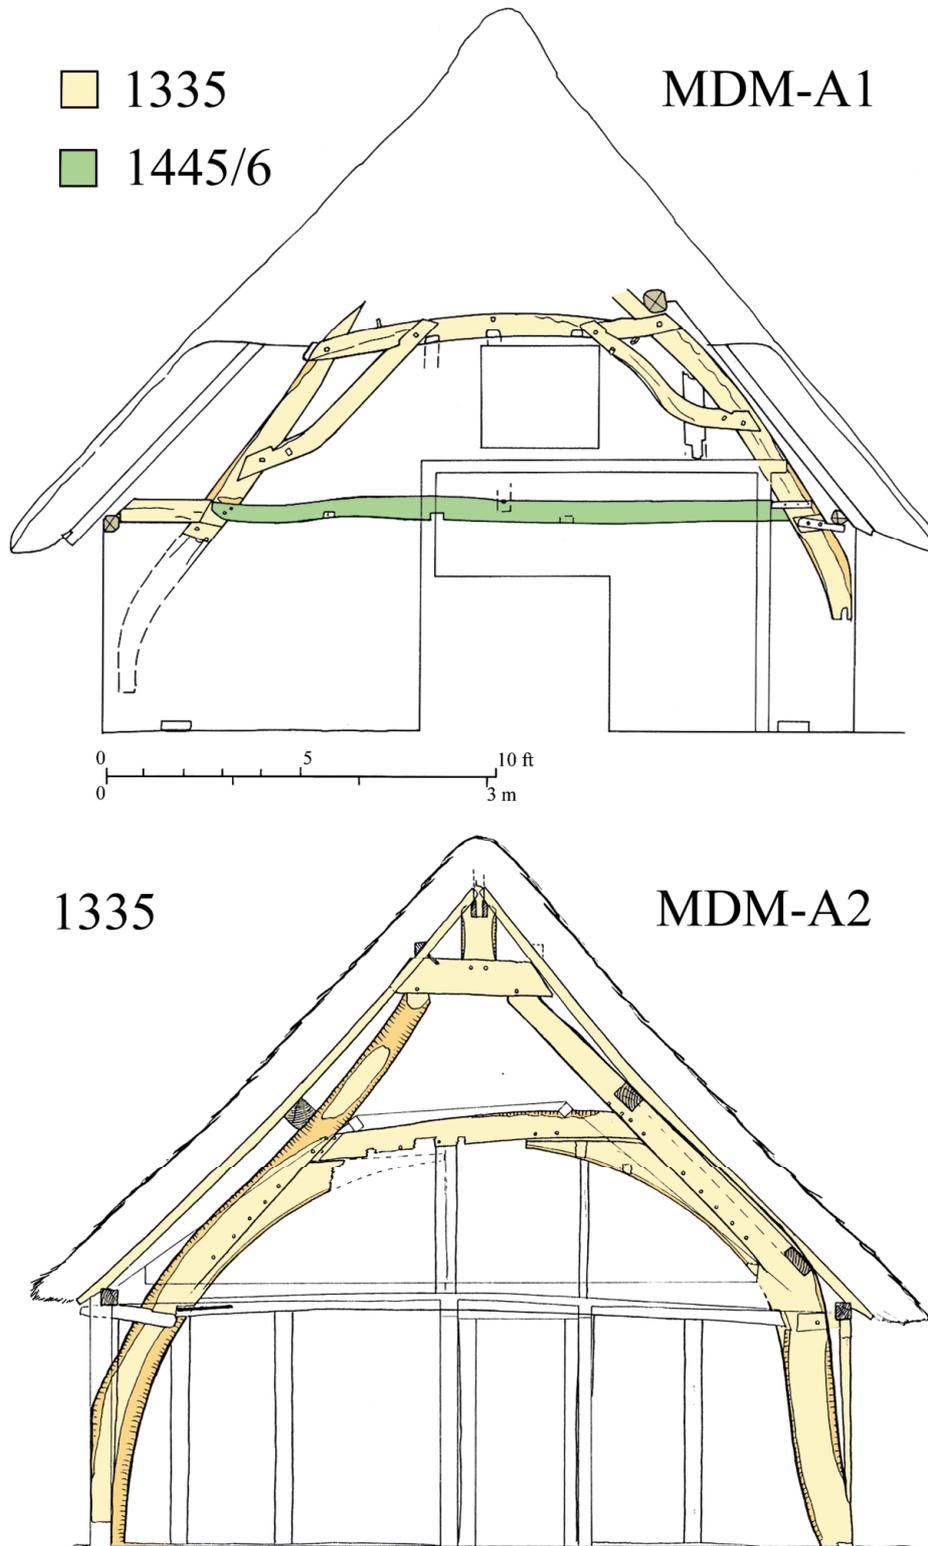
PHASE 1: The structure consists of three bays with three cruck trusses, the northernmost truss being boxed framed (Figs. 4(a)-(d)). Each bay measures approximately 15ft 6in long between the trusses, and externally the building is 18ft wide. The southern truss, T1 carries a half hip, whose profile was almost certainly continued by the rafters of the lean-to bay 0. As it exists now, it would be classified as a type 'V' cruck (truncated end truss), but originally it would have been of type 'W' (truncated internal truss). The truss carries a primary collar, strengthened by straight braces, and the crucks terminate above this. The collar is attached with an early type of skew-pegging and the braces use notched halvings (Figs. 5a-b); the present tiebeam was added in 1446. The whole roof structure here is deformed, with this truss par-

ticularly affected, as a result of the western corner subsiding by almost two feet. The rafters of the half-hip are now supported by an early twentieth century strut.

Fig. 4a-b. Sections of trusses: (a) T1, from south; (b) T2, from south.

Truss T2 is an open truss with the rear blade being of elm and the front one of oak. Both have been dated and are coeval. The blades are 10in deep at the bottom, tapering to 6in at the top. They are joined by a saddle carrying a king-post to support the ridge (type 'F1' apex). The saddle measures 6 by 10-11in, and the king post is 10in wide by 4½in deep, with run-out chamfers on all four arrises. The two arch braces have 1¼in chamfers, and the western brace has been mutilated at some stage. The collar is tenoned into the cruck blades and measures 8in wide by 4in deep. The crucks have cruck studs outside them which are notched into the back of the crucks and rise to meet the short cruck spurs (halved onto the blades).

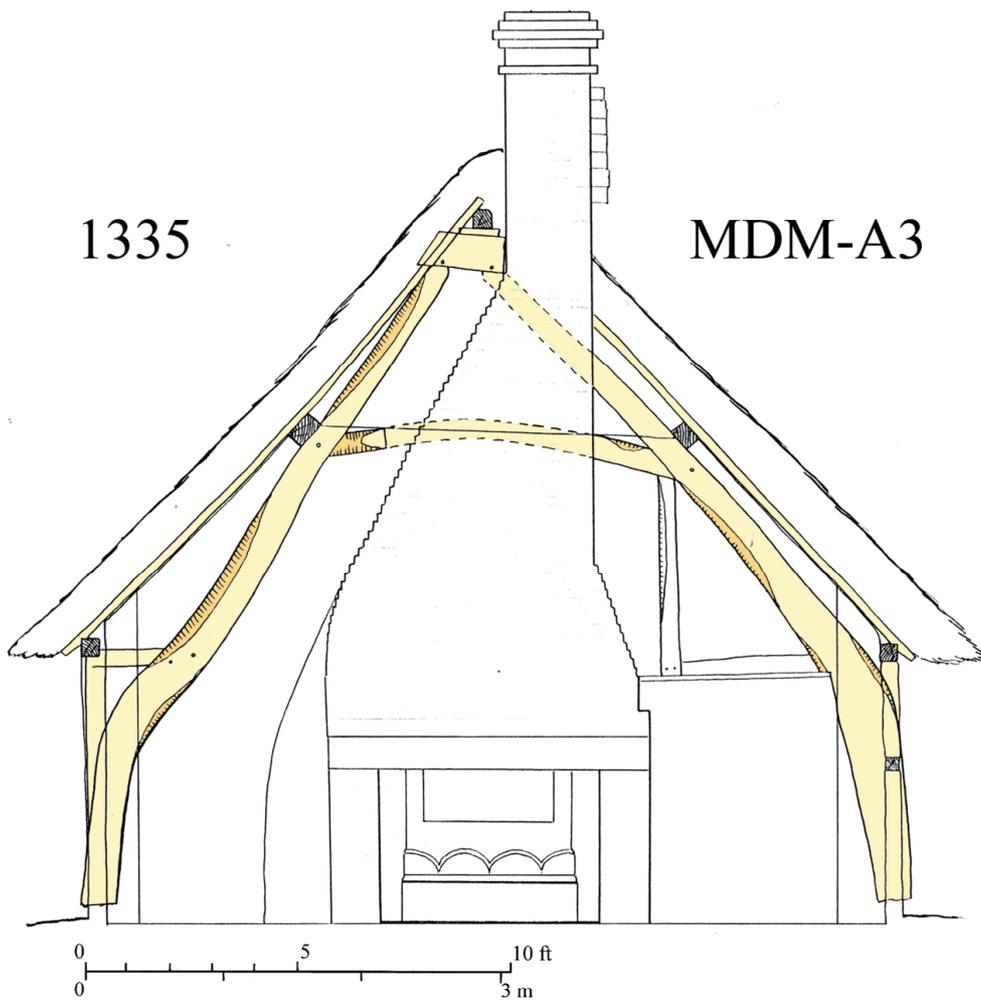
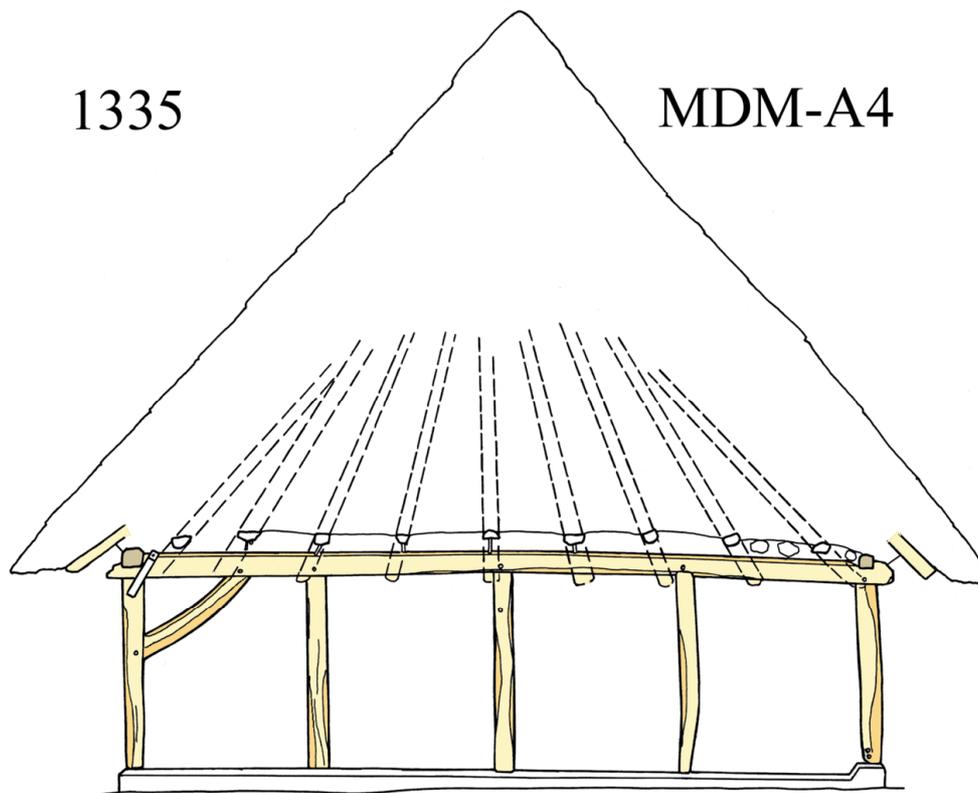
Fig. 4c-d. Sections of trusses: (c) T3, from north; (d) T4 from north.

Truss T3 is a closed truss with a collar and tiebeam, both jointed into the cruck blades with half-lapped joints. Most of this truss is now incorporated into the chimney stack. At the front, it retains a similar cruck stud to that in T2. The end truss T4 is box-framed with a full hip and is clearly part of the 1335 work. The roof in this bay is smoke blackened although the soot deposits are considerably lighter than in bays I and II. The truss has two 5½ by 6in corner posts and uses reversed assembly, the elm tiebeam resting directly on the corner posts with the wall plates, again of elm, being trenched into the top of the tiebeam. This end wall has the best preserved of any of the original framing (Fig. 6). The framing comprises three studs, the sill beam and one brace which is slightly ogee in shape and is flush with the external face of the truss. The studs are 5½in wide, the tiebeam 6½in square and the brace is about 4½in square. The panels still retain what may be their original wattle-and-daub infill.

LATER PHASES: The principal later work comprises the reconstruction of truss T1 in 1446, discussed above, and the insertion in about 1500 of the chimney at T3, which severed the tiebeam and collar, and truncated the saddle (Fig. 4c). This chimney is built of narrow bricks (9½ by 4½ by 2in), and it serves back-to-back fireplaces in bays II and III. That in bay II is closed in, but in bay III the fireplace has been opened up to reveal a fine scalloped shaped fireback in moulded brickwork (Fig. 10). The jambs are splayed and the chimney breast is supported on a reused timber beam (inserted in the 1980s). A short section of the original timber mantel beam is visible to the side of the bay II fireplace. The chimney stack has an unusual protruding vertical band of bricks at the position of the dividing wiff (flue partition). To the west of the stack was a semi-circular recess for a copper, and to the east a bread oven, probably early nineteenth century, which collapsed in 1979 and was removed.

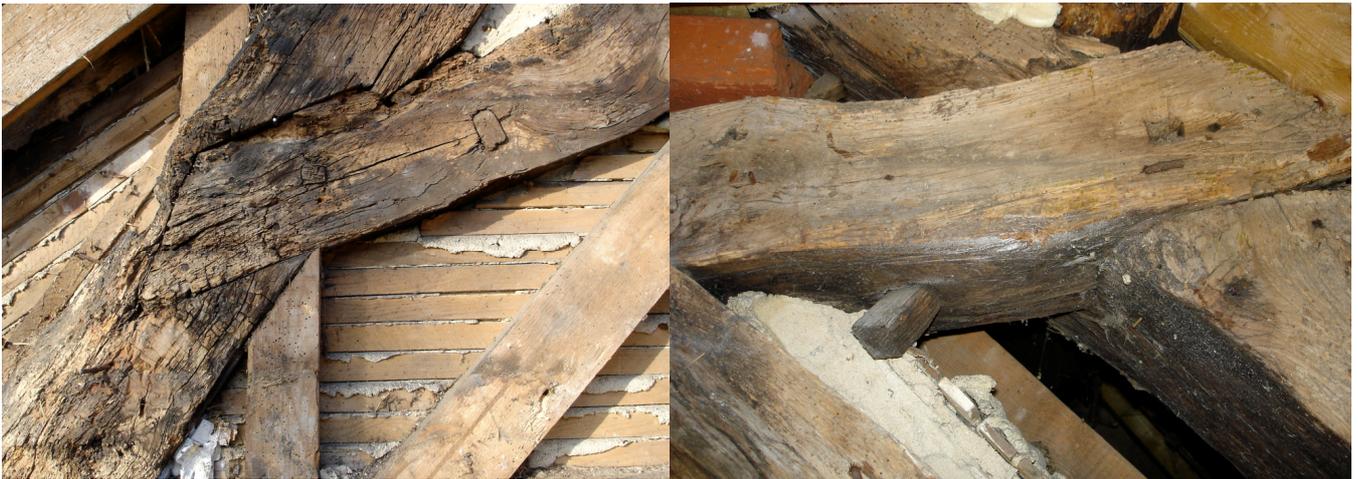
Fig. 5. Joints in truss T1 (left) notched-lap joint (refined entry) between cruck and brace; (right) halved joint between collar and cruck

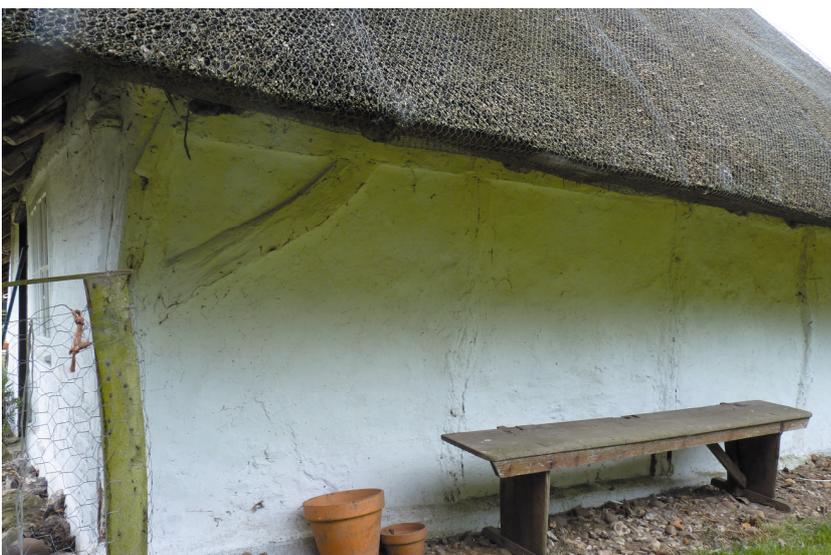
Fig. 6. Framing of the north end of the house.

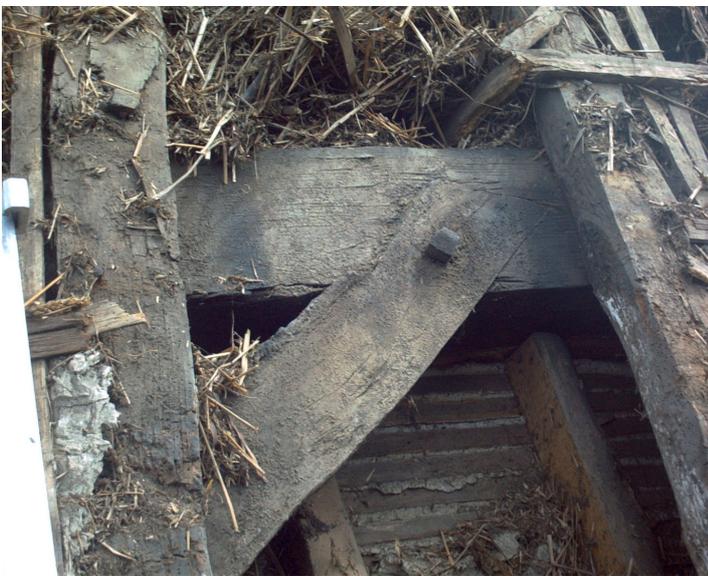
Fig. 7. The windbrace-purlin lap joint, on the east side of bay I.

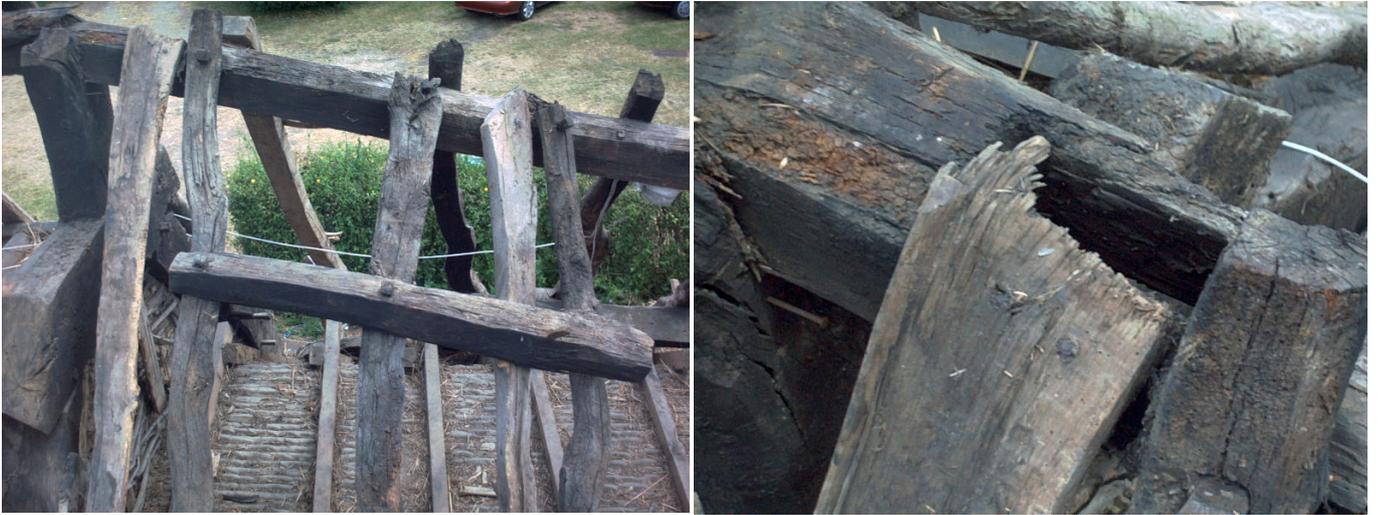
A particularly intersecting feature is the substantial evidence for the original smoke louvre.<sup>2</sup> The louvre is located immediately to the south of the open truss (T2) and, as in other houses where we have

evidence of the louvre position (cf. Pithouse Farm, Mapledurham, MDM-B; Kingsholm, East Hagbourne, DID-B; The Leopard, Bishop's Tachbrook, BIT-A), it was fixed to the rafters, about 18in down from the ridge (Figs. 8a-b). The evidence for its reconstruction is examined in Chapter 5, and Fig. 9 shows its suggested original form.

Fig. 8a-b. The louvre at Mill Farm, Mapledurham (MDM-A, 1335): (left) View of the louvre base plate. The fractured tenon of the ridge post can be seen behind the right-most front rafter, and the empty mortice is concealed behind the left-most rafter; (right) View of the ridge at Mill Farm, showing the empty mortice of the louvre post.

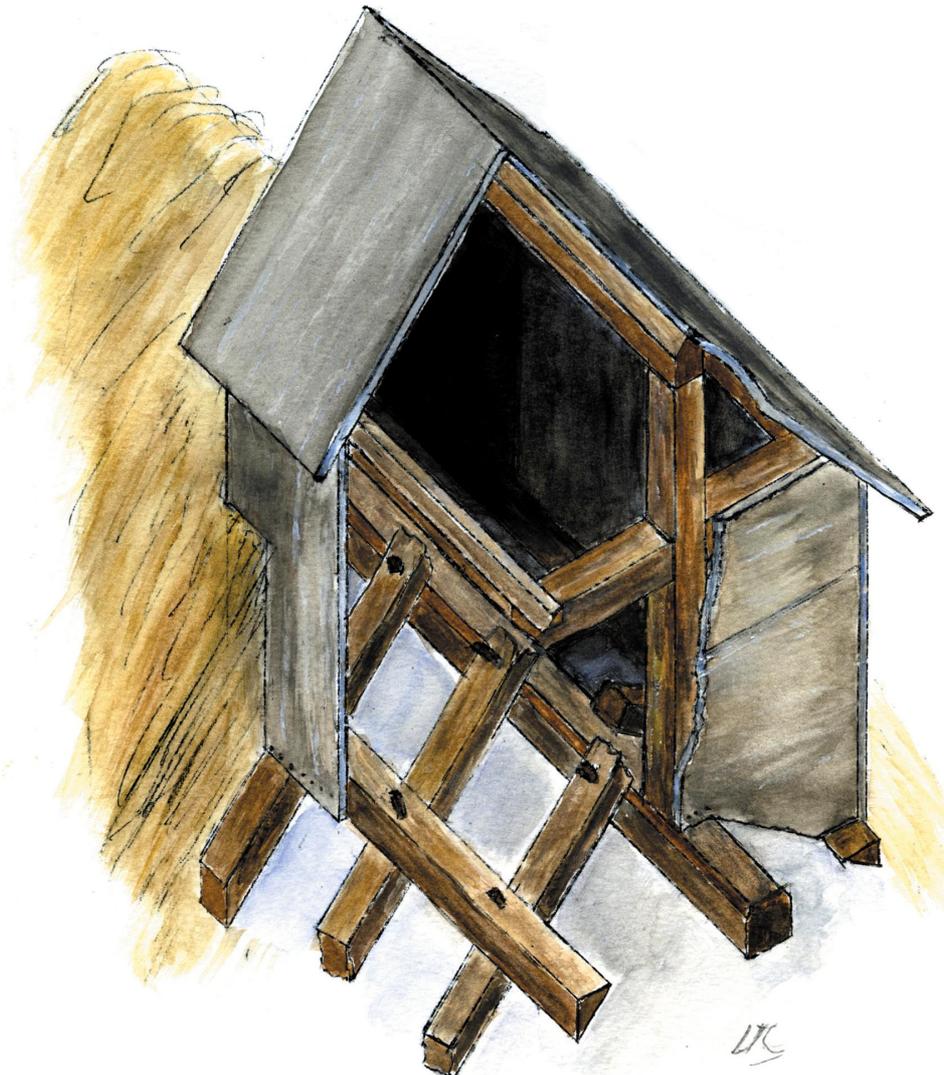
Fig. 9. Reconstruction drawing of the louvre at Mill Farm, Mapledurham (watercolour by Lynn Courtenay based on a sketch by Nat Alcock).

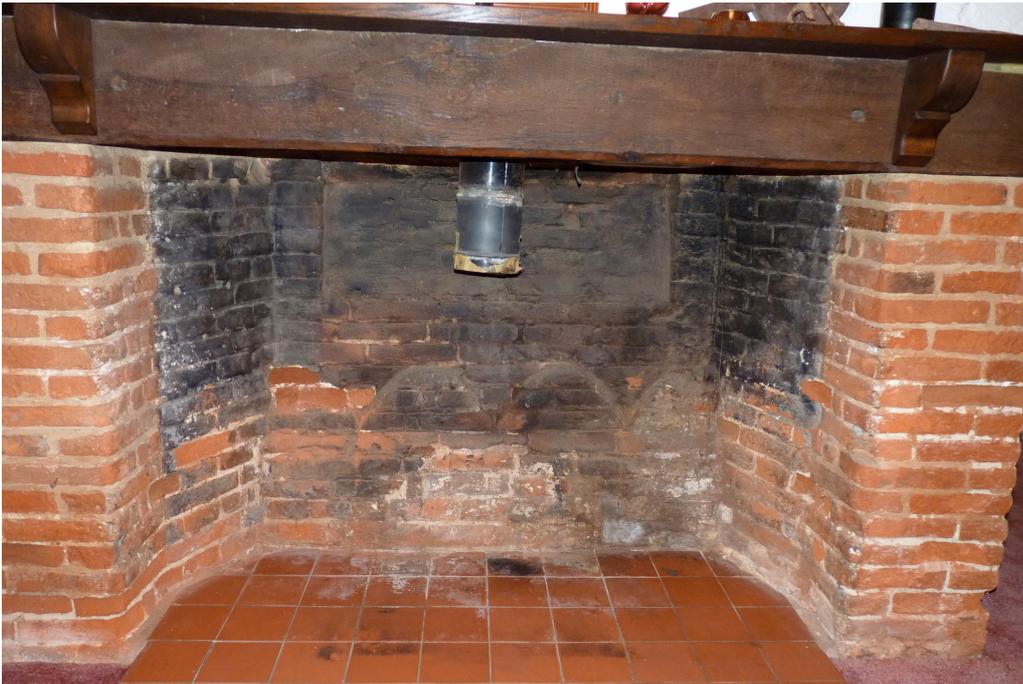
Fig. 10. The fireplace in bay III.

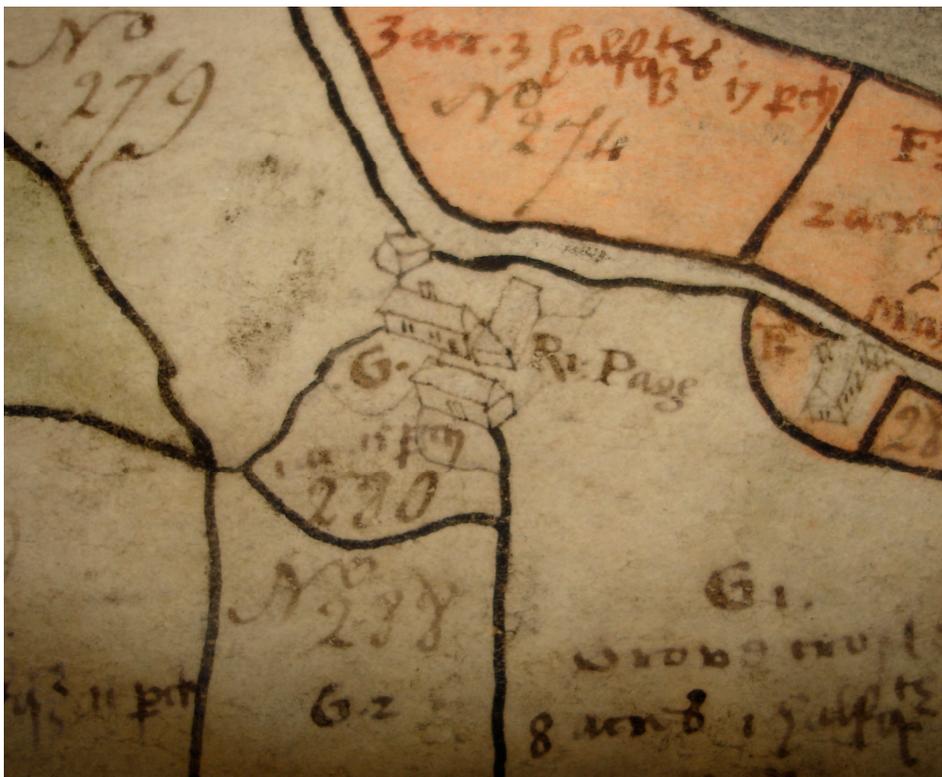
The documentary history has not been extensively investigated, although the Mapledurham estate archives undoubtedly contain much information about the house. It is clearly shown on the Blagrave map of the Mapledurham estate in 1587, in a bird’s-eye view from the west, when it was in the tenure of Richard Page (Fig. 11).

Fig. 11. View of Mill Farm on the Blagrave map of 1587 (at Mapledurham House, reproduced with the kind permission of Mr J.J. Eyston).
