Report for
Manor Cottage, Sutton Courtenay, Oxfordshire

Site Code: SUC-A

SUC-A: MANOR COTTAGE, SUTTON COURTENAY, OXFORDSHIRE

Grid reference: SU 5035 9416

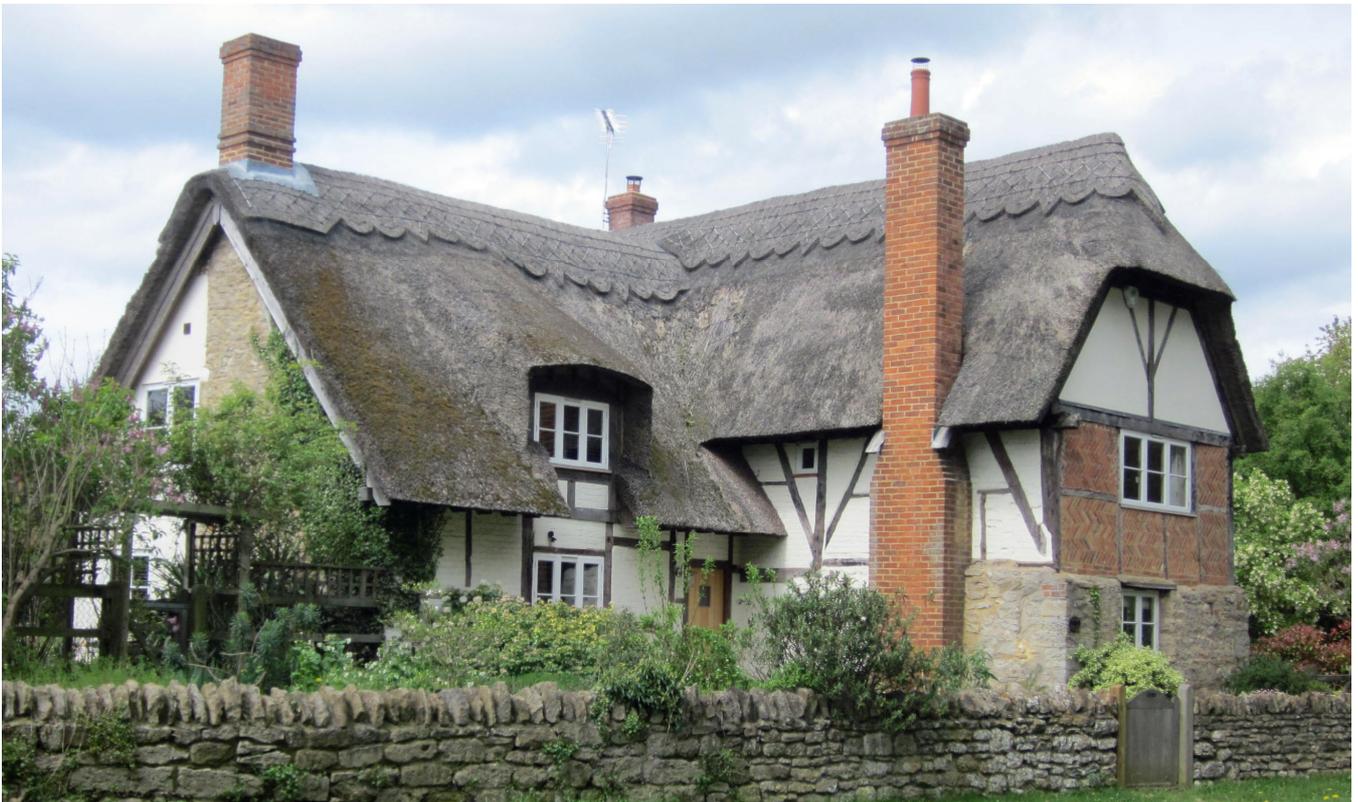
Fig. 1. View of the cruck range, from the south (Photo: D. Clark).

PHASE 1: The house faces east across the village street, to the south-west of the Manor House. The existing house comprises a two-bay cruck-built open hall (bays I-II) (since truncated at the south end), and a three-bay floored crosswing with crown-post roof (bays III-V). The upper floor of the wing appears to have been a great chamber. Both hall and crosswing have been tree-ring dated to 1317/18. The original entry was most probably to the south of the present hall chimney, possibly with a service bay beyond this. Although hall entries adjoining cross-wings have been recorded (42 High Street, Milton,

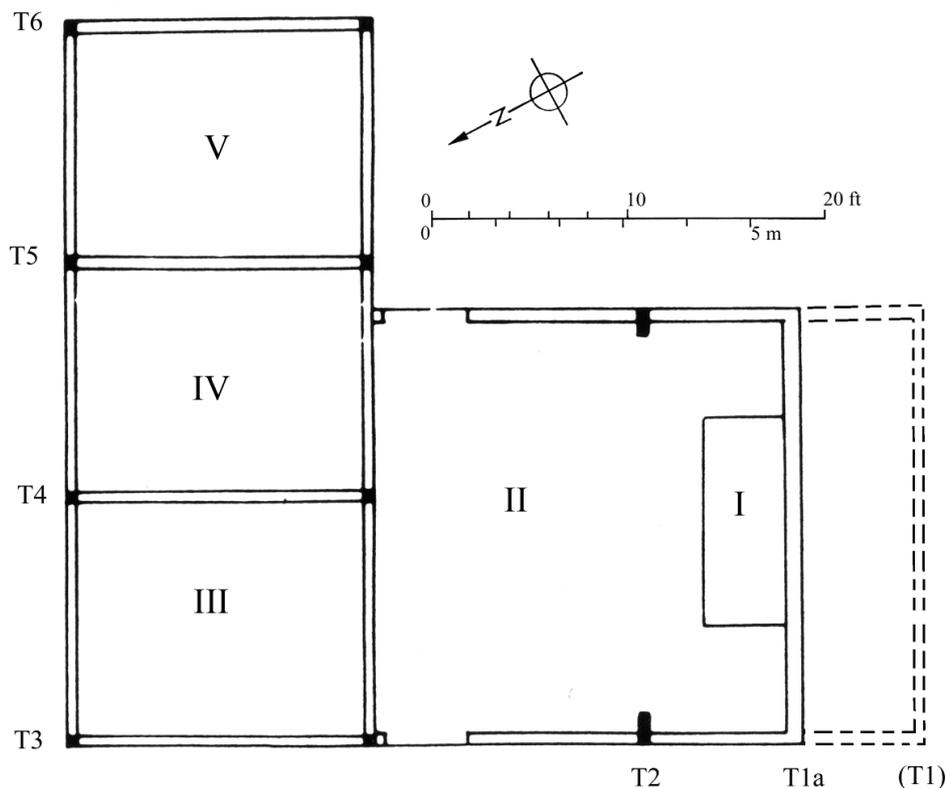
Fig. 2. Plan, showing truss and bay numbering.

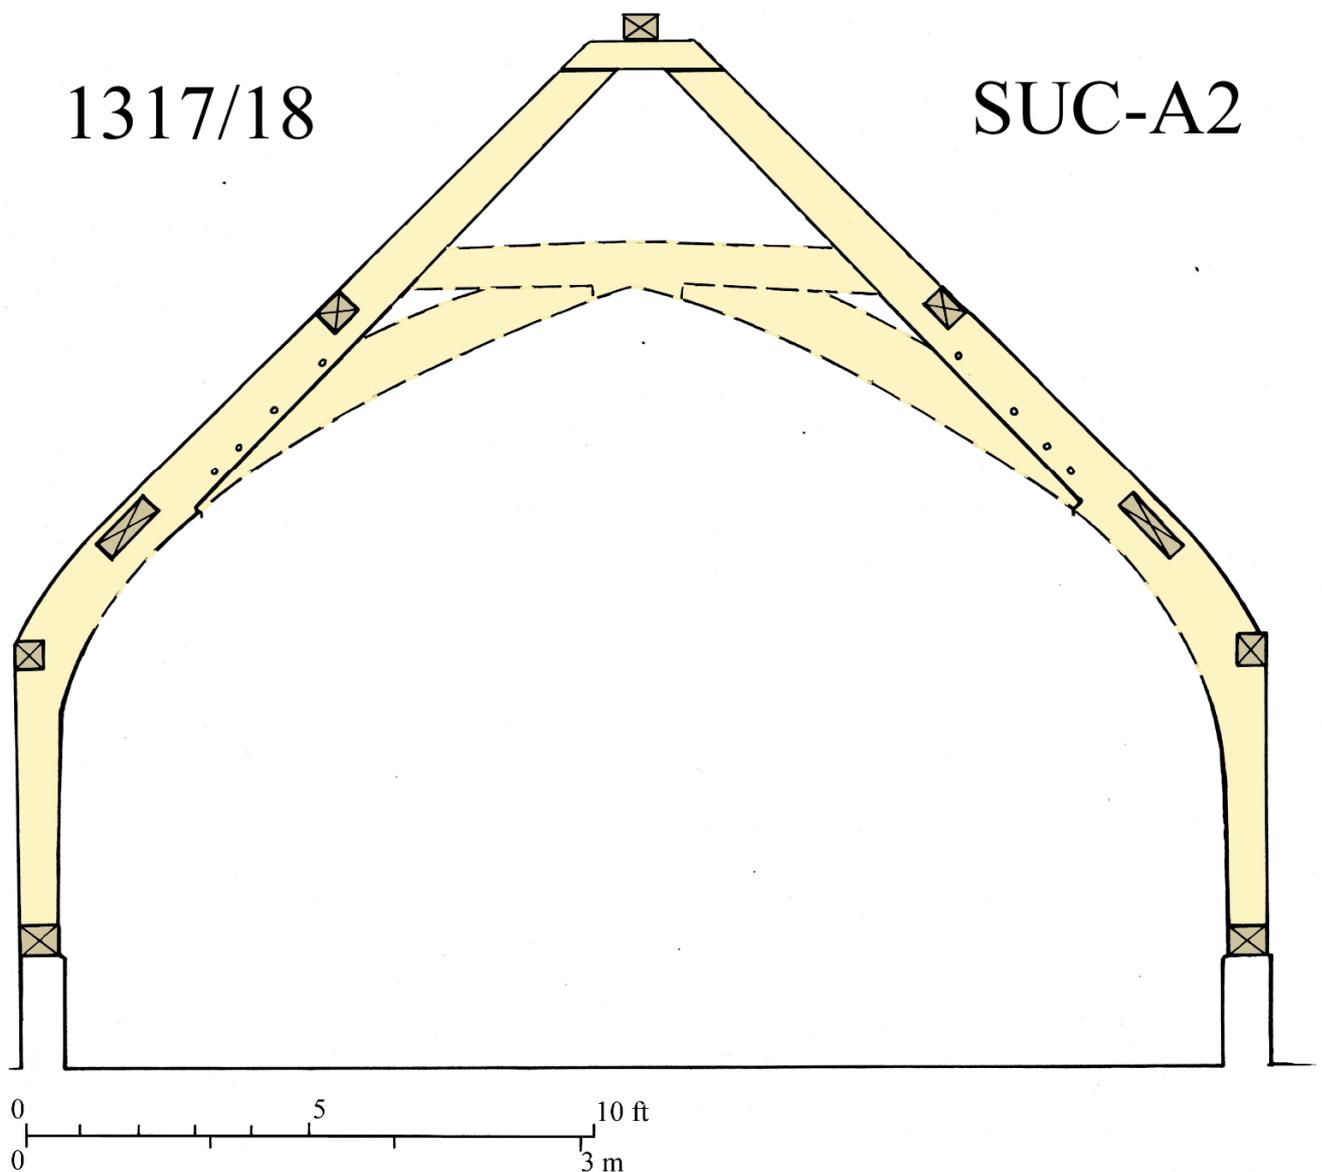
Fig. 3. Section of truss T2.

PHASE 1: The open truss (T2) has sharply elbowed blades of thick cross-section with a saddle apex (type C); the removed collar was arch-braced. On one side, the wall plate rests on a step on the cruck, but the other plate is butt-jointed to the blade. The purlins are tenoned into the cruck blades and have the square-section chamfered windbraces lap-jointed to them. There is no truss adjacent to the wing, but the hall frame is carried on the corner post of the wing (east) and on an intermediate stud in the wing frame (west).

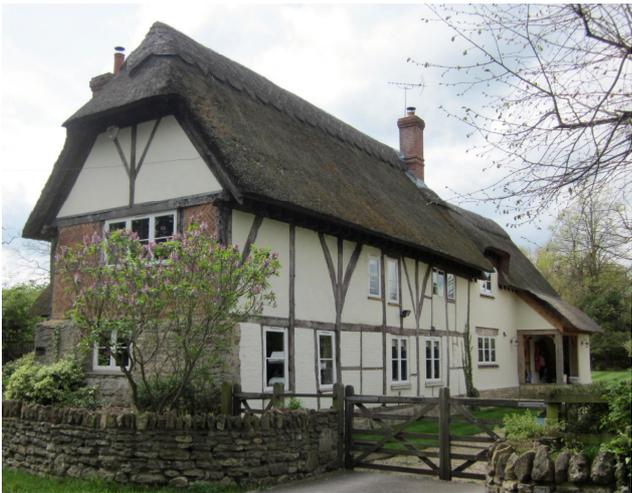
Fig. 4. View of the box-frame range (Photo: D. Clark).

In the wing, the front (east) wall may have been jettied, as it is now under-built in brick and stone. The principal posts have a variety of head forms, slight jowls, upstands, and unjowled. The wall-framing is in large panels, with intermediate studs in each bay and with braces to the wall plate; some of the braces are straight and are fixed by single pegs, while some are curved, with double pegs; the latter seem likely to be replacements. The intermediate studs are not characteristic of fourteenth century structures. Although they were not sampled for dating, they also seem likely to have been inserted during a repair. The wall plates have *trait-de-Jupiter* scarfs.

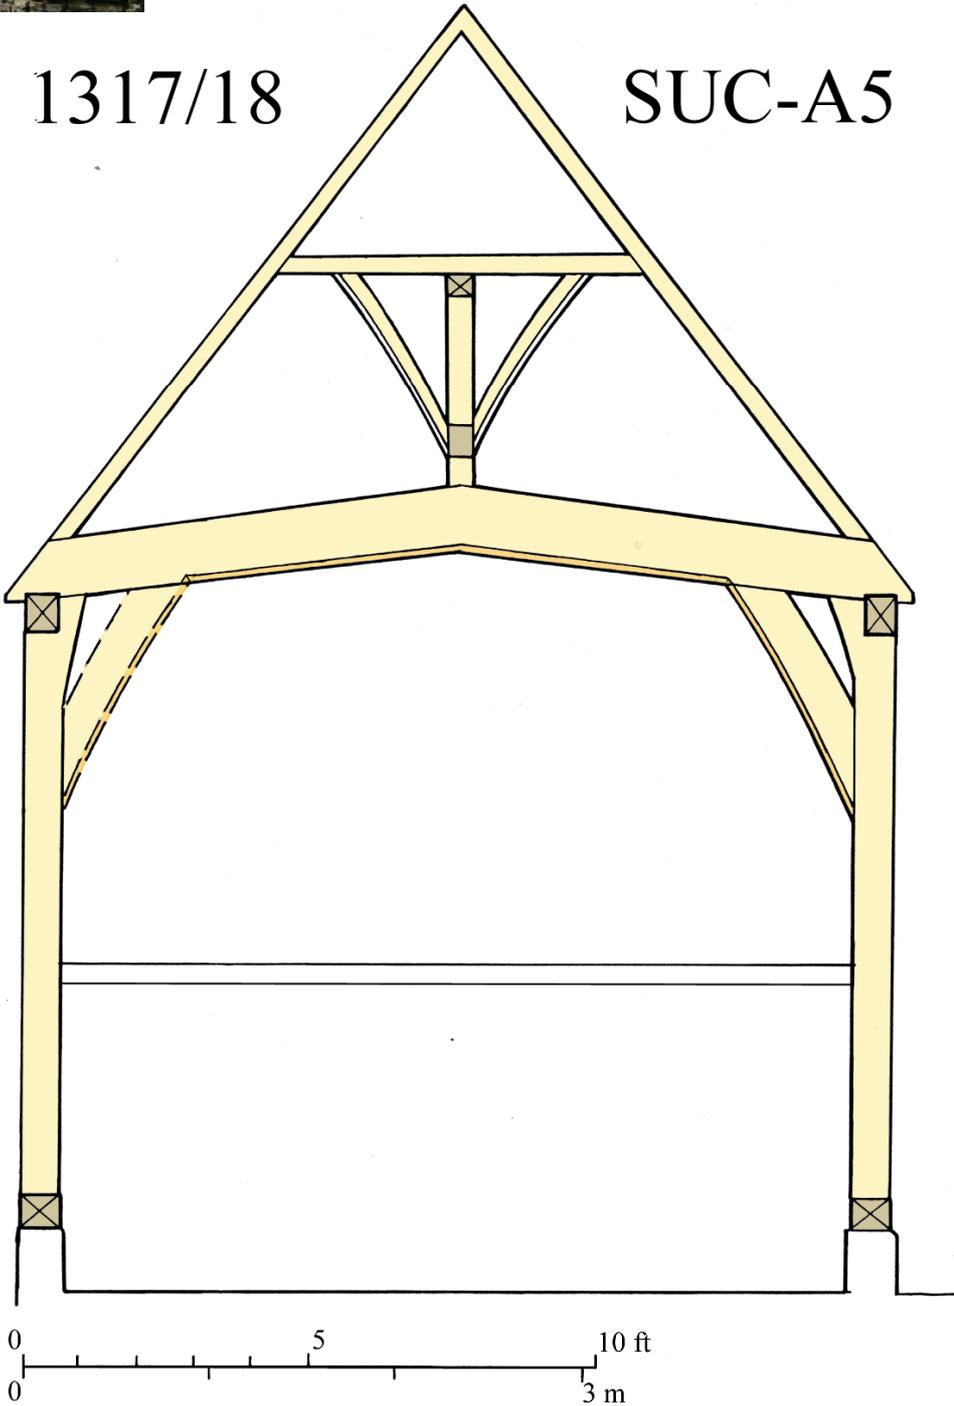
Fig. 5. Section of truss T5.

The two internal trusses in the wing (T4, T5) are open, indicating that the upper floor comprised a single large chamber. They have cambered and steeply arch-braced chamfered tiebeams. They carry jowled crown posts with four-way up-bracing, similar in character to the hall windbraces. The chamfered crown-plate is tenoned to the crown posts. Draw stops are used throughout. The west end truss (T3) also has a cambered tiebeam, though that at the east is flat. Both have dragon ties, although these are not used on the internal trusses.
