Report and Documentary History for
Loxley Farm, Loxley, Warwickshire

Site Code: LOX-A

The Medieval Peasant House in Midland England

LOX-A: LOXLEY FARM, LOXLEY, WARWICKSHIRE

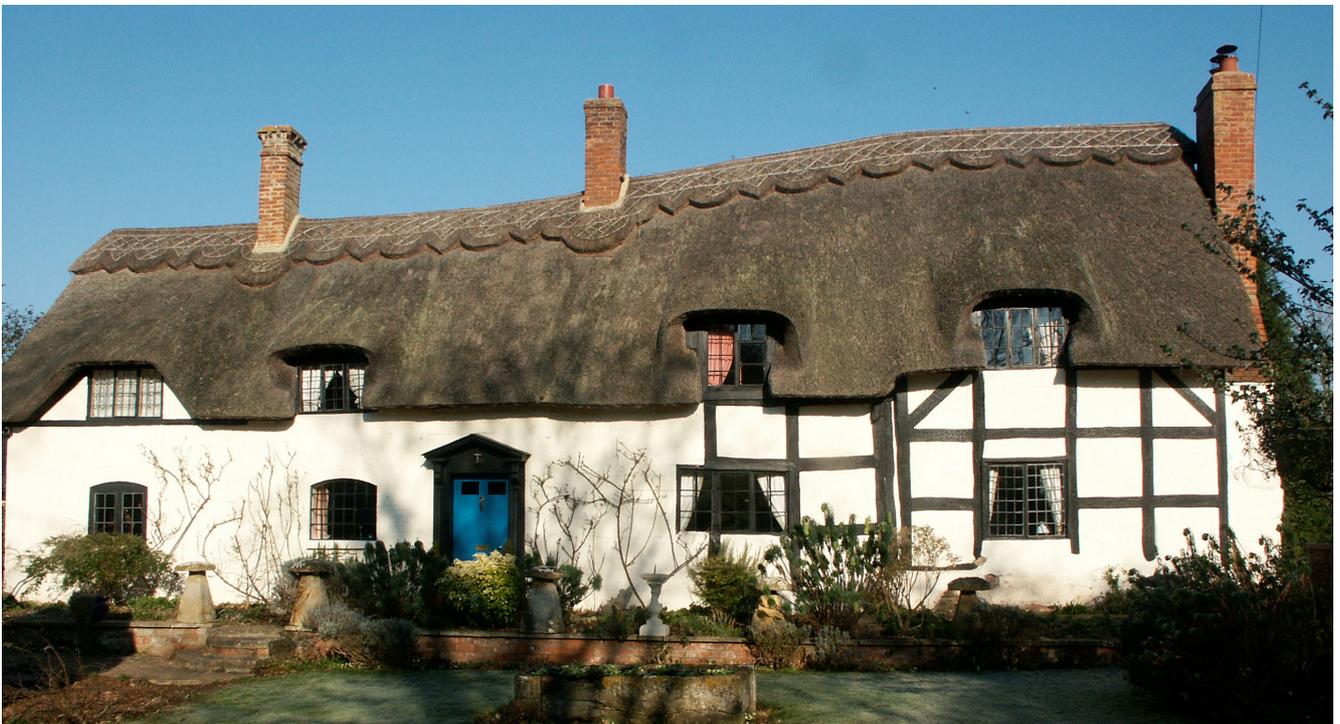
Fig. 1. View of the house from the south.

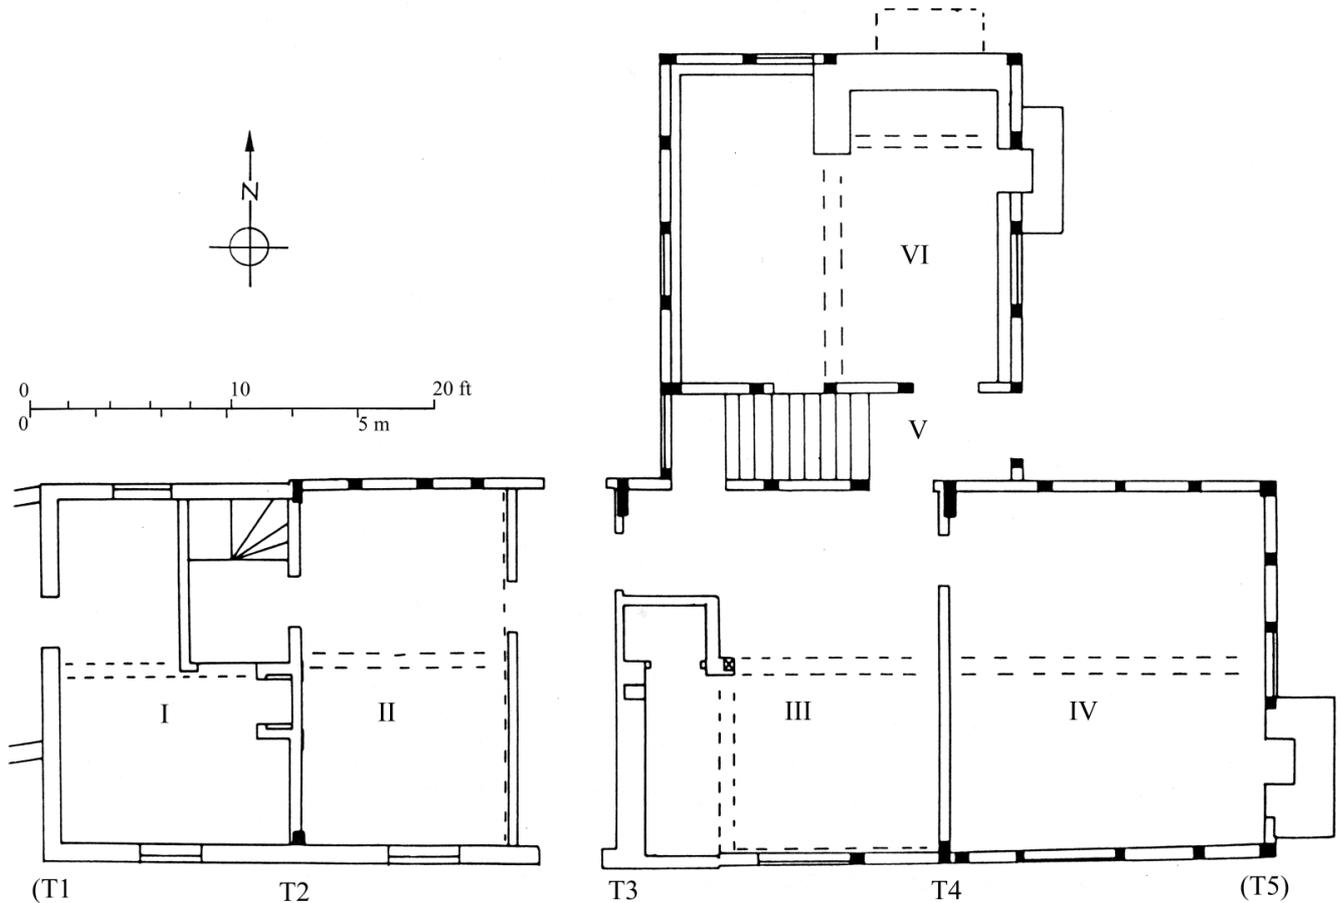
Fig. 2. Plan, showing truss and bay numbering.

PHASE 1: The cruck-built house originally had four bays, from which three cruck trusses survive. Tree-ring dating has been unsuccessful, but a fifteenth century date is likely on architectural grounds. Bay IV was the chamber end (replaced) and bay III the hall. Bays II and I were probably used as service and kitchen respectively, from the presence of smoke-blackening. The cross-passage was certainly present in the seventeenth century, and seems likely to be original. There is no evidence to suggest that T3 might have been the open central truss of a two-bay hall.

LATER PHASES: Probably in the sixteenth century, the hall was modernised by the insertion, first, of a firehood and then of a ceiling with moulded beam; a stair extension was also added (bay V). In the seventeenth century, bay IV of the cruck was replaced by a parlour bay, and a rear bakehouse/storage loft was added (bay VI).

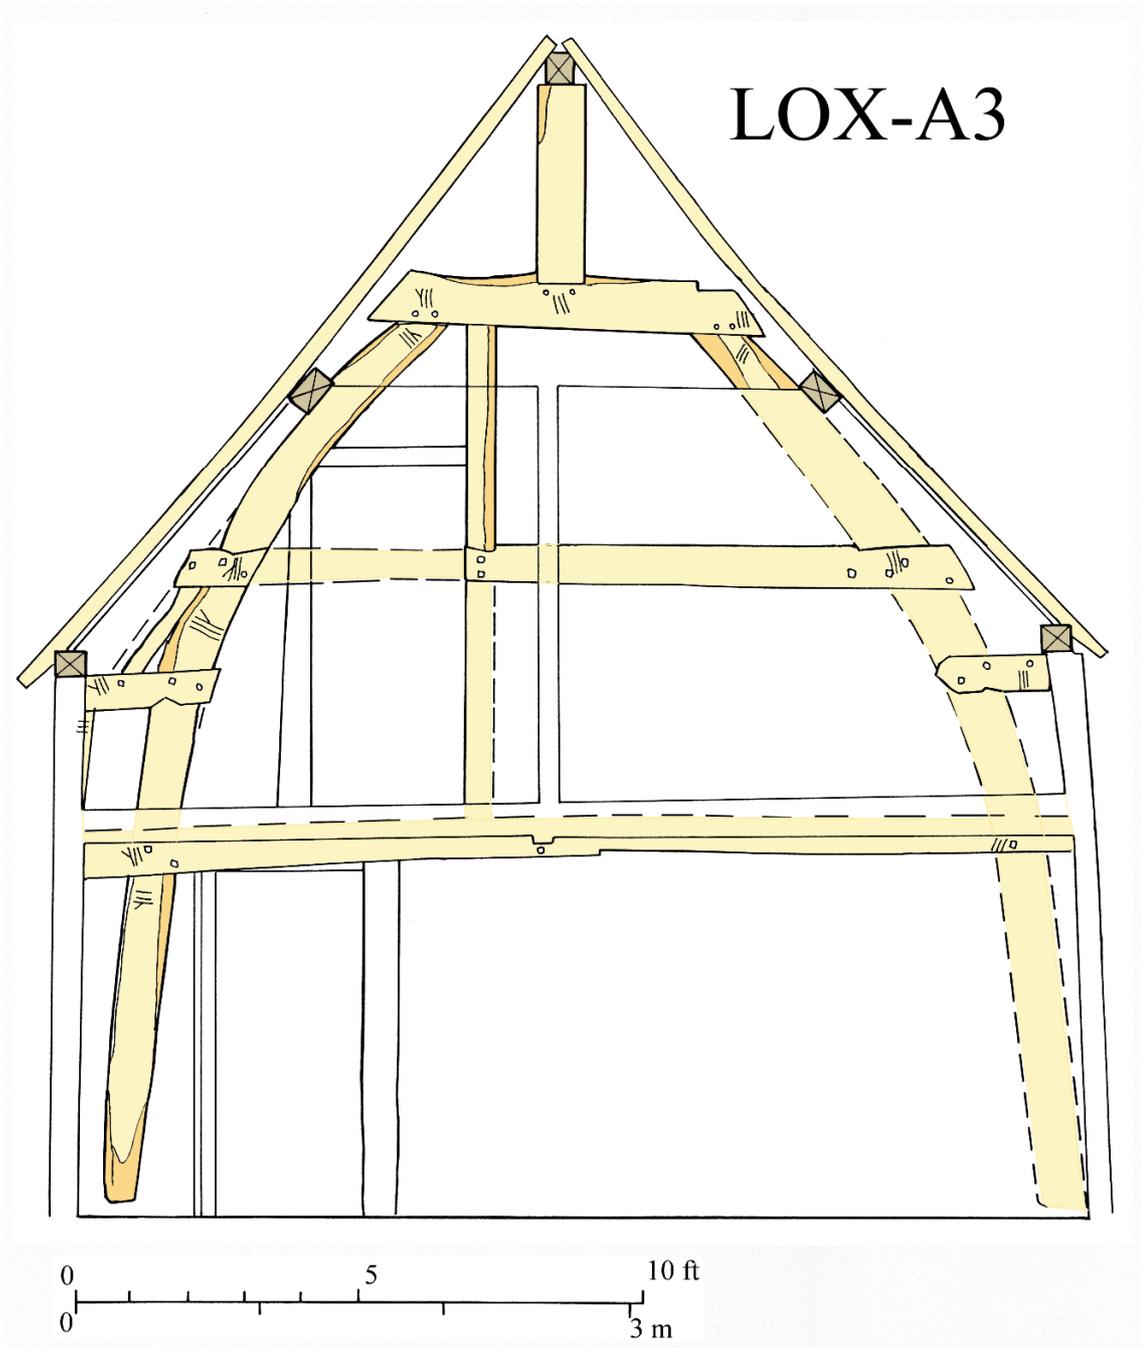
Fig. 3(a). Section of truss T3 from west.

PHASE 1: Cruck trusses T2, T3 and T4 remain from the original structure. Truss T4 has a saddle carrying the ridge directly (C apex) while in T2 and T3 short king-posts rise from the saddles (F1 apexes); they appear all to have had packing pieces (mostly now hidden), with cruck spurs and tiebeams. Carpenters marks are visible on the west sides of T3 and T4 (three and four scribed lines respectively, the north sides differentiated by additional tag lines).

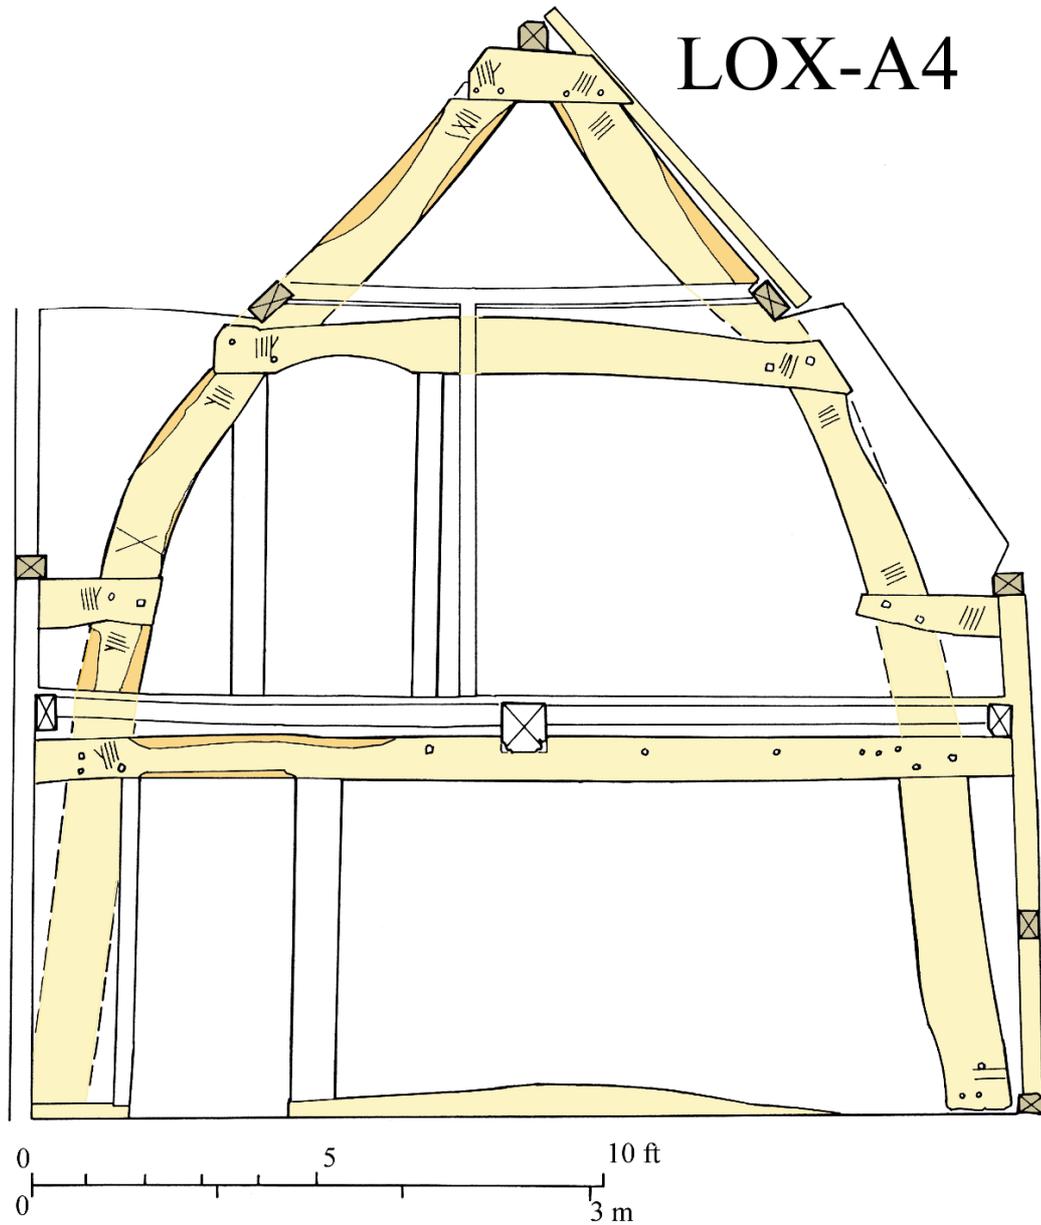
Fig. 3(b). Section of truss T4 from west.

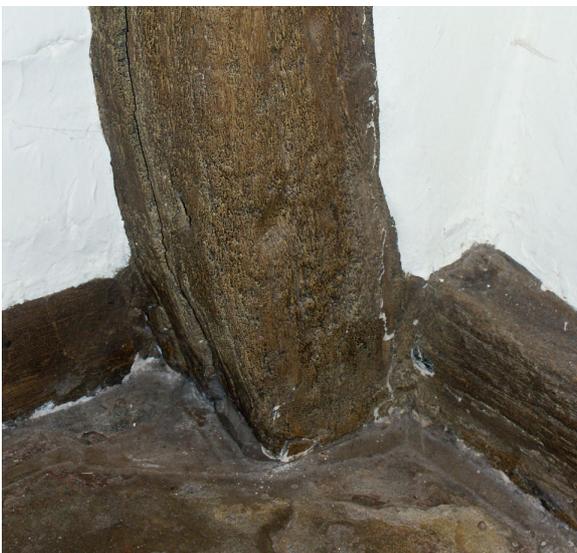
The foot of cruck T3 (rear) is visible (Fig. 4), set in front of the sill beam and apparently resting on a pad stone at the level of the present (early) floor. It could well have originally have been earth-fast. The purlins in bays II and III have pegs for removed windbraces, which rose from the packing pieces. The wallplates and purlins have splayed scarfs on the west sides of T2 and T3, the latter positions confirming the former presence of bay IV.

Fig. 4. Foot of truss T3

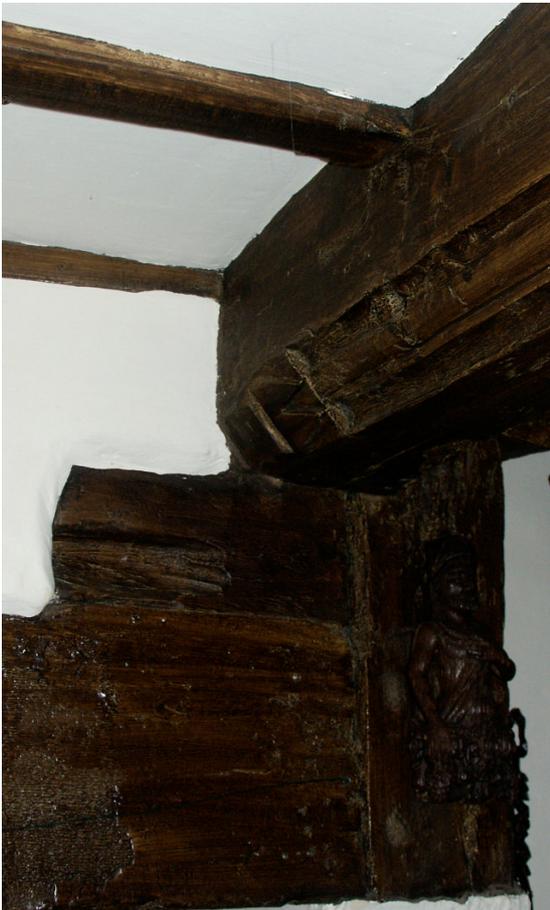
LATER PHASES: The first improvement was probably the insertion (presumably in the sixteenth century) of a framed firehood in bay III with a plain lintel supported by a post (cut-off below the lintel) (visible on the lower part of Fig. 5); the post rose to the ridge and carried two horizontal framing members. The firehood cannot be dated, but preceded the later sixteenth-century insertion of a finely moulded hall ceiling beam (tentatively dated from the moulding and stop; Fig. 5); the beam on the south wall is ovolo-moulded with a step stop. After the replacement of the firehood by a chimney, a brick smoking chamber was constructed beside the fireplace, with an open lattice-work door (Fig. 6). Perhaps contemporary with the flooring of the hall, a framed stair projection was added behind the hall (bay V), though this lacks any direct dating evidence. The ceiling beam in bay I has a plain unstopped chamfer, and that in bay II a scroll stop, indicating flooring in the seventeenth century. This beam is stopped against the passage partition, indicating that the passage existed by this period.

Fig. 5. End of inserted hall beam with firehood post and lintel

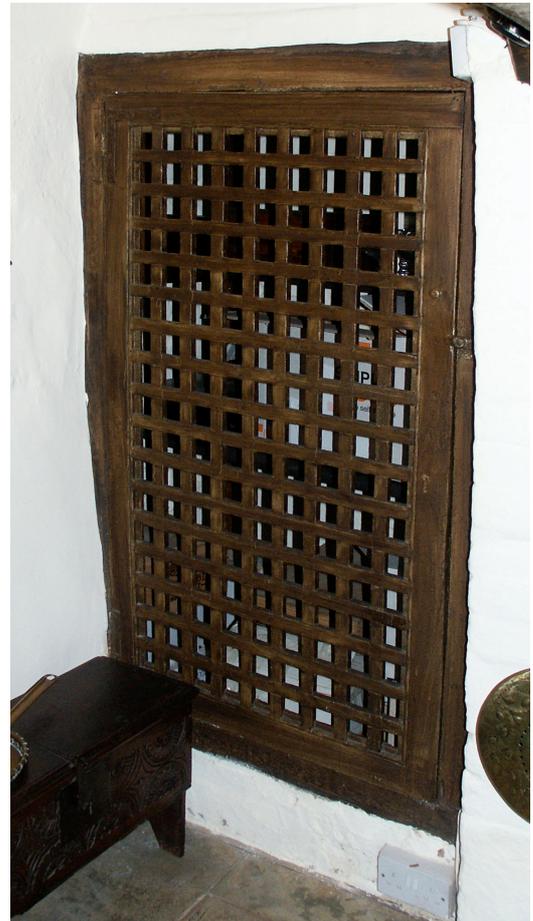
Fig. 6. Lattice-work door of smoking chamber.
