Report and Documentary History for  
**High Beams, 8-9 Vicarage Road, Stoneleigh,  
Warwickshire**

*Site Code: STO-C*

The Medieval Peasant House in Midland England

STO-C: HIGH BEAMS, 8-9 VICARAGE ROAD, STONELEIGH, WARWICKSHIRE

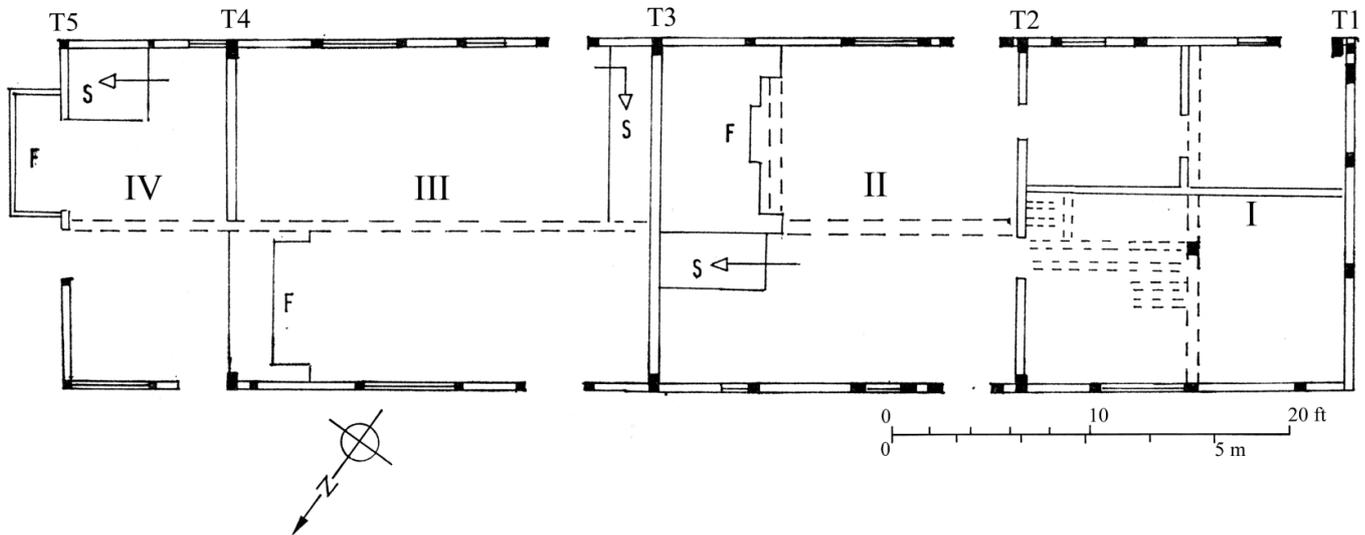
Fig. 2. Plan, showing truss and bay numbering (from Alcock *et al* (1971-3), 186).

PHASE 1: Three of the four original closed cruck trusses remain, defining the three original bays. The trusses have a pronounced lean towards the west, and in 1910 the fourth truss fell and was replaced. The blades are boxed heart with relatively regular profiles; the trusses have very large saddles carrying a square-set ridge (type 'C' apex). The collars and tiebeams are halved, and the tiebeams function as spurs, none of the trusses have any decorative features, but windbraces are used over bays I and II. The sill beams are carried on low sandstone walls. Of the original wall-framing, only the cruck studs survive, carried in V-cuts on the outer sides of the cruck blades.

The original floor in bay I survived to be recorded. A transverse ceiling beam carried heavy axial square joists, and a trimmer defined the original stair position. The mortice for a post indicated the position of an axial division, and the ceiling beam is chamfered up to the post on both sides.

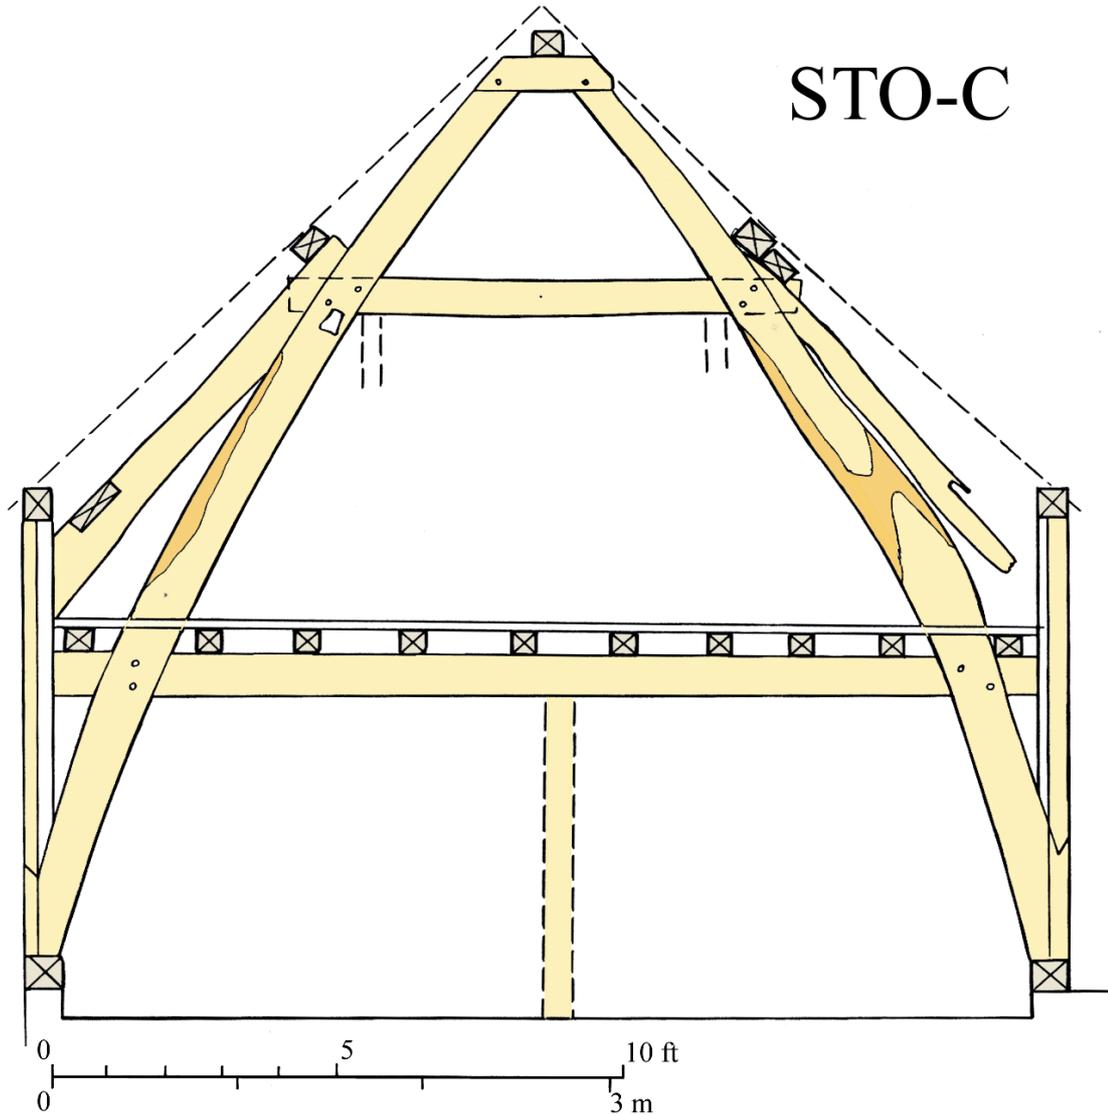
Fig. 3. Section of truss T2.

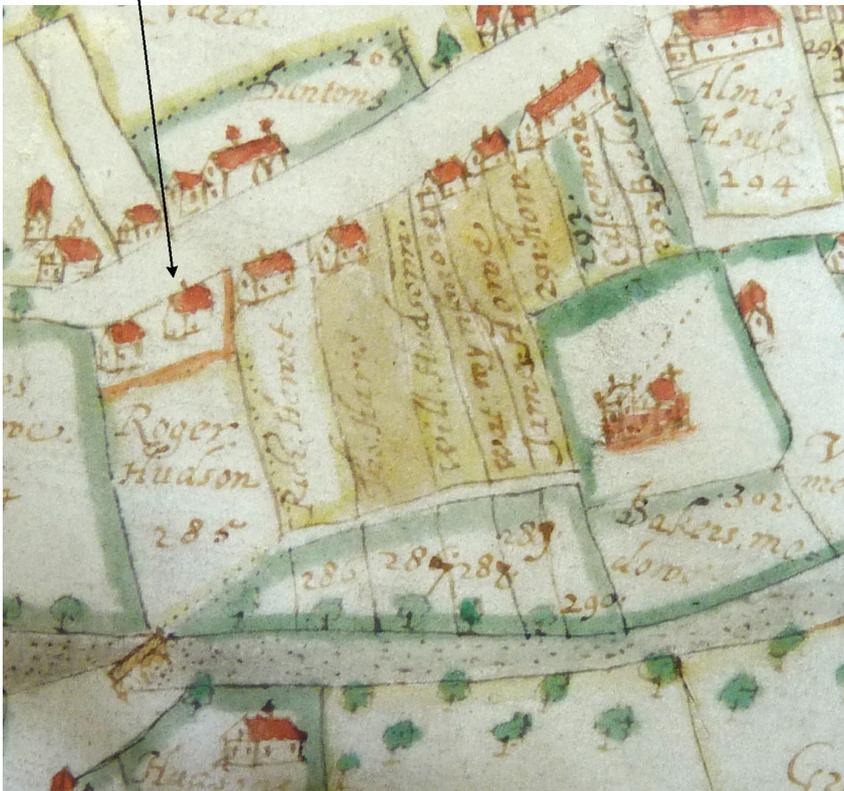
Fig. 4. Section of the 1597 map of Stoneleigh (SCLA, DR671/3, reproduced with permission).

The house can be traced continuously from Roger Hudson, the tenant shown on the 1597 map (Fig. 4), through estate rentals and surveys back to the mid-fifteenth century (Table 1). Throughout, it was held with only a 2 acre field and was occupied by people of fairly low status, although a tanner was tenant in 1610. Probate inventories of 1610 and 1756 allow the room uses to be identified at these dates (Alcock, 1993, p. 107).
