## THE LATER IRON AGE FARMSTEAD

### 5.1 • THE STRUCTURAL EVIDENCE

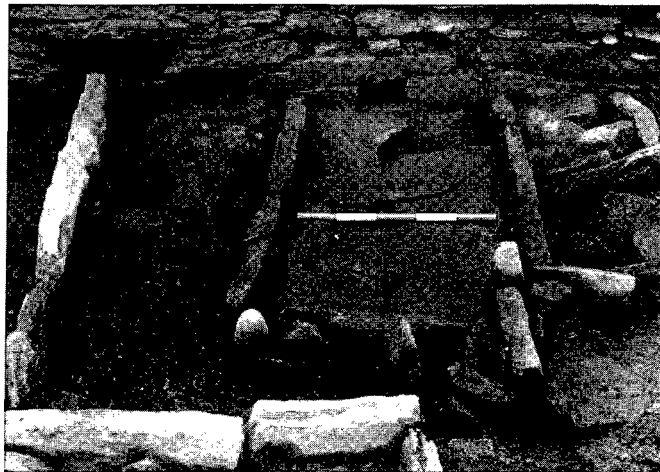
Illus 66

Later Phase 8 buildings: stage 5. Inset shows close-up of hearth of reused *E* building; scale – 50cm; from S.

Alterations to the internal fittings of both the *East* building and the adjoining room, *A*, to the S took place during this Stage. The rectangular hearth in the *East* building was covered with earth floor material and replaced by two smaller, fragmentary hearths to the S. Three stones of a collapsed partition, 1.2m long, were inserted from the S wall between the hearths. During this Stage, a pile of butchered bone and rubble accumulated besides the N entrance. In room *A*, the hearth was replaced by one to the N. This had considerable use as it was repaved and contained ash deposits. The end of the earlier hearth was made into a post setting for the new one. After this, room *A* was abandoned and not reoccupied.

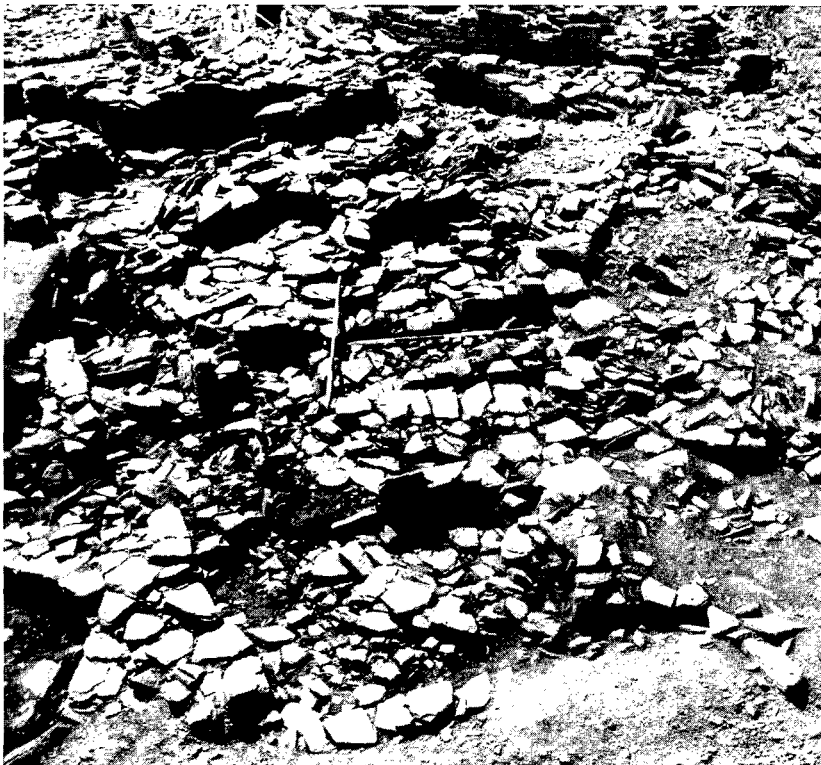
Illus 71  
Later Phase 8 buildings during excavation in the E half of the site; scales – 2m; from S.

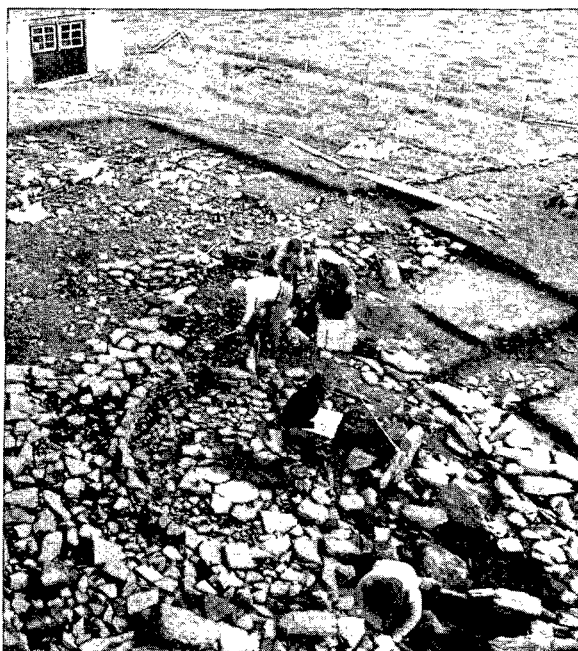
Illus 73

Excavation of Later Phase 8 buildings on the W part of the site. Part of the stage 10 figure-of-eight building, U, can be seen in the lower centre; from NW.
