THE 1984 EXCAVATIONS

The excavation findings have enabled the site's development to be divided into five main periods:

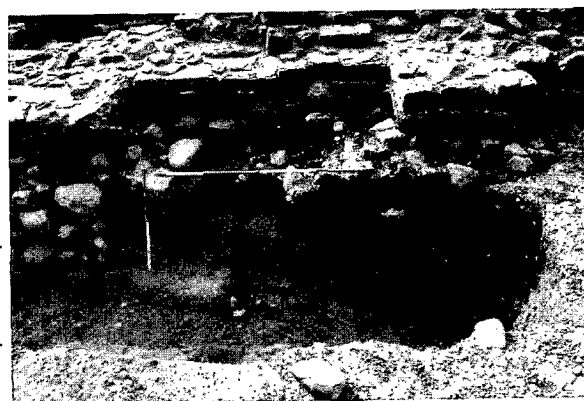
Illus 12
Ditch 928 and adjacent
features: a) plan;

b) the N terminal of ditch
928; from the E; note the
proximity of the East range
foundations to the ditch
edge;

c) sections across the ditch.

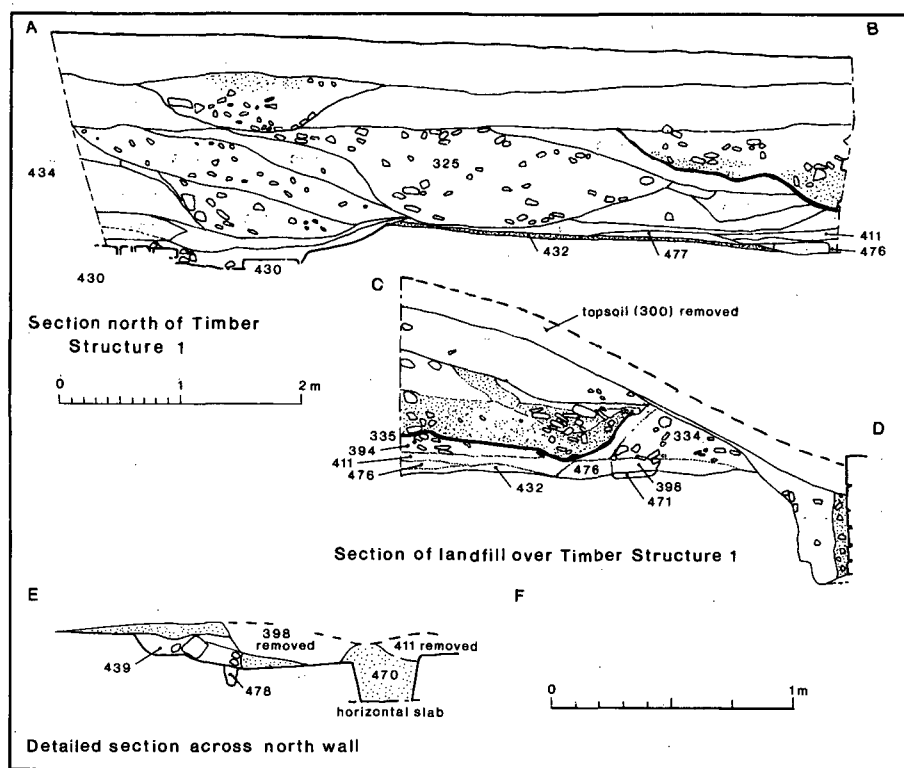
Illus 14
a) Sections through deposits overlying Timber Structure 1, mainly reflecting extensive post-monastic landscaping in the claustral area;

b) section across midden deposits to the S of revetted bank 487.

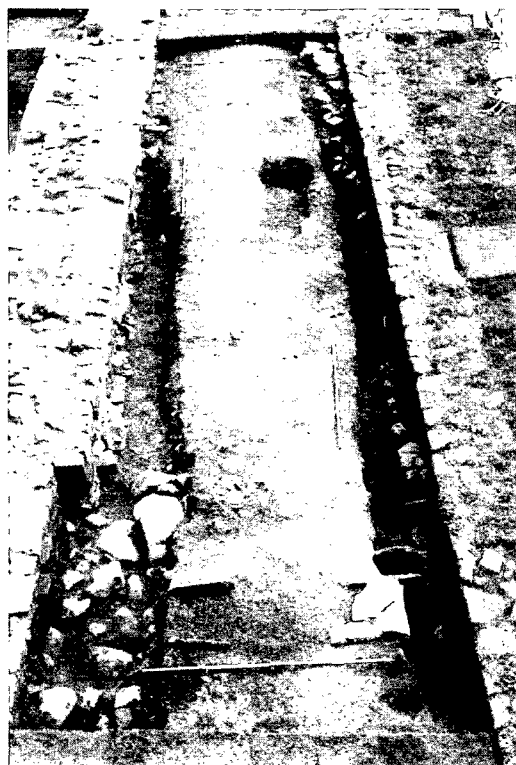
Illus 15

The East cloister alley: a) plan;
b) (below) view of the alley showing
some of the graves partly exposed;
from the N.

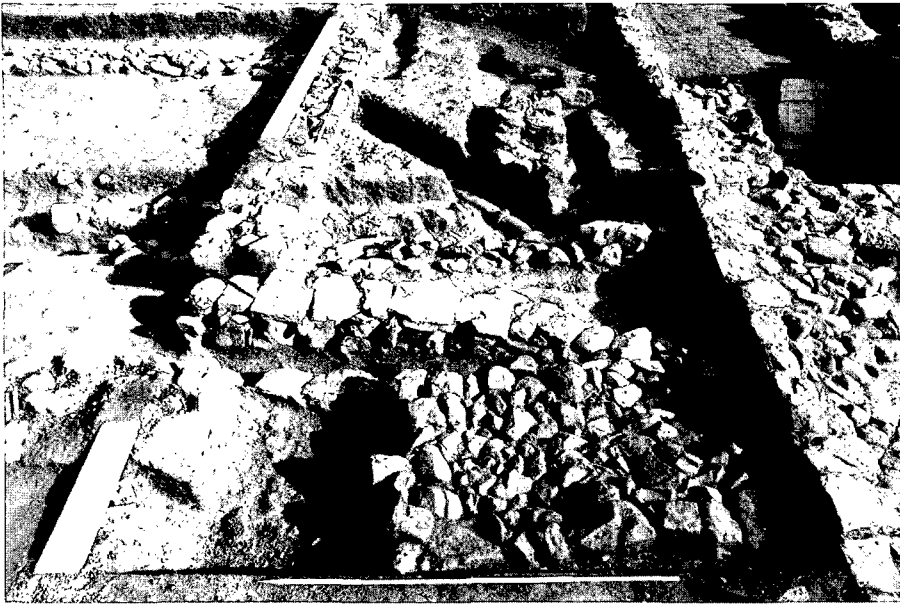
Illus 17
Drain and the foundations of the
walkway in the South cloister
alley; from the W.

The original South alley (illus 17) was 3.4m wide: only one damaged feature from this period, Grave 1308, survived within it. The contents of the grave had been removed before 1984, leaving

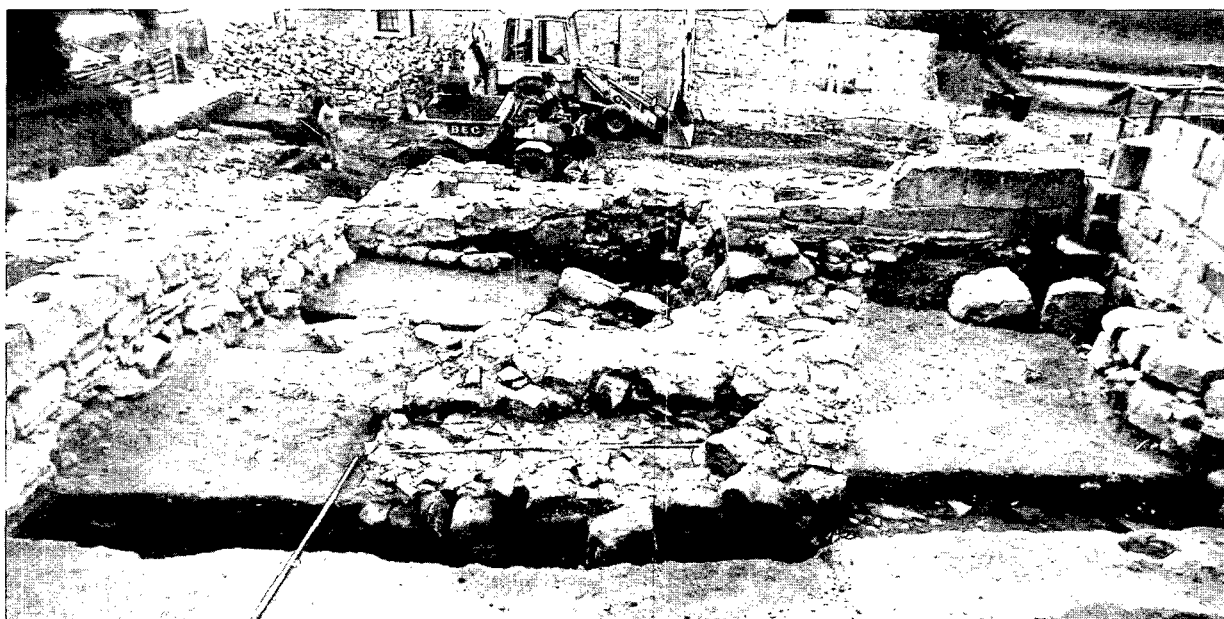
Illus 22

The probable footings of the day stair in Room 4; viewed from the N.

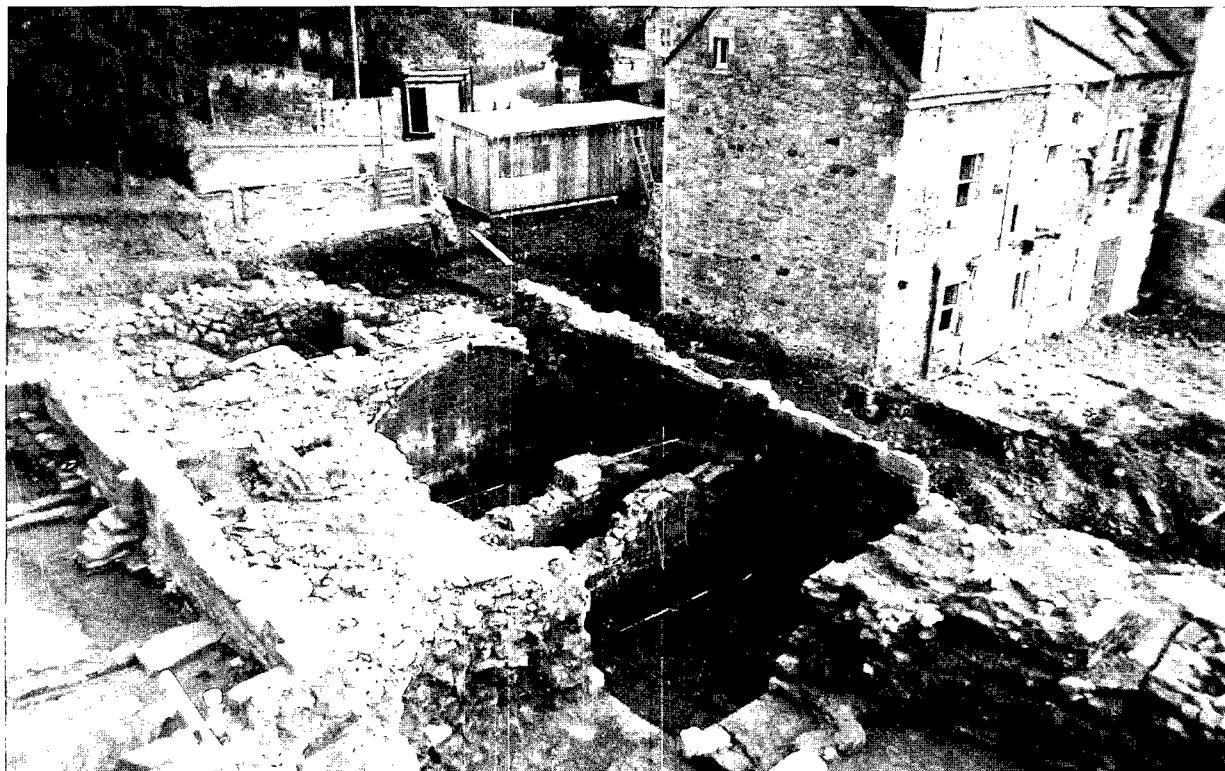
Illus 25

The S end of the East range. Note the massive walls on the N, E and W sides of Room 6. No 4, Abbey Bridge End (now a visitor centre) stands over the remains of the reredorter; from the NW.

The undercroft was two bays (approximately 8.0m) wide and, although at least two bays long, its original extent could not be ascertained because the building was badly damaged at its S end (illus 25). The thickness of the E wall increased from 1.3m to

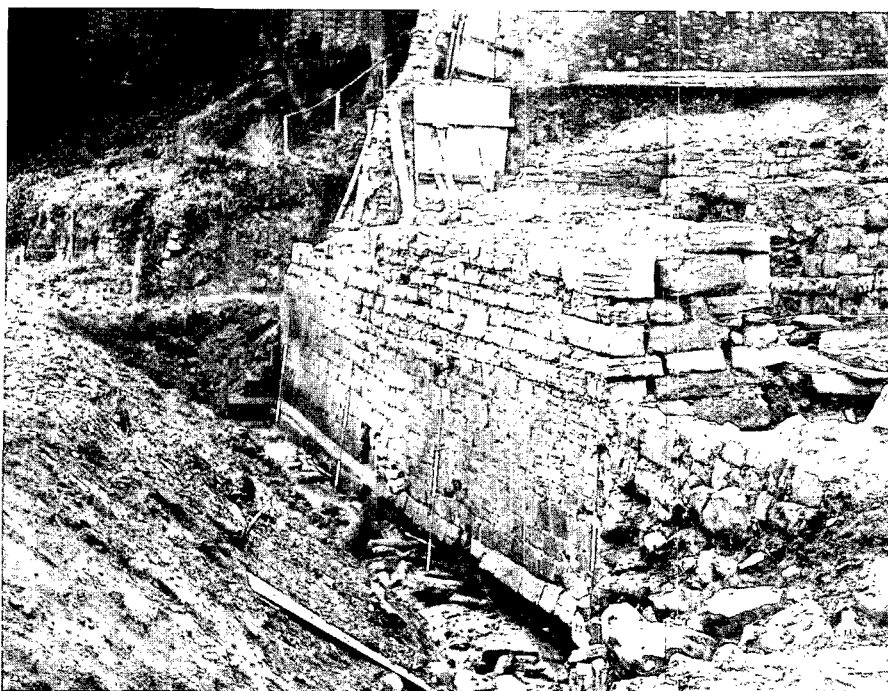
Illus 30
The S wall of Structures 8 and 13;
from the SE.

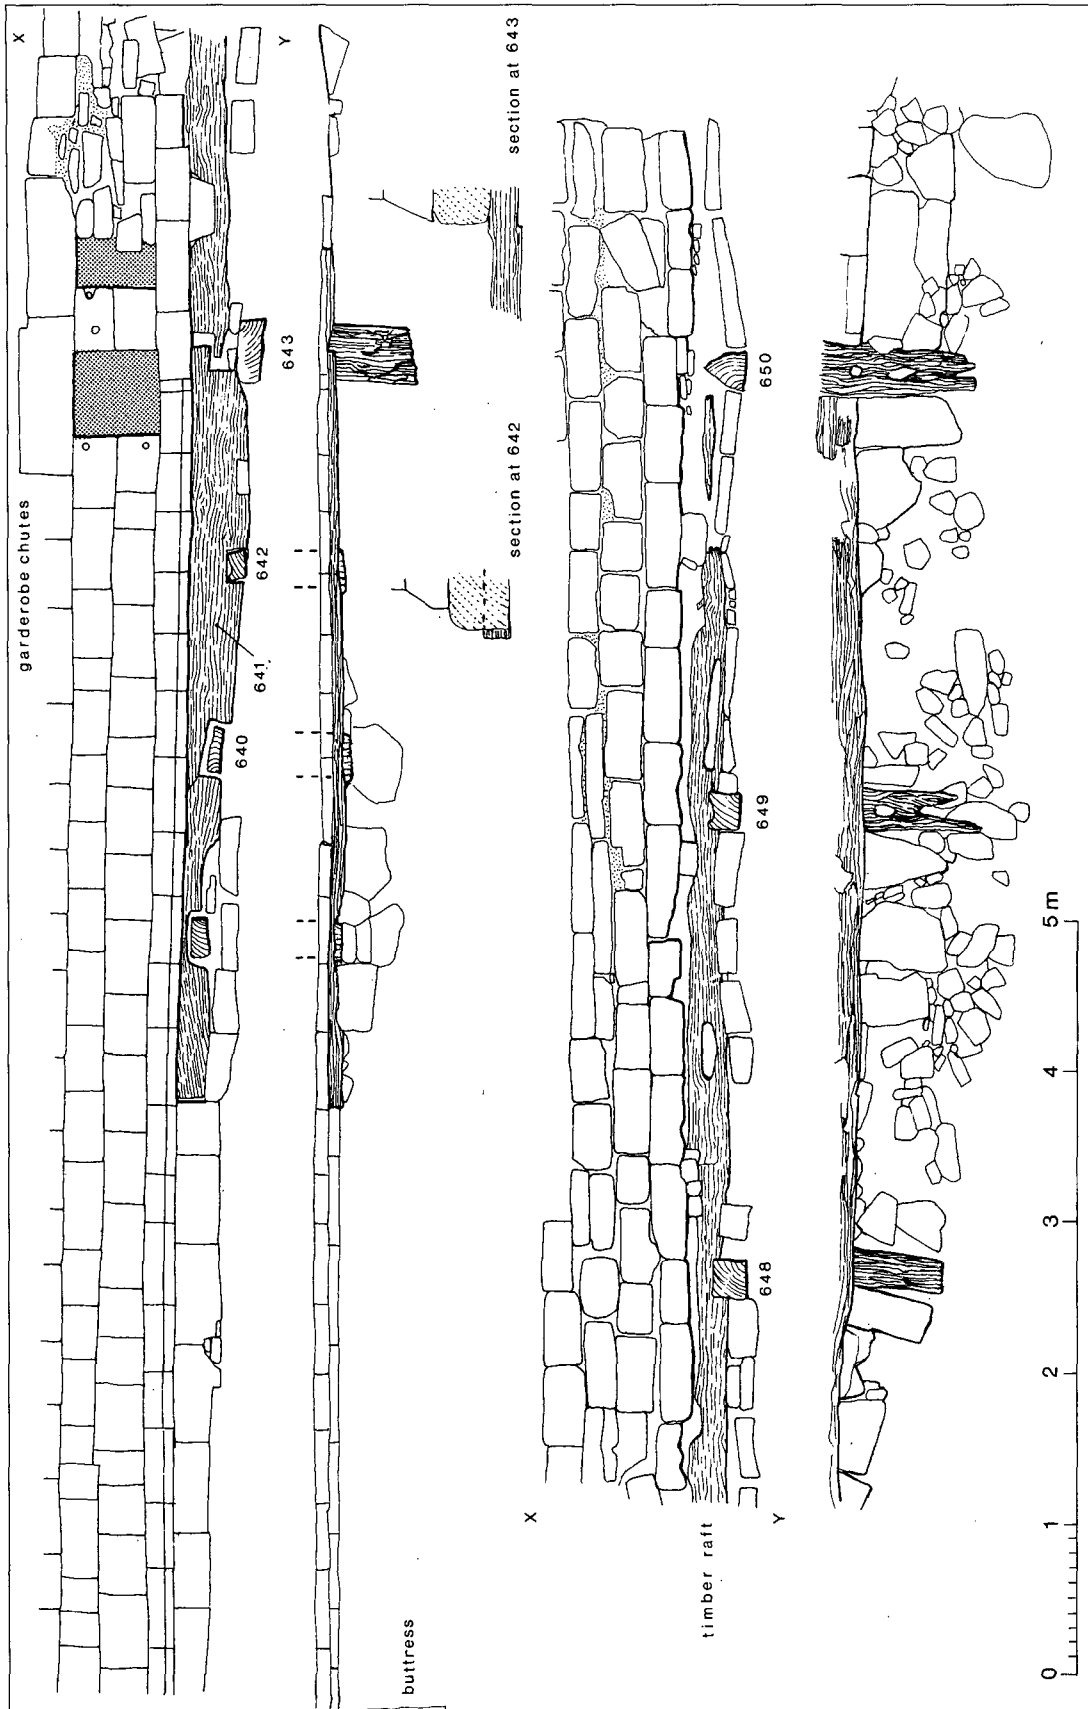
Illus 31
Elevation and plan of the lower courses of the S walls of Structures 8 and 13.

The wall was constructed of large ashlar sandstone blocks (illus 31), mortar-bonded and of general uniformity, with an average width of 1.4m and an overall length of 10.5m. At its S face, the stonework was built over a substantial timber raft and, to the N, it had foundations of river boulders (as noted in the sondage at the E face of 2005). The use of timber was necessitated by the fact that the wall was built over clays rather than bedrock (compare with the W end of the added Period III S wall) and so the ability of such a construction to spread the weight of the masonry more

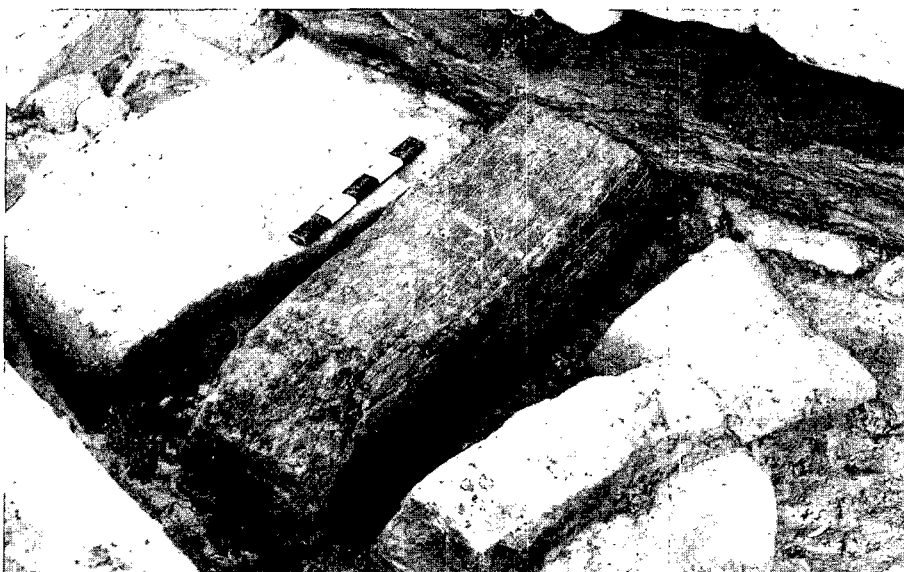
Illus 32
Detail of cross member (648), in a stone setting, supporting the timber raft.

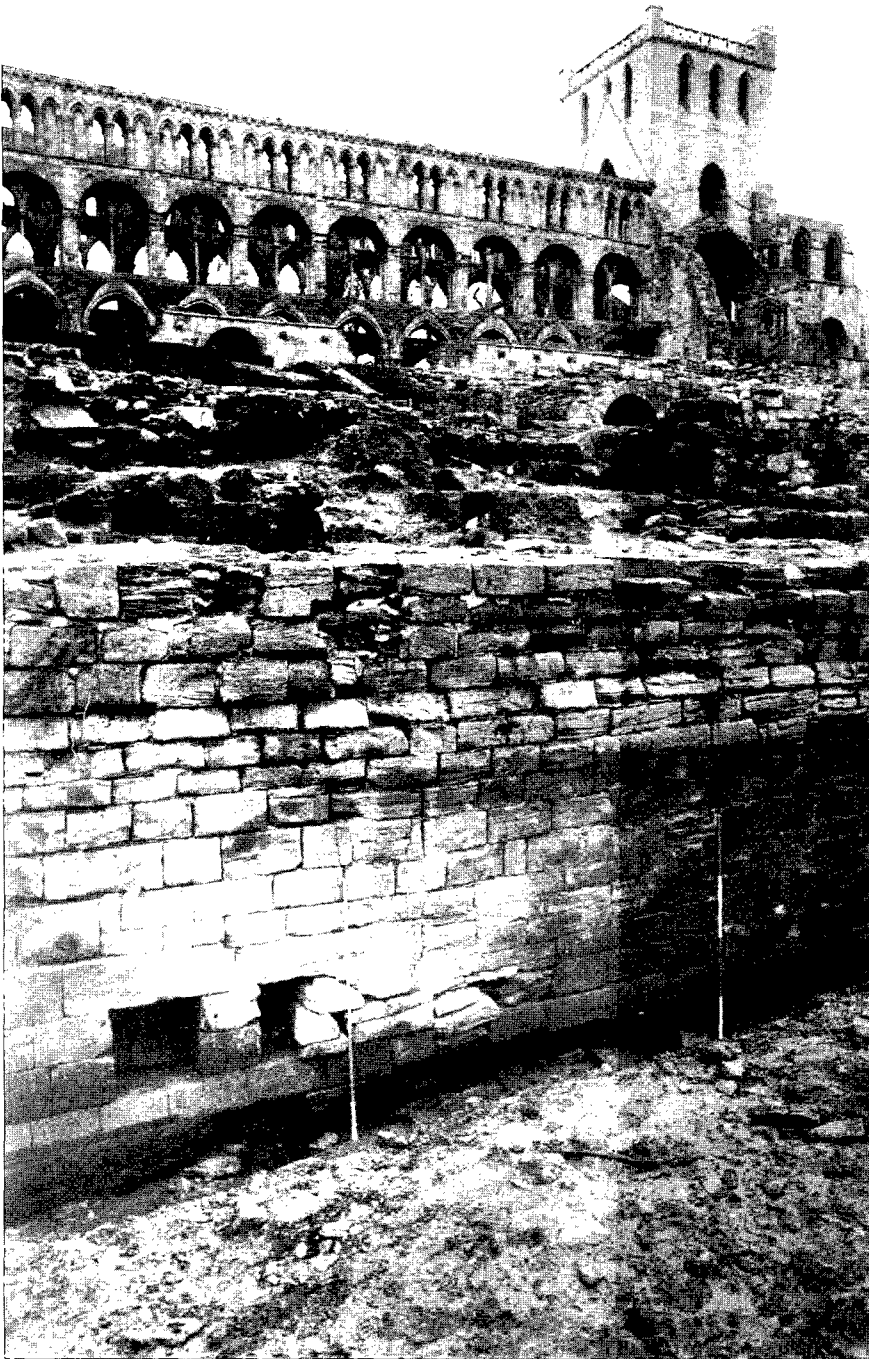
Illus 33
Detail of the S wall of Structures 8
and 13, showing garderobe outlets
and timber raft; from the S.

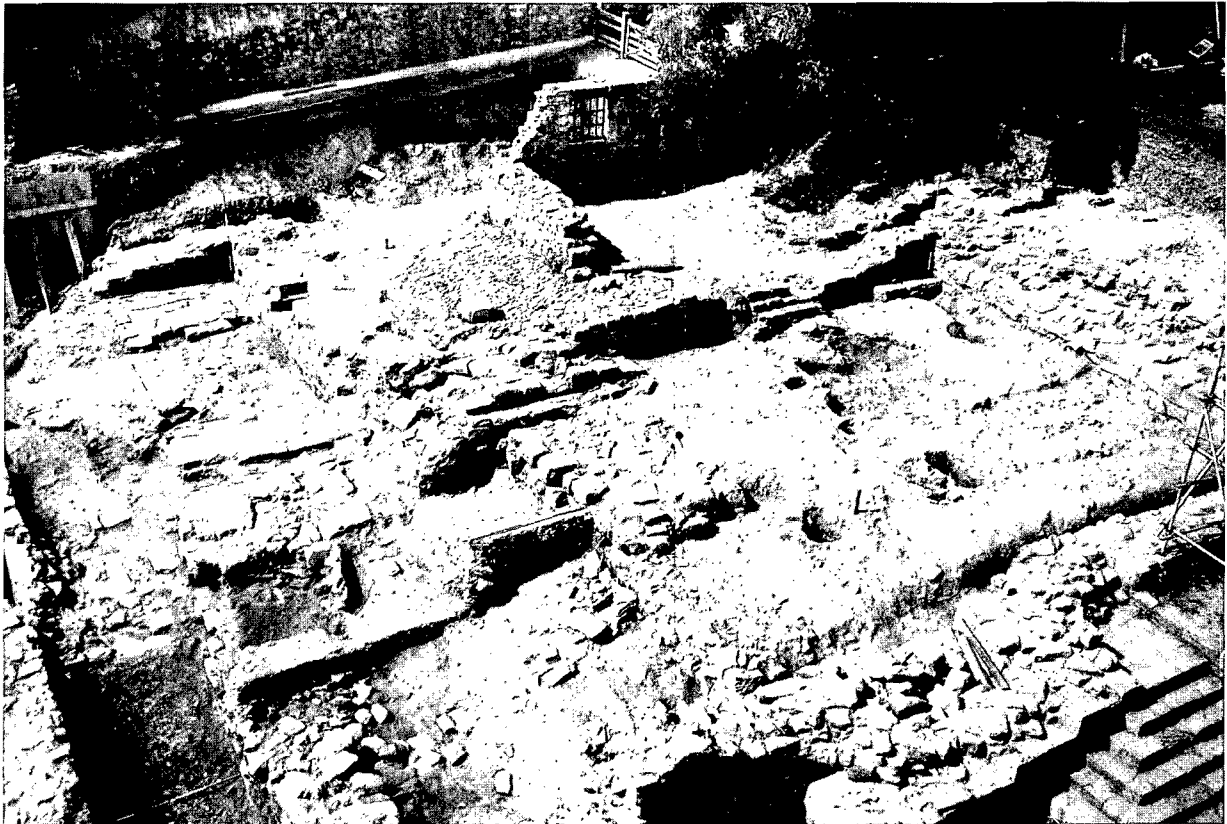
Illus 34

Structure 8 (Structure 13 is in the left background); from the E. The pend lies towards the bottom left. The steps on the bottom right were associated with Structure 9. To the top left are the remains of an outbuilding contemporary with the manse.

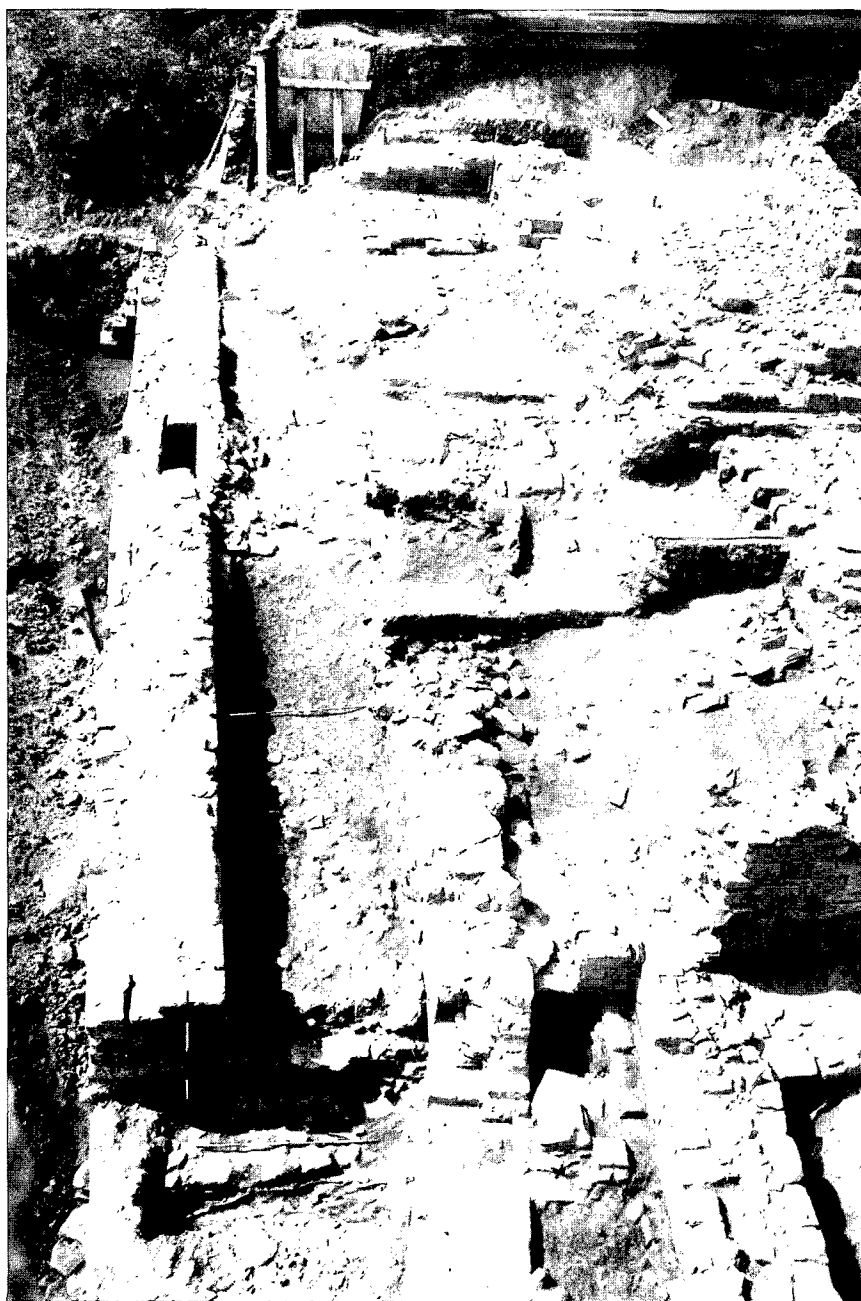
Illus 36
The pend leading into Structure 13;
from the E. The W end of Structure
9 is visible at the bottom of the
picture with drain 386 issuing
through its S wall.

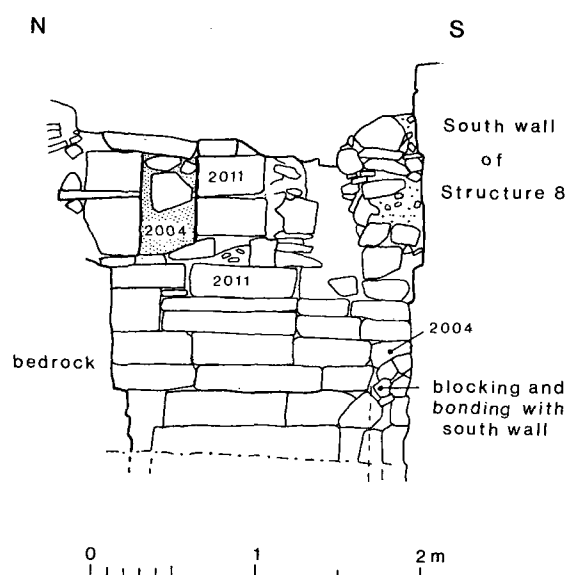
Illus 39
Elevation of the outlet for the phase 2 W drain.

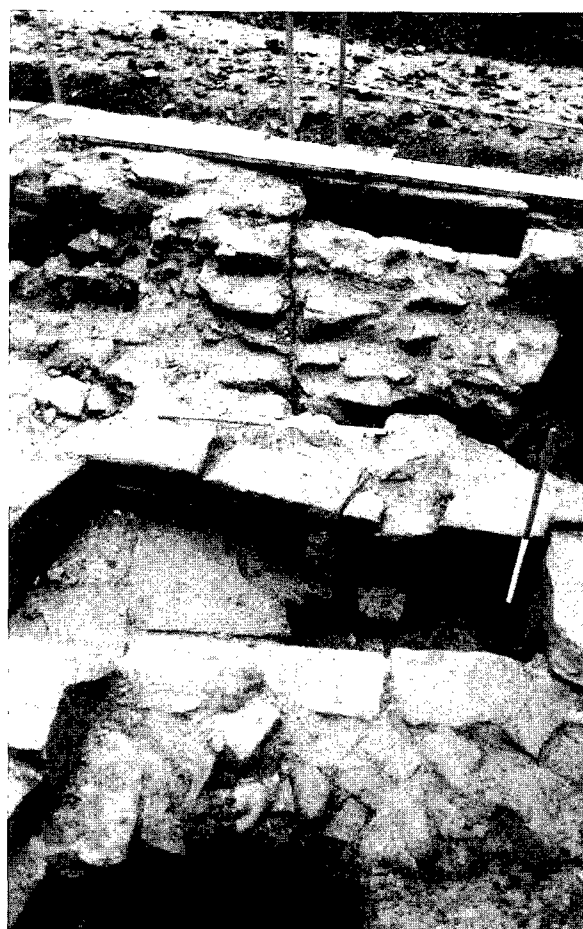
Illus 40
Phase 2 W drain; from the N. The junction between Period II platform C and masonry associated with the W drain (2011) is plainly visible towards the centre of the picture.

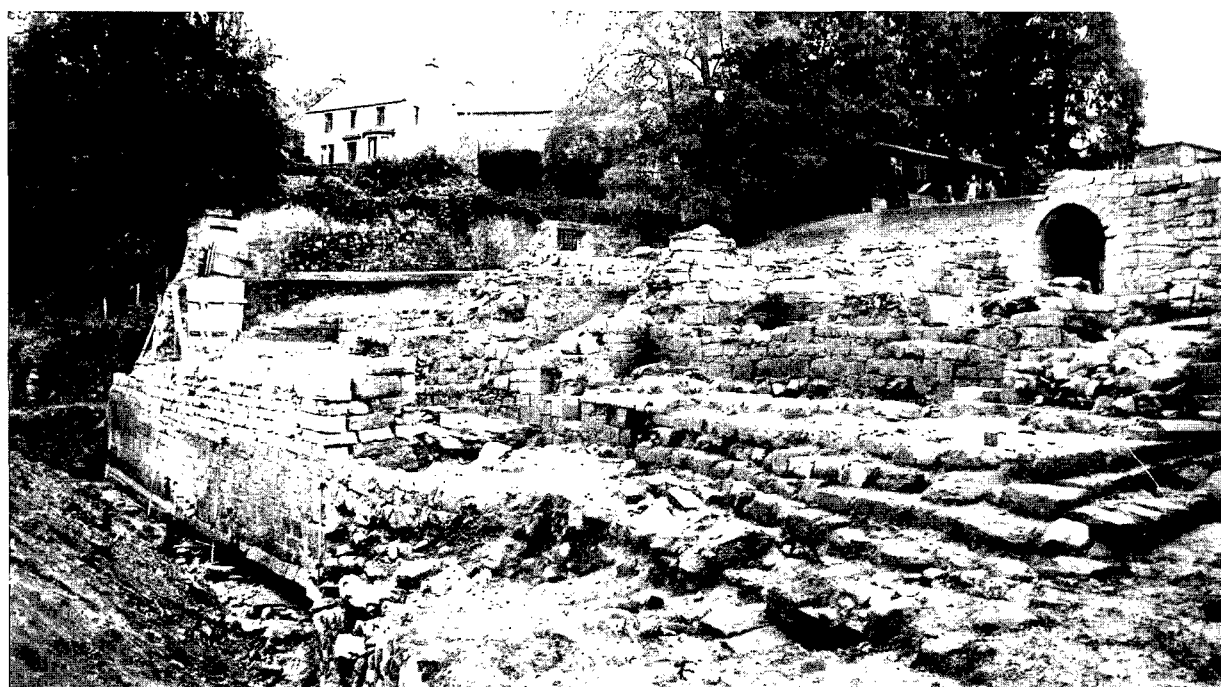
Illus 42

The stepped S wall of Structure 9; from the SE. The S limits of the Period II masonry are partially obscured by the Period IV roadway along the edge of the river

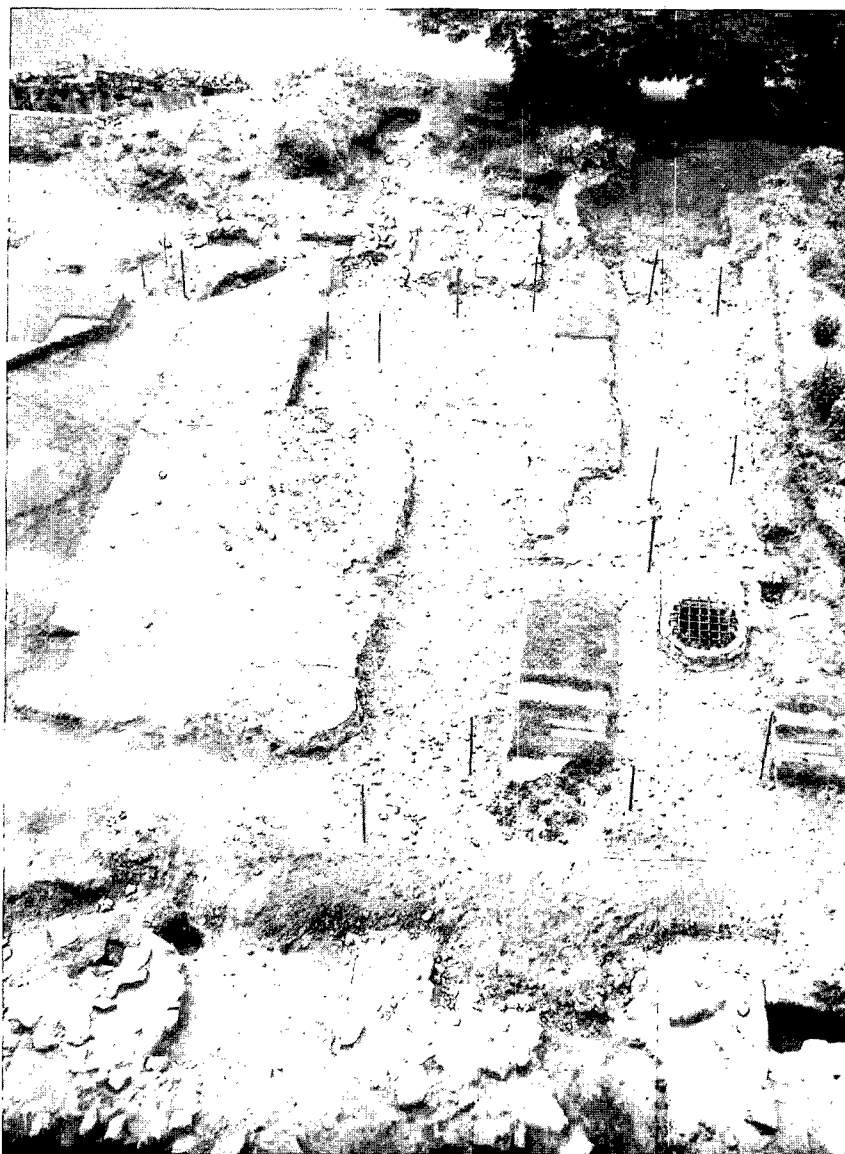
Illus 45

b) the West cloister alley in 1984, with pier base 1215 in the centre; from the N; evidence of plant beds and late drainage channels can be seen to the top of the frame.

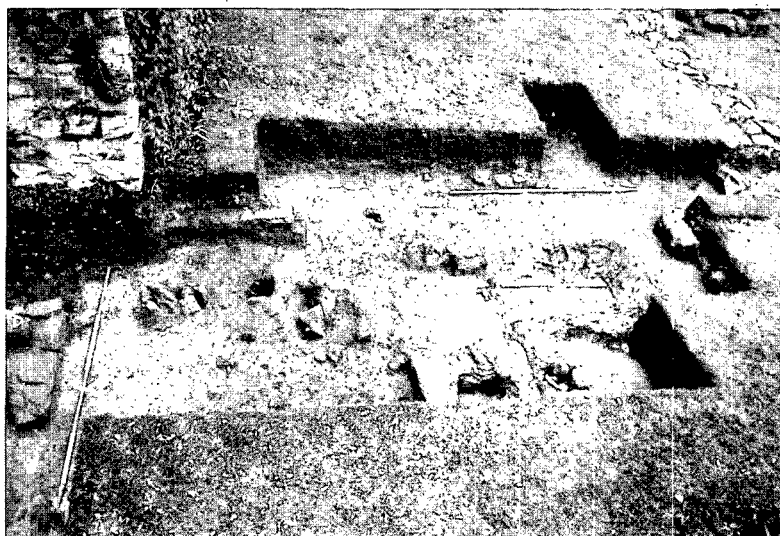
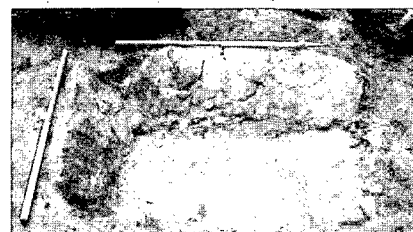
Illus 46
The industrial complex:
a) plan;
b) (below left) view from
the S; the lead-lined
trough lies towards the
centre of the picture
while fragments of
mortared surface 1230
can be seen towards the
left;
c) (below right) close-up
of the lead-lined trough;
from the N.

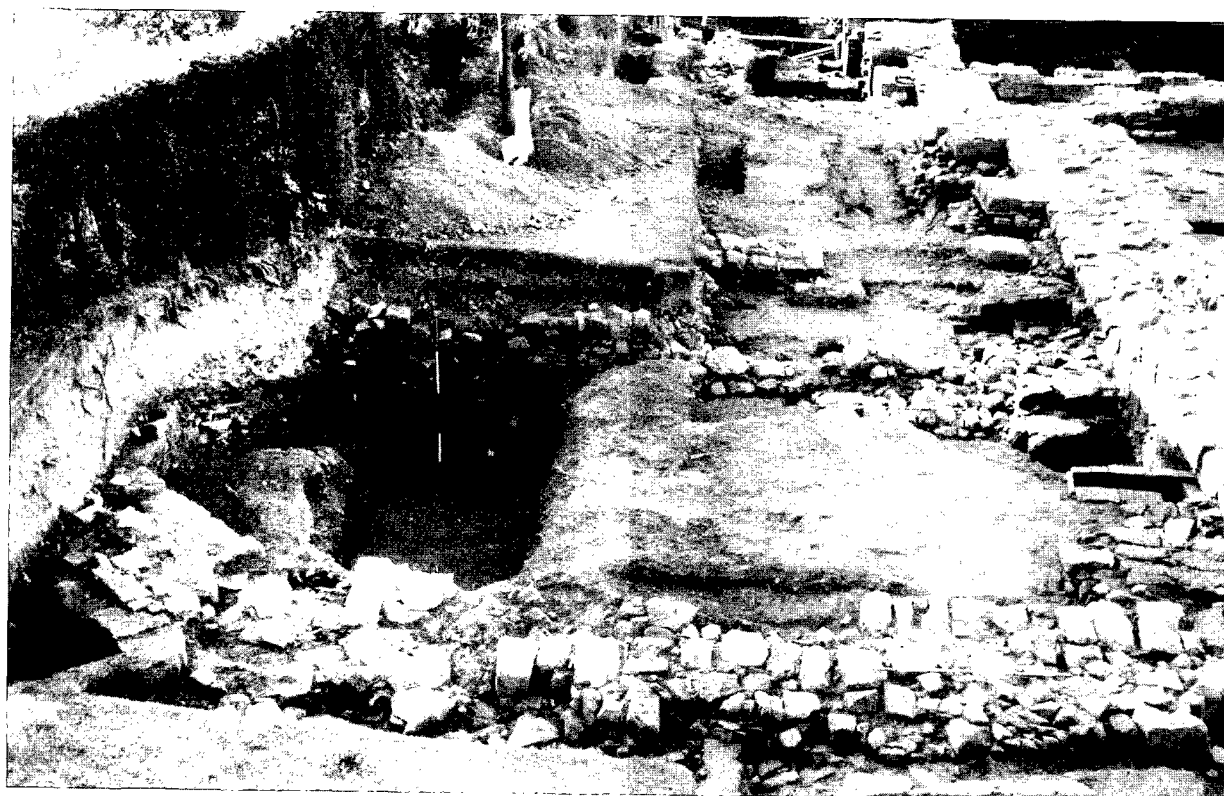
Illus 48
The E end of the Period III Chapter house. The robber trench for the E wall of the building is to the left; viewed from the N.

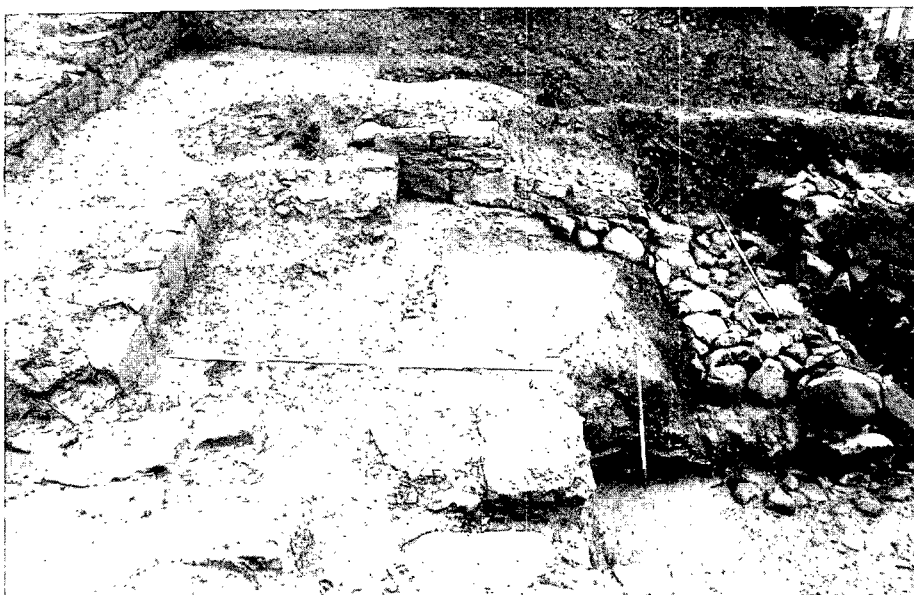
Illus 51
Room 12; from the W.

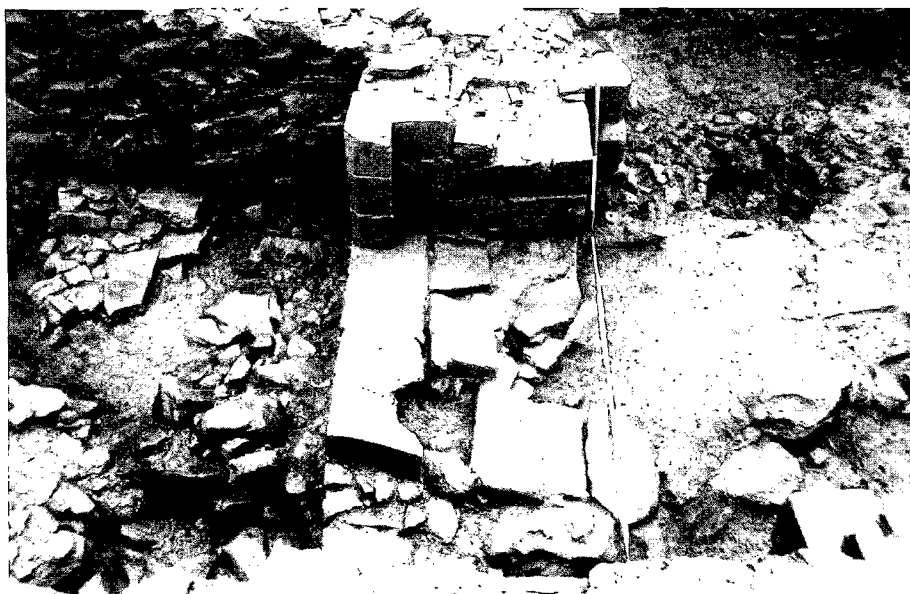
Illus 52
The doorway, built of reused
13th-century ashlar, between
Rooms 6 and 12; from the W.

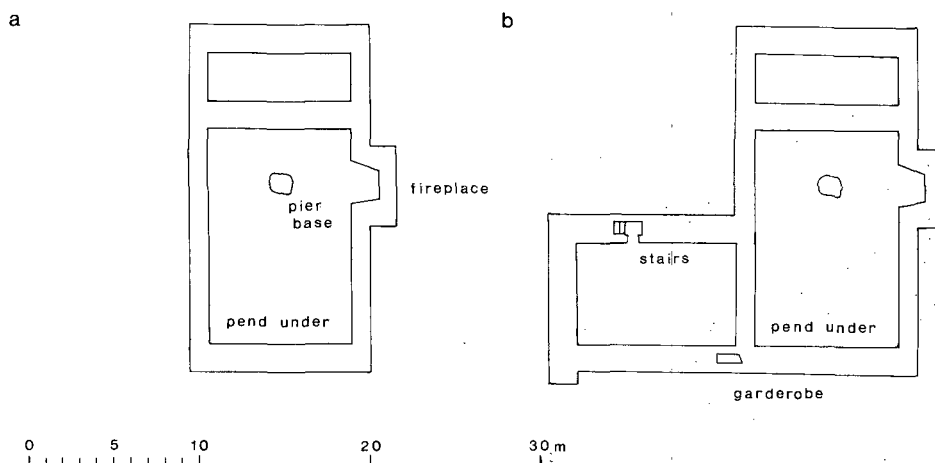
Illus 56
Diagrammatic plan of
Structures 8 and 13.

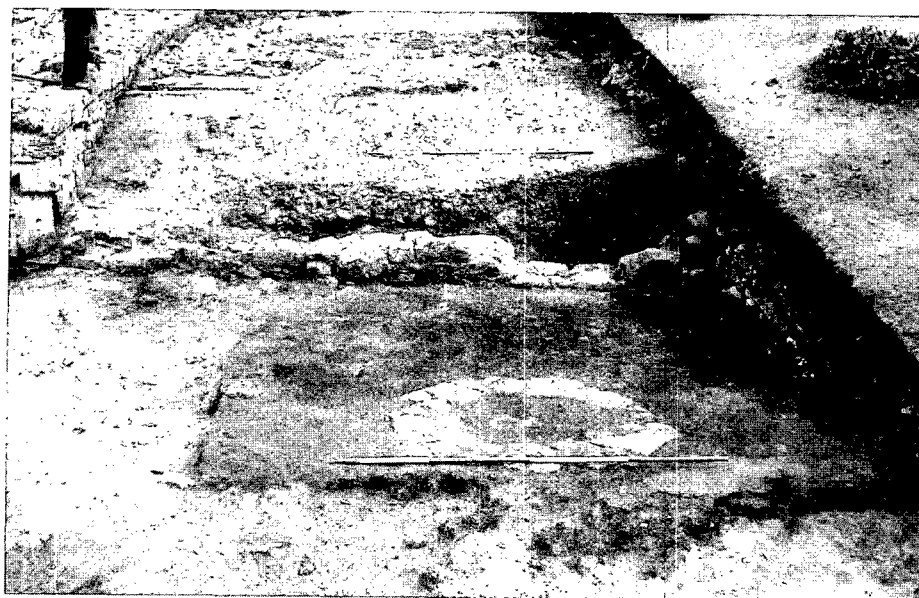
Illus 70
Room 16 (John Preston's house), built in the 18th century and converted to a smithy the following century. In the foreground is the circular stone setting for an anvil; from the S.
