DISCUSSION OF THE EXCAVATION RESULTS

6.1 PRE-AUGUSTINIAN ACTIVITY (PERIOD I)

6.2 THE BUILDING OF THE ABBEY (PERIOD II)

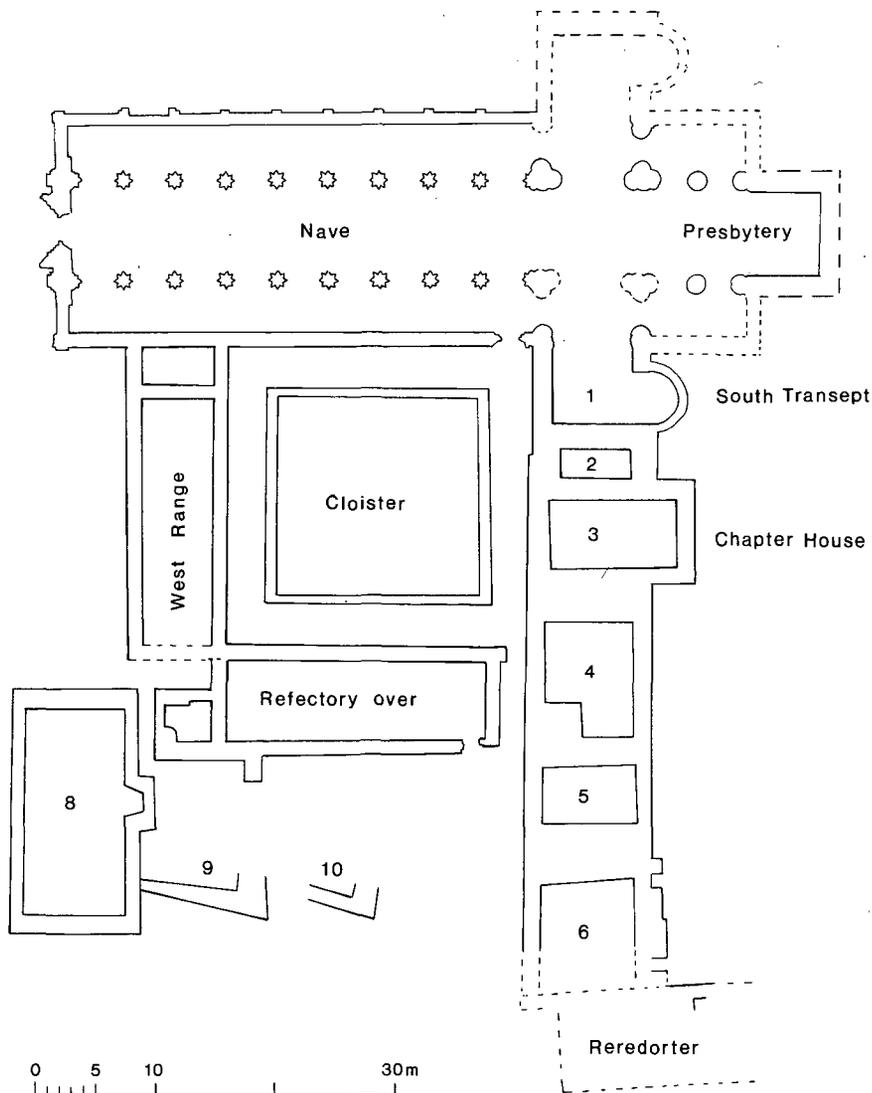
Illus 99
The layout of the abbey by the mid-13th century.

THE MAIN BUILDING PHASE (illus 99)

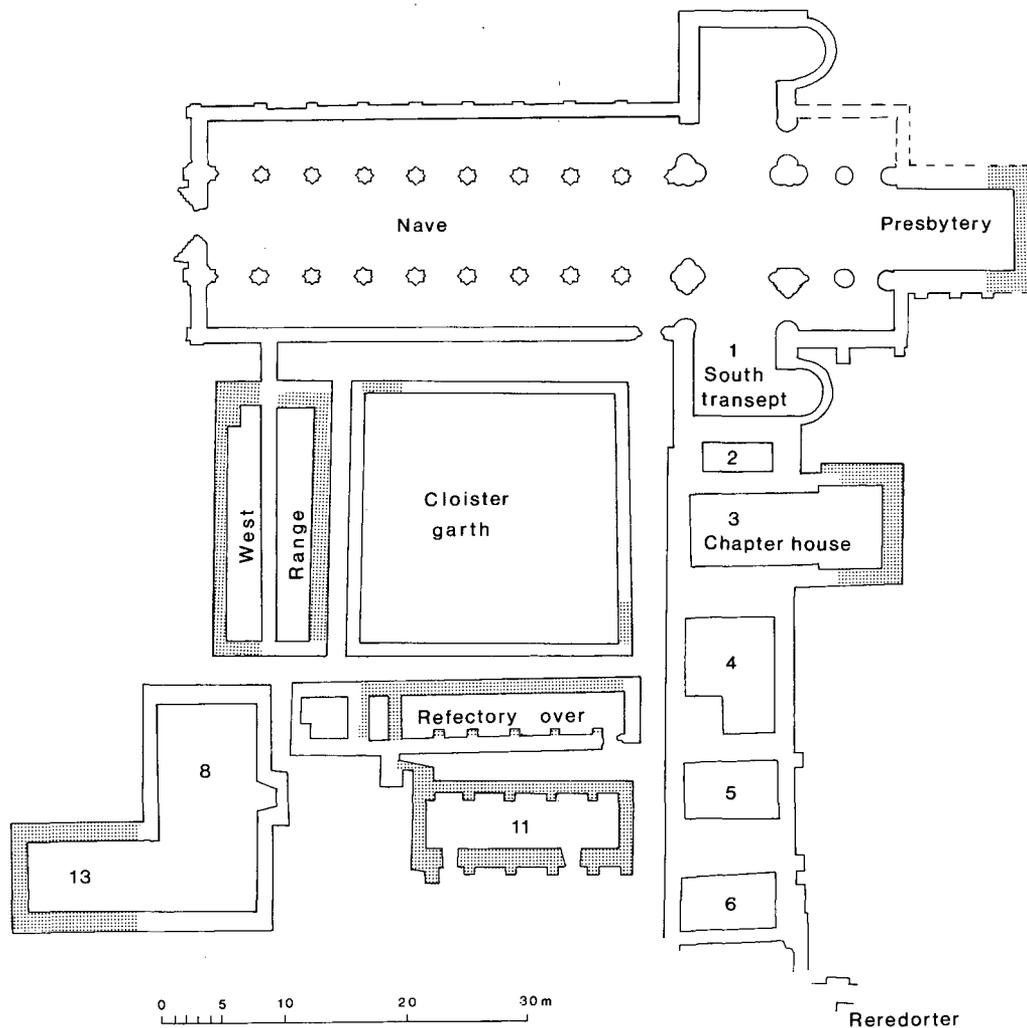
Illus 101
The layout of the abbey in the 14th and 15th centuries.

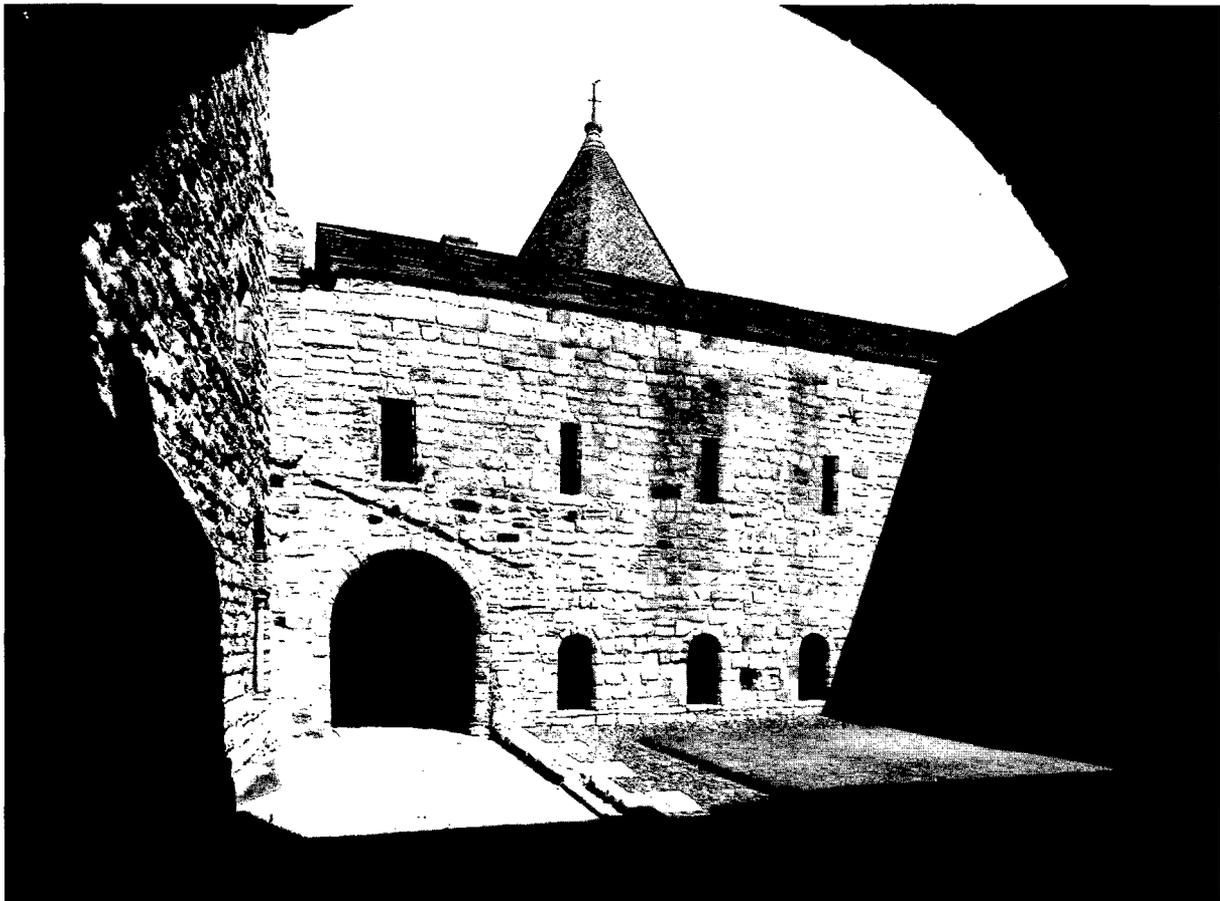
Illus 102
Inchcolm Abbey: the refectory over the South cloister alley.

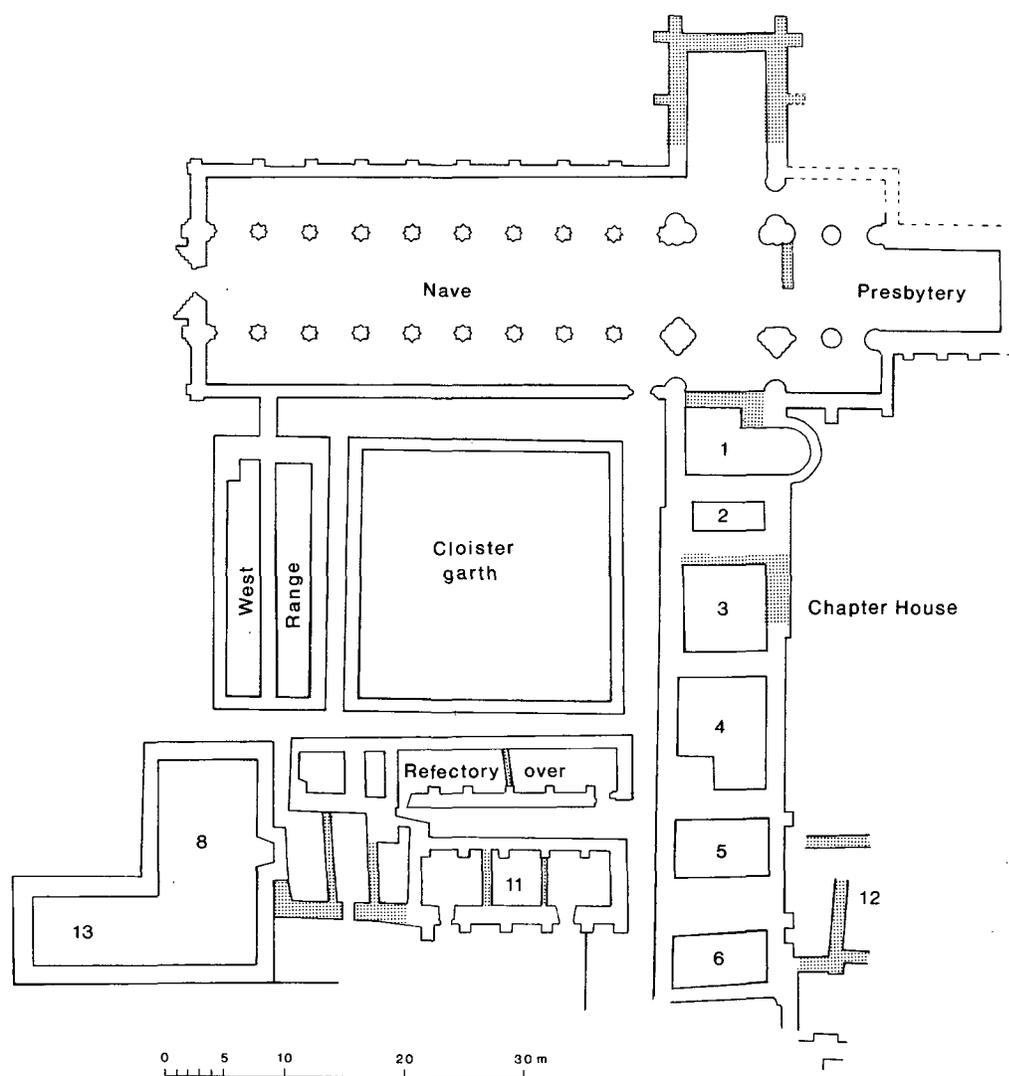
Illus 104
The layout of the abbey in the early 16th century.

6.4 LATER REPAIRS AND ALTERATIONS FROM THE LATE 15TH TO MID-16TH CENTURIES (PERIOD IV) (illus 104)

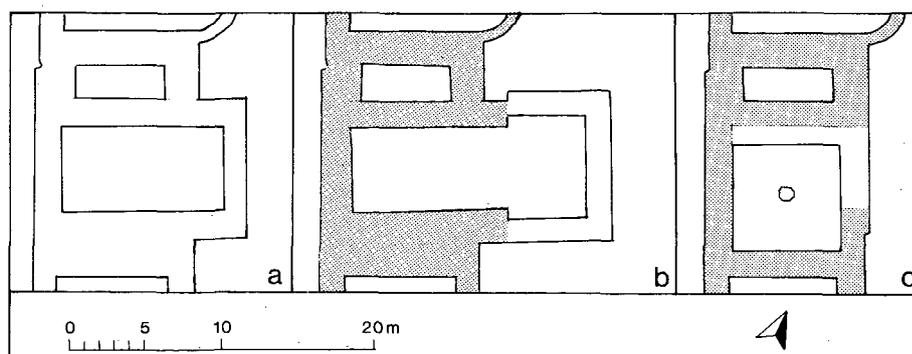
Illus 105
The principal structural phases of the Chapter house: a) Period II b); Period III; c) Period IV.

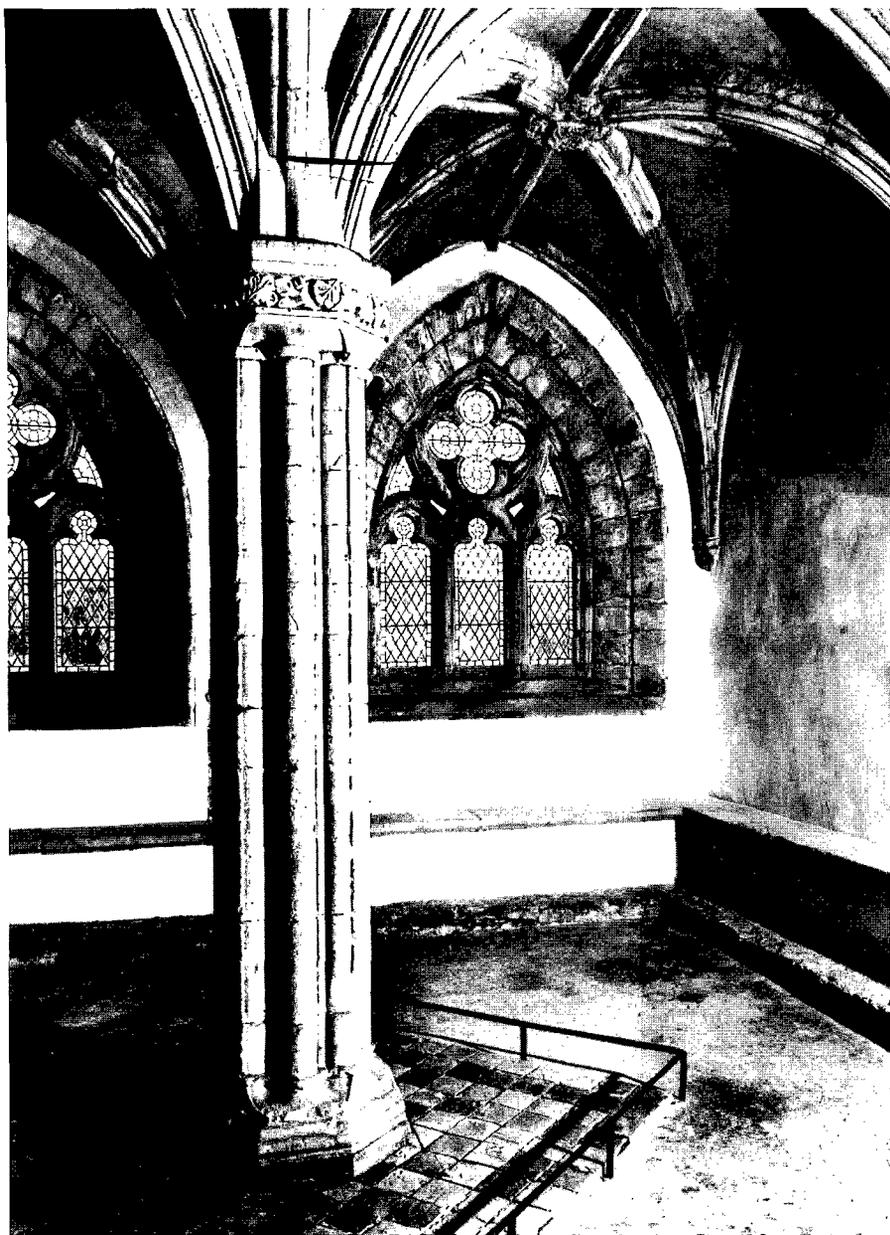
Illus 106
Glenluce Abbey: the interior of the early 16th-century Chapter house, its roof supported by a central pier.

A late 15th- or early 16th-century date for this radical change is suggested by the similarity between the octagonal pier in the centre of the chamber and those in the chapter houses at Cambuskenneth, Crossraguel and Glenluce abbeys (RCAHMS 1963, 128; MacGibbon & Ross 1896, III, 138; RCAHMS 1912, 106). The small number of interments (all coffin burials) that post-dated this change – three in the backfilled robber trench 888 and two adjacent to the N wall – support a relatively late date for this phase of reconstruction.

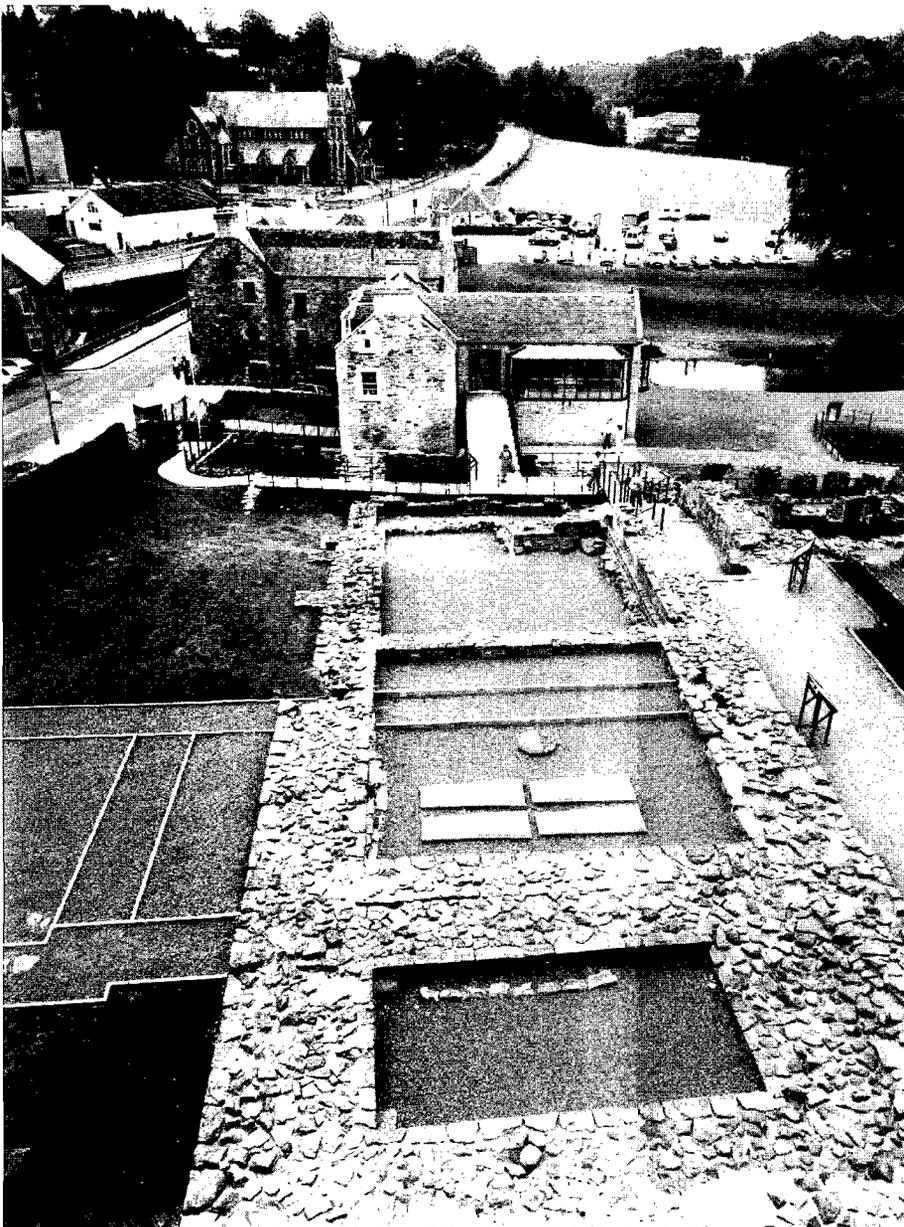
Illus 107
The East range in 1987,
showing the layout of the three
phases of the Chapter house.
The new visitor centre stands
beyond the S end of the range.
