MILTON LOCH CRANNOG I. A NATIVE HOUSE OF THE
2ND CENTURY A.D. IN KIRKCUDBRIGHTSHIRE.

BY C. M. PIGGOTT, F.S.A., F.S.A.Scot.

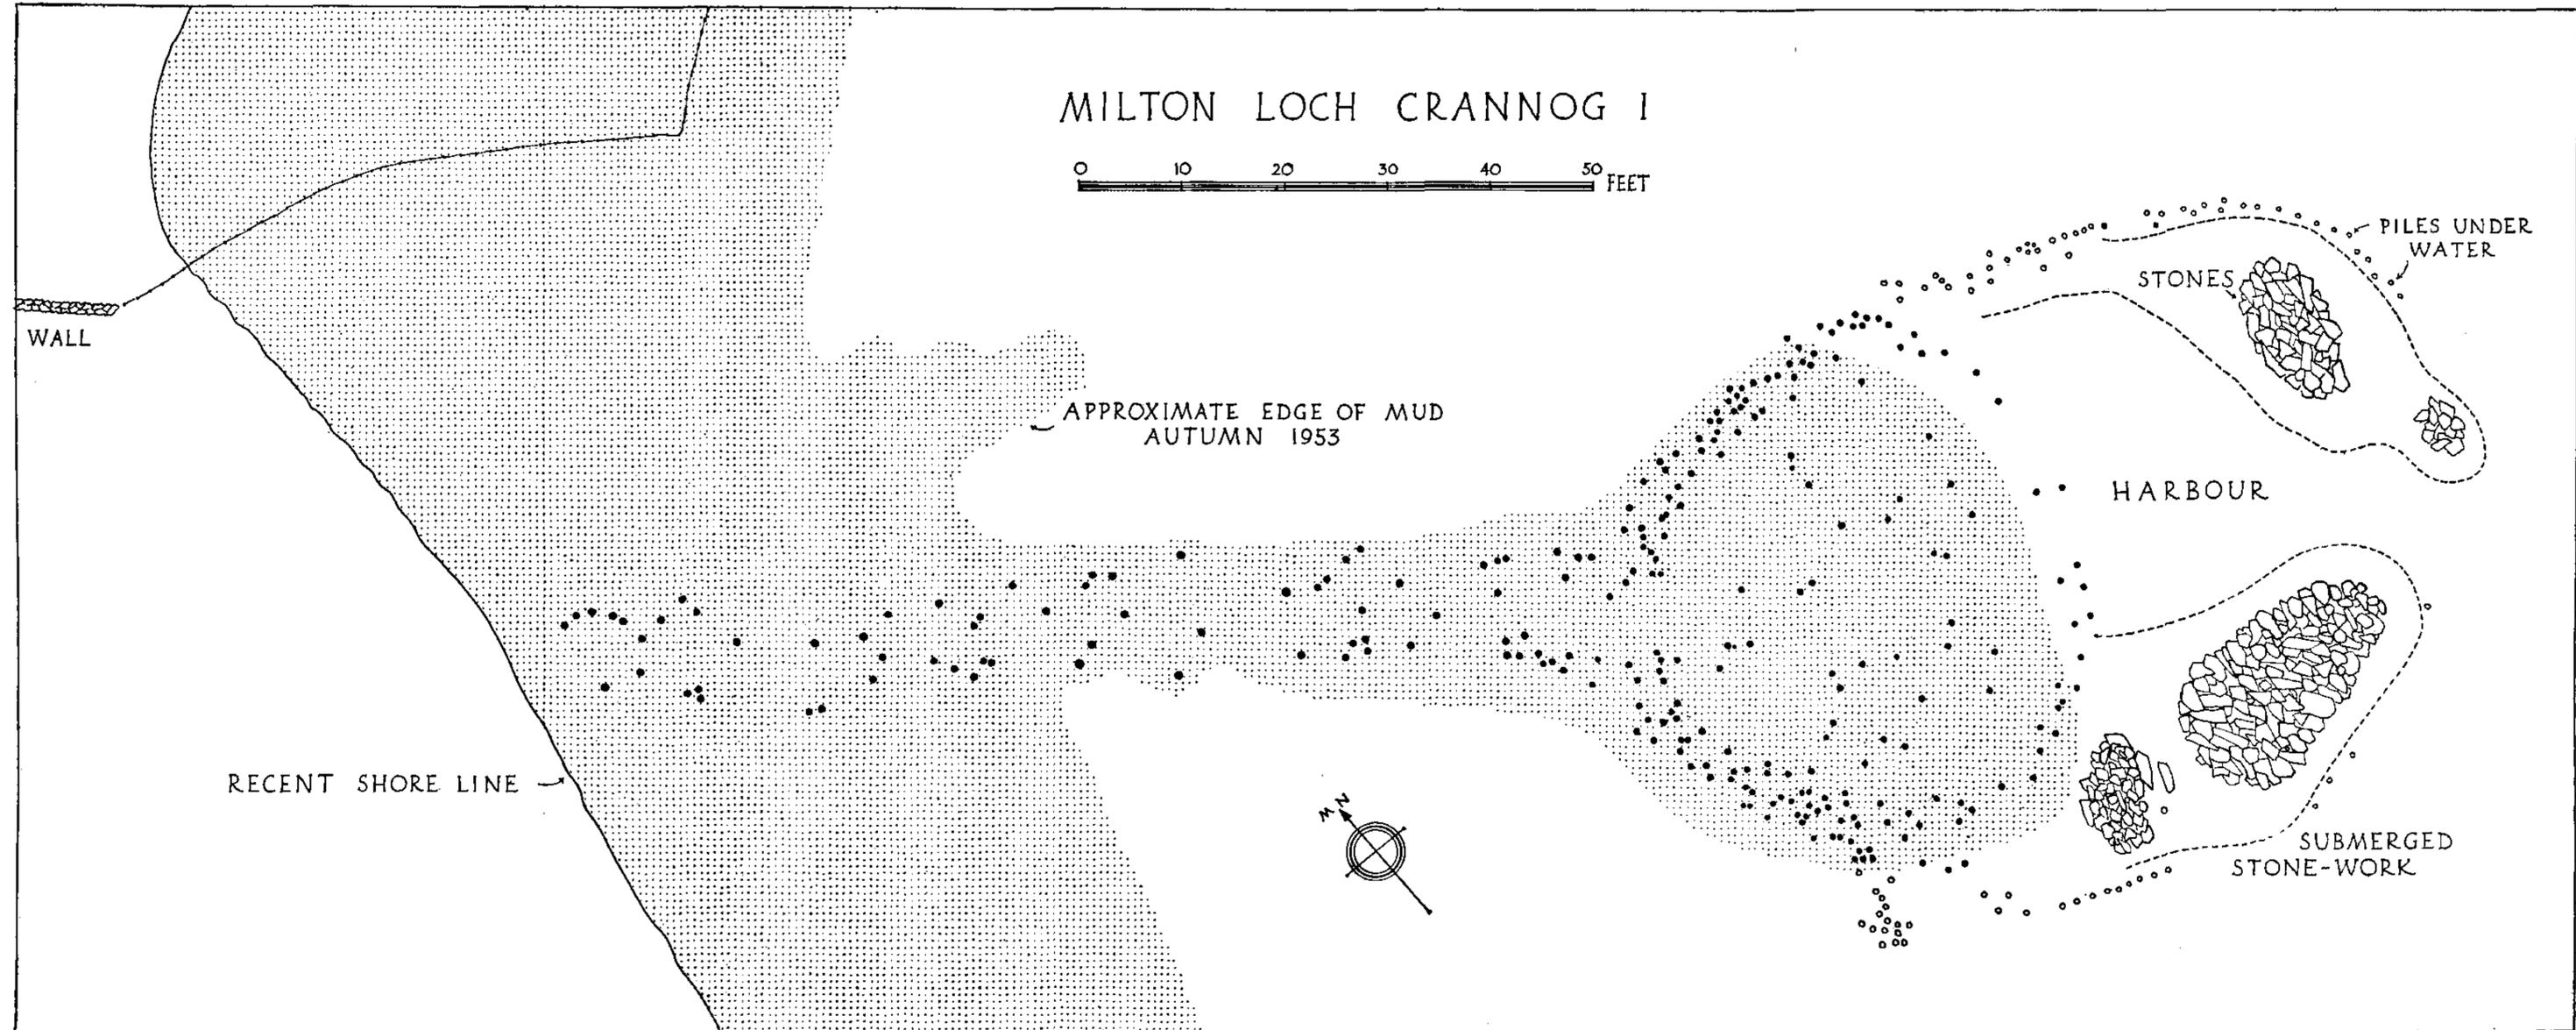
Fig. 2. The crannog with its causeway and harbour.

At the beginning of the excavation the crannog appeared as a round stone-covered island some 35 ft. across, and joined to the shore-line by a causeway represented by two approximately parallel lines of upright posts (Pl. X and fig. 2). Stumps of similar posts were protruding through the stones of the crannog itself, and beyond it into the water on the SW. On the S. side the radial arrangement of the foundation timbers was clearly visible, though on the E. these foundations were altogether absent, and had no doubt been displaced and washed away in the course of many years of exposure to the prevailing winds blowing offshore from the S. and W. Beyond the crannog on the SE. a group of piles suggested an external mole or jetty, which unfortunately at no time was sufficiently clear of water and mud to permit excavation. As can best be seen from fig. 2, an irregular collection of piled stones, mostly long and flat in shape, evidently marked the position of a retaining wall to the harbour.

From the recent shore-line, marked by a low bank, the causeway was visible from the beginning of the excavation, and measured rather over 100 ft. to the entrance of the house. The arrangement of the piles appeared to be haphazard, and can be seen in fig. 2, marking an approach, no doubt once platformed over, and about 10 or 12 ft. in width. These piles were identical with those uprights used in the foundations of the house itself.

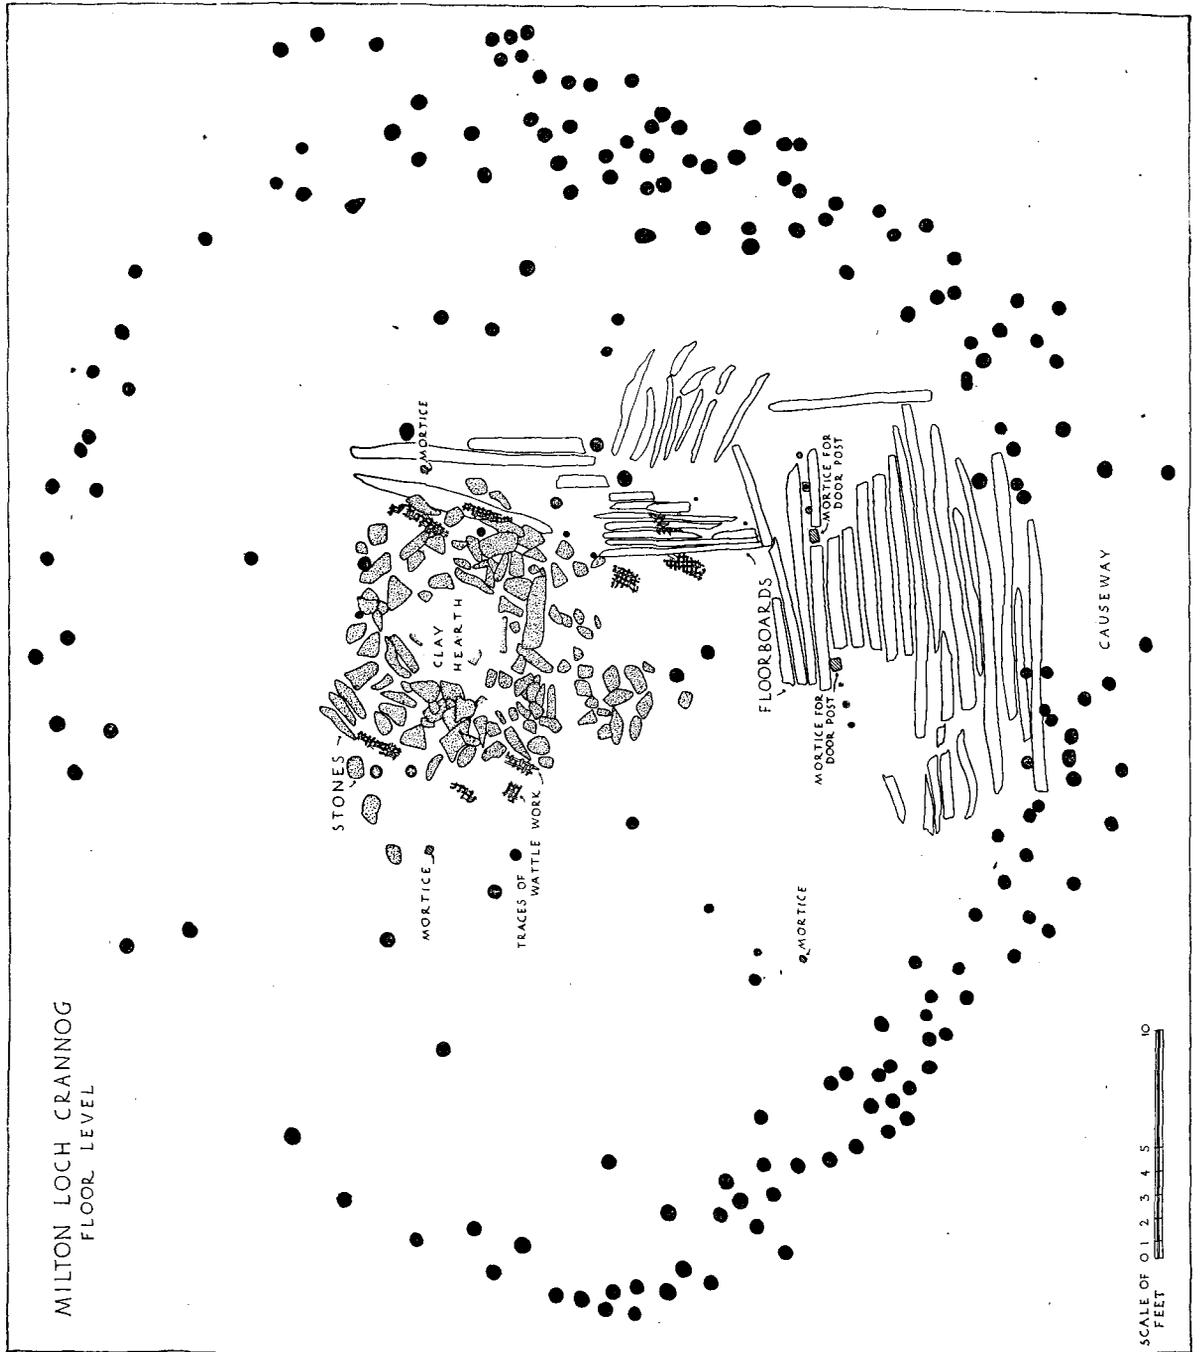
Fig. 3. Plan of floor level.

A large number of floor timbers were found *in situ* on the causeway side of the crannog. These timbers had been carefully laid side by side, and though somewhat shrunk by time and weathering, they must originally have provided a contiguous flooring. Analysis of the wood employed shows them to have been alder, which though rounded in section on the lower surface seem to have been flat on the upper side.

Large patches of wattling in a very decayed condition were visible here and there, as shown in fig. 3, overlying the floor structure, and had no doubt represented a hurdle fence of unknown height surrounding the inner room. This hurdling was of very light construction, and it should be stressed that it could never have been part of the actual outer wall of the house. At least some of this hurdling had collapsed on to the hearth area, but it had not been burnt: it had evidently, but not unexpectedly, fallen after the abandonment of the house.

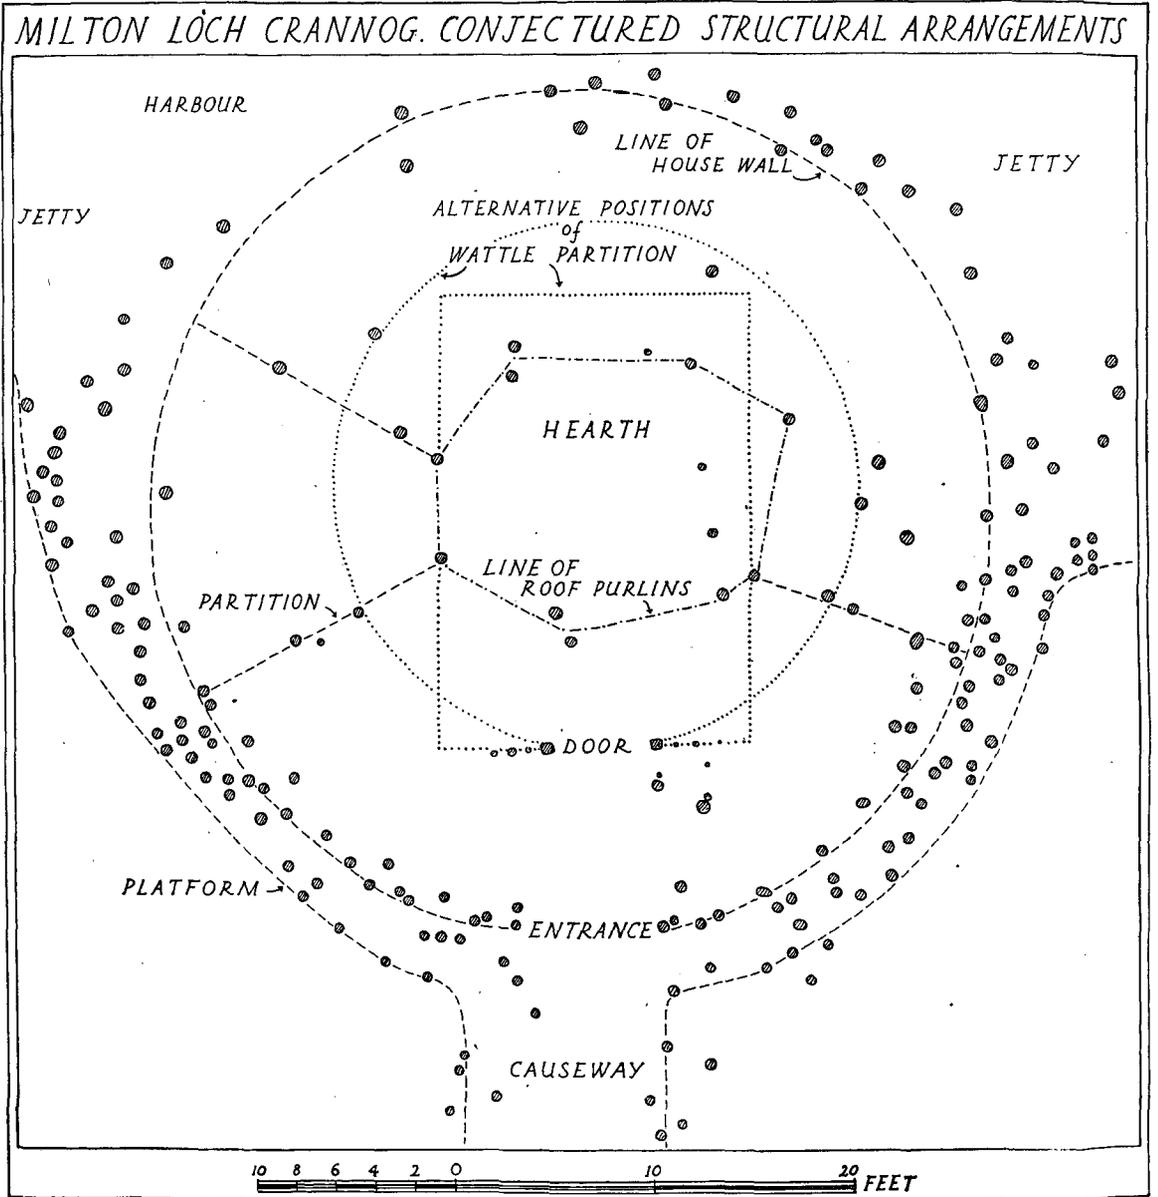
Fig. 4. Plan showing alternative internal partitions and roofing.

What can be said of the shape of this internal room? Here again, unfortunately, the answer cannot be obtained. Two alternatives have been suggested in the drawing (fig. 4) but the vital evidence was lacking. It is perhaps worth noting that it is possible to find analogues for both shapes of internal room from the native settlements of Iron Age Britain. In those examples excavated by Bersu in the Isle of Man,¹ the room was circular and concentric with the outer wall of the house, but on the other hand at Lochlee² the internal subdivision appeared to be squarish; though as in this case the excavation was not very scientifically conducted, it must be borne in mind that the features recovered might have belonged to more than one period of construction. In the opinion of the excavator the rectangular plan was slightly more convincing for the Milton Loch site, and has therefore been so shown in the isometric reconstruction of fig. 5 and model Pl. XV.

The large number of piles set at random outside the wall of the house, as seen most clearly from fig. 4, must surely have been the supports for an external platform. Such a platform would have been a necessity not only for providing access to the harbour from the land without going through the house, but more important, it would have been a valuable space for outside work such as repairing and drying nets, tying up boats, as well as being a suitable firm stand for ladders used in roof repairs and thatching. This platform, which was about 5 ft. wide, probably led straight round behind the house on to the two stone jetties on each side of the small harbour.

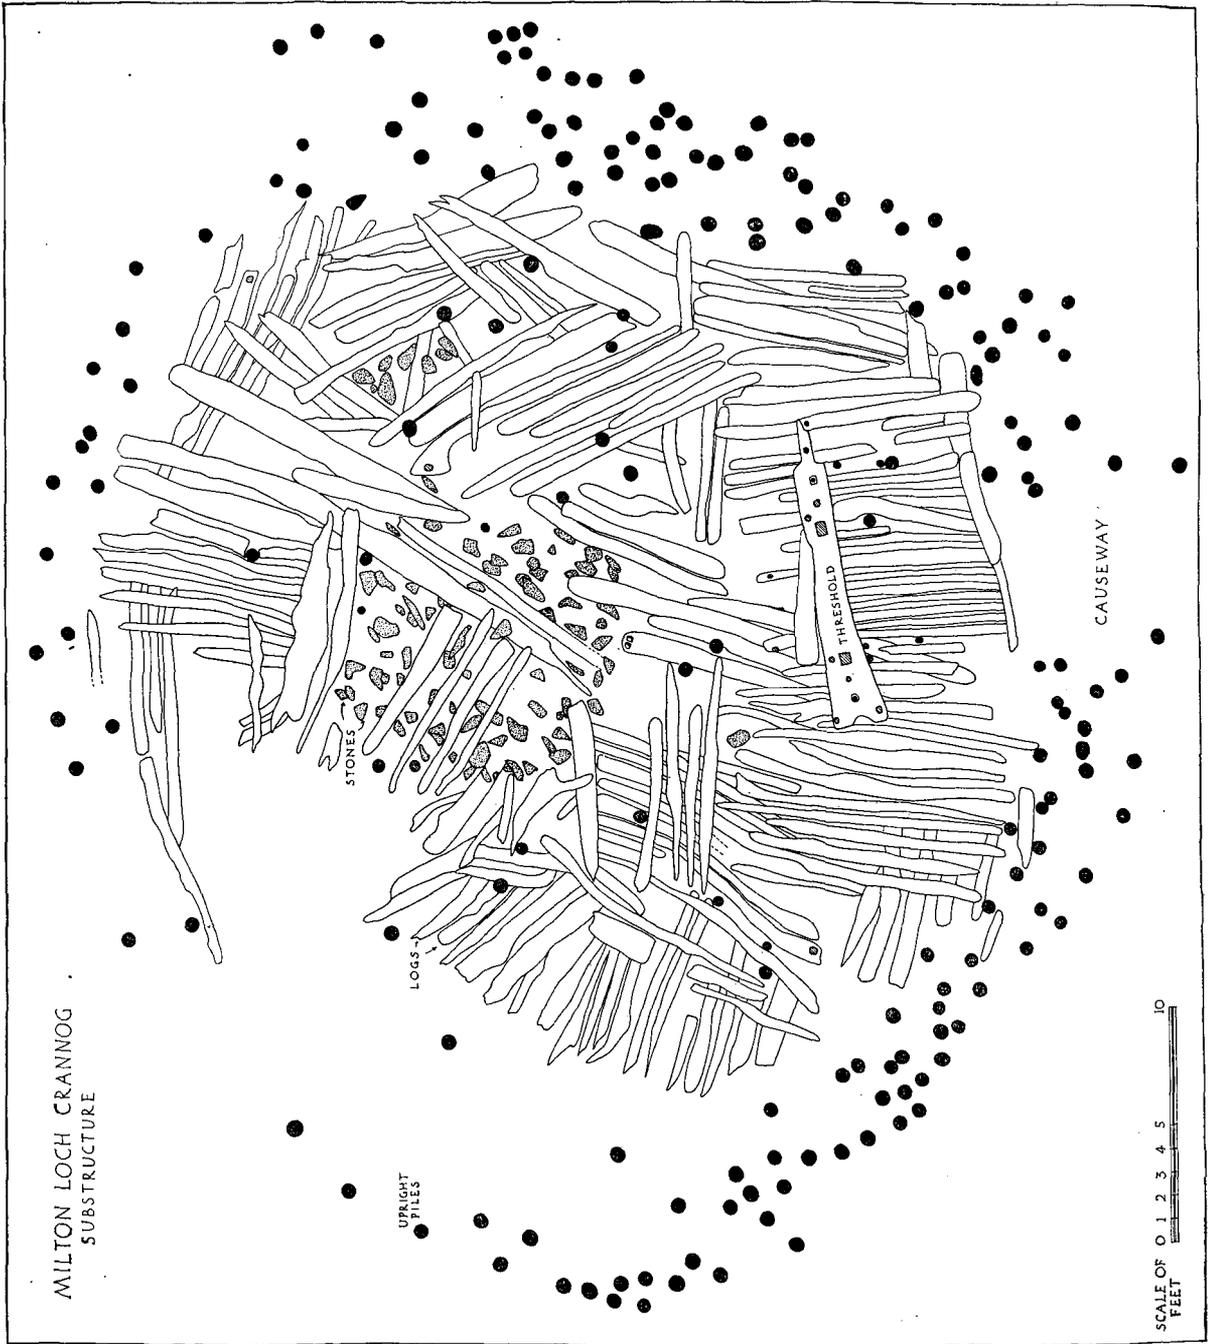
The Substructure (Pl. XIV and Plan, fig. 6).

The lower foundations, which were waterlogged, had evidently been built on a raft principle, floating on thick black mud. No *terra firma* could be found by probing, and the whole island could be made to shake by jumping

on it. Large logs, round in section and still in some instances retaining their bark below water-level, had been laid both radially and concentrically with the wall of the house, as can best be seen from the plan, fig. 6. As has already been said, much of this wood had floated away, blown loose no doubt by the prevailing wind lashing the island from the west. So much however remained that a fairly complete plan was achieved, and had the excavation been possible on a drained rather than an undrained loch, a great deal more information could have been wrung from it.

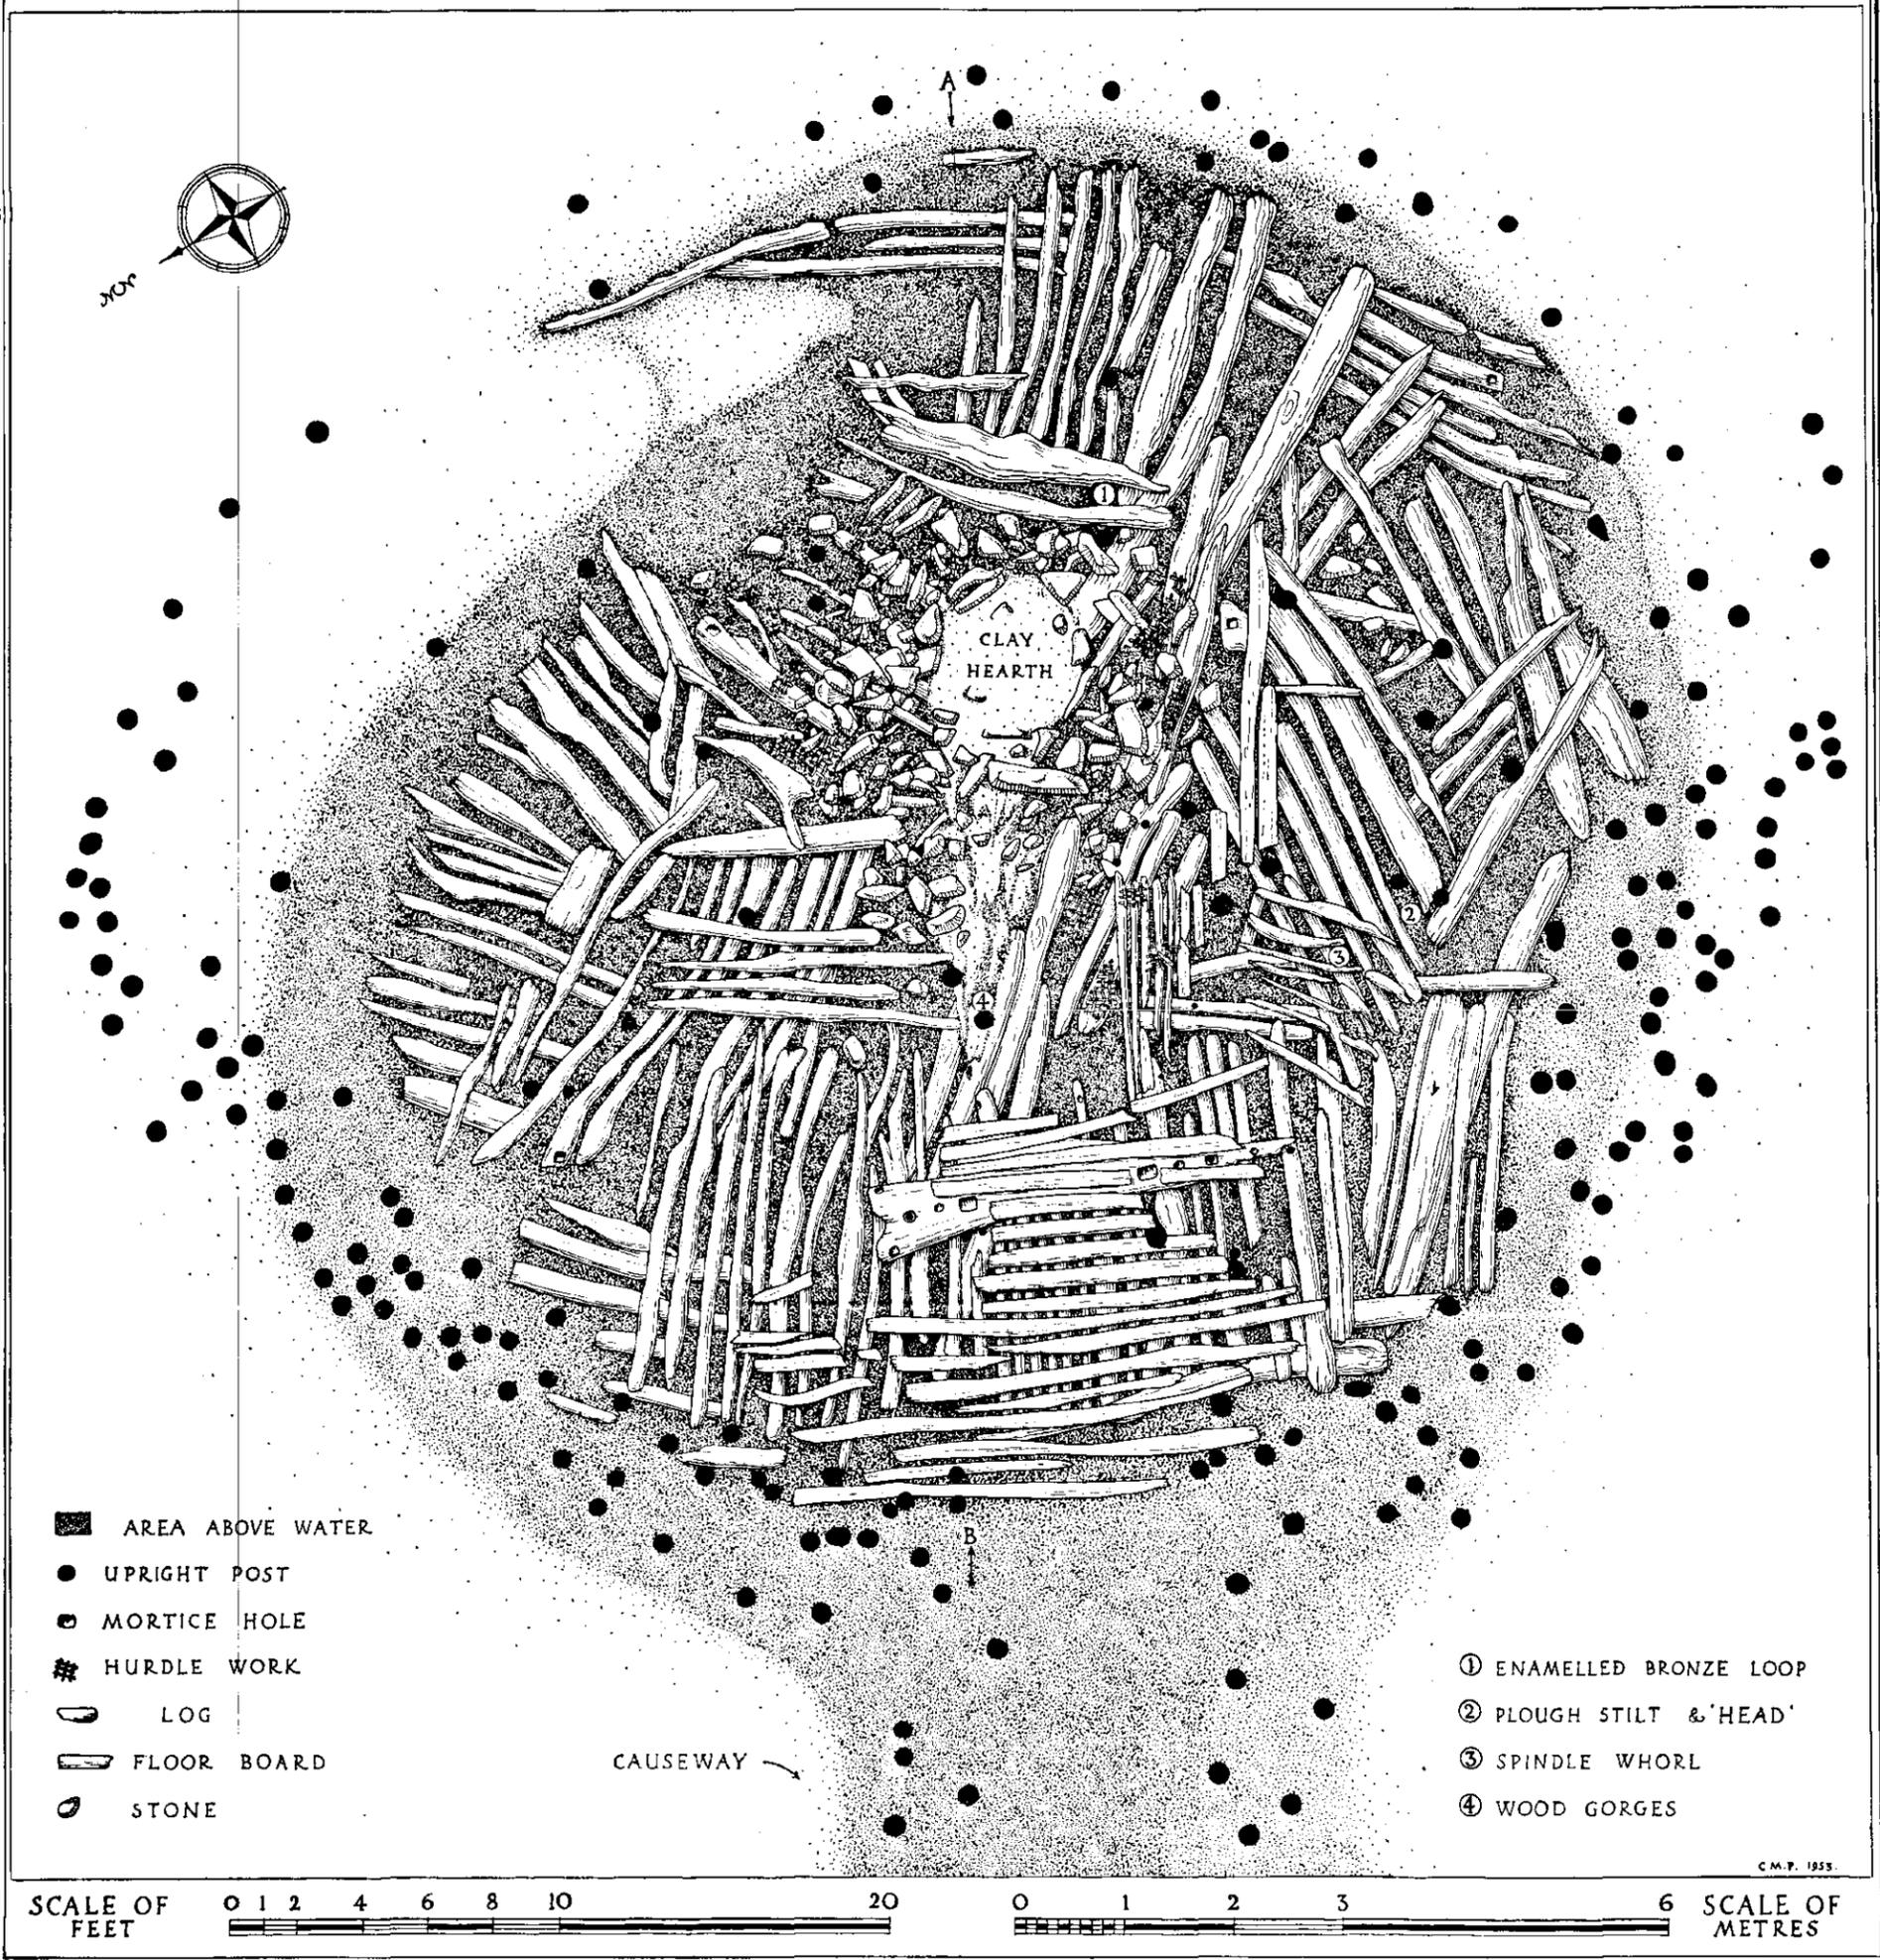
Fig. 7. Milton Loch Crannog I.
Showing structural arrangements and location of finds. (Line of Section A-B.)

From the inside of this room several finds were made on the floor surface. All are described below, and their position can be seen in fig. 7. They included two wooden gorges for catching water-birds or large fish, which were near the hearth, a crudely made stone spindle-whorl, and a bronze loop enamelled in red and yellow (fig. 9). This last find fixed the date of the crannog to approximately the 2nd century A.D.

A find of considerable interest and archæological importance was discovered at a point shown as no. 2 on the plan, fig. 7. Beneath the foundations of the crannog was found the stilt and head, originally in one piece but broken before discovery, of a wooden plough. This plough, which was

This bronze loop was found within the area of the house at a point marked 1 on the general plan, fig. 7. It retained traces of red and yellow enamel in the roundel, and doubtless originally would have been enamelled richly. It belongs to a type of ornament of which the exact use is unknown, but which may have been belt fasteners or horse harness loops. Though

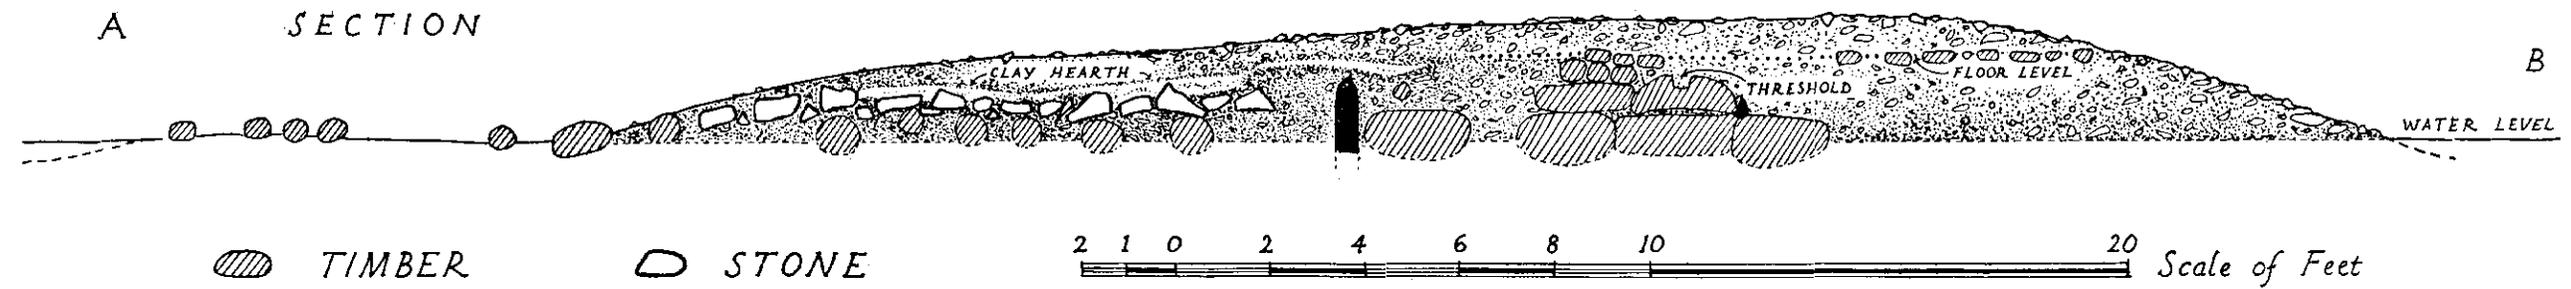
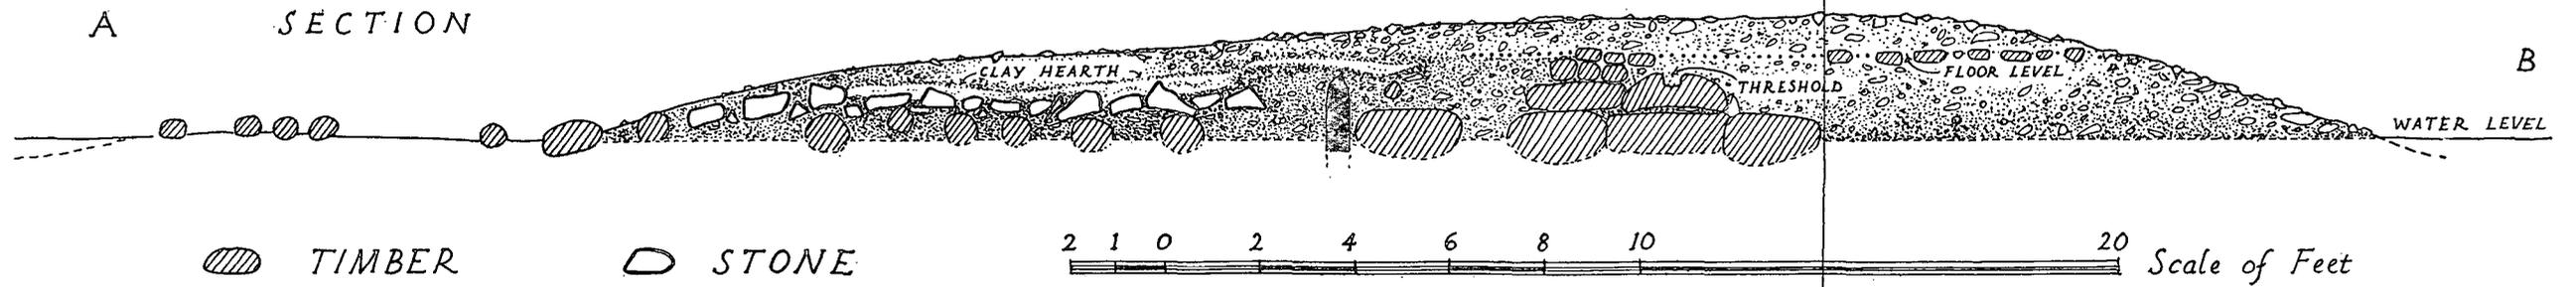
Fig. 8. Section across crannog. (For position of A-B see plan fig. 7.)

The actual floor was, unfortunately, at so high a level that it had inevitably been much damaged through the action of water, wind and plant roots (see section, fig. 8). It did however produce evidence of building technique which had not previously been recorded for study from Scotland.

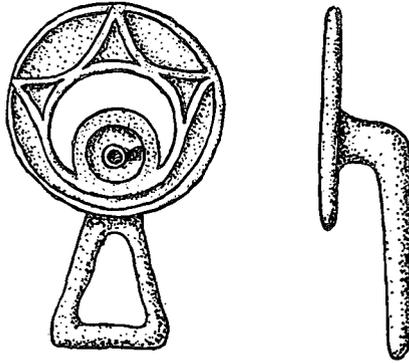
Fig. 9. Bronze enamelled loop. ($\frac{1}{2}$.)

it is difficult to find parallels for this example from Britain, there are fairly comparable examples amongst the bronzes made in Pannonia and nearby territories in the first two centuries of the Christian era (see I. Sellye, "Les Bronzes Émaillés de la Pannonie Romaine," in *Dissertationes Pannonicae* (Budapest, 1939) pl. vii). In this case, since we know that Pannonian auxiliaries were posted in North Britain, it is reasonable to suppose that the occupant of the Milton Loch house acquired it from a member of the army of occupation. (For the Pannonians in Britain see Cheesman, *Auxilia Rom. Imp. Army* (1914), 148, 176-7.)

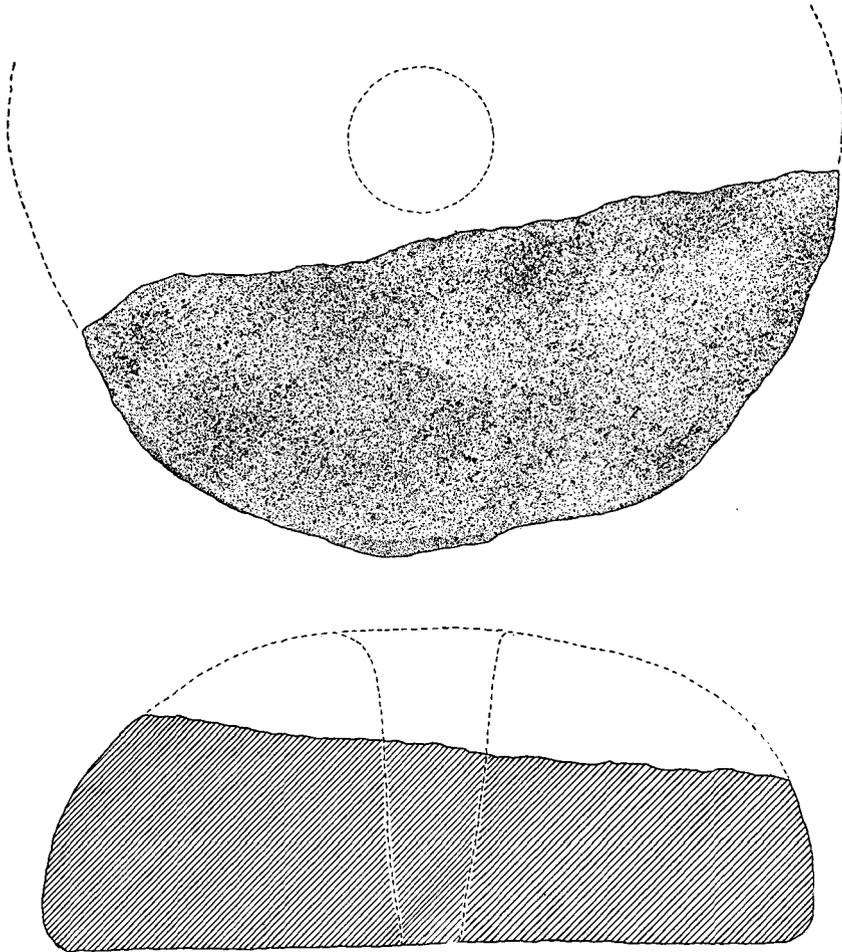
Fig. 10. Fragmentary quern. ($\frac{1}{2}$.)

A fragment of quern made of local granite was found among the surface stones overlying the crannog. Its suggested type is shown, but it was too fragmentary for this to be certain. Diameter about 12 ins.

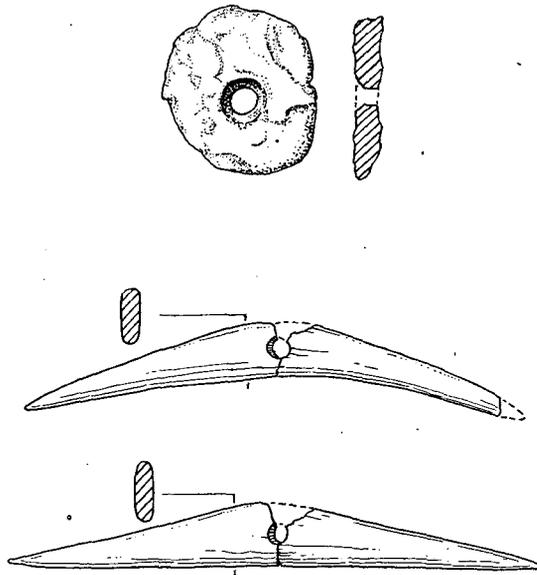
Fig. 11. Spindle whorl and wooden gorges. (†.)

Again made of local stone, this whorl was very roughly bored with an hour-glass perforation. Found on floor-level of the house at point 3 on the general plan.

These were found together at point 4 on the plan, and nearby was a fragmentary wooden peg with which they may at one time have been associated. Floor-level.

Commenting on these most carefully made gorges, which have parallels from a few sites in Britain, including Glastonbury, Mr A. B. Duncan writes: "I cannot believe they were used for any other bird than the cormorant, which of course was presumably then as now a visitor to the loch. There is no evidence that there were pelicans in these parts at that time, and I would rather doubt the Glastonbury identification." At all events their use for catching birds rather than fish is suggested by the large size of these specimens.

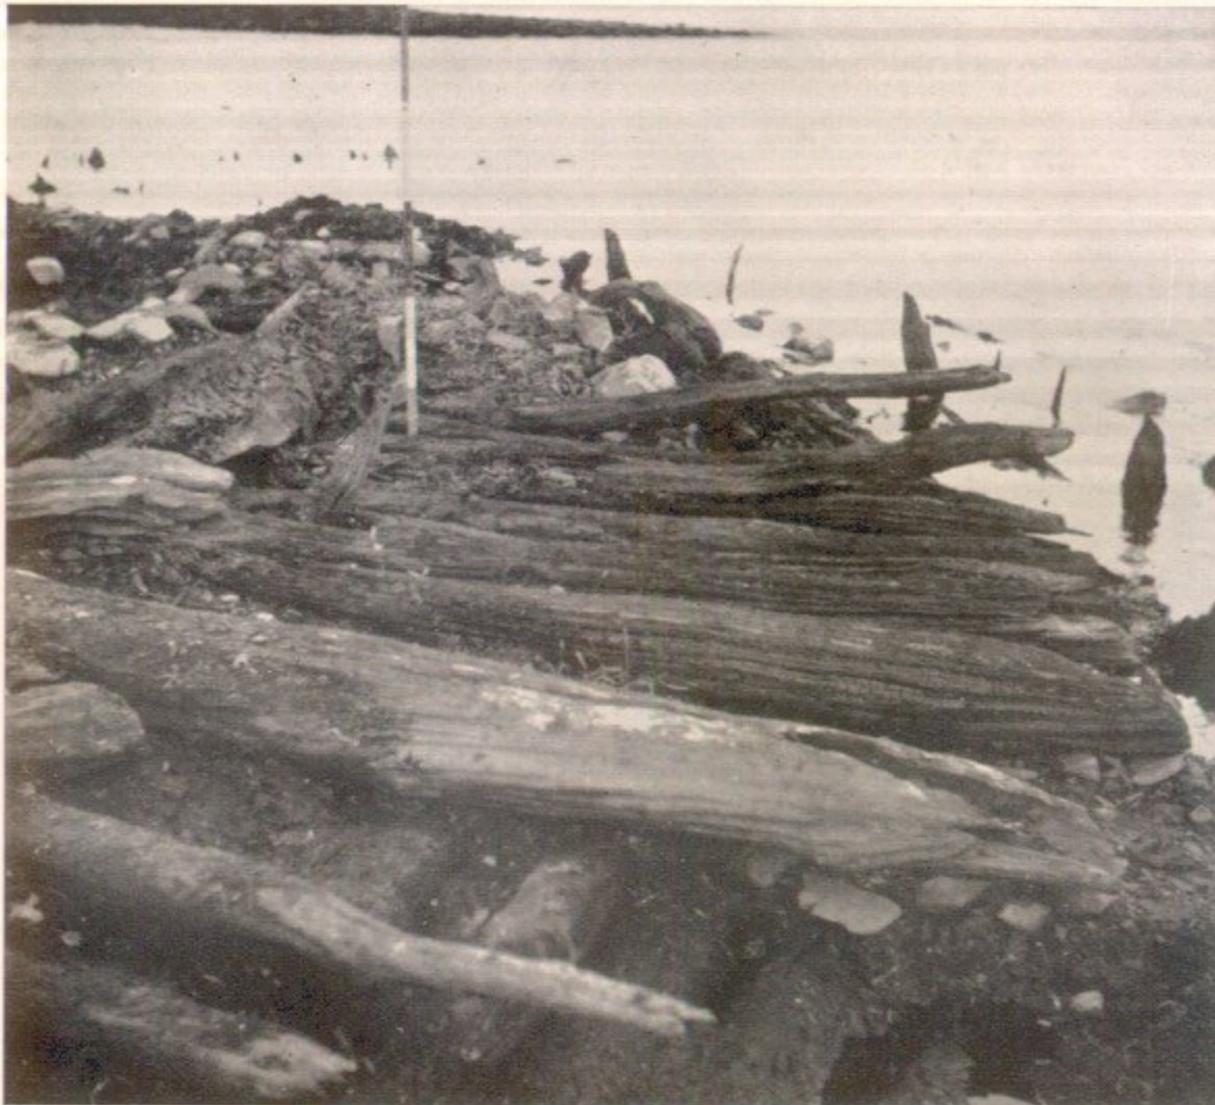
2. The outer edge of crannog, showing radially arranged timbering.

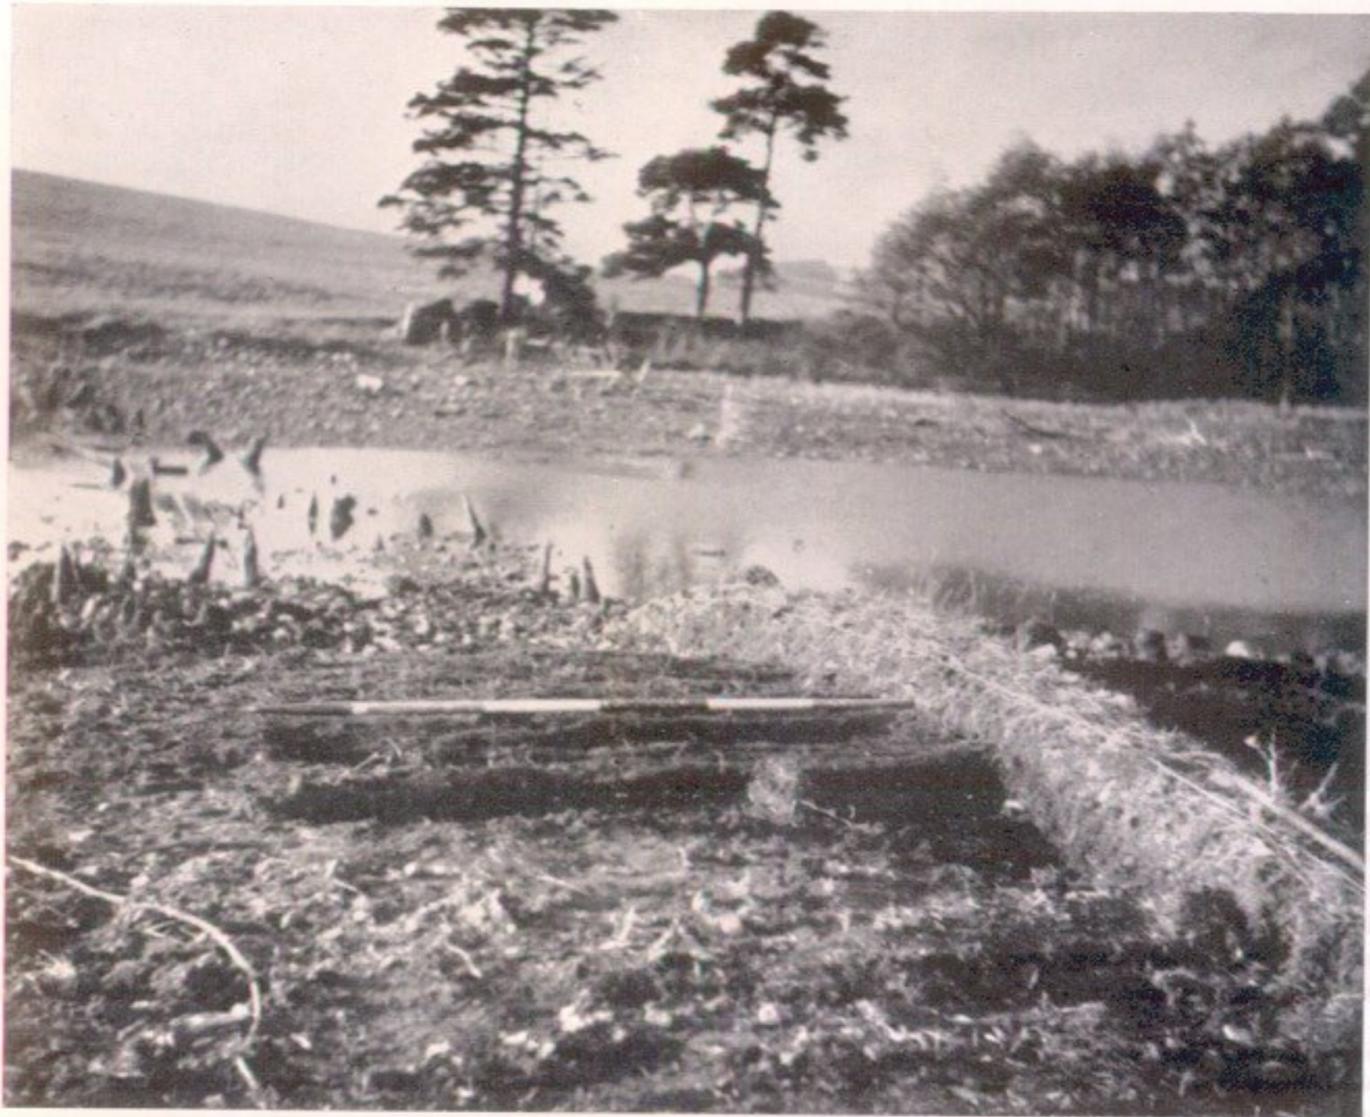
1. Floor boards: causeway in background.

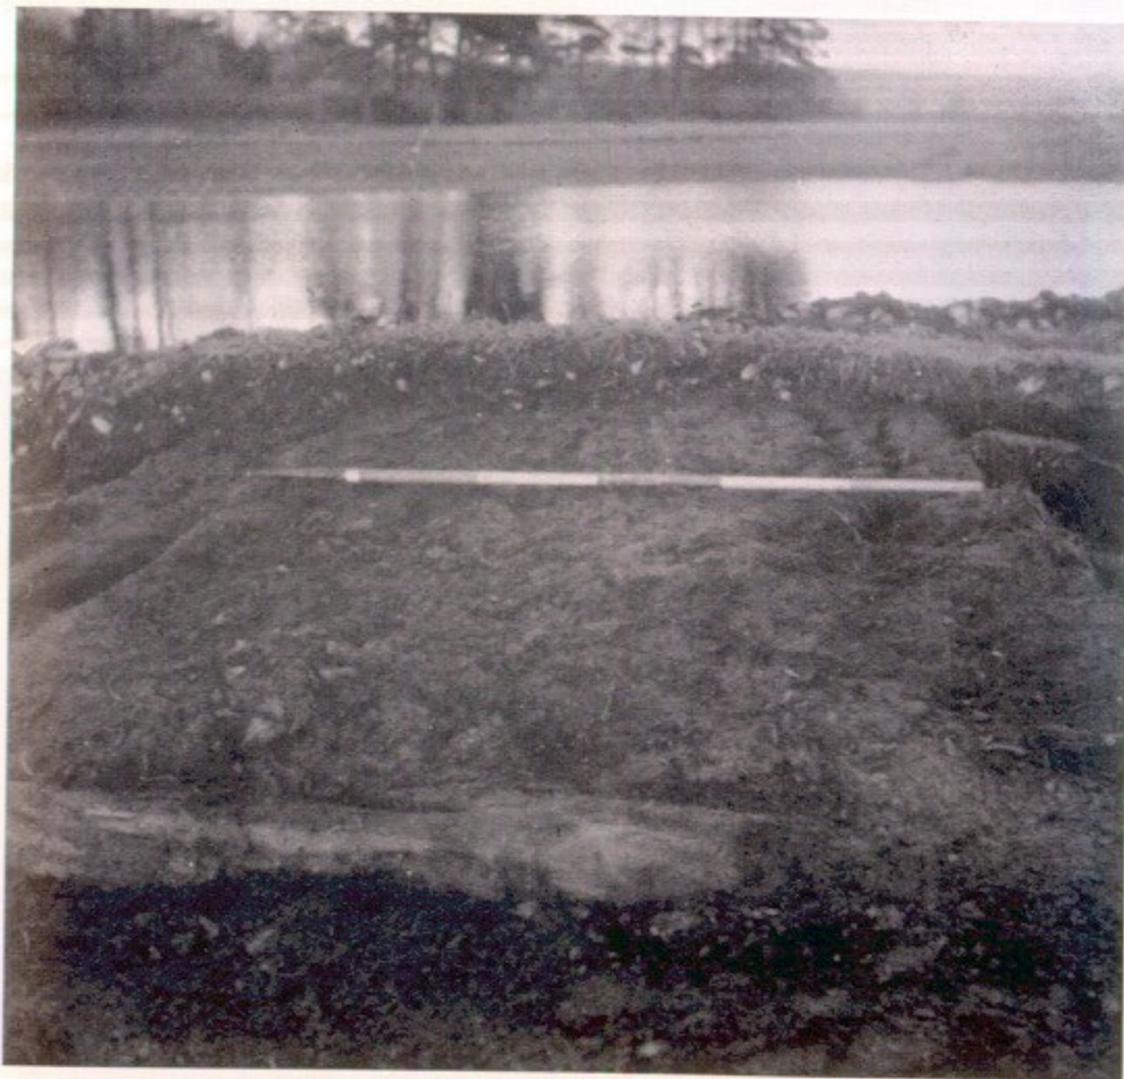
2. The floor boards *in situ*.

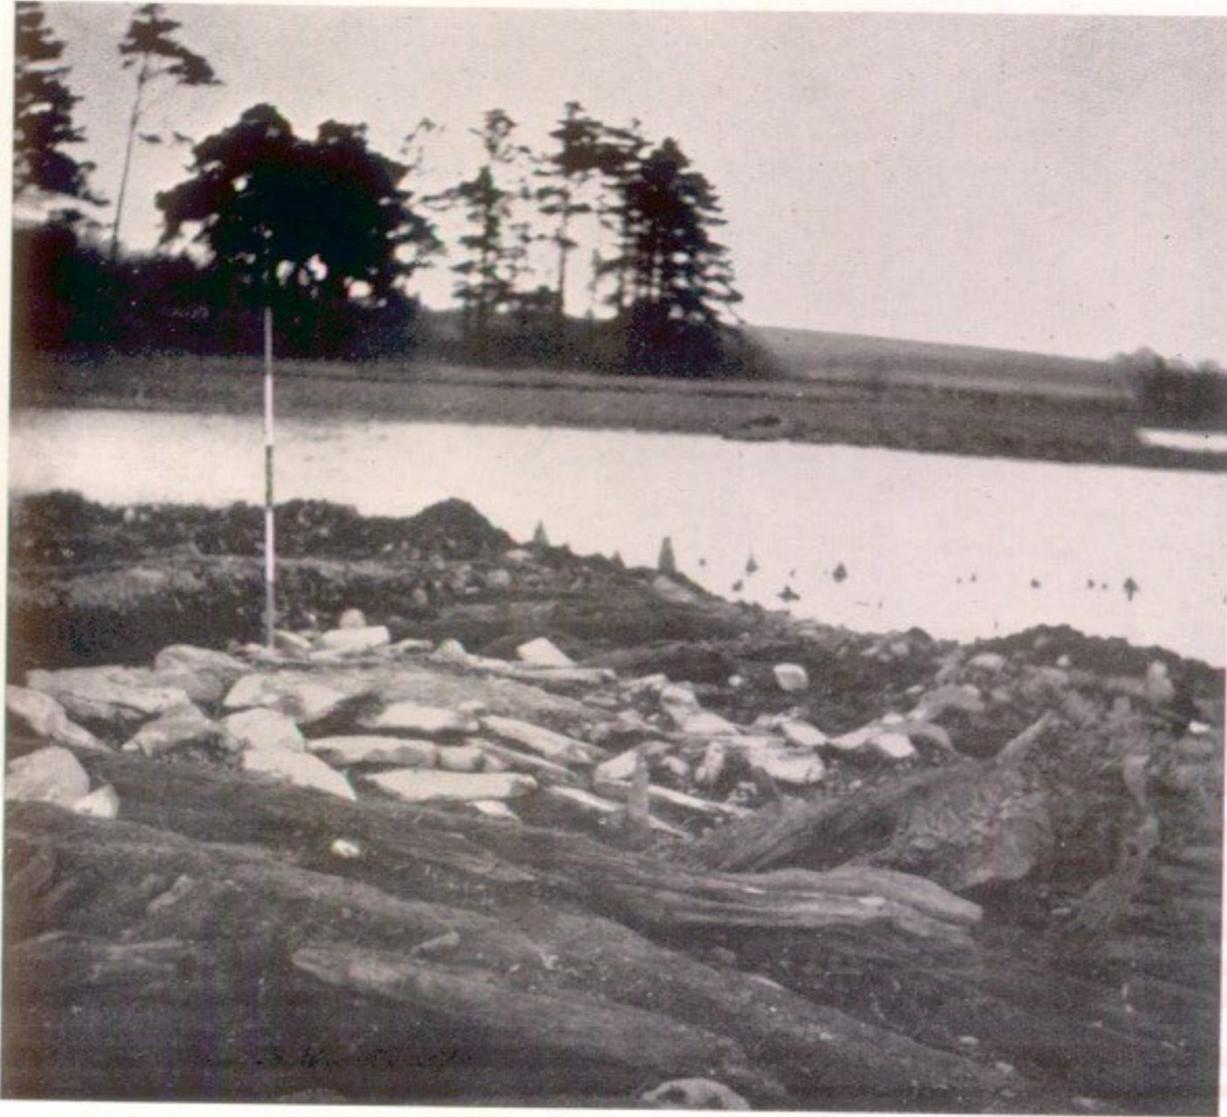
1. The hearth during excavation. [Photo: A. Graham.

Beyond this second series the remaining part of the internal room consisted of the hearth. Large flat stones had been selected from the shore and dumped into an approximately square area about 12 ft. across. This had then been daubed with clay which originally, no doubt, lagged the whole hearth into a smooth surface. From this surface, much of which had been worn away by the time of excavation, a number of seeds and fragments of food refuse were submitted for analysis, and are reported on below. Unfortunately, the bone fragments were all so burnt and powdery that no information could be got from them.
