MILTON LOCH CRANNOG I. A NATIVE HOUSE OF THE
2ND CENTURY A.D. IN KIRKCUDBRIGHTSHIRE.

BY C. M. PIGGOTT, F.S.A., F.S.A.Scot.

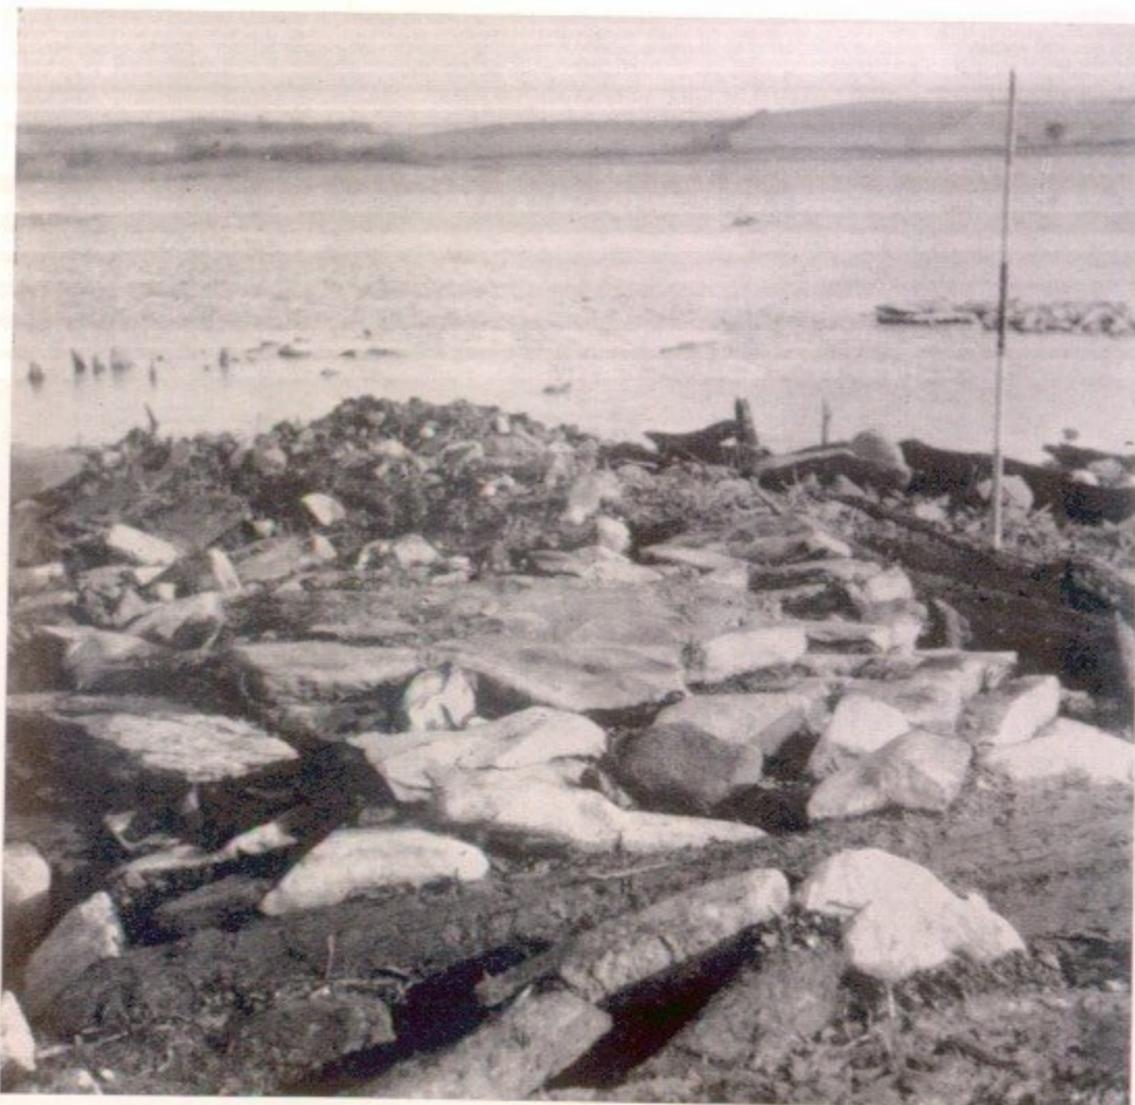
2. The hearth: in the centre can be seen the remains of the clay surface.
Harbour in background. [Photo: C. M. Piggott.

Beyond this second series the remaining part of the internal room consisted of the hearth. Large flat stones had been selected from the shore and dumped into an approximately square area about 12 ft. across. This had then been daubed with clay which originally, no doubt, lagged the whole hearth into a smooth surface. From this surface, much of which had been worn away by the time of excavation, a number of seeds and fragments of food refuse were submitted for analysis, and are reported on below. Unfortunately, the bone fragments were all so burnt and powdery that no information could be got from them.

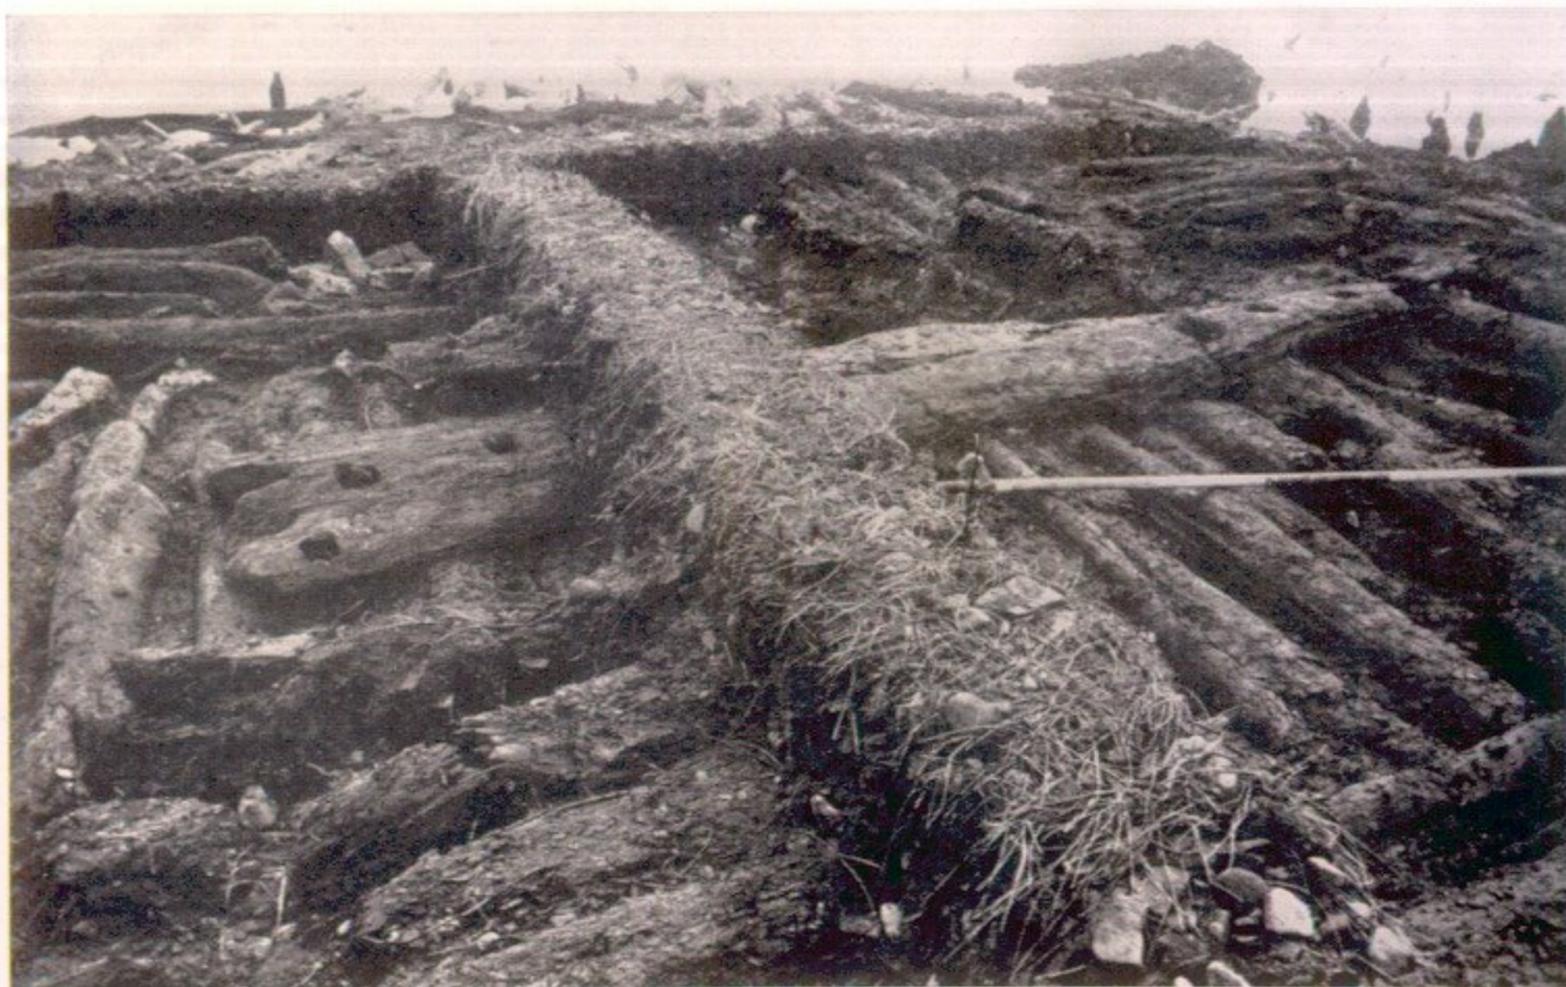
2. The "canoe" *in situ* among the foundation timbers.

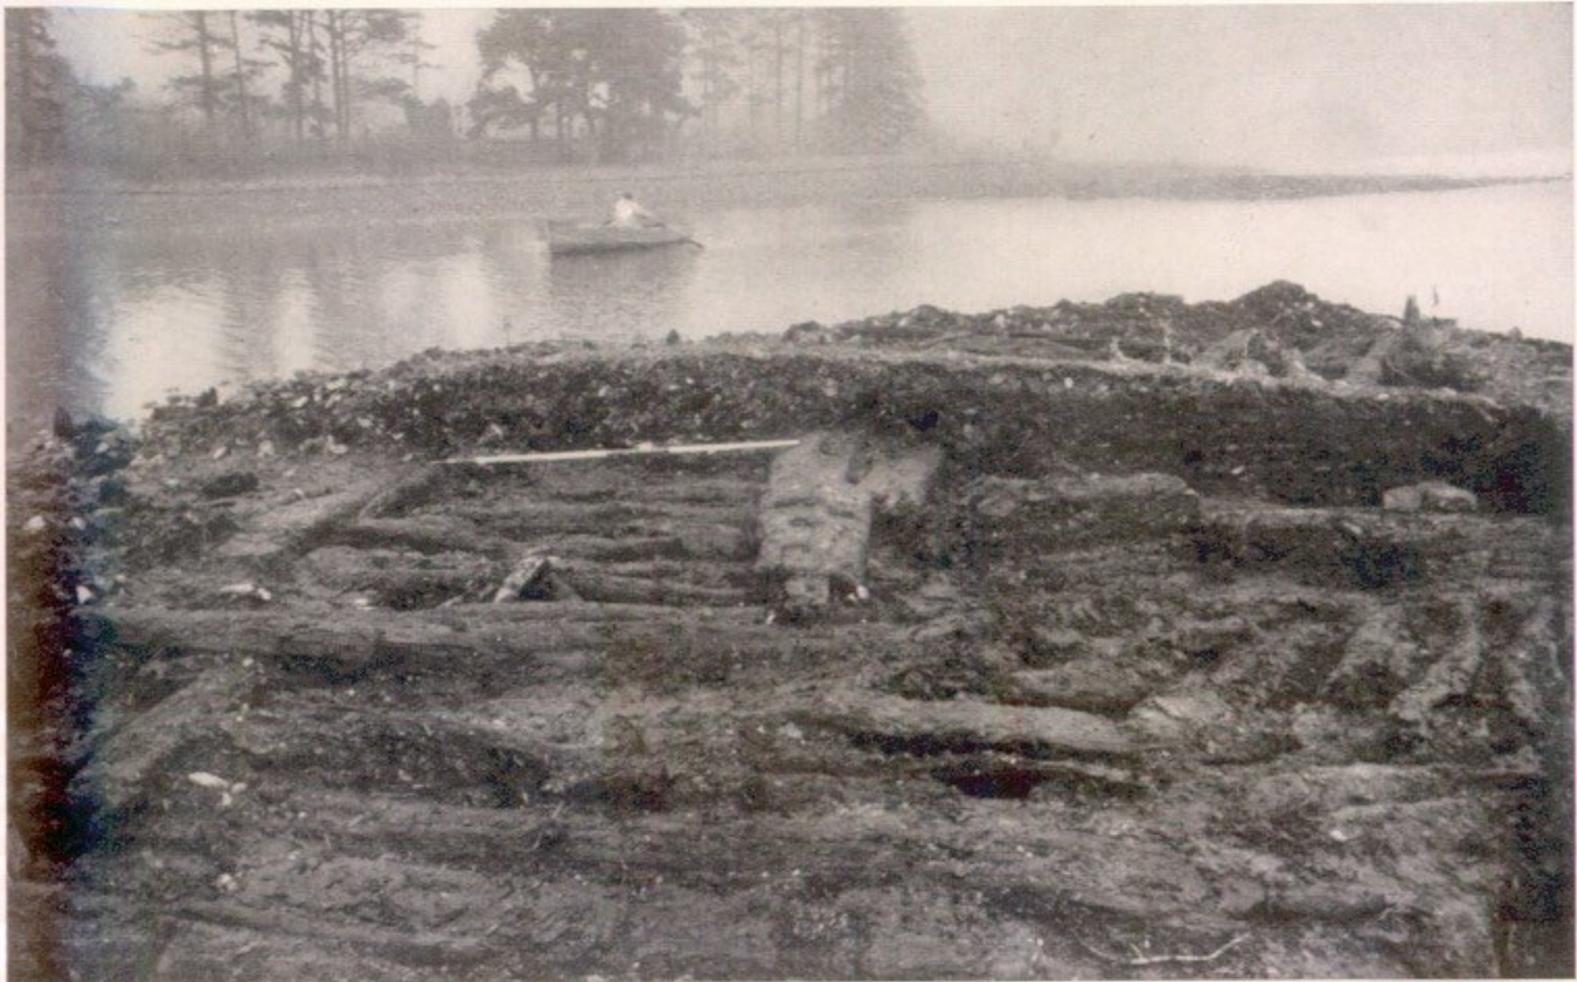
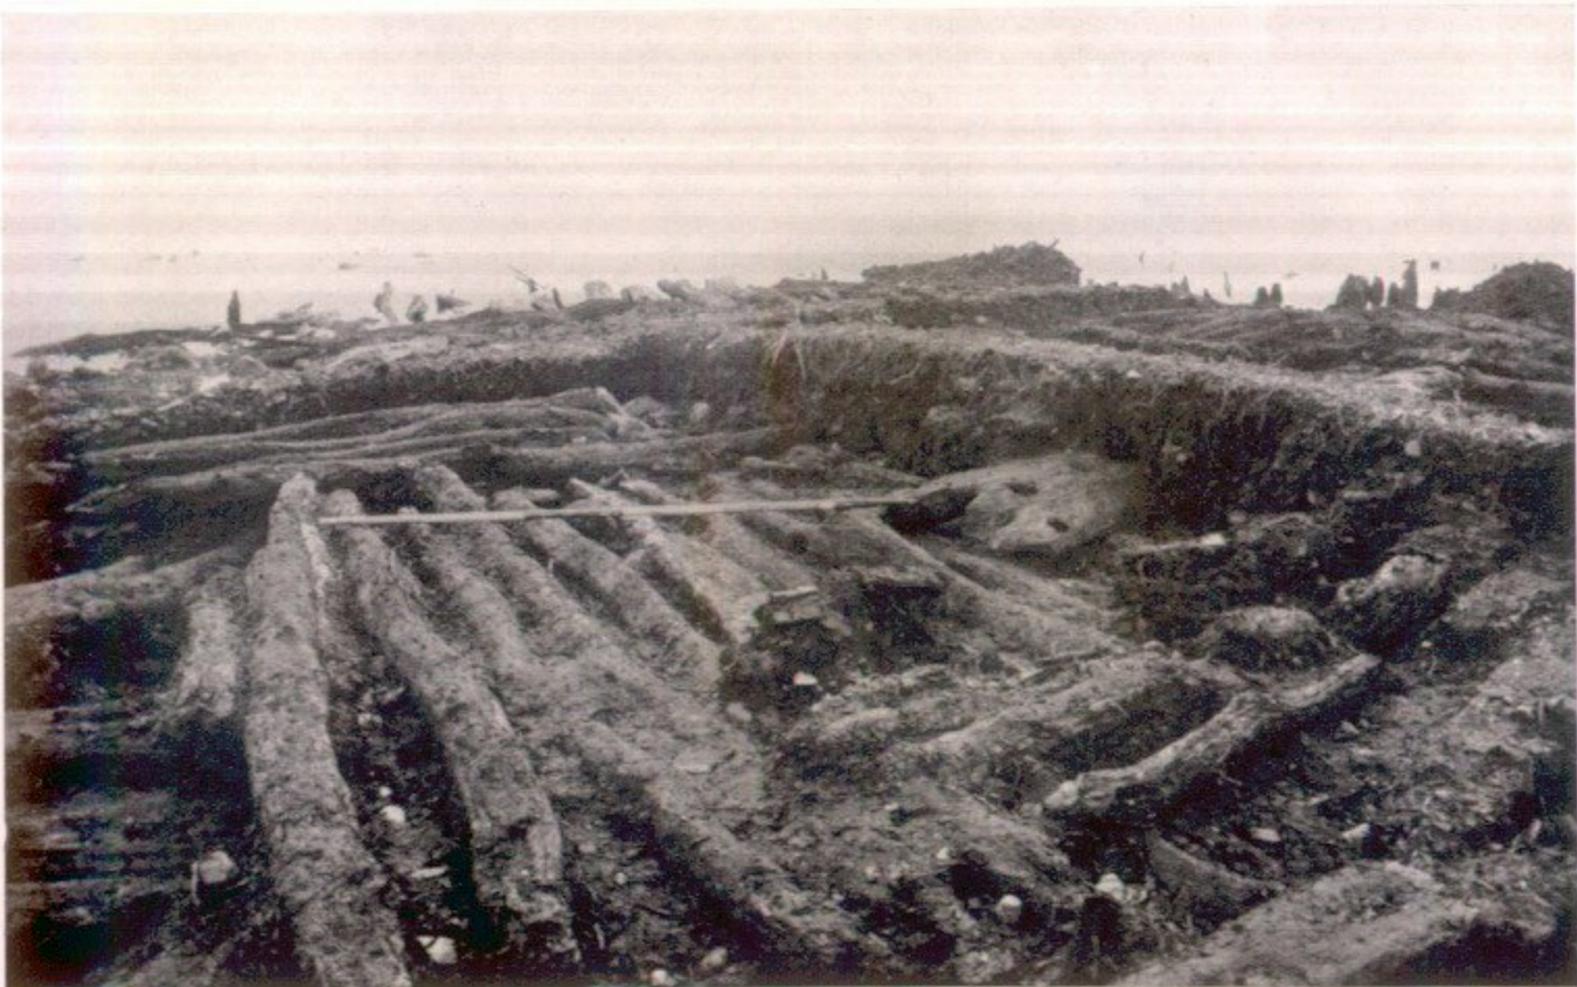
The foundations during excavation.

The lower foundations, which were waterlogged, had evidently been built on a raft principle, floating on thick black mud. No *terra firma* could be found by probing, and the whole island could be made to shake by jumping

on it. Large logs, round in section and still in some instances retaining their bark below water-level, had been laid both radially and concentrically with the wall of the house, as can best be seen from the plan, fig. 6. As has already been said, much of this wood had floated away, blown loose no doubt by the prevailing wind lashing the island from the west. So much however remained that a fairly complete plan was achieved, and had the excavation been possible on a drained rather than an undrained loch, a great deal more information could have been wrung from it.

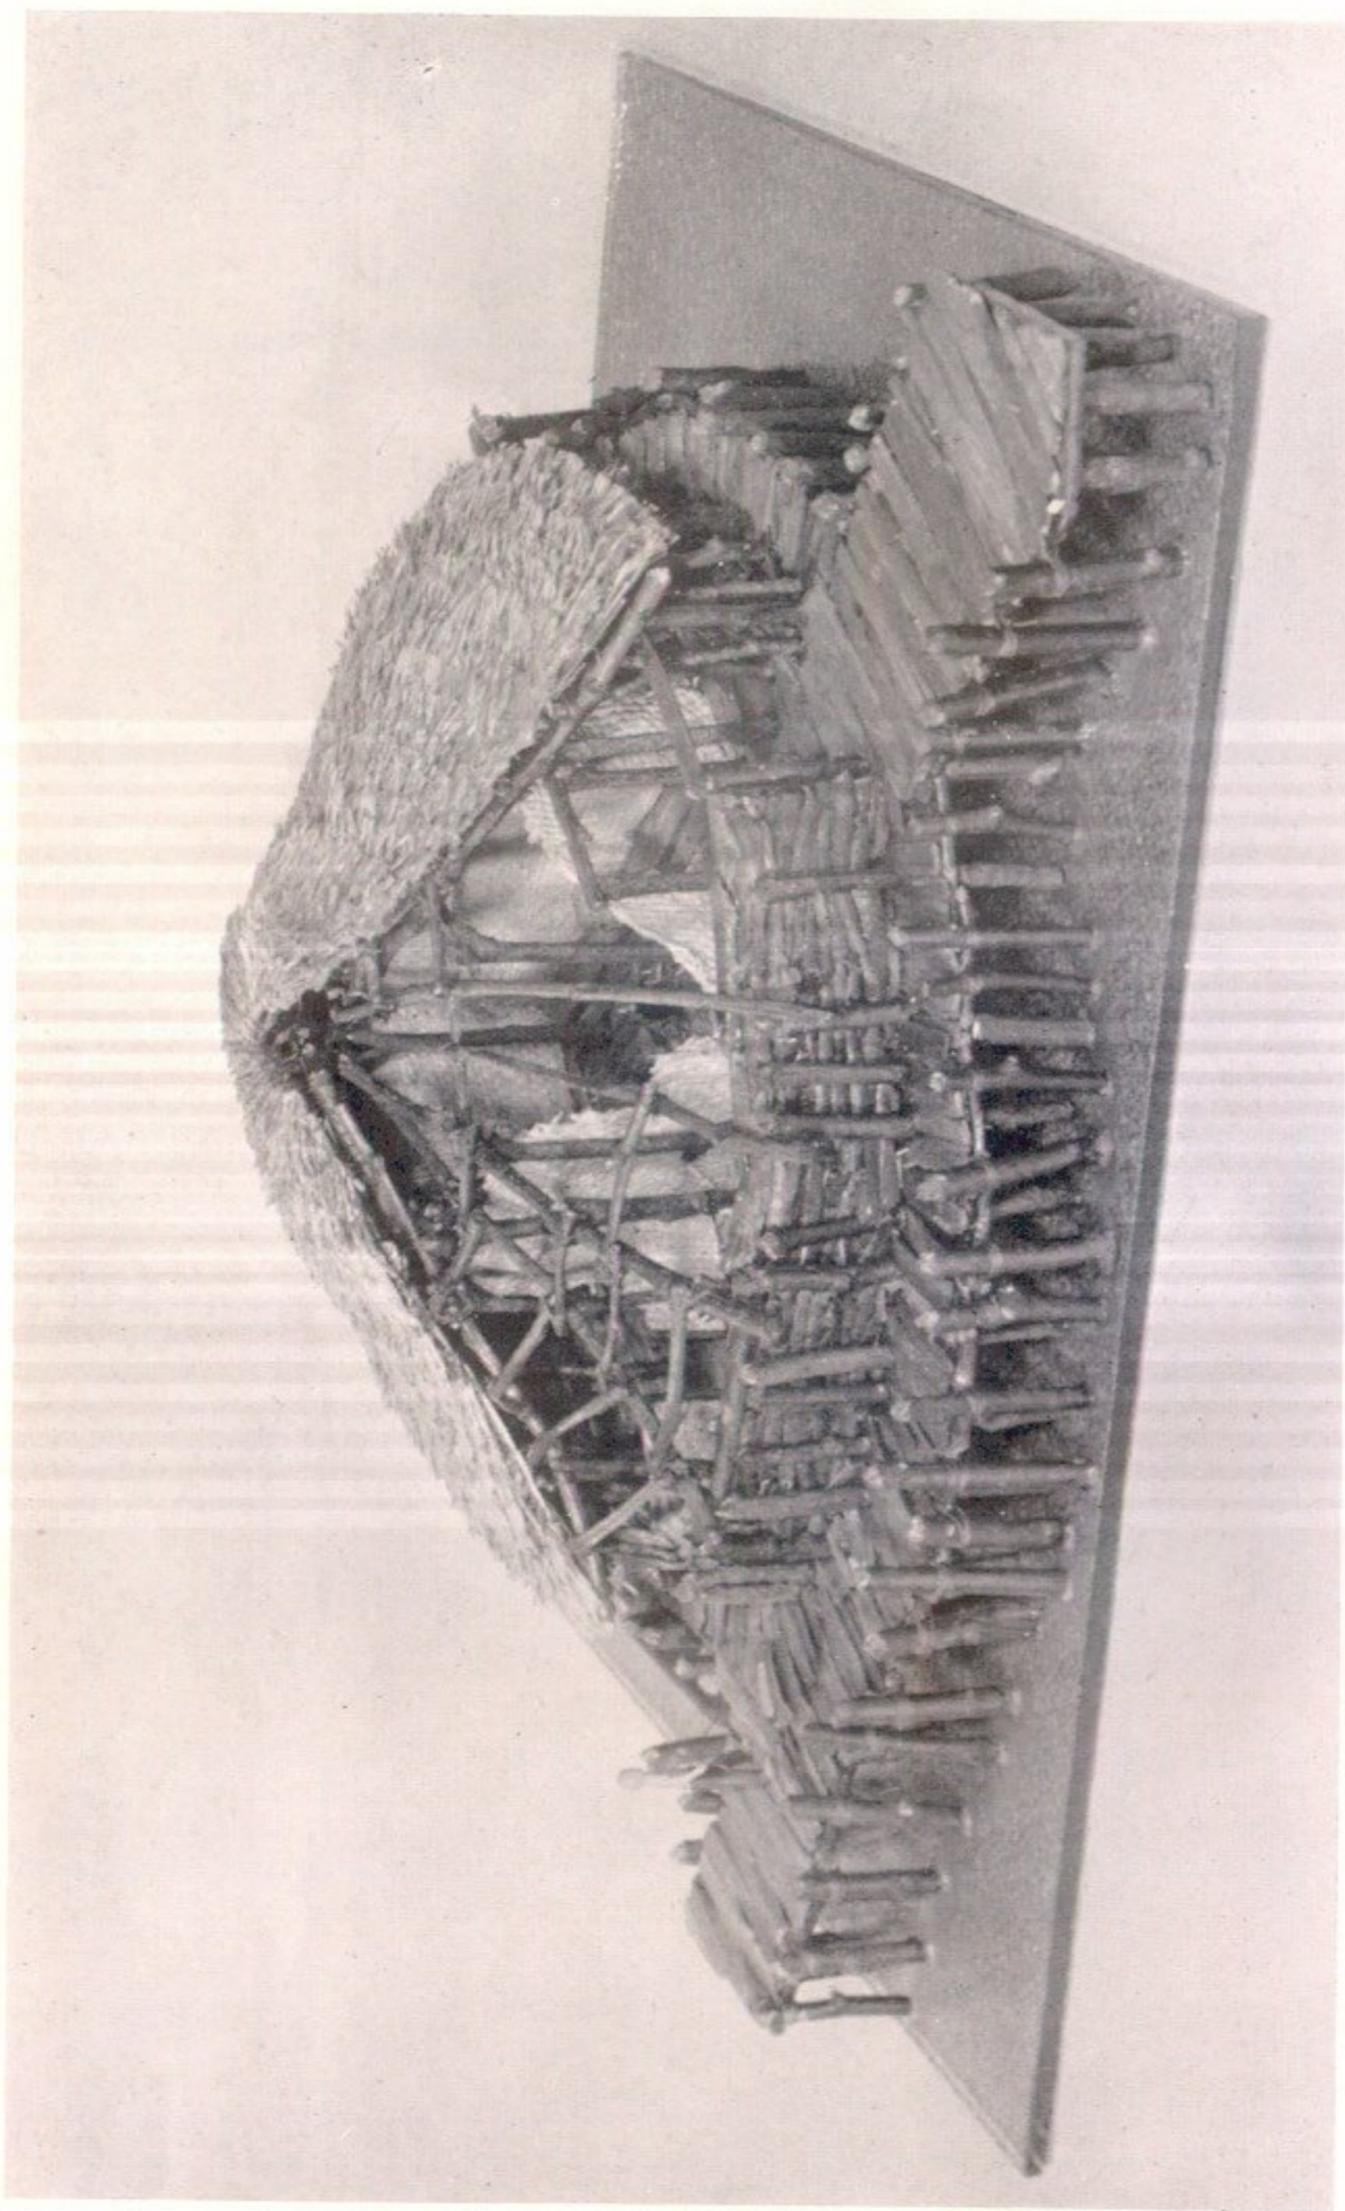
Model of Milton Loch Crannog, made by J. and M. Scott.

What can be said of the shape of this internal room? Here again, unfortunately, the answer cannot be obtained. Two alternatives have been suggested in the drawing (fig. 4) but the vital evidence was lacking. It is perhaps worth noting that it is possible to find analogues for both shapes of internal room from the native settlements of Iron Age Britain. In those examples excavated by Bersu in the Isle of Man,¹ the room was circular and concentric with the outer wall of the house, but on the other hand at Lochlee² the internal subdivision appeared to be squarish; though as in this case the excavation was not very scientifically conducted, it must be borne in mind that the features recovered might have belonged to more than one period of construction. In the opinion of the excavator the rectangular plan was slightly more convincing for the Milton Loch site, and has therefore been so shown in the isometric reconstruction of fig. 5 and model Pl. XV.

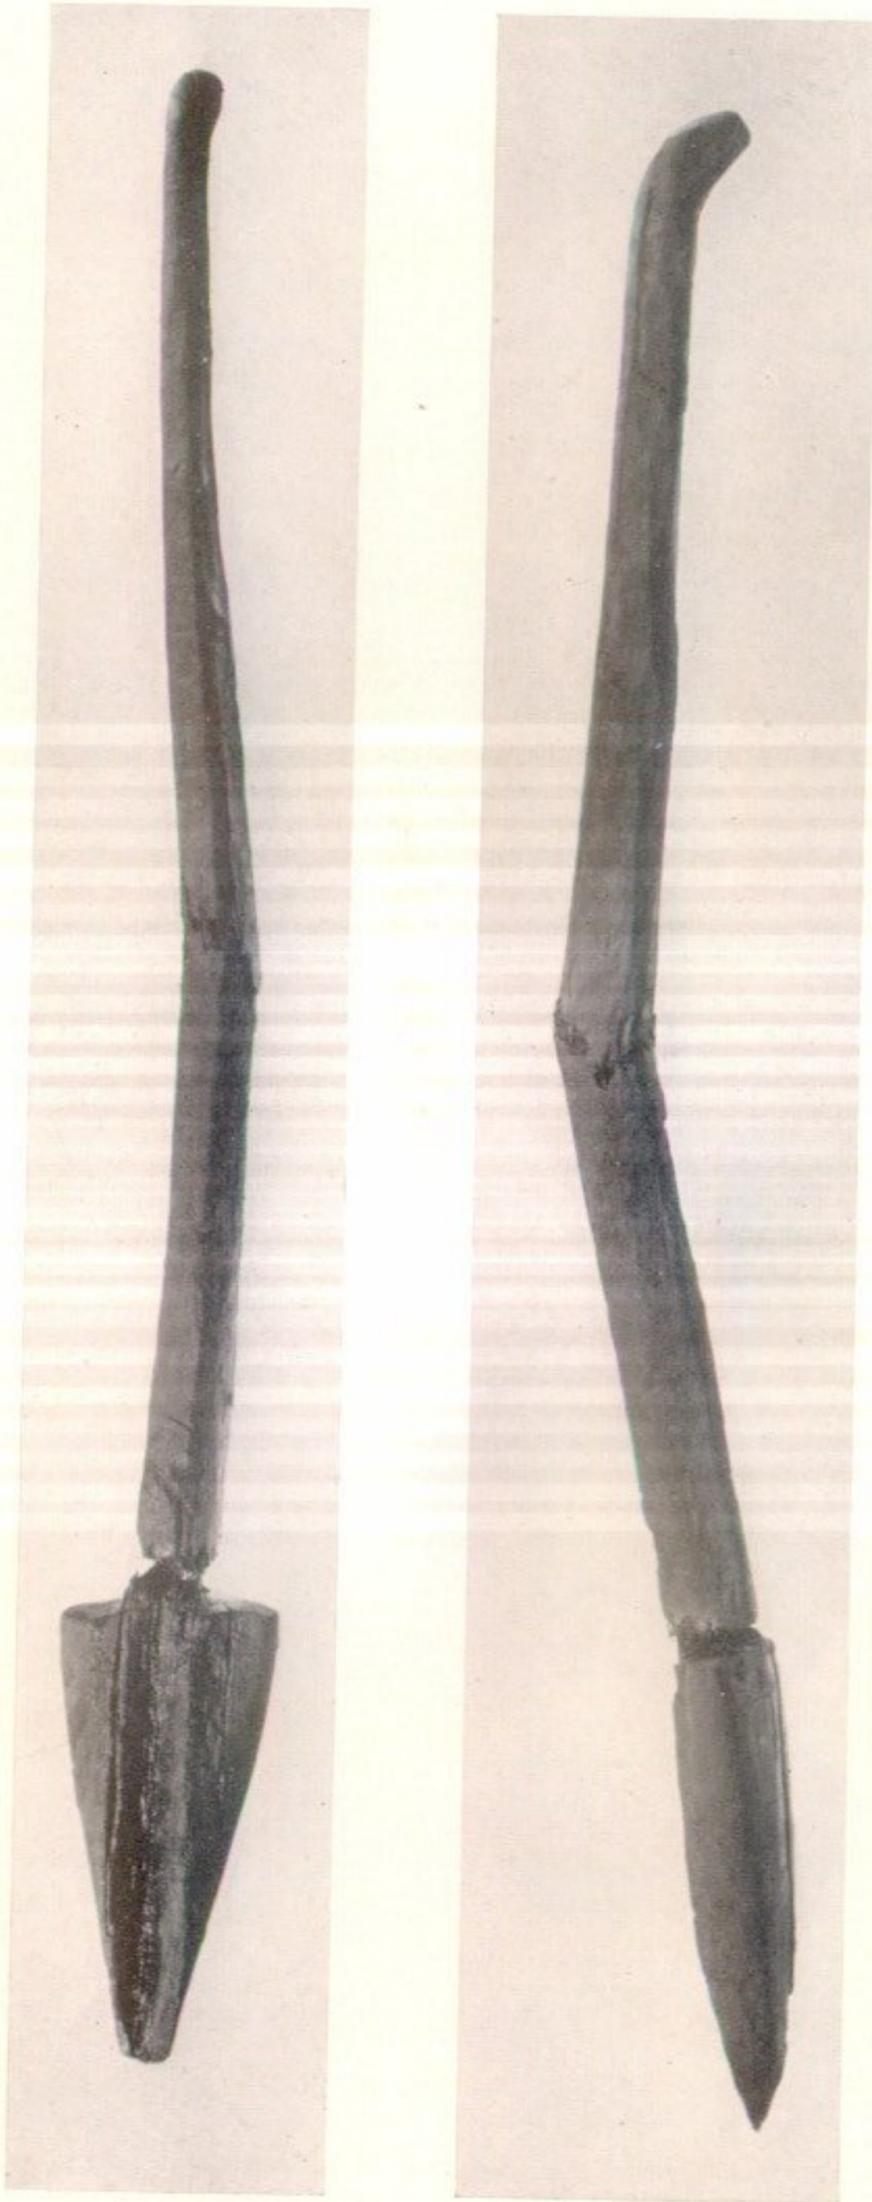
Oak Plough stilt and head from Milton Loch Crannog.
Top and side views. Length 4 ft. 2 ins.

A find of considerable interest and archæological importance was discovered at a point shown as no. 2 on the plan, fig. 7. Beneath the foundations of the crannog was found the stilt and head, originally in one piece but broken before discovery, of a wooden plough. This plough, which was

briefly described with illustrations in the *Illustrated London News* for 9th January 1954, was almost certainly deposited deliberately beneath the house foundations as a ritual offering to the gods who might provide good and abundant harvests, and in this connection it is reminiscent of Scandinavian examples, not however closely dated, from Døstrup and Trollerup. The Milton Loch plough fragments have also been made the subject of a paper by Dr Burchard Brentjes,¹ in which he claims that it may be representative of a half-way development between a digging stick and the more developed *curved* Døstrup type. It is not the intention here however to describe or discuss this find in detail, for at the time of writing it is still being given treatment in Copenhagen, where the kind co-operation of the Nationalmuseum is here most gratefully acknowledged. After the treatment has been completed the plough can be fully described, and its significance in early agriculture better assessed, in a paper devoted to that purpose.

Attention should here be drawn to a mistake made in describing this plough in the *Illustrated London News*, and the writer is indebted to Mr F. G. Payne for kindly pointing this out. It was described as "the stilt and share of a two-piece plough" whereas in fact it is the *plough-head and stilt*. Mr Payne writes: "The size of the groove on the comparable Døstrup plough-head seems to indicate that it was intended to receive an oak share similar to the Trollerup example which has a ridge on its under surface (*Acta Archaeologica*, xvi, 99, fig. 6). Should this be so, then the plough should be at least three-piece: head and stilt, main share, beam. Probably even four-piece by the addition of the usual bar-share."
