Excavations at 43 High Street, Reigate 1981

by DAVID W WILLIAMS

Summary

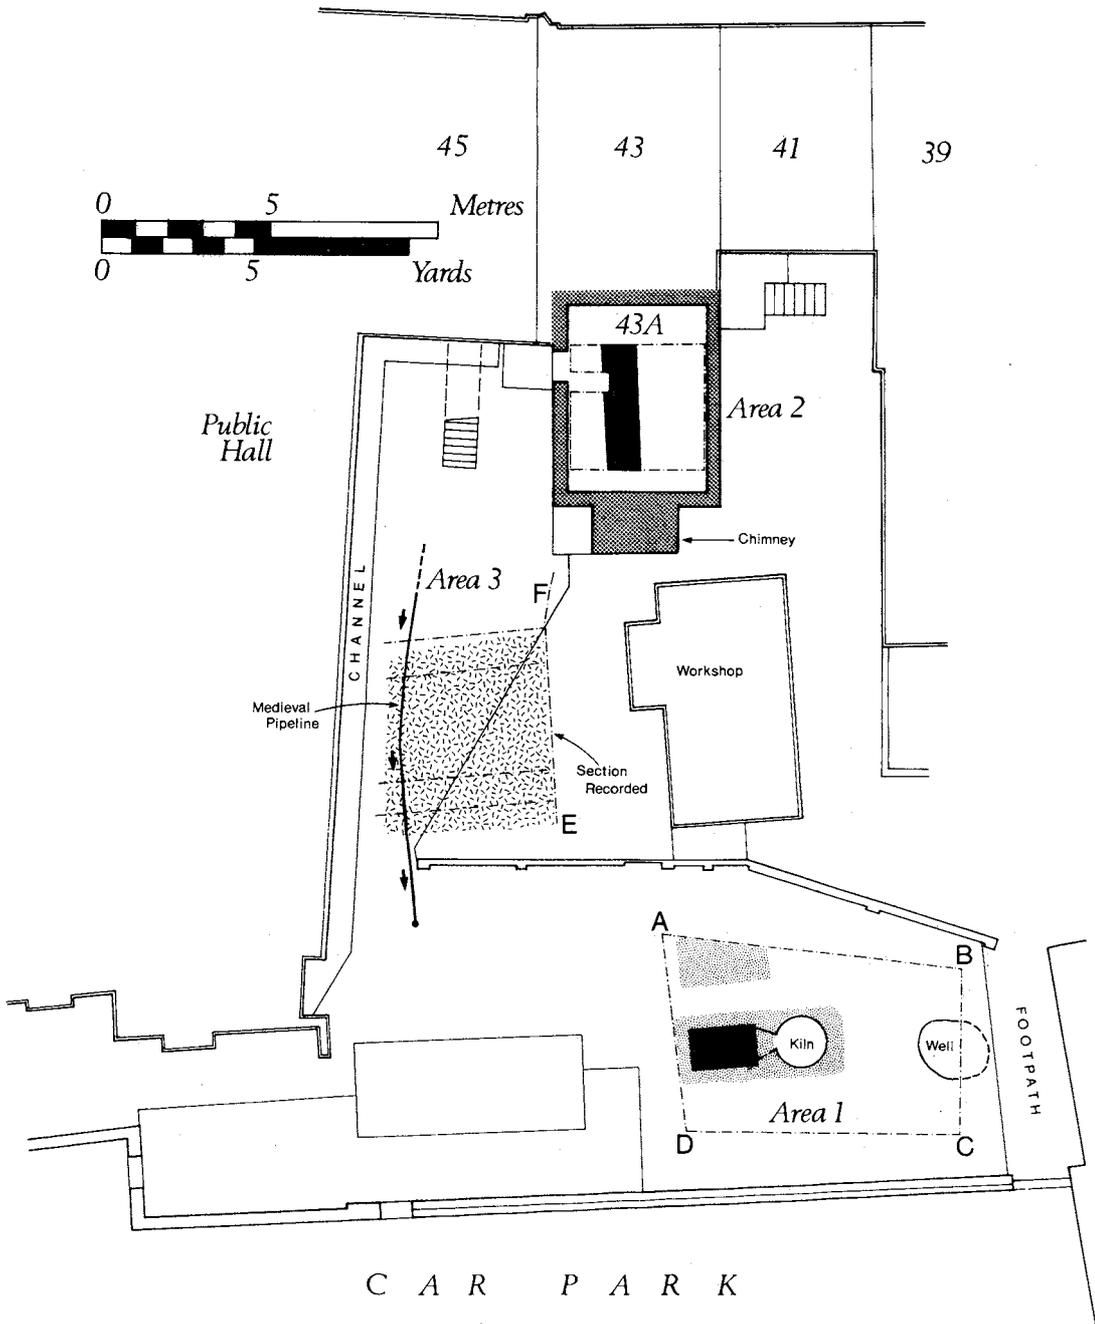
Fig 2. 43 High Street. Location of excavated areas. Extent of chalk layer in Area 3 shown as tint.

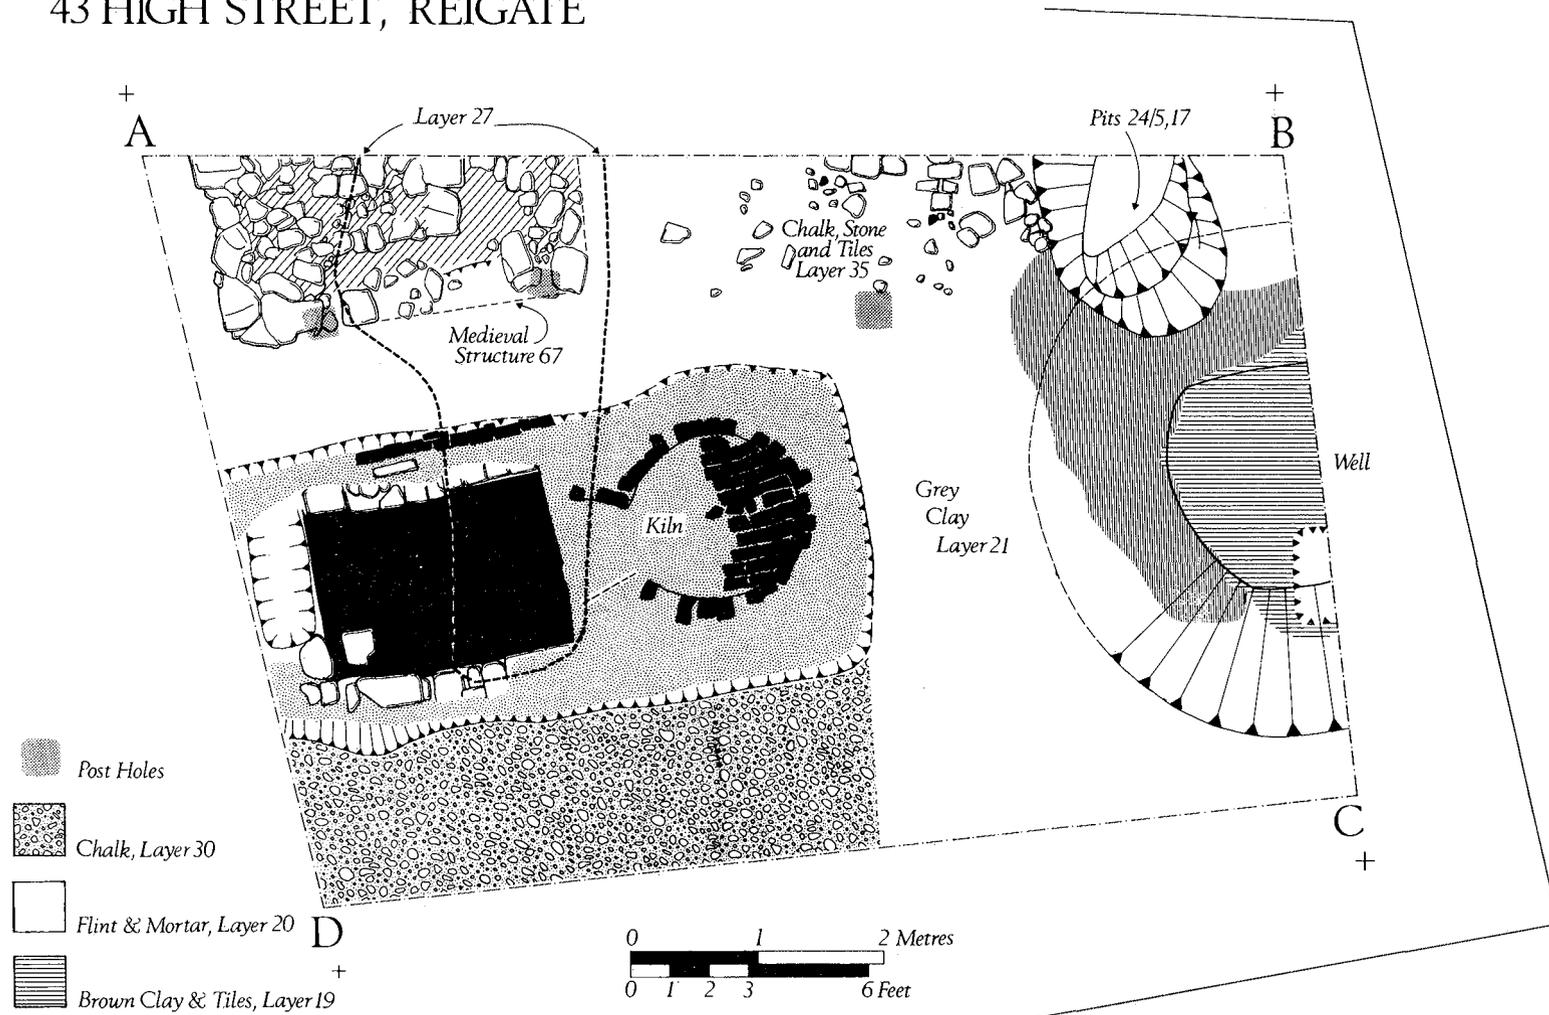
Fig 4. 43 High Street. Plan showing main features excavated in Area 1.

Along the north side of the trench the edge of an area of stone blocks (layer 35) and a chalk spread (layer 35A) were noted lying mostly outside the excavation. A similar, probably identical chalk spread was noted in Area 3. Time prevented the removal in full of all these deposits. Partial removal of layer 21 revealed a spread of brown clay (layer 64) cut by three post holes. Partial removal of layer 64 revealed part of a medieval structure of mortared stone (67), possibly a further kiln, lying mostly outside the area to the north.

Along the northern side of Area 1, overlying and partly set into layer 21 was the edge of layer 35 (fig 4). This consisted of worn, sometimes shaped blocks of Reigate stone, brick, tile and chalk. Continuing this layer to the west was the southern edge of a layer of packed chalk (layer 35A) which filled scoops cut into the underlying layers 21 and 64. It is likely that this is the edge of a very similar deposit covering most of Area 3 to the west. In Area 3 two sherds of Raeren stoneware overlay this chalk suggesting a date prior to c 1500 for its deposition.

In the northeast of the trench were two intersecting pits, 17 and 24/5 (fig 4). Pit 17 contained a mass of broken window glass in small pieces. This proved difficult to excavate but seemed to have been cut by a further pit containing layers 24 and 25. Both pits were c 0.8m deep. The latter pit contained two distinct deposits. The lowermost (25) contained part of the base of a late type

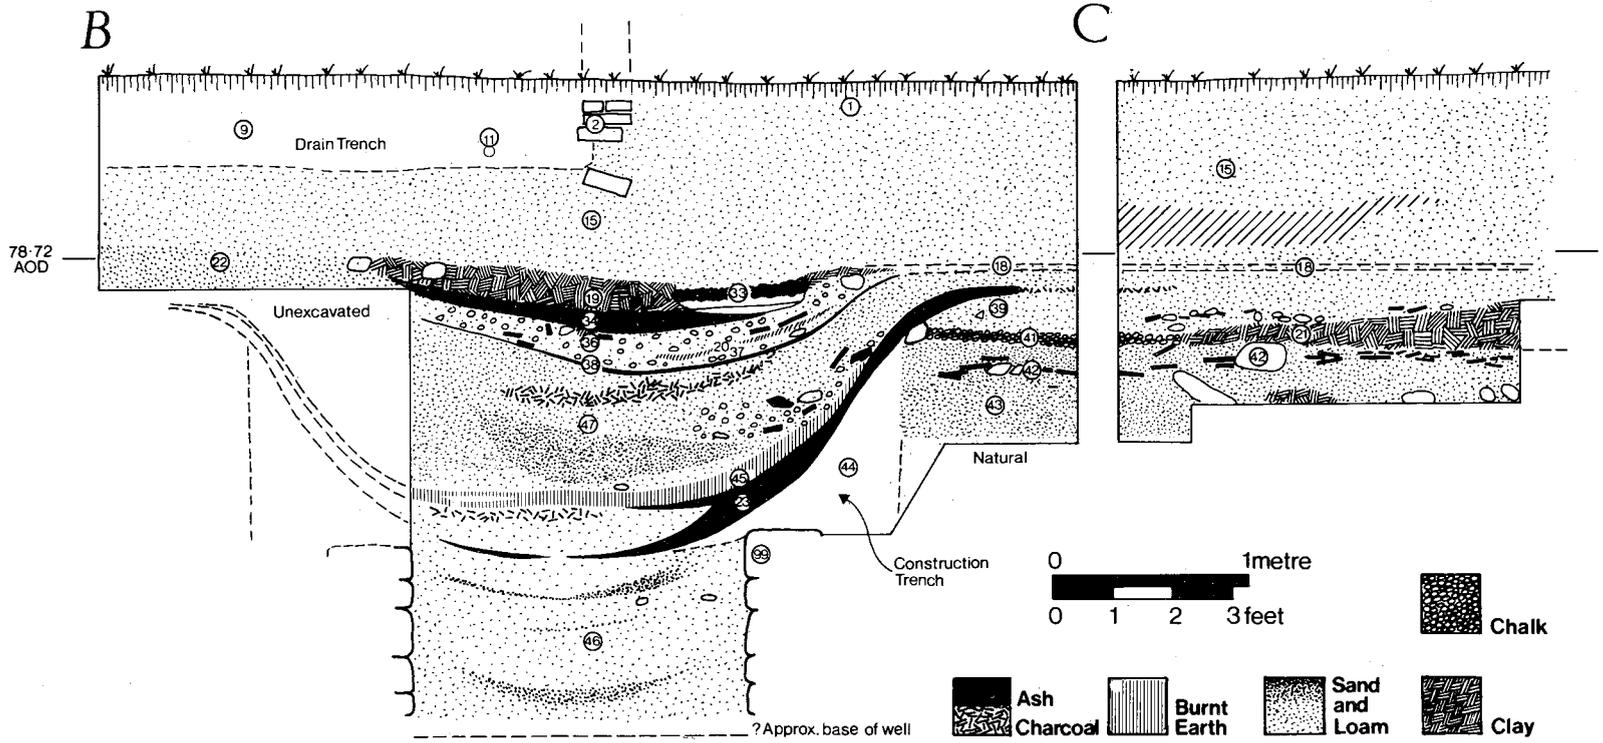
Fig 5A. 43 High Street. Section BC in Area 1. For location see fig 4.

In the south-east corner of Area 1, above layer 43 (which may be identical to 66) a layer of tiles and stone was noted beneath layer 21 and assumed to be of medieval date (fig 5A).

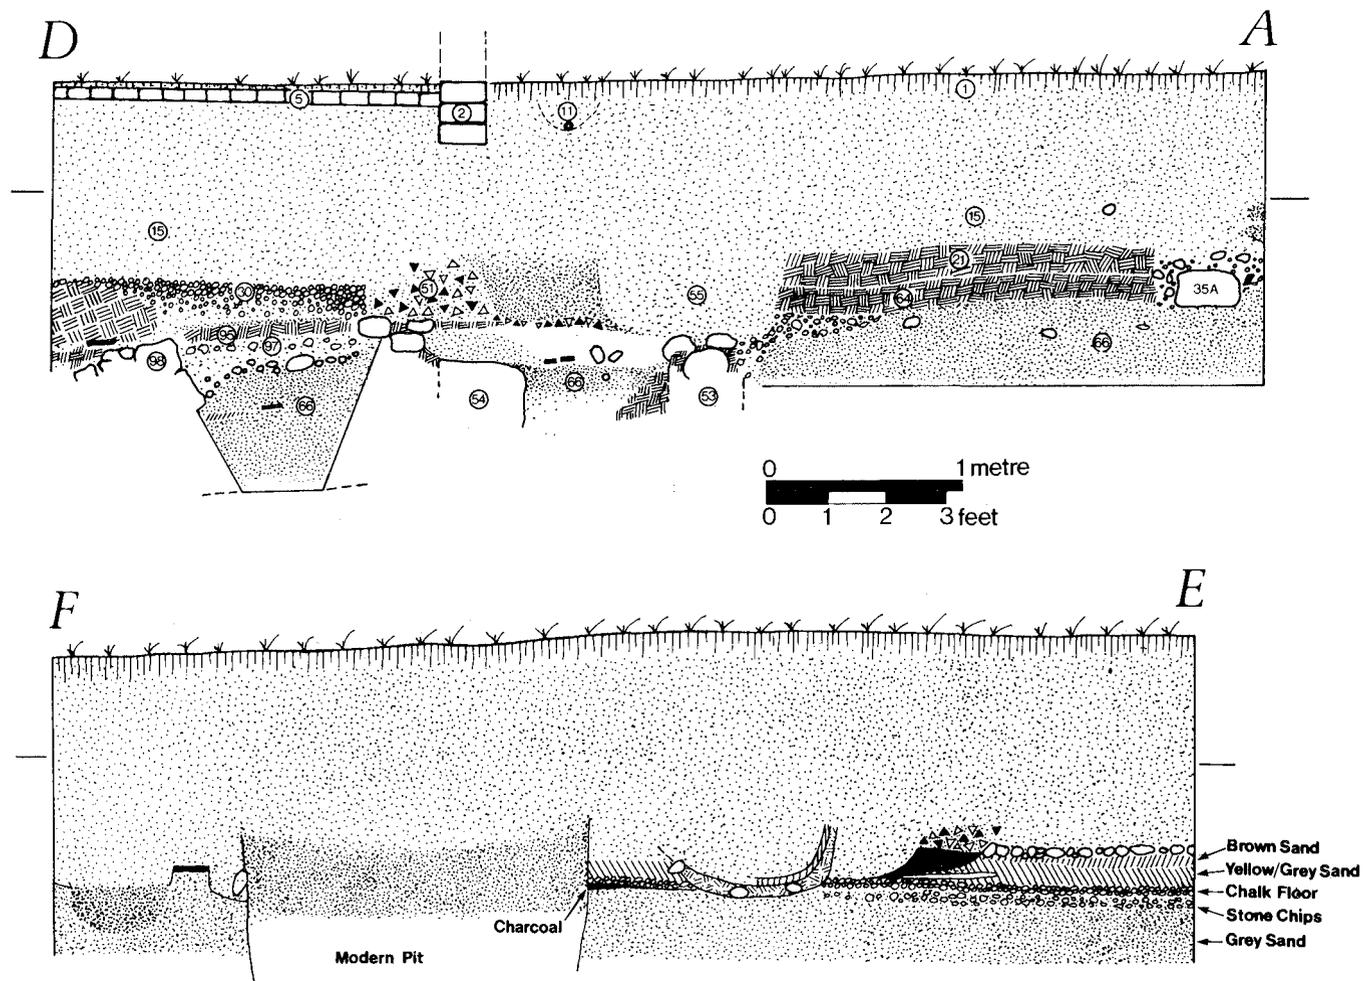
Fig 5B. 43 High Street. Sections AD and EF in Areas 1 and 3. For locations see figs 2 and 4.

The north-south section exposed by machine (fig 5B:EF) showed that mostly topsoil had been removed. Cleaning back from this face in two rough strips approximately 1.5m wide, a layer of flint and chalk was traced for a distance of c7m (area of tone on fig 2). Overlying this was the remains of a spread of yellow/grey sand containing a few sherds of late medieval pottery, thin and unglazed, and two sherds from the upper half of a Raeren stoneware mug of c1500. The northern half of this area had been heavily disturbed by modern pits. The area to the west was effectively delimited by the site of the Public Hall whose construction had removed all earlier levels. The layer of flint and chalk is thought to be identical to layer 35A in Area 1.

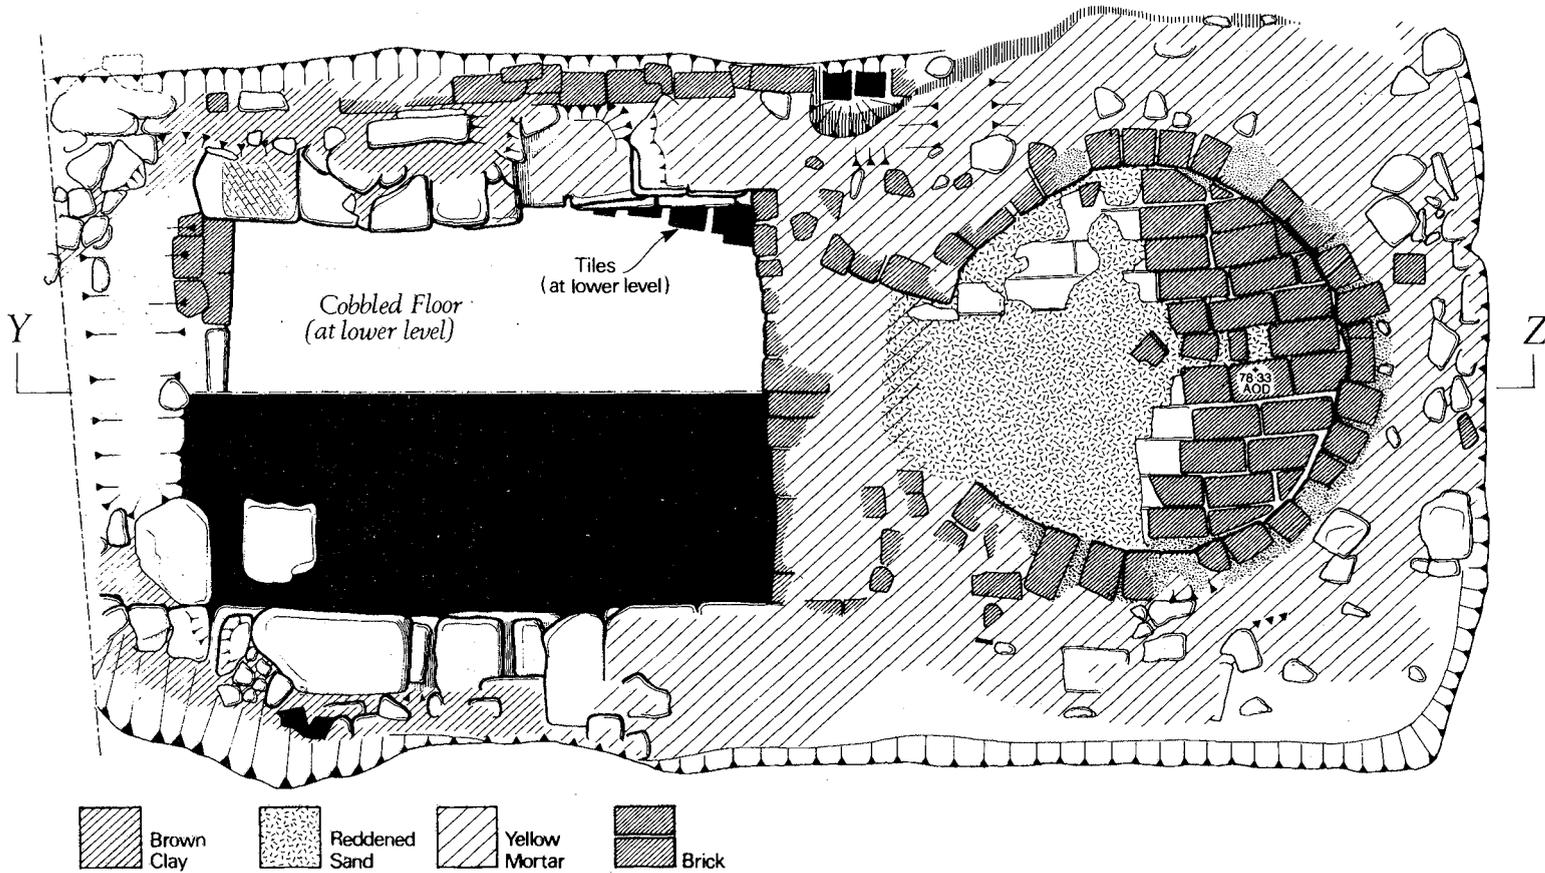
Fig 6A. 43 High Street. Plan of probable malting kiln.

The east side was formed by a brick wall (74) on whose top surface lay the remains of the north side of a splayed opening. This led onto the kiln platform which consisted of a partially robbed brick floor enclosed within a circular brick wall bonded with pink mortar (pl 1). This brick floor lay on a mortar base overlying a thin bed of yellow sand which, in the western half of the enclosure, had been reddened by heat.

The circular platform was surrounded by a tightly packed deposit of stone and occasional brick and tile fragments set in yellow mortar. This obscured the junction of the brick (74) and stone (53 and 54) walls.

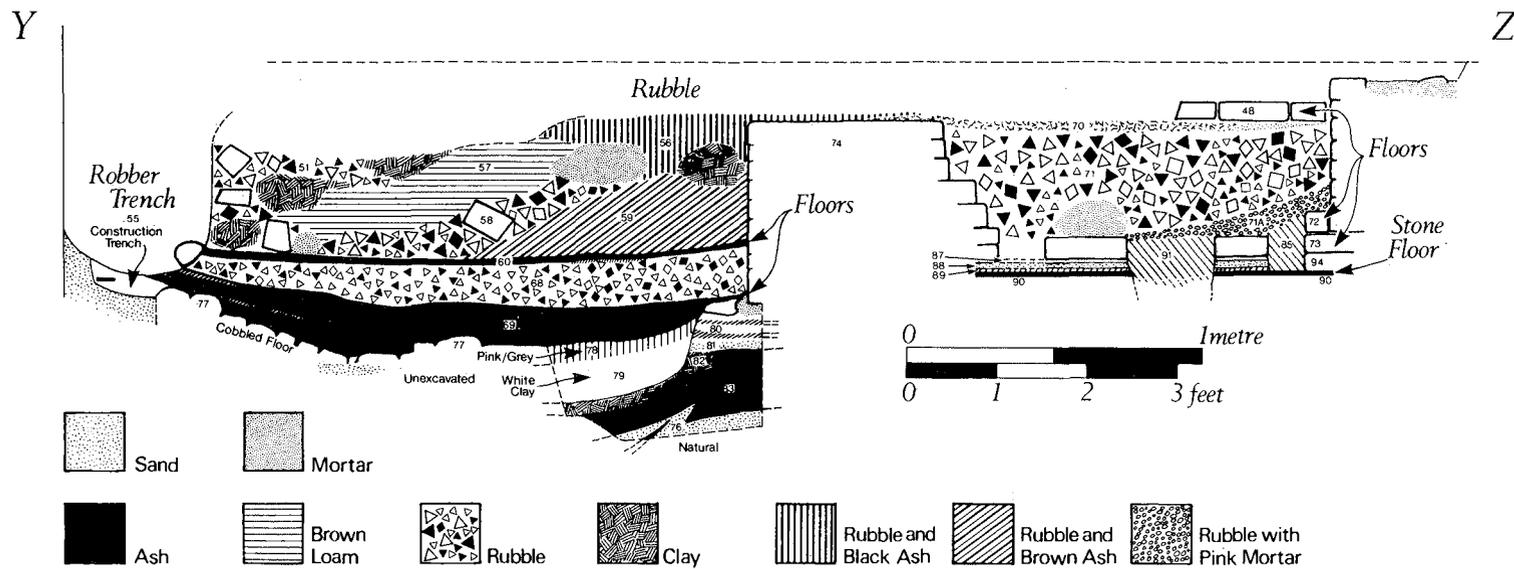
Fig 6B. 43 High Street. Section through probable malting kiln.

Neither of the two lower brick floors had survived intact (fig 6B). Floor 72, the uppermost, survived mostly around the periphery, butting against the enclosing wall. Beneath was floor 73.

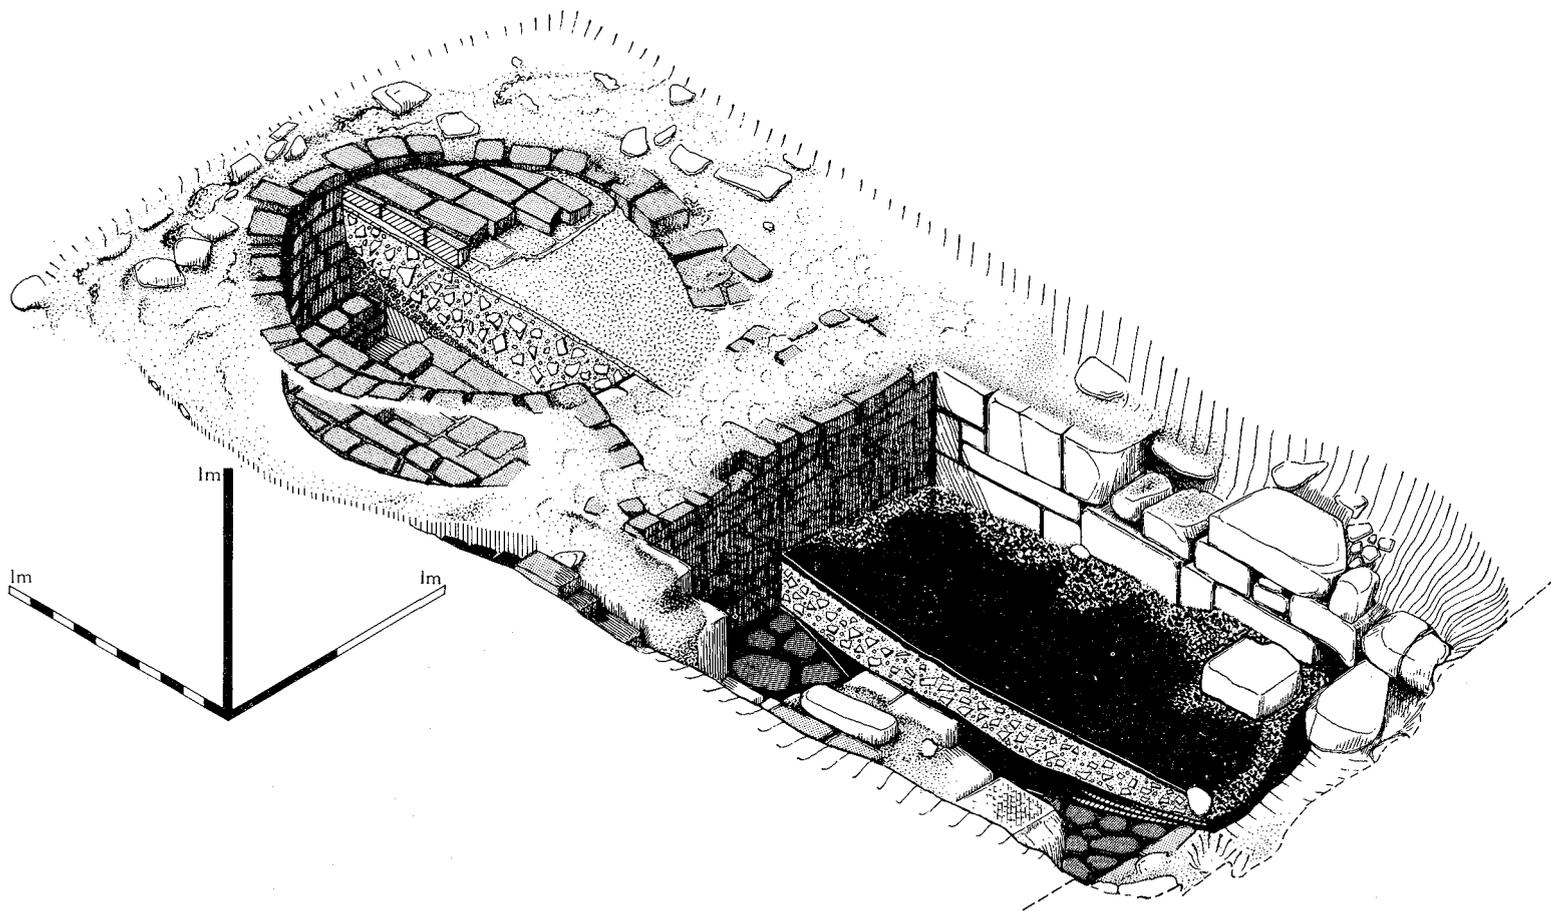
Fig 7. 43 High Street. Probable malting kiln. Isometric reconstruction.

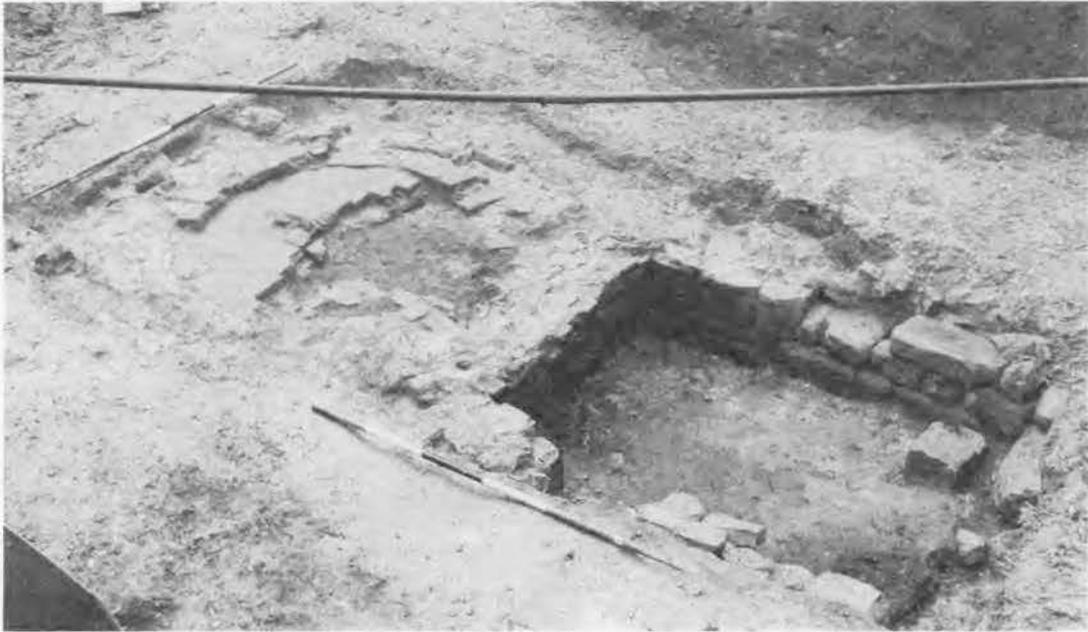
Plate 1. 43 High Street. Probable malting kiln from northwest, as uncovered. Scale in feet.

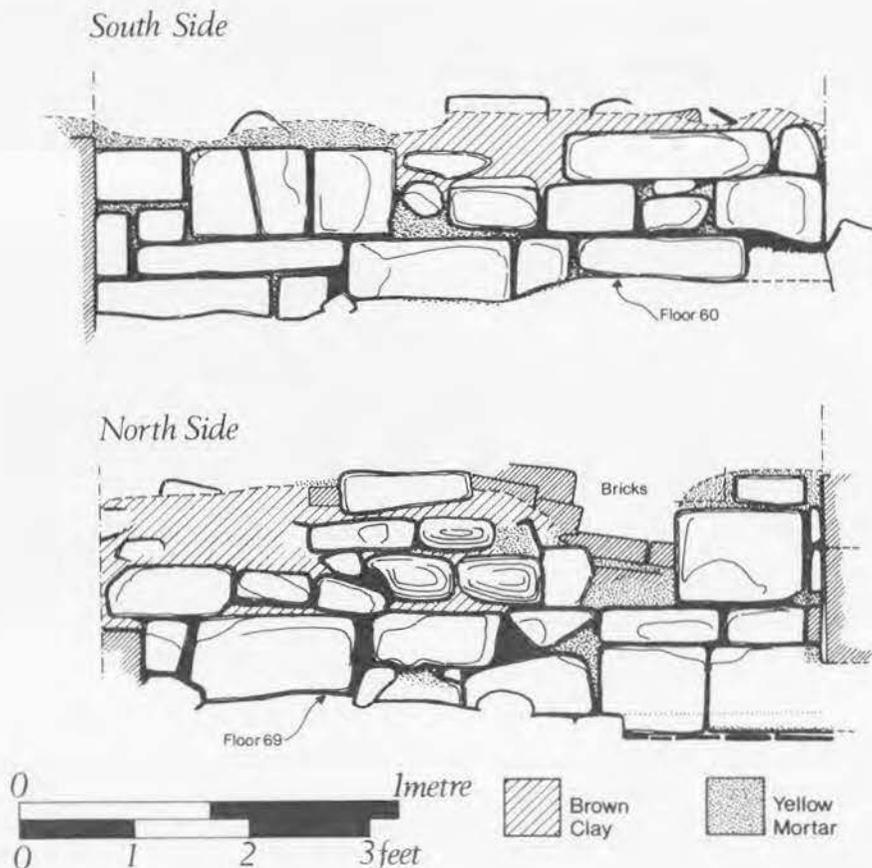
Fig 8. 43 High Street. Probable malting kiln. Elevations of north and south stone walls of stoking chamber.

Both north and south walls (53 and 54) bore evidence of reconstruction (fig 8). The original construction, which was better preserved towards the east, consisted of irregularly-laid finely-cut, blackened Reigate stone ashlar blocks set in yellow mortar (pl 3). To the west these had been replaced with later work of inferior quality consisting of rounded blocks of irregularly-sized Reigate stone bonded with brown clay. The remains of the west wall were bonded with a similar brown clay which contained a pin (fig 13:3). An ashlar block, lying where it had fallen on the floor, came presumably from the west wall. The floor (layer 60) consisted of a thin layer of coal dust and ash.

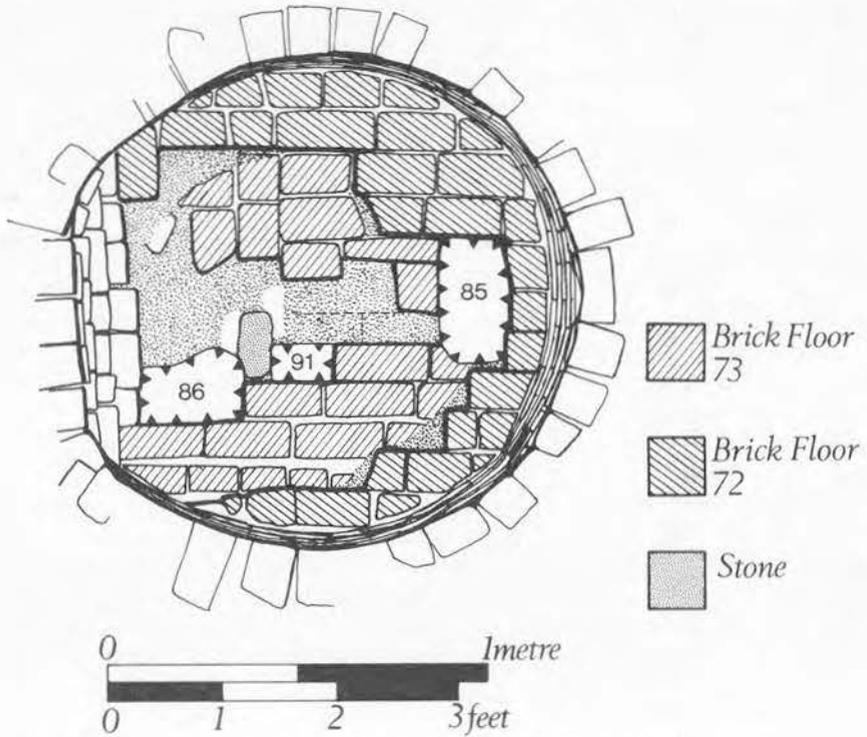
Fig 9. 43 High Street. Probable malting kiln. Plan of kiln floors after removal of brick floor (48).

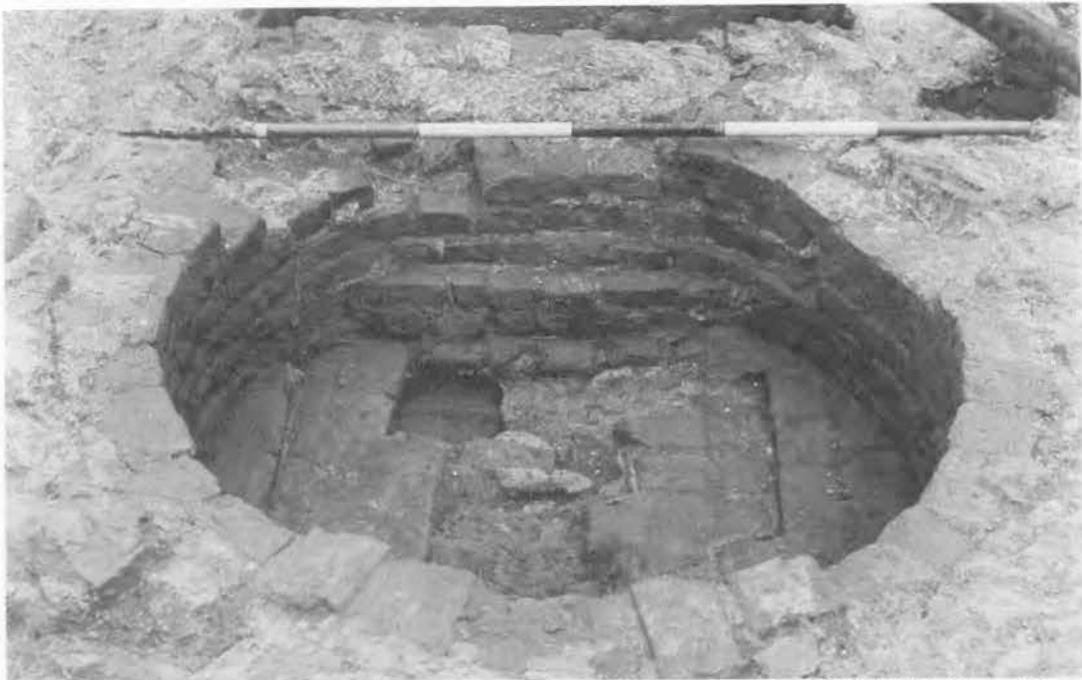
Plate 2. 43 High Street. Probable malting kiln, showing Period 2 kiln platform and Period 3 brick blocking wall keyed into earlier circular brick kiln wall. Partially visible through the hole in the brick floors is the Period 1 stone floor (90). Scale in feet.

Removal of the brick kiln floor (48) and the underlying sand (70) revealed the circular enclosing wall continuing beneath the level of this floor as a brick cylinder. At its base were the remains of two more brick floors (figs 7 & 9). The intervening area, up to layer 70, was filled with a brick rubble containing a few clinker-like lumps and a thinner deposit of pink, stony rubble occupying the east half of the area and tailing off to the west (layers 71 and 71A). The brick wall (74) which was found to be c. 0.65m wide at the top was stepped outwards and downwards and was keyed into the circular wall (pl 2).

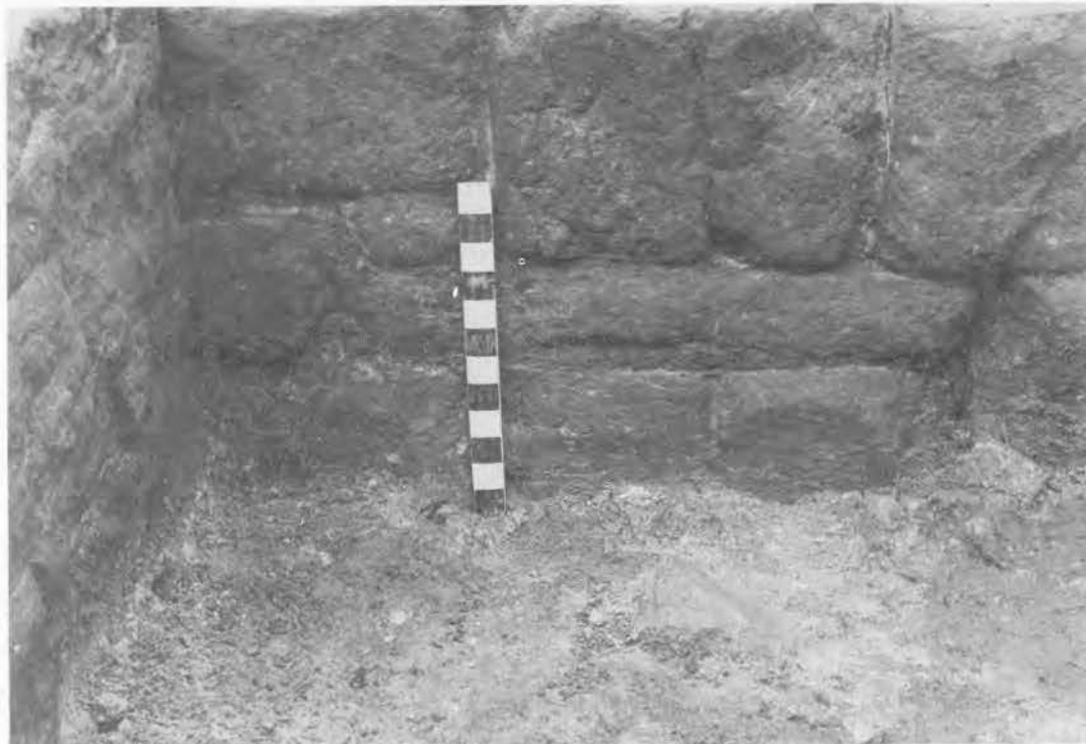
Plate 3. 43 High Street. Detail of ashlar blocks of Reigate stone forming part of the south wall of the Period 1 stoking chamber. Scale in inches.

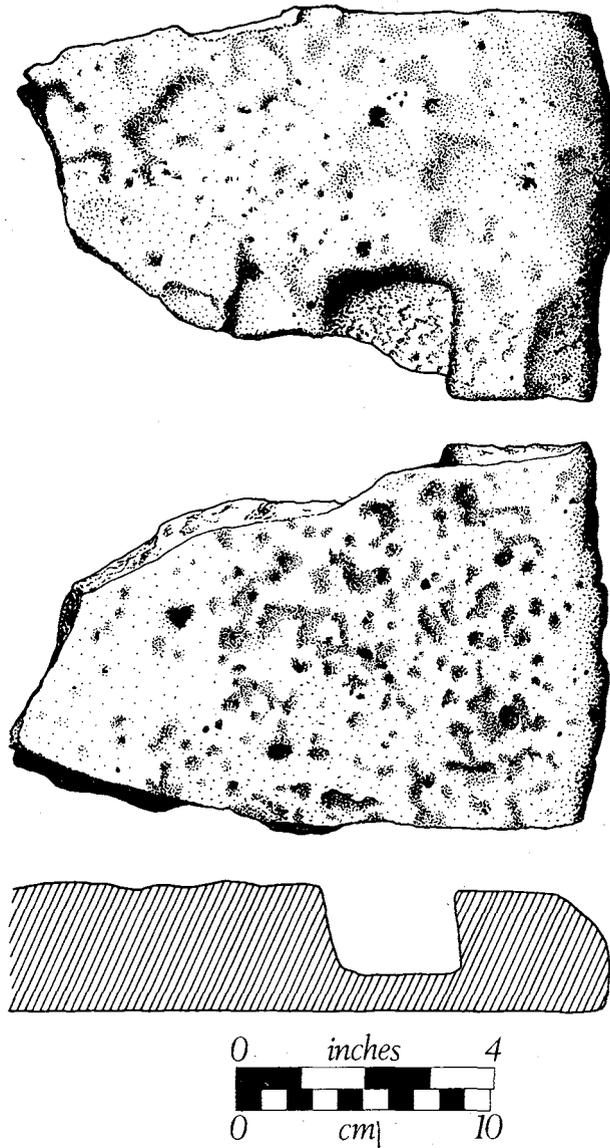
Fig 14. 43 High Street. German lava quern. (1/3)

The millstone was submitted to R W Sanderson of the Petrology Unit, Institute of Geological Sciences, to whom I am grateful for the following identification. Mr. Sanderson comments: 'This is a dark grey, moderately finely scoracious basaltic lava with sparse hornblende phenocrysts. This is undoubtedly . . . an example of the German Niedermendig millstone lava — a tephrite rather than a basalt in the strict sense'.

I am also indebted to J Kenneth Major who examined a drawing of the stone, for the following comments: 'My reading of the fragment is that it was part of a rotary quern and was indeed the upper or runner stone of the pair of stones. It would appear that its original diameter was probably between 24 and 30 ins. The hole on top of the stone was used to attach a handle. This could have been no more than a loosely inserted stick of the right thickness. The stone also

appears to be very worn. To have a thickness of only 2 inches implies a very considerable use. The holes in the grinding face do not differentiate between the blow holes of the lava and the natural pitting which the stone has acquired in use. The great advantage of the Niedermendig stone is that it is like *Aero* chocolate; as you wear through one set of holes the next holes are there. This porosity is of considerable advantage in preparing meal. One thing is certain and that is the fragment was long out of use before 1800. It would have no connection with brewing as these stones are not known to have been used in malt mills. My guess, and it can only be that, is that this is a medieval quern which after it was accidentally broken was found and used as a building stone'.

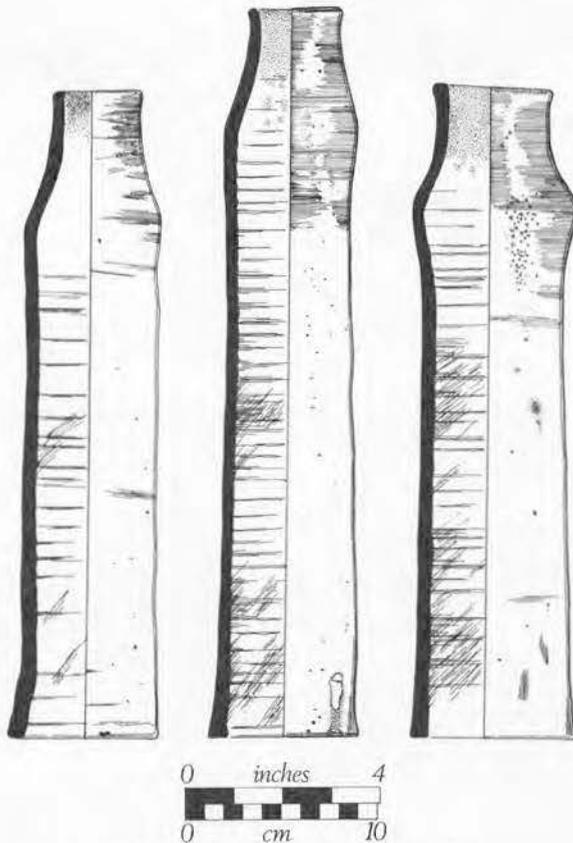
Fig 15. 43 High Street. Examples of medieval drain pipes. (1/4)

The average length was 35.5cm with extremes ranging from 33cm to 41cm. The wide end varied from 5.4cm to 6.6cm internally and the narrow end from 3cm to 4.8cm also internally. Fig 15 shows the extremities in the forms.

The pipes are made in a fine sandy orange fabric, oxidised, of Earlswood type. The surface is occasionally dark grey but this can merge into orange on the same pipe. Clear glaze is used very sparingly only on the inside of the narrow ends. One pipe bears a kiln scar on its wide end. This

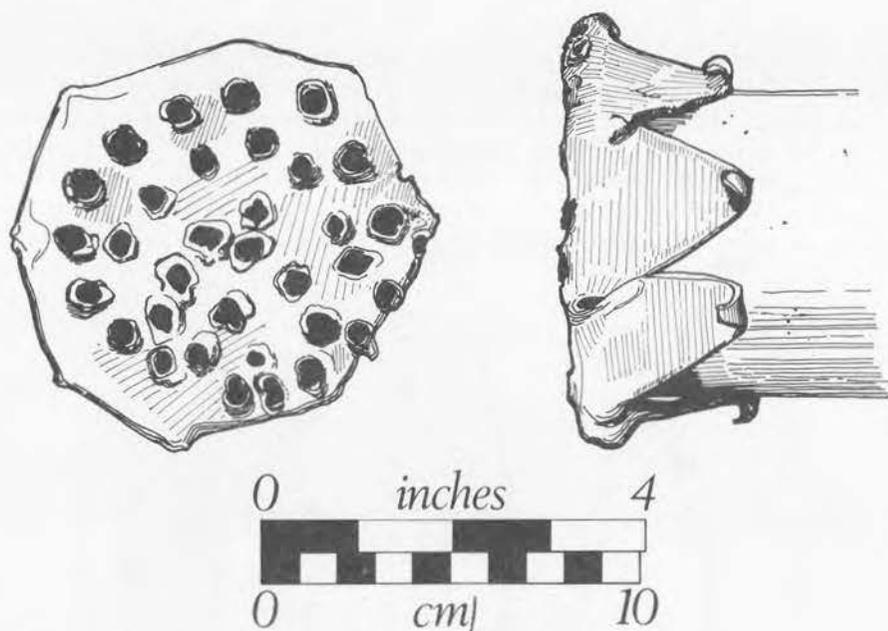
Fig 16. 43 High Street. Perforated lead terminus of drain pipe. (1/2)

The perforated lead cover (fig 16) is a simple, rather crude affair, secured by bending triangular tabs over the splayed end of the pipe.

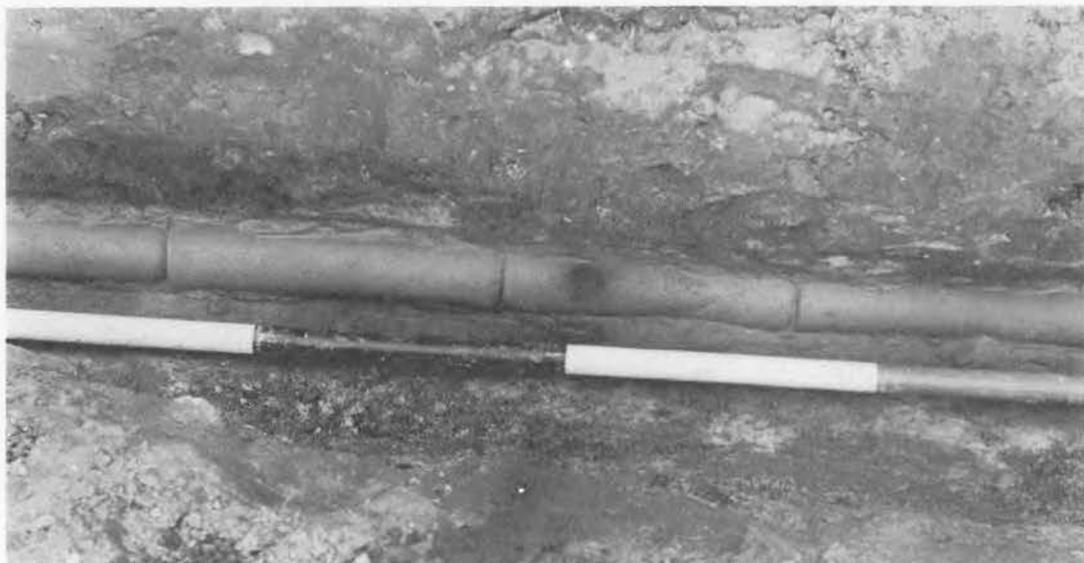
Plate 4. 43 High Street. Medieval pipe drain in situ. North to left. Scale in feet.

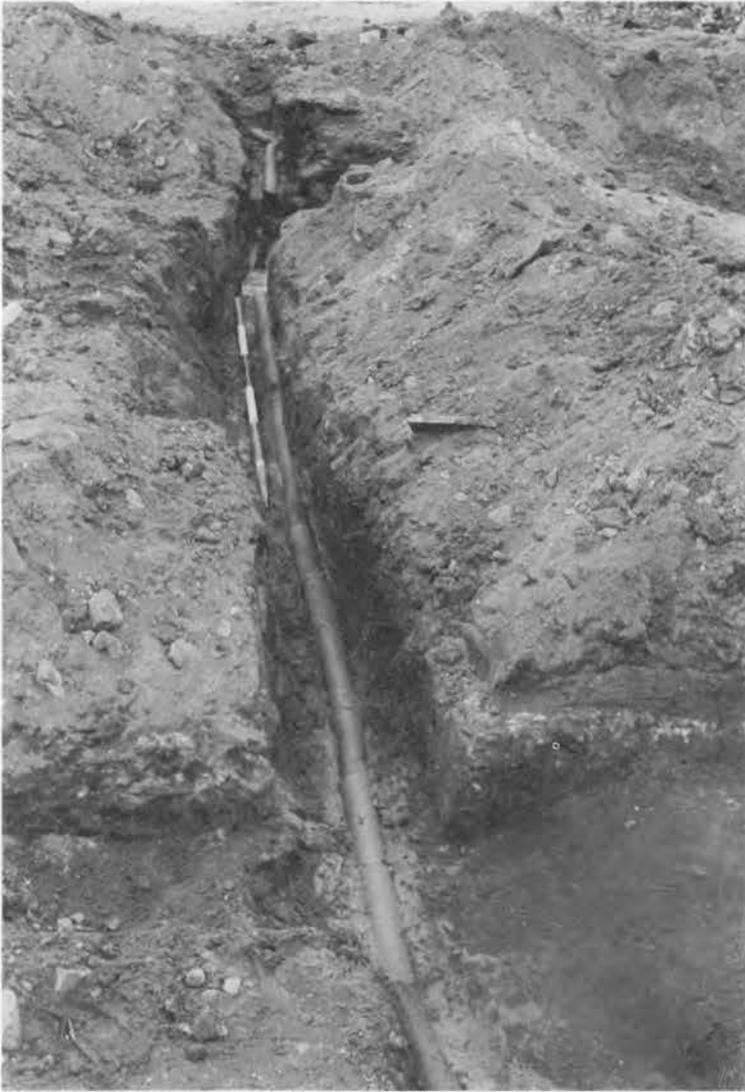
Plate 5. 43 High Street. Medieval pipe drain after salvage excavation, looking north. The break in the line caused by the site engineer's test pit is clearly visible. Scale in feet.

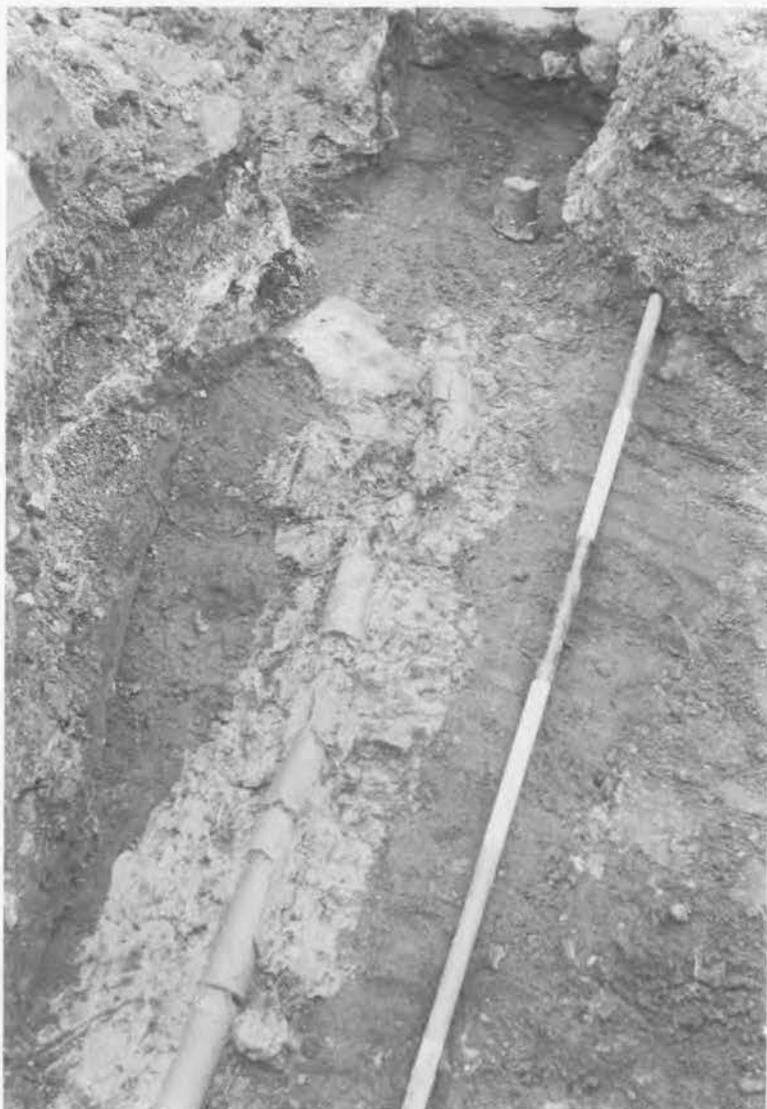
Plate 6. 43 High Street. Medieval pipe drain, showing damaged condition of southern terminus in its clay surround. The lead cover with its associated pipe fragment has been replaced in position as found. Note stone wall immediately beyond. Scale in feet.

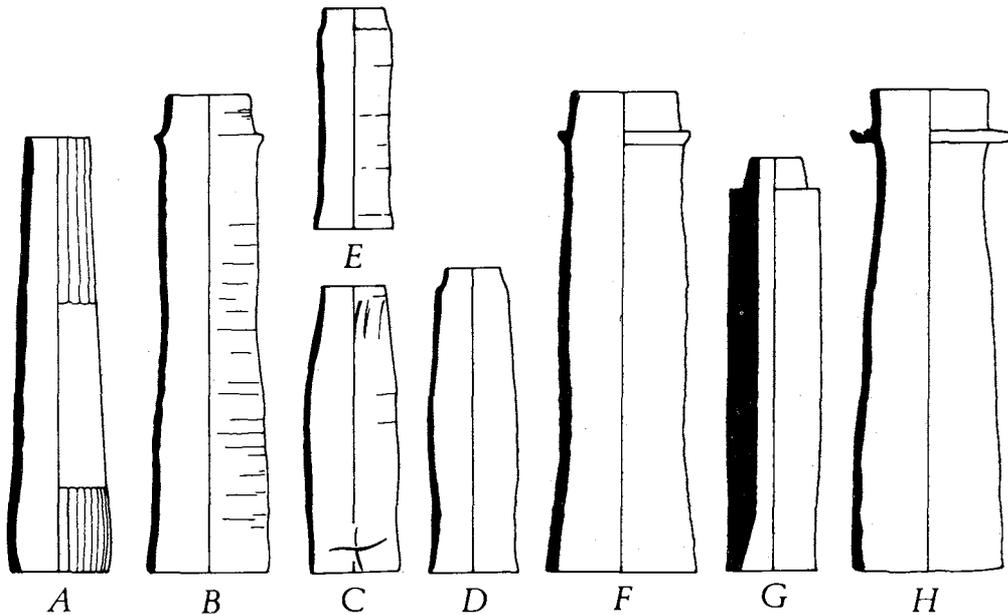
Fig 17. Examples of medieval water or drain pipes from Britain. (1/8) For key, see text.

Other sites where pipes have been found, either singly or in runs include: Ely (fig 17:A), a complete specimen and fragments of others, all with overall external glaze, found during roadworks in the town (Dunning 1967); Laverstock pottery kilns, fragments, 13th century (Musty *et al* 1969); Marwell Manor, Owslebury, Hants (fig 17:F), fragments of uncertain date; Basing House (fig 17:B), ten complete or near complete unglazed pipes, mid 16th century (Moorhouse 1970); Hadleigh Castle, Essex, two 15th century fragments (Drewett 1975); Whitby Abbey, several fragments (Dunning 1967); Linlithgow Palace (Dunning 1967); Canterbury (fig 17:H), a complete pipe and one fragment dated to the first half of the 14th century (MacPherson Grant 1978); and Christchurch, four complete unflanged and fragments of flanged pipes. These are dated as late medieval (Jarvis 1983). A possible fragment from Weybridge, Surrey (Hanworth & Tomalin 1977, fig 44:144) is perhaps more likely to be the stem of a lamp. Jarvis (1983) also refers to a pipe from an excavation at St Catherine's Hill in 1966 (68, fig 28:174), but the context is not clear.

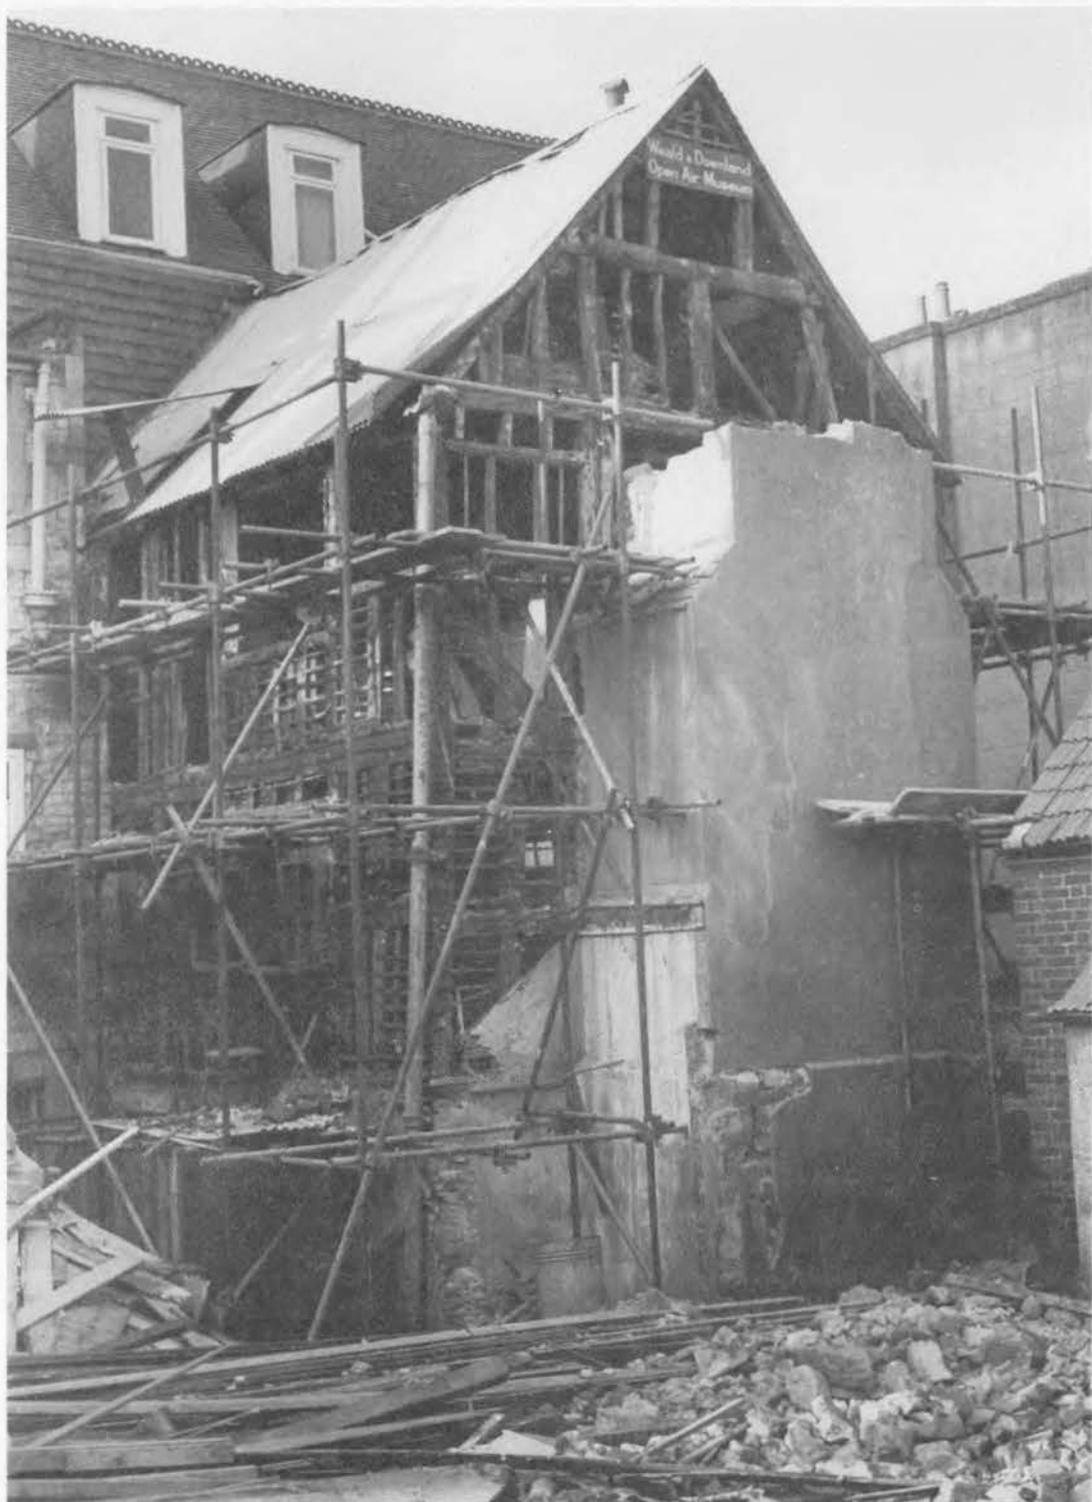
Plate 7. No 43A High Street, Reigate during its dismantling by the Weald and Downland Open Air Museum in Spring 1981.

The main storey of the building contained the parlour, and was roughly level with the High Street. Because of the steeply sloping ground, however, it was at first floor level relative to the ground behind. Above it was a room of similar quality, the parlour chamber. The roof contained

a habitable attic, and the building sat on a stone basement. In the gable wall was a chimney stack of Reigate stone, with an external width of 9' 0" at the base.

The chimney stack formed an integral part of the south gable wall of the building. It provided each of the two main rooms with a fine carved stone fireplace, with four-centred heads and 'pumpkin' stops to the mouldings. Comparison with other similar fireplaces suggests a date in the early 17th century, perhaps c1620, and this evidence may be taken to date the whole wing. The soft stone of the chimney had deteriorated badly: large areas had been rebuilt in brick, and the whole of the outside had been covered with hard cement render.
