## **A 15th century tile kiln and the 18th century ‘Abbey Gate House’ excavated at Furnitureland, Merton**

*An archaeological excavation was carried out by the Museum of London Archaeology Service on the site of Furnitureland, Merton High Street, SW19. This archaeological work was undertaken following the positive results of an archaeological evaluation. It was carried out in order to explain the nature, extent and date of a number of foundation walls revealed during the evaluation phase of work and to reveal the full extent of a building known as ‘Abbey Gate House’ known from cartographic evidence. The excavation revealed a previously unknown late 15th century tile kiln. This kiln was placed within an earlier structure that consisted of a sunken building representing an open-ended forming shed for the manufacturing of tiles. Truncating the kiln were the chalk foundation walls for a small 16th or 17th century building which was later incorporated into a much larger 18th century brick house historically known as ‘Abbey Gate House’.*

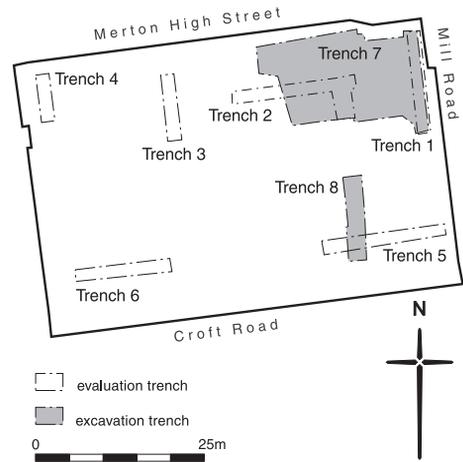
Fig 2 Furnitureland, Merton. Trench location plan.

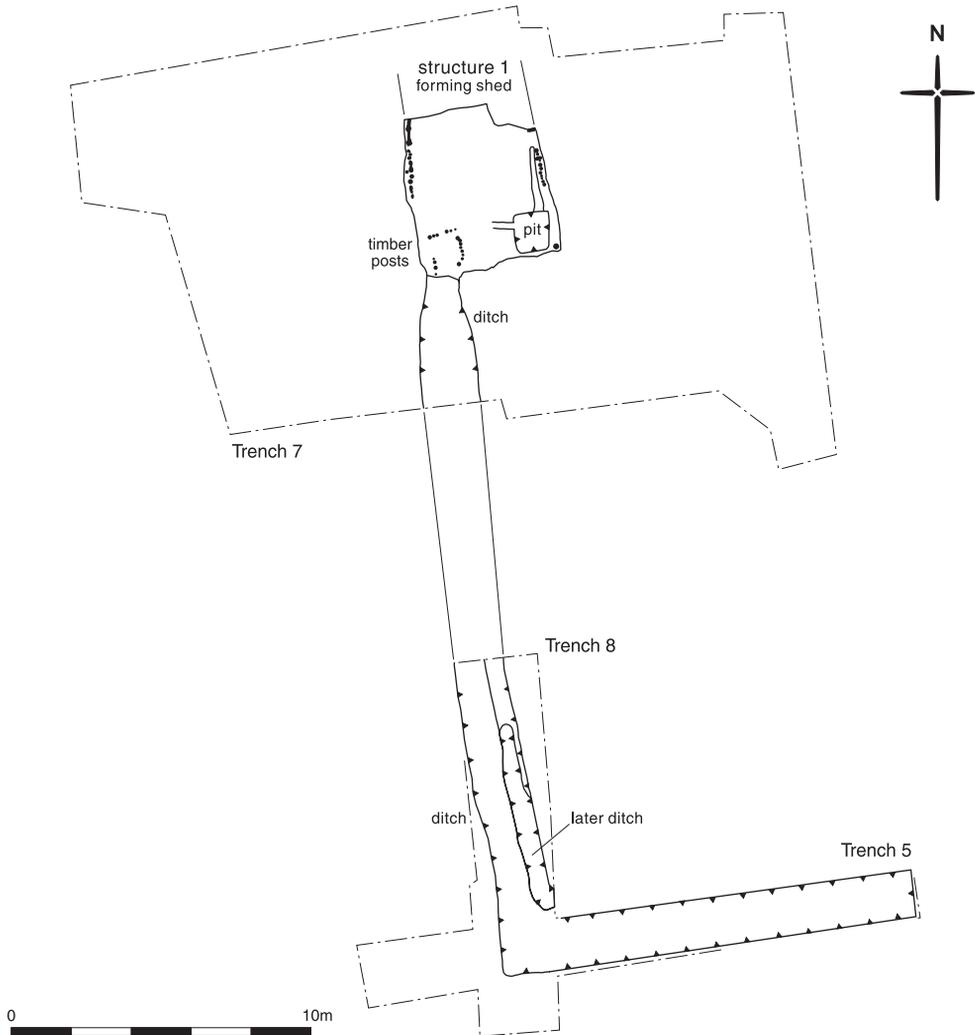
During the mid-late 15th century, roof tile manufacturing was undertaken on the site. This included an open-ended forming shed and a tile kiln. The forming shed (fig 3) measured over 5.50m from north to south (truncated at the northern end by the later 18th century Abbey Gate House walls), 4.50m from east to west and was c 0.50m deep. Along the eastern and western sides of the structure were lines of post/stakeholes each measuring around 100mm in width x 100mm deep. The roof would have had to be light, pitched (probably timber framed) and able to span the 4.50m internal space (no central roof supports were located), so may have been lightly thatched.

Within the structure were two gullies, probably intended to aid internal drainage. The gully on the eastern side of the structure drained from north to south before entering into a pit located within the south-eastern corner of the shed. A second smaller gully also emptied into the pit from the west. The pit measured 1.35m north-south x 1.15m east-west x 750mm deep. Within the middle of the pit was a small sump or slot measuring 600mm north-south x 300mm east-west x 150mm deep. This feature was probably originally timber-lined, judging from the profile. The pit may have been a combination of a sump and a puddling pit. It is probable that damp, puddled clay was stored in the pit until required.

Associated with the forming shed was a ditch running south from its south-western corner. The ditch measured 29.50m north-south (visible in trenches 7 and 8) and then turned to the east (evaluation trench 5). The ditch was around 2m wide x 1m deep and cut with the upper sides at around 45° leading to a lower gully with vertical sides and a flat base. This lower ditch slot was probably timber lined at its northern end and was filled with yellow/grey fine sandy silt.

The ditch was lined with clay where it cut the natural sandy gravel. Within the northern end of the ditch, in the forming shed, were a number of square oak timber posts. The posts measured around 80–100mm in width, were placed at 100mm intervals and may have held timber planking. The lower main fill of the ditch was a 200mm thick mid-grey clayey silt (11) with frequent charcoal flecks and roof tile fragments. Pottery recovered from this fill dated to 1280–1500, and ceramic building material had a date range from 1480 to 1800.

Fig 3 Furnitureland, Merton. Plan of the 'forming shed' and the north-south aligned ditch.

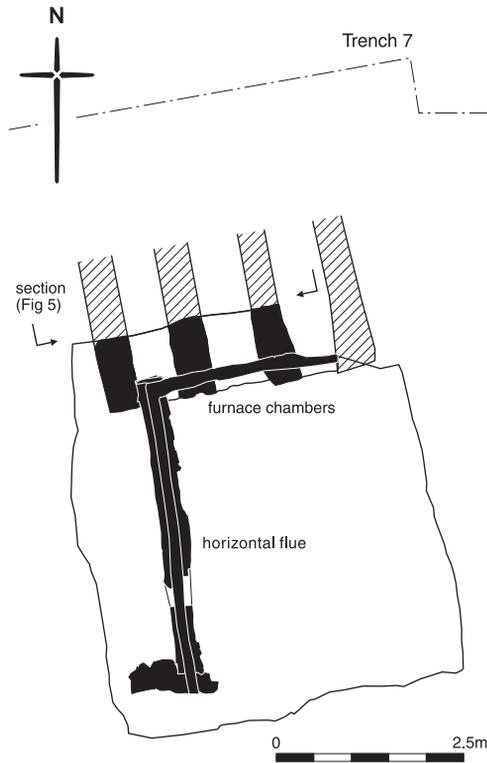
The 'forming shed' may have produced tiles for a single firing as no further 'forming sheds' were found during the excavation. After the 'forming shed' was no longer needed a tile kiln was constructed within its walls (fig 4). The kiln itself was constructed from either waste tiles from earlier firing, unfired tiles or re-used tiles from Merton Priory. The kiln comprised three furnace chambers and measured 3.60m east-west and survived for 1.00m north-south. The furnace chambers were each 500mm wide, with a base of vertical peg tiles, and horizontal roof tiles forming the walls of each chamber (67, 73). The tiles used in the construction of the tile kiln have a date range between 1480 and 1800 and were bonded with clay and mortar (Smith 2000). The arched roofs for the furnace chambers did not survive, but the reconstruction allows for a semi-circular vault (fig 5). Some of the peg tiles were faced in a

Fig 4 Furnitureland, Merton. Plan of the tile kiln.

During the early firings, a north–south aligned flue (53), constructed from peg tiles, was placed along the back of the kiln to help feed air to the kiln fires. This flue was first connected to the westernmost furnace chamber, but was then extended along the length of the furnace chamber openings, measuring 3.90m north–south x 300–380mm wide x 120mm high. The internal opening of the flue measured 200mm wide x 60mm high. The southern end of the flue was mortared onto a line of five east–west aligned re-used medieval Reigate stone blocks. These blocks were placed upon the partly backfilled northern end of the earlier north–south aligned ditch. The flue was constructed by laying tiles on the base, overlain by bonnet/ridge tiles forming the roof and bonded with a pale grey lime mortar. The peg tiles used in its construction are fairly unusual, and have been knife-trimmed along the edges of the sanded face. It is clear that the tiles were de-moulded onto their struck faces for subsequent treatment – ie pushing through the holes and trimming the edges of the faces. This may represent particular manufacturing procedures at a specific yard. Two ridge tiles in fabric 2586 are of particular interest, and although broken, join to form complete tiles. They were initially made as a 1-foot (300mm-) square tile and bent to form the ridge-tile shape; the latter task was probably done on an appropriately shaped wooden ‘saddle’. All the ridge tiles from the site have the familiar profile with a curved crown and more or less straight sides; there is no creasting, no socket holes for attached finials and the tiles are unglazed (Smith 2000).

During a subsequent phase of construction, the northern end of the flue was blocked with the insertion of a vertical roof tile placed flush against the flue opening. The flue was extended east to west along the back of all three of the furnace chambers with small openings placed at intervals for each furnace chamber (figs 6 and 7). This flue connected to the north to south flue by an opening 65mm wide x 40mm cut into a tile located at the northern end.

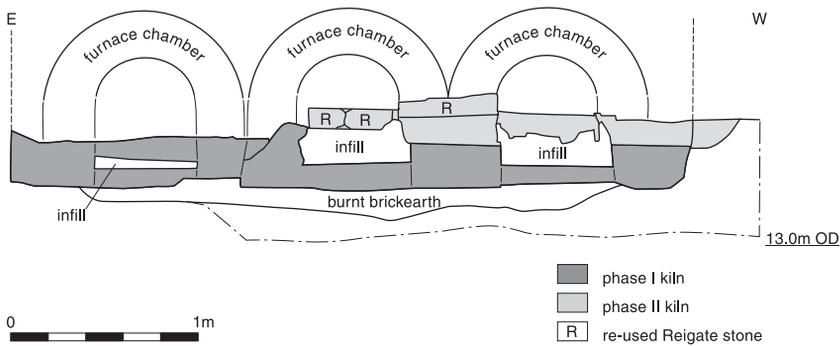
Fig 5 Furnitureland, Merton. Section of the truncated north side of the tile kiln with the conjectured roofs of the furnace chambers.

After one or more firings the kiln was dismantled and rebuilt. The east–west aligned flue went out of use as the furnace chamber floors were raised by 300mm. Over each of the furnace chambers, new walls and vaults were constructed. The construction followed the same type as the previous phase, with walls of horizontal roof tiles bonded with a lime mortar and clay. The upper part of the wall shows signs of forming an arch for the tile structure. The furnace chambers included re-used 12th century Reigate stone capital fragments, presumably from a building at Merton Priory that had been demolished before the Dissolution.

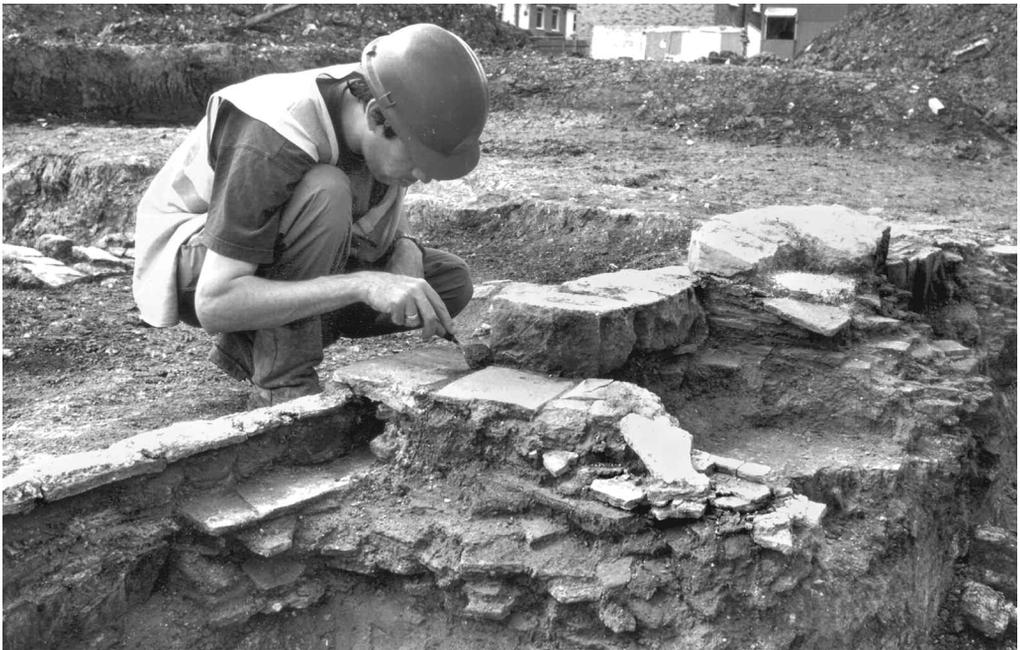
Fig 6 Furnitureland, Merton. Cleaning the tile kiln, with the horizontal flue to the rear of the furnace chambers visible.

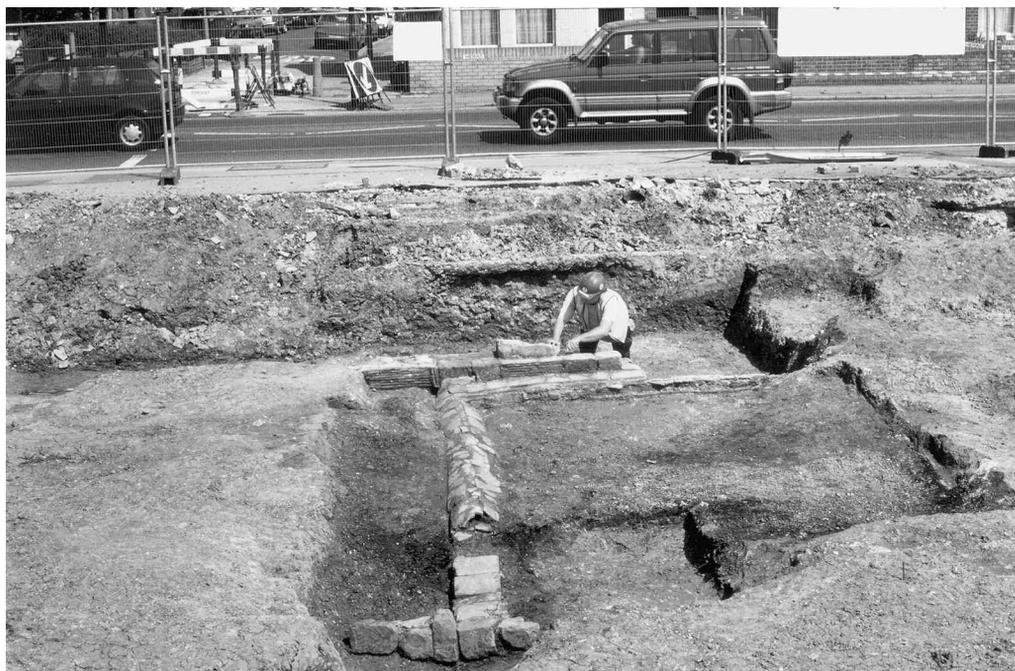
Fig 7 Furnitureland, Merton. Photograph of the rear of the tile kiln showing the horizontal flue.

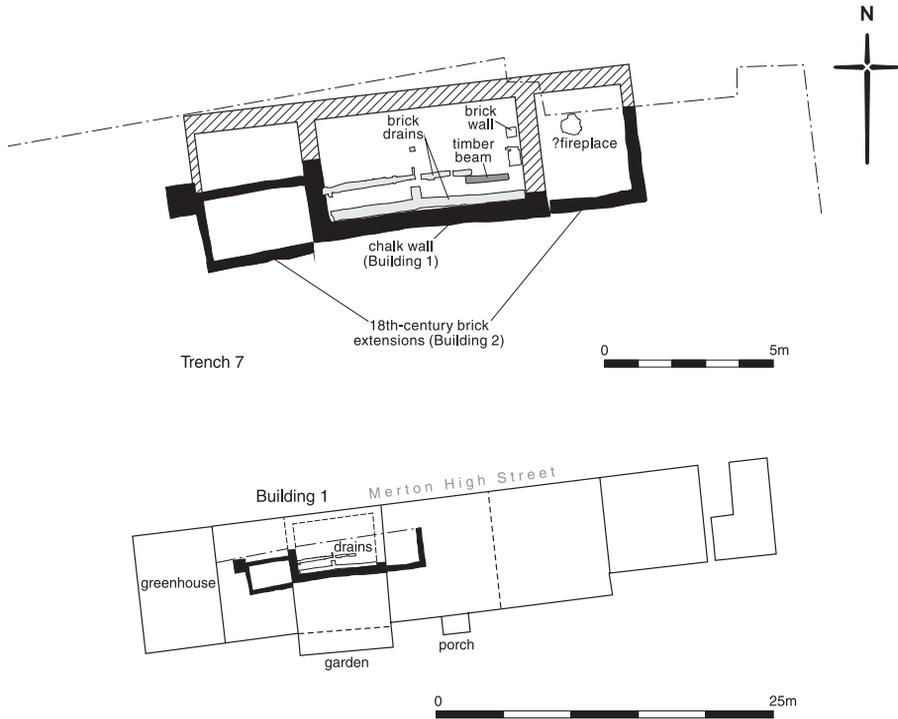
Truncating the northern part of the tile kiln were the chalk foundations for a 16th or 17th century building (fig 8). The excavated foundations occupied an area measuring 7.20m east–west x 2.40m north–south (to the limits of excavation). The building, based on modern cartographic evidence, would have been around 4.50m north–south. The foundations measured 550mm thick and were bonded with a light orange mortar with small chalk flecks. The eastern wall was not found, but a slight cut in the natural clay suggests that the wall turned northwards.

Fig 8 Furnitureland, Merton. Plan showing the 16th century chalk walls of Building 1 and the 18th century brick cellar walls of Building 2 (top), plan of Building 1 and Building 2 in relation to the conjectured location of Abbey Gate House from cartographic evidence (bottom).

During the middle of the 18th century, Building 1 was incorporated into a large three-storey building later known as ‘Abbey Gate House’ measuring some 36m in length (east–west) and between 7 and 9m wide (north–south). The walls were placed on shallow foundations and thus did not survive subsequent rebuilding. However, two small brick cellars abutted the walls of the earlier Building 1 (fig 8).

Adjoining the western end of Building 1, a brick cellar measuring 3.20m east–west x 2.40m north–south was constructed from red unfrosted bricks dating from *c* AD1750. A make-up deposit between the walls comprised a very compacted 100mm-thick layer of grey/red broken brick, mortar, flint and chalk that contained pottery dating to 1665–1750.

The eastern cellar measured 2.80m east–west x 2.80m north–south. Most of the walls had been robbed out, but within the western part of the cut were the remains of a single red brick-width wall bonded with a hard white lime mortar. Between the walls of the building were brick- and tile-lined drains and a possible fireplace/hearth (38) constructed from brick. This hearth measured 600 x 550mm and was constructed of randomly placed red unfrosted bricks forming a circular area covered with ash and charcoal.

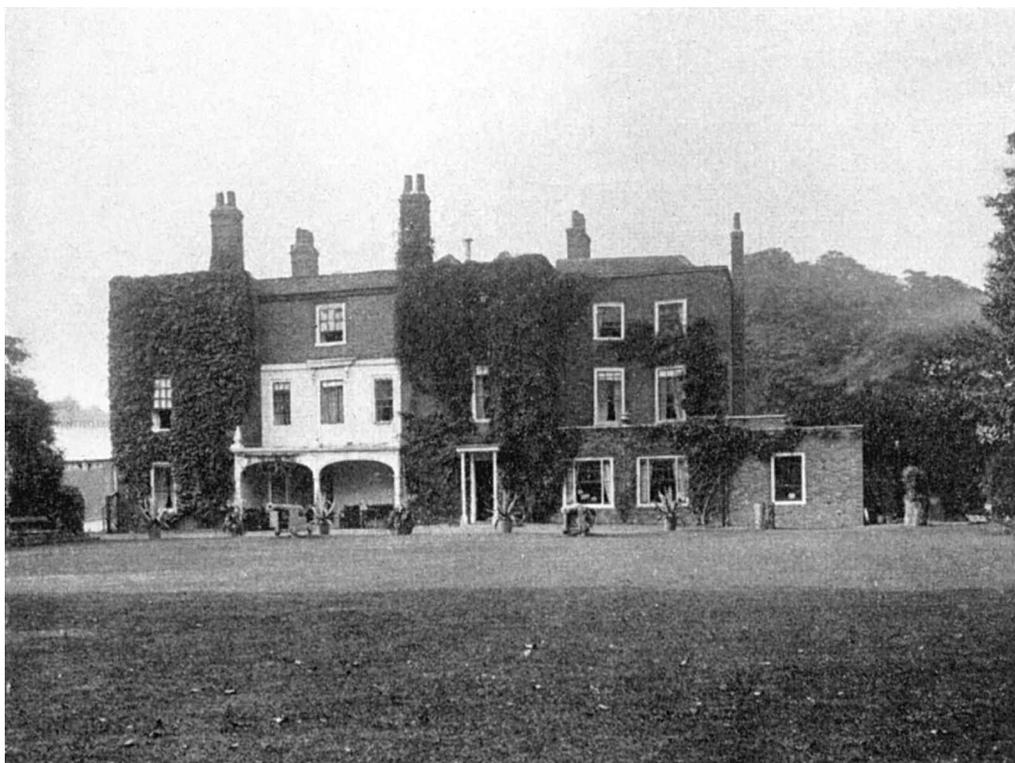
Fig 9 Furnitureland, Merton. Photograph of the rear of the Abbey Gate House taken prior to its demolition in 1906. (Reproduced by kind permission of Wimbledon Society Museum of Local History)

In the middle of the 18th century the chalk walls of Building 1 were incorporated into a much larger building known as the 'Abbey Gate House' (fig 9). The two brick cellars abutting Building 1 were built at this time and by overlaying these excavated walls on the 1898 OS map the cellars appear to be located at the north-western part of the building, fronting Merton High Street.
