The gatehouse wing at Sutton Place, near Guildford: excavations and other fieldwork 1981–2 and further research

DAVID BIRD

Small-scale excavation and observation of construction works at Sutton Place, near Guildford, in the 1980s recorded a hint of earlier medieval occupation at the site and some archaeological evidence for the gatehouse (north) wing, the foundations of the east wing, a few buried features elsewhere around the house and earlier landscaping to the north. Subsequent research on the appearance of the north wing leads to the suggestion that elements of the demolished gatehouse were re-used in the late 18th century to make the existing grand entrance to the south range.

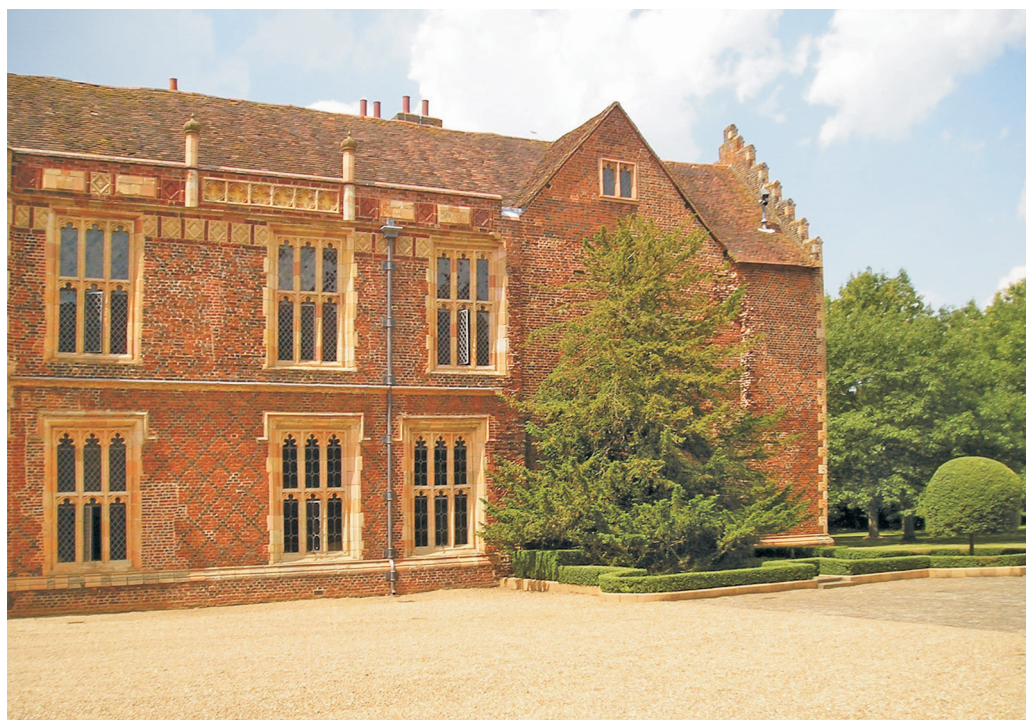
Fig 1 Sutton Place. The northern end of the west wing in 2006 showing the location of its original junction with the north wing (vertical scars either side of the tree below the gable) and in the foreground one of the planting beds marking the outline of the gatehouse wing (in the wrong place). (Photograph: Martin Higgins, © Surrey County Council Heritage Conservation Team)

Harrison (1893, 136 n1) notes that ‘the exact line of the northern wing, both on its inside and outside walls, is easily traceable, the return of the moulding of the skirting or base being visible both on the east and west wings,’ and it remains the case that the original location of the join between east and north and west and north wings is obvious (fig 1). He adds that ‘the ground has been recently opened and trenched by Mr. Sidney Harrison, who has made careful measured plans. From these the exact line of the building can be followed’ (Harrison, 1893, 140 n1 and pl O opp 154). This plan differs considerably from C F Hayward’s overall plan of the house also dated 1891 (Harrison 1893, pl HHH between 140 and 141), but the excavation in 1981 and other considerations (see further below) indicate that Sidney Harrison’s plan was much more accurate (fig 2). Perhaps for some reason Hayward did not have sight of Harrison’s plan. Using the latter and analysis of the views it is possible to suggest the most probable original appearance of the exterior and courtyard faces of the north wing. Nevertheless, not all the differences in the views can be reconciled and it is worth stressing the cautionary tale that however accurate an old ‘view’ may look it is unwise to trust it absolutely (cf Howard 1994, 5–6)!

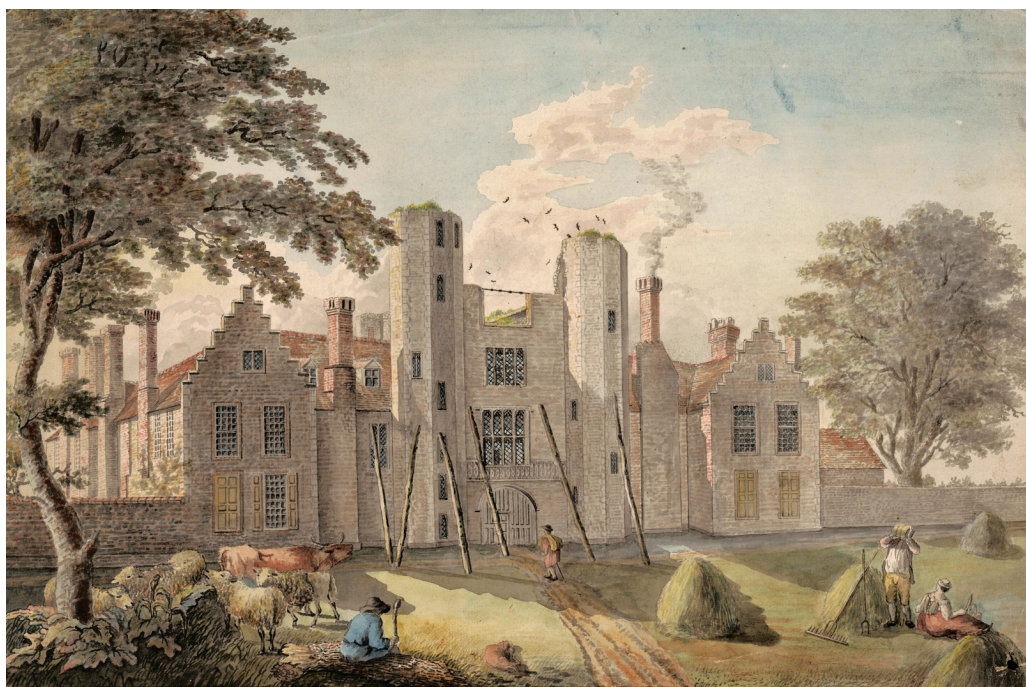
Fig 3 Sutton Place. View of Sutton Place from the north-east probably about 1780. (© Surrey History Centre, acc no 8363/1/69/2; see Appendix, View 12). (Reproduced by permission of Surrey History Centre and Mrs Handa Bray)

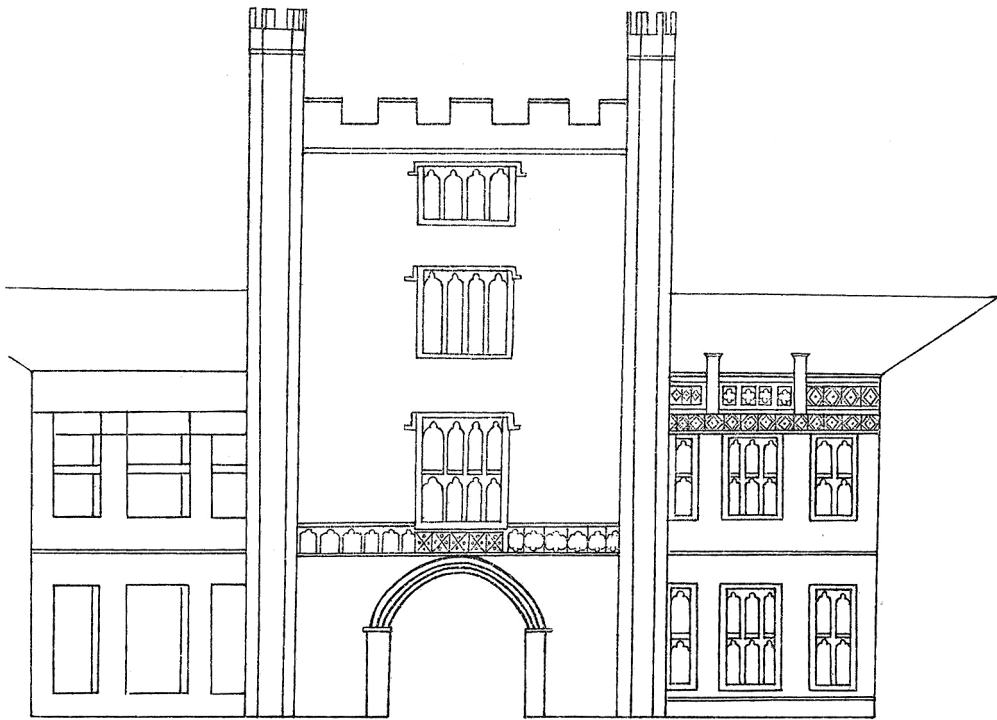
“Front of Sutton towards the Court, as it stood 22nd January,
“1750-1, The little pillars 67½ high and 5 f. diameter. The Court
“81.3. square exclusive of the base.”

Fig 6 Sutton Place. Drawing by J Woolfe of the courtyard side of the north front in the mid-18th century (from Harrison 1893, 140, and pl P opp 156; see Appendix, View 3).

The gatehouse tower sat in the centre of the wing and, if the Wolfe drawing is to be trusted, on either side of the courtyard elevation were two rows of three windows, those on the first floor rather smaller than those below but of the same width. Probably all had terracotta mouldings

View 3 (fig 6). A pencil drawing of the courtyard side of the north wing (Harrison 1893, 140, and pl P opp 156). For discussion, see View 2.

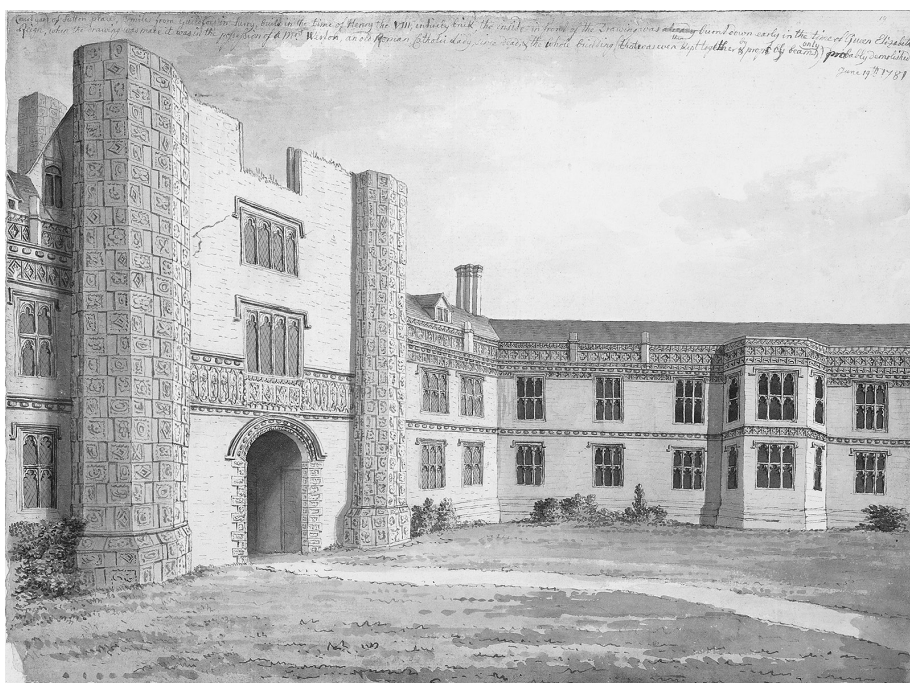
Fig 8 Sutton Place. View of the courtyard side of the gatehouse wing and part of the east wing, 1781. (© The Bodleian Libraries, The University of Oxford, Gough Maps 30, fol 61, item a; see Appendix, View 10)

View 10 (fig 8). Gough Maps 30, f 61, item a. A grey version of View 8 but with no drawn frame and some differences in detail. Written in ink across the top of the drawing, possibly in the same hand not seeking to be neat and careful: 'Courtyard of Sutton place [sic], 3 miles from Guildford in Surry [sic], built in the time of Henry the [sic] VIII, entirely brick, the inside in front of the Drawing was ['already' crossed through] burnt down early in the time of Queen Elizabeths [sic] Reign, when the drawing was made it was in the possession of a Mrs Weston, an old Roman Catholic Lady, since dead, & the whole building (that was even ['then' inserted] kept together by props of beams only) probably demolished'. Separately (ie clearly date of drawing and not of the probable demolition): 'June 19th 1781'.

There can be little doubt that this is an earlier version of View 8, used as the basis to produce a properly finished picture. The differences between the two versions are interesting and are considered further below, in discussion of View 11. Particularly noteworthy in View 10 is a curving path in the foreground, coming from the gatehouse and implying that the entrance in the south front was not in the centre but on the western side.

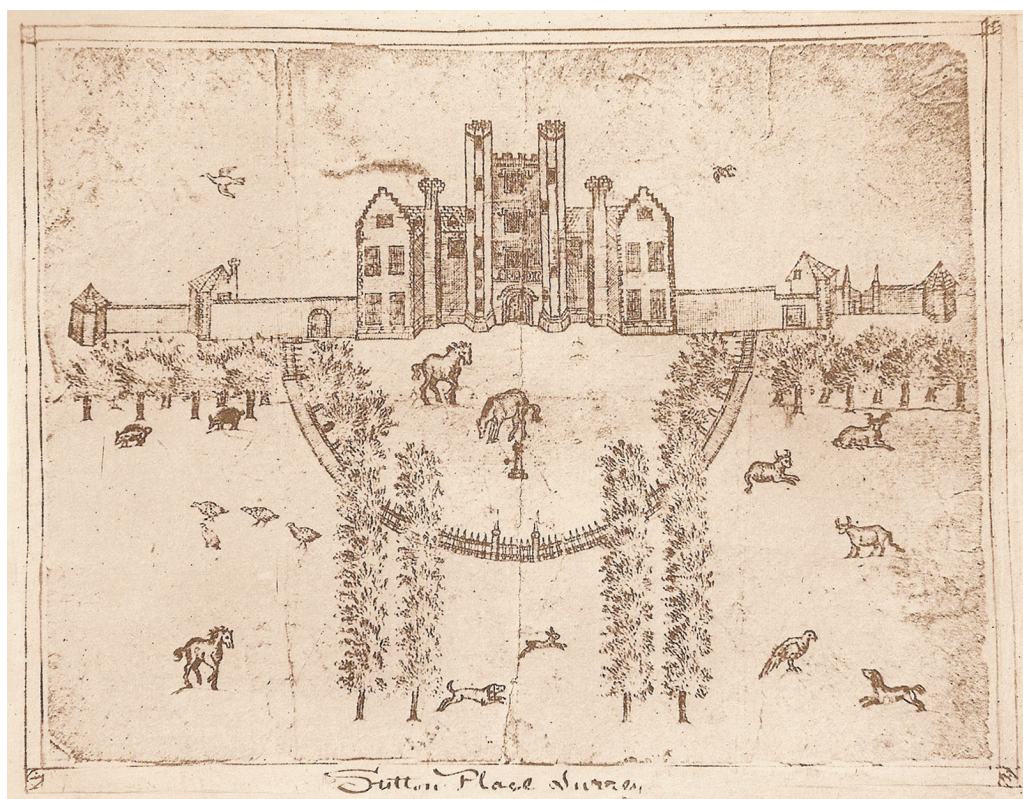
Fig 11 Sutton Place. Probably an early 18th century view of the north front and its surroundings (from Harrison 1893, pl 3 opp 1, and 132; see Appendix, View 1).

View 1 (fig 11). Harrison reproduces an ‘Old Drawing, Sixteenth Century, showing Gateway and Tower, North Front’, also described as ‘being about the beginning of the seventeenth century, say 1600’ (Harrison 1893, pl 3 opp 1, and 132). He gives no reason for the date and it is open to challenge. Up until at least the mid-17th century part of the north wing was fire damaged and abandoned, according to Harrison himself. The tree-lined avenues are likely to have been planted around 1700 (see discussion of the setting of the house, above), the writing and drawings of animals also have the look of such a date (Shirley and Emma Corke, pers comm), and it may be noted that the trees seem to be young. There are good grounds too for thinking that the large windows in the ends of the east and west wings are likely to be later. It seems probable that the drawing is closer to 1700, and perhaps around the time of the restorations in the 1720s.

In most respects the drawing is similar to other views of the outside of the north wing with only a few minor differences. It is the only one to show much of the wider setting of the house, with garden walls on each side, both with inset angles inside which small garden buildings are set, and with smaller angular buildings still further along. Although there is no indication of the western service court, there is a noticeably elaborate gate in the west garden wall that might well have given access to it.

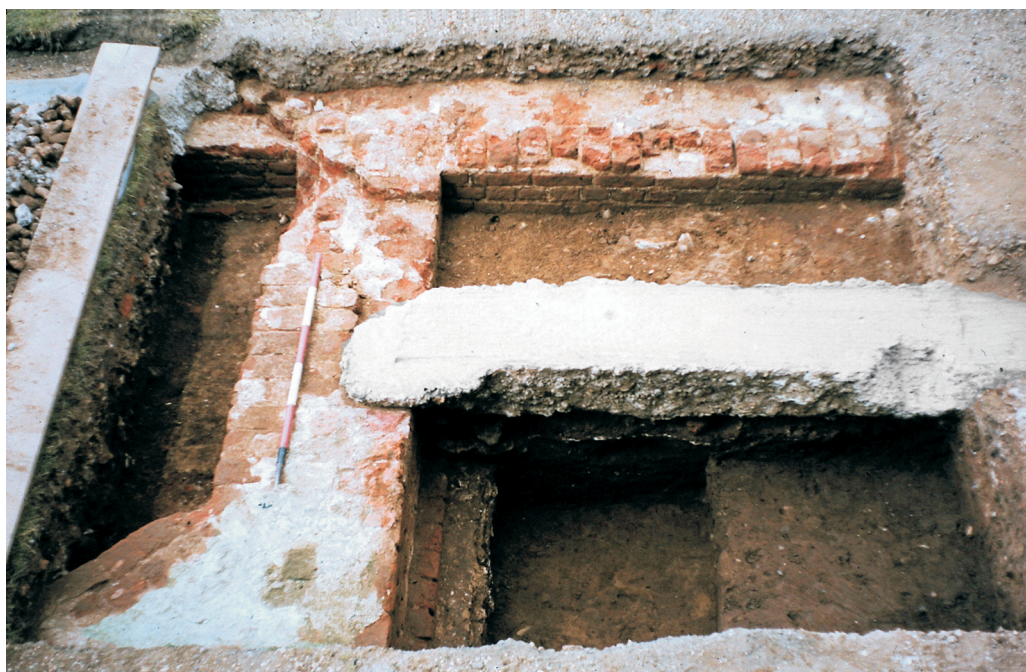
Fig 14 Sutton Place. Overall view of the 1981 excavation from the west.

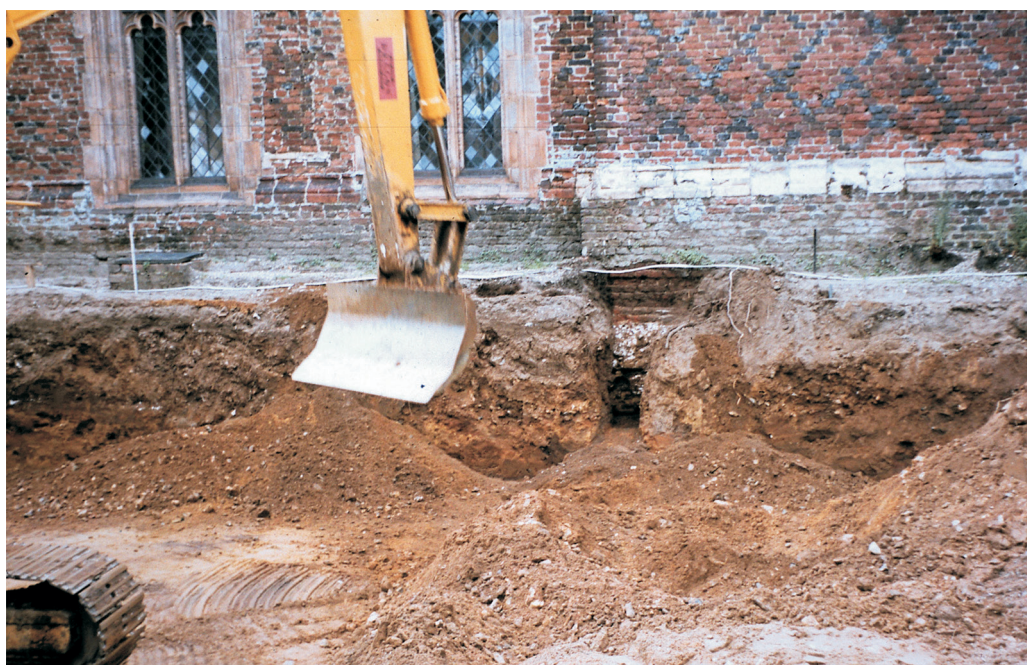
Fig 15 Sutton Place. View of the machine-cut east wall foundation section.

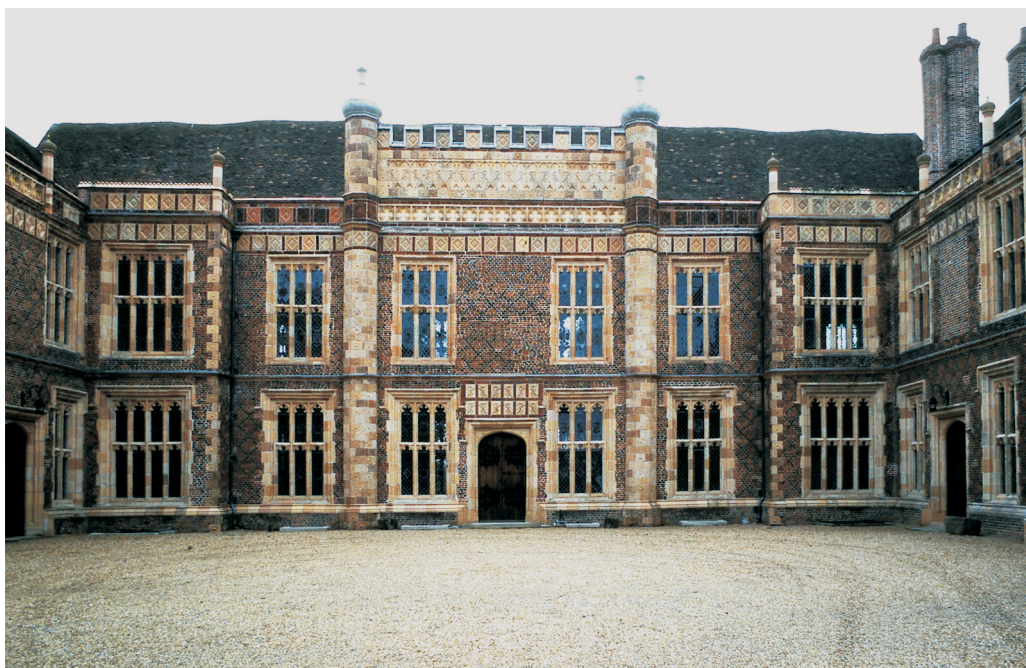
Fig 16 Sutton Place. The centrepiece of the south wing in 1981.
