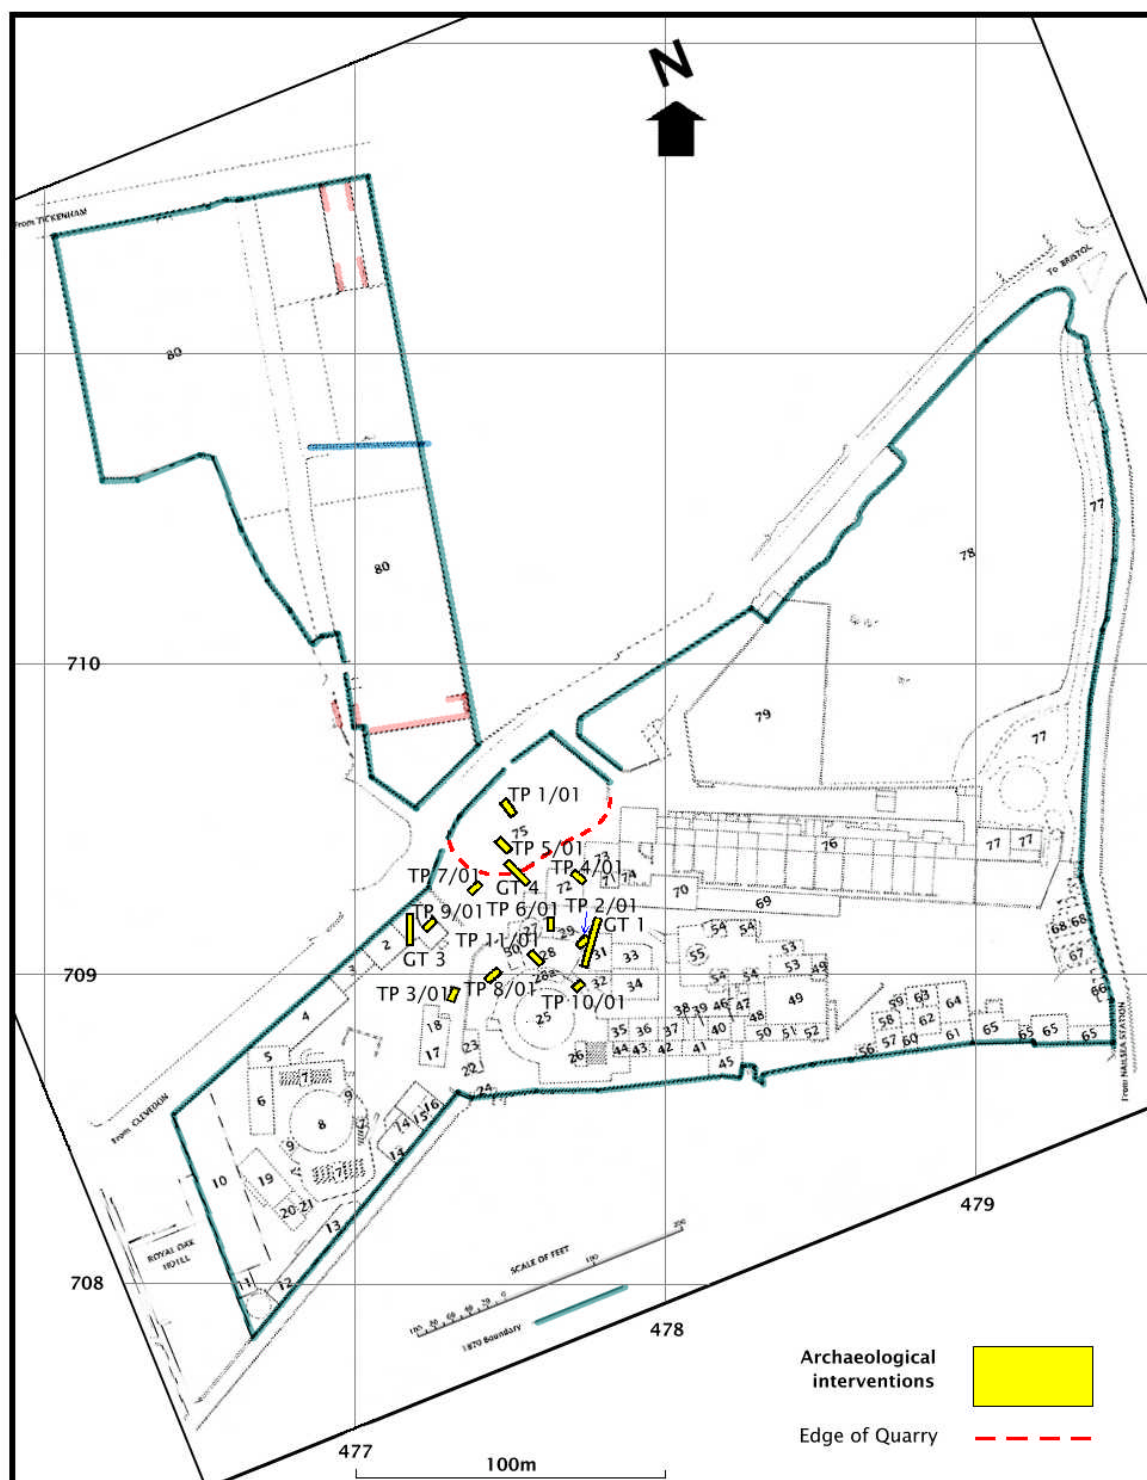
Figure 2.42: 2001 investigations superimposed on the 1870 plan.

In summary, the 2001 investigations confirmed that there were “significant archaeological deposits associated with the former Old House glass furnace in the area of the former Avon Motor Centre.” “The archaeological deposits were mostly preserved immediately below the modern concrete surfacing and were noted across the site to a depth between 1m – 1.5m.”

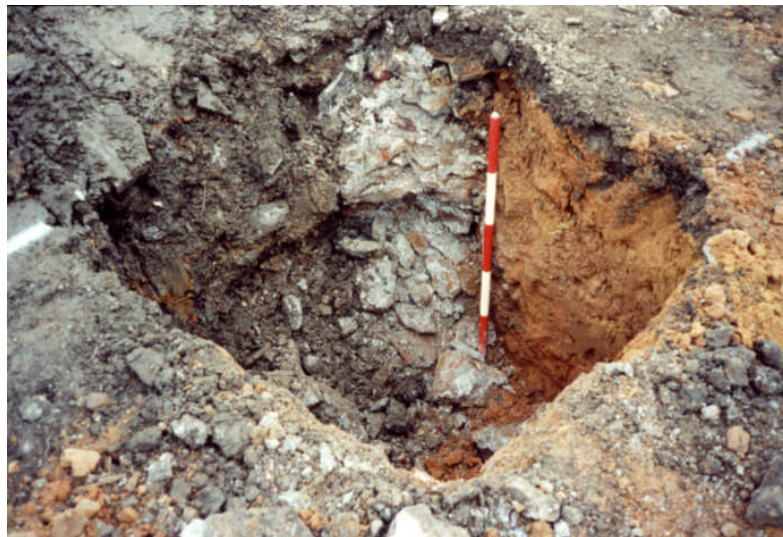
Figure 2.43: Foundation Pit No 50 from ESE.

The records show that some sixty-four pits were observed, these being of varying sizes, from 1000mm square by 500mm minimum depth to 2750mm square by 1375mm minimum depth. This obviously took the contractors down to, or very close to, the level of any surviving archaeological remains. These pits were for the mass concrete bases for steel stanchions forming the frame of the building. One quarter of the pits had archaeological material in them to a greater or lesser degree. Because of the small areas involved, and the fact that they are now under mass concrete, only a quick examination has been made to correlate with the 1830s and 1870 plans, with some success principally in the vicinity of the Old House Cone and on a line running approximately north-east from the brick kiln {27} to {71} and {74}. (Figures 2.44 and 2.45 below). Only five could not be related to either plan, (e.g. No 50) which possibly leaves unanswered questions. Details are in the archive, which “will be deposited with North Somerset Museum ... under Accession Number WESTM 2004.14.”³⁰

This begs the question as to how much of the underlying archaeology had actually been destroyed by the construction and subsequent demolition of the garage complex. A typical pit, cutting archaeology, (No. 50), is shown in Figure 2.43, centred at NGR ST 47725 70898.

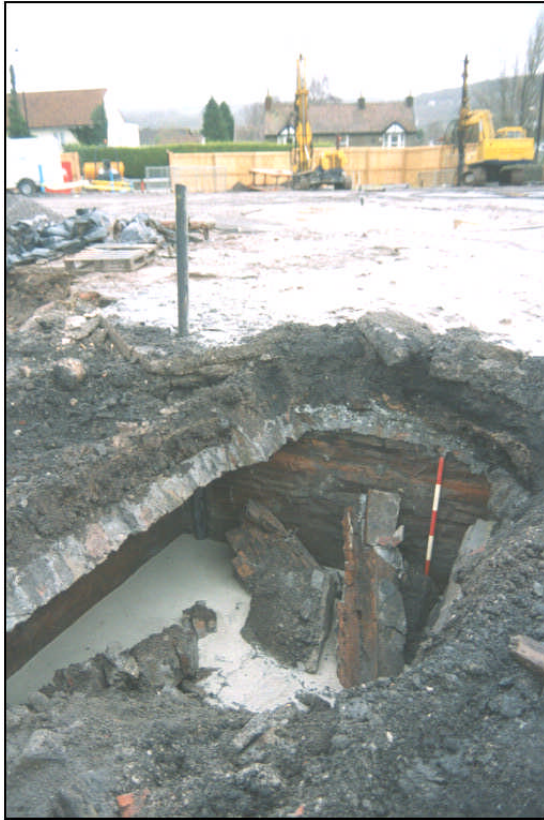
Figure 2.46: Northern chamber.

The first was in the vicinity of the northern corner of the former garage building, which would put it in the area centred approximately at NGR ST 4777 7054. It is described as, “A vaulted stone cellar/chamber 3.1m x 3.5m x >1m deep exposed immediately below the foundations at the approx. N corner of the former garage.” With two inlets, “The structure appears to have been wholly intact prior to disturbance by plant and seem to represent a water store/cistern of c. 19th century date. The structure will be filled with inert fill and remain in situ (probably).” (See Figure 2.46, a view looking approximately WNW.) The location would put it in the vicinity of {72} and {73} in 1870 and/or possibly an “Engine House” in the 1830s.

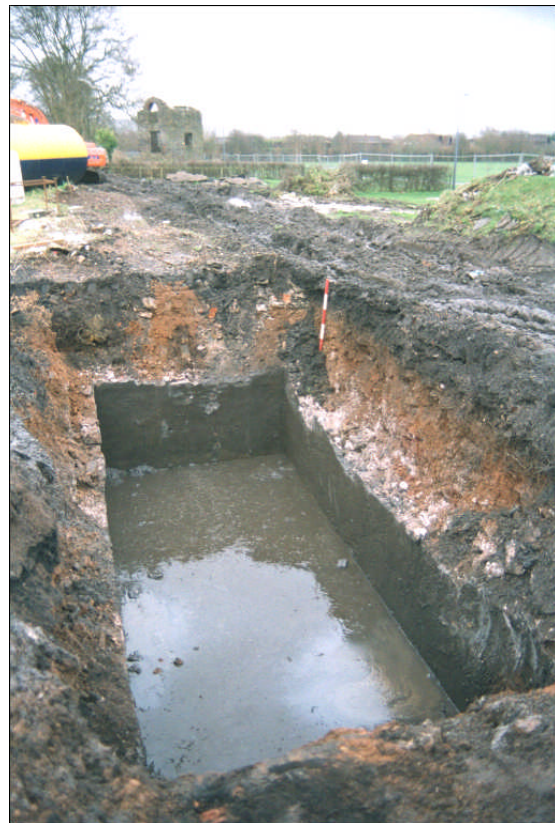
Figure 2.47: Southern chamber

The second was on the southern boundary of the main site. It is believed to lie “adjacent to and ? inside the former boundary wall separating the site from the playing fields.” [To the south.] Its dimensions were c. 7m x 2.5m x c. 2m deep, and it was “formed of sandstone rubble, faced and rendered with greenish-grey mortar.” The waterline was about 2.5m below modern ground surface. (See Figure 2.47, view looking approximately east.) The foundations of the boundary wall were not observed, so to that extent the position is conjectural, but its location as

recorded does correspond with an open feature shown on the 1988 OS 1:1250 Sheet 4770NE, centred on NGR ST 47772 70865. In this position it would have lain between the southernmost extension to the Old House Cone and the adjacent boundary, as shown on the 1870 plan.
