Gallowgate, Glasgow:

Historic Building Recording and Archaeological Works

Data Structure Report

AOC Project No: 21742

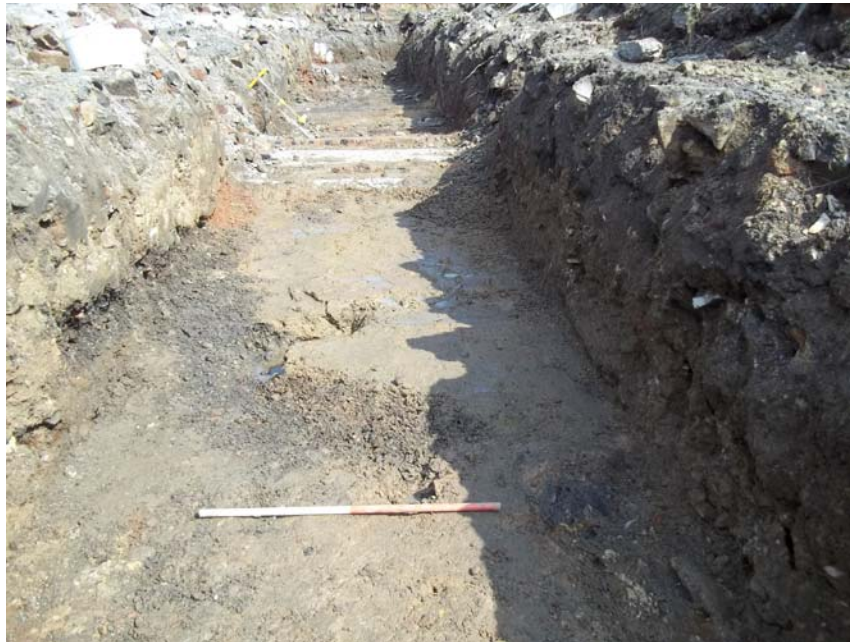
- 5.3.1 The evaluation consisted of three targeted trenches within the SW corner of the development site (Figure 1) to cover the locations of the main drainage trenches that would be excavated through the most sensitive archaeological area. Trench 1 revealed the top of a pottery waster pit [101] as well as an adjacent small pit [103] (Plate 46). Both features were encountered at a depth of 1.1m below the existing ground surface. Samples of the pottery from the waster pit (Find No.'s 1 and 2) were taken; however neither pit was excavated as the required depth for the drainage had been reached.

Plate 46 - Pits [101] and [103] in evaluation Trench 1

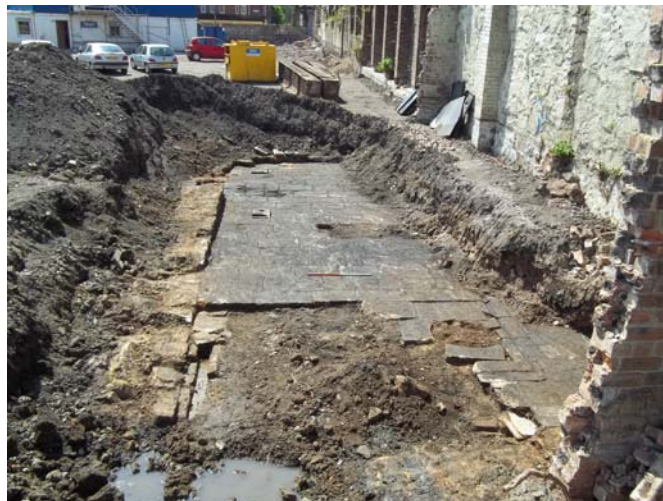
5.4.2.2 During general reduction and excavations for piling activity the remains of a sandstone rubble courtyard [003], as well as a sandstone structure [060] were uncovered (Figure 22, Plate 47). The structure is believed to be the Barrack Canteen Cellar and consisted of sandstone walls [016], [017], [052] and [053], which formed the SW, NW, NE and SE walls respectively. The structure also consisted of the truncated remains of a sandstone flagstone floor [031]. Under the floor, a complex drainage network consisting of three drains [032], [054], and [056], was revealed and a possible red brick built well [058] was built into the flagstones (Plate 48). An entrance occurred in the SE wall, below the level of the courtyard (003). Several artefacts (Find No.'s 8, 9 and 29) were recovered from the demolition layers filling the structure.

Plate 47 - Structure [060]. Canteen Cellar

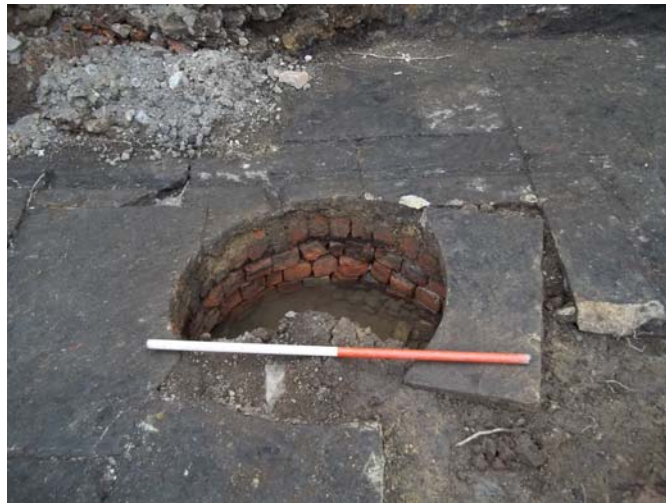
Plate 48 - Well [058] in Canteen Cellar Floor

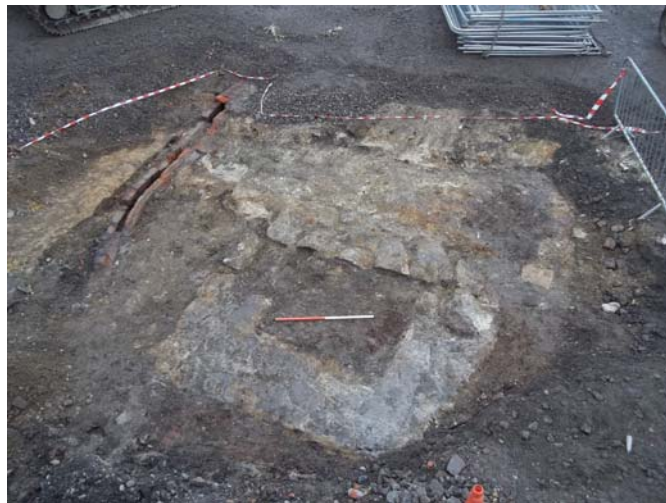
5.4.2.3 Within service tracks and other ground reduction works more sandstone foundations relating to the Barracks were revealed (Plate 49). These consisted of truncated sandstone foundations [259], [260], [264], [266], [267], [269] and [279] as well as drains [029] and [265] which are all related to the Barrack structures in the SW corner on the 1st Edition Ordnance Survey (Figure 16). A number of these foundations were seen to cut into an earlier madeground deposit [261] indicating that the Barrack construction impacted upon the previous pottery works on site. No artefacts of any significance were found around these structural remains.

Plate 49 - Truncated Barrack structures in SW corner

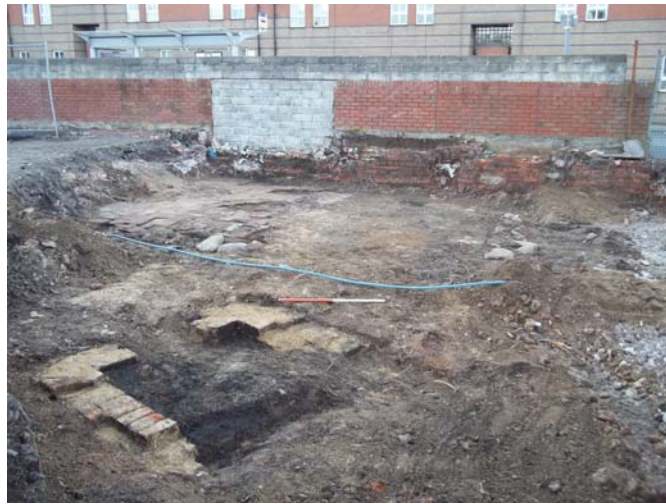
5.4.2.4 During excavations for the new entrance, a brick tile floor [091] and sandstone walls [092] and [093] were revealed next to a truncated square-shaped brick feature and possible chimney base [094] (Figure 25 and Plate 50). The structures were interpreted as the NW corner of the 1722 'Pighoose' pottery building, given the location of the structure in relation to the later 18th Century maps (see Figures 17 and 19) and due to the artefactual evidence from the deposit [141] under the tile floor. These included pottery shards, brass objects and most significantly a George III copper coin dating to 1775 (Find No. 61). Further excavation of the entrance area also revealed two waster pits, [088] and [178] (Figure 17) containing abundant fragments of red earthenware jugs (George Haggarty pers comm.). The second of these two pits, [178] was identified under both the tile floor and make-up deposits of the pottery building, so would have related to an earlier phase of the pottery works (Figure 25).

Plate 50 - 'Pighoose' Pottery Building and possible Chimney [094]

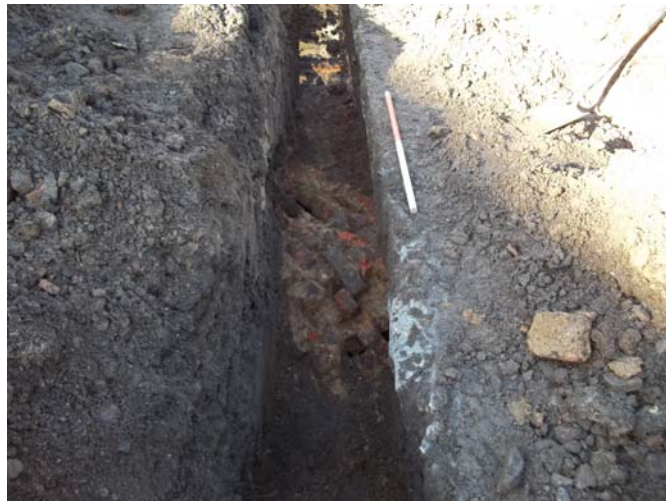
5.4.2.5 The final phase of works within this area involved the excavation of a number of linear trenches for drainage, services and the new boundary wall. Within one of the drainage trenches the bottom half of a circular brick built flue [280] was revealed in section running approximately E-W away from where the possible kiln [171] was revealed under the new building foundations (Figure 17). A further section of this flue, recorded as feature [293], was located to the SW and showed a much greater level of survival in this area (Figure 17; Plate 51 & 52). To the north of the flue line, brick surface [283] abutting a sandstone wall [282] was also revealed along with a small section of brick wall [284] (Figure 27 and Plate 53). A black sooty deposit covered the surface [283] suggesting it may be the floor of an industrial structure such as a kiln or chimney.

Plate 51 – Part of Flue [293] running West from kiln [171]

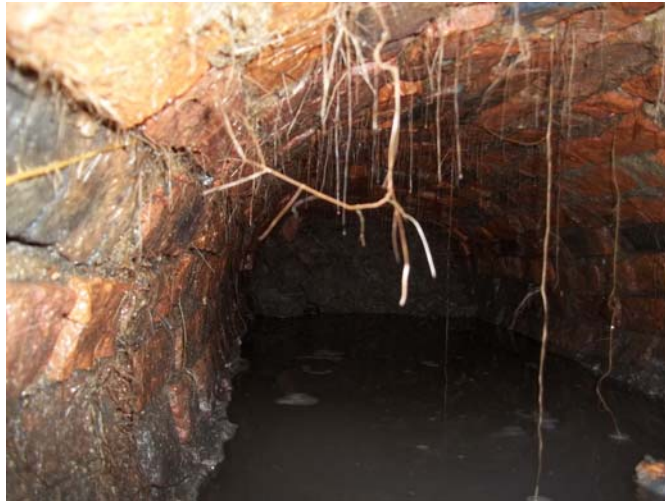
Plate 52 - Internal view of flue [293]

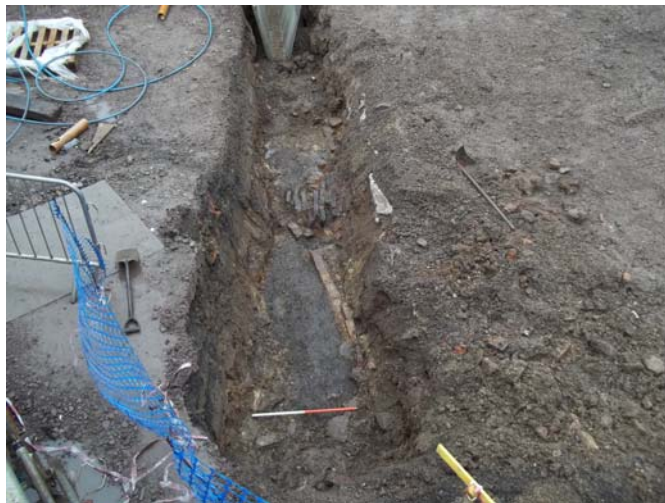
Plate 53 – Surface (283) and wall (284)

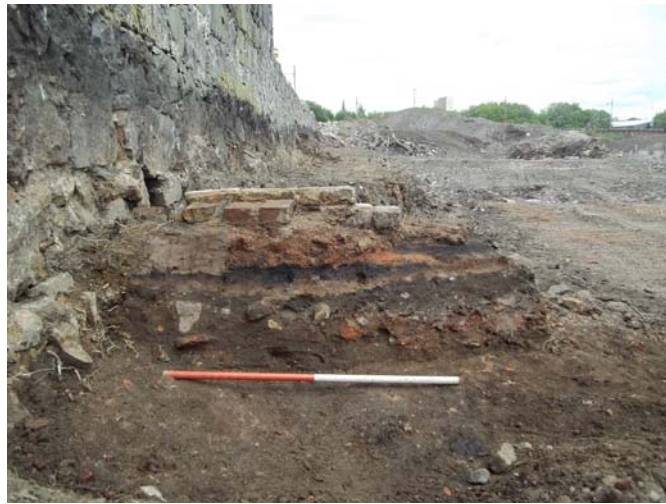
5.4.3.2 A small section of a fragmented brick wall [194] and part of a brick surface [183] were revealed at the southern end of the bund (Plate 54 and Figure 17a). These structural remains had clearly been truncated by the Barracks wall construction cut [192] and therefore relate to one of the buildings that was in place along the western edge of the site prior to the Barracks construction. These fragmentary remains were built on to the underlying made ground [188], [189], [190] and [191], as were the Barrack wall foundations [027] suggesting that there may be preserved remains of earlier activity below this level.

Plate 54 - Deposits under wall (194) and surface (183)

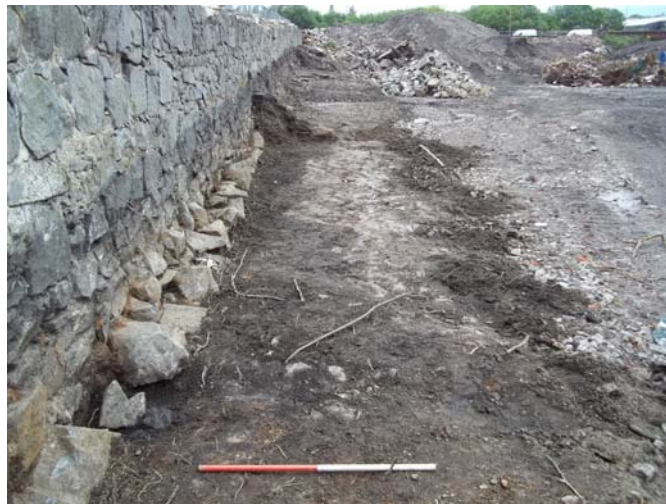
5.4.3.3 The fragmentary remains of an unroofed structure (Plate 55) relating to the Barracks were revealed abutting wall [027]. The SW wall [198] had been truncated by modern activity but the NE wall [201] still survived with a small area of whinstone cobbling [203] present around the top of the wall remains. To the immediate north of this, there is a blocked up hole [223] in wall [027] level with cobbling [203] that is possibly a drain relating to the Barrack Urinal marked on the 1st Edition Ordnance Survey (Figure 8).

Plate 55 - Unroofed Barrack structure with wall (201) in the background

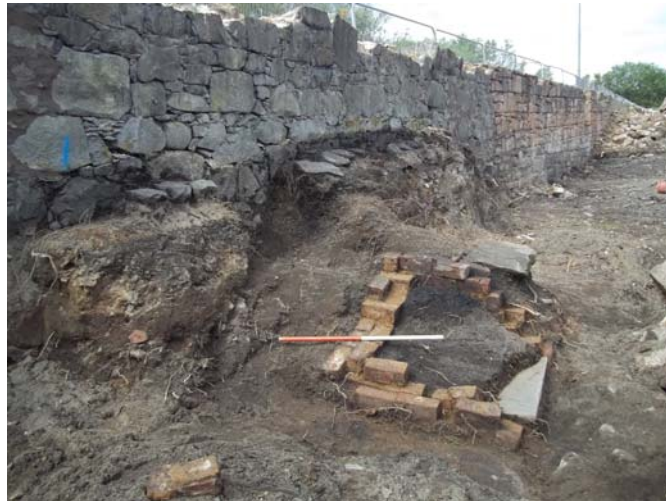
5.4.3.4 At the far north end of the bund, a brick structure [239] with associated sandstone flagstone flooring (237) was revealed (Figure 26; Plate 56). This feature had previously been discovered by the FIRAT evaluation and is denoted as Site 3 in Trench 11). These features were located underneath the whinstone cobbling [228] relating to the Barracks, demonstrating their earlier date. The brick structure is U-shaped with the E face open to reveal a slate base [242]. Ashy deposit [241] and soot/coal dust deposit [240] sit within the structure suggesting it may have been a kiln or other industrial feature. The northern edge of a possible pit [235], truncated to the east by modern activity, is covered by the madeground around this structure suggesting an even earlier use of the site. To the south of feature [239], and possibly contemporary with it, were the remains of a possible brick flue [224] running NE-SW and truncated by Barrack wall [027] at its SW end (Plate 57). The deposit (225) that fills flue [224] is very similar to deposit (240) within feature [239].

Plate 56 - Feature [239] first revealed in FIRAT evaluation

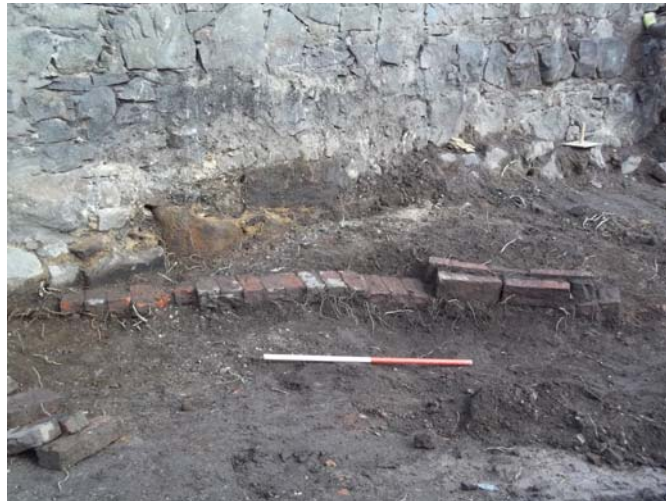
Plate 57 - Flue [224] related to feature [239]

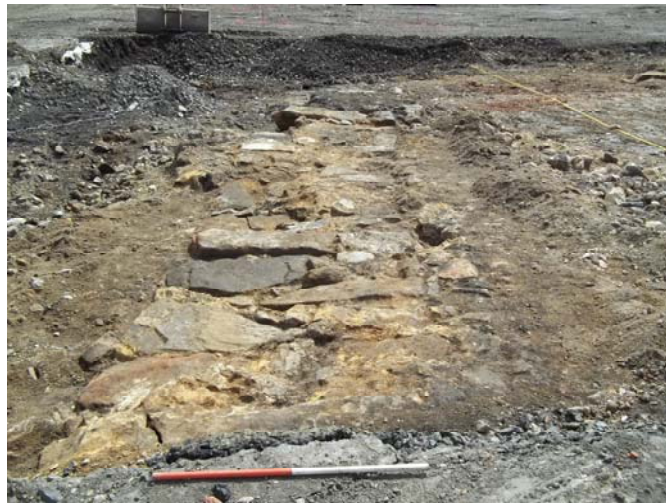
5.4.4.2 During the excavations for piling activity a large section of the western Soldiers Barracks was revealed (Plate 58), consisting of the NW wall [043], the SW wall [044] and the SE wall [047] (Figure 21). The walls were constructed of large sandstone blocks and were over 2m wide. Two rubble drains [045] and [049] were revealed that were related to the Barracks structure. Nothing above foundation levels had survived the modern activity in this area. To the north of these structures, and under the Barrack courtyard [003], a deposit containing an abundance of cow horn cores [051] was revealed within an undefined pit.

Plate 58 – Outer wall [047] of Soldiers Barracks

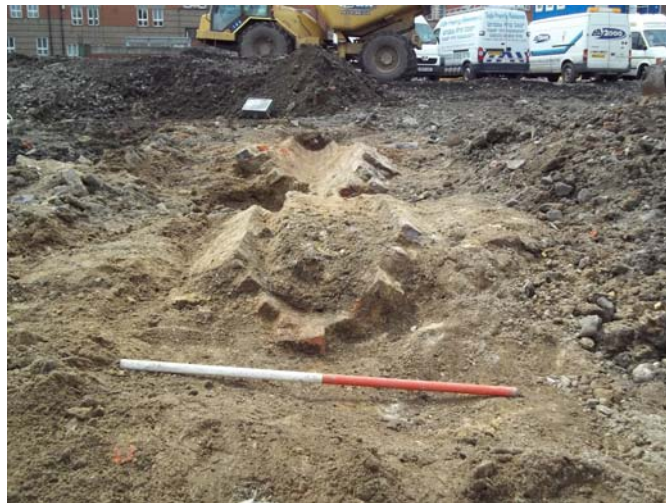
5.4.4.3 To the south of the Barracks structure, and under its associated courtyard [003], the truncated remains of a brick flue [039] and a pottery waster pit [033] were revealed (Figure 17). The north to south aligned flue (Plate 59) had been truncated at its northern end by the levelling of the site for the Barracks courtyard [003] and the walls of the Soldiers Barracks. Only the bottom half of what would have been a circular flue survived. To the immediate east of the flue, the western half of a pottery waster pit [033] was revealed and excavated (Plate 60). The pit would have originally been a clay extraction pit for use in the pottery works and was later backfilled by demolition material and waste material from the kilns. An abundant amount of red earthenware jug fragments were collected from the pit deposits (Find No.'s 15, 17-19) (George Haggarty pers comm).

Plate 59 – Remains of Flue [039]

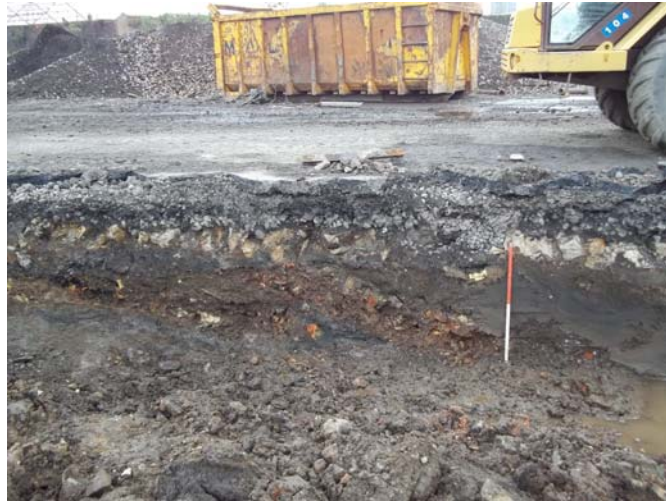
Plate 60 - Section showing courtyard [003] covering waster pit [033]

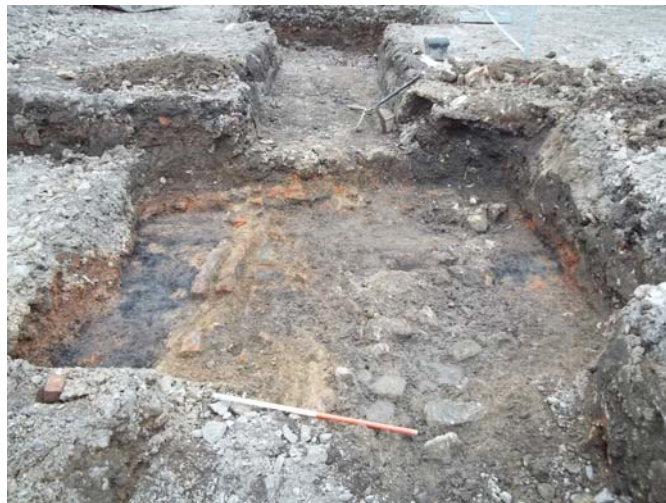
5.4.4.4 During the store's foundation excavations a number of features were identified underlying the features and structures associated with the Barracks and so pre-dating them. The southern edge of a large pit [135] of unknown use containing deposits of sandy rubble [137] and a sandy clay deposit [138] were revealed in the section of one of the foundation bases along the western edge of the building. Further to the south, another brick flue [172] (possibly the same as [039]) was revealed in two of the bases along with a truncated sandstone wall [161] (Plate 61). This flue continued to the SW corner foundation where the edge of a possible circular brick kiln [171] was also revealed (Figure 17; Plate 62). All of these features would have related to the 'Pighoose' pottery and were able to be preserved *in situ* under the new foundations.

Plate 61 - Sandstone wall [161] and flue [172] in foundation base

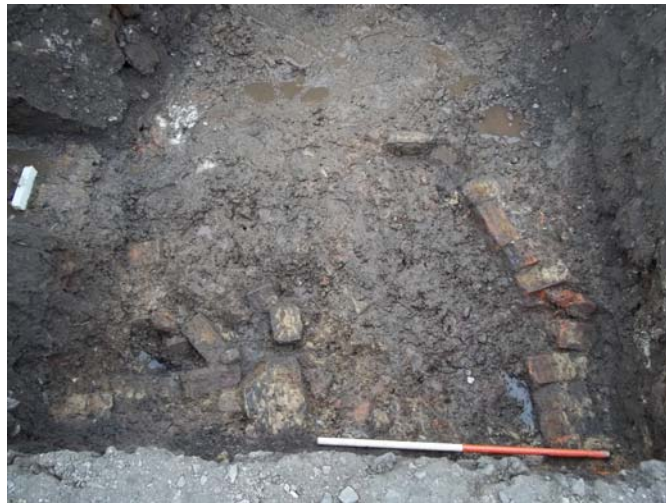
Plate 62 - Flue [172] and edge of kiln [171] in another foundation base

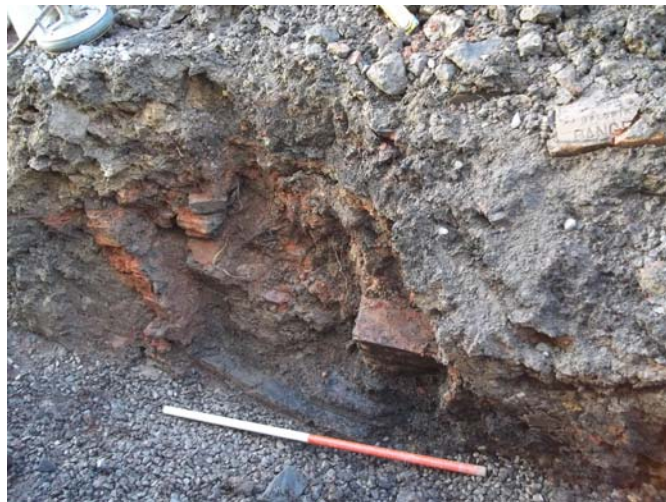
5.4.4.5. Finally, excavations of a storm drain along the front of the site revealed a brick feature [288] in section that could be interpreted as the opening for a kiln or furnace (Plate 63 and Figure 17). The opening faced north and had a black ashy deposit (290) to the north and west.

Plate 63 - Opening for possible kiln [288]

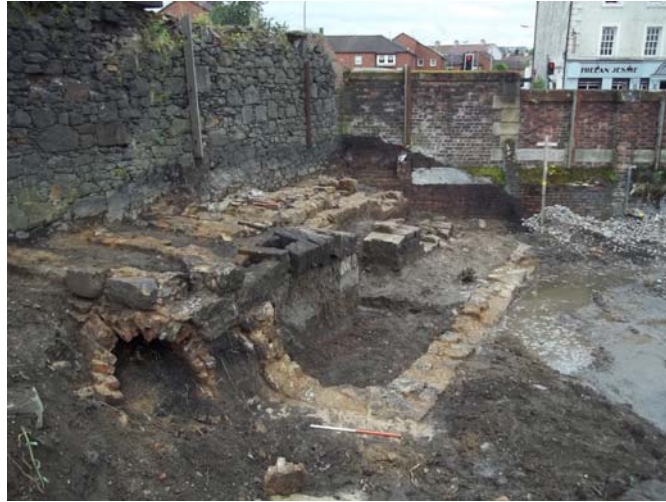
5.4.5.2 Underneath the bund the remains of four sandstone structures were revealed that abutt the main boundary wall of the Barracks [147], and relate to structures noted on the 1st Edition Ordnance Survey (Figure 8). Structure [065], measured 9.8m by 5.7m and consisted of a basement level and an upper level bounded by walls [066] to the west and [084] to the north (Plate 64 and Figure 24). The basement level had a sandstone flagstone floor [070] leading to an arched recess [067] at the north end of the structure (This arch had previously been

discovered by the FIRAT evaluation and was denoted as Site 2 within Trench 14; FIRAT 2006). The south end contains a probable stairwell [072] leading to the upper level supported by wall (068). The upper level floor had been truncated and removed with only the drainage that would have been under the floor surviving. These small brick lined drains, [075], [080], [082], and [083] ran at various angles to drain away from the boundary wall [147]. The fill of the drains [076] and [081] contained a number of artefacts such as clay pipe stems and bowls, and a number of ceramic and brass buttons relating to soldiers activity on the upper level.

Plate 64 - General view of Structure [065]

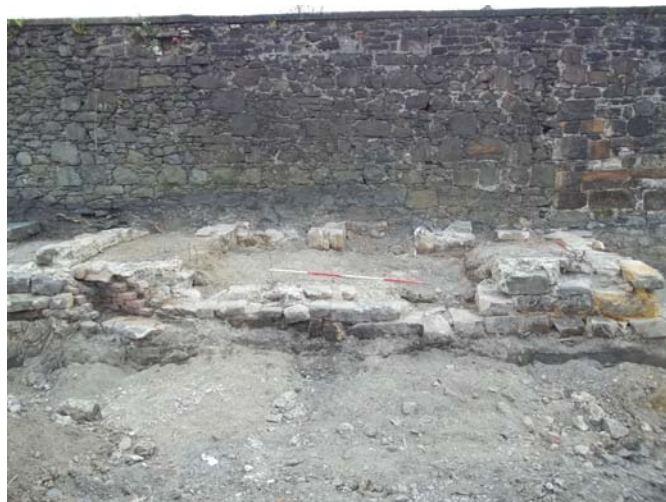
5.4.5.3 Structure [104] measures 8m by 3m and occurs 3m north of Structure [065] (Plate 65 and Figure 24). It consists of sandstone foundations [105], [106], and [107] with some internal sandstone buttresses, [254], [255], and [256]. A possible remnant of a brick floor survives in the form of deposit [108], but it appears as though the floor level of the structure has been removed by later works. Any floor that would have been within the structure would have sat on a mortar bed [257] which was supported by a layer of re-deposited clay sitting on the old ground surface [249]. The structure would have been drained by drain [103] that runs SW from wall [105] into sewer [077] (The sewer had also previously been discovered by the FIRAT evaluation and denoted as Site 2 in Trench 14). No artefacts relating to this structure were found.

Plate 65 - General view of Structure [104]

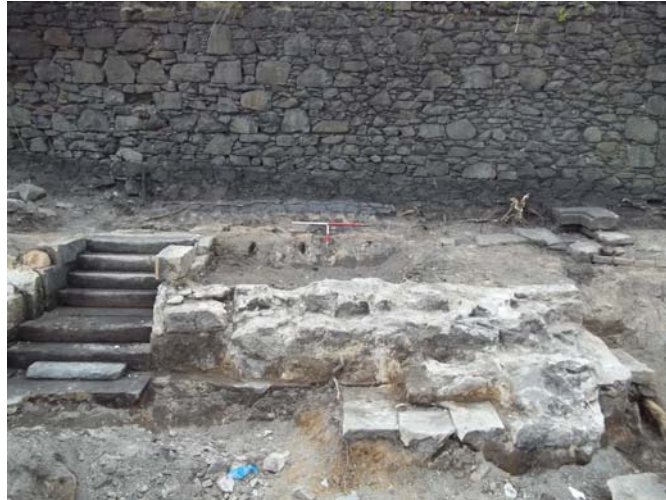
5.4.5.4 Structure [116] was expected to be the Barrack Armoury, however it would appear that this has been demolished so that only the foundations and drainage underneath the floor have survived (Plate 66 and Figure 24). The structure is loosely defined as the area between the north end of stairwell [120] and the end of wall [124] to the south. Sandstone wall [118] forms the western boundary and whinstone cobbled surface/gully [119] may have formed part of the floor within the structure. It is possible that the Armoury would have been accessed via the flagstone surface [123] and then by stairwell [120]. The madeground below the floor levels was similar to that of Structure [104], with stairwell [120] being constructed into the original ground surface [149].

Plate 66 - General view of Structure [116]

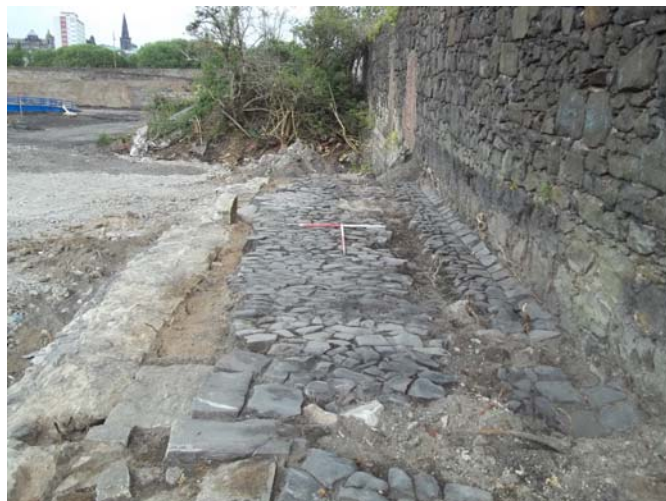
5.4.5.5 To the north of Structure [116], the eastern wall of the eastern Barrack block [121] survives and can be seen to act as a retaining wall for the cobbled surfaces [125] and [129] that form a path around the eastern expanse of the Barrack block (previously discovered by the FIRAT evaluation and was denoted as Site 1 within Trench 13; 2006). The cobbles are irregularly sized whinstone cobbles with the easternmost setts abutting wall [147] laid to form a shallow v-shaped gully running north to south (Plate 67). The cobbles cover an extensive drainage network consisting of main drain [131] that is fed by smaller drains [244], and [247] and gully pot [246].

Plate 67 - Wall [121] and cobbles [125] and [129]

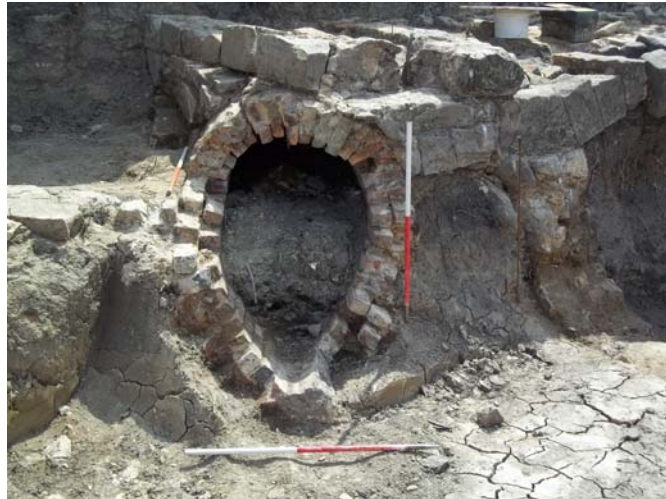
5.4.5.6 Between Structure [065] and Structure [104], the remains of a large brick arched drain/sewer [077] survived running south-east through the boundary wall [147], most likely connecting to the main sewer out on Barrack Street (Plate 68 and Figure 24). The drain cross-section is an inverted egg shape measuring 0.8m horizontally and 0.93m vertically. The top of the drain is covered by walls [085] and [113]. All drainage from under Structures 2 and 3 would probably have connected to sewer [077] by a series of drains and gully pots running north to south starting with brick arched drain [131] (Plate 69). This main drain runs into gully pot [112] which then feeds into drain [109] which is truncated by the railway activity at its SW end. This series of drains provided a number of artefacts (Find No.'s 68-74) such as clay pipe stems and bowls, brass buttons, ceramics, metal objects and glass that would relate to the use of the pathways and structures at the time of the Barracks.

Plate 68 - Sewer [077] next to Structure [065]

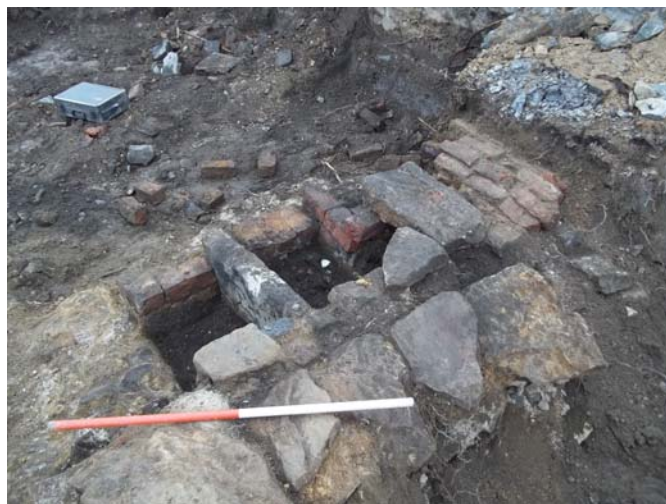
Plate 69 – One of the drainage pots under the cobbles

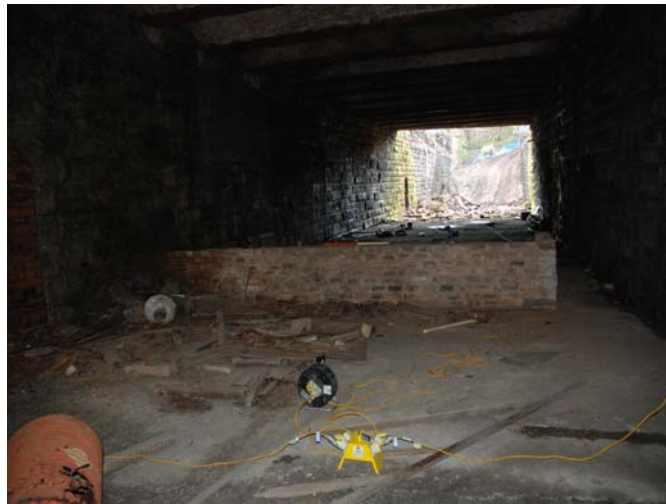
5.4.6.1 During the demolition of the tunnel, structures were noticed by the workmen. Upon investigation it was possible to make out four sets of linear and L-shaped foundations running perpendicular to the tunnel wall [022], [023], [024] and [026], and one fully upstanding brick wall (1.12m high) with an associated sand pit behind it [025] (Figure 15; Plate 70). Several artefacts (Find No.'s 10, 13 and 14) were also located in and around the area, including a target board (Plate 71), an "Ambulance Box", an oil lamp, and a number of perforated metal plates. These foundations and

artefacts all relate to a previously unrecorded World War II rifle range created within the disused tunnel.

Plate 70 - Rifle range wall [025]

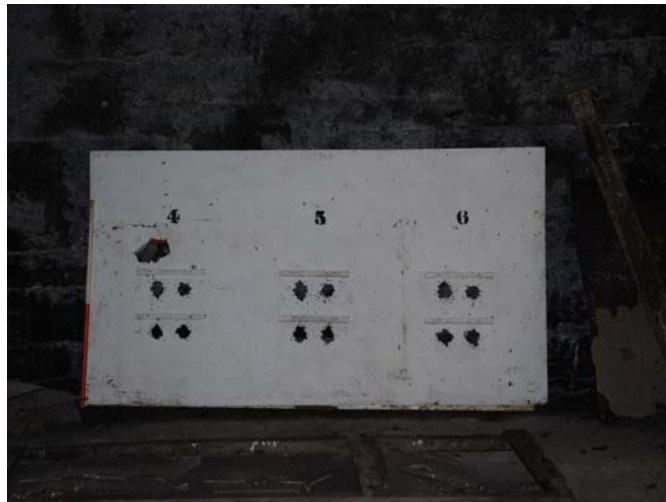
Plate 71 - Target Board from WWII rifle range

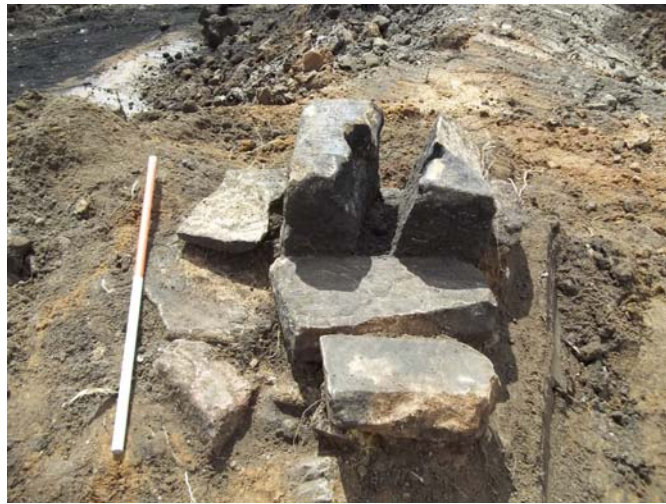
5.4.7.2 During the ground reduction works, a small sandstone feature [061] along with the remnants of a sandstone flagstone surface or path [062] was revealed (Figure 16; Plate 72). The sandstone feature was upstanding to 0.45m and had a circular hole (0.12m diameter) cut into the top,. A possible flagpole base, it is likely this feature related to the Barracks, being situated on the highest point of the site, to the north of the barrack prison and next to the barrack store room.

Plate 72 - Possible sandstone flagpole holder [061]

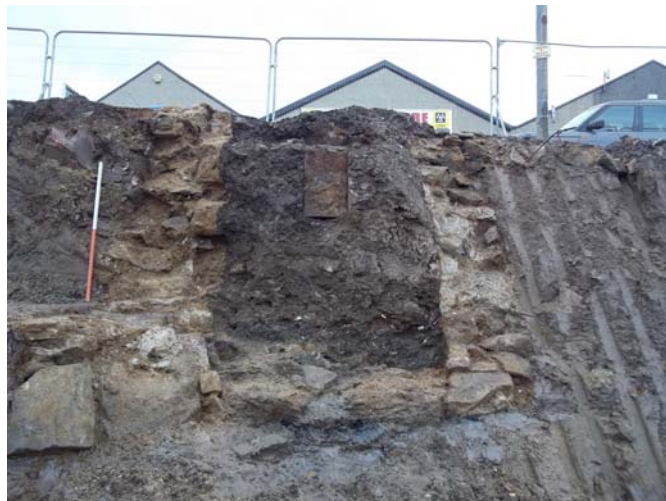
5.4.8.2 The soldiers Barracks Privy [207] survived the construction of the railway building as it was constructed into the clay at a depth of 3.2m. Only seen in section (Plate 73), it consisted of two sandstone walls [208] and [209], and an irregular sandstone floor [211] contained within the construction cut [219]. The primary fill of the structure, deposit [210] contained numerous ceramic, glass and metal objects (Find No.'s 90-101, 120) typical of material that might be found in a barracks. That said, a Scottish Cream Ware sherd dating to the mid 18th century was found, and is a piece of high status pottery more likely to be found within a wealthy town house (George Haggarty pers comm.).

Plate 73 - Soldiers Barracks Privy [207]

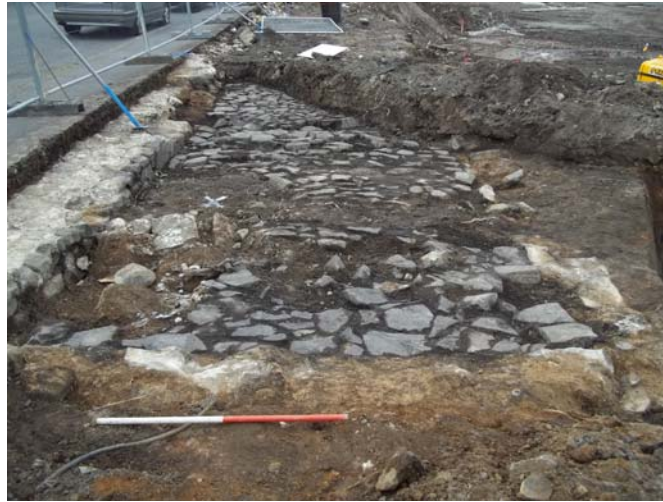
5.4.8.3 The unroofed structure was located under the hardstanding to the north of the railway building and consisted of two sandstone walls [221] and [222] forming the north and west boundaries respectively, along with wall [147] forming the eastern boundary of the structure (Plate 74). A

cobbled surface [220] was contained within the walls, but no indication of function for the structure could be interpreted and no artefacts were found.

Plate 74 - Walls [221], [222] and cobbles [220]

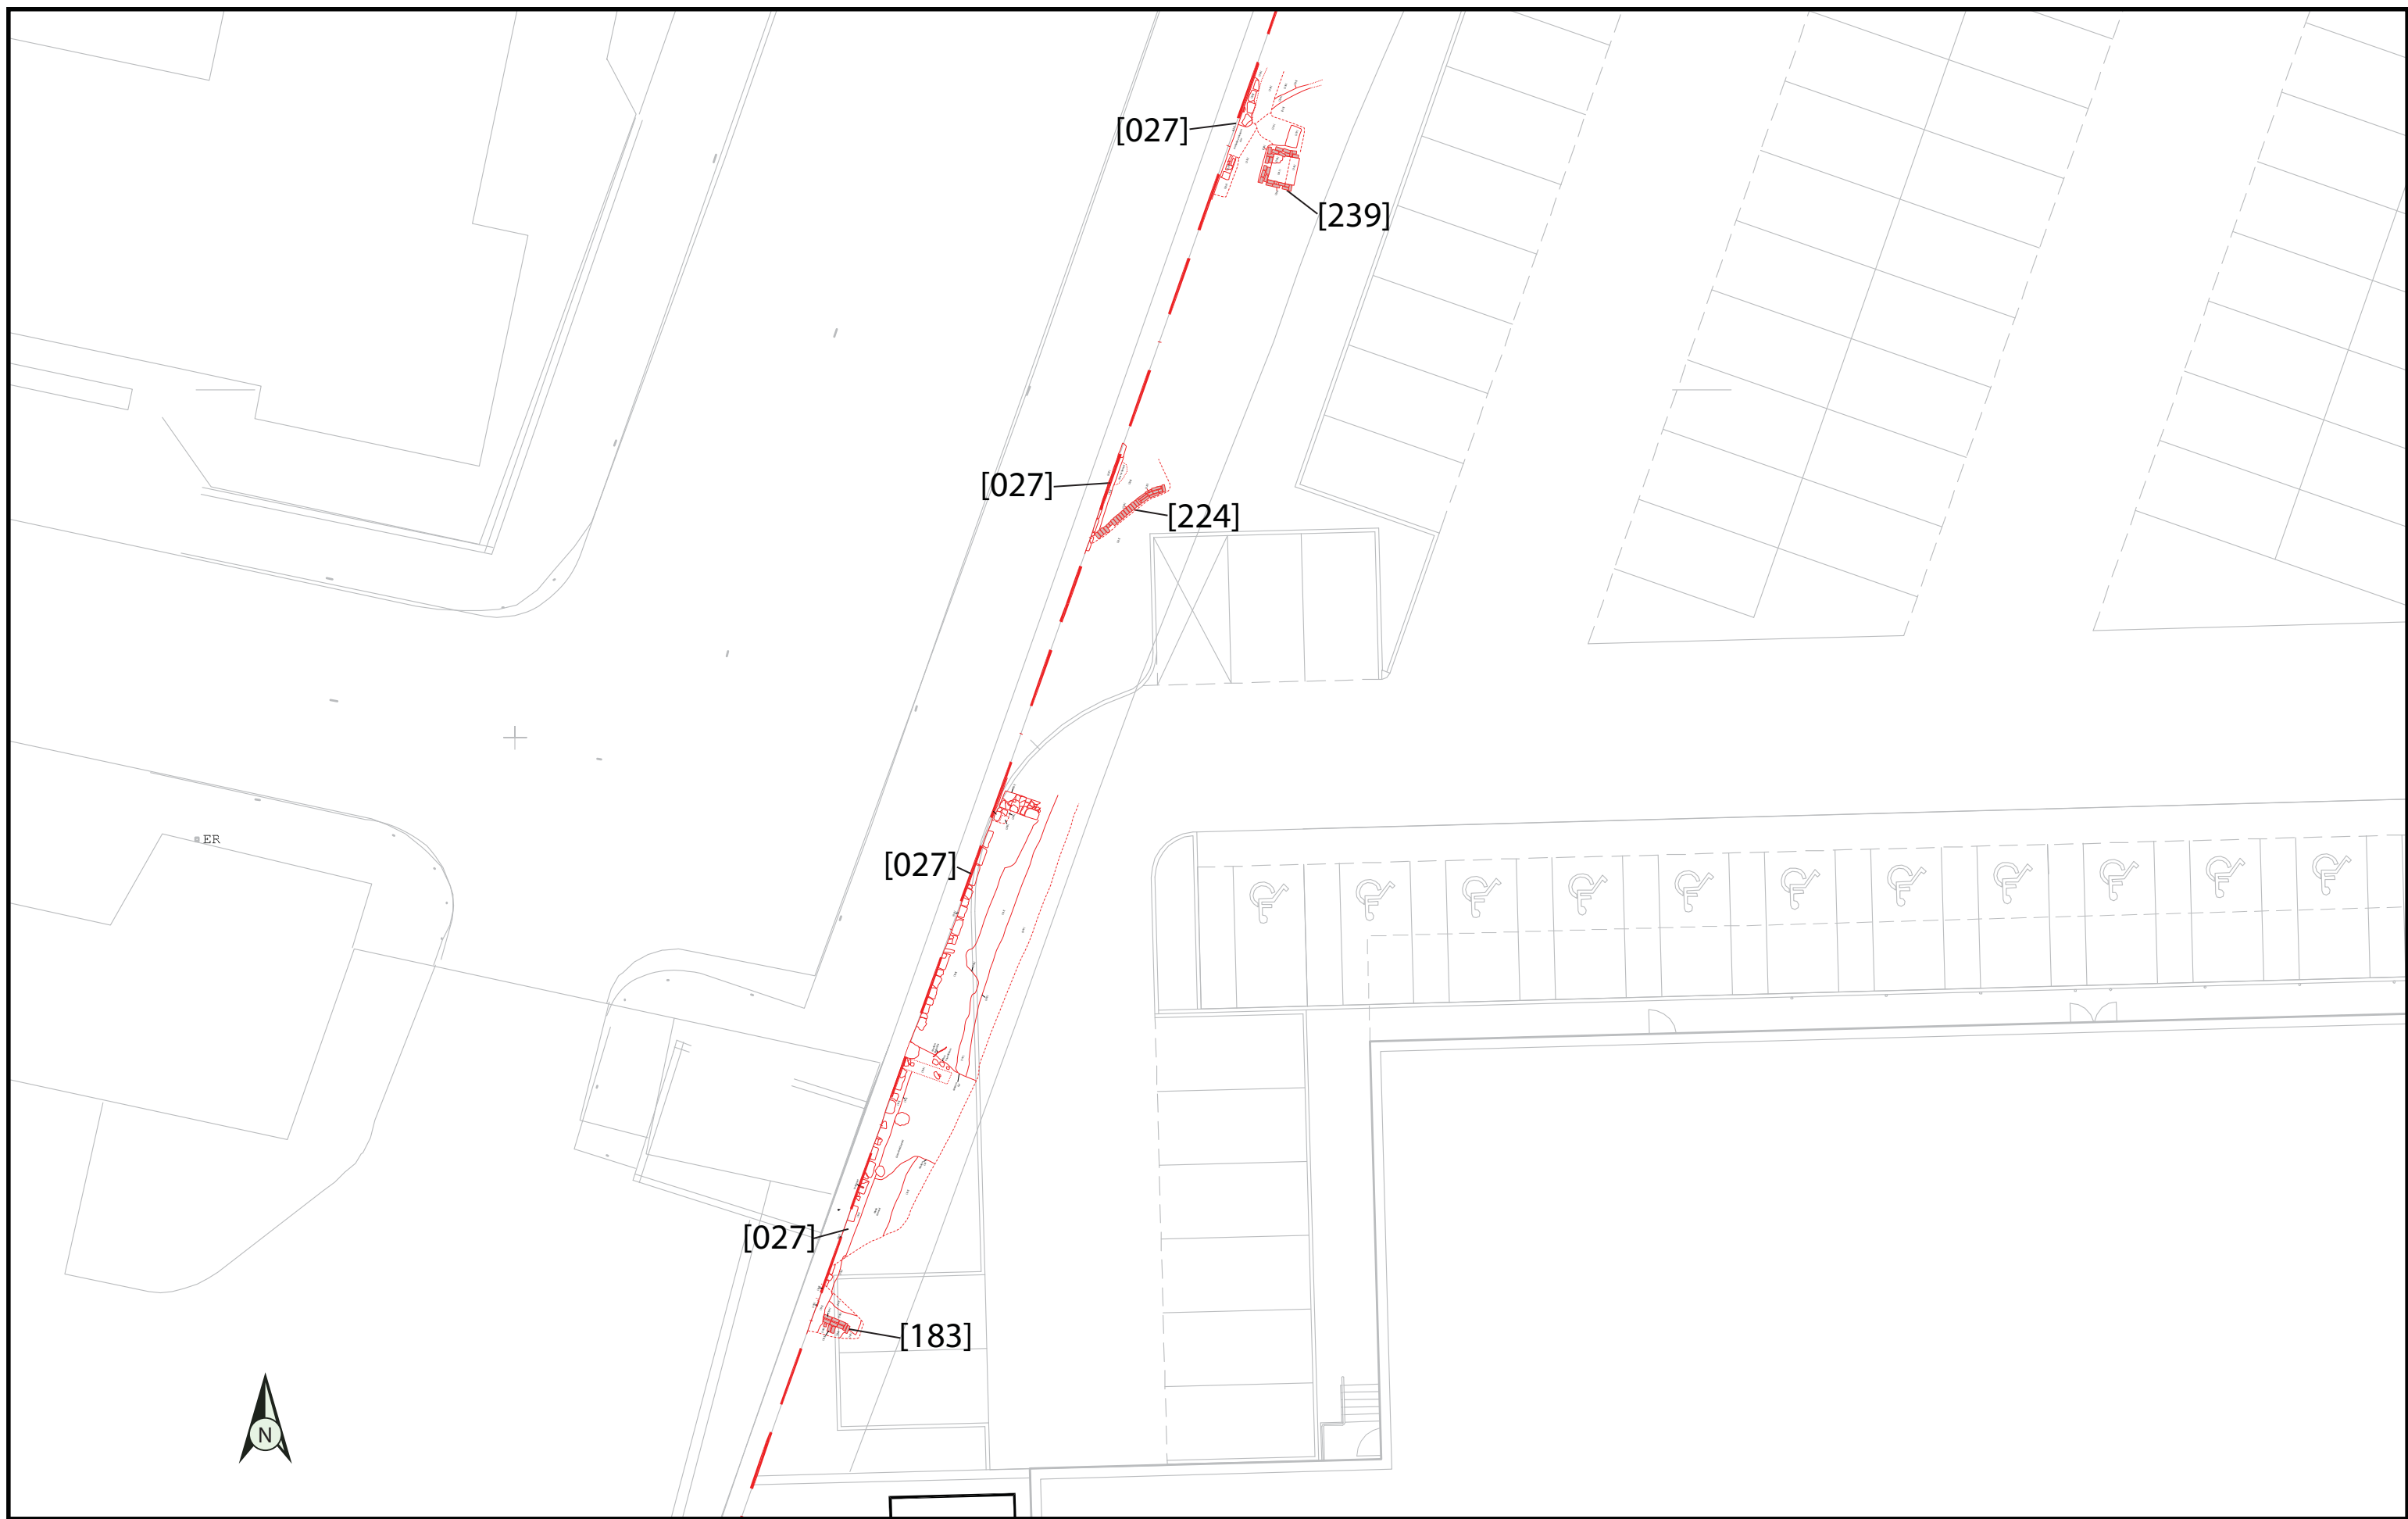
Figure 17a: Plan of features within the WE bund

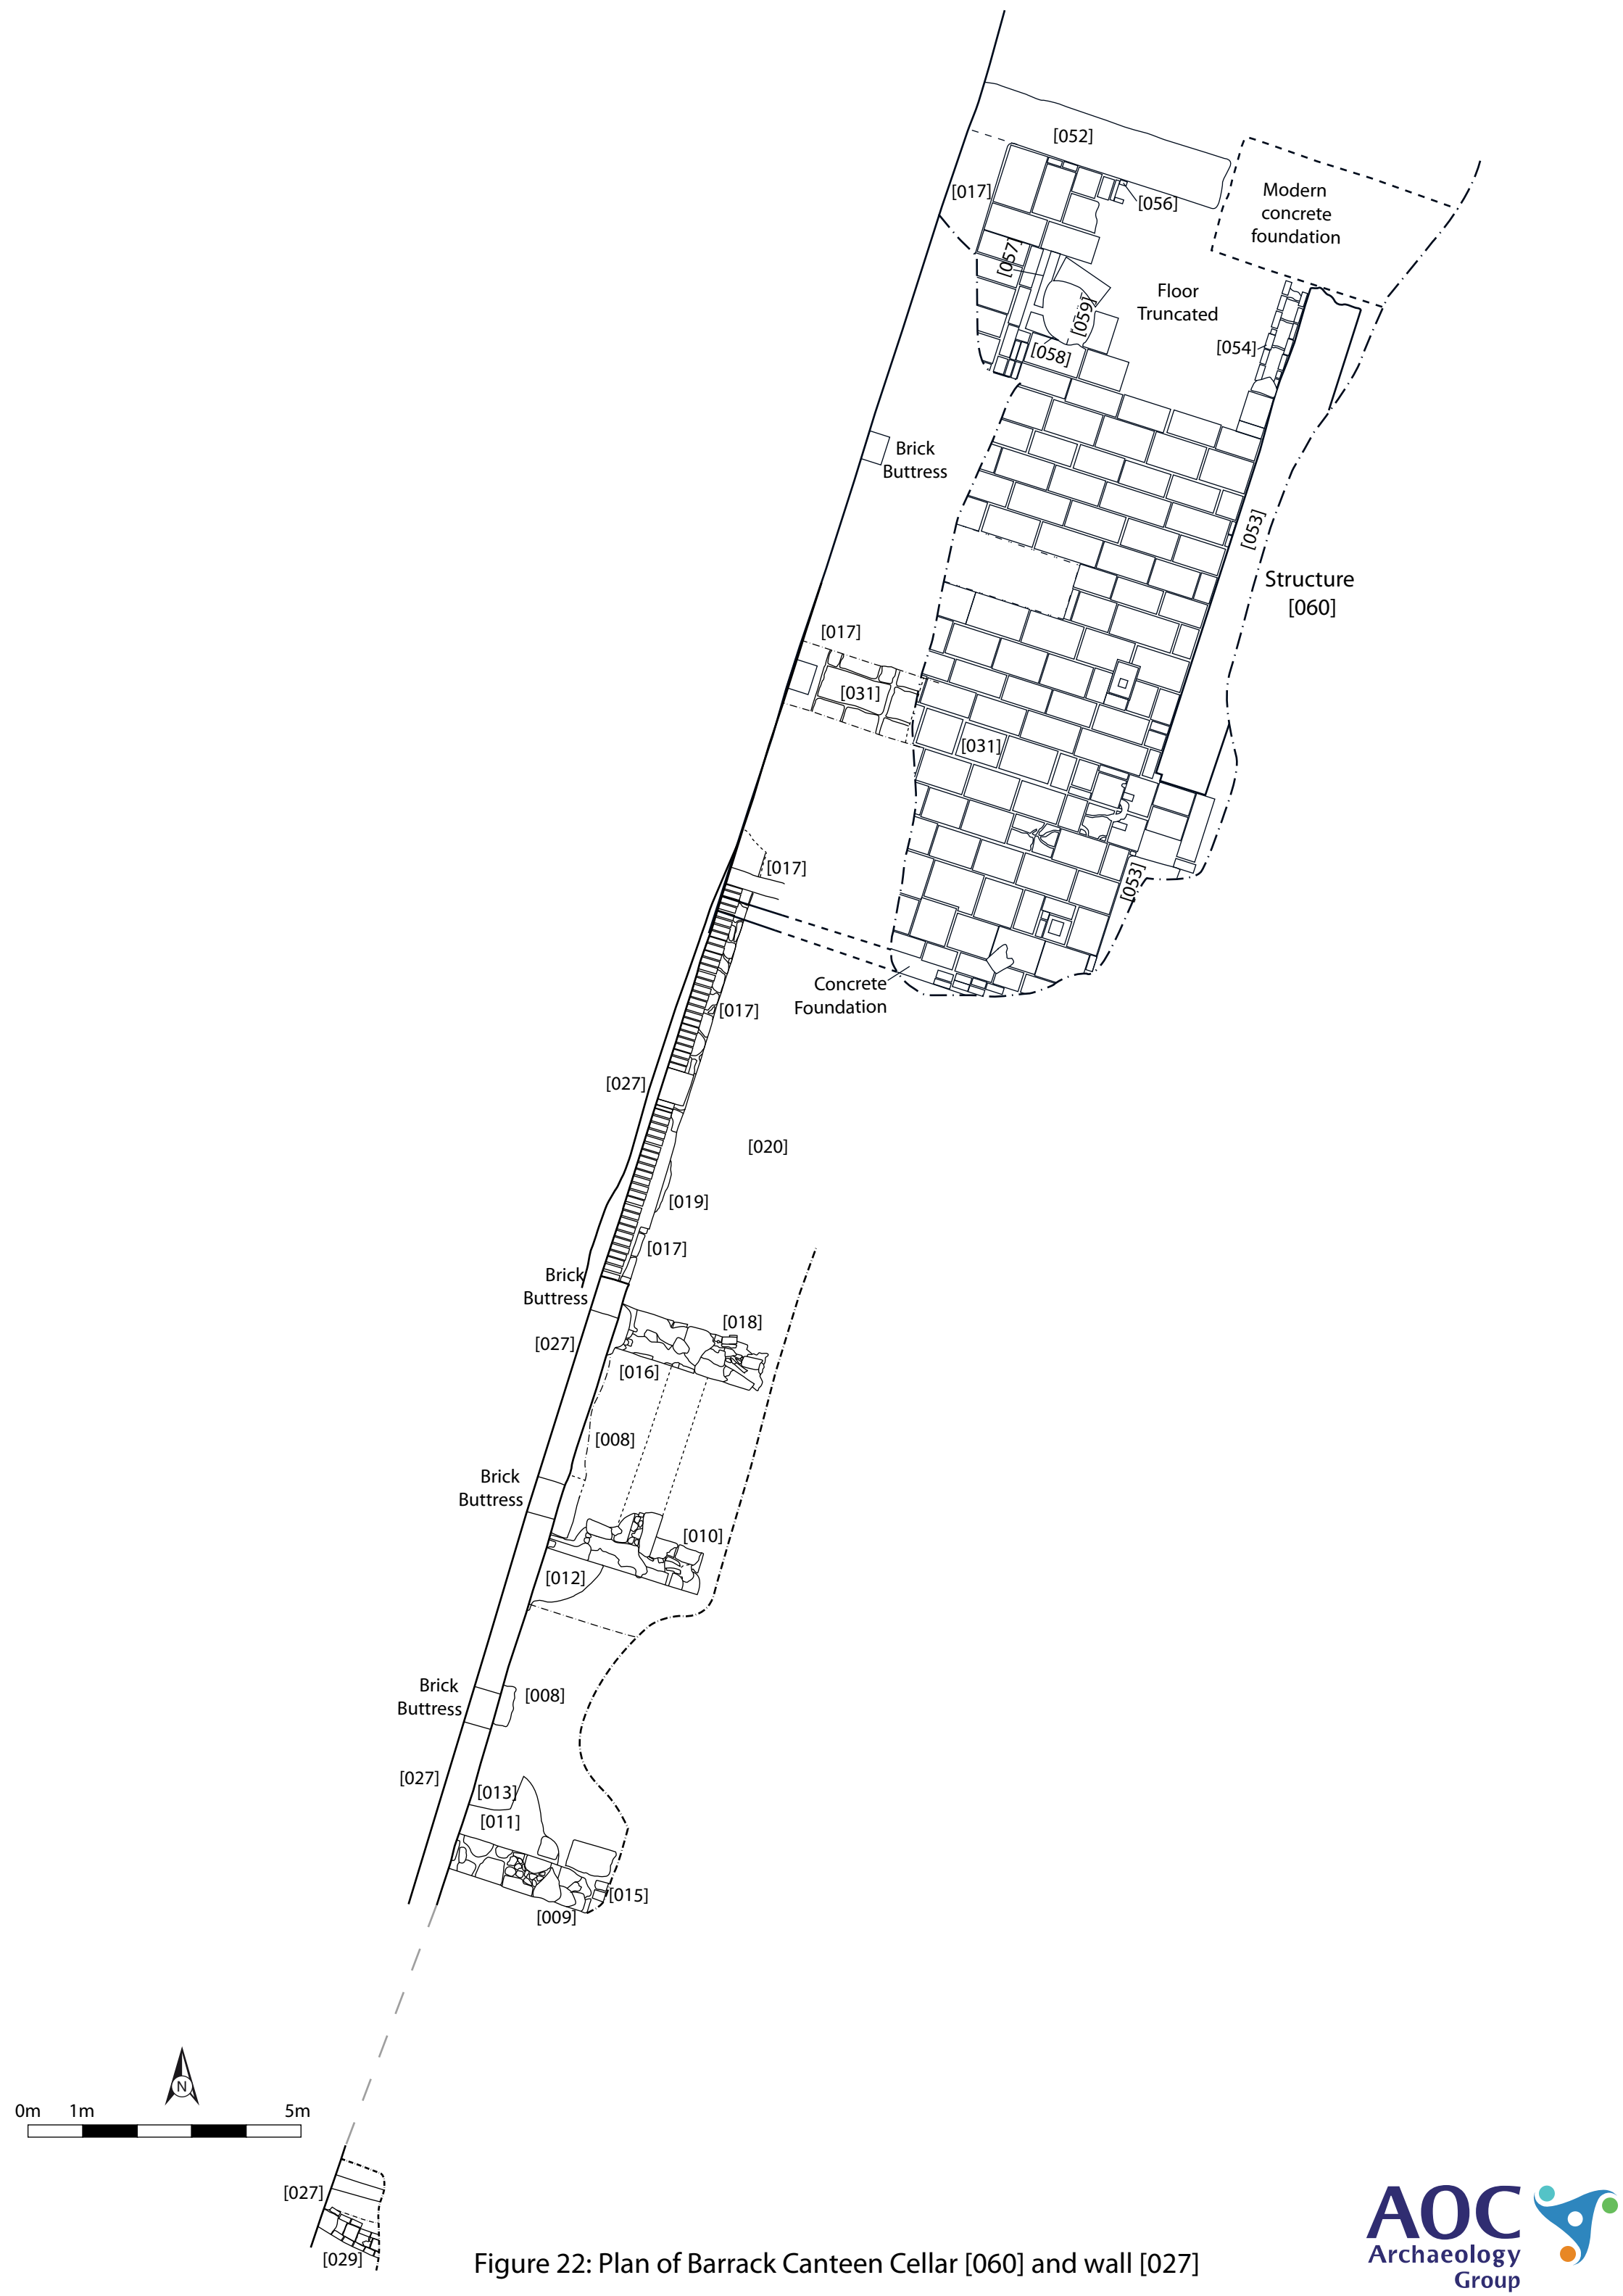
Figure 22: Plan of Barrack Canteen Cellar [060] and wall [027]
