Gallowgate, Glasgow:

Historic Building Recording and Archaeological Works

Data Structure Report

AOC Project No: 21742

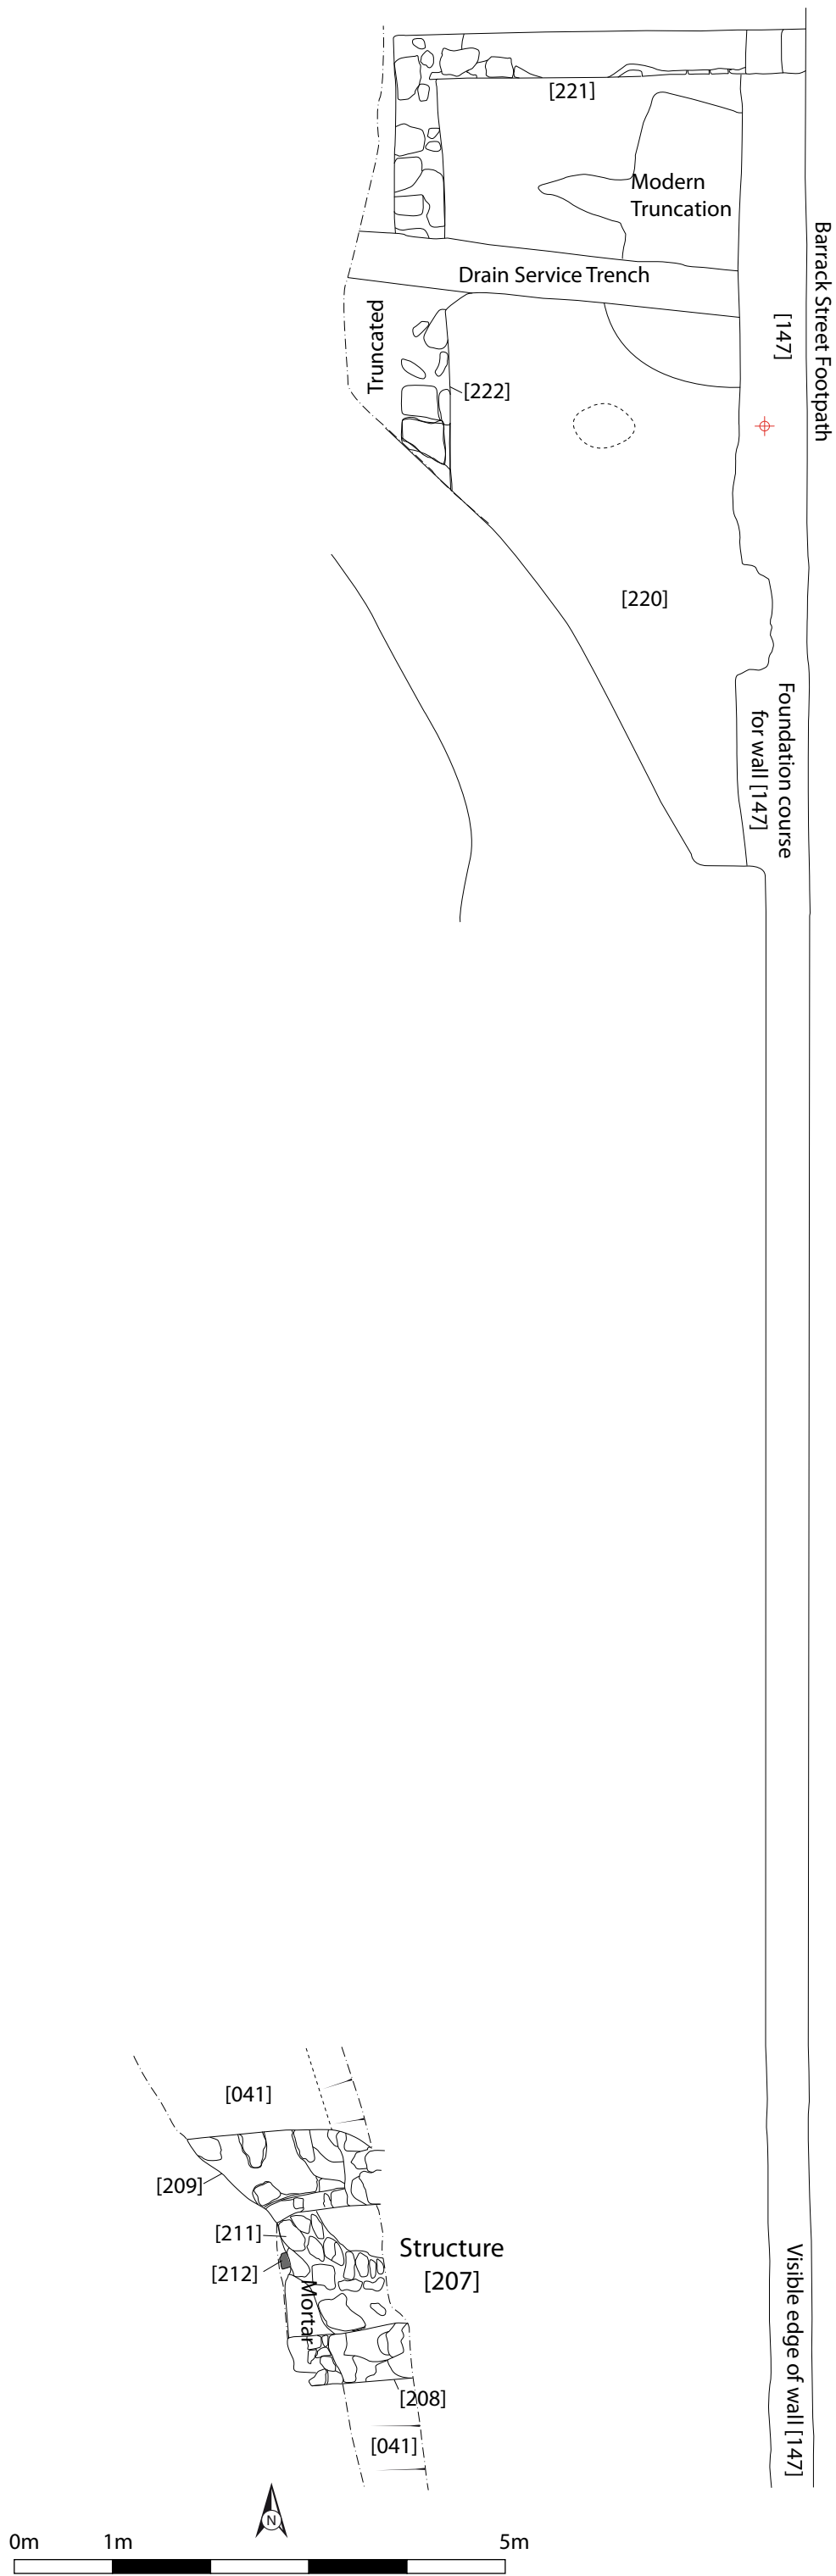
Figure 23: Plan of unroofed Barrack Structure, Structure [207] and Wall [147]

5.4.8.1 This embankment covered an approximate area of 806m² and consisted of an area of hardstanding to the immediate north of a large brick building dating to the beginning of the railway activity on site. The embankment was retained by a sandstone wall to the north of the building. Excavations revealed the most northerly part of the Soldiers Barracks block; the Privy, as well as the walls and floor of an unroofed structure also relating to the Barracks (Figure 23).
