Whippielaw Steading,
Pathhead, Midlothian

Archaeological Evaluation
and Historic Building Assessment

Data Structure Report

July 2007

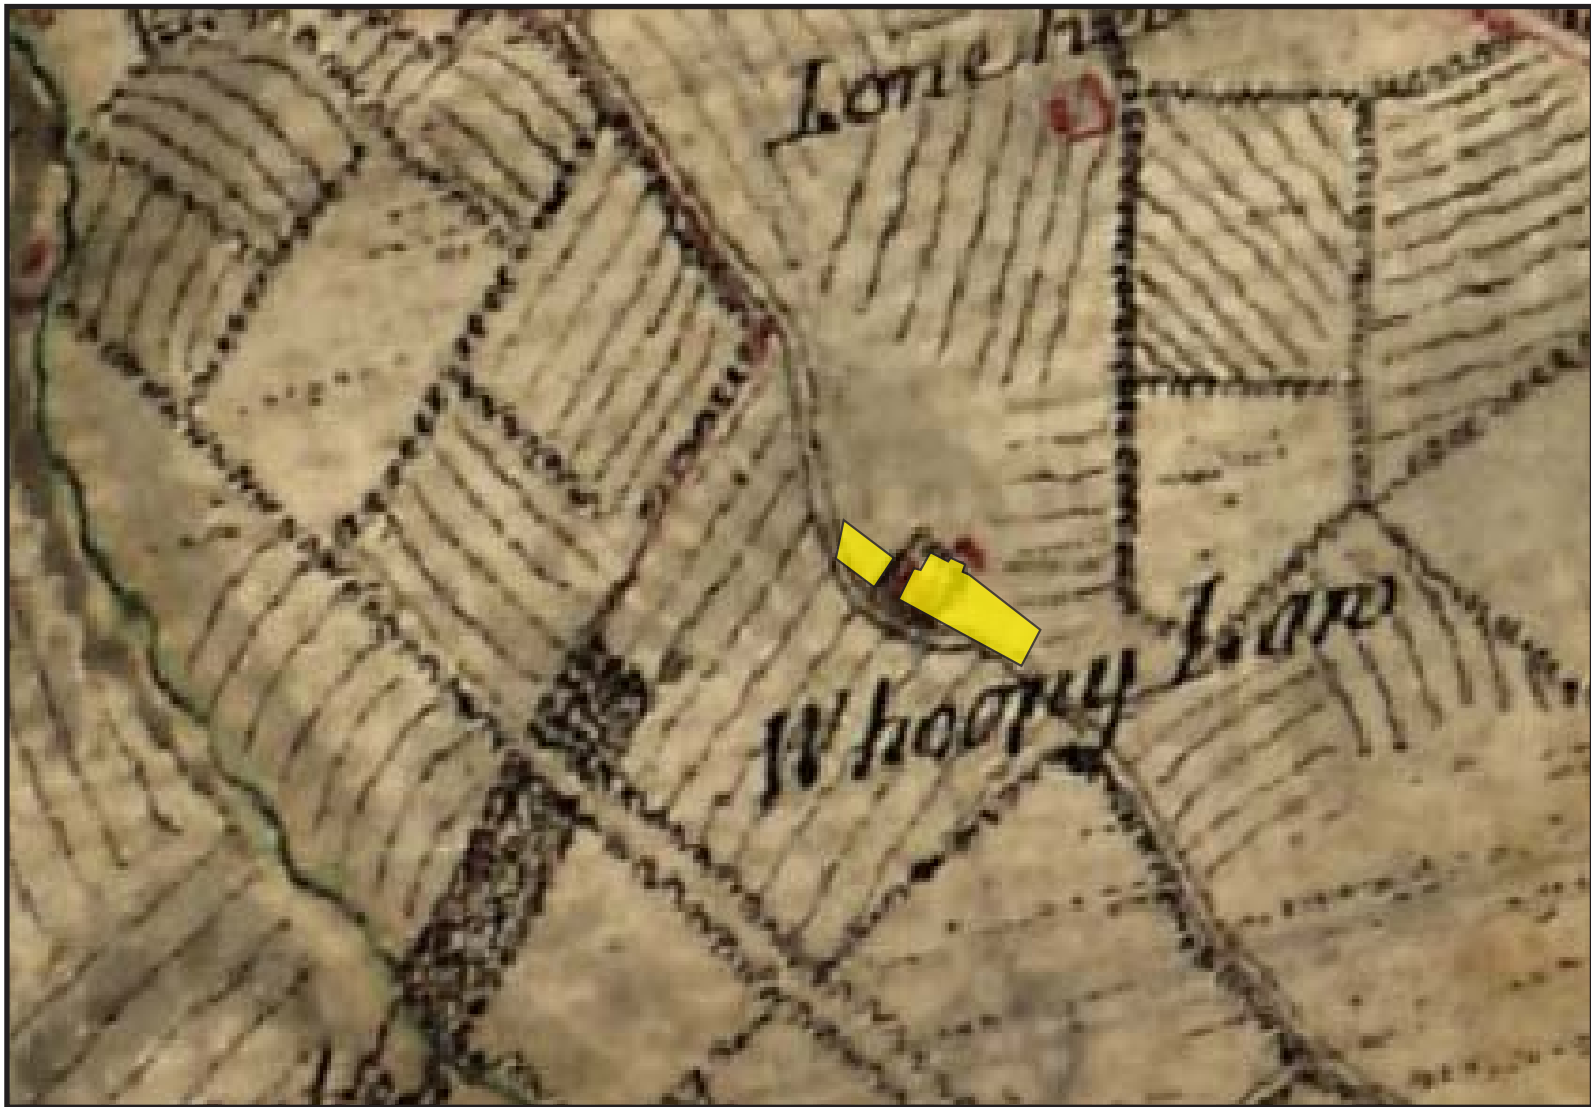
Figure 2: Extract from map by General Roy, c. 1747-1755

- 2.4.3 Whippielaw, itself, appears on maps as early as the mid 18th century, when it appears on General Roy's map as 'Whoopy Law' (**Figure 2**). Laurie's map of 1786 (**Figure 3**) shows a U-shaped range with what is presumably a courtyard to the south-west. By the time of the publication of Kirkwood's map in 1817 (**Figure 4**) Whippielaw appeared as an L-shaped range with the main elevation fronting on to the road. Ainslie's map of 1821 (**Figure 5**) shows Whippielaw on the south-west side of the road. Greenwood, Fowler and Sharpe's map of 1828 (**Figure 6**) indicates the building on the south-west side of the road to be a school; while they indicate that Whippielaw was made up of three separate rectangular buildings located on the north-east side of the road. On Hunter and Anderson's map of 1834 (**Figure 7**) Whippielaw is again depicted as a U-shaped range as in Laurie's map (**Figure 3**).

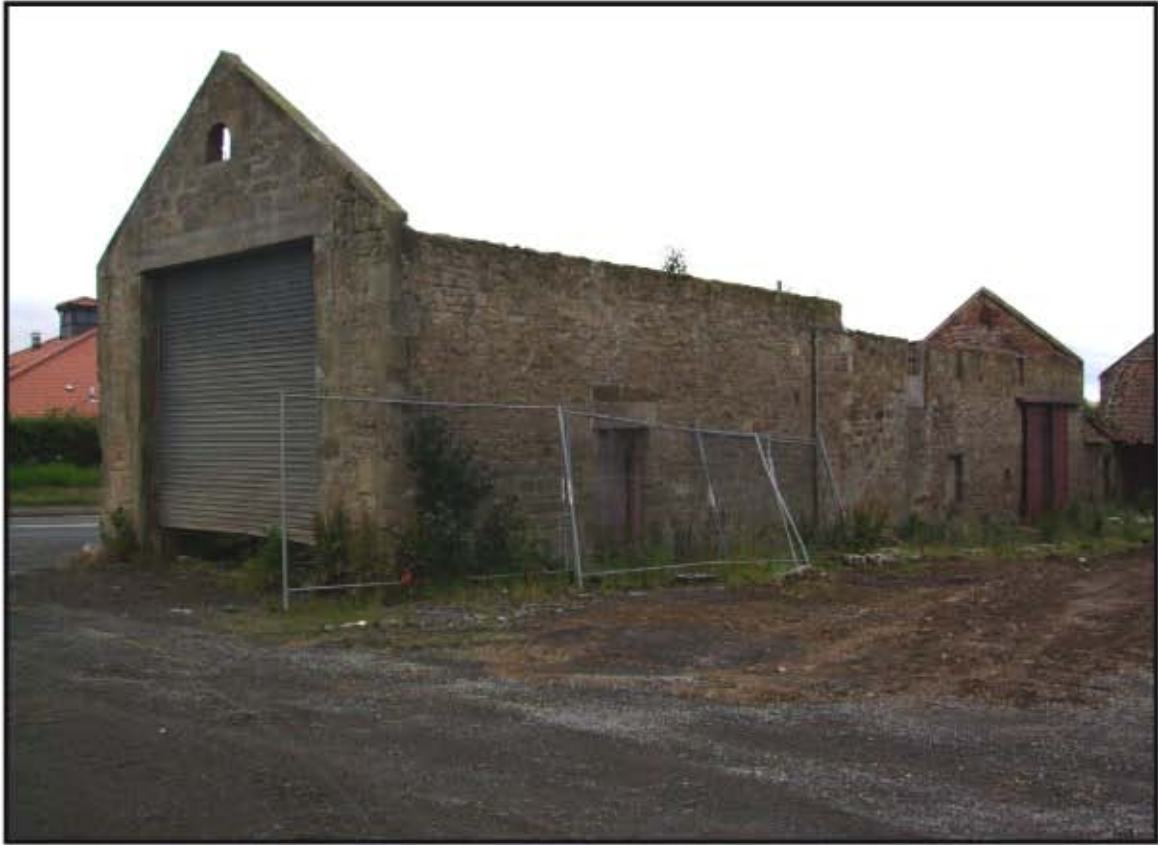
Plate 1: General view of Building A from the north-east

- 6.2.1 Building A is constructed of chisel dressed stone rubble with comb-dressed quoins and surrounds to openings (**Plate 1**). The east wall is a tall gable end with an original cart entrance – although the steel roller door has been inserted with a brick surround and repair to the original opening. A small opening - possibly for some kind of dovecote-style arrangement - is located at the top of the gable. The south wall contains a single ground floor window and two first floor windows (**Plate 2**). The quoins to the west side partially survive to the upper levels and it is clear that Building B is a later addition, abutting Building A, which was later heightened (**Plate 3**). The same indications are given on the north wall, which has a single ground floor doorway.

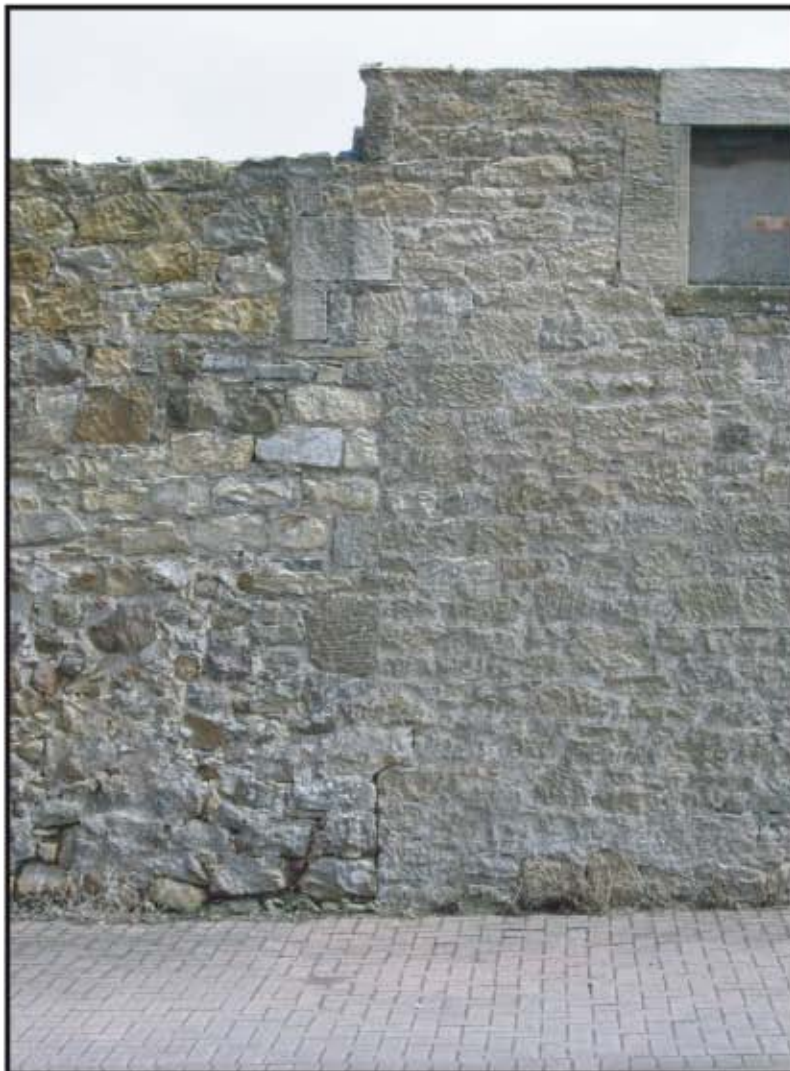
Plate 3: Detail of the phase line between Buildings A & B on the south wall

- 6.3.1 This barn abuts Building A to the west and is constructed of stone rubble. As with A, the roof has collapsed because of fire damage. What is particularly interesting about this building is that it has clearly been built up at least twice in its lifetime, something which can be seen quite clearly on the south wall. The phase line between this and Building A (see **Plate 3**) is clear on this side, as is the phase line between this and Building C (**Plate 6**). However, the lower levels of Building C look to be contemporary, with a later heightening of the building (see **Plate 6**). The north wall of this building has several features, including the scar of a former external stair clearly seen on the east side (**Plate 7**). This originally led to a loading door to access the storage areas on the first floor, although this has been reduced to create a window. Another ground floor doorway has wider droving than that seen in the north wall of Building A, further indicating a different phase of build.

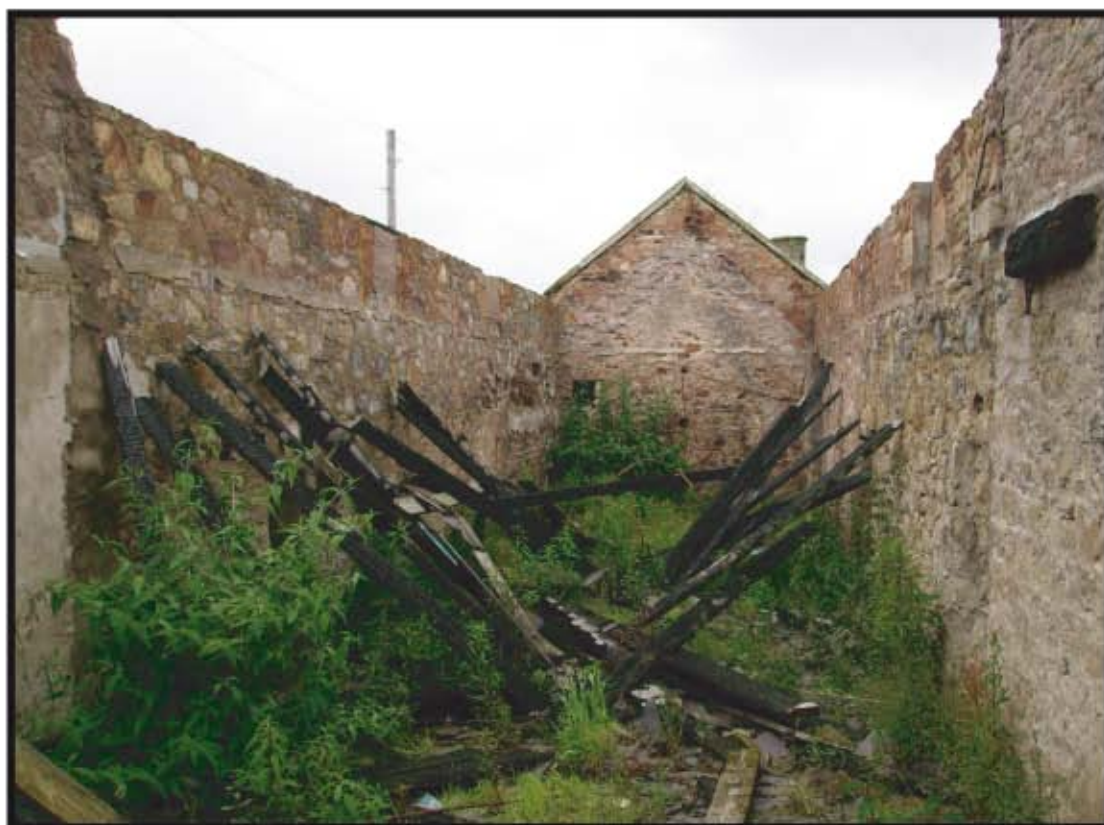
Plate 4: General view of the interior of Buildings A & B from the east

- 6.2.2 The interior of Building A is open to Building B, and both barns have been subject to extensive fire damage which has caused the charred roof to collapse (**Plates 4 & 5**). The windows to the first and ground floor were bricked-up.

- 6.3.2 The interior of Building B is an open space through to Building A (see **Plates 4 & 5**) and contained the plain stone rubble walls. Evidence of an earlier roofline (no doubt associated with the earlier levels of the building) is located along the east wall (**Plate 8**).

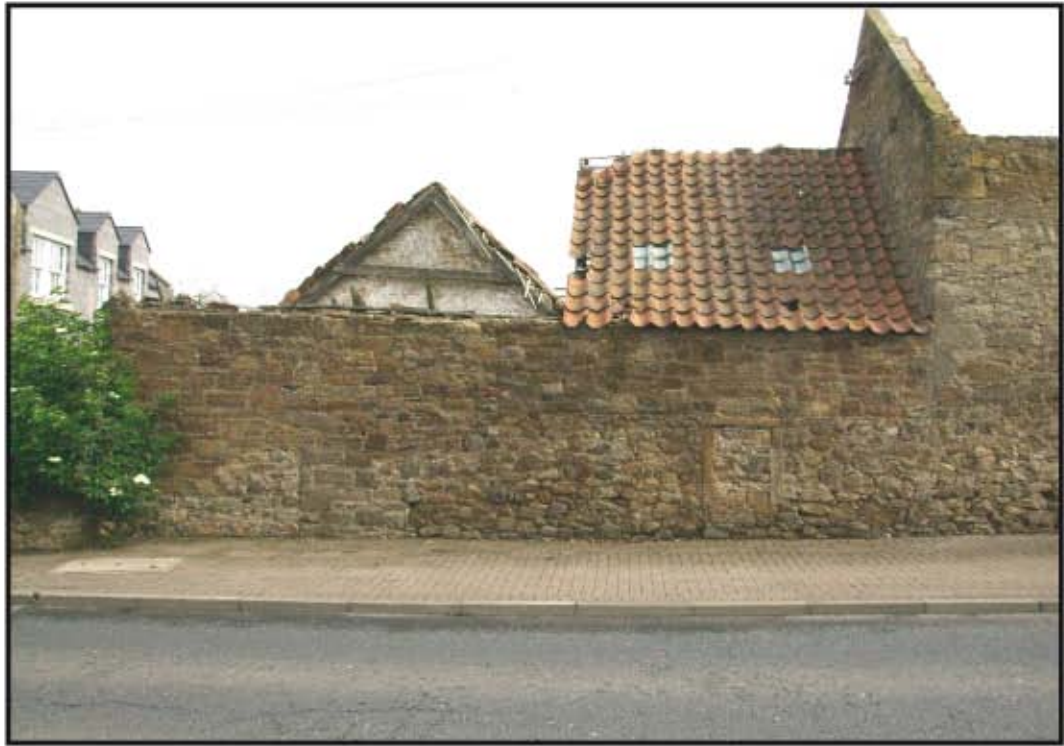
Plate 9: General view of the south wall of Building C

- 6.4.1 This smaller building is a further addition along this southern range, abutting Building B (at least on the upper levels) which can clearly be seen on the south wall (**Plate 9**). There is a small stone-blocked window also along this wall with a

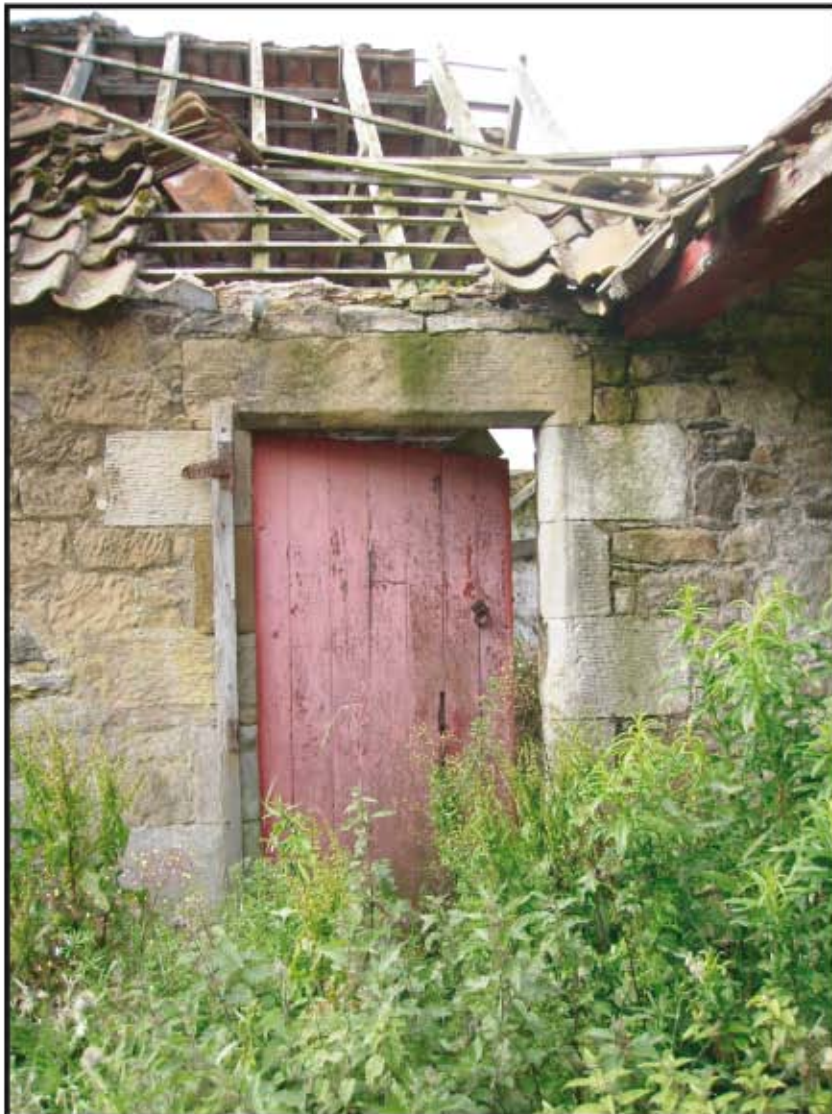
Plate 10: Detail of the door on the north wall of Building C

small plain surround and there is at least one more stone blocked opening. The north wall has a doorway with chamfered lintel and comb-dressed surround (**Plate 10**) and looks to be one phase of build to the west of this doorway until it is abutted by Building D.

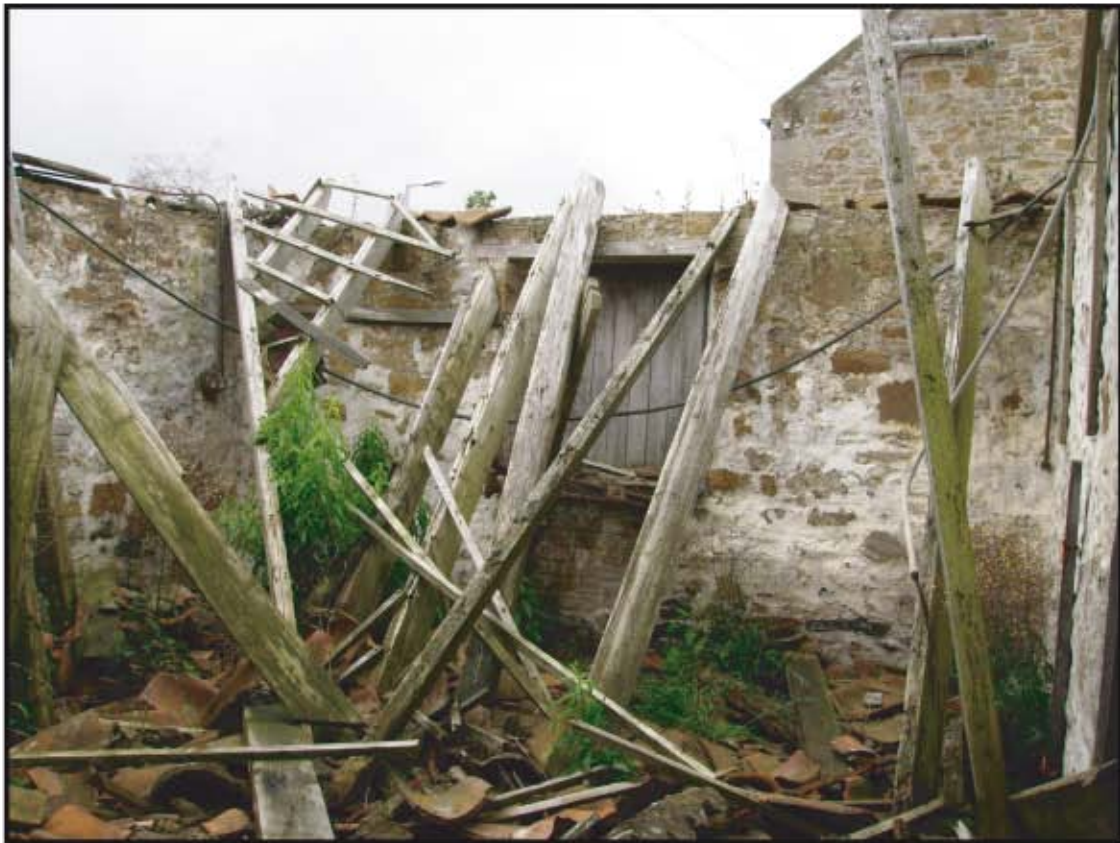
Plate 11: General view of the interior of Building C from the north-east

- 6.4.2 The interior of Building C is whitewashed stone rubble. Health & Safety issues denied full access to this barn, which had a partially collapsed roof, although the main openings (including a window along the west wall) survive (**Plate 11**).

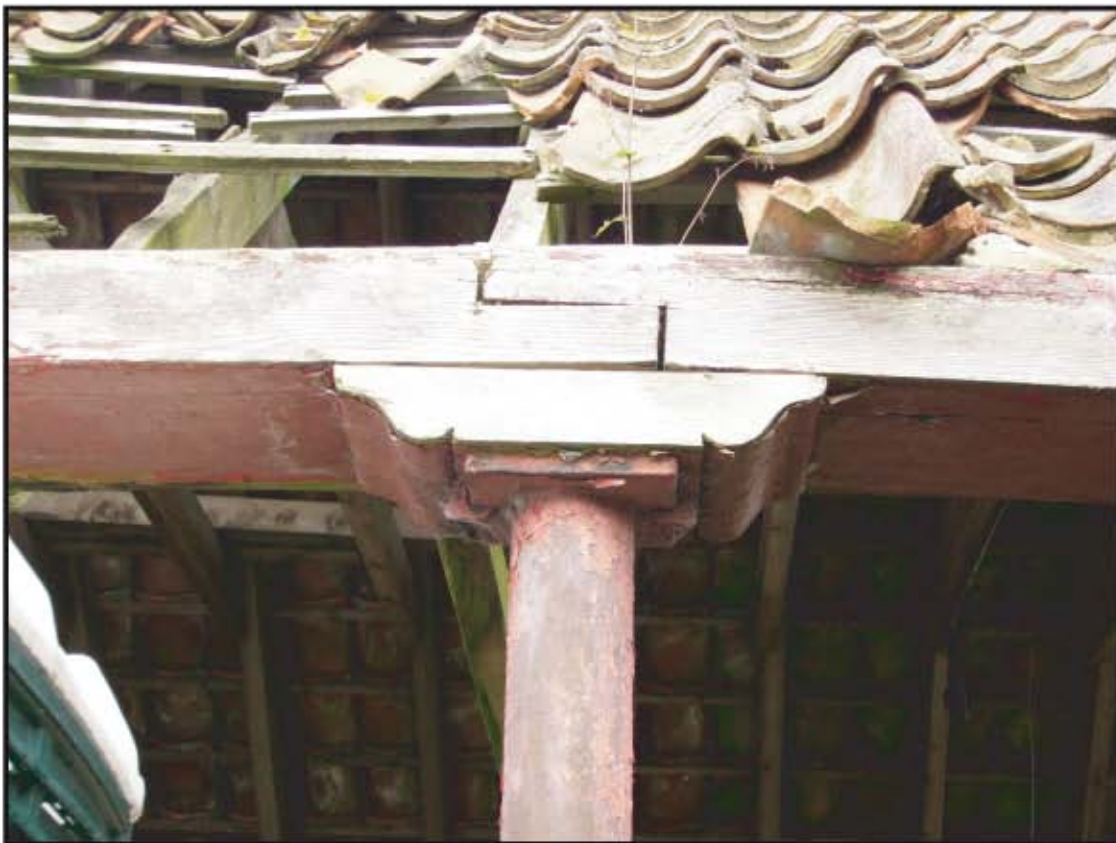
Plate 12: Detail of the cast-iron column head supporting a sill beam for the rafters of Building D from the east

- 6.5.1 This is an open barn with an exterior west and north wall, abutting Building C and partially abutting Building E. The roof of the barn to the east is resting on a beam which was supported by two plain cast-iron columns on stone pads (**Plate 12**). The exterior faces of this wall are seen adjacent to Whippielaw Farmhouse (west-facing) and contains a central doorway (**Plate 13**).
- 6.5.2 The interior faces of this barn are heavily remortared, and a large structural crack is located in the north-west corner (**Plate 14**).

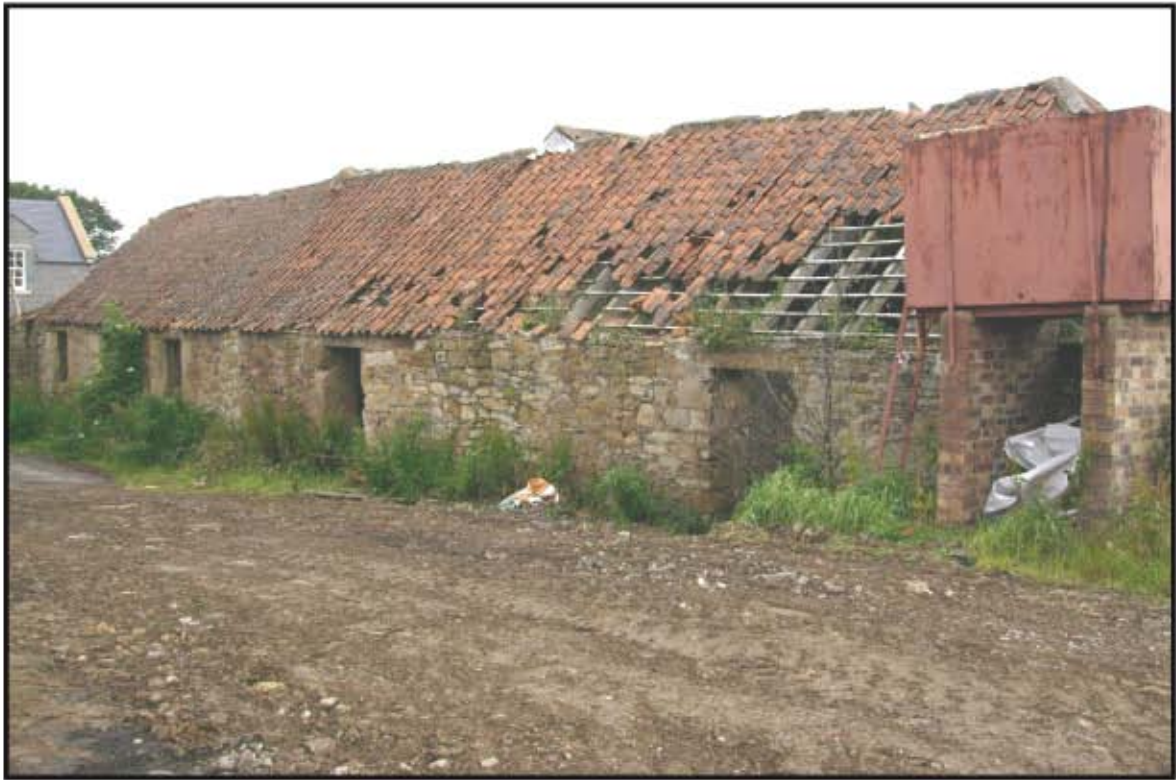
Plate 15: General view of Building E from the south-east

- 6.6.1 Compared to Buildings A & B opposite, this barn is constructed of stone rubble build and was single storey with a low hipped roofline, the timber framing of which is still relatively intact, although the pan tiles are partially removed (**Plate 15**). The south wall has five bays with a doorway flanked by windows, all with comb-dressed surrounds, to the west side and two more doorways to the east side, which had slightly cruder surrounds and may have been inserted. The east wall is low and mainly concealed by vegetation.

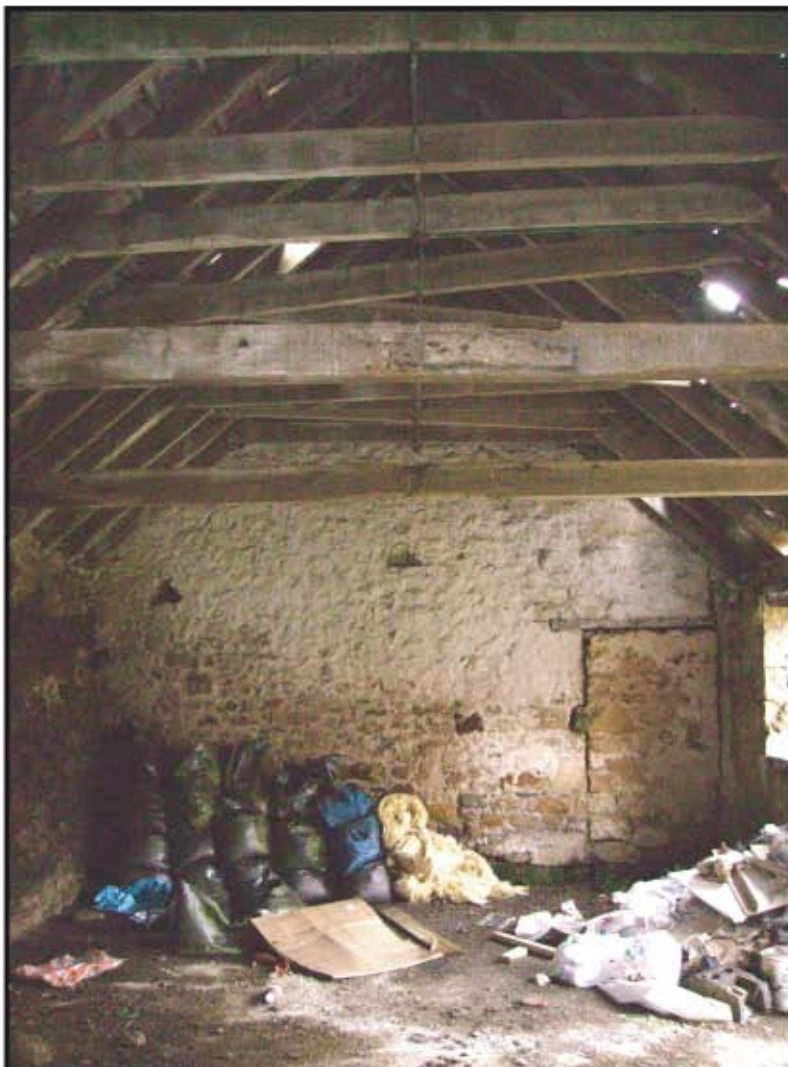
Plate 16: Detail of the stone blocked door in the westernmost room of Building E

- 6.6.2 The interior of this barn consists of three rooms. The westernmost room has a concrete floor and stone rubble walls. The east wall has a stone blocked door (**Plate 16**) and the widely chamfered door and windows were located in the south wall. There was evidence that there was once an upper storage area, with beam slots still in place. The central room is similar in style to the westernmost room, with a central door through to Building G (this would have originally been an exterior door prior to the construction of Building G). Another stone blocked doorway is located to the west of this (**Plate 17**). The stone blocked door carries on to be seen in the west wall here, and the east wall is plain. The easternmost room had opposing doorways on the north and south walls with a raised, possibly stone-lined path between (**Plate 18**). Further evidence of phasing can be seen in the door in the north wall, possibly altered during the construction of Buildings F or G (**Plate 19**).

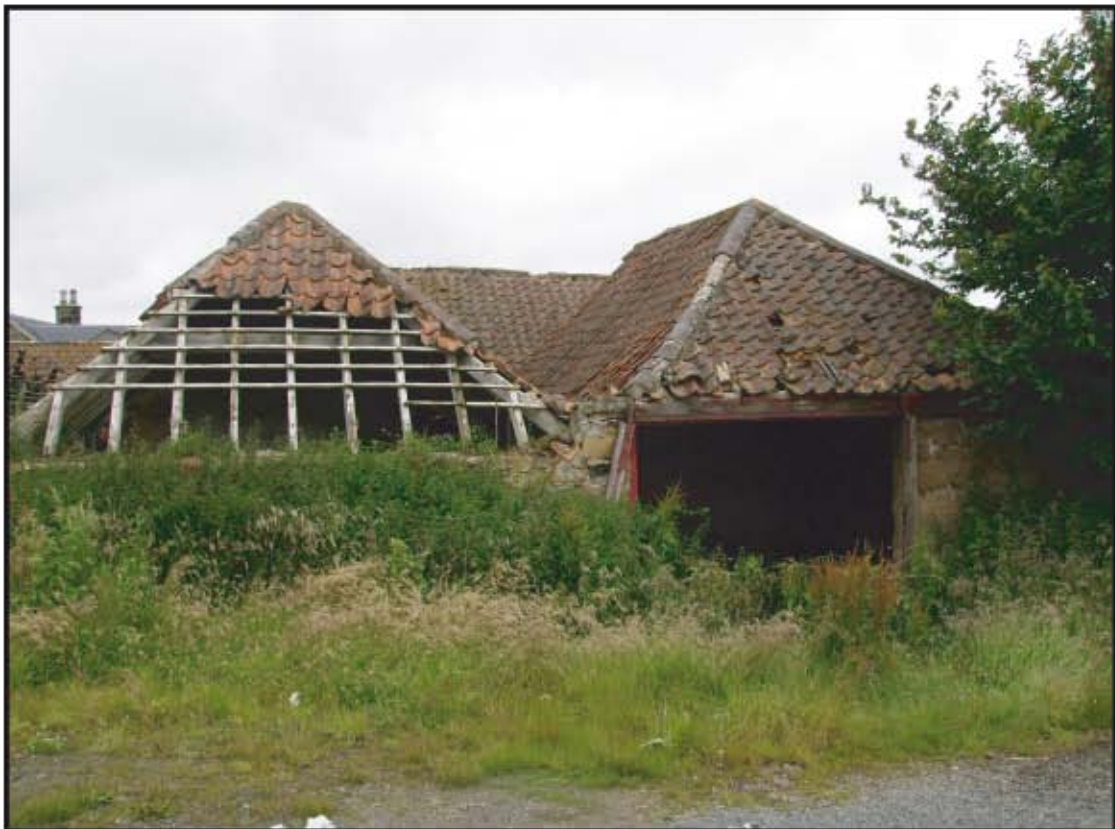
Plate 20: General view of the east wall of Buildings E & F

- 6.7.1 Building F is a clear abutment to Building E (something which is best seen in the interior). A wide cart entrance is located on the east wall with the timber remains of a sliding cart door (**Plate 20**). The north wall is located under a later timber barn erected to the north side of this barn, and contains no features. There are chisel-dressed quoins to the east side, and it is abutted by the later large cow shed Building G.

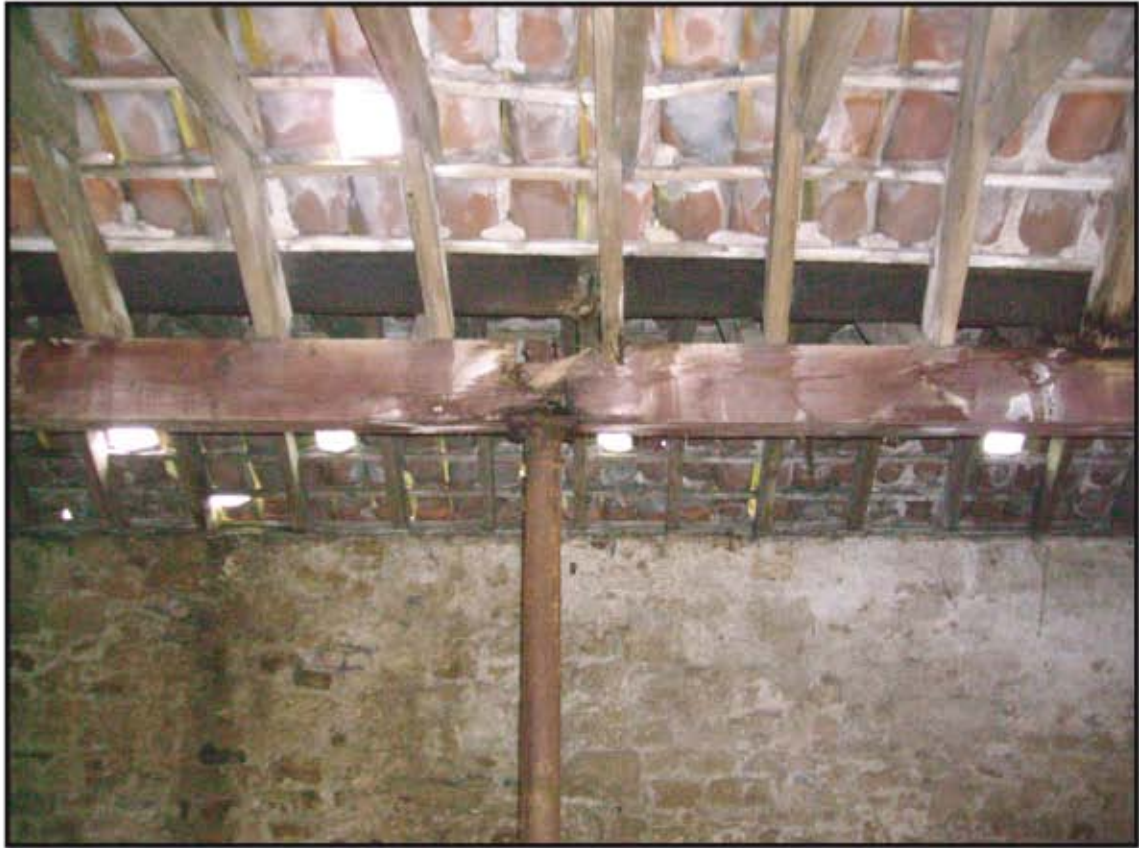
Plate 21: Detail of the cast-iron column supported in the east/west roof beam in Building F from the south

- 6.7.2 The interior of Building F consists of one room to the east. It has an earthen floor with stone rubble walls and a two-bay hipped roof, the sill beam supported by a plain cast-iron column (**Plate 21**). To the west wall, the southern side, an original cart entrance, has been engulfed behind by the later cow shed, Building G. There is a large cart entrance to the south side of the north wall. The south wall consists of the original exterior wall of Building E.

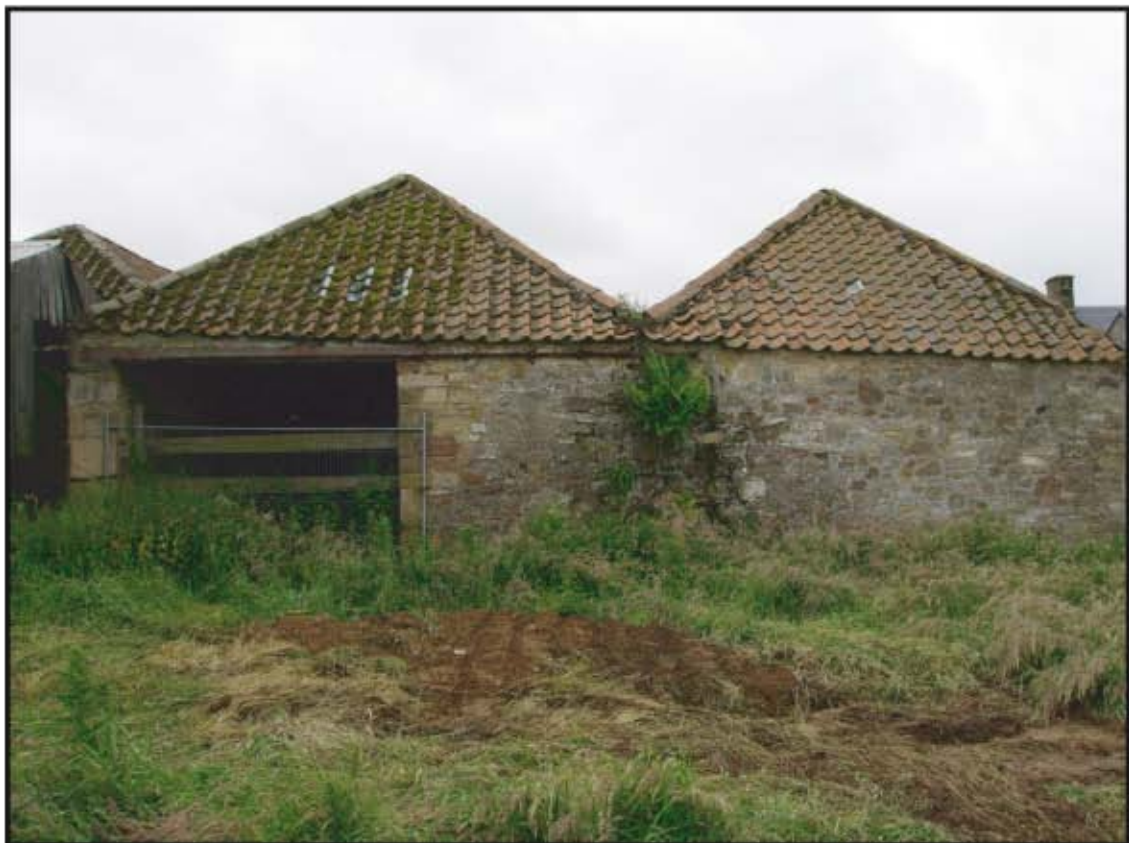
Plate 22: General view of the north wall of Building G

- 6.8.1 This large cow shed appears to have been the latest phase, as it abuts both Buildings F and also E, with the interior south wall consisting of the original exterior wall of E. Externally, the west wall shows that the original access arrangement on this side was a wide cart door entrance, which was later stone blocked to accommodate a pedestrian access and window, once the internal east/west feeding stalls were added. This may mean that Building G had a different function originally, but more investigation will need to be undertaken. There are no more features to the exterior of Building G – which has a double hipped roof to the west side, apart from a single cart entrance in the north wall (**Plate 22**).

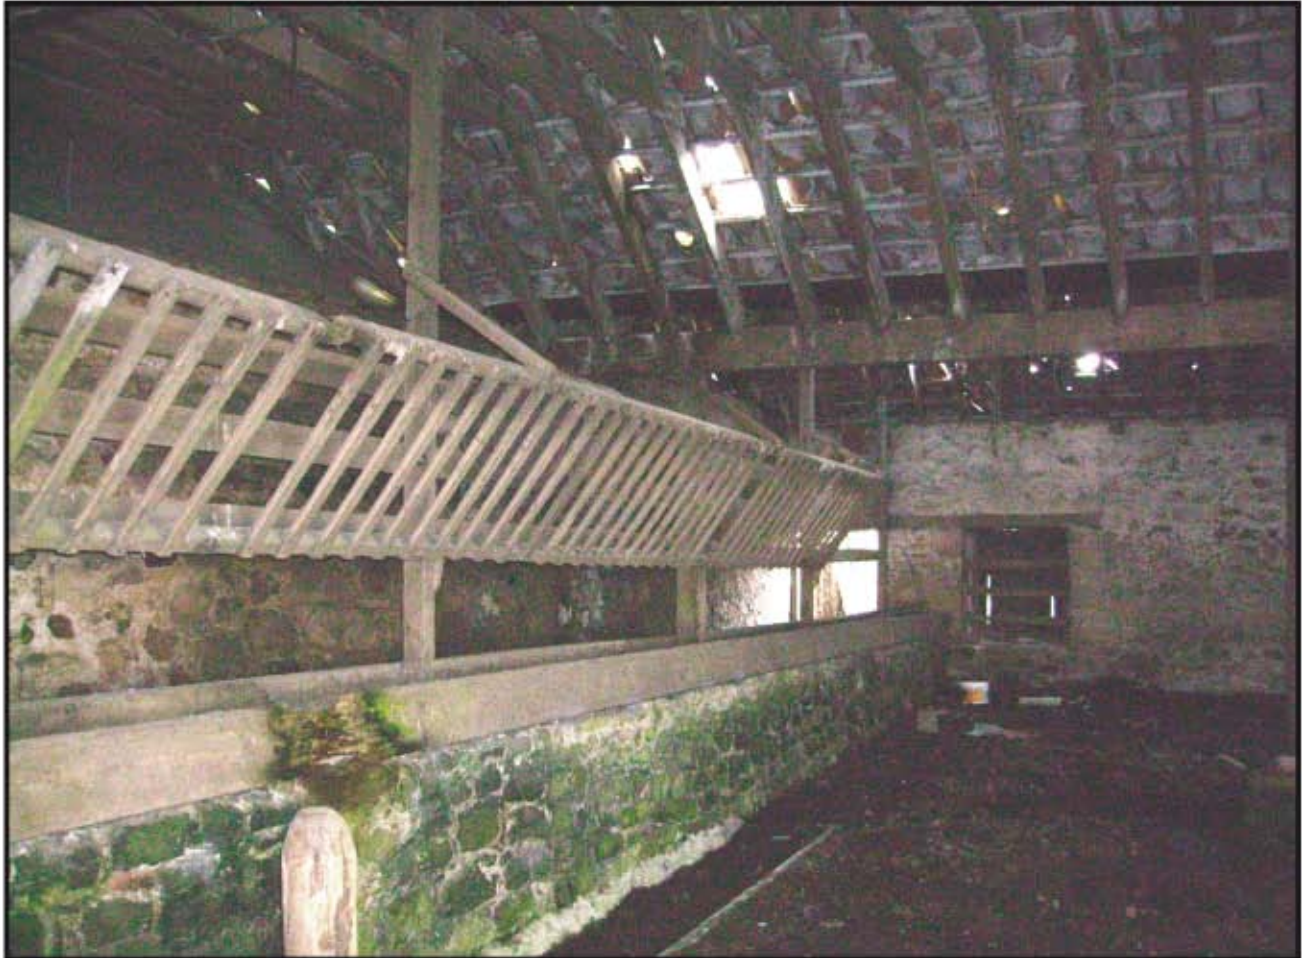
Plate 23: General view of the interior of Building G from the east

- 6.8.2 Internally, Building G consists of one large cow shed. The south wall - originally the exterior wall of Building E, had a single doorway and in front was the east/west cow stalls. As the room extended to the west, it consisted of a three-bay hipped roof, the north/south roof beams supported by plain cast-iron columns (**Plate 23**).
