**David Street:
Evaluation**

Data Structure Report

AOC Archaeology Project No: 20,338

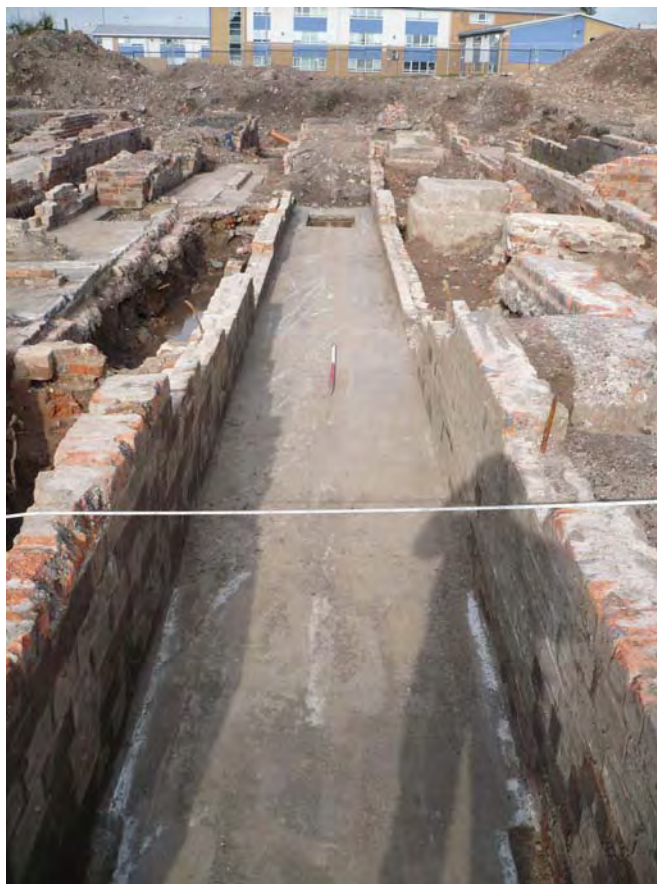
Figure 3: Detail of Kiln [047], with the enclosing wall [046] and 'inspection pit' [049].

Generally, the kilns survived as a long brick built 'corridor', floored by a concrete surface (Figures 2 and 3). They were built on a concrete base which directly overlay a deposit of building debris, detritus and occasional ceramic sherds [214] and the natural grey boulder clay. The most intact example, Kiln [047], measured approximately 31 m in length by 1.50 m in width and up to 1 m in depth. The walls were generally built of two aligned courses of brick, which had been reinforced by steel pinnings, an important development of this time (George Haggerty pers comm). The walls of the kiln also contained controlling mechanisms to allow gases/heat to move around the structure, which comprised a steel handle which moved an overlying panel. In only one example, Kiln [041], did the kiln walls survive to any height, and in this case the wall was found to curve in towards the middle, suggesting they had curved ceilings.

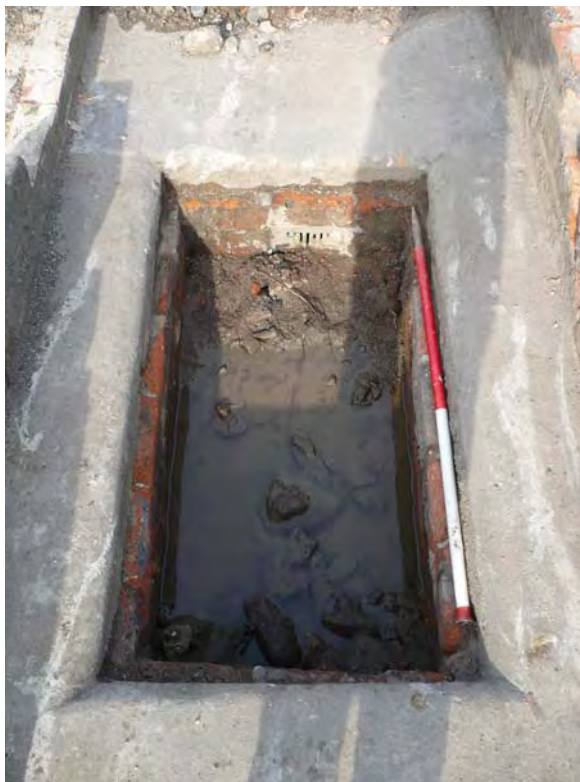
Figure 4: Detail of 'inspection pit' [036]

A central 'inspection pit' [036] (Figure 4), apparent in four of the kilns ([208], [210], [047] and [043]) comprised an iron setting set in to the floor surface. The pits all contained grates in the western wall face raising the possibility that these served as drainage features. The example identified in Kiln [208], was excavated to reveal that the concrete flooring [014] was built over an iron bogey [067], suggesting that even the apparently simple kilns went through at least two phases of development. The occurrence of the bogey suggests that at one point the ceramic material would have been transported in to the kilns by rail, implying some sophistication in an earlier phase of the works. However, the subsequent concreting over of the bogeys implies that this method became redundant in the later development of the works.

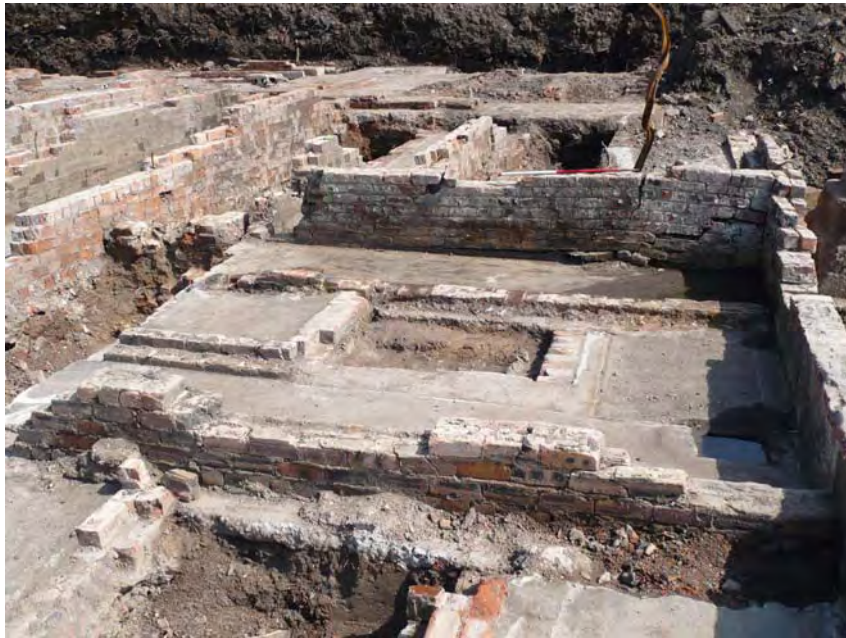
Figure 5: Detail of inserted Room [209] built over the eastern ends of Kilns [208] and [210]

In at least two examples the kilns were truncated by the construction of some sort of workroom - [209] being built over the eastern end of Kilns [208] and [210]. The construction of this room would certainly have ended the functioning ability of the two truncated kilns, but for what purpose is as yet unclear.

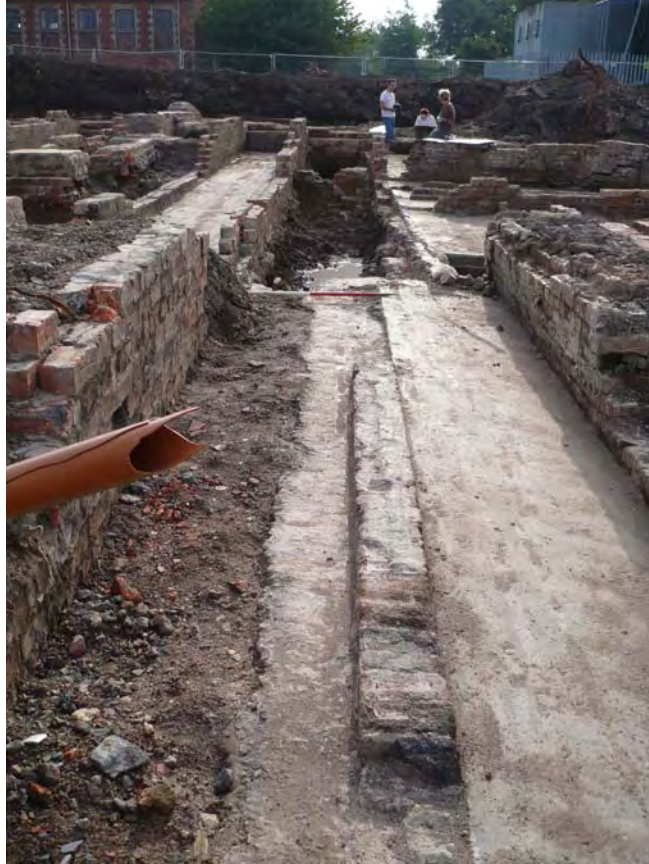
Figure 6: Detail of Kiln [041] built in between Kilns [047] and [210]

The construction of Kiln [041] would have compromised the use of Kilns [210] and [047], creating a structure between the two earlier examples. It seems likely that this development took place either due to the increase of production of ceramic which may have required larger kilns, or due to the technological advances made in the distribution of energy.

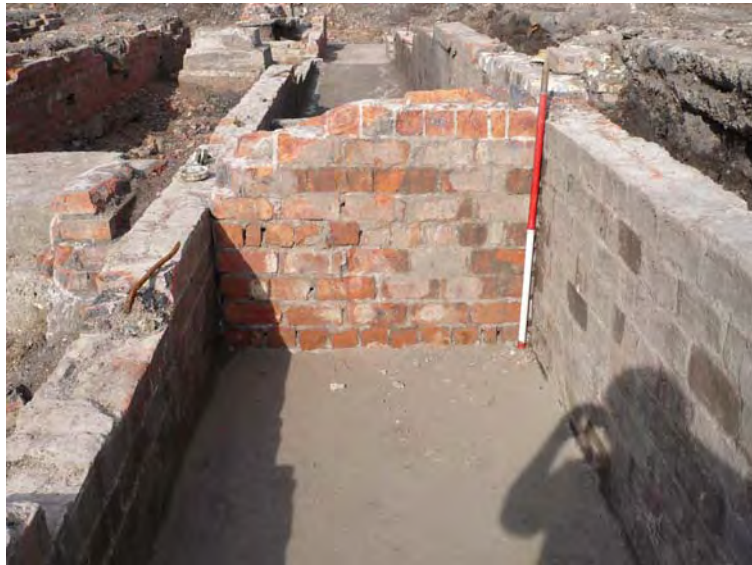
Figure 7: Detail of wall [074] inserted within Kiln [058]

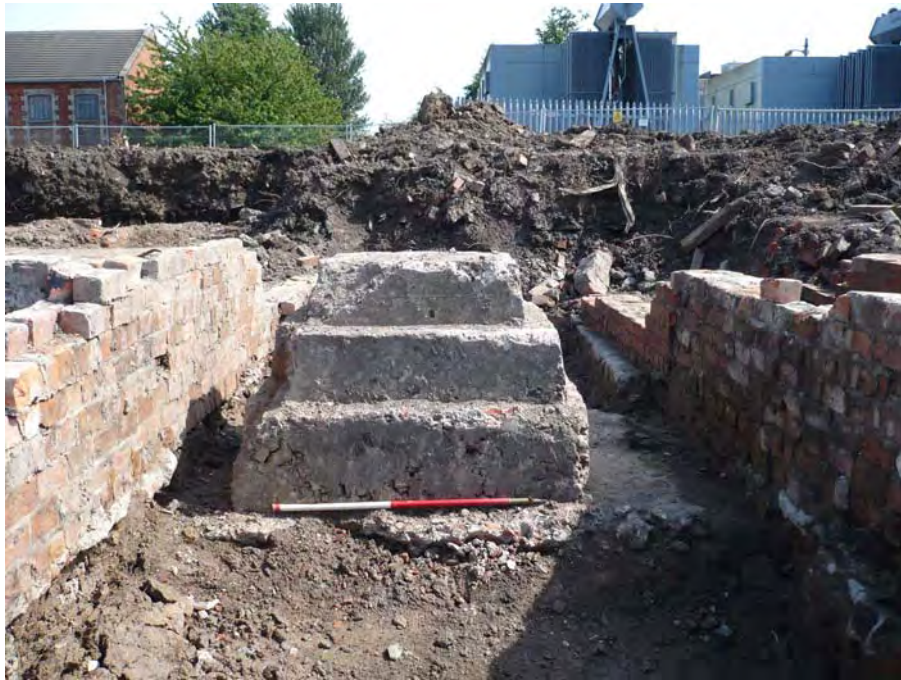
Figure 8: Detail of concrete foundation [003]

The kilns were built between large concrete foundation pedestals (for example [052], [055] and [056]) and red brick (for example [021]), which would have supported the superstructure of the pottery building. It is likely that the intervening areas would have supported the areas of access around the kilns, as evidenced by the floor level [034] identified in area [051].

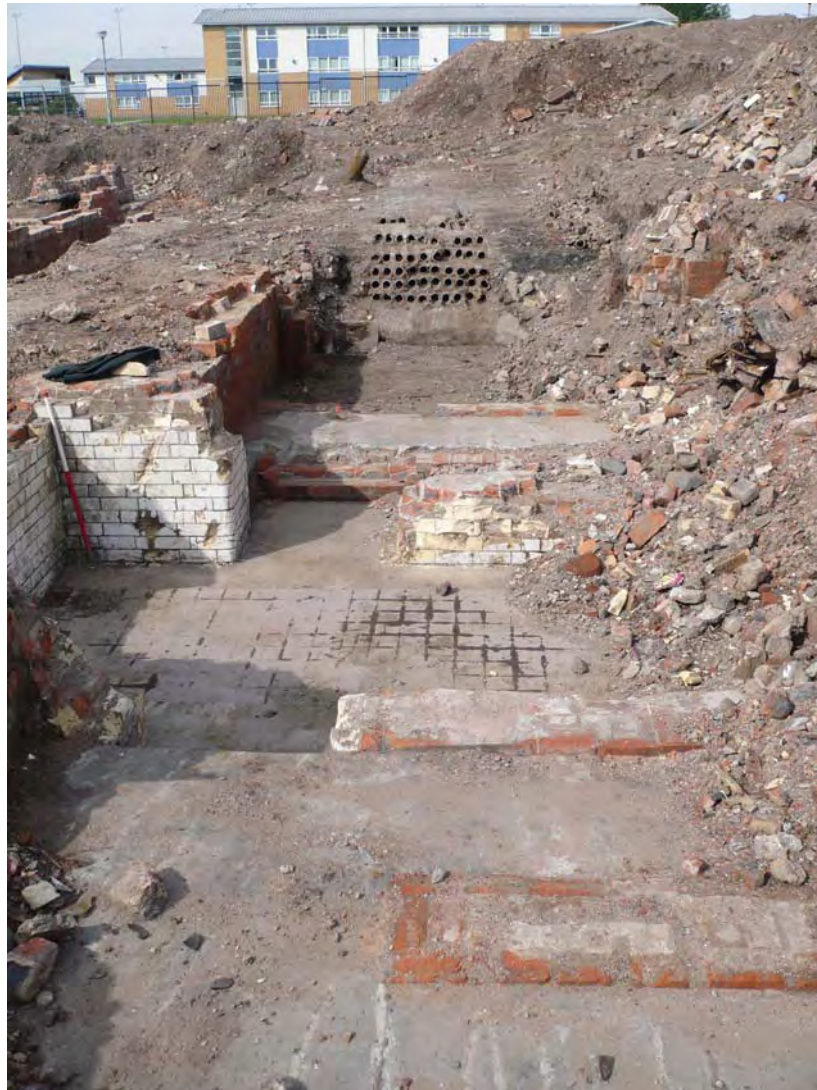
Figure 9: Detail of Boiler Room [085] and associated Pipes [099]

The boiler room was located to the north of the site, to the immediate north of the main alignment of kilns, but was only partially excavated. The boiler room complex comprised a set of adjoining areas assigned the general number of *Room [085]*. The area measured at least 9.50 m east to west, by up to 4 m north to south and in contrast to the workshop areas was floored and walled with a mixture of red and white tiles. At least some of the tiles showed evidence of oil stains which led to the initial interpretation of a boiler room. Further proof of this suggestion was the recognition of metal bolts inserted within the floor, which would have held large elements of machine plant.

5.2.6.2 A conjoined set of pipes [099] up to 15 m in length led in to the eastern part of the boiler room. These probably constituted the method of either distributing heat or gases around the ceramic works. The cast iron pipes were encased in ceramic

tubing, providing further insulation. More specifically, the pipes may have been the means of distributing steam to the Throwing Shops where the clay was prepared (Ms Diana Connell pers comm).
