# Jedburgh Health Centre: Evaluation Data Structure Report

AOC 21079  
July 2008

## Jedburgh Health Centre Evaluation Data Structure Report

On Behalf of:	Borders Health Board Ltd Newstead Melrose TD6 9DB
National Grid Reference (NGR):	NT 6515 2057
AOC Project No:	21079
Prepared by:	Mr Daniel Rhodes
Illustration by:	Mr Graeme Carruthers
Date of Fieldwork:	4 <sup>th</sup> July to 9 <sup>th</sup> July 2008
Date of Report:	July 2008

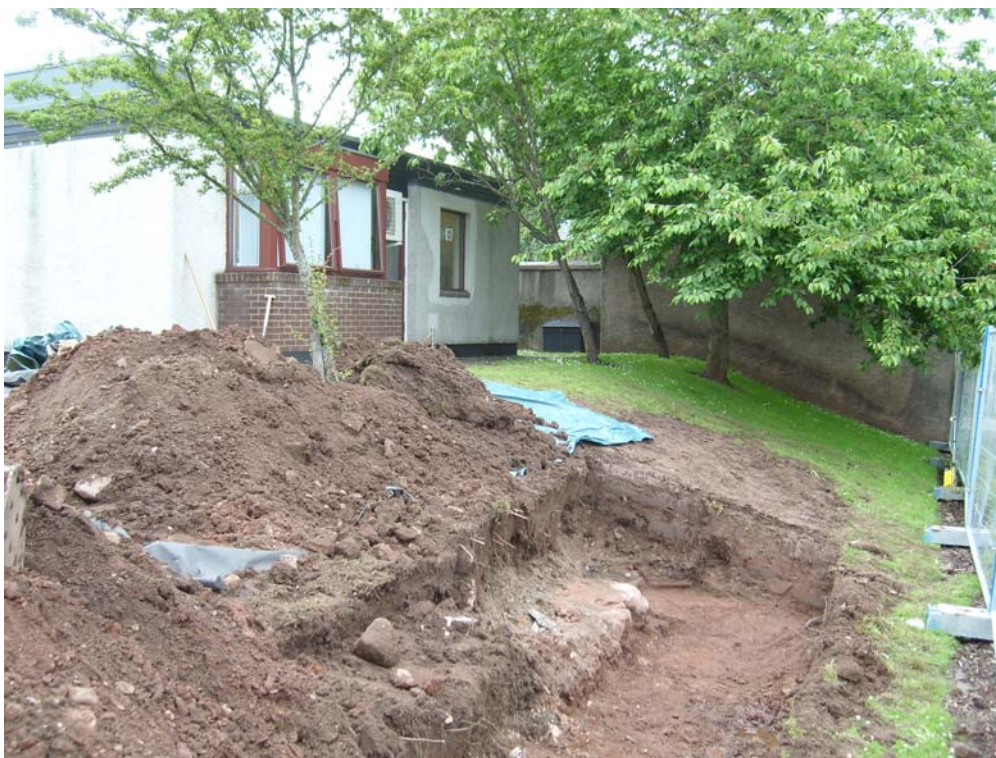
*Plate 1: showing sloping nature of the site plus tree location*

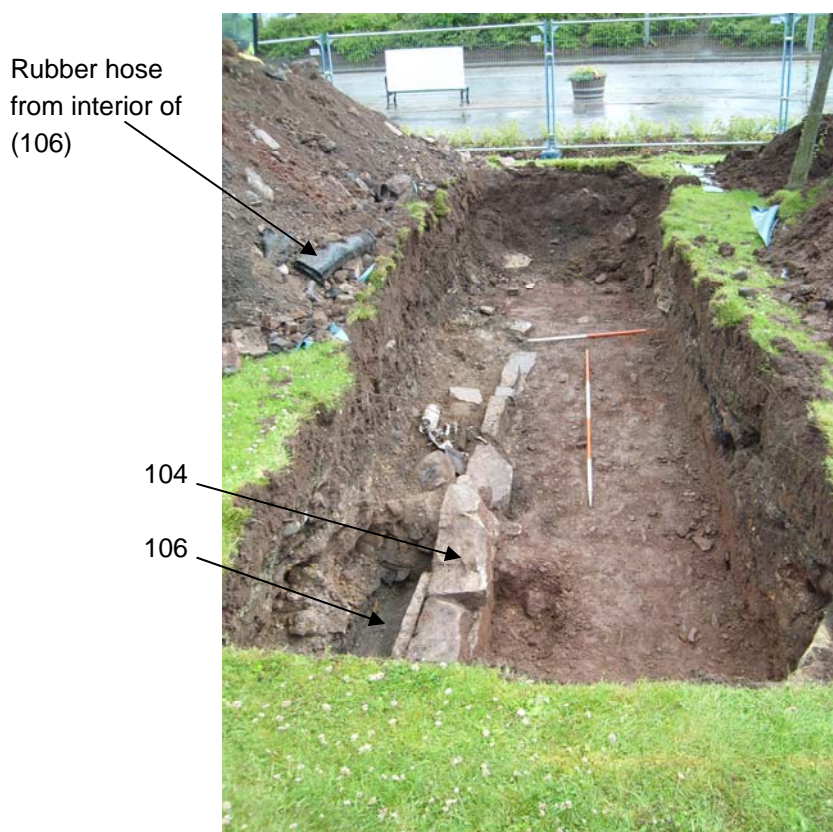
- 4.1 The various data gathered from the evaluation are presented as a series of appendices:
- i) Appendix 1 contains trench summaries;
  - ii) Appendix 2 contains the photographic register;
  - iii) Appendix 3 contains the drawing register;
  - iv) Appendix 4 contains the finds register;
  - v) Appendix 5 reproduces the *Discovery & Excavation in Scotland* entry.
- 4.2 Trench 1 (Plates 2 and 3; Figures 3 and 5) contained one archaeological feature at its northern end. This consisted of two courses of a north to south running sandstone and lime mortared wall (104). The wall measured 4 m in length, was 0.3 m wide and stood to a height of 0.52 m. To the east of the

wall at its northern end it was abutted by a concrete conduit (106) running north to south (within which was a rubber hose and ceramic pipe). It is, however, unclear if this conduit was contemporary or later than the sandstone wall. It may be that the conduit represents a re-use of an earlier wall. A supposition supported by the differing nature of the stones used within the two visible wall courses. The lower course consisted of well worked square blocks and the upper of roughly worked rounded blocks. This may suggest two different phases of construction, the upper relating, not to the original wall, but to the concrete conduit.

- 4.3 Overlaying this feature in Trench 1 was a thick deposit of building rubble (107) relating to the demolition, in 1965, of the brewery which formerly occupied the site.

*Plate 2: Overview of Trench 1 from north*

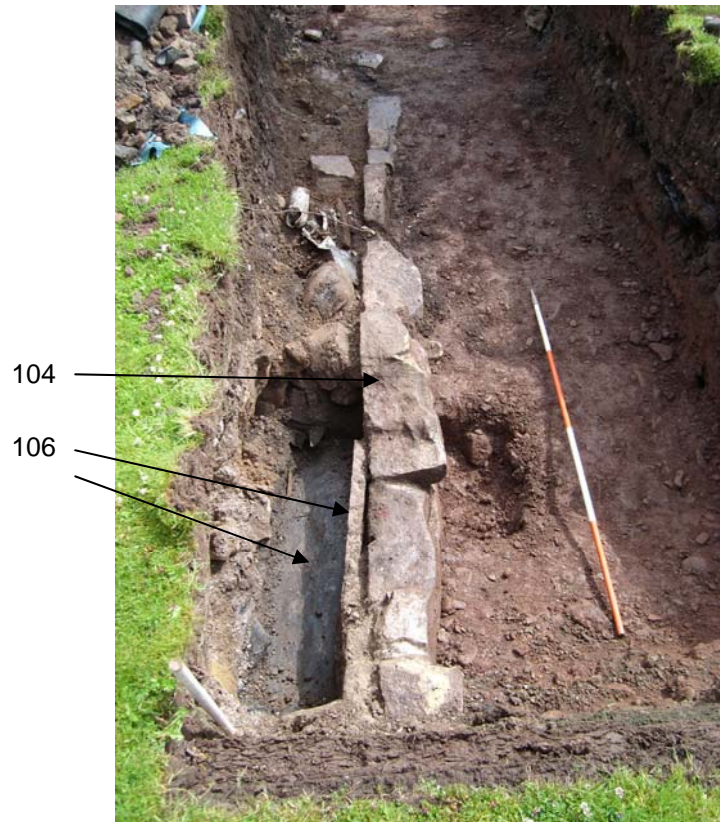
*Plate 3: Close up of features in Trench 1 from north*

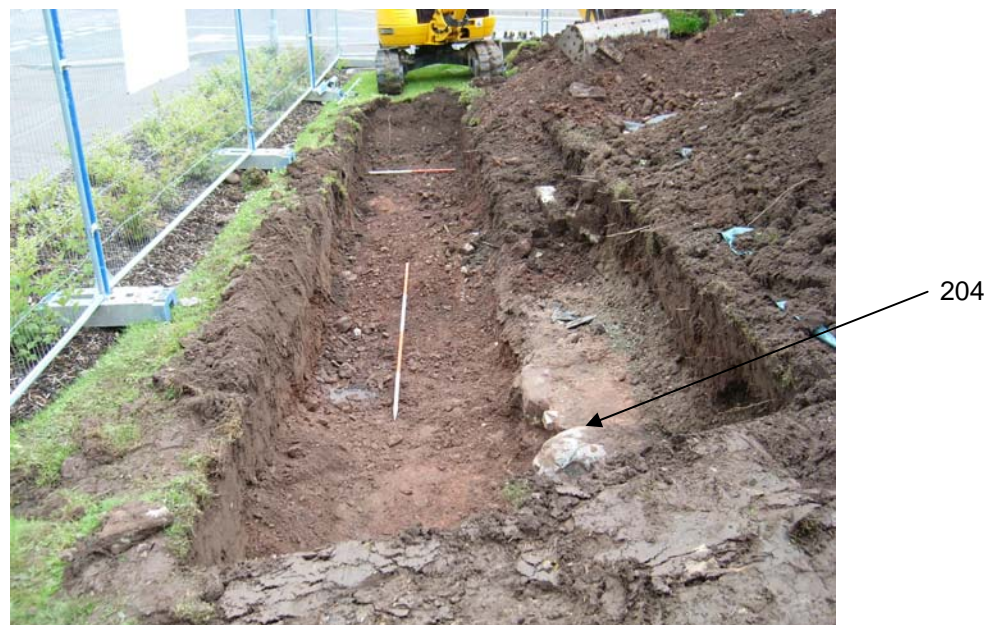
- 4.4 Trench 2 (Plates 4 and 5; Figures 4 and 6) contained further structural evidence in the form of a single course of large rounded sandstone boulders (each averaging 0.60 m in diameter) and small angular sandstone fragments (204) (overall measuring 2.20 m east to west by 0.70 m north to south, with a height of 0.60 m). This was abutted upon its eastern side by a 0.10 m thick concrete slab (207) filling the entire area of the eastern end of Trench 2 (3.75 m east to west by 2.30 m north to south). As in Trench 1 the sandstone blocks represent the basal course of a north to south running wall, however, it is unknown whether the concrete slab to the east is contemporary or later than this wall. Again, as in Trench 1, it may be that the concrete slab floor represents the redevelopment of an earlier building (204).

- 4.5 Overlaying the wall feature (204) in Trench 2 was a further thick deposit of building rubble (203), again relating to the demolition, in 1965, of the brewery which formerly occupied the site. Four finds were recovered from the interface of this context and the lower context (205). These include a sherd brown transfer printed ceramic (Find No. 3), a sherd of plain brown glaze ceramic (Find No. 2), a patterned ceramic tile (Find No. 1) and a corroded coin (date as yet unidentifiable) (Find No. 4).

*Plate 4: Overview of Trench 2 from east*

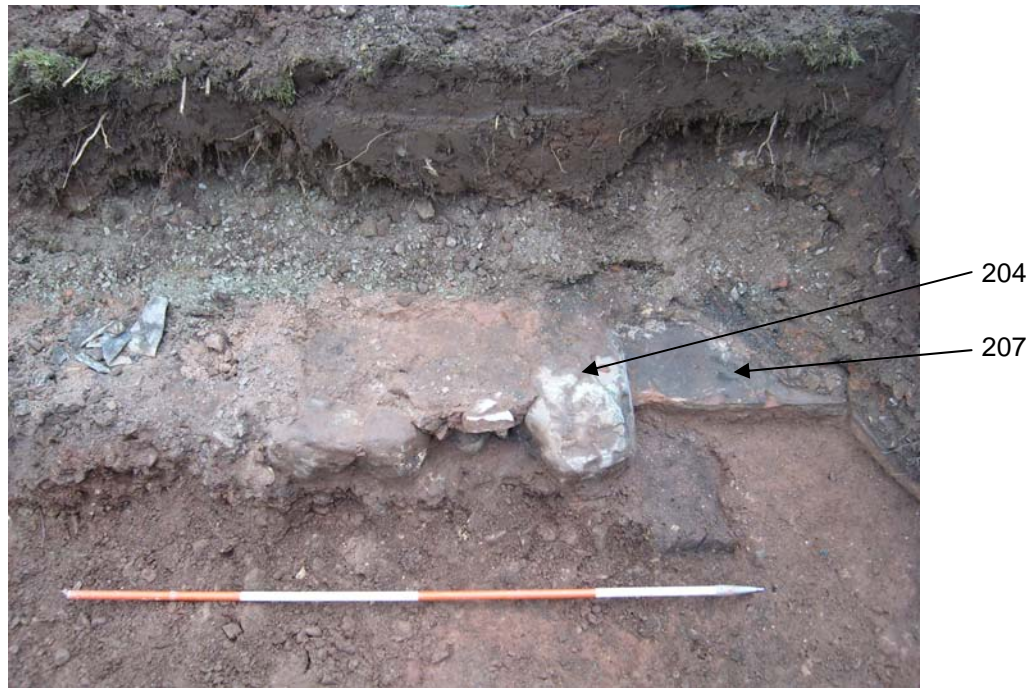
Plate 5: Showing wall 204 and concrete

- 6.1 The structural remains that were unearthed are both poorly preserved and limited in extent. No plausibly early floors survive. The limited artefact assemblage recovered from a non-secure context appears to be late, probably 19<sup>th</sup> century. The trial trenching has shown the site to possess only very limited archaeological potential.
- 6.2 No further archaeological works are considered necessary. It must be noted that this recommendation will require confirmation by Borders Council

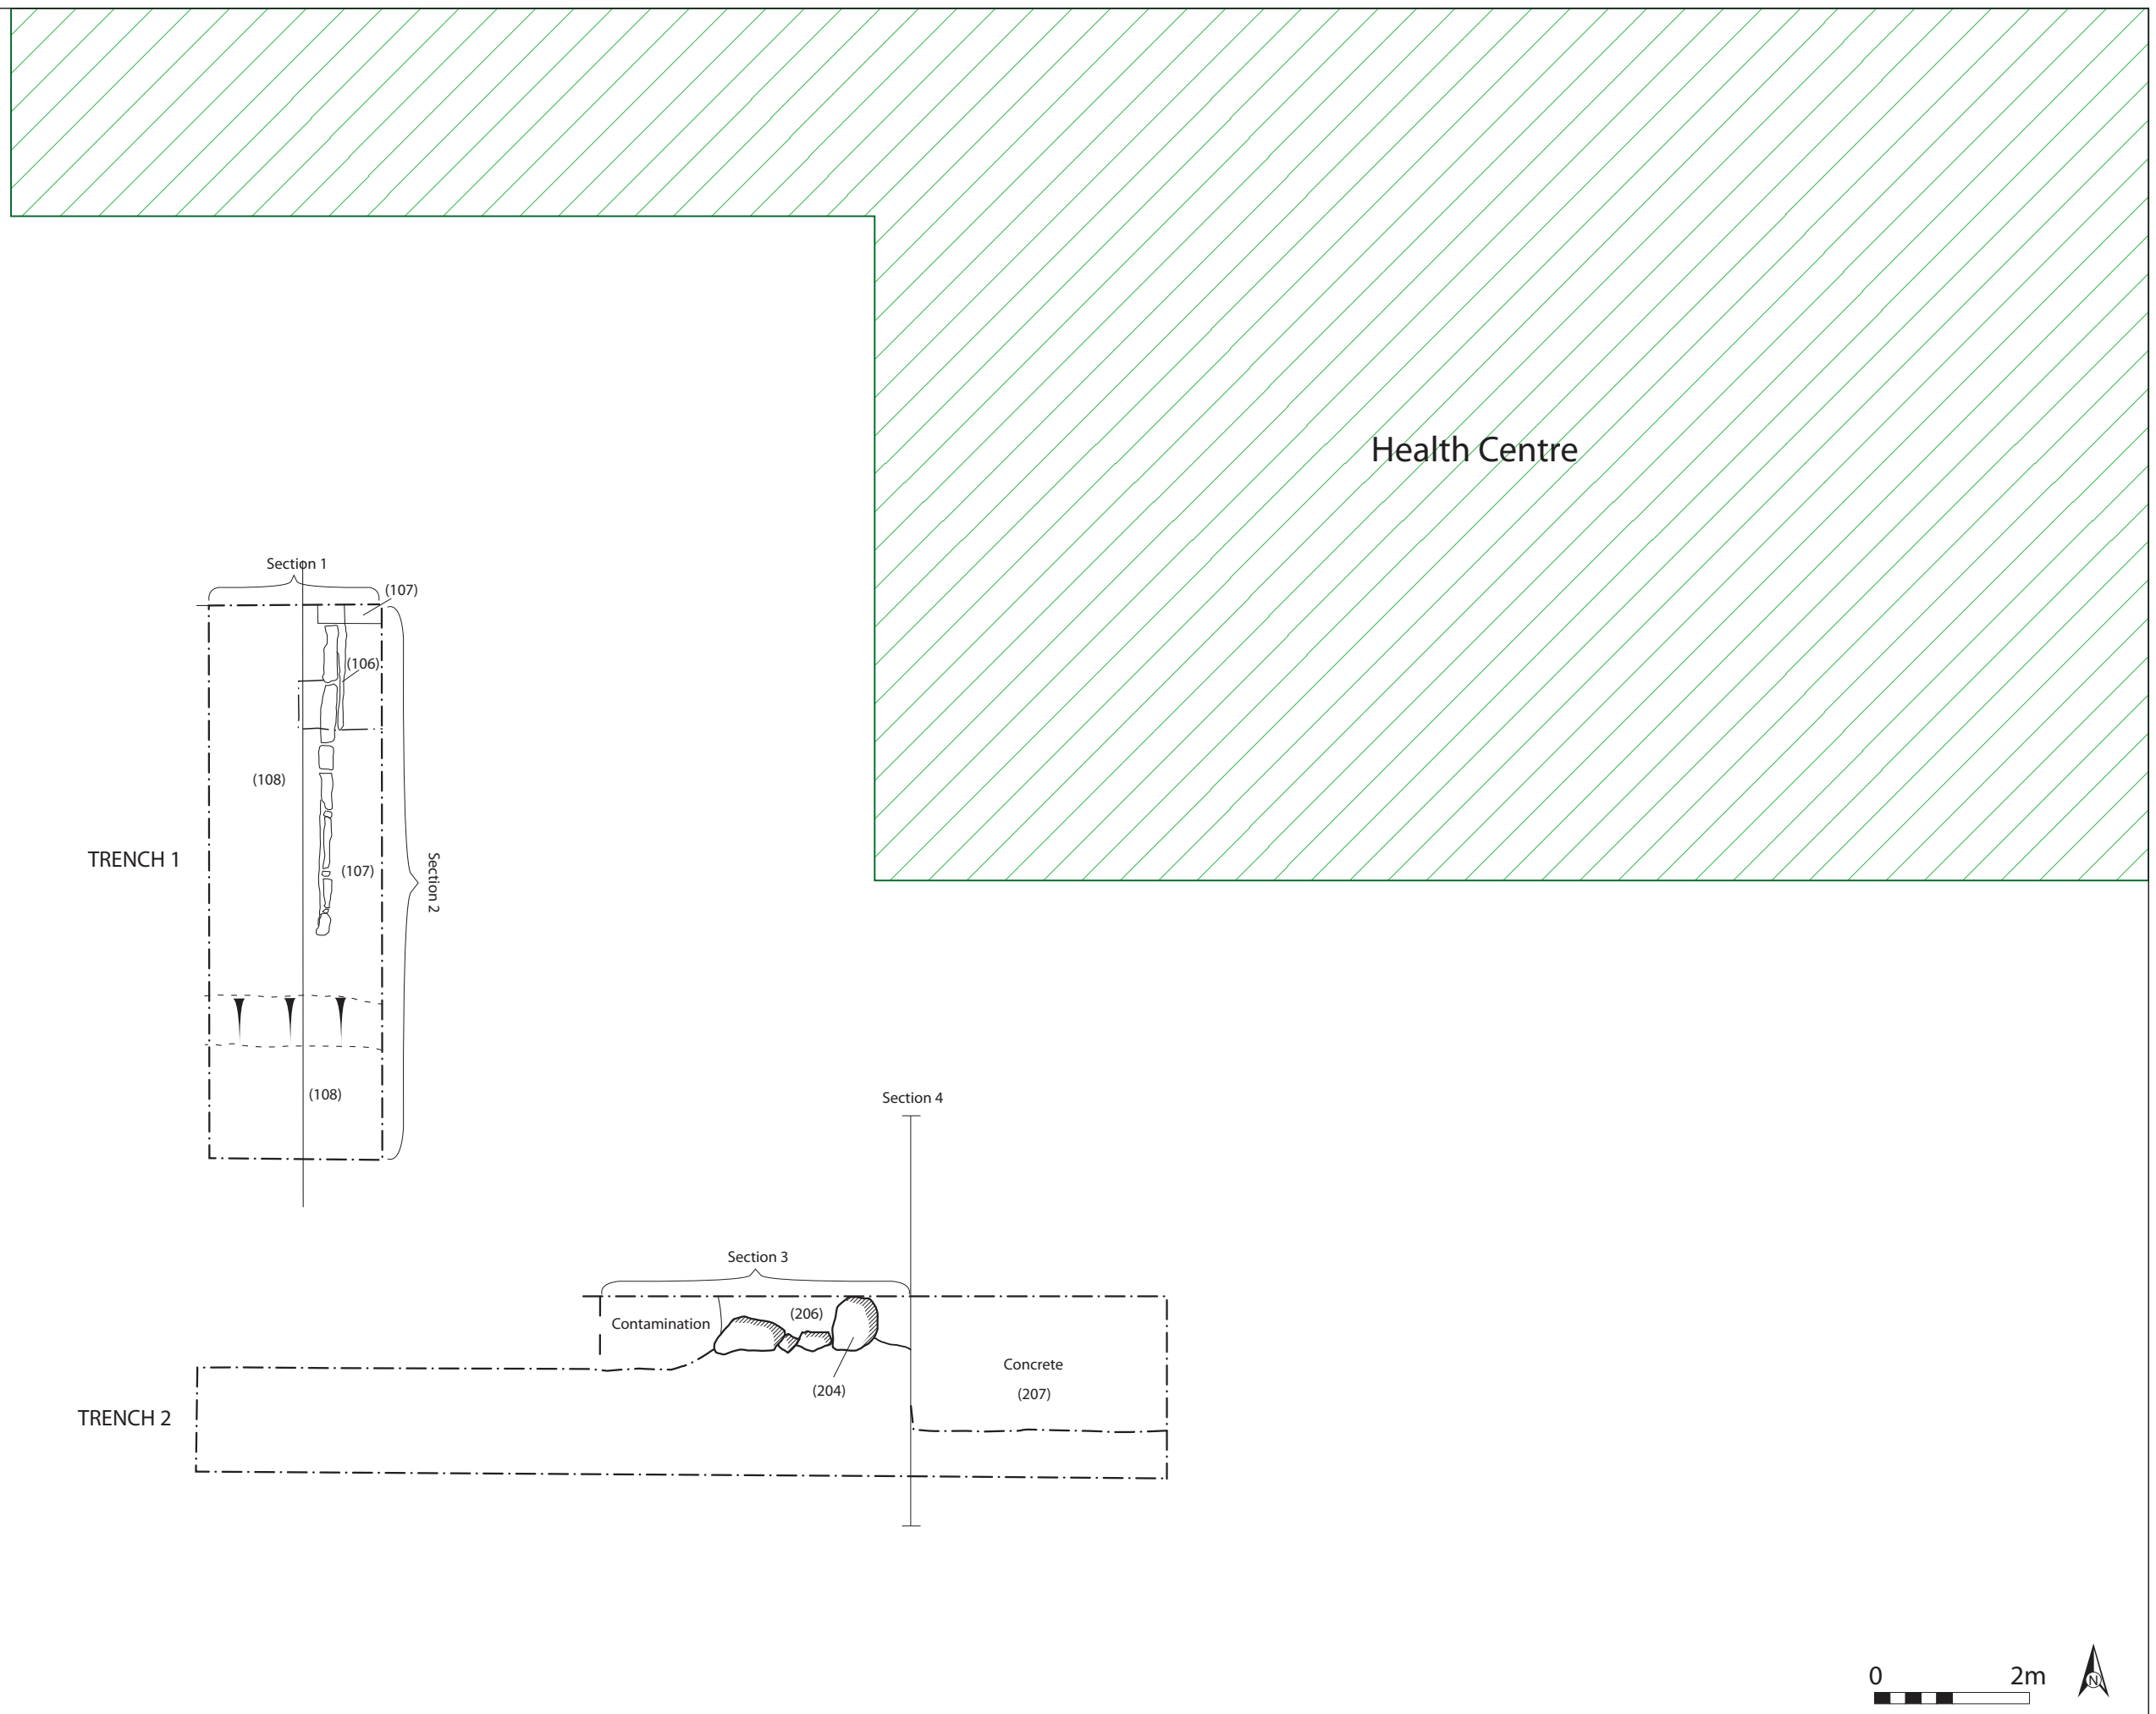
Figure 2: Site Plan showing southern edge of Health Care Centre and Test trenches 1 and 2

- 3.1 The evaluation consisted of two trenches dug by means of a mini digger fitted with a toothless ditching bucket. In total 40 m<sup>2</sup> were excavated (Figure 2). This is a reduction from the total specified in the *Written Scheme of investigation* and is due to the sloping nature of the site and the need to preserve the trees that occupy the site (Plate 1). The extent of Trench 2 was further limited by the exposure of asbestos contamination. Excavation was carried out in shallow spits until the first archaeological horizon or natural geology was encountered and was monitored by an experienced and qualified archaeologist.
