# South Street, Saint Andrews: Data Structure Report

AOC 20428  
July 2008

This report details the results of an Archaeological Watching Brief at 169-173 South Street, St. Andrews, Fife. During ground reduction works the remains of a single post-hole complete with packing stones and one large pit were recorded in the garden area to the rear of the property. Ground reduction also took place within a listed standing building, also to the rear of the property. During this phase of work three large rectangular stone-lined pits complete with stone flagged bases were also recorded. An assemblage of post-medieval pottery, bone and shell associated with these features was recovered.

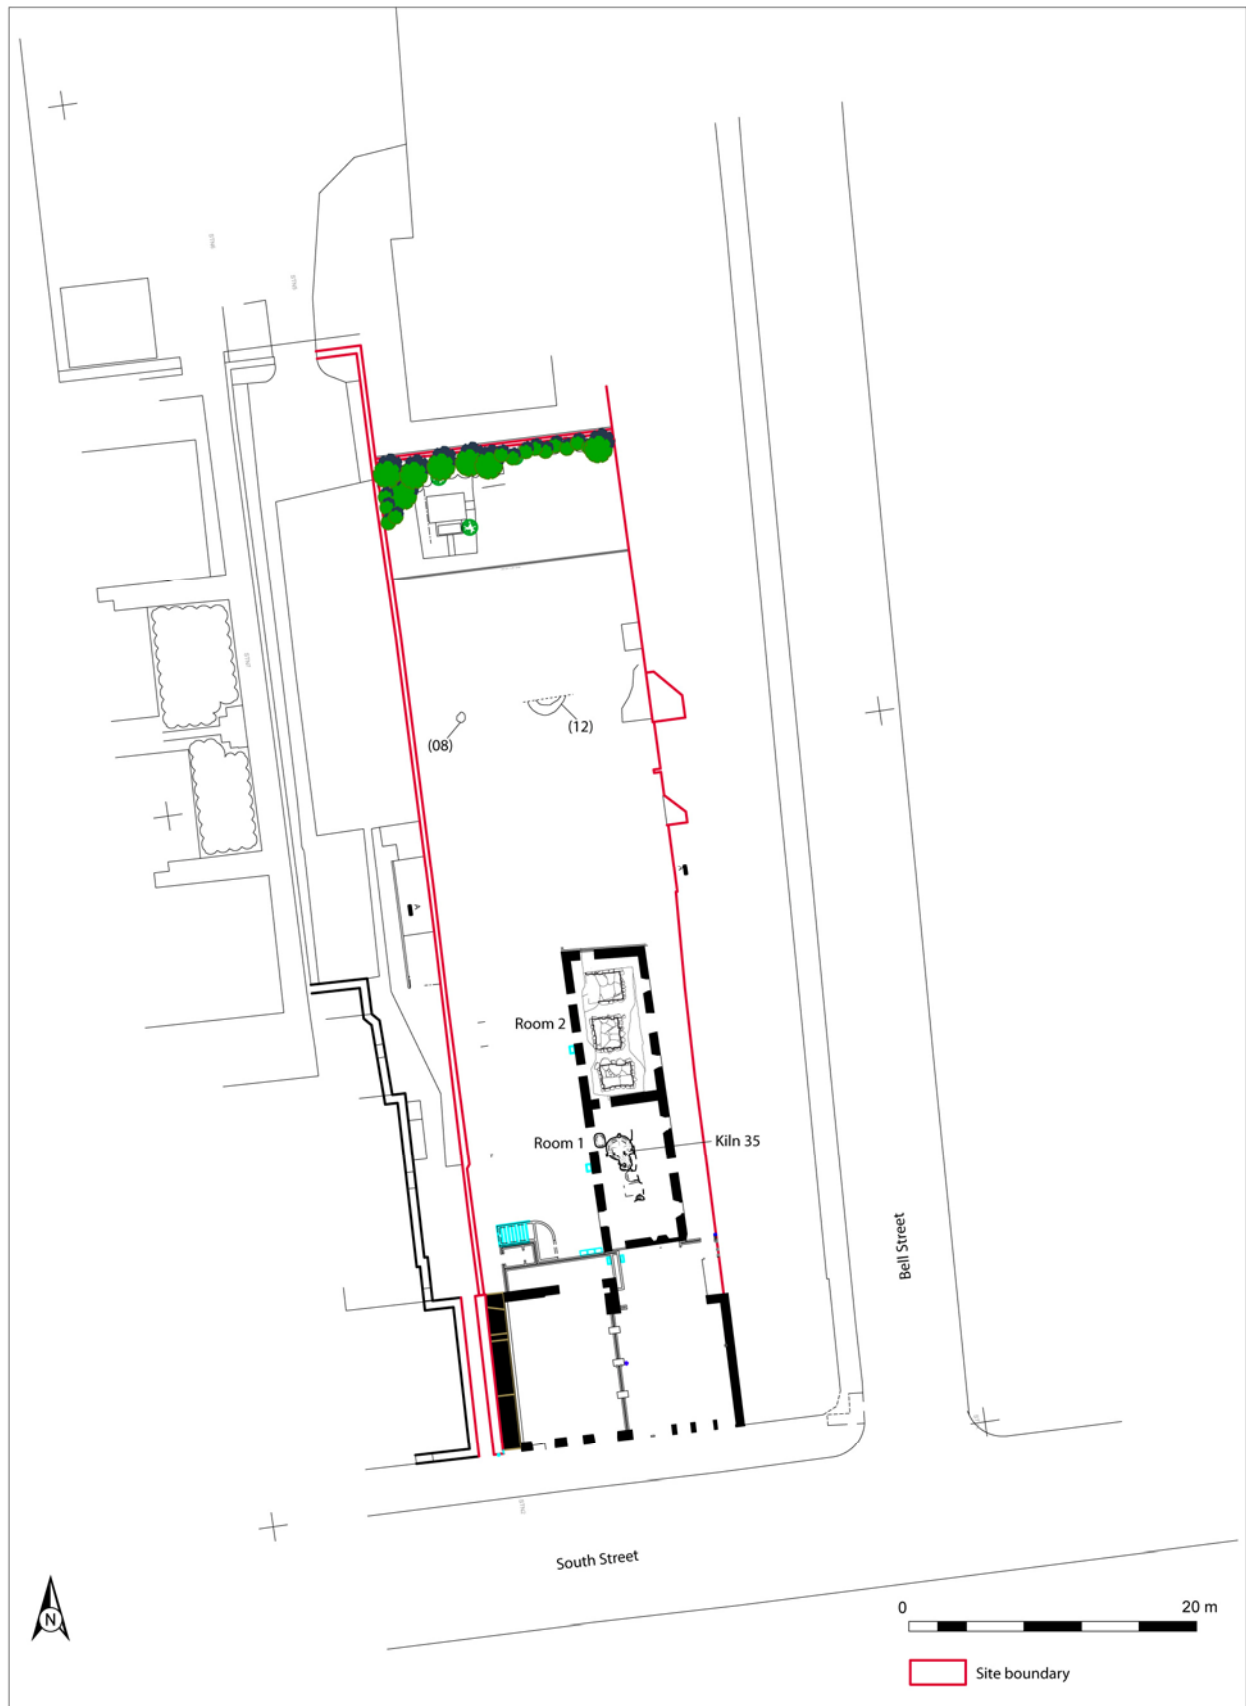
**Figure 2: Site plan**

## 4.2 Watching Brief Phase 1 (Figure 2)

- 4.2.1 Prior to ground reduction the open space to the rear of the investigation area was split by a single terrace. The higher area to the extreme rear had been used as garden space divided by a modern stone-built garden wall (03) aligned north to south. The lower area to the front of the terrace had been laid to concrete. Ground reduction showed that the garden topsoil (00) had a depth of 0.5 m and contained fragments of 19<sup>th</sup>/20<sup>th</sup> century pottery of which a small sample was retained (Find No. 1). This soil covered the whole extent of the raised area. The topsoil overlay a layer of compact light brown sandy silt (01) which was confined to the NW corner of the raised area and had a depth of 0.6 m. Pottery and bone fragments were recovered from this deposit (Find Nos. 2 & 3). This, in turn, overlay a compact dark brown sandy silt (02) ranging from 0.15 m thick in the NW corner up to 0.3 m thick elsewhere across the raised area and contained fragments of pottery and bone (Find Nos. 4 & 5). Natural compact orange brown sand (05) was exposed below soil (02).

- 4.4.1 Ground reduction within the building uncovered four archaeological features. These were located within two rooms, numbered Rooms 1 and 2 (see Figure 2). Room 1 to the south and Room 2 to the north.
- 4.4.2 Room 1 contained the remnants of a kiln or furnace (35) cut into the natural sand (05), with two associated post-holes (54 and 56) and a small pit to the south-east (28) (Figure 7).

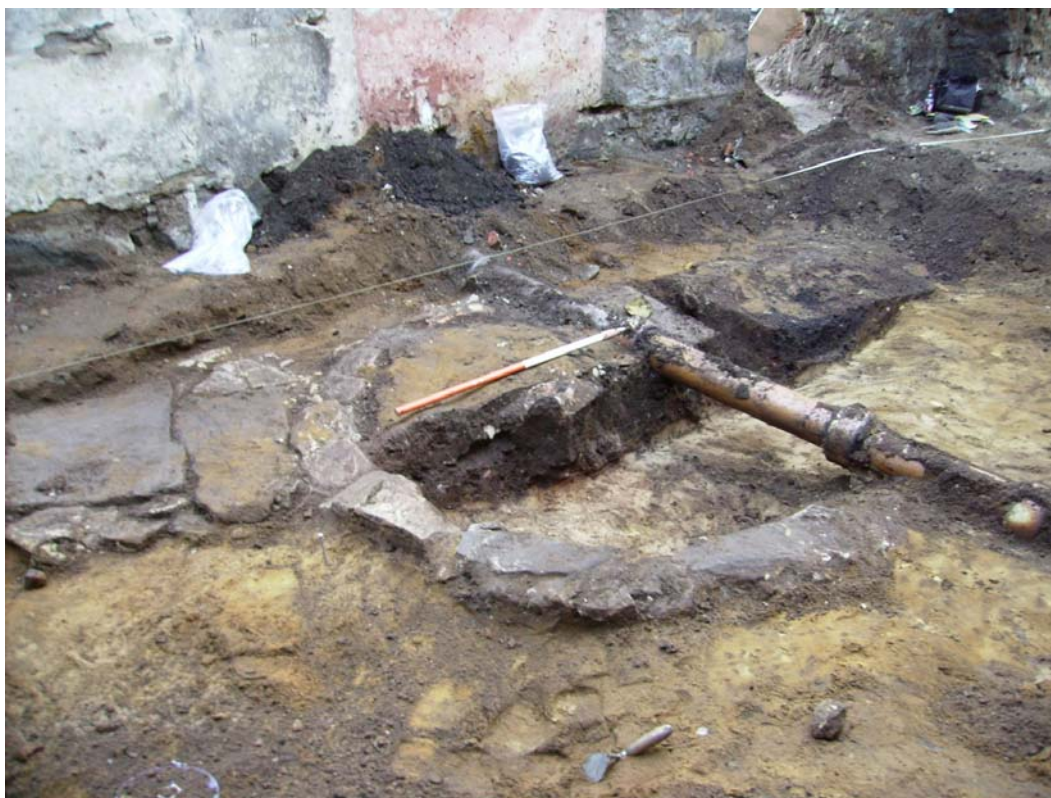
**Figure 8: Kiln/Furnace (35) mid-ex, looking south-west**

- 4.4.3 Kiln/furnace (35) measured 6.34 m north-south and from 0.41 m to 2.06 m east to west. It was key-hole shaped in plan with the bowl to the south and a linear flue running northwards. The bowl was truncated by a modern drainage pipe. The cut of the kiln/furnace had a maximum depth of 0.3 m in the bowl, shallowing to 0.2 m at the northern extent of the flue. The kiln/furnace bowl contained three archaeological deposits (Figures 8 & 9). These consisted of contexts (32), (34) and (36). Context (34) was a circular arrangement of single coursed, roughly faced and unbonded sandstone blocks (the blocks averaged 0.36 m by 0.20 m and stood to a height of 0.30 m). The main fill (36) consisted of a moderately compacted mid to light-brown silty clay with occasional charcoal flecks and chunks (<0.05 m dia) and occasional burnt clay chunks (<0.05 m dia). It measured 1.98 m east to west by 2.98 m north to south and was 0.38 m deep. Within this context (36) two sherds of green glaze pottery and a number of metal fragments were excavated. Also within this main fill, toward its southern side, a lens of dark grey/black charcoal rich soil was excavated (32). This lens measured 1.20 m east to west by 0.50 m north to south and was 0.03 m deep.

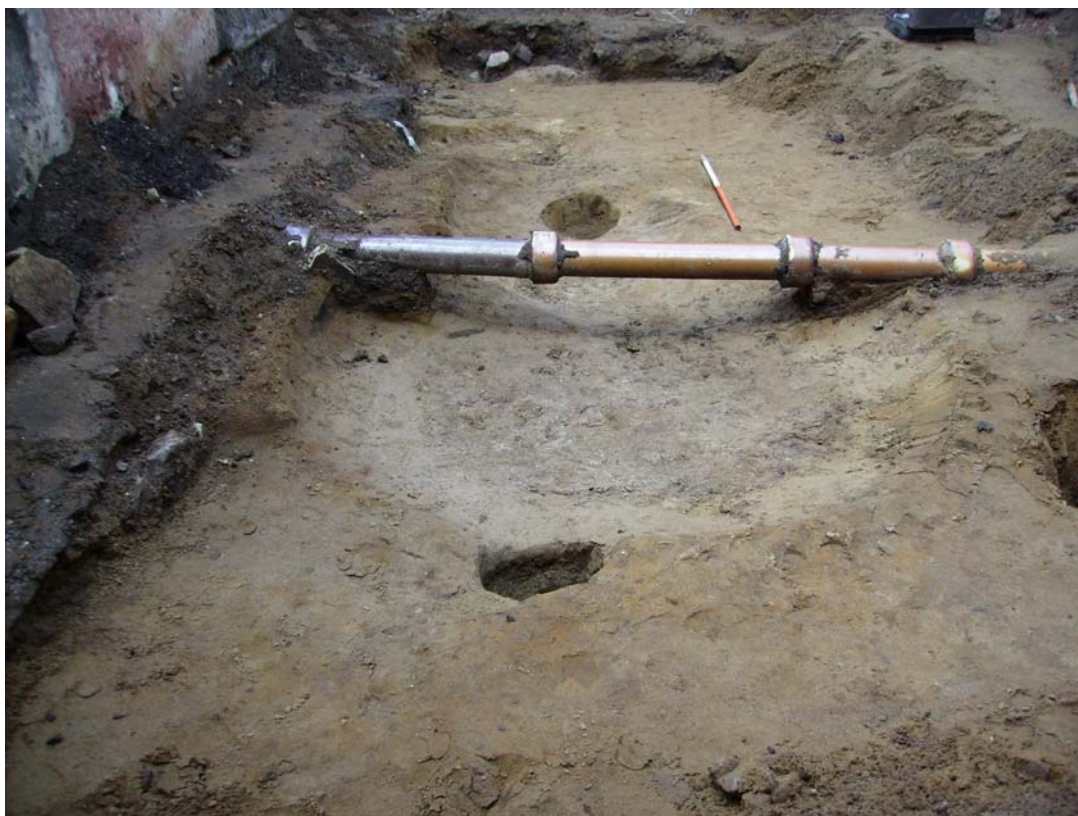
**Figure 10: Kiln/Furnace (35) post-ex, looking south**

- 4.4.5 Upon excavation of the kiln/furnace base, two post-holes (54) and (56) were discovered (Figure 10). These were located at the southern edge of the bowl and at the northern edge of the bowl where it interfaced with the flue. Both were circular in plan with vertical sides and contained single fills of moderately compact light-brown sandy silt, (55) and (57), with a lens of dark brown sandy silt at the base of post-hole (54).

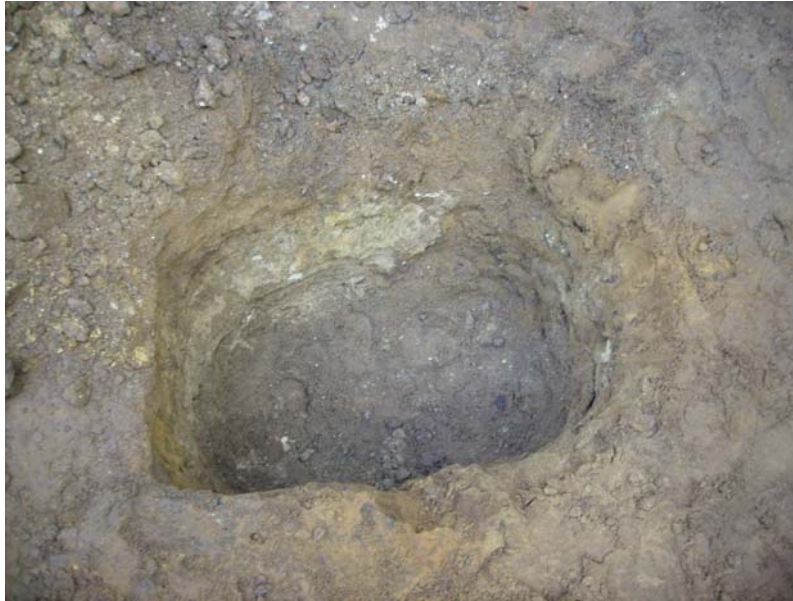
**Figure 11: Pit (28) post-excitation, looking north-east**

- 4.4.7 To the south-east of the kiln/furnace bowl (35) at a distance of 0.50 m was a large sub-rectangular pit (28) measuring 1.20 m north to south by 0.88 m east to west, with a maximum depth of 0.76 m (Figure 11). It contained a single fill (29) of moderately compacted mid-brown sandy clay with occasional charcoal chunks, two fragments of bone and a single ceramic sherd (Find Nos. 36 & 37).

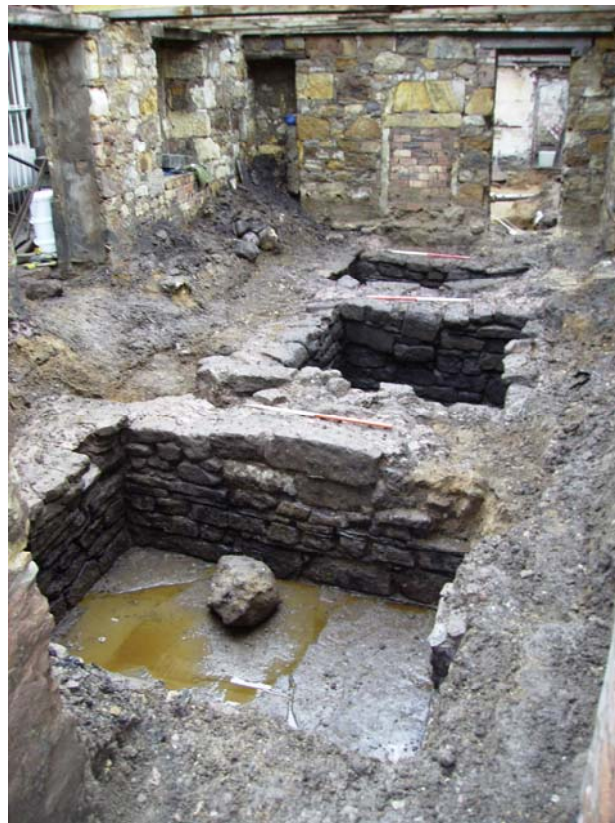
**Figure 12: Room 2, looking north-east**

- 4.4.8 Room 2 contained significant archaeological features in the form of three large stone-lined pits (Figures 12 & 13). These pits were however, only partially excavated as the lower parts were preserved *in situ* below the formation level of the current development. The pits were oriented north to south along the central axis of the rooms and were designated context numbers (47), (41) and (25) from north to south.

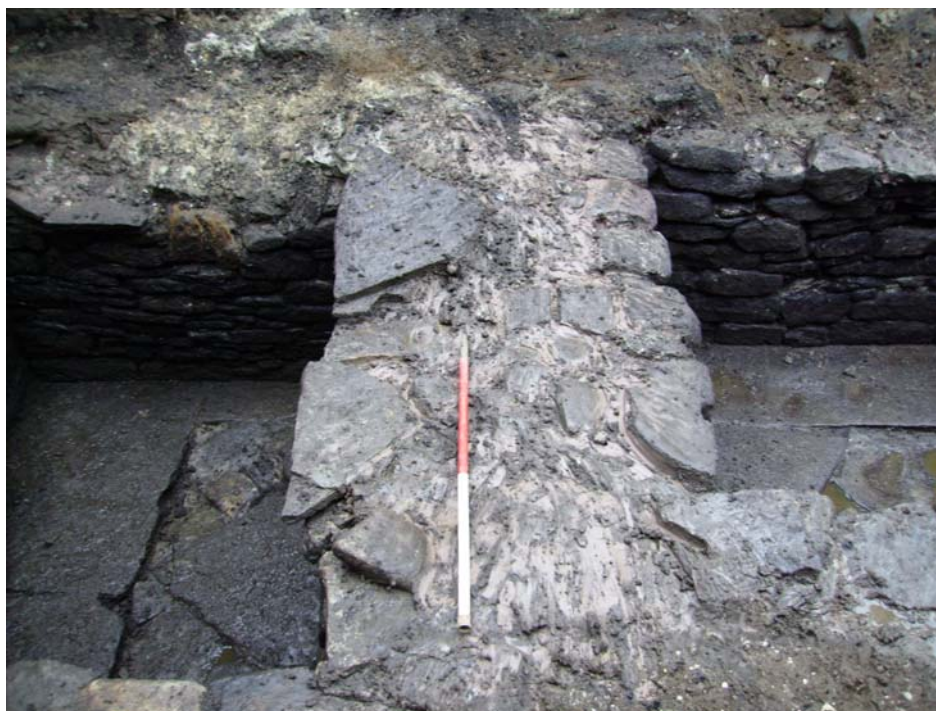
**Figure 15: Clay lining (71) between pits (25) and (41), looking west. Note re-used broken quernstone in northern elevation of pit (41)**

4.4.10 The pits were constructed within two large rectangular cuts. Pits (25) and (41) sat within cut (73) which measured 5.60 m north to south by 3.65 m east to west and was at least 1.50 m deep. Pit (47) sat 0.40 m to the north in cut (72) which measured 2.70 m north to south by 2.70 m east to west and had a depth of at least 1.50 m. The walls and base of both these cuts were lined with a sterile compact light pinky-brown clay (71), varying from between 1.10 m and 0.40 m in thickness (Figure 15). The stones used to line the pits were set within this clay, thus securing them in position.

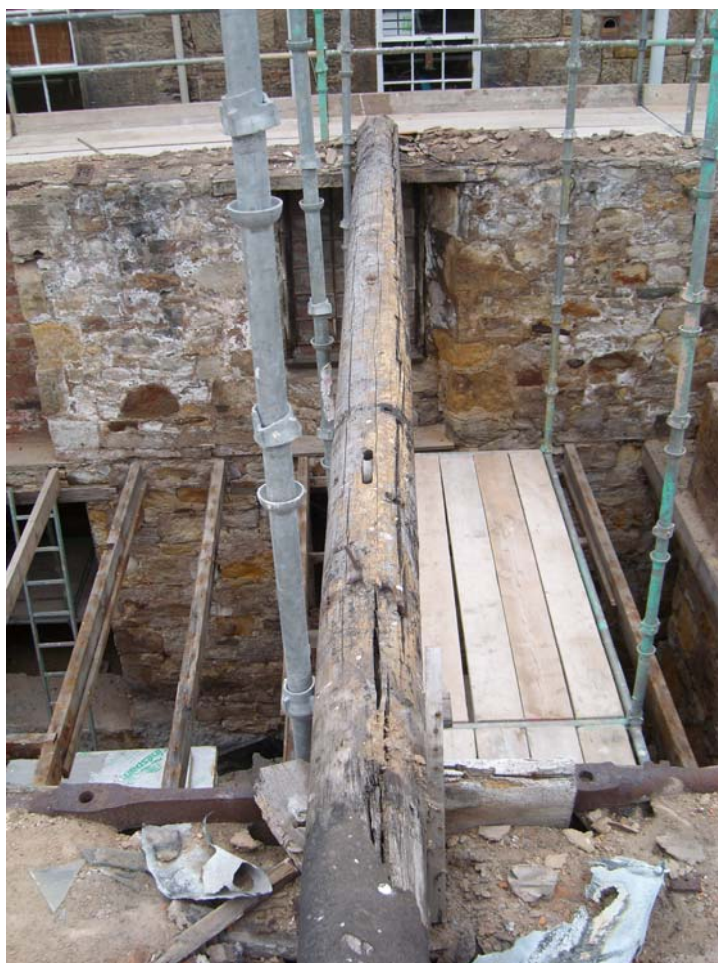
**Figure 17: Re-used ship's mast and axle on top of Room 2, looking east**

- 4.4.12 A ship's mast (Figure 17) was also recorded in Room 2. This was located towards the south on the top of the north to south oriented outer walls of the building and laid in an east-west direction. The timber was roughly circular in section and tapered from a diameter of 0.24 m at its eastern end to 0.18 m at its western end. Upon the timber were fixed three pulley wheels. One upon the underside of the timber on the west adjacent to a second storey window, and two set within the timber itself (one at the western end and one at the centre of the timber's length). Upon the western wall of Room 2 the timber sat upon what appeared to be an iron axle bar, which has been re-used as a window lintel. It is believed that this timber is a re-used ship's mast, the analysis of which is to be arranged by Fife Council Archeology Unit.

- 5.2 Further archaeological investigation by the Fife Council Archaeological Service into the ship mast discovered at the site will also serve to further develop historical and archaeological knowledge pertaining to St Andrews.
- 5.3 This DSR report is both preliminary and provisional, with many issues raised by the excavation data still to be addressed. In ascertaining a fuller knowledge of the excavation results, a post-excavation research design will be prepared in conjunction with the planning authority's archaeological advisor.
