52 High Street, Linlithgow Watching Brief: Data Structure Report

AOC Project No: **21179**

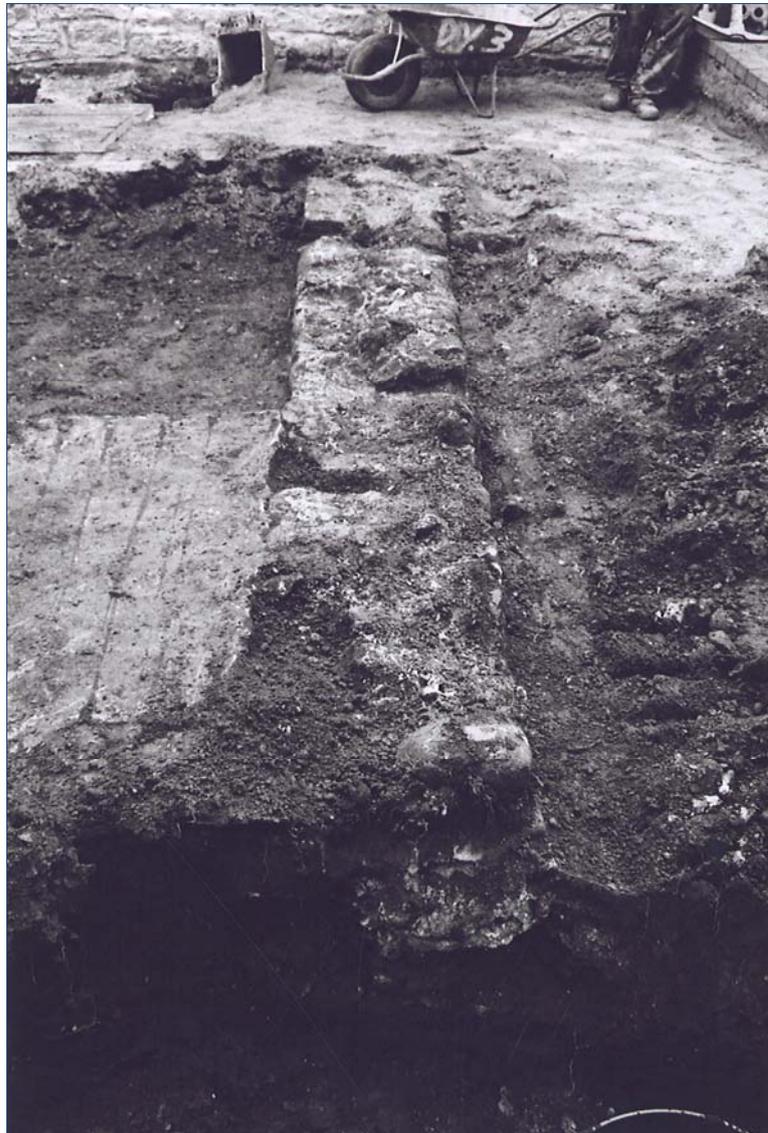
Plate 1: Sandstone Wall 102 from west

- 4.6 The excavation of the foundation and service trenches along with the reduction of the entire area of the extension by approximately 0.50 m revealed a number of post-medieval features including sandstone walls and brick and cobble surfaces (Figure 2). The initial feature identified was an east/west aligned sandstone wall (Context 102), constructed of irregularly shaped sub-angular boulders and sandstone bonded with a cream mortar (Figures 2 and 3). It was observed for a length of 3.9 m from the western edge of the service trench. The wall was between 0.58 m and 0.65 m wide and observed to a maximum depth of 0.50 m in the service trench section. The wall was revealed at a depth of only 0.20 m below the original

ground surface and its foundation cut (Context 104), where visible on the north side of the wall, was found to cut into the make-up soil (Context 100). The uppermost course of the wall was removed following full recording but the lower courses were left *in situ*.

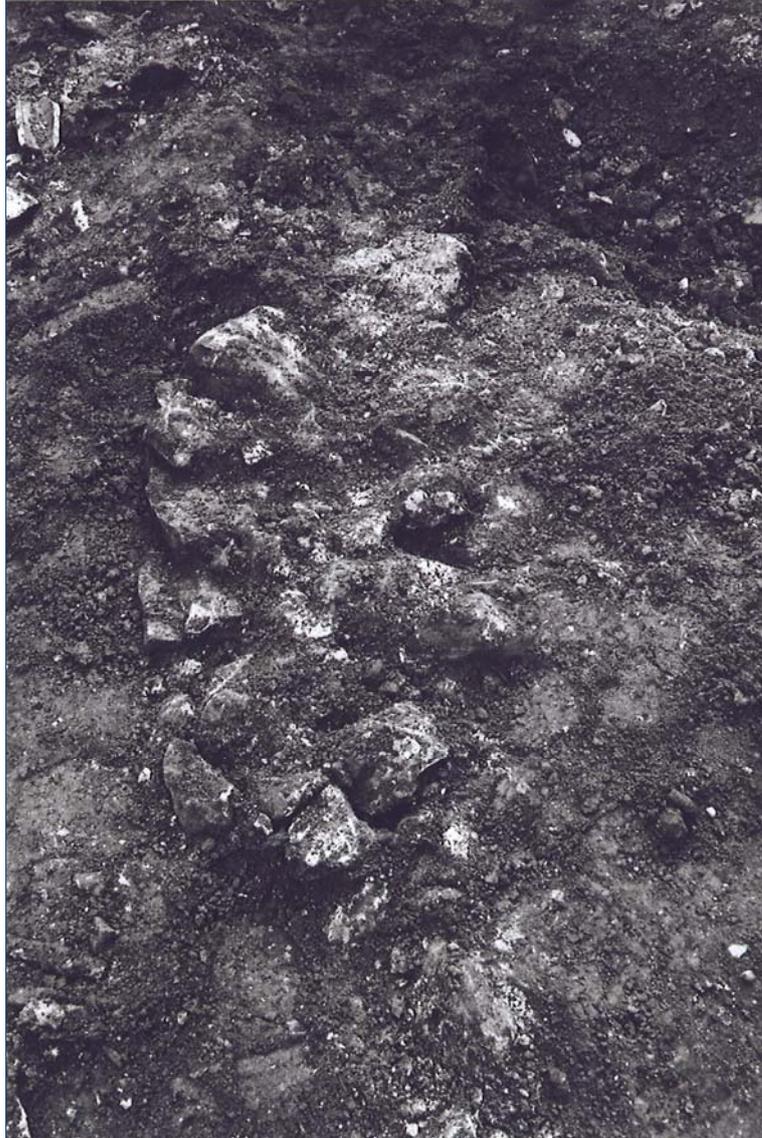
Plate 2: Stone Drain 106 from north

- 4.9 To the north-east of surface 101 the remains of a sandstone structure (Context 106, Figure 2) was uncovered running NNW/SSE in a slight curve. The structure was formed of sub-angular stones bonded with a rough creamy brown mortar. Only one course of the structure was visible with a length of 1.70 m and width of 0.60 m. The feature seems to be part of a drain running through this area as it is connected to a modern ceramic drain.

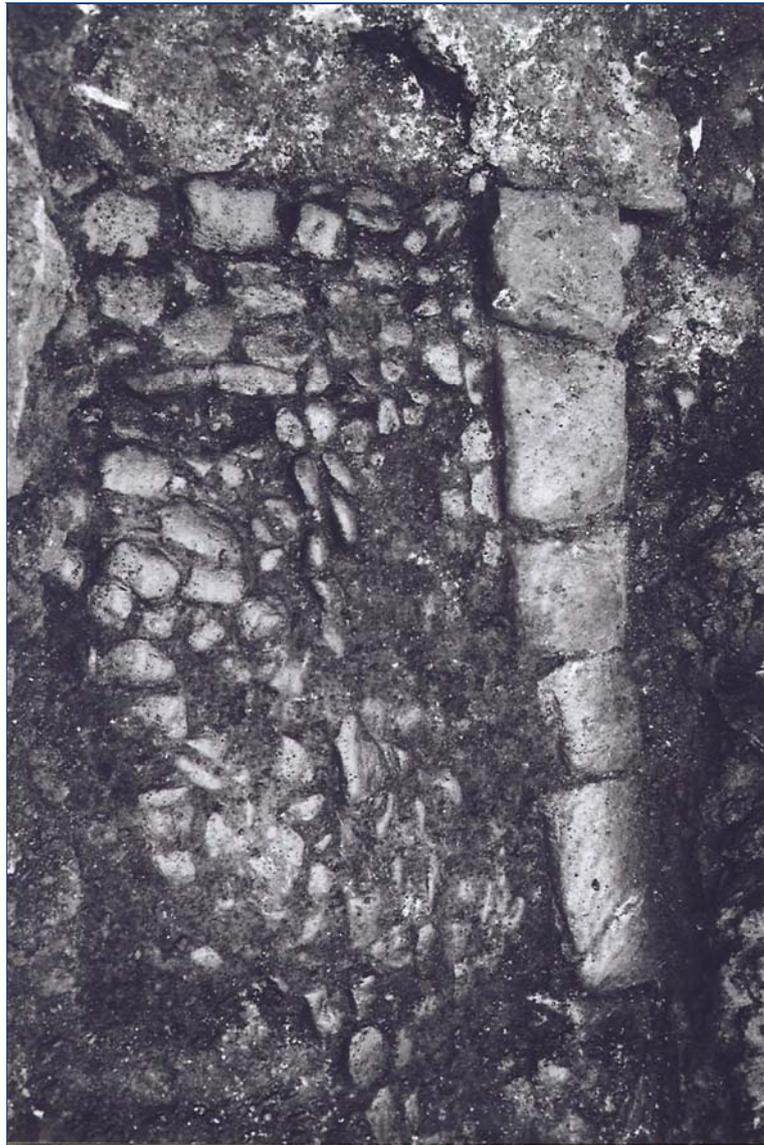
Plate 3: Cobbled Surface 107 from east

- 4.10 At the very southern extent of the site a cobbled surface (Context 107, Figure 2) was revealed running 2.25 m east/west before being truncated to the east by modern services, with a width of approximately 1.00 m north/south visible from the southern edge of the site. The surface consisted of rounded cobbles of varying size and shape set into a layer of hard compacted clinker material (Context 113), which in turn overlay a layer of decayed sandstone (Context 114) which overlay the make-up soil 100. Fragments of modern nails, pottery and glass were found within surface 107 and the clinker material 113 below. At the northern edge of 107 a line of kerb stones (Context 108) formed a boundary to the edge of the surface. The kerb stones had an average length of 0.35 m each and a total length of

approximately 2.5 m north/south; the stones were bonded together with a creamy brown mortar.
