# Leith Street, Edinburgh: Watching Brief

AOC Project Number 20715  
July 2008

<b>On Behalf of:</b>	Kilmartin Property Group 7 Castle Street Edinburgh EH2 3AH
<b>National Grid Reference (NGR):</b>	NT 2599 7412
<b>AOC Project No:</b>	20715
<b>Prepared by:</b>	Martin Cook
<b>Illustration by:</b>	Alan Hunter Blair
<b>Date of Fieldwork:</b>	Jan-July 2008
<b>Date of Report:</b>	July 2008

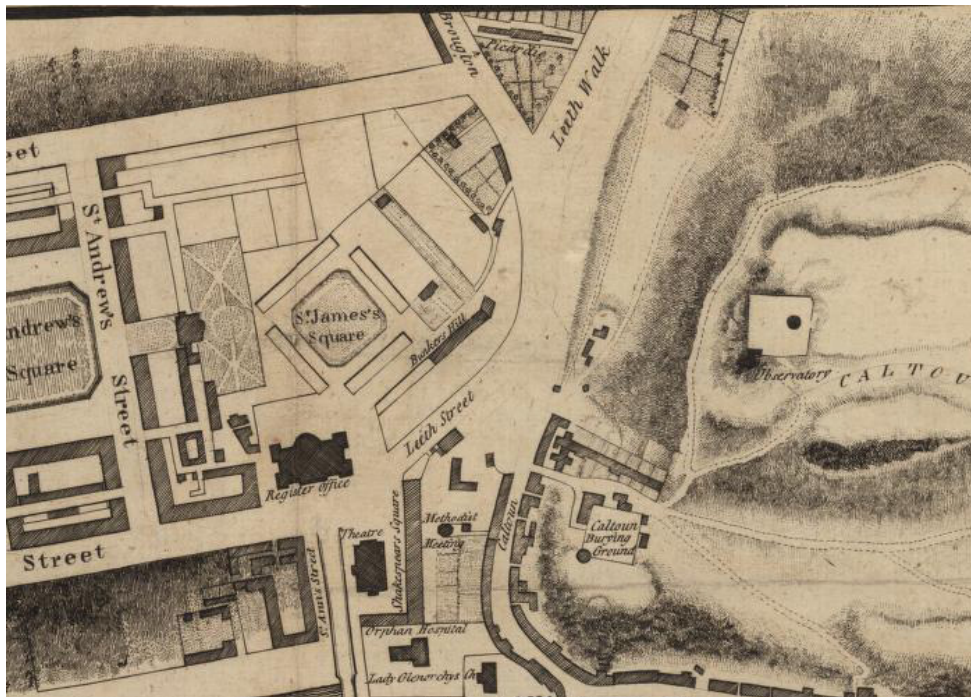
Figure 3: John Ainslie's City of Edinburgh, 1780

- 3.2.2 The rapid expansion of the New Town westwards from St Andrew's Square encouraged the development of the top of Leith Walk and the surrounding area as demonstrated by Ainslie's 1780 Edinburgh map (Ainslie 1780, Figure 3).

3.2.3 By 1780 the proposed development itself was occupied by a series of tenement buildings and their associated back lands. The same buildings were recorded as occupying the proposed development on Ainslie's second Edinburgh map (1804), but by the publication of 1<sup>st</sup> Edition map (1849), they had been demolished and replaced. The 2<sup>nd</sup> Edition OS map identified the probable building that occupied the site as the Temperance Hotel (1890), which formed part of a series of Georgian townhouses on Leith Street (Figure 5). The buildings were subsequently home to a series of business including Crown Wallpapers, Fairley's Bar, Jerome Portraits, Hardy and Co and William P Harrower Ltd (NMRS: NT27SE3589). The buildings were subsequently demolished in the 1960s to make way for the associated works of the St James' Centre.

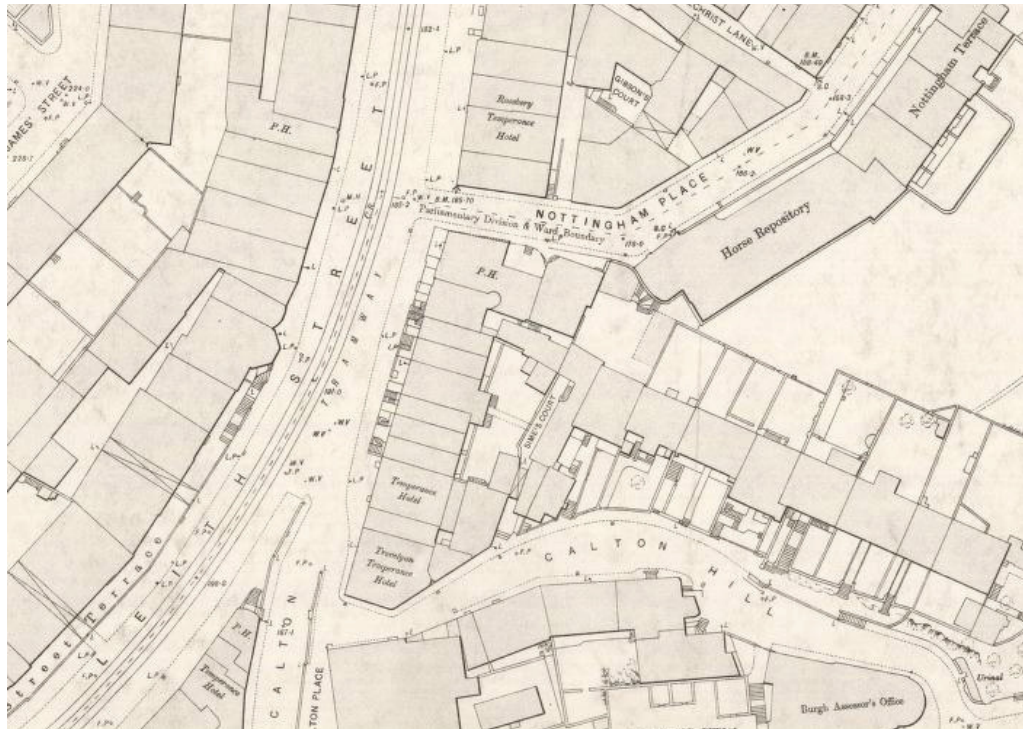
Figure 5: 2<sup>nd</sup> Edition Ordnance Survey of Edinburgh, 1890

- 6.5 Isolated features were recorded across the whole site and usually comprised single walls or arches and include walls [100], [102], [104] and arch [101]. All fours structures were identified in section, underlying the pavement, and are thought to represent the frontages of Victorian or Georgian buildings that lined the street (for examples see Figure 5).

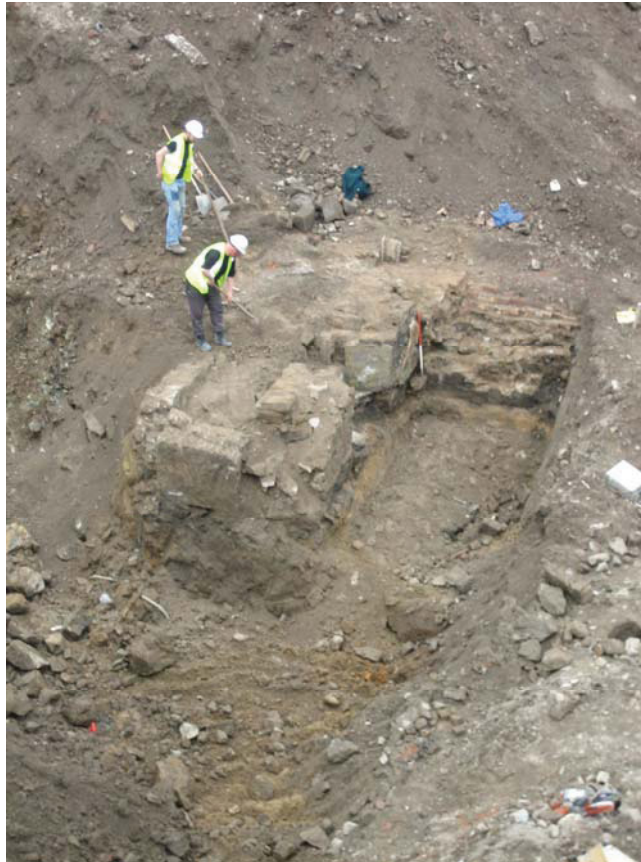
Plate 1: Plate to illustrate Structure/Tenement [179]

- 6.3 Structure [179] formed part of the basement level of a tenement block, comprising a probable room/basement and associated threshold/steps [166]. The sandstone structure was rectilinear in shape, comprised of walls [160], [162], [163] and [164] and measured approximately 4.7 m east to west by 1.50 m north to south and up to 0.90 m in height. The presence of the white bricks tiles suggest that at least part of the building was built or restructured in the Victorian period. The small room was associated with wall [170], which probably represents the outer/external wall of the same building.

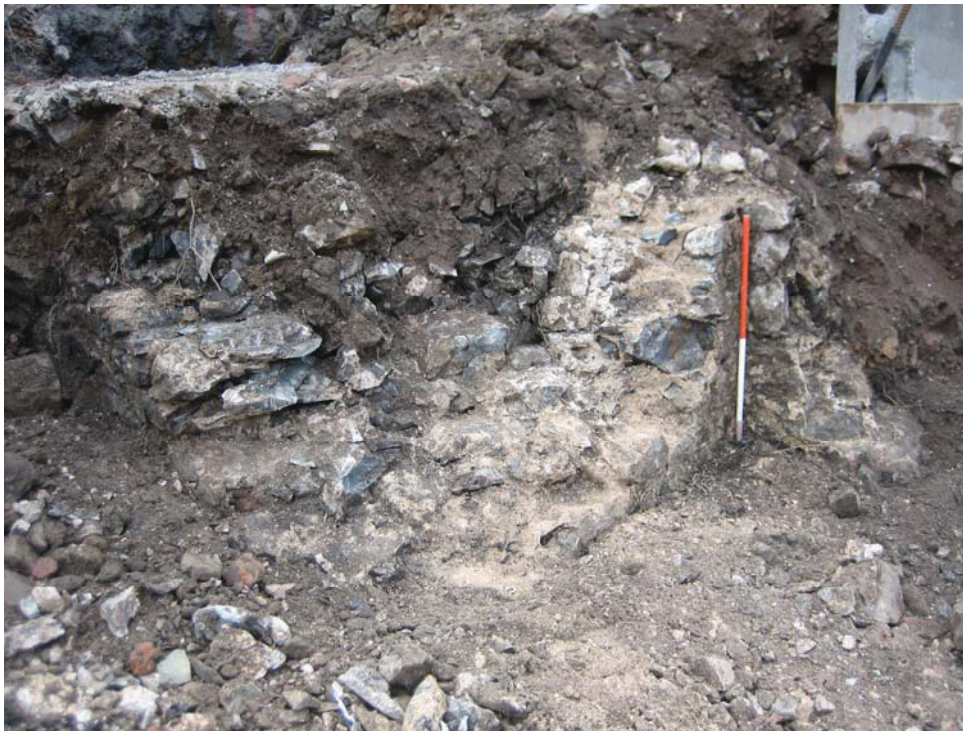
Plate 4: Plate to illustrate wall [178]

- 6.6 A wall [178] identified to the south-west of the site, on the edge of Calton Hill (the street rather than the hill itself) comprised of roughly bonded sandstone blocks. The location of the wall on the northern side of Calton Hill suggest it may have formed part of one of the Georgian or Victorian tenement buildings built aligning the street (Figures 2 and 3; Plate 4).
