102 West Port, Edinburgh: Watching Brief Report

20368
July 2008

On Behalf of:	Kenmore Westport Ltd c/o Cyril Sweett Ltd Apex 3, 95 Haymarket Terrace Edinburgh EH12 5LQ
National Grid Reference (NGR):	NT 2507 7318
AOC Project No:	20 368
Prepared by:	Martin Cook
Illustration by:	Graeme Carruthers
Date of Fieldwork:	March - July 2008
Date of Report:	July 2008

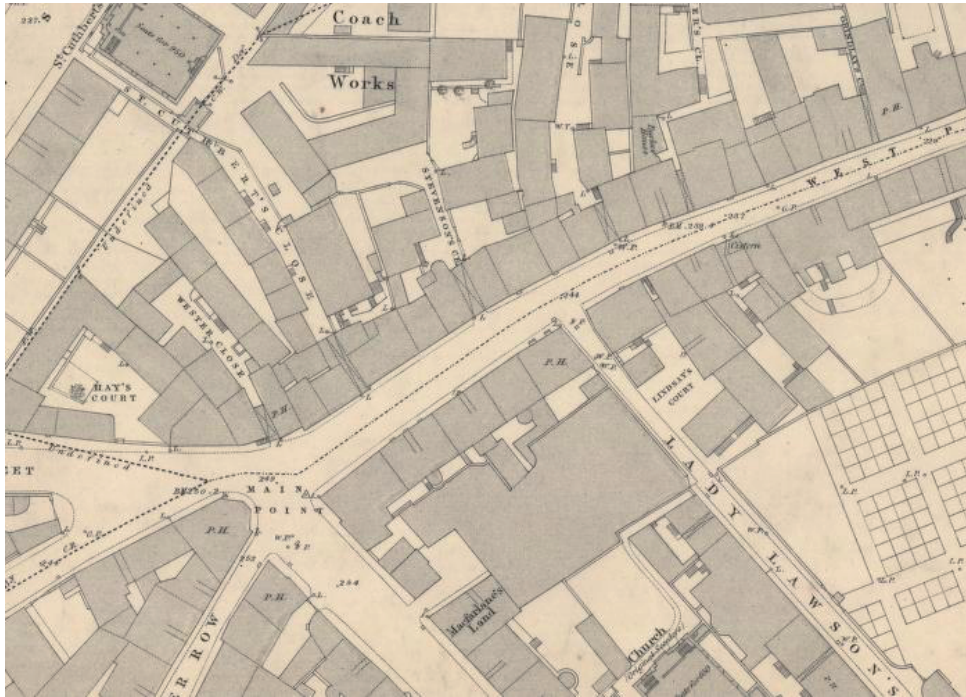
Figure 2: Town Plan of Edinburgh 1876-7

- 1.3.2 As Edinburgh expanded the proposed development site was built over by a series of developments, both residential and commercial. By the time of the publication of the Ordnance Survey Map of 1876 the site was occupied by Victorian tenements buildings and a public house (Figure 2). The buildings were subsequently demolished and replaced by the Beverly Cinema (NMRS: NT27SE5195) in 1930. The cinema itself was closed in 1959 and was replaced by a pub and an office block in the 1960s.

- 4.4 The reduction of the ground level within the development area revealed a number of archaeologically significant features. These included a series of ten sandstone walls, a stone-capped culvert and a well/sump. All the walls were constructed of unshaped sandstone blocks set upon large rectangular cut sandstone slab foundations and bonded with a clayey sand mortar. The walls remain averaged 0.75 m to 1 m in width and stood to varying heights (between 0.5 m and 2 m). All the foundations sat directly upon natural red or grey sterile clay subsoil. These walls were constructed to the north and west of the development site and generally conformed in plan (along their longest axis) to the line of West Port Road and Lauriston Street. It seems likely that the walls form the remains of the Victorian tenements recorded on the Ordnance Survey Town Plan (Figure 2).

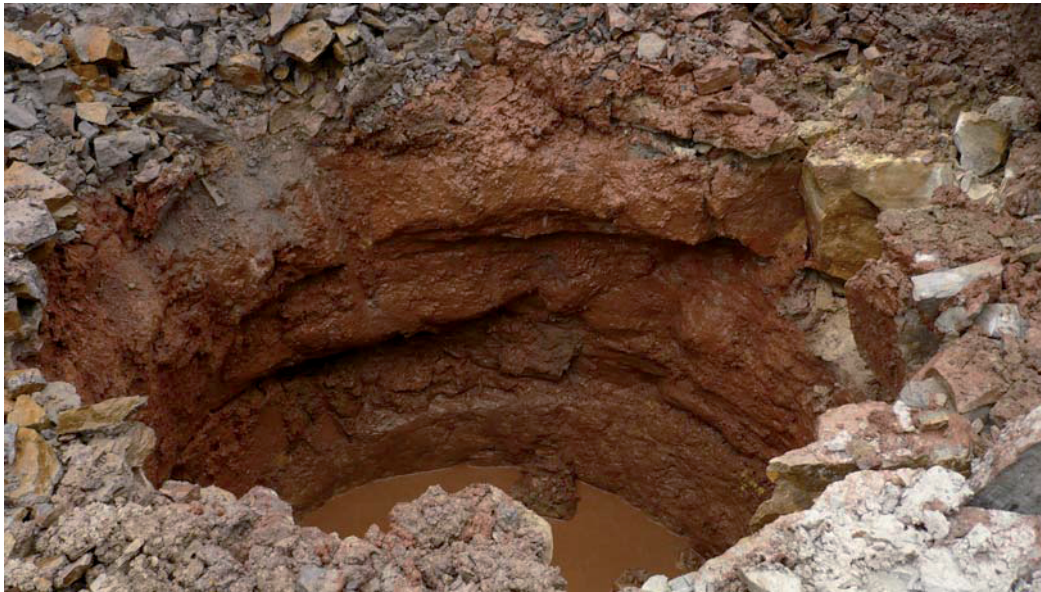
Figure 3: Stone-lined well feature [015]

- 4.6 A large partially rock cut well [015] was identified to the immediate south of the culvert feature (Figure 3). As the well was identified below the proposed foundation levels of the building the feature was only partially exposed and excavated. Due to Health and Safety factors the lower part of the well was excavated by machine and later capped by concrete. The well comprised a 2.40 m cut at least 3 m in depth. The lower part of the well was excavated through the natural bedrock, while the upper level was lined with sandstone coursing [019]. The base of the cut was not identified. No datable material was recovered from the well, and its shape and form are diagnostic to neither period nor function. It seems likely that the feature is a well of probable post-medieval date.
