**GREAT DOVEHILL, GLASGOW**  
**STAGE 2 ARCHAEOLOGICAL WORKS**  
**DATA STRUCTURE REPORT**

# GREAT DOVEHILL, GLASGOW: STAGE 2 DATA STRUCTURE REPORT

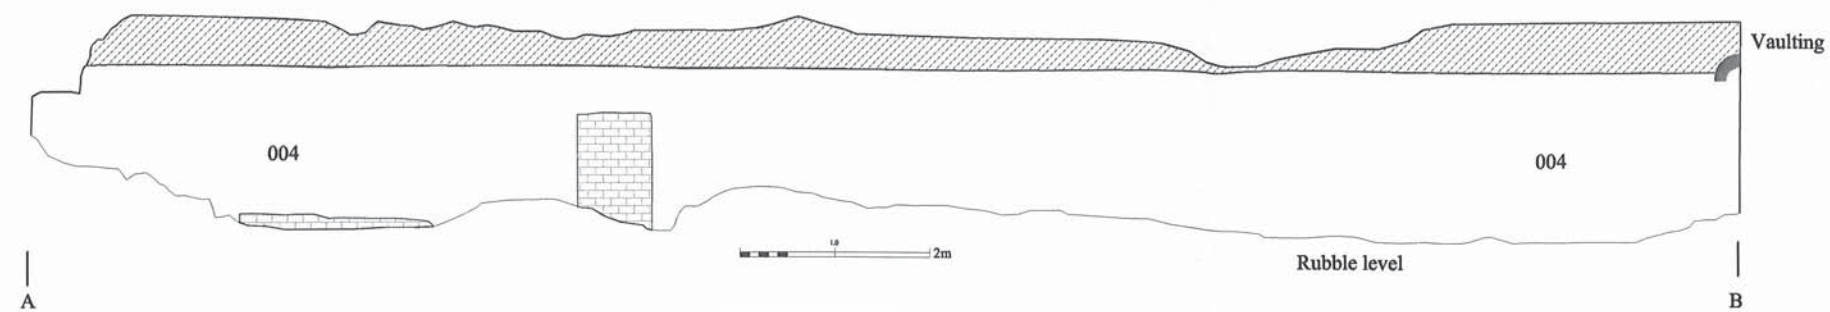
Figure 2: North elevation of vault

- 5.2.1 The vault was discovered during excavations undertaken prior to the presence of an archaeological supervisor and as a consequence, the western end of the structure was badly damaged, and nothing remained of the west wall. However, the wall footings of the west end of the structure were preserved, so that the full extent could be determined. The structure comprised a rectangular cellar, measuring 18.8 m east/west by 3.8 m north/south. The walls were constructed of coursed sandstone blocks [004], varying in size but averaging around 0.2 by 0.3m and mortared with a light yellow/cream mortar. The sandstone walls stood to a maximum of 1.8 m, where they were capped by brickwork vaulting [006] (Plate 1). Near the west end in the north wall, the sandstone blocks appeared to have been repaired and underpinned by brickwork (Plate 2). An area of brickwork in the north wall may have been a blocked aumbry (Plates 3 + 4). There appear to have been three means of access to the cellar, two of which were in the south wall; the easternmost of these had been modified with brickwork, and possible remains of wooden steps were noted on the floor of the cellar at this point (Plate 5). The third entry point, in the east wall [009], measured 1.25 m by 1.0 m and had been bricked up (Plate 6).

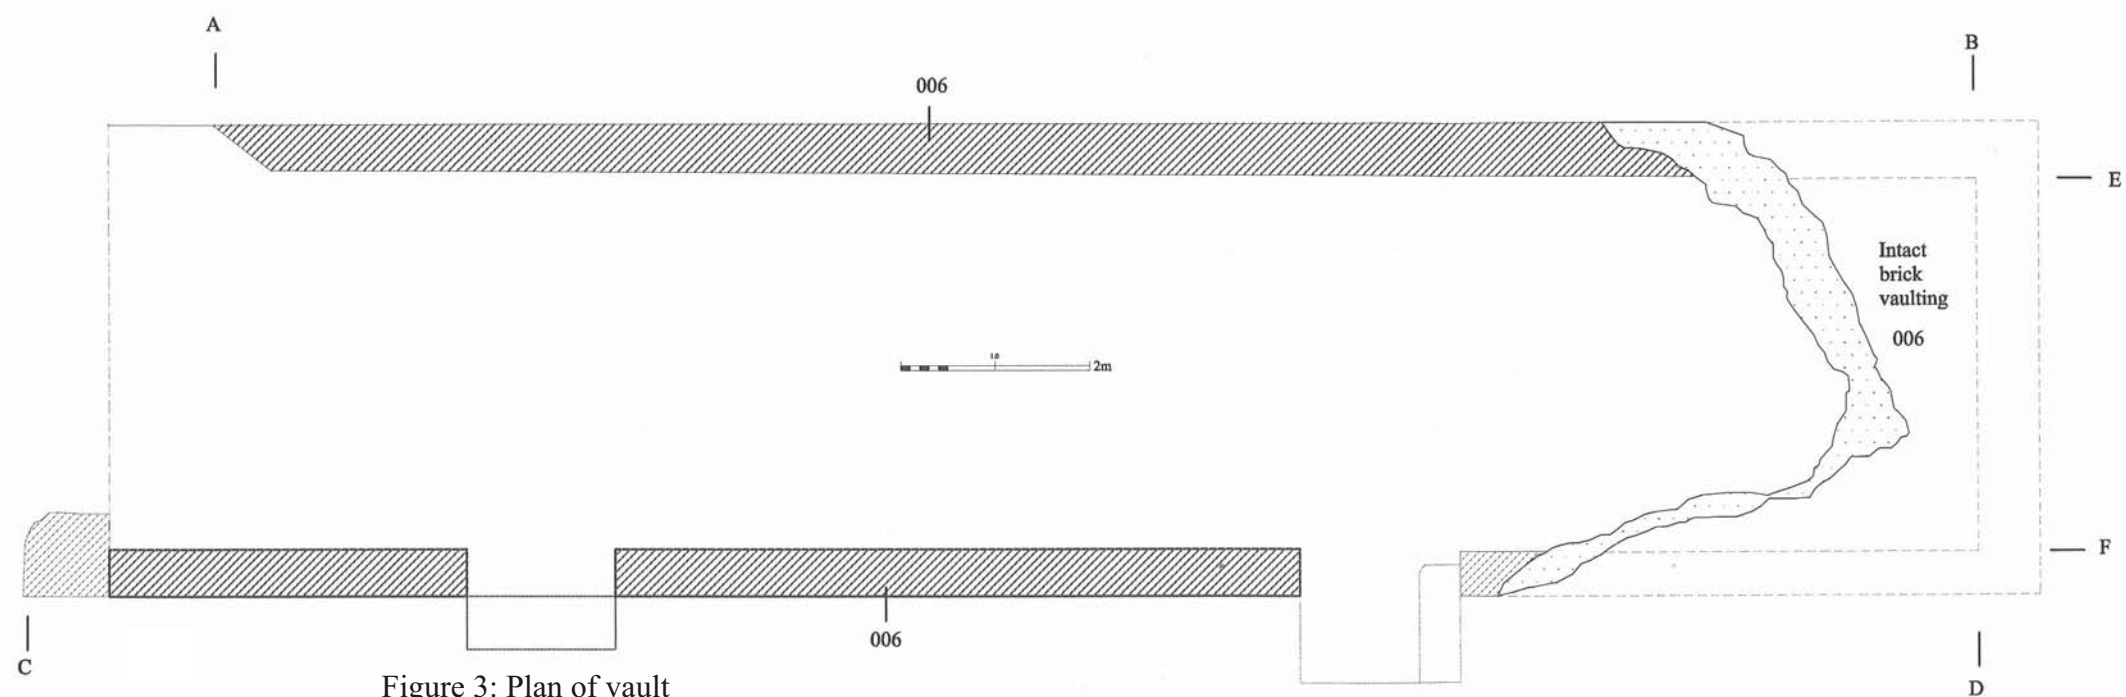
Figure 3: Plan of vault

- 5.2.3 The floor of the structure seems to have been modified during the history of the cellar's use. An excavated sondage was started across the floor, but as work progressed this had to be abandoned due to fear of collapse of the sandstone walls and the piled overburden around the site. From the initial results of the sondage, it seems that the floor may have been repaired by brickwork in places, with poured asphalt used as a later floor covering [007] (Plates 6 + 7). Natural sand was uncovered beneath the brickwork on the floor [002].

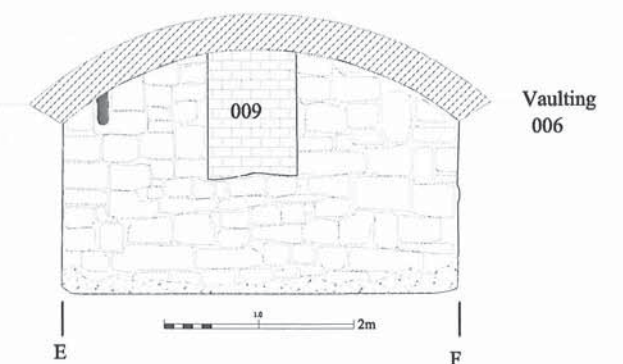
Figure 5: East elevation of vault

| No. | Type | Description |
|---|---|--|
| 009 | Entrance | Bricked up opening in east wall of vault. Around 1.25 m in height and 1.0 m wide. Depth unknown but probably 0.80 m, same as width of walls. A hole in the brick roof [006] at the top of this opening has been blocked with a large stone. |

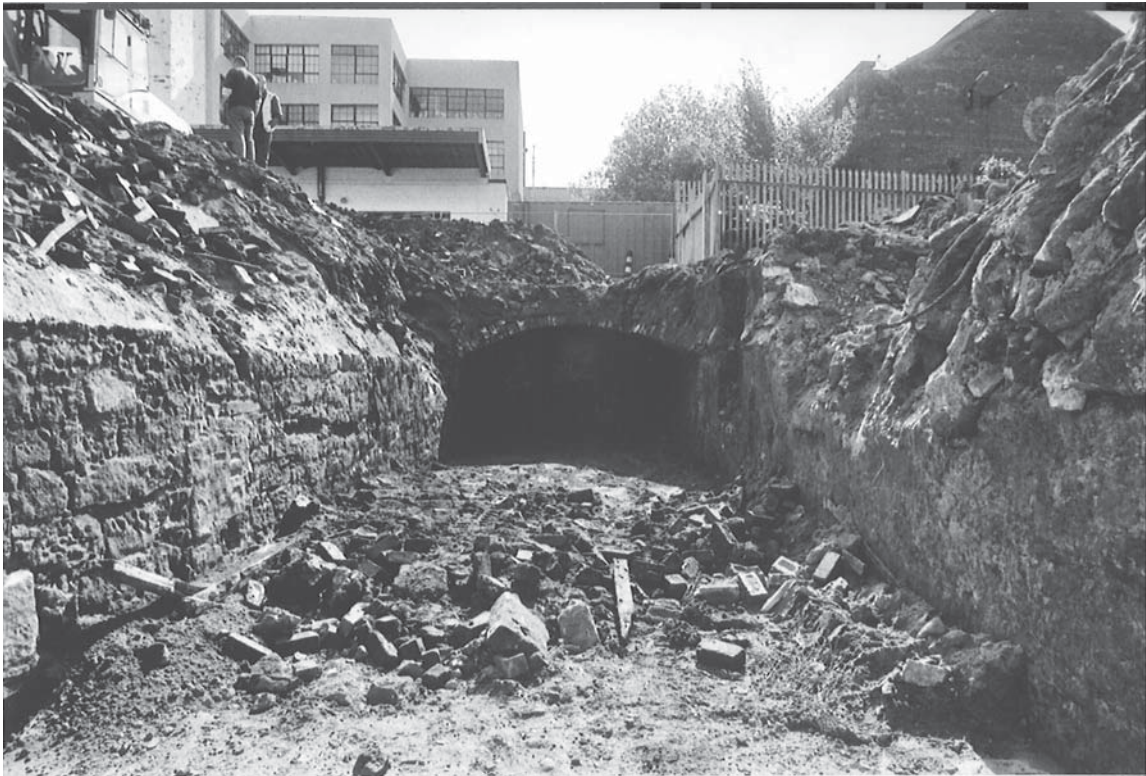
Plate1:Brickwork vaulting [006]

- 5.2.2 The vaulted ceiling was badly damaged for most of the length and appeared to have been deliberately knocked through, possibly during the construction of the modern car park which occupied the site prior to the current development. The vaulted roof of the structure did survive at the east end, however, where it formed a ceiling over the room with a maximum height of 2.46 m, and was composed of red bricks bonded with a light white/grey mortar.

| No. | Type | Description |
|---|---|--|
| 006 | Roof | Brick vaulted roof of vault. Sits on top of sandstone walls [004]. Bonded with light white/grey mortar. Only present intact in the very east end of the building. |

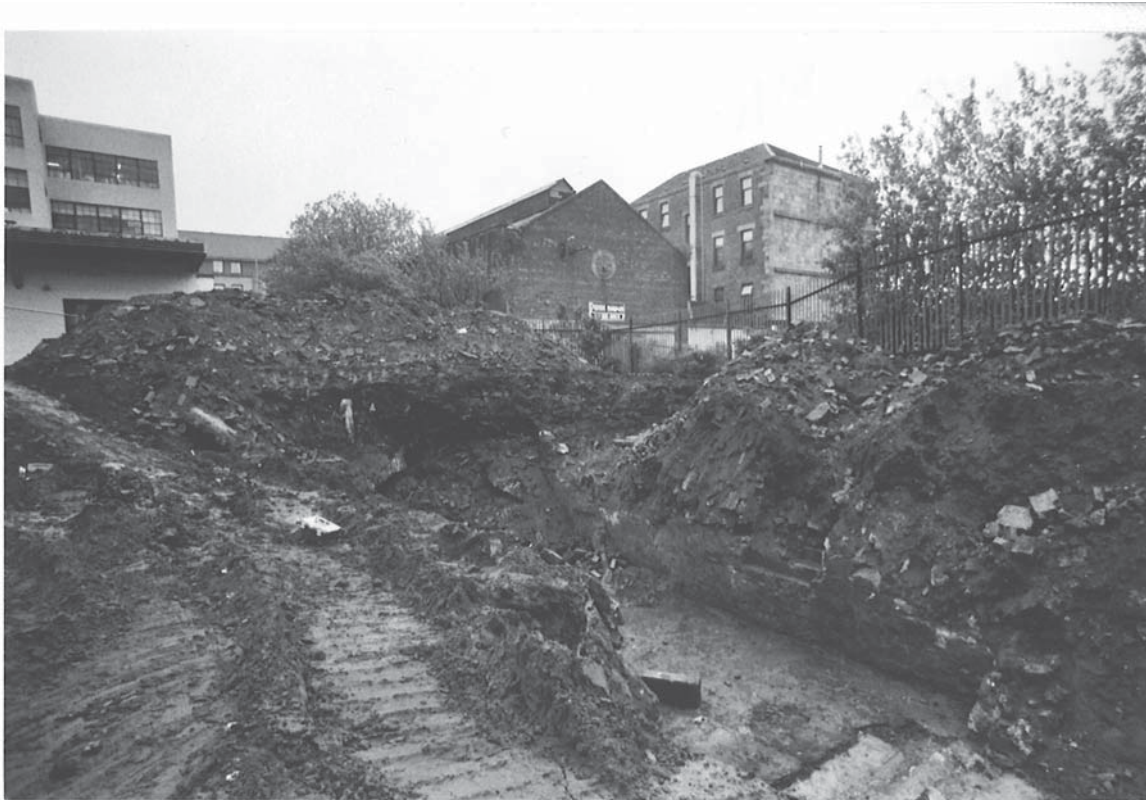
Plate 7 : Asphalt floor [007]

| No. | Type | Description |
|---|---|--|
| 007 | Floor | Asphalt floor of building. Unlikely to be original floor of building but a later replacement. (Sondage begun but unfinished showed 0.1 m of asphalt over c. 0.15 m of mixed crushed brick and sand with glass etc make-up layer over natural clean sand). The asphalt has wood pressed into the surface in patches throughout its area and has patches of bricks towards the west end with impressions where more are missing. Repairs? Very uneven all over. Lies over natural sand [002]. |

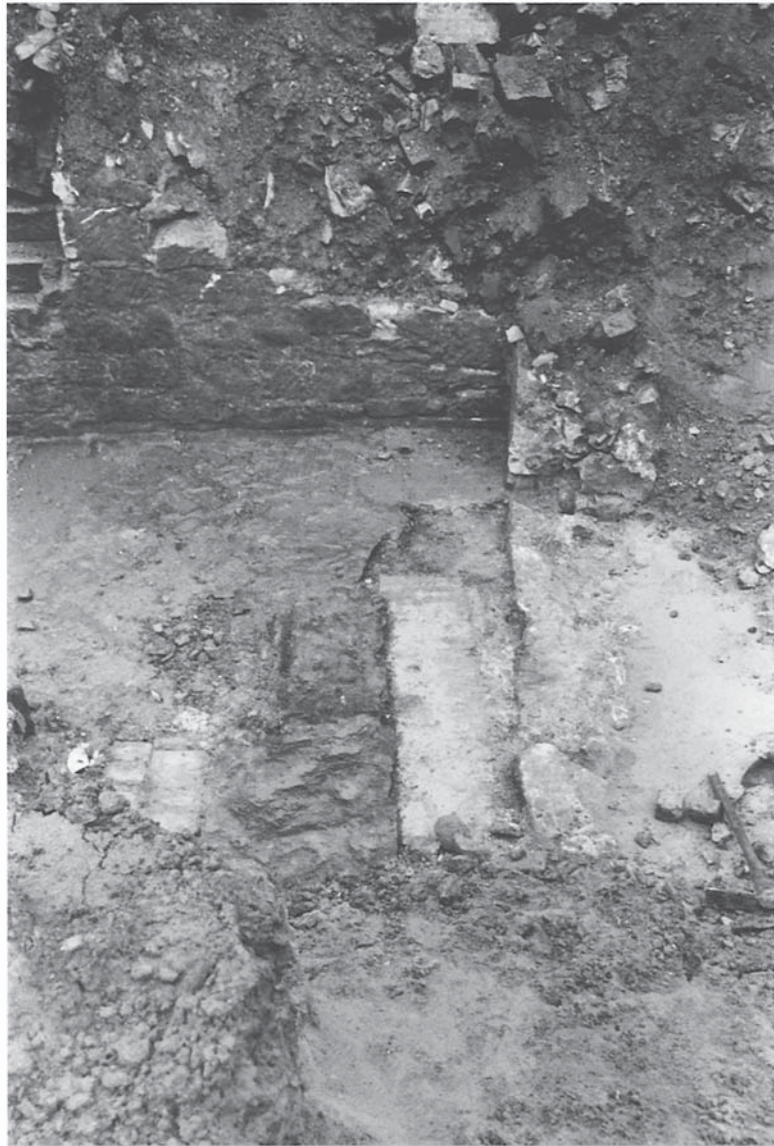
Plate 9 : Secondary brick wall [008]

- 5.2.4 A secondary brick wall [008] was observed in the interior of the structure, adjacent to the foundation of the west wall (Plate 8). This wall was three courses deep, although due to disturbance during machine excavation it was not clear whether the wall cut or underlay the floor [007]. The bricks used in the construction were a combination of frogged and unfrogged red bricks, and were bonded with a mid-grey mortar, apparently of relatively modern date.

| No. | Type | Description |
|---|---|--|
| 008 | Wall | Brick wall/foundation seen at west end of building, up against west sandstone wall [004]. Originally thought to be part of brick floor but unfinished sondage showed it to be only 0.25 m wide. At least 3 bricks deep and cut into natural sand [002]. Possible supporting wall at west end did not continue across entire width of building. Uncertain as to whether it cuts floor [007] or was beneath it. Constructed of both frogged and unfrogged bricks (re-using some perhaps?) |
