15 Old Church Lane, Duddingston, Edinburgh: Evaluation Data Structure Report

AOC 21451
August 2009

Evaluation Data Structure Report

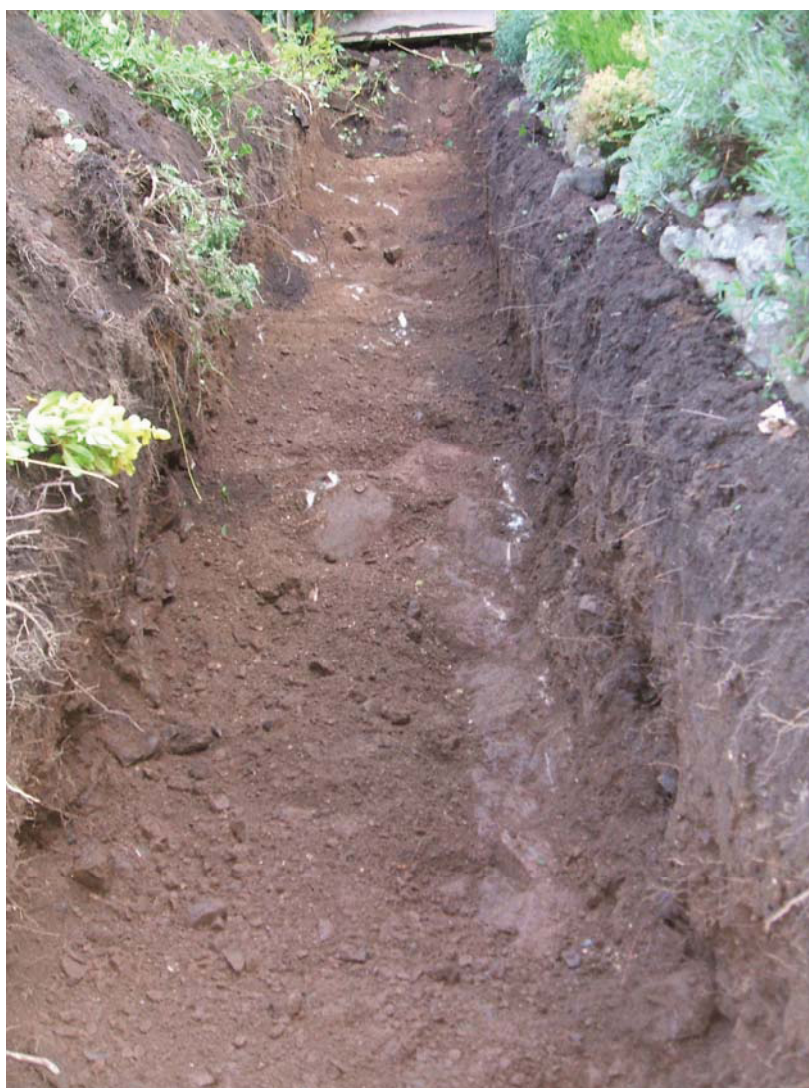
Plate 1: Trench 1 from south showing bedrock and gravel rich subsoil

- 4.2.3 The bedrock was present at depths of between 0.3 m and 1.4 m. At the southern end the bedrock was close to the surface and directly underlay the imported topsoil. Moving north the bedrock fell away very sharply to depths of up to 1.4 m before gradually rising to about 0.4 m at the northern end of the trench. Across the base of the trench the bedrock sloped sharply from the east to west downwards towards Duddingston Loch. On the surface of the bedrock there were varying patches of a red brown friable sharp fractured gravel natural subsoil.

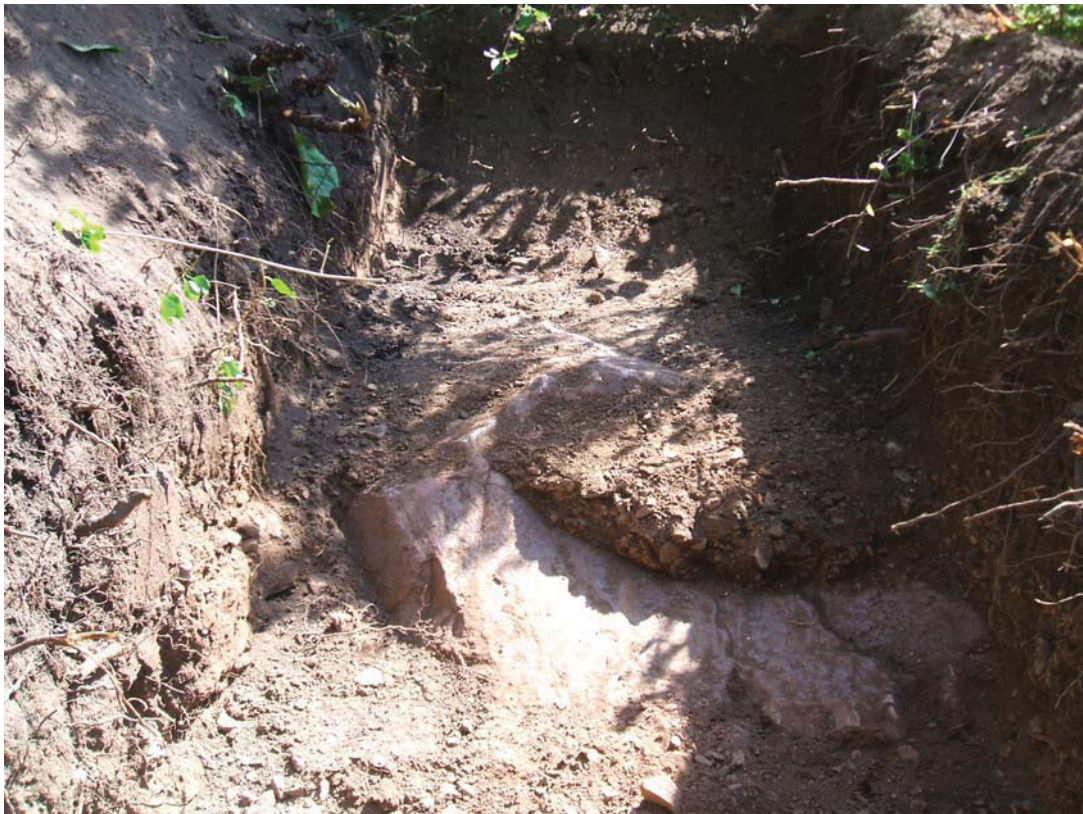
Plate 2: Trench 3, view of sloping bedrock and gravel rich subsoil

- 4.4.3 The bedrock was present at depths of between 0.4 m and 1.0 m. At the southern end the bedrock was closer to the surface at 0.4 m before sloping down to nearly 1.0 m and finally rising towards the end of the trench where it was encountered at a depth of 0.7 m. From the midpoint of the trench, the bedrock was characterised by *in situ* fractured stone infilled with a red brown friable sharp fractured gravel natural subsoil.
