**A Building Appraisal of the
Mansfield Community Hospital,
Stockwell Gate, Mansfield,
Nottinghamshire
(centre SK 5324 6081)**

A Building Appraisal of the Mansfield Community Hospital, Stockwell Gate, Mansfield, Nottinghamshire (centre SK 5324 6081)

Summary

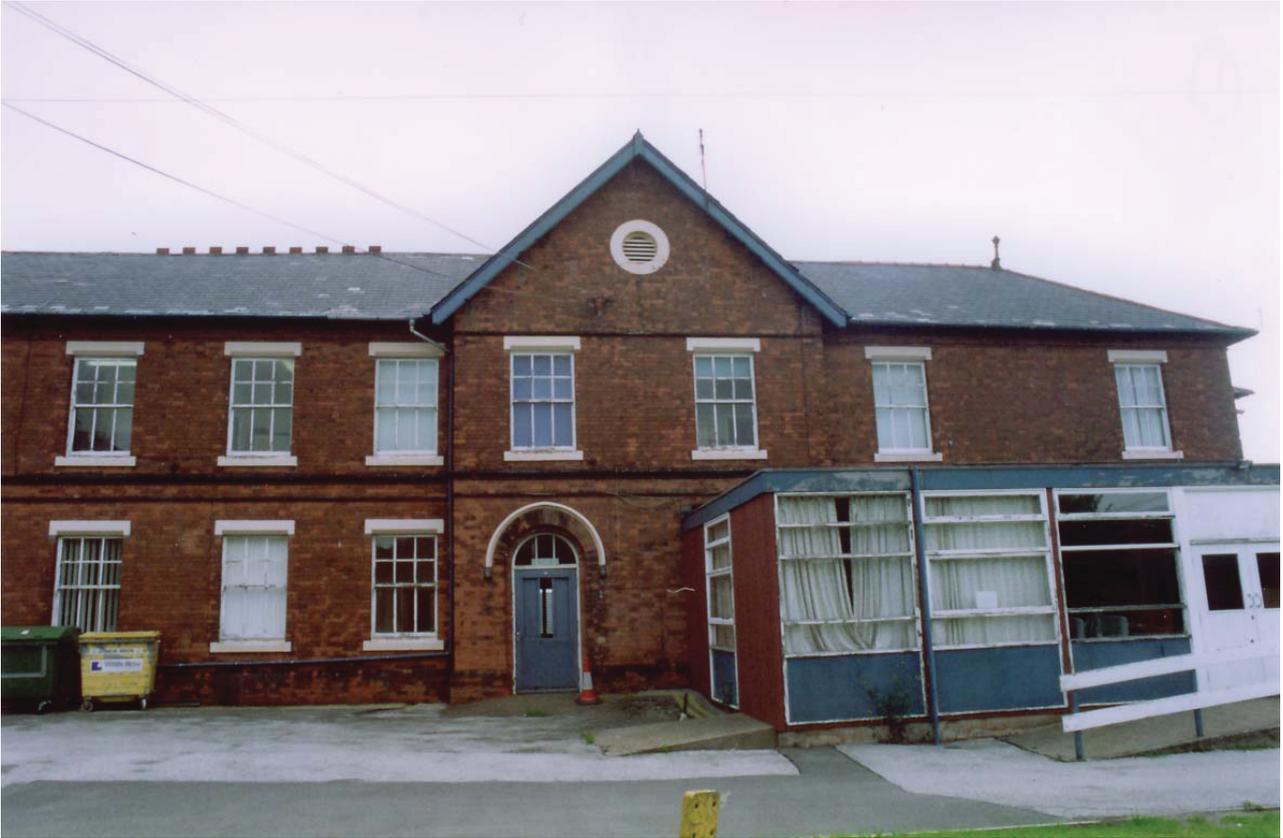
1. Block A: south part of the west elevation with principal entrance and to right a later flat-roofed addition.

5.2.1 A long and narrow (approx. 75m x 6.8m) two storey brick built block with hipped slate roof, its long axis aligned approximately north-north-west to south-south-east (hereafter north to south for convenience). The west front is the principal elevation, with projecting gabled entrances either side of a central 11 bay section. Beyond the gabled sections the pattern of fenestration changes. Lower and narrower two storey outer ends have similar hipped and slate covered roofs. At the north end this block is rendered. The southern projecting gabled section has a round-headed doorway with hoodmould, panelled door and overlight (Photo 1). An equivalent northern doorway, (assuming there was one) is masked by a later addition. In the apex of both gables is a circular vent with, to the south, a series of blocked slit vents also. Windows are 6 over 3 pane timber sashes with painted stone sills and heads. There is a moulded brick stringcourse at first floor level and a moulded brick course

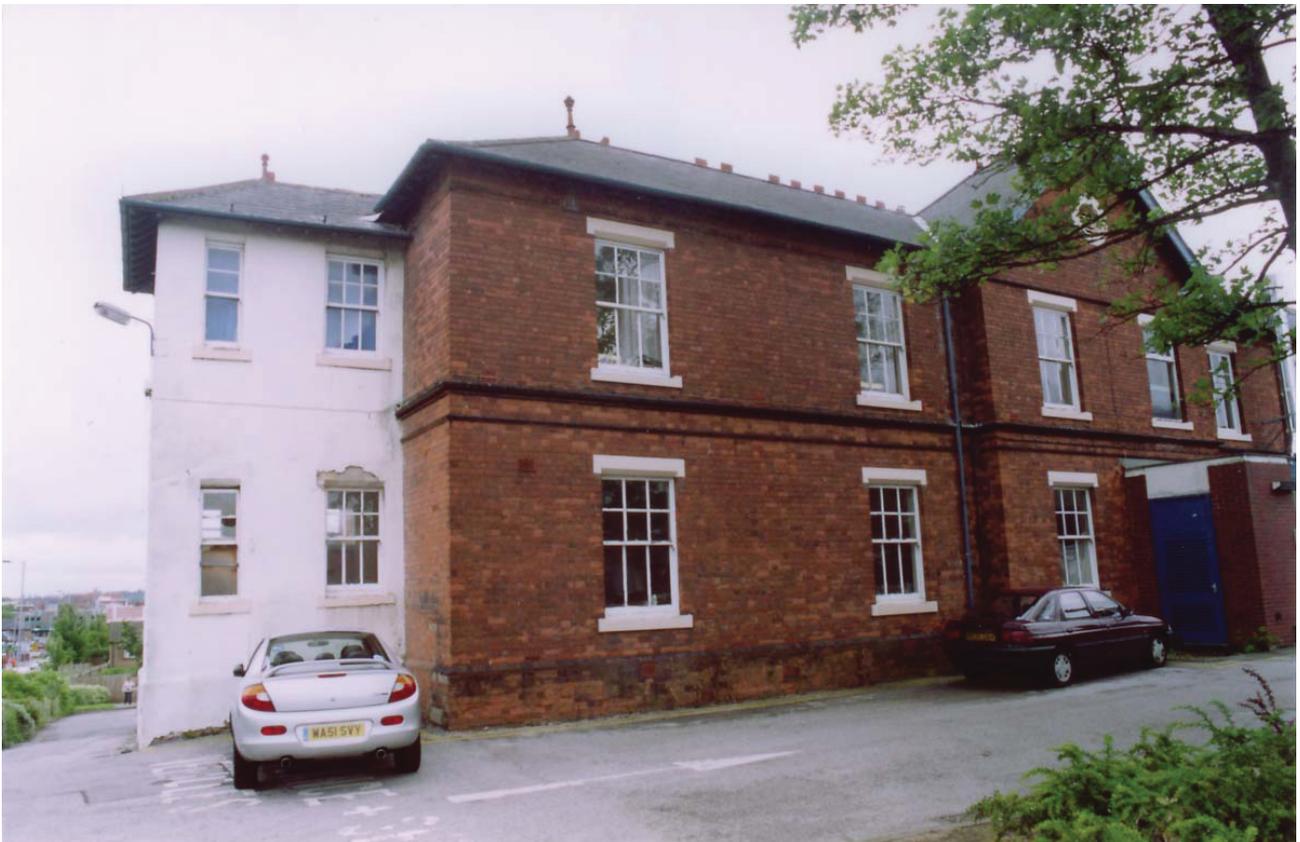
2. Block A: north part of the west elevation with rendered northern section to the left. Note lack of stringcourse on this section of the building.

above the first floor window heads. A chamfered brick course surmounts a brick plinth. The rendered block at the north end lacks the stringcourse, possibly indicating an earlier building phase (see Photo 2 and below). The roof has terracotta finials with the remains of decorative ridge tiles between. To the rear (east) are various projecting wings housing sanitary accommodation, a lift (modified staircase), etc. (Photos 3 & 4). These have been altered and extended at various times. At either end iron fire escapes are supported on cast columns and decorative brackets.

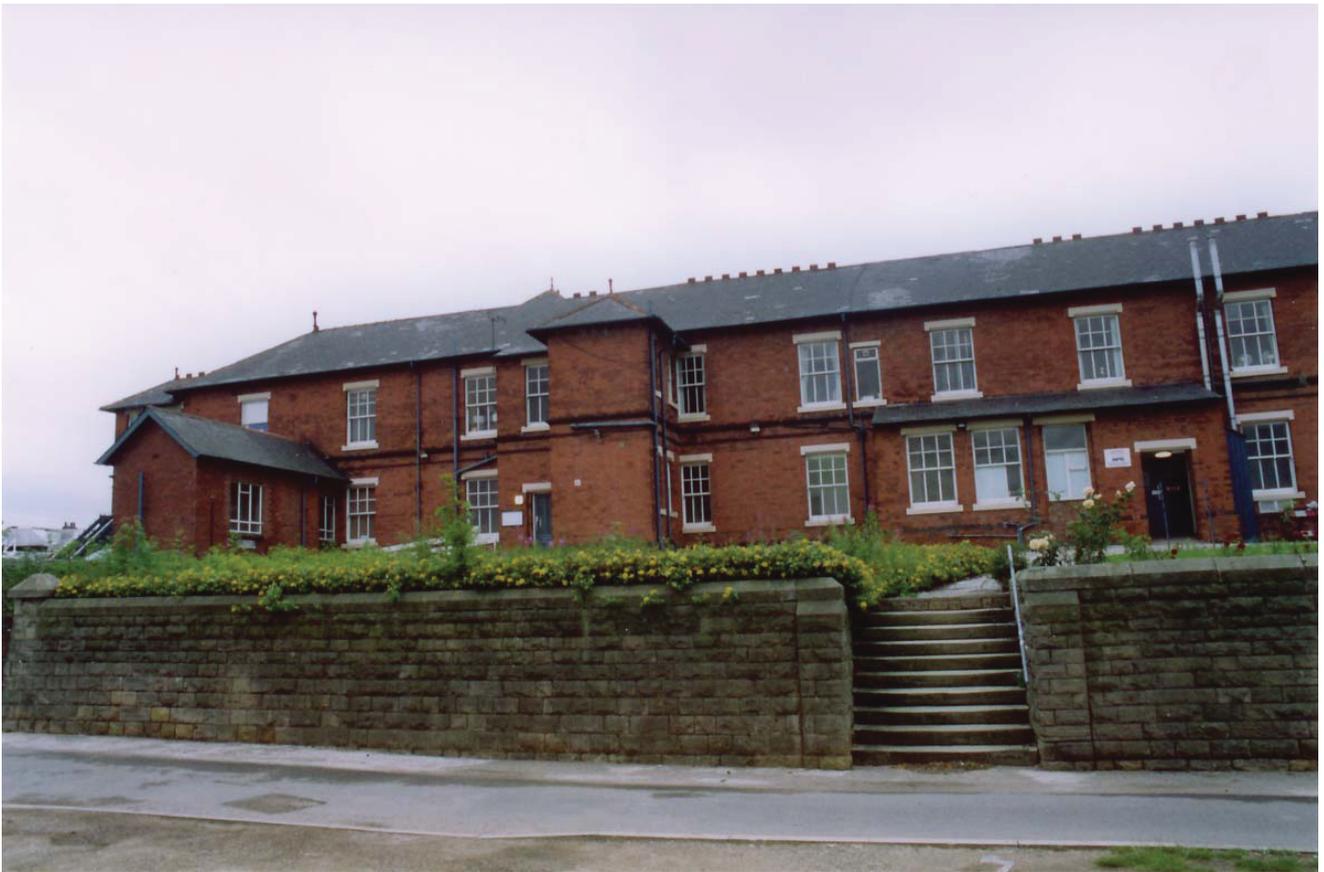
3. Block A: south part of the east elevation. Note ?earlier stone boundary wall.

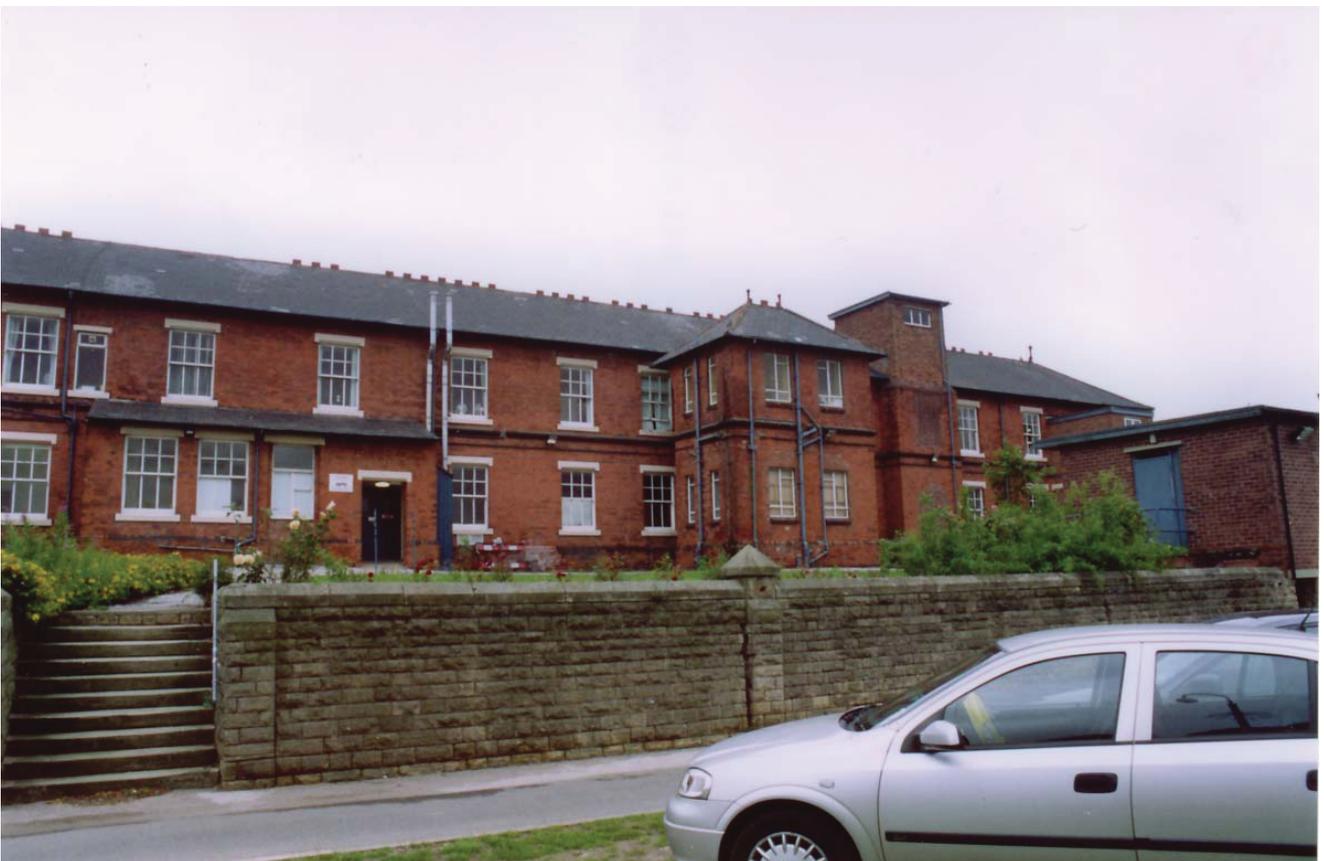
4. Block A: north part of the east elevation.

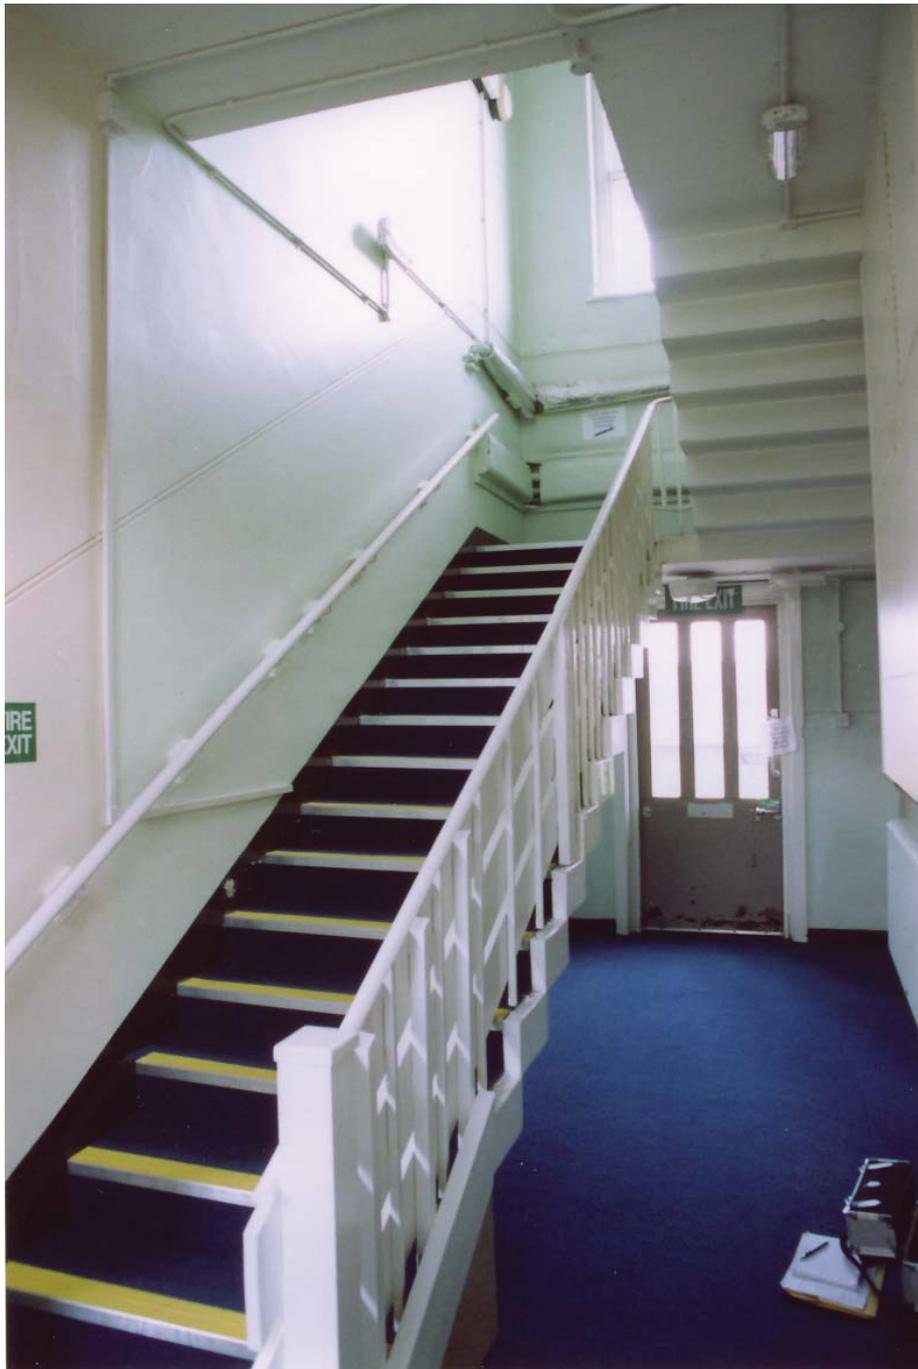
5. Block A: staircase. Note replacement timber handrail and balusters to modified lower section.

5.2.2 Internally decoration is minimal, as would be expected. Early door architraves survive in one or two places on the ground floor and there are panelled ceilings on the first floor. Some of the former wards are subdivided to form offices, although a sense of the original layout is gained in rooms now used for the storage of equipment and records (Photo 6). Some of the wards were in use as recently as the early 1990s. Access to the first floor is via a staircase, off the round-headed entrance doorway. This is of pre-cast concrete type with integral structural iron balustrade and handrail. At some stage the lower section of the balustrade and handrail has been removed, leading to structural problems; the lower section of staircase is now propped from below (Photo 5).

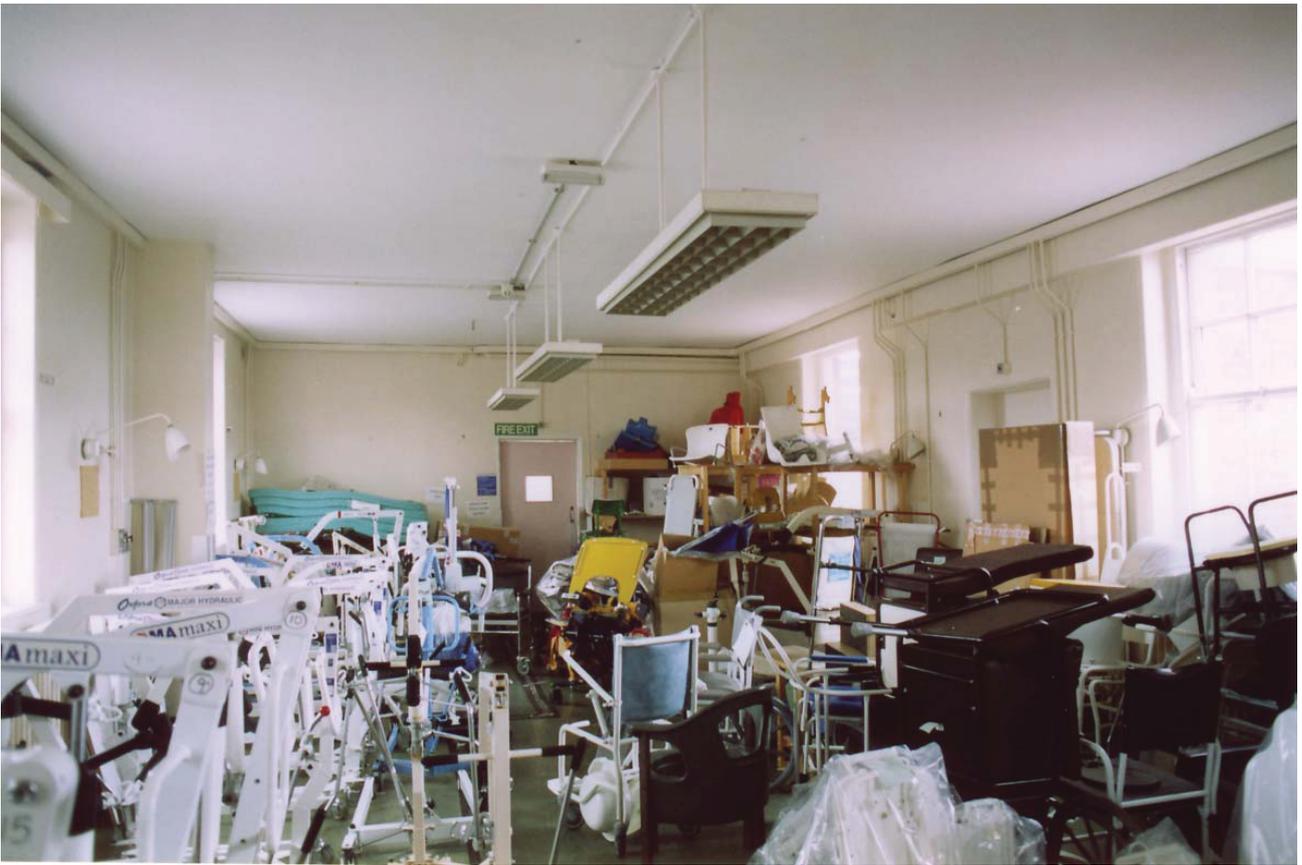
6. Block A: interior of former 'Nightingale' ward, now used for equipment storage.

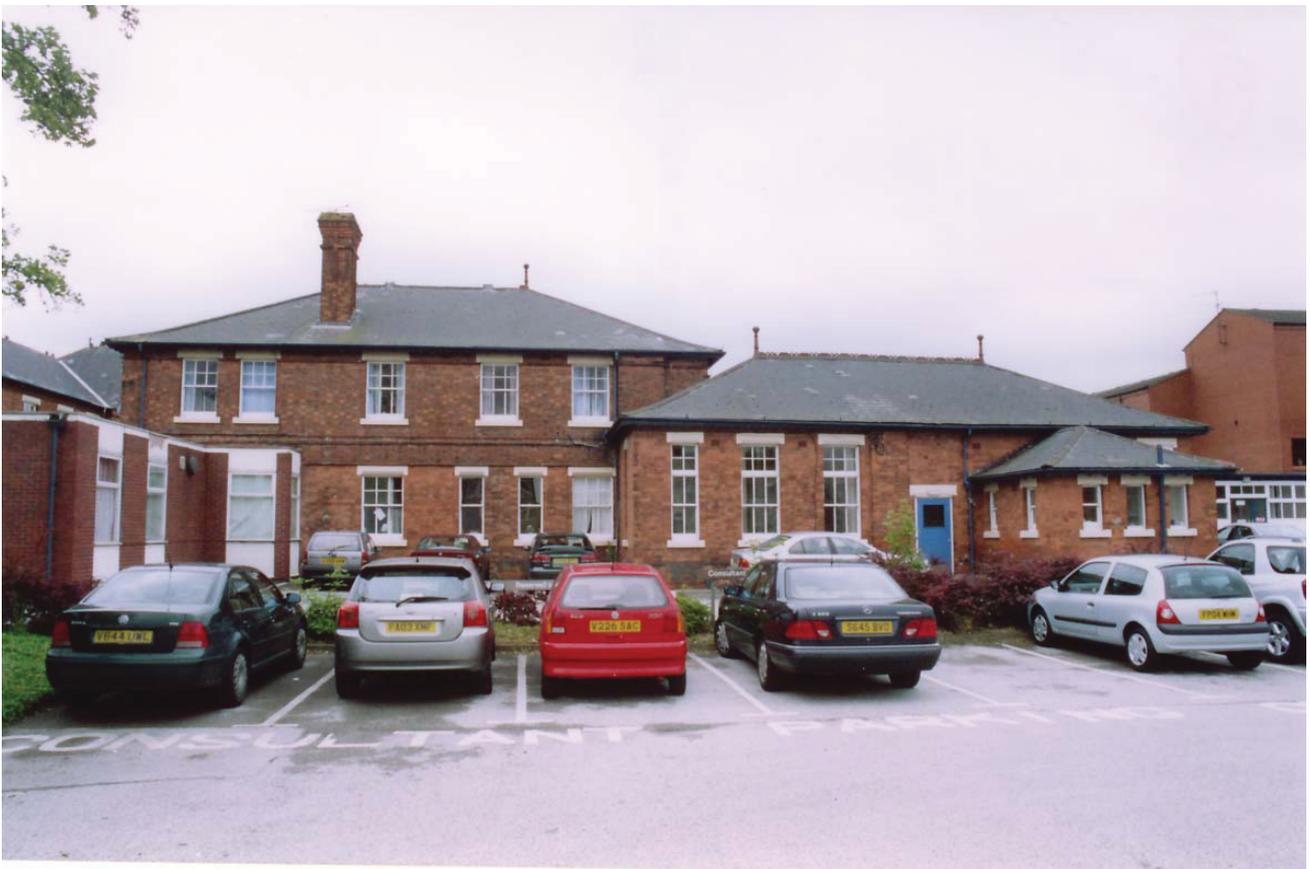
7. Blocks B (left) & C (right): north elevation.

5.3.1 This is a two storey brick building with hipped slate roof, its principal elevation facing north (Photo 7). It is similar in style to block 'A', with similar windows, plinth, stringcourse, finials and ridge. On the south elevation at the west end is a canted bay-window (Photo 8). Between this and a rear wing housing the sanitary accommodation is a modern, single storey extension. Internal access was limited as most of the rooms are presently in use as offices; however there is an early timber staircase with balusters boxed in and a plain newel (Photo 9), some skirting on the ground floor and one or two part glazed panelled doors with original surrounds.

5.4.1 A tall, single storey block attached to the west side of 'B' (Photo 7). In a similar style to A & B. There is a late extension to the rear (south) (Photo 10), with the original rear wall now forming one side of an internal corridor (Photo 11). Internally there is a panelled ceiling similar to those on the first floor of 'A'.

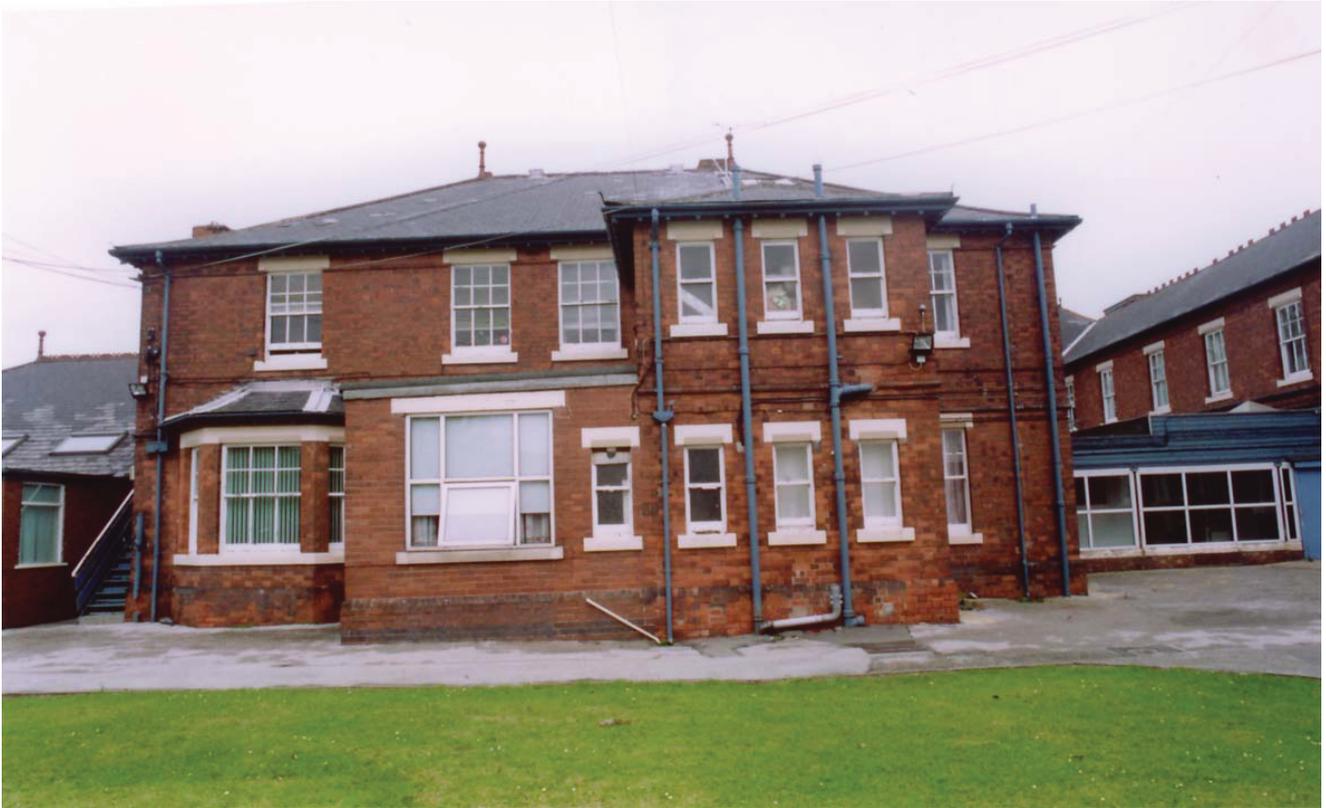
8. Block B: south elevation with canted bay window on left.

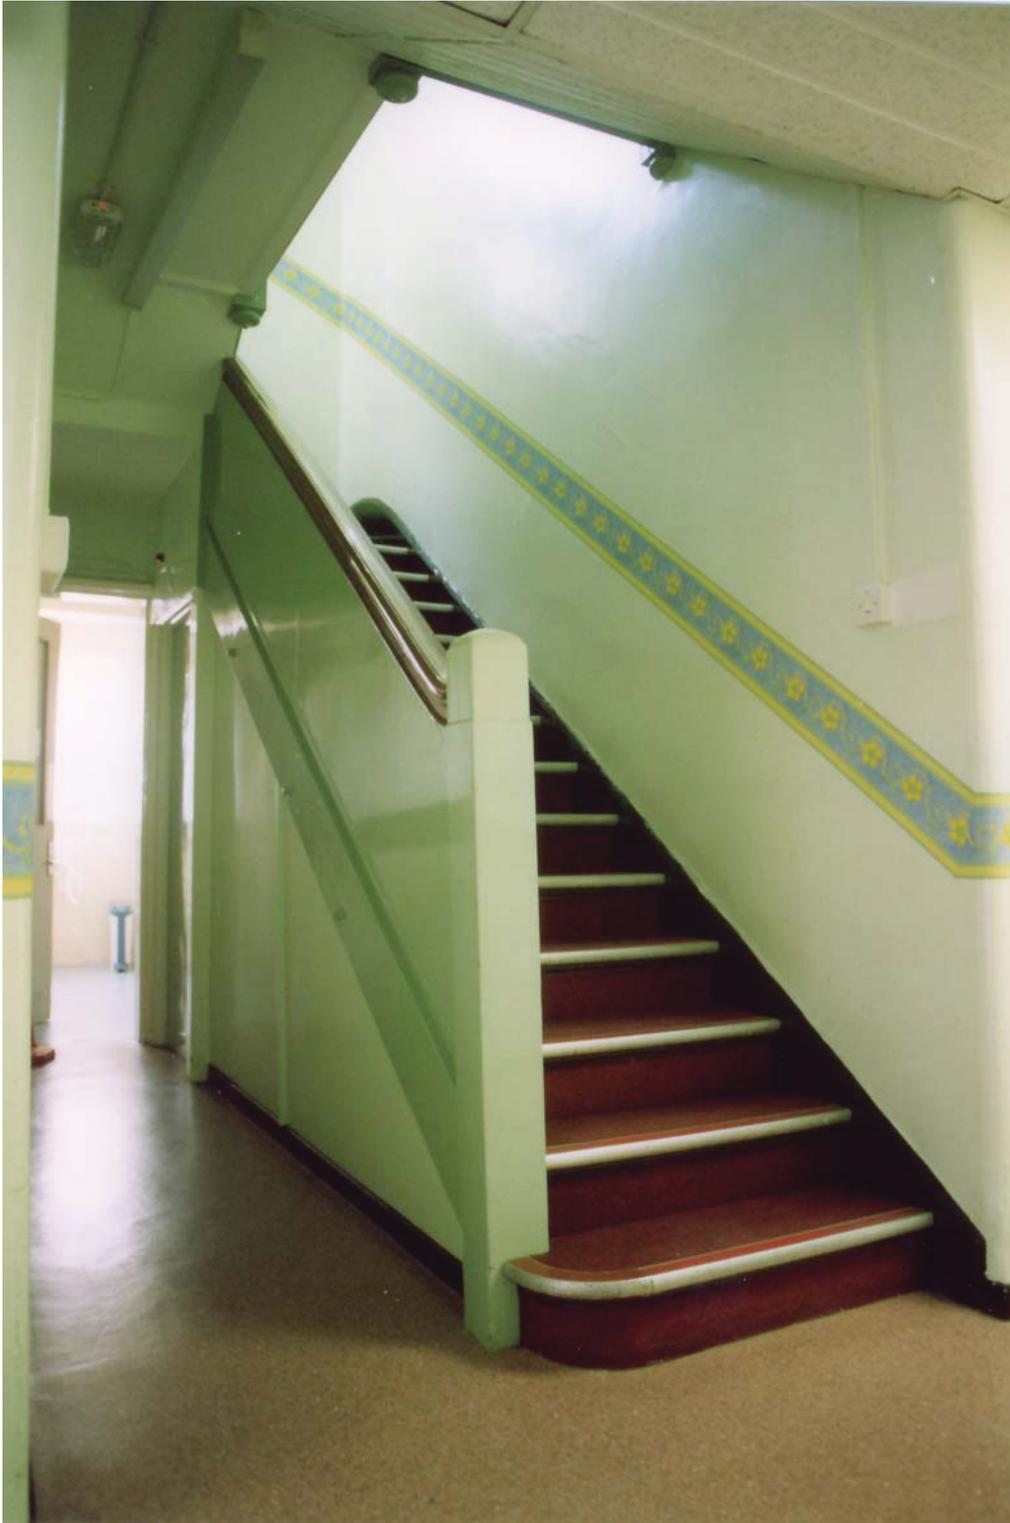
9. Block B: staircase.

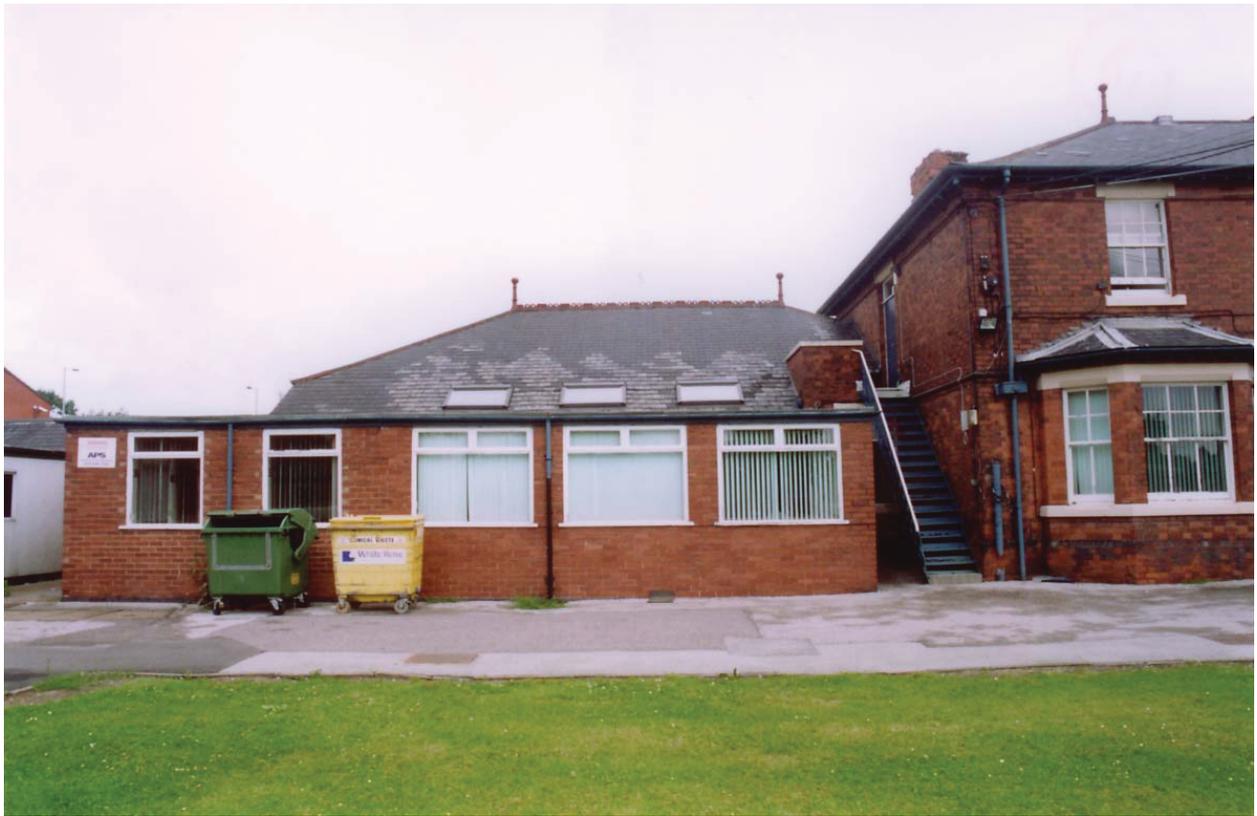
10. Block C: south elevation, showing later extension.
The roof lights light the corridor shown in photo 11.

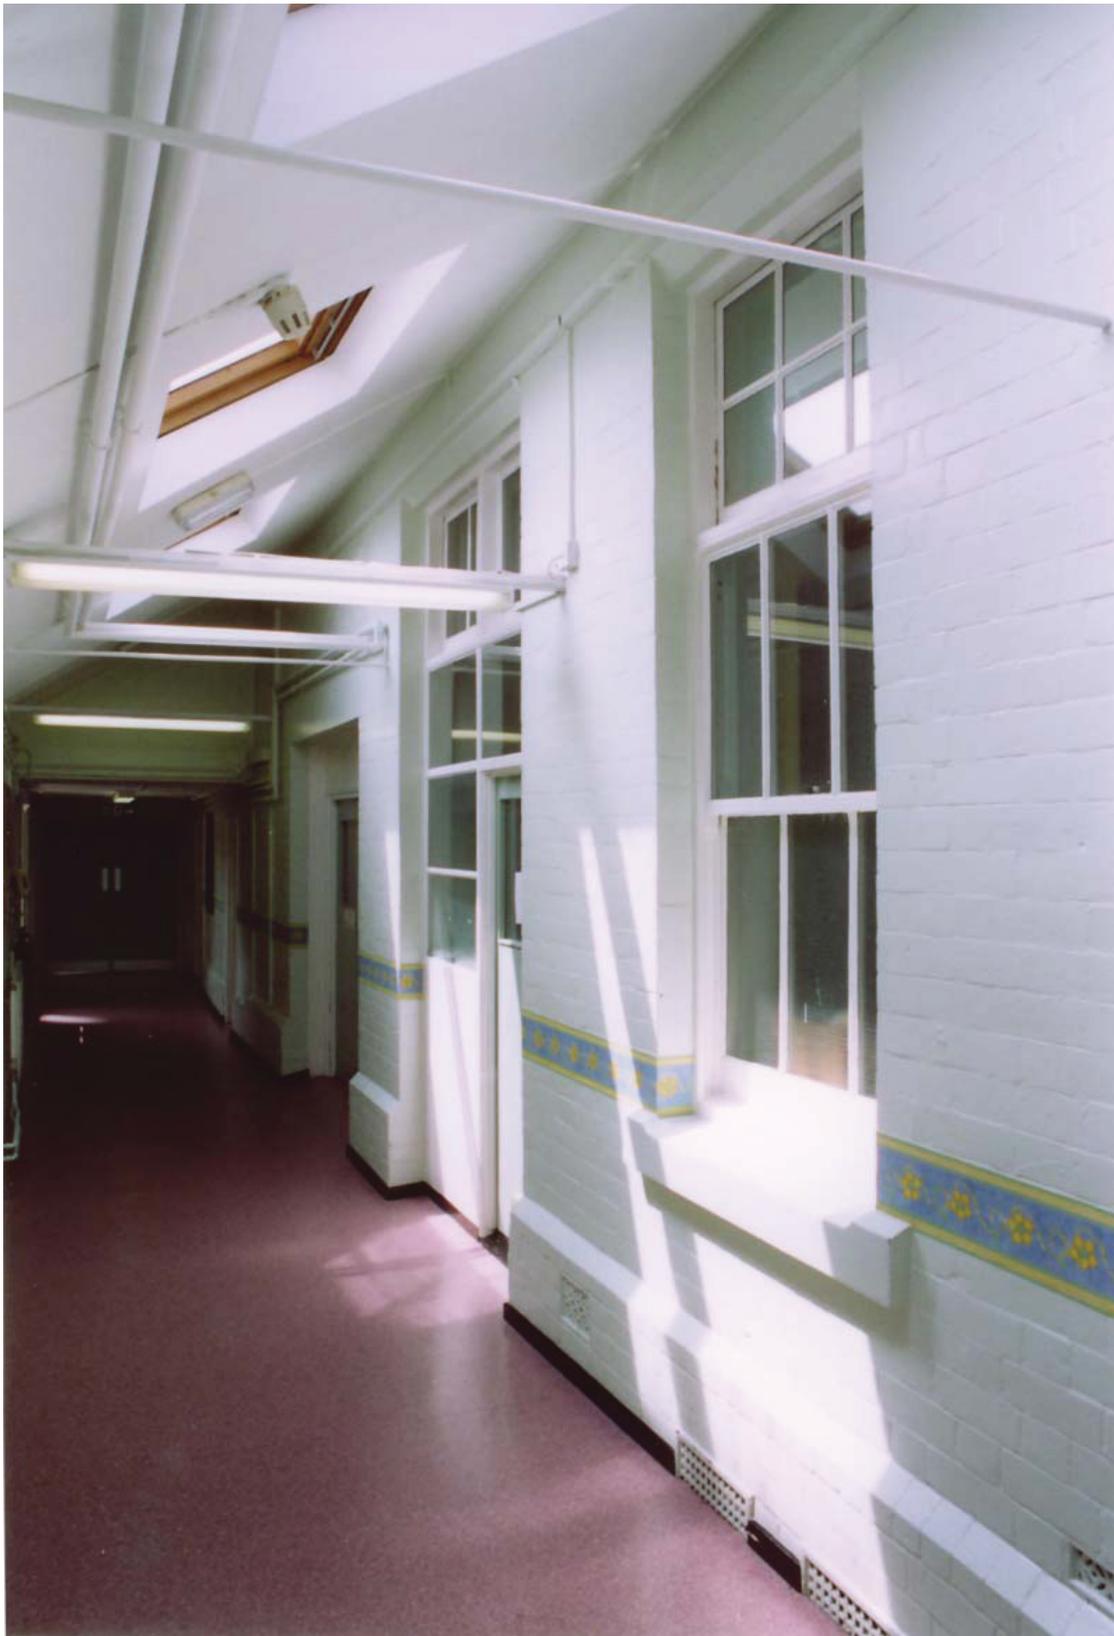
11. Block C: corridor with original external face of south wall of block C on right.

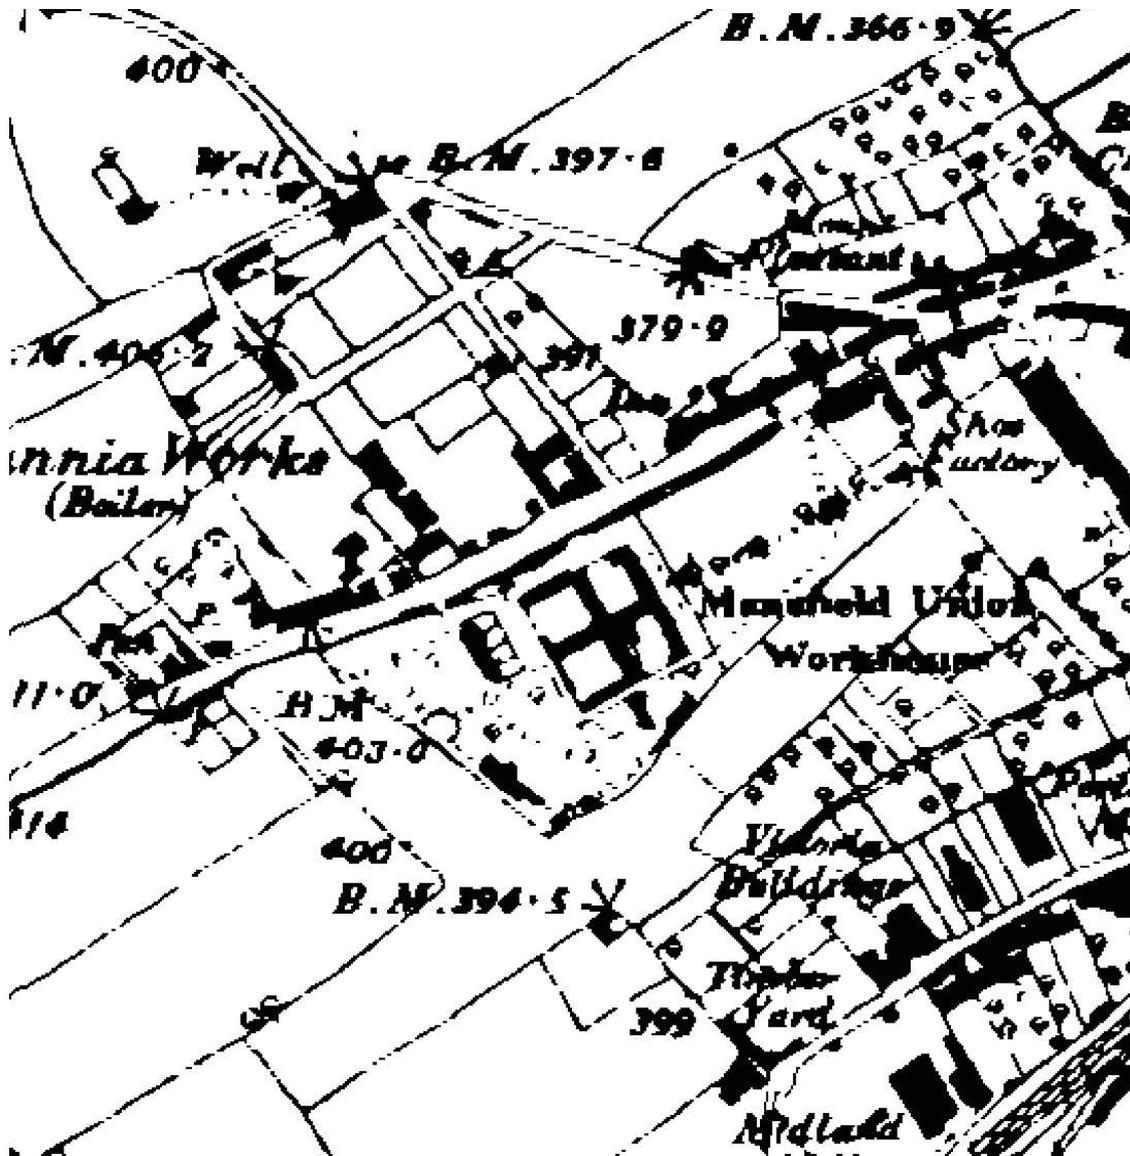
Figure 3: 1887 Ordnance Survey map 6" showing location of Mansfield Union Workhouse and Victoria Hospital

7.1.1 The 1887 Ordnance Survey map of Mansfield is recorded as having been surveyed after the construction of the initial additional infirmary block to the Mansfield Union Workhouse in 1883. The plan of the site clearly shows the layout of the workhouse with subsidiary buildings to the south, west and south-west. The building to the west would certainly lie within the footprint of the existing block A at the site.

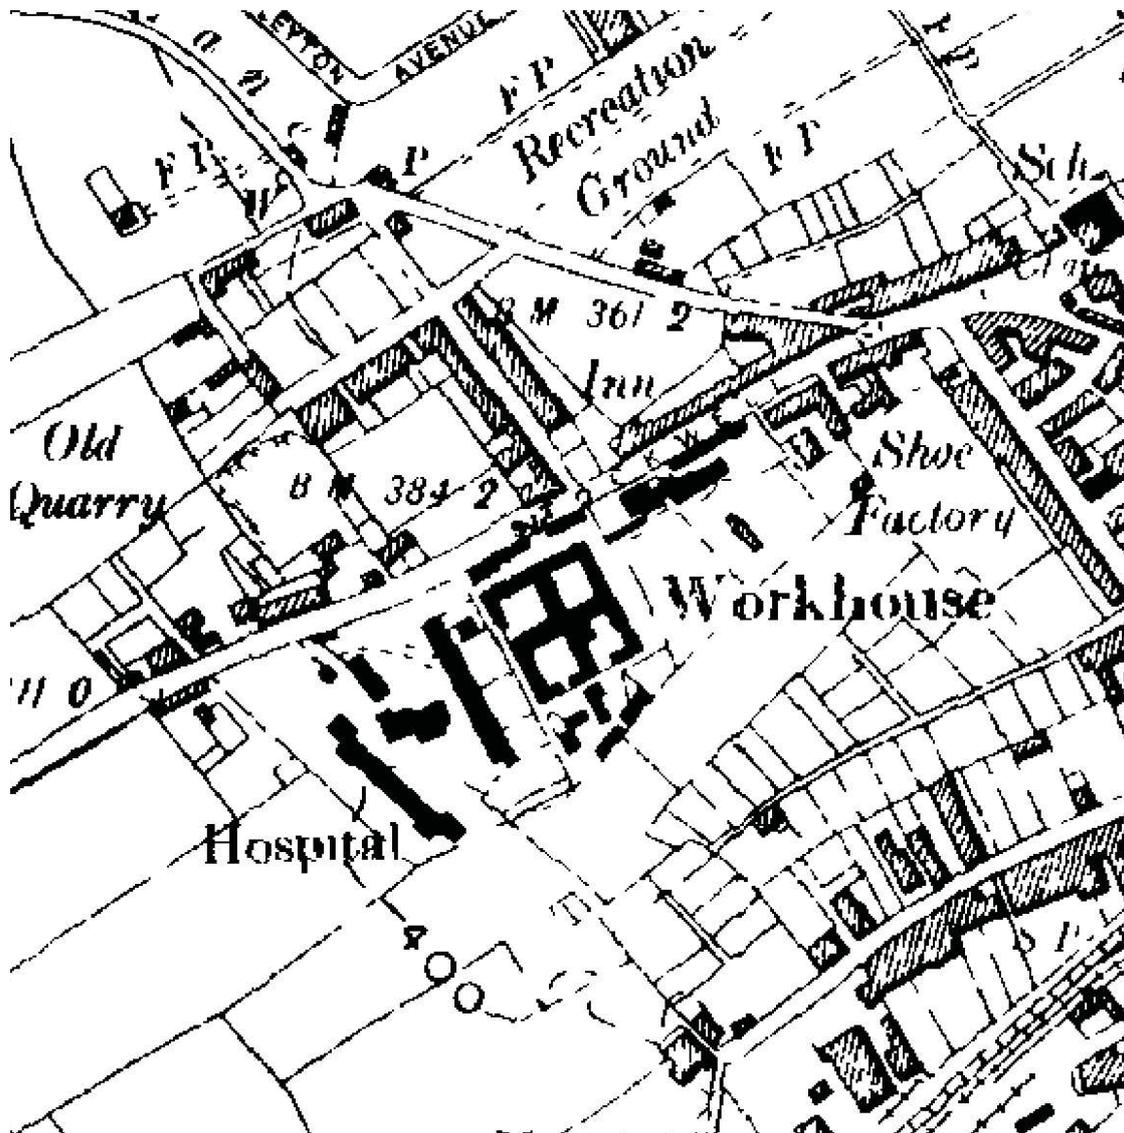
Figure 4: Detail of 1900 Ordnance Survey map 6" showing location of Mansfield Union Workhouse and Victoria Hospital

7.2.1 The 1900 Ordnance Survey map was surveyed after the construction of the Victoria Hospital Building in 1897/8. The layout of the workhouse to the east of the hospital is still clearly visible, with additional buildings having been constructed to the south. The layout of the Victoria Hospital includes the existing blocks A, B and C (only B and C are attached, with A being an unconnected wing to the east. The former south-western wing of the hospital is also shown, and is similarly unconnected to the other buildings.

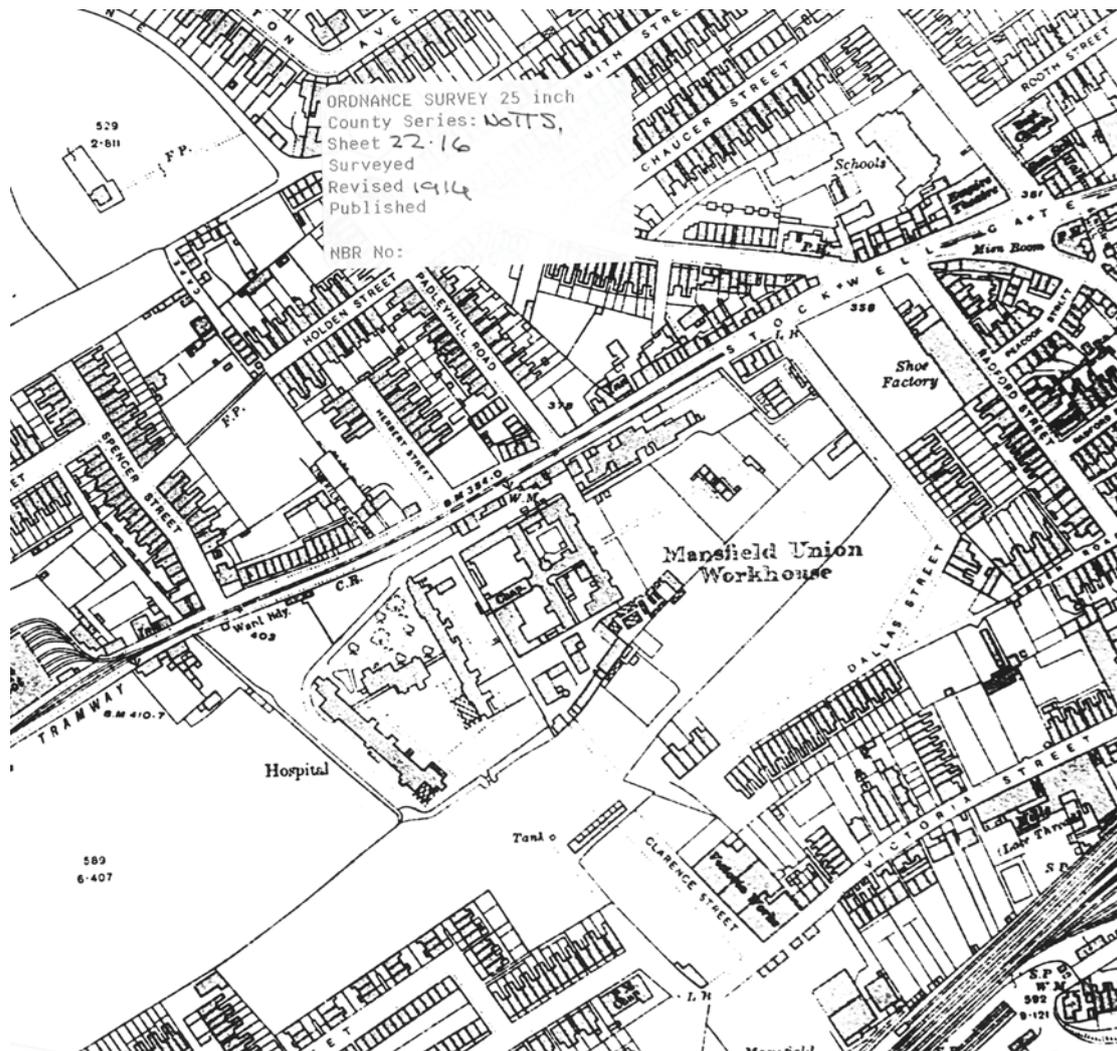
Figure 5: Detail of 1914 Ordnance Survey map 25" showing location of Mansfield Union Workhouse and Victoria Hospital

7.3.1 The 1914 Ordnance Survey map shows the site area in more detail. The Workhouse itself is portrayed in more detail, and includes the labelling of the location of the chapel in the central part of the western side. The Victoria Hospital buildings are indicated with connecting passages linking the structures. Possible additions to the main buildings are also indicated on the southern ends of both the south-western and eastern wings of the hospital.

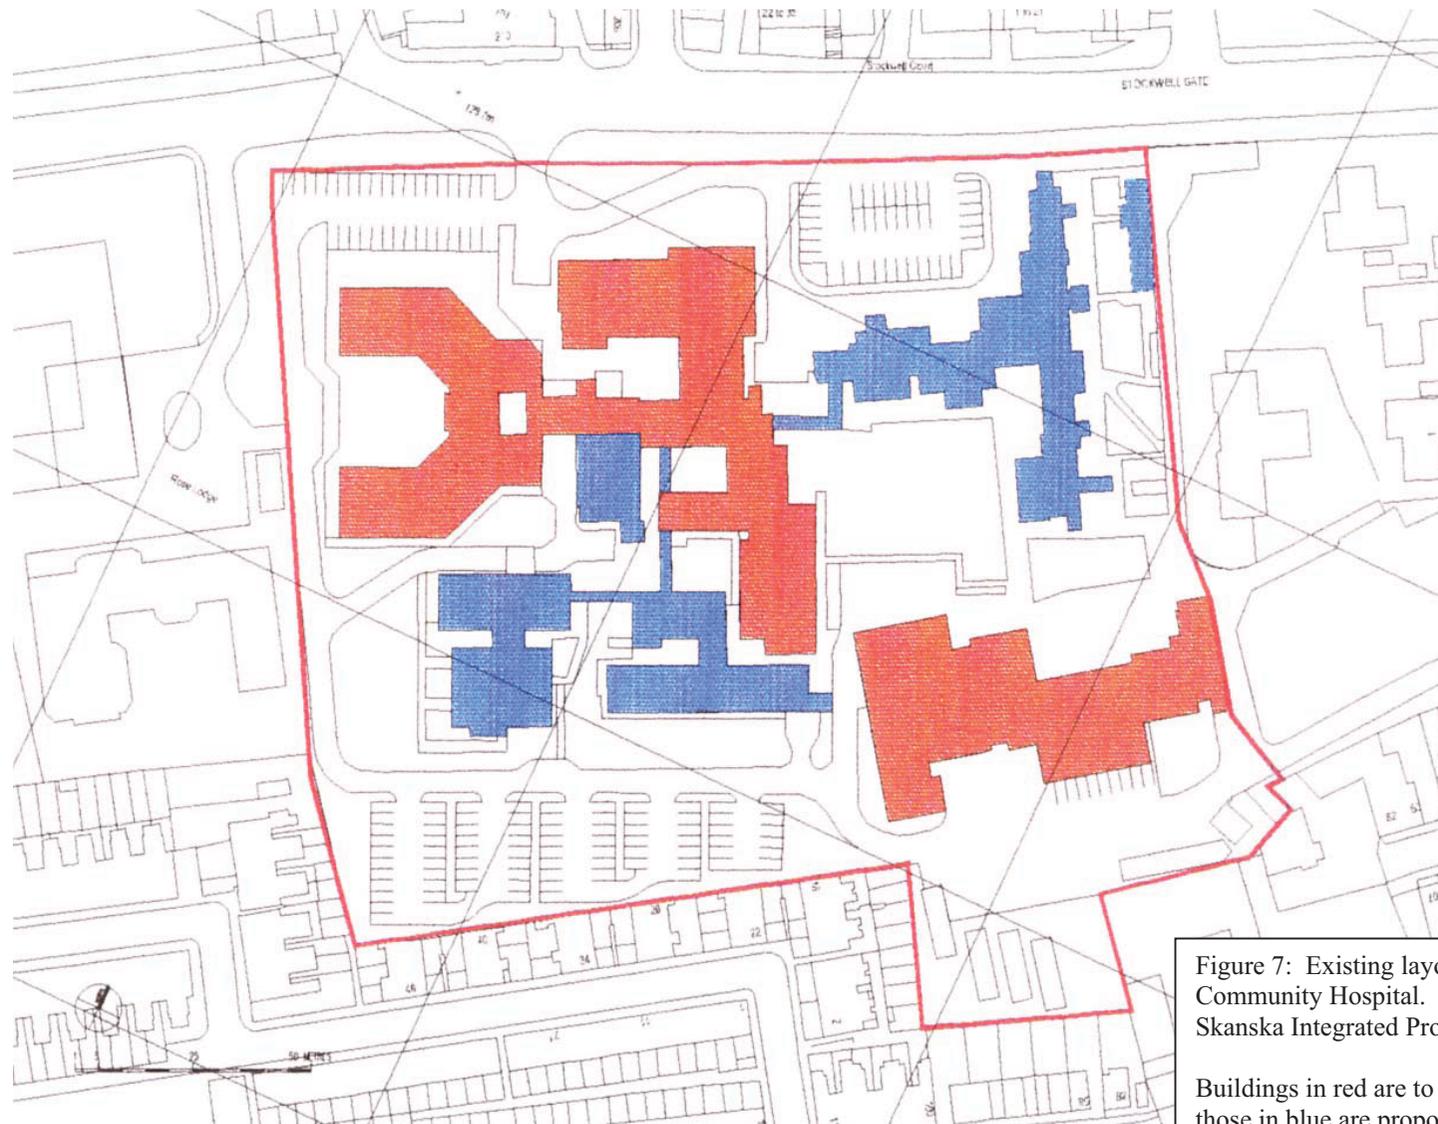
Figure 7: Existing layout of Mansfield Community Hospital. (Plan supplied by Skanska Integrated Project Services)

Buildings in red are to be retained and those in blue are proposed to be demolished.

7.5.1 All traces of the workhouse, save for the probable western boundary wall have been demolished. The south-western wing of the former Victoria Hospital was demolished in the 1980s and replaced by modern hospital buildings. The three surviving parts of the former Victoria Hospital have been added to and altered over the years, but in general their original form is still visible.
