SVM07

Date: October 2007

Client: FM Developments

Southern View, Marykirk, Aberdeenshire: An Archaeological Evaluation

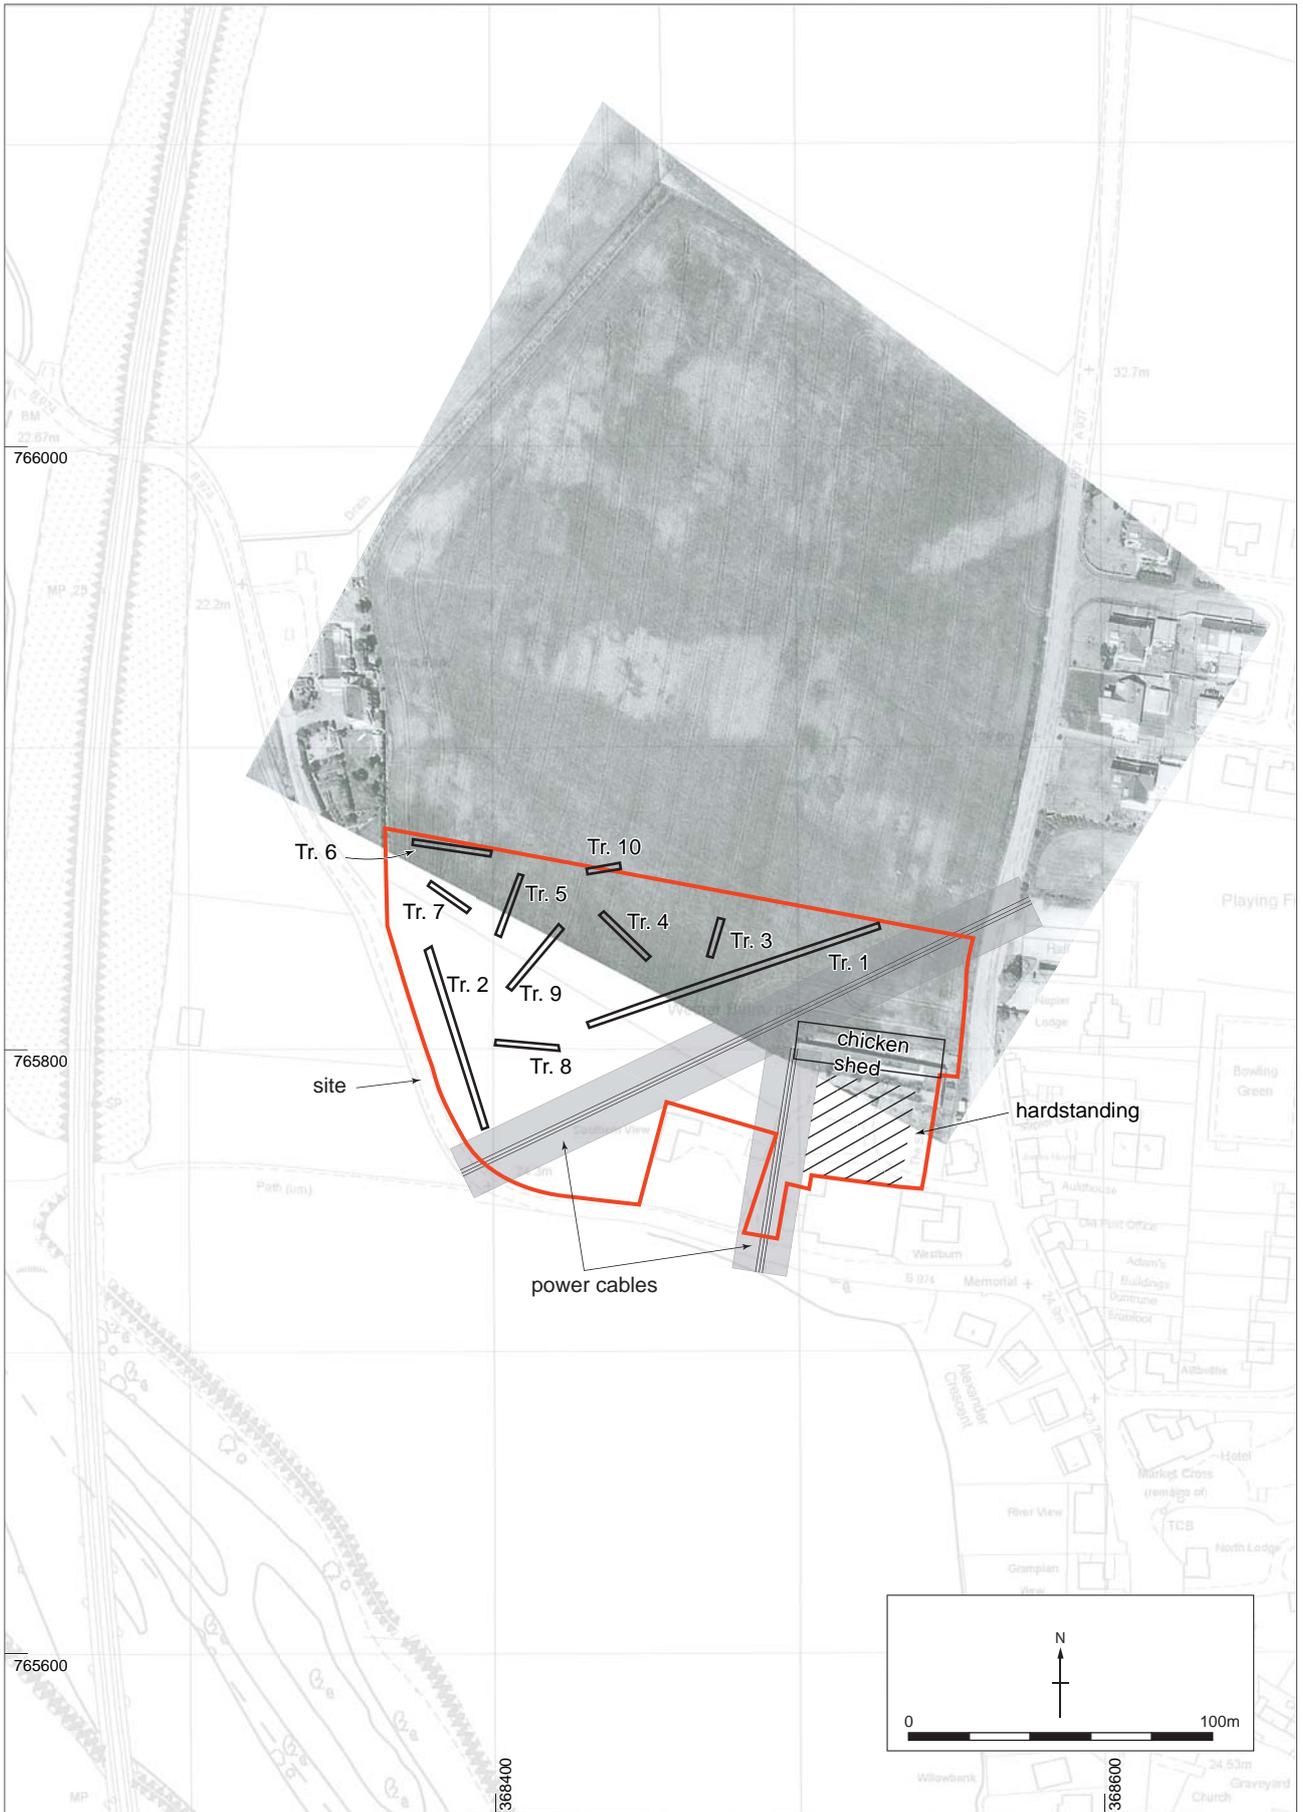
Figure 2: SVM07, Southern View, Marykirk - Trial trenches in relation to rectified aerial photograph.

A total of ten trenches were excavated within the accessible area of excavation (Figure 2). The trenching revealed a deep layer of loam, forming a plough soil (1) covering the whole area. This in turn overlay a lighter sandy loam (2). Six north – south orientated furrows (4), 0.30 – 0.40m wide, cut into the underlying geological sediments (4) (“the natural”) were recorded in Trench 1. An unmarked modern service trench, probably carrying a sewage pipe, was encountered in Trenches 6, 8 and 9. Both the top and sub-soils appeared clean of artefacts associated with manuring. The natural encountered throughout was noted as light – mid reddish brown sandy gravel, interspersed by occasional patches of rounded gravel. A number of small – medium sized tree throws and tree bowls were visible in the natural. No archaeologically significant features or finds were identified.

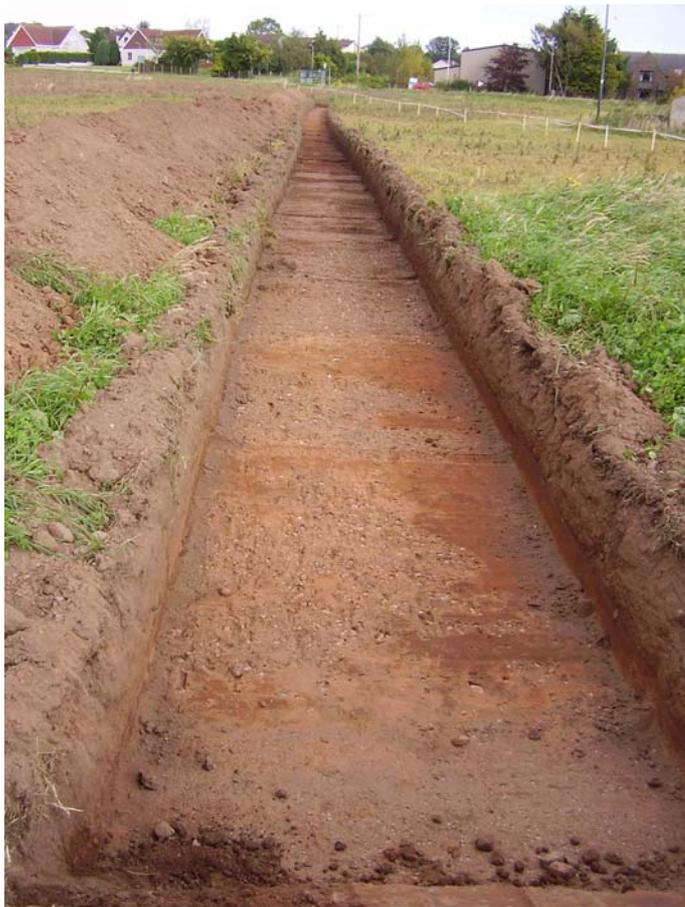
Plate 2. Trench 1 general shot. Southern View, Marykirk, Aberdeenshire

| Trench No. | Description | Length (m) | Av. Topsoil/subsoil Depth (m) |
|---|---|---|---|
| 1 | Oriented E-W. Topsoil (1) overlay a sub-soil (2), which overlay the natural sediments (3). Several furrows were encountered in the trench running NE – SW from 15.0m from the E-end. A ceramic field drain was encountered running N-S 43.80m from the E-end. The natural become stonier 68m from the E-end. | 100 | 0.65 |

| Context N ^o | Trench N ^o | Description |
|---|---|---|
| 4 | 1 | Furrows: Six parallel, linear furrows, aligned NE – SW. These were generally 0.30 – 0.40m wide and were 0.60 – 1.0m apart. They were filled by (2). They were faint and truncated by later agricultural activity. They were grouped together in the NE top third of Trench 1. The remains of pre-mechanised ploughing. Possibly they survived here because this part of the trench is slightly higher and the slope is slightly steeper than the rest of the site, so the plough cut deeper into the natural. |

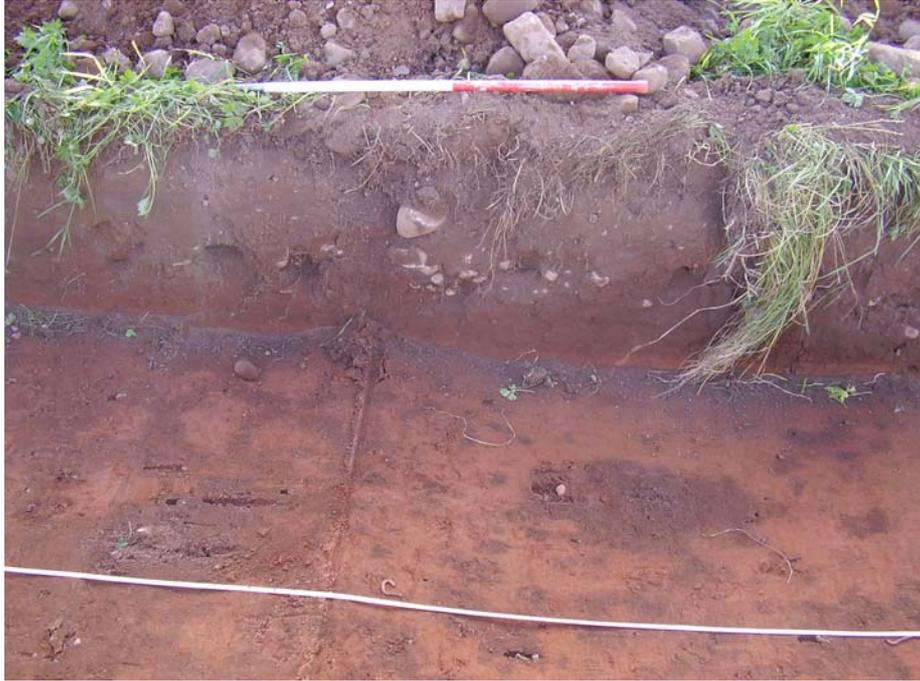
Plate 3. Trench 2, representative stratigraphy. Southern View, Marykirk, Aberdeenshire.

At present at Southern View, the B974 demarcates the extent of arable land with the land south of the road given over to pasture. Recently, the evaluation area, as well as the fields to the north, have been ploughed east – west, but the layout of the field, the topography and especially the accumulation of soil along the southern field boundary suggest that this area was traditionally ploughed north – south. A large concentration of sub-rounded large cobble to boulder-sized stones was encountered within the plough soil about 0.30m below the present ground surface along the southern field boundary. The unstructured nature of the deposit led to it being interpreted as the remains of clearance cairns. The landowner who remembered them in this field from his youth in the 1950's confirmed this. These were locally known as *stane gaitherin's*. The depth of plough soil above the stones suggests a lot of erosion in the last 50 years (Plate 3).

| Trench No. | Description | Length (m) | Av. Topsoil/subsoil Depth (m) |
|---|---|---|---|
| 2 | Orientated N-S. Stratigraphy as in Trench 1. No significant archaeological features or finds were uncovered. There was a marked concentration of sub-rounded cobbles – boulders in the top and sub-soils. These were random and are the remains of clearance cairns, still collected within living memory. This trench contained several small tree bowls. | 62 | 0.75 |
