Project Code: SBD05
Planning application reference number: 05/03128/FUL
Date of report: May 2008
Client: Frasers Hamilton (Shrubhill) Ltd.

Shrubhill Transport Depot, Edinburgh Results of Archaeological Evaluation

Shrub Hill Transport Depot, Edinburgh

Results of Archaeological Evaluation

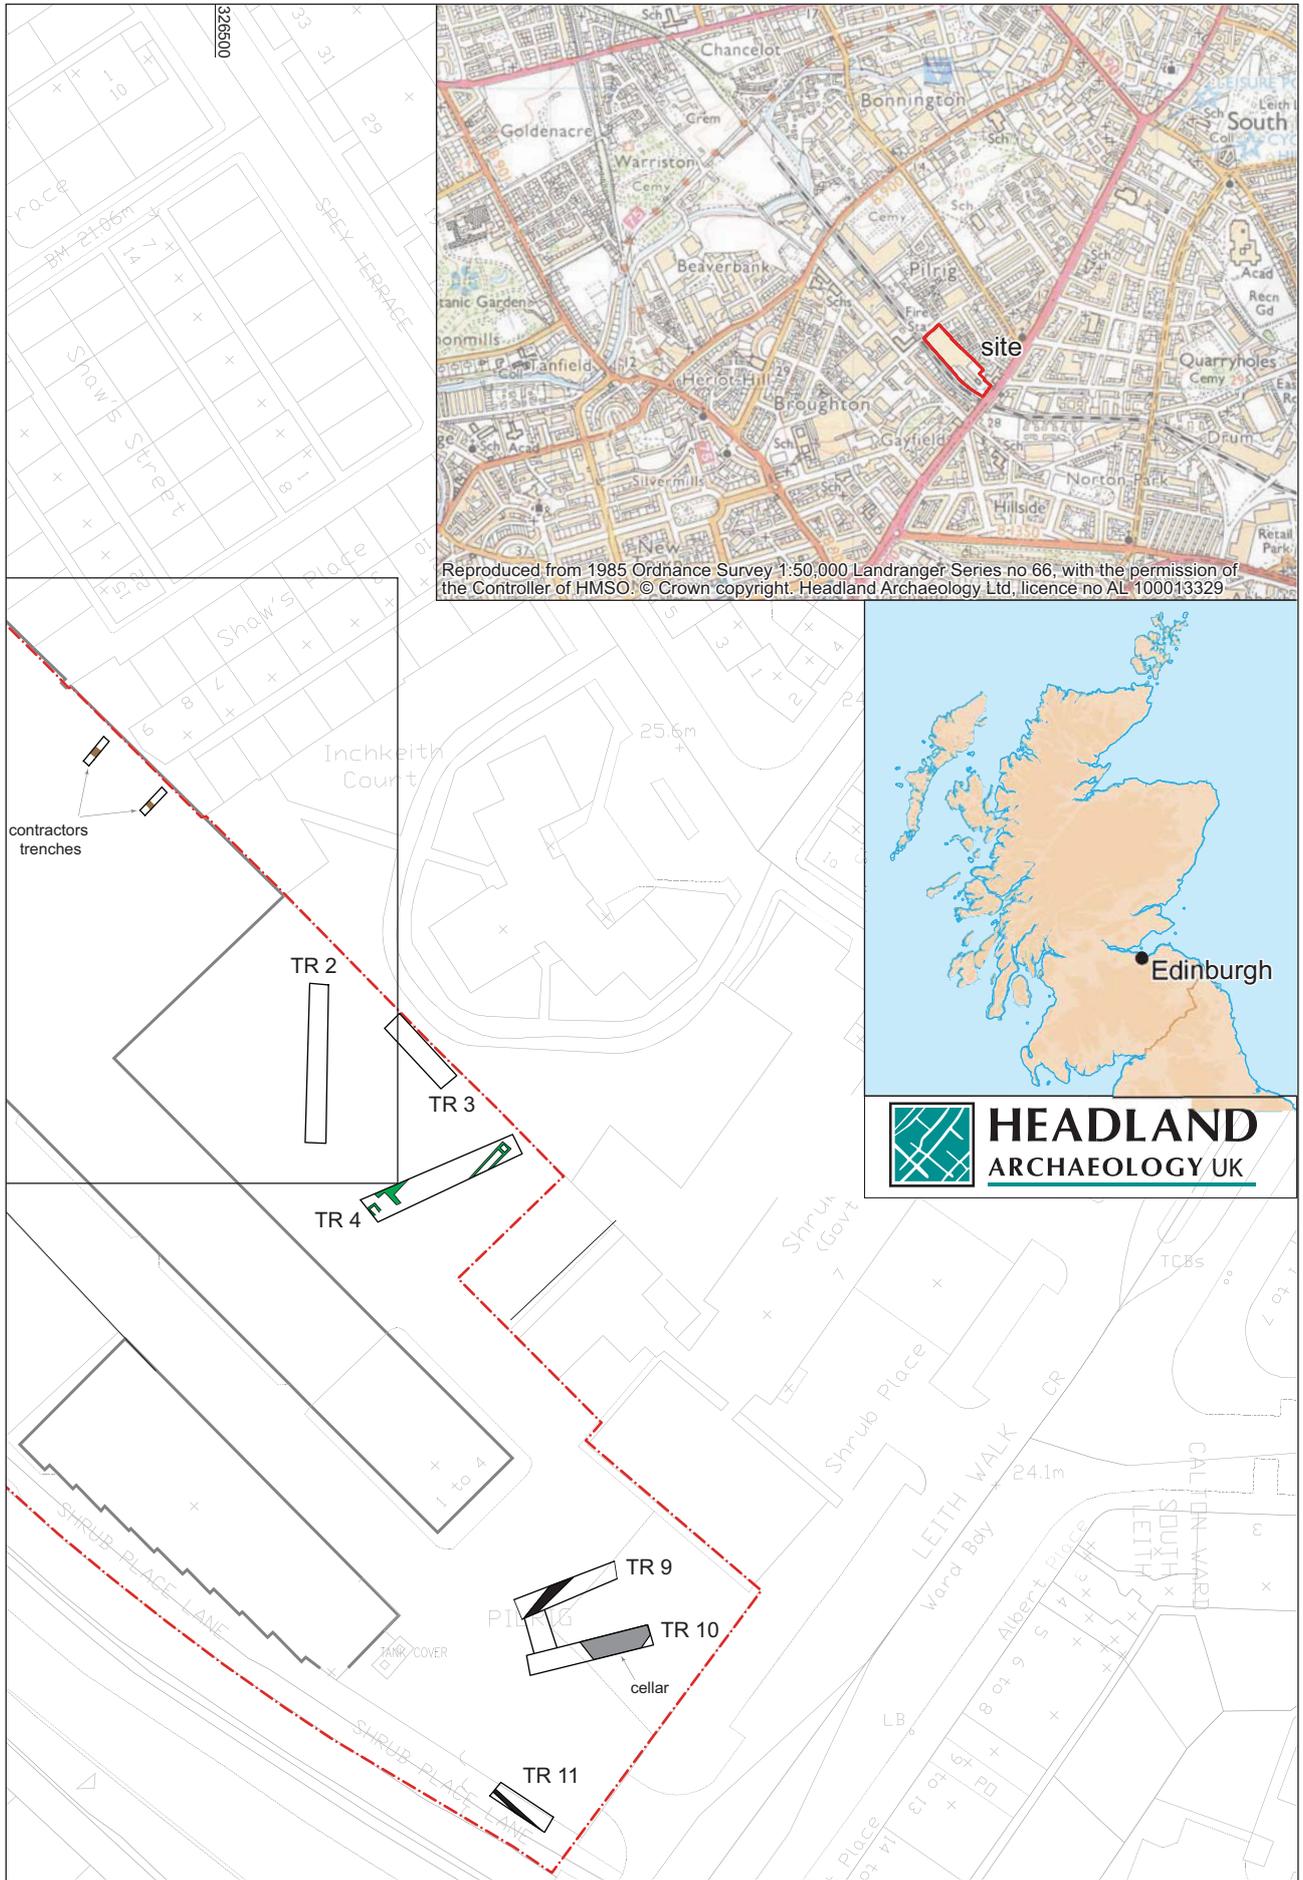
Illus 1
Trench and site location

A series of 11 trial trenches was excavated in the open areas around the standing buildings. The remainder of the trenches were distributed across the site at locations considered to have the highest archaeological potential and the lowest levels of truncation.

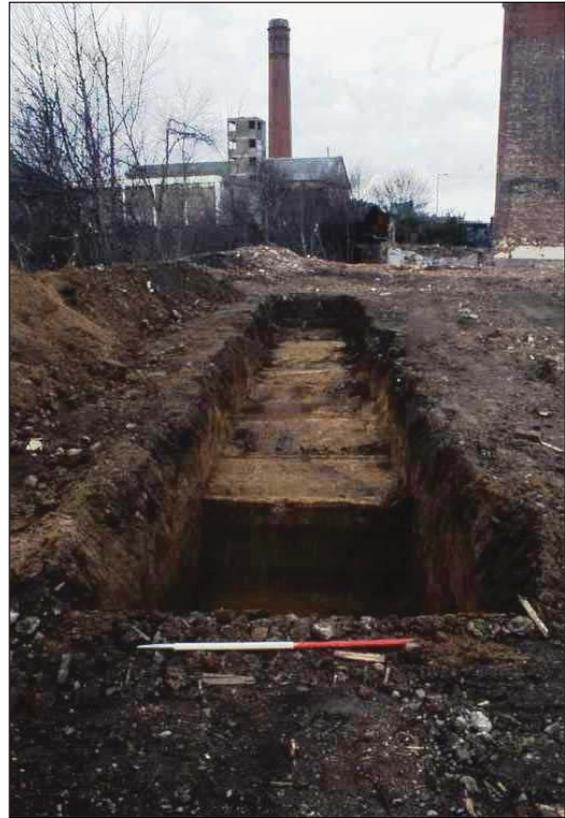
Illus 2

Trenches 1 and 7 were excavated to an average depth of 1.3m with a machine cut sondage 2m deep at the southern end of Trench 1. In both trenches, orange yellow sand was revealed, becoming coarser with occasional clayey patches at its lower levels. In both trenches this was overlain by relatively recent building rubble. The partial remains of a brick and concrete structure was identified at the southern end of Trench 7 and the cut of a north-south aligned drainage trench was observed in Trench 1.

Trench 1 showing sondage through glacial sands

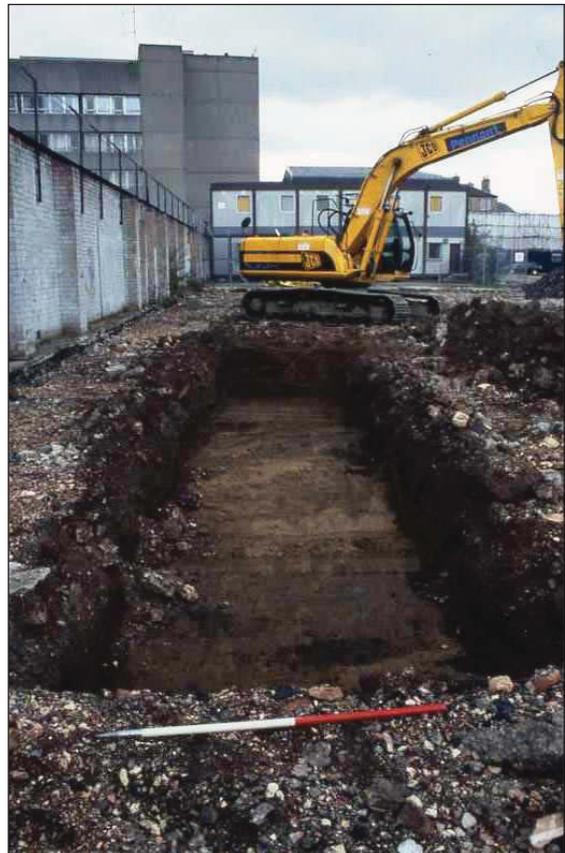
Illus 3

Trenches 2-4 were excavated on the site of the former Shrub House. Despite the presence of numerous fragments of worked masonry thought to have originated from this structure, no evidence of Shrub House was encountered. Instead, below a layer of demolition rubble at an average depth of 0.75m, clean windblown sand was encountered. Evidence of later structures was identified in the form of a

Trench 3 showing natural sands on site of Shrub House

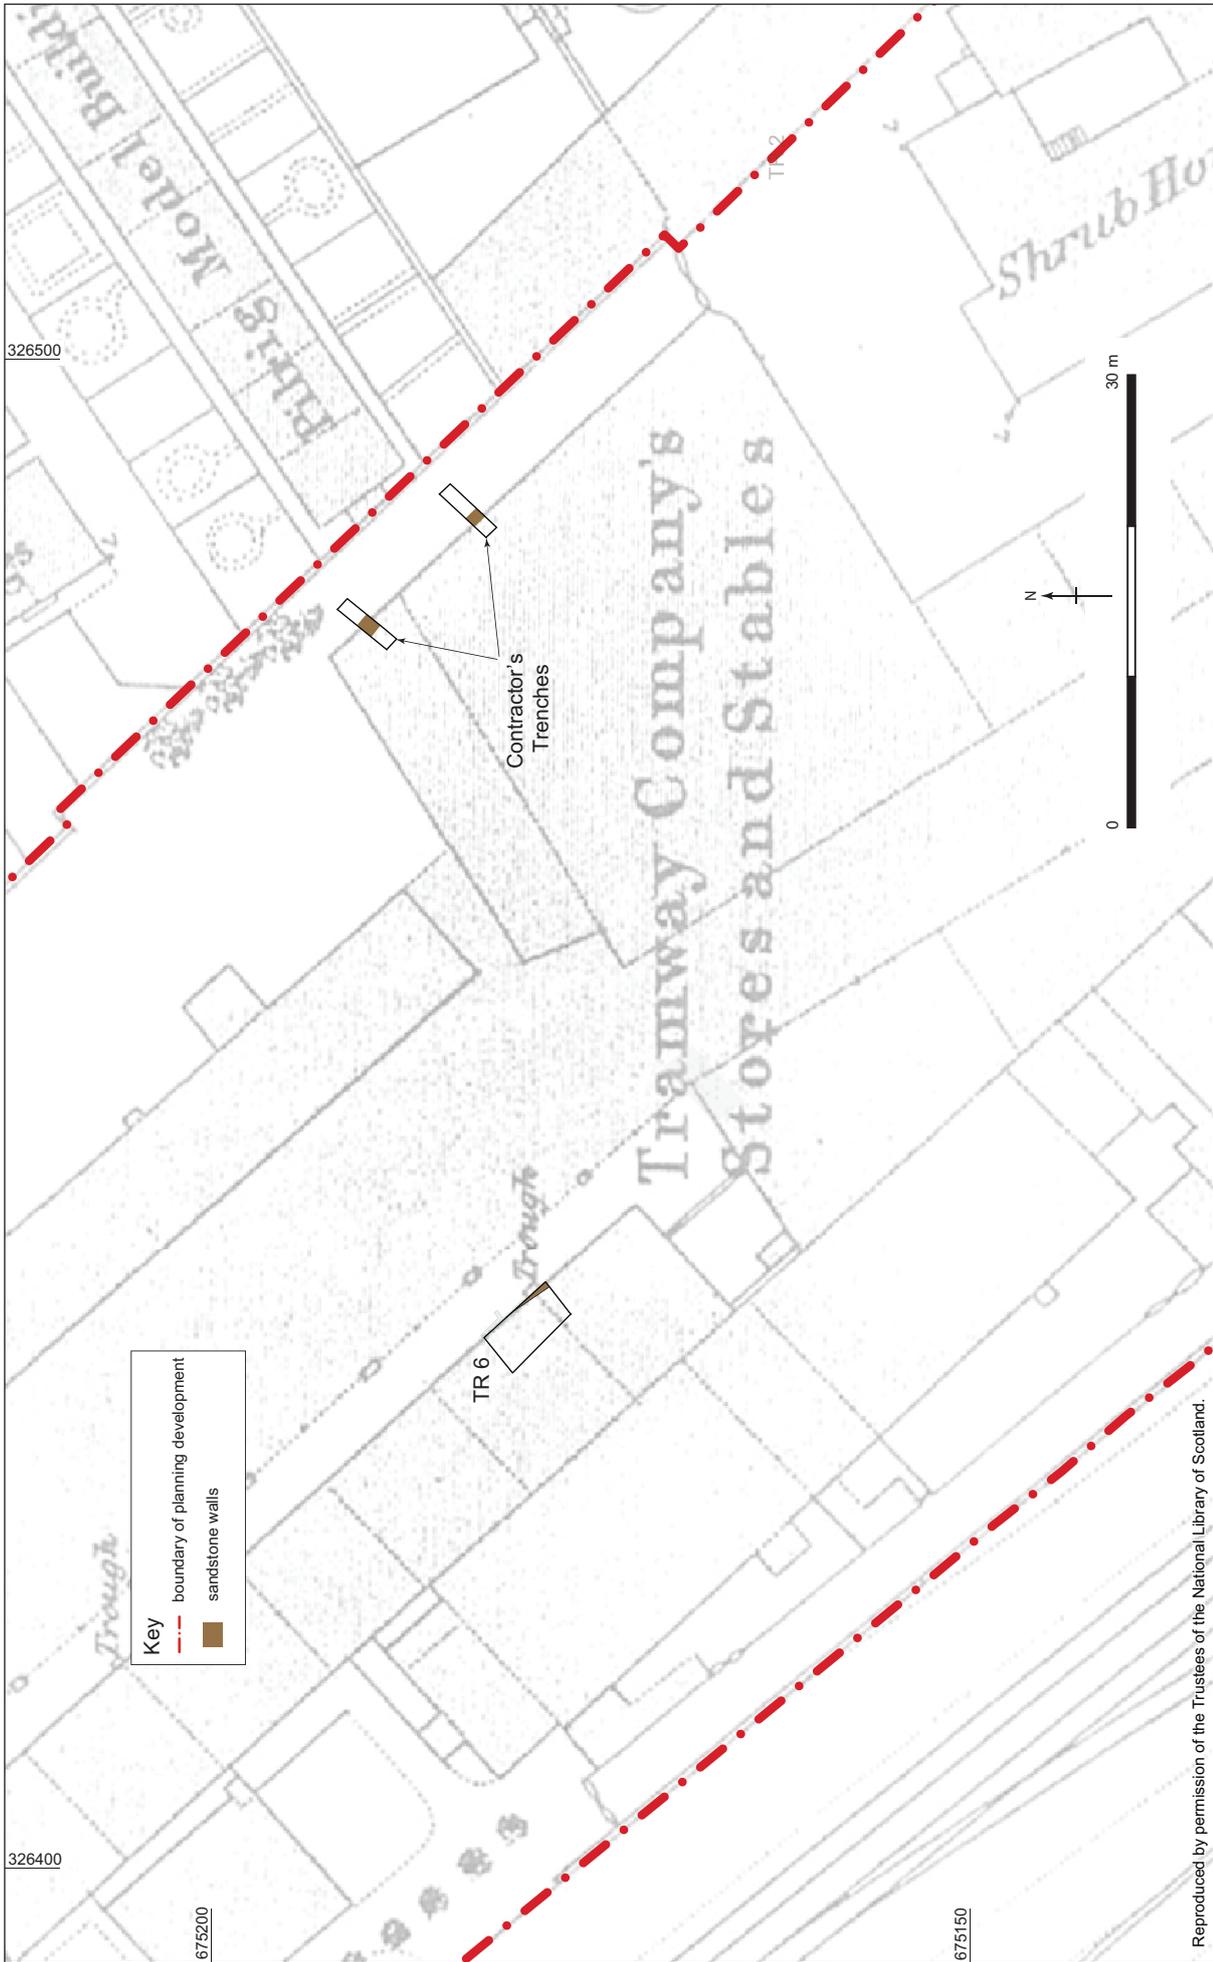
Contractors' excavations for structural supports at the north-eastern edge of the site revealed the remains of a substantial sandstone wall. A second fragmentary wall was identified in evaluation Trench 6, toward the western side of the site on a similar northwest-southeast alignment. Both walls appeared to represent parts of buildings associated with the 'Tramway Company's Stores and Stable's' as depicted on the Ordnance Survey map of 1877.

Illus 4
Sandstone walls identified on 1877 plan of site

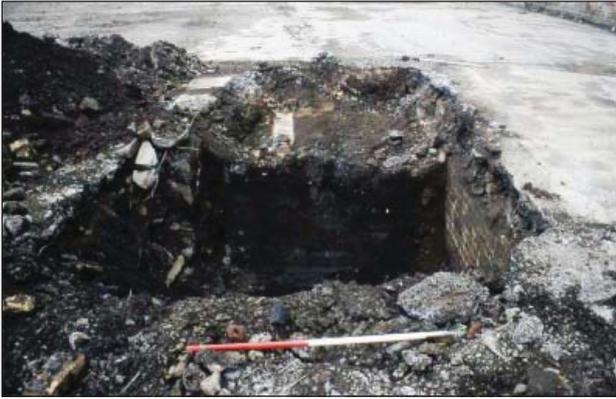
Illus 5

Trench 6 showing remains of truncated sandstone wall

Context No.	Description	Depth of deposit
600	Concrete floor	0.30m
601	Dark brown silt-loam with rubble fragments	1.30m
602	2 modern brick structures 1.50m x 1.50m sealed by (600).	1.30m
603	Sandstone wall 2.5m long x 1.3m deep in south-west facing section. Block size ave. 0.30mx 0.25m, lime mortared. Truncated by (602)	1.30m
604	Pale yellow Natural sand	<1.6m

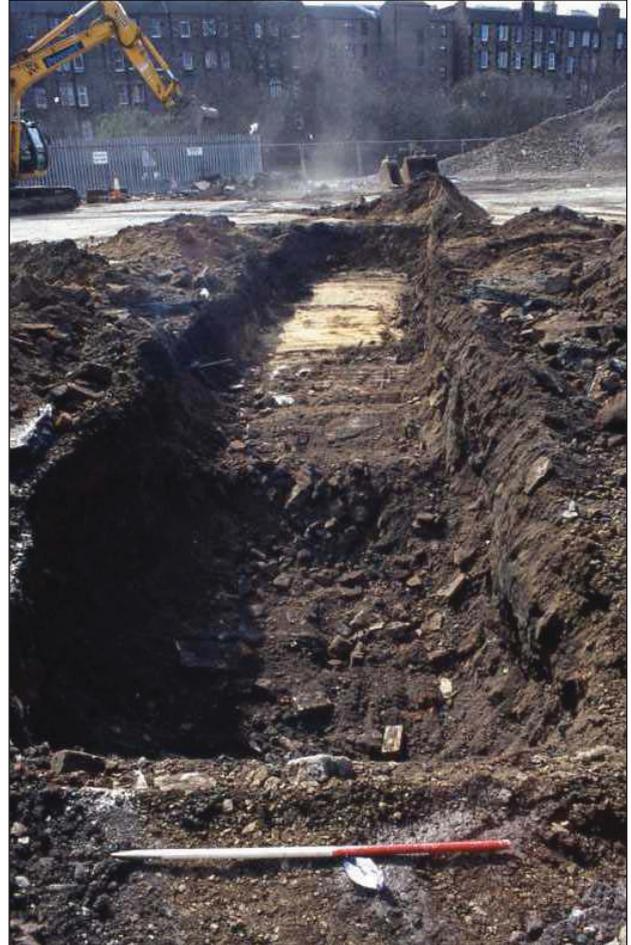
Illus 6

Trench 10 showing area of backfilled cellaring

Trenches 9, 10 and 11 were located in the area fronting onto Leith Walk toward the south-eastern limit of the site. Due to the presence of a thick layer of tarmac it was necessary to link Trenches 9 and 10 with a short adjoining to better facilitate their excavation. Trench 9 was aligned roughly east-west and was located just to the east of the access ramp leading down to the level of the main tram shed. The natural, windblown sand was encountered at a maximum depth of 0.80m, disturbed only by the line of a former service trench at its eastern end and sealed by a layer of brown sand-loam containing building rubble, similar to that seen in other areas of the site. The short length of trench adjoining Trenches 9 and 10 revealed a continuation of this stratigraphic sequence. Trench 10 was excavated at 90° to the short adjoining trench and ran parallel to Trench 9, 5m to the south. The eastern end of the trench showed a continuation of the sequence in Trench 9. The western end of the trench, however, was occupied by a large expanse of vacuous building rubble, excavated to a depth of 2.2m and subsequently abandoned for

Context No.	Description	Depth of deposit
1000	Tarmac	0.30m
1001	Partial yard surface; granite setts in north facing section at western end of trench.	0.20m
1002	Dark brown sand-loam with rubble fragments	0.50m
1003	Vacuous rubble infill of former cellar at western end of trench.	<2.20m
1004	Pale yellow natural sand	<0.8m

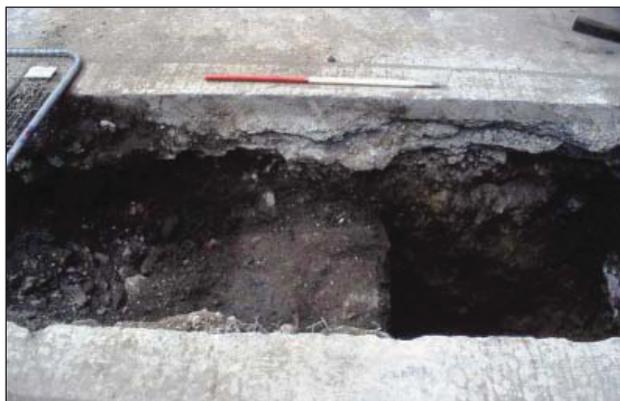
A series of narrow structural support trenches were excavated toward the eastern site boundary along the retained gable of the main tram shed. Two of the trenches, toward the southernmost end of the gable, contained the remains of a substantial, north-west-southeast aligned, stone wall. The wall, measuring approximately 0.9m wide was visible to a depth of approximately 1.75m below modern the modern ground surface. No construction cut for the wall was visible within either of the trenches in which it appeared and no further investigation was possible for reasons of health and safety. The position of the wall appeared to coincide with one depicted on the 1877 Ordnance Survey as part of the complex of buildings associated with the early tram depot.

Illus 7
Contractors trench showing sandstone wall

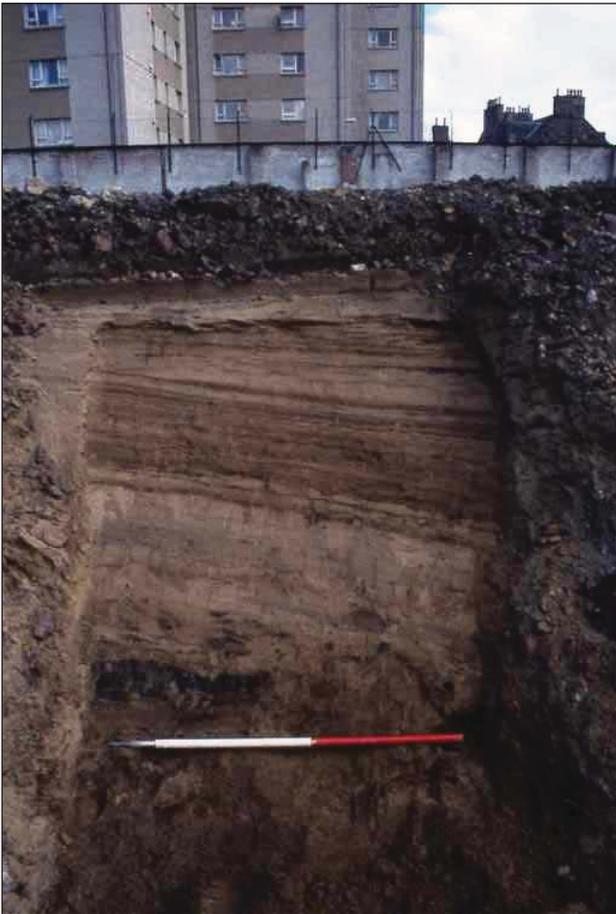
Illus 8

The ground surface, to a depth of 0.30m was represented by 0 - 0.3m of demolition rubble and made ground. Below this was 30-50 cm of loose pale yellow sand followed by 0.50- 1.0 m alternating fine (2-3 mm) laminae of fine pale yellow sand, coarse pale yellow sand and thicker laminae (4-5mm) of red brown coarse sand with a straight lower boundary. At a depth of 90 cm from the ground surface was a thin layer of coarse grit and small stones.

This was sealed by Laminae of fine pale yellow sand, with occasional laminae of dark coarse sand and occasional layers of red brown humic silty sand to sandy silt, varying from 0.01 to 0.03 m in thickness, to a maximum depth of 1.75m. The lower boundary of this sequence was also straight.

At a depth of 1.75-2.15 m Laminae of fine pale yellow sand and coarse pale yellow sand with a convoluted lower boundary. The material at the base of the sequence, at a maximum depth of 2.70m was observed to be massive dense fine, slightly silty, sand.

Assuming that the dense pale yellow slightly silty sand recorded in both sequences is the same unit, then it is possible to suggest a natural sequence for the site from the end of the last glacial period. The sequence appears to consist principally of wind blown sand, given the degree of sorting noted in most of the deposits. The sequence has mostly been one of deposition. In contrast only two significant erosive episodes were noted. The contact between the lowest unit in the Road exposure and the unit above has a convoluted form indicative of erosion. Higher up the sequence (at approximately 0.9m) there is a line of stones and grit which is sufficiently sorted to suggest that it is a deflation lag deposit, i.e. that which is

Profile of natural sand formation below site of Shrub House

left behind when finer material is blown away by the wind. In the unit from 1.0-1.75m accumulation has been intermittent and the intervals between episodes of deposition that soil formation has occurred. The resulting stabilisation layers are not very thick; suggesting that any hiatus in deposition was relatively short lived, perhaps in the order of a few years.
