Project Code: MESR08  
Planning application reference number: N/A  
Date of report: 25<sup>th</sup> July 2008  
Client: Erskine Stewart's Melville Schools

## The Mary Erskine School, Ravelston, Edinburgh Results of an Archaeological Watching Brief

# The Mary Erskine School, Ravelston, Edinburgh

## Results of an Archaeological Watching Brief

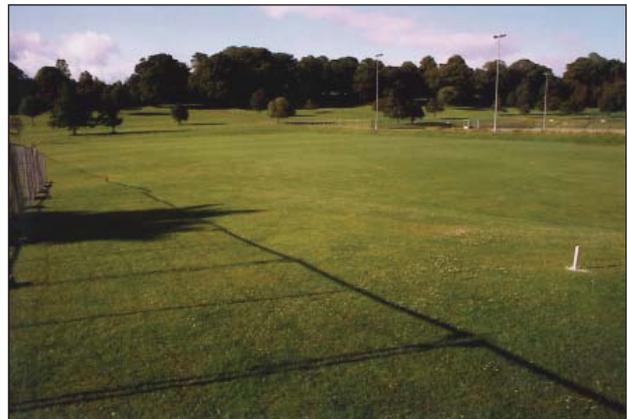
**Illus 2**

View looking S-W showing extent of terracing. The trees in the background mark the former line of Ravelston Dykes.

Beneath the turf, the topsoil averaged 0.2m in depth, and consisted of a fine, mid-brown slightly clayey silt. Below this, a more clayey layer (containing frequent small-medium stones and occasional fragments of modern china) of around 0.4m in depth masked an orange–grey weathered fluvio-glacial silty-clay subsoil. The area slopes down somewhat towards the east and the earlier pitch had been terraced into this slope by up to 1m on the western side (see illus 1). This would have removed much of the subsoil - in one place it had been removed entirely, leaving a mid-dark grey stony till exposed. In some areas, the subsoil appeared to have been redeposited, and contained occasional fragments of modern ceramics. This suggests that some of the excavated subsoil had been re-used to level the site (see illus 2). Localised

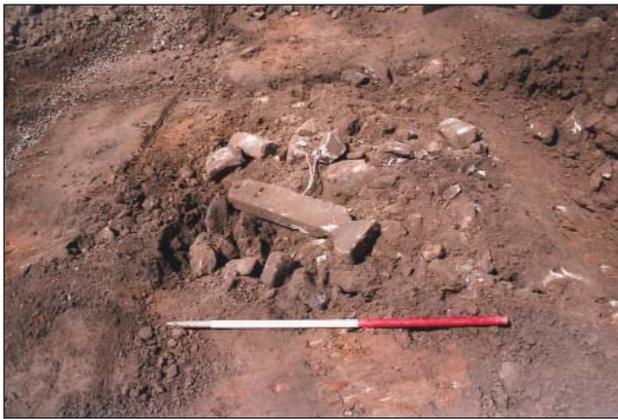
Illus 3

One of several areas of rubble infill.

hollows had been filled with mixed rubble, including bricks, metal wire, metal fence posts, and in one instance, an uprooted concrete water-mains marker (see illus 3). In two places, these areas of infill took on a more linear shape but appeared to run for only a few metres, and so are probably not culverts (see below). They may, however act as sumps draining the surrounding areas.
