Project Code: CORO08  
Date of report: 10<sup>th</sup> October 2008  
Client: The National Trust for Scotland

## Historic Building Survey of Coroghan Castle, Canna

*A Historic Building survey of the ruins of Coroghan Castle, Canna was carried out by Headland Archaeology Ltd from 12th to the 14th August 2008. The castle is owned by The National Trust for Scotland and is located at the E end of Canna, situated on the NW side of a stack some 25 m high that is otherwise surrounded by the sea.*

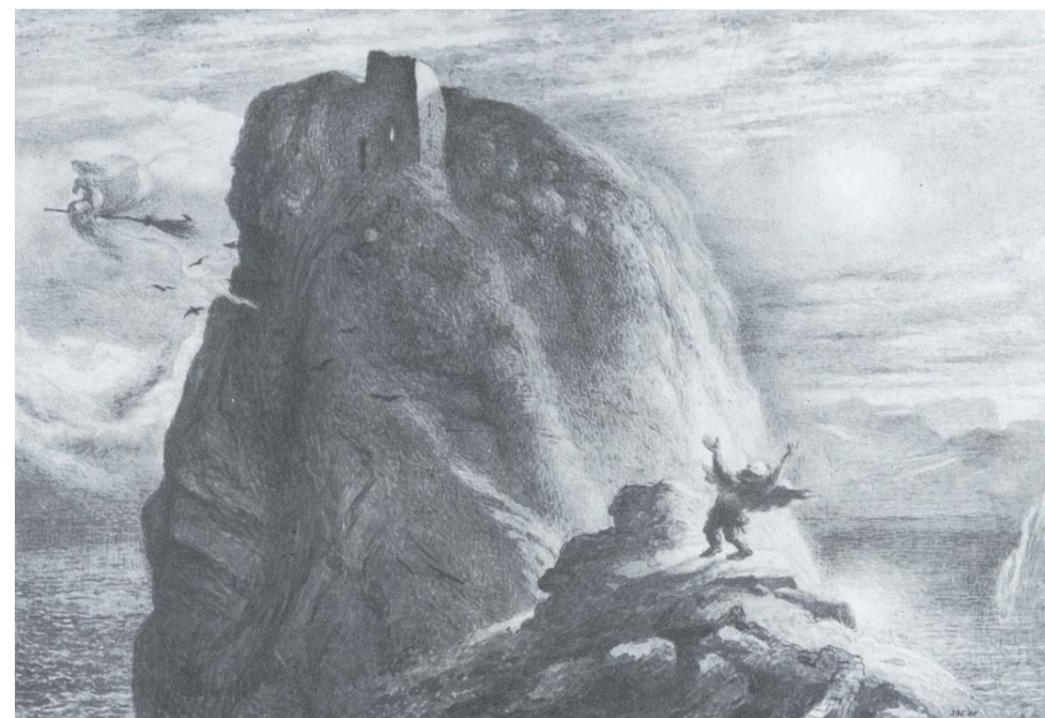
‘The Witches’ Home’ (Coroghan). Sketch by Dickey Doyle, 1875. Doyle visited Canna in 1875 on Viscount Sherbrooke’s yacht.

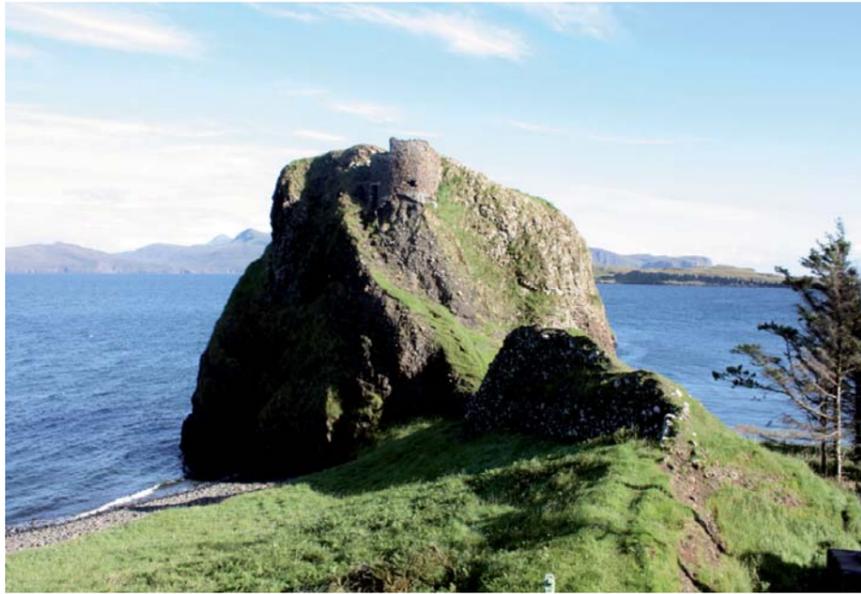
**Illus 2**  
Castle on side of stack seen from NW

The building is located on the side of a stack some 25 m high and with a flat sub-rectangular top 17 m long and 4 to 7 m wide. It is built across the only accessible route up to the summit on the NW side of the stack and overlooking the approach from the mainland (Illus 2).

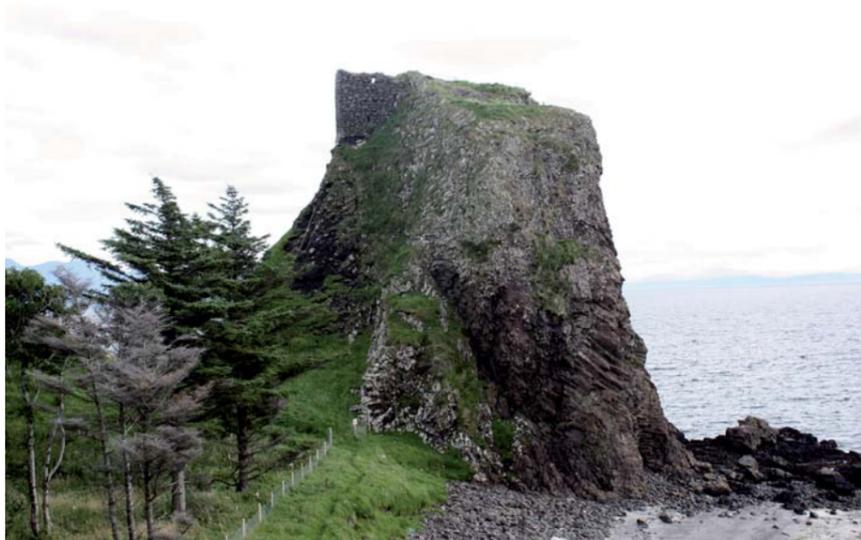
**Illus 3**  
Castle on side of stack seen from SW

the top of the stack and measures 4.4 m by 5.5 m with a rounded external corner to the NW (Illus 3). Natural rock-faces have been incorporated into its structure to form the walls to the S and E. The walls are up to 6 m high and built from mortared random rubble. The outer and inner faces are faced by larger stones while the wall core comprises smaller rubble. The outer walls vary in thickness from 0.8 m at the NW corner down to 0.4 m above the entrance to the NE.

There are extensive scars at the base of the outer wall faces to the W and N where the outer facing stones have been lost, exposing the wall core. This is likely to be one of the reasons the building is becoming unstable.

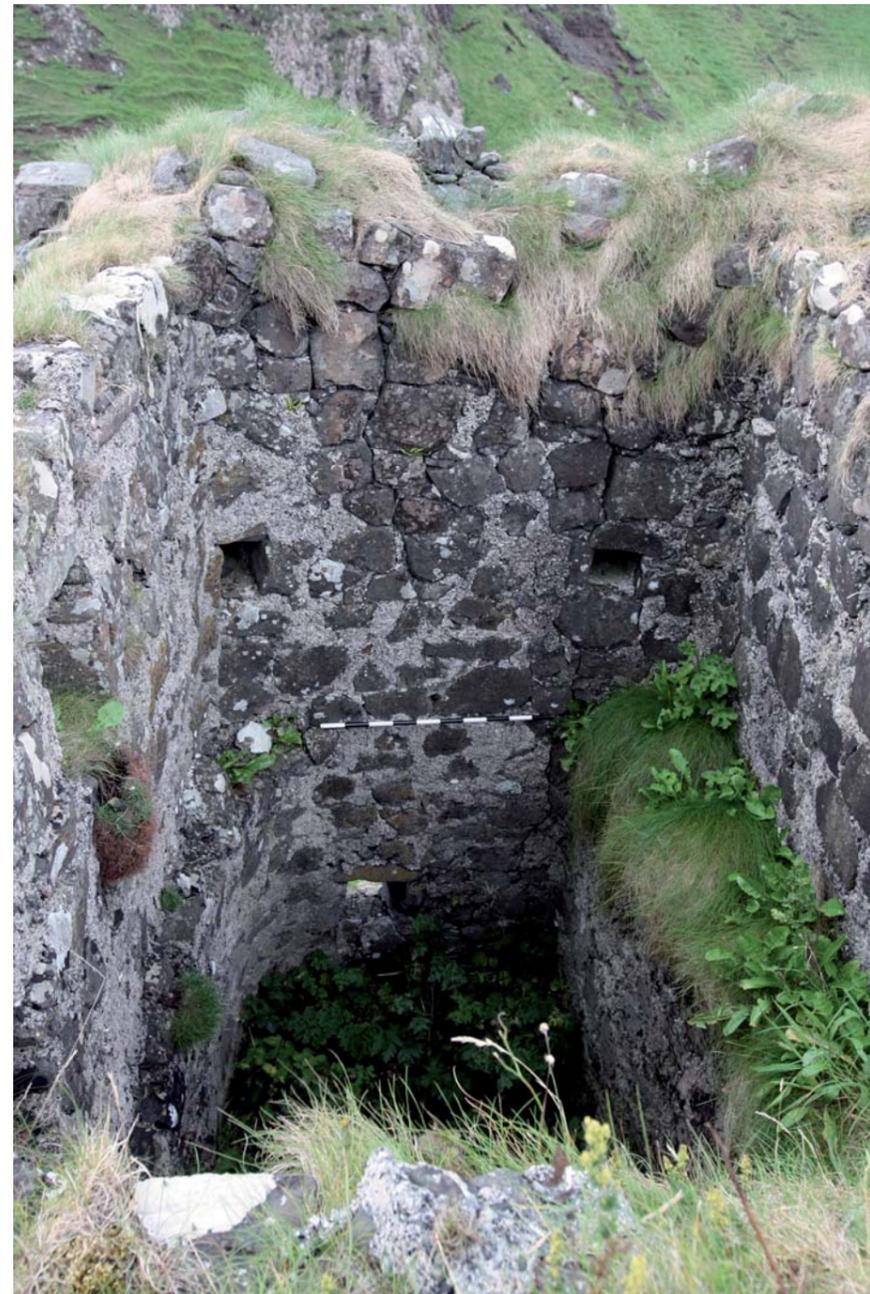
**Illus 7**  
Internal S-facing elevation of the W wing Chamber A.

Chamber A is located at ground floor level in the W part of the building. It is 2.4 m long by 1.5 - 1.6 m wide. The NW corner is rounded reflecting the form of the outer wall face, while the other three corners are roughly square. The masonry that makes up the rounded corner forms a small scarcement at the first floor level (Illus 7). The E half of the S wall comprises exposed bedrock; the remaining walls comprise mortared random rubble with remains of harl pointing still surviving in some areas.

The chamber has no visible entrance and must have been accessed through a trapdoor in the floor of Chamber C above. There are five sockets in the W wall

indicating the position of the floor joists of the chamber above. If the current surface represents the original floor level in the chamber it would only have been 1.45–1.55 m high.

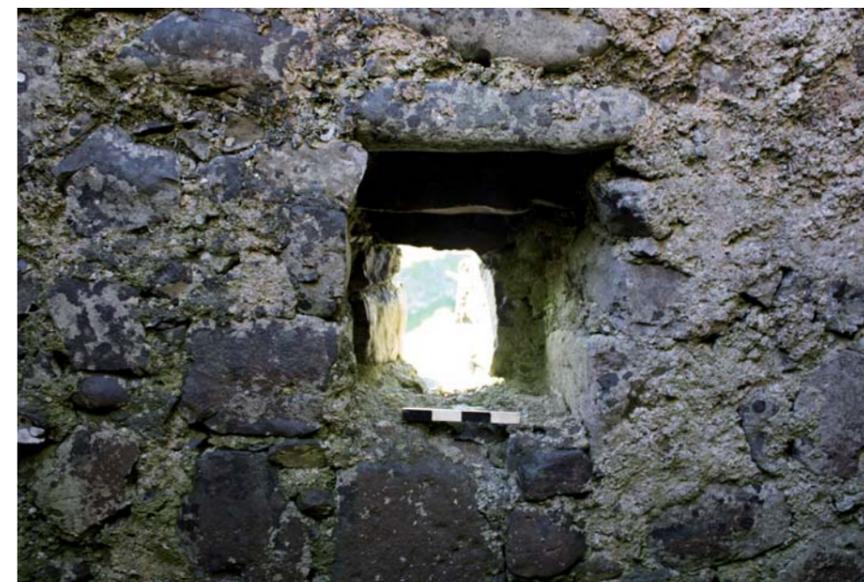
**Illus 8**  
Opening F01 in the W wall of Chamber A

F01 is an opening located near the middle of the W wall. The opening is situated only 0.3 m above the current ground level. It measures 0.35 m wide by 0.46 m high at the inner wall-face and has a stone lintel. The rough sill of the opening is level, while the top of the opening is stepped down twice to reduce the height to some 0.27 m at the outer wall-face. The sides of the opening are also stepped in and angled reducing the width to 0.11 m on the outside. There are remains of harl pointing on the inside of the opening.

Four of the openings (F1, 2, 11 and 12) had a much smaller aperture on the outside which may suggest that they were built also to function as gun loops. F1 and F2 were located some 0.3 m above the floor suitable for a lying down shooting position, the other two that were located 0.9 m and 1.1 m above the floor indicate a kneeling or crouched shooting position.

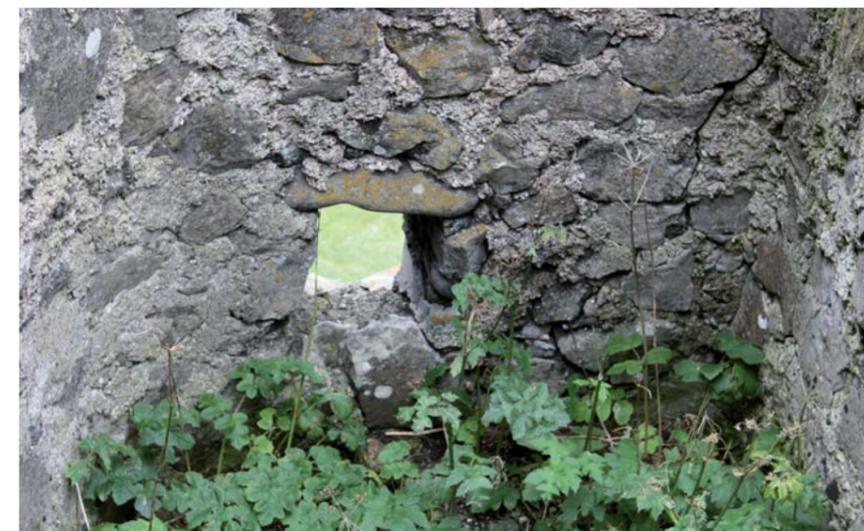
**Illus 9**  
Opening F02 in the N wall of Chamber A

F02 is an opening in the W half of the N wall overlooking the approach to the building. It is similar in size and position to F01, the feature being located close to the original floor level at only 0.25 m above the current ground level. The opening has an interior stone lintel and measures 0.28 – 0.33 m wide by 0.45 m high. The rough sill of the opening is largely level while the top is stepped down reducing the height to 0.35 m. The outer face of the wall has collapsed around the opening. There is harl pointing across the rough sill of the opening.

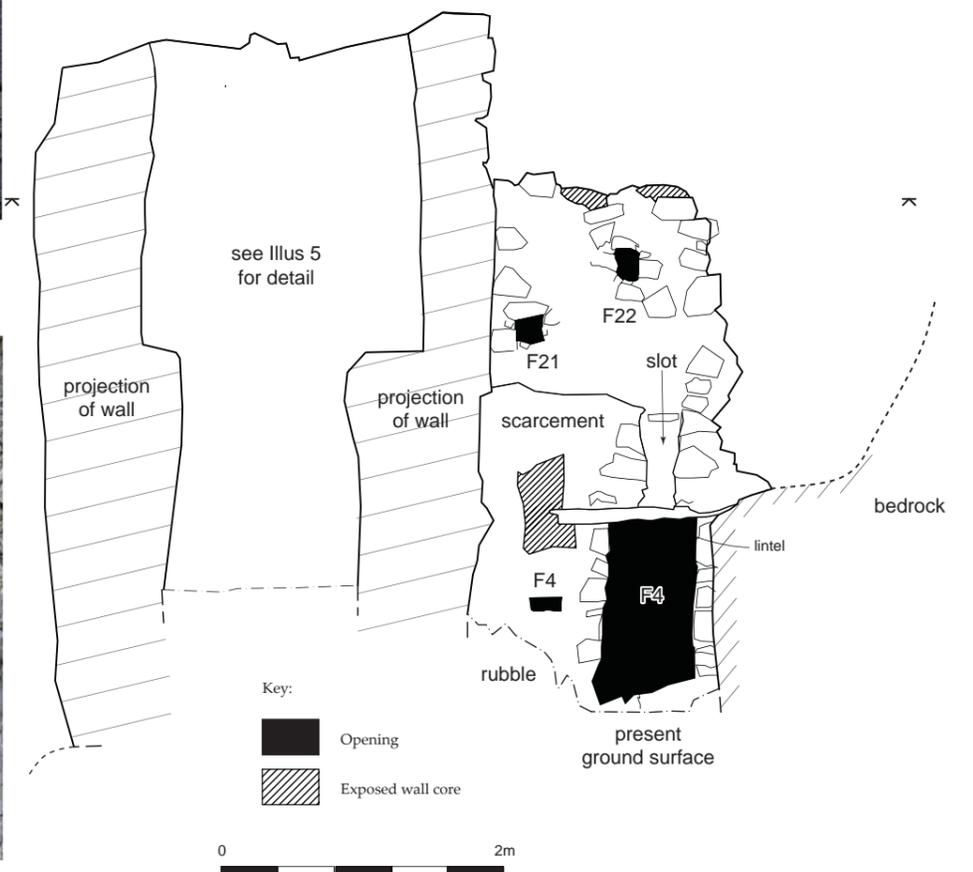
**Illus 10**  
Chamber B, D. Internal N elevation

Chamber B is located at ground floor level in the E wing and contains the main entrance into the building. The chamber is defined by mortared stone walls to the N and W. Remains of harl pointing still cover most of the W wall. The NW corner is rounded, the curving masonry forming a scarcement in the corner at first floor level (Illus 12). The E side largely comprises bedrock with a small area in-filled with masonry next to the door to the N. There are no visible remains of the S wall at this level, but the rising level suggest that chamber was no more than 1.3 to 1.5 m wide and 1.7 m long. Due to the steeply rising ground the height of the chamber varies

from 2.4 m at the entrance down to 1.4 m to 1.6 m under the S end of the floor of the chamber above.

The chamber is partly filled with rubble including a fairly large block of collapsed masonry located just inside the main entrance

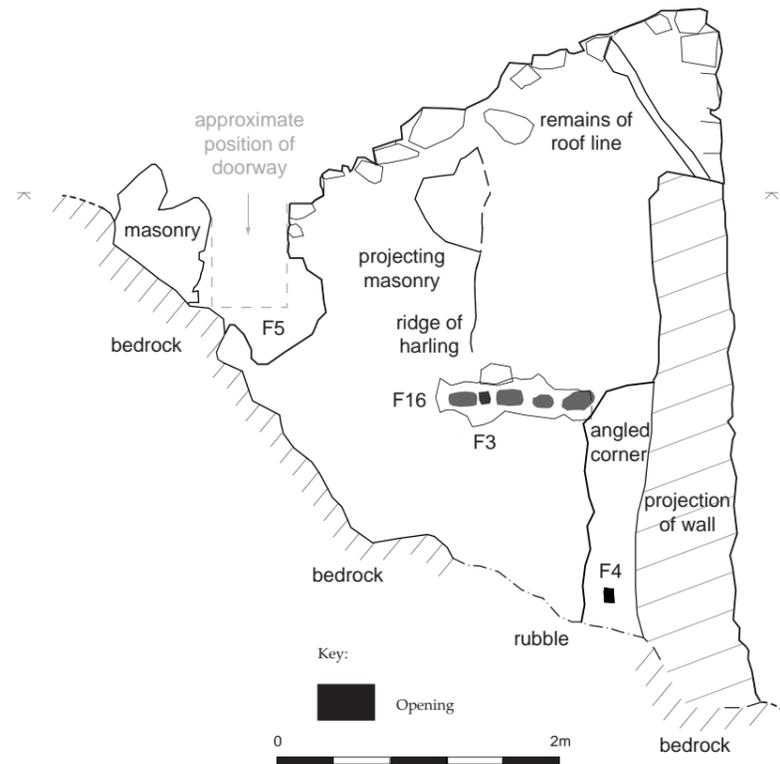
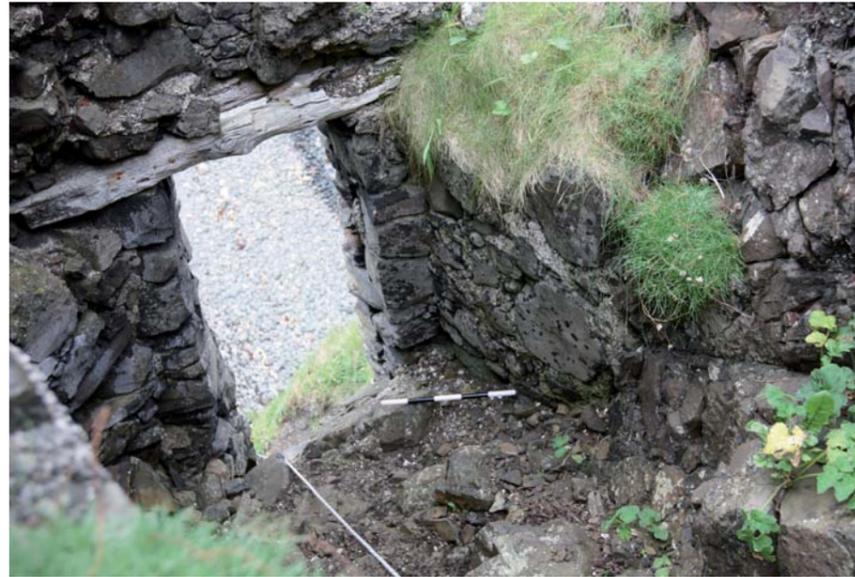
**Illus 11, 12, 13 & 14**  
Chamber B and D. Internal W elevation (top left)  
Internal S-facing elevation of the E wing (bottom left)  
Masonry to N of door F04 (above)  
Door-opening F04 seen from the S (below)

The doorway into the building is 0.7 m wide and 1.85 m high with two stone steps leading up to the door from the outside. The lintel comprises two wooden beams. The outer beam is 1.1 m long, 0.19 m wide and 0.12 m thick. There is a 0.12 m wide and 0.04 m deep slot in the upper part of the beam indicating that the timber is re-used from some other wooden structure.

The inner lintel appears also to be re-used timber as its W end has been worked. It is 1.44 m long, 0.18 m wide and 0.12 m thick. There is a 0.07 m gap between the outer and inner lintel. A 0.06 m deep and 0.22 m wide slot is cut into the inner beam above the middle of the doorway forming a rectangular hole 0.22 m by 0.13 m up against the outer beam. A rectangular slot in the inner wall face above the doorway corresponds with the hole in the lintel below (Illus 14). A 1.1 m deep bar-hole is located on the W side of the doorway.

The E wing contained the entrance into the building. There were no traces of any doorframe or hinges in the masonry at the opening suggesting that the opening had contained a door. It is possible that a door frame was attached to the masonry using pegs hammered into gaps in the masonry, but here were no clear indications of this and it would not provide a very secure fixing of the door to its opening. However, there was a slot in the inner wall face above the door extending down to a corresponding slot in the wooden lintels above the door suggesting that the opening and a possible door was blocked by lowering a thick wooden beam from above. A deep slot in the masonry on the W side of the door may have held a second wooden beam that would have secured this beam horizontally.

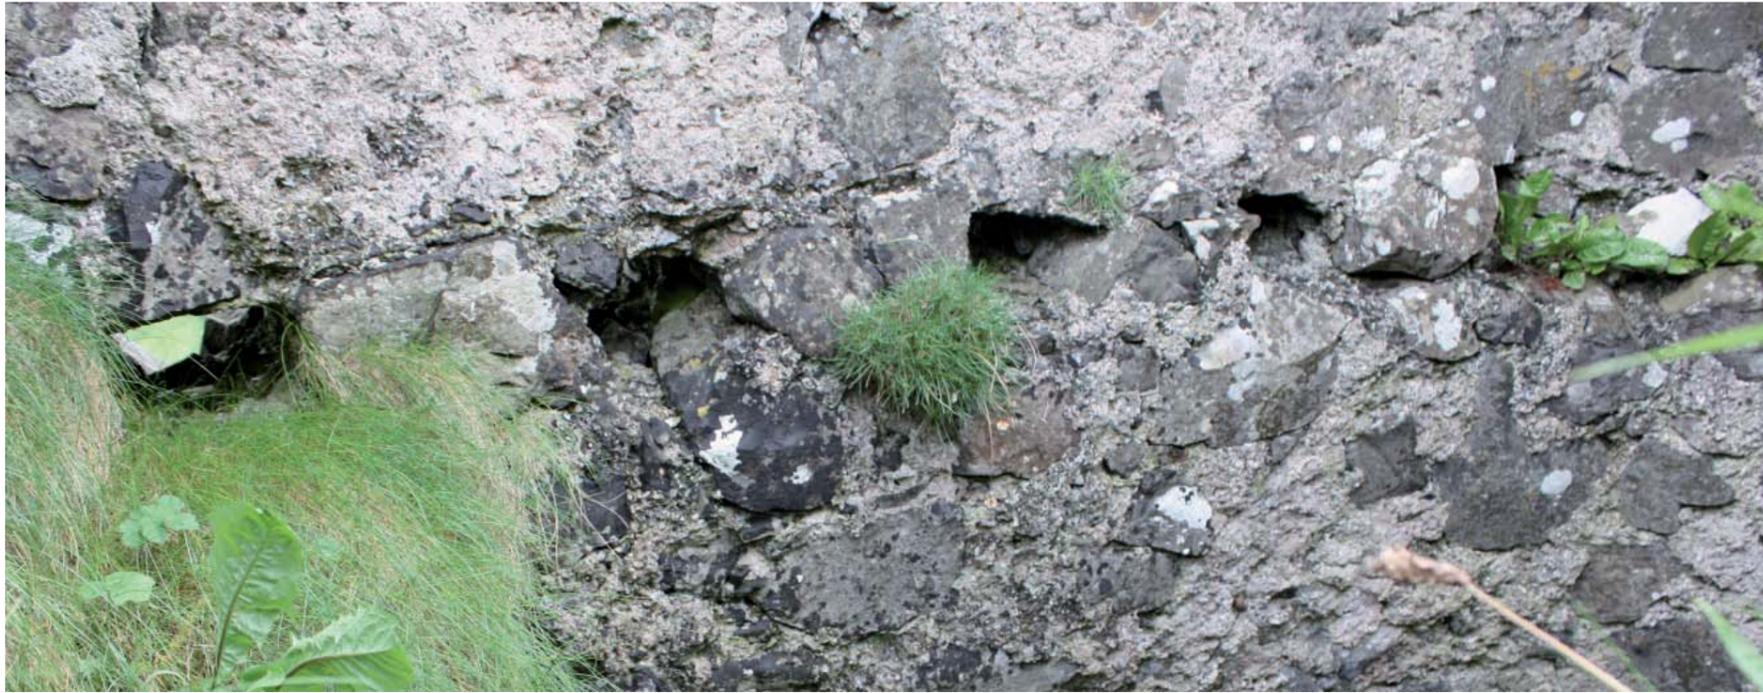
**Illus 16**  
Five slots in the W wall for the floor joists of Chamber C

The floor level of the chamber is defined by the broad scarcements and five sockets (F06 – F10) for the floor joists in the W wall. The sockets indicate that the joists were spaced out at around 0.5 m centre to centre (Illus 15).

F06 is a rectangular socket 0.21 m wide by 0.15 m high. It is located towards the SW corner and is on the same level as the front edge of the scarcement along the S wall. It is one of five sockets that used to hold the floor joists in Chamber C. The socket is lined with mortar that forms a cast of the joist. Today the socket is visible externally as the outer wall-face has fallen away at this point.

F07 is an oval socket 0.18 m wide by 0.16 m high to the N of F06. The shape of the socket indicates that it held a sub-oval joist with a flat upper surface. As with F06 to the S the socket continues through the wall, but is likely to originally have been sealed off on the outside.

F08 is a rectangular socket 0.20 m wide by 0.13 m high to the N of F07. The form of the socket indicates that it held a rectangular joist. The socket continues through to the outer wall face, but a lip of mortar deep inside the hole indicates the original depth of the socket that was originally sealed off on the outside.

F09 is a D-shaped socket 0.19 m wide by 0.13 m high to the N of F08. As with the three sockets to the S, the shape of the floor joist is preserved in the mortar lining the socket. The socket is 0.27 m deep.

F10 is a sub-rectangular socket 0.23 m wide by 0.12 m high. It is located 0.23 m to the N of F09 and 0.2 m to the S of the NW corner. The shape of the socket indicates that it held a rectangular floor joist that extended 0.18 m into the wall.

Imprints of the five wooden floor joists are still clearly visible in the W wall. The two chambers are fairly small measuring 3.7 m<sup>2</sup> and 6.2 m<sup>2</sup> respectively. None of the walls in the W wing are preserved up to their original wall head, but it seems likely that the surviving remains are close to their original height. Since the wall heads are not surviving it is not clear how the roof was pitched.

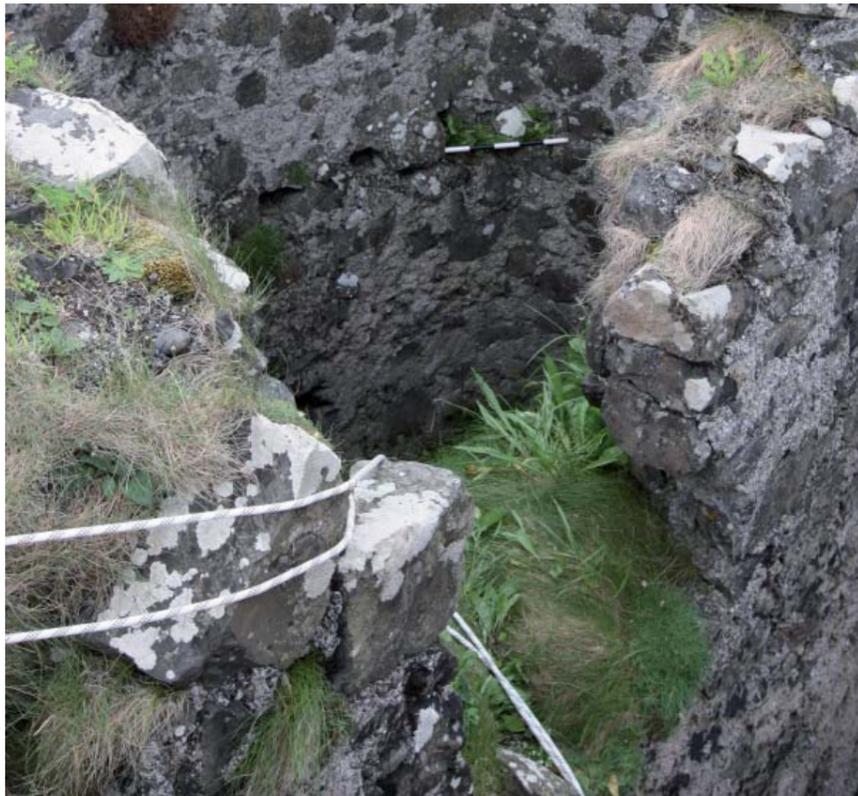
**Illus 17 (left)**  
Door F05 at the SE corner of Chamber C

The door opening leading into Chamber C is situated at the SE corner in the E wall. It is 0.55 m wide and survives up to a height of 0.8 m. An 0.11 m wide and up to 0.10 m deep vertical slot at the E end of the S wall indicates the position of the S door cheek. The slot is D-shaped in cross section reflecting the cross section of the door post. Only a small part of the other side of the door opening survives, but also it shows traces of the door cheek.

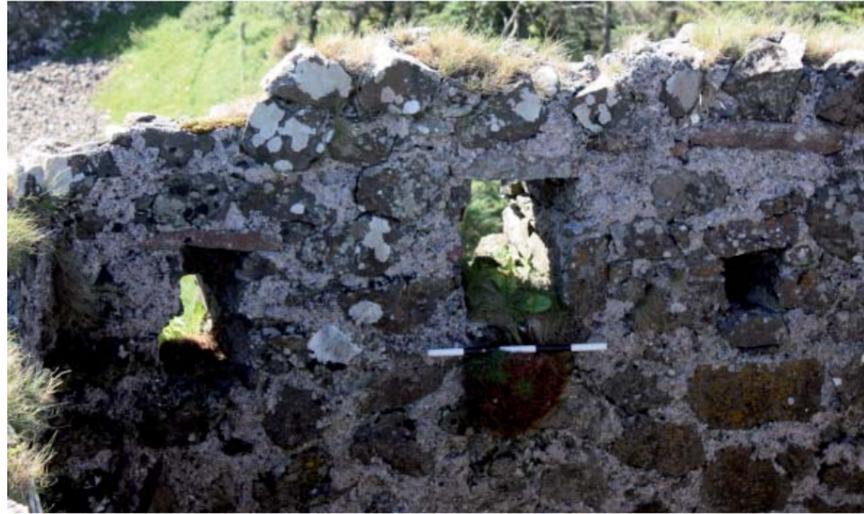
**Illus 18**  
Openings F11-13 in the W wall of Chamber C

F11 is a sub-rectangular opening located in the S half of the W wall. At the inner wall-face it is 0.44 m high by 0.16 m wide capped by a stone lintel. The base of the opening is level and is 0.9 m above the floor while the top of the opening is stepped down twice to reduce the height to 0.26 m at the outer wall-face. The sides of the opening are slanted inwards reducing the width to 0.16 m at the outside.

F12 is a rectangular opening located near the middle of the W wall to the N of F11. It is 0.40 m high by 0.26 to 0.31 m wide with a stone lintel. The opening is placed 0.2 m higher in the wall than F11 to the S with the base of the opening at 1.1 m above the floor level. The top and base of the opening are roughly level, while its sides are splayed reducing the width to 0.18 m on the outside.

F13 is a small rectangular opening located in the N half of the W wall 0.46 m to the N of F12. It measures 0.16 m wide by 0.20 m high and has a small stone lintel and a similar sill. The sill is at the same height as F12 to the S at 1.1 m above the floor level. The opening slants down at a 30 degree angle towards the outer wall face. As a result the lintel on the outside lies 0.15 m below the sill on the inside.

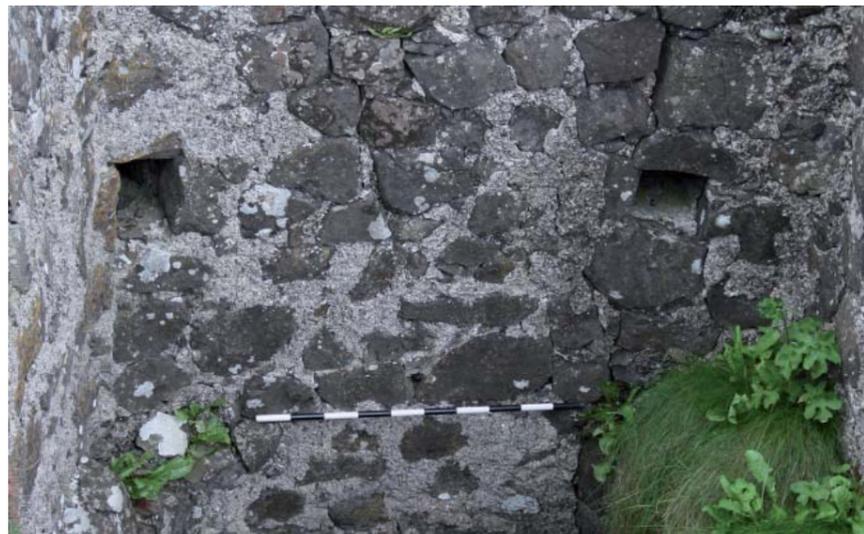
**Illus 19**  
Openings F14-15 in the N wall of Chamber C

F14 is a rectangular opening located in the N wall at the NW corner of the chamber. It is 0.24 m high by 0.17 m wide with a stone lintel. The opening is aligned towards the NW and at right angles to the rounded corner. The base of the opening is 0.54 m above the floor level on the inside but slopes downwards towards the outer wall at an angle of 16 degrees where it appears as a triangular opening 0.11 m high by 0.15 m wide.

F15 is a rectangular opening located in the N wall near the NE corner of the chamber. It is 0.24 m high by 0.17 m wide with a stone lintel. The base of the opening is at the same level as F14 to the W but in contrast to F14 it slopes upwards towards the outer wall-face at an angle of 15 degrees.

Opening F15 is different from all the others as it slopes upwards through the wall. This renders it fairly useless for observation or firing. One reason for its incline might be that it served as a primitive chimney. There were no traces of any fireplaces in the chamber, but this could have been heated using a brazier situated up against the wall below the opening letting the smoke out. However there was no trace of soot on the wall or inside the opening to support this suggestion.

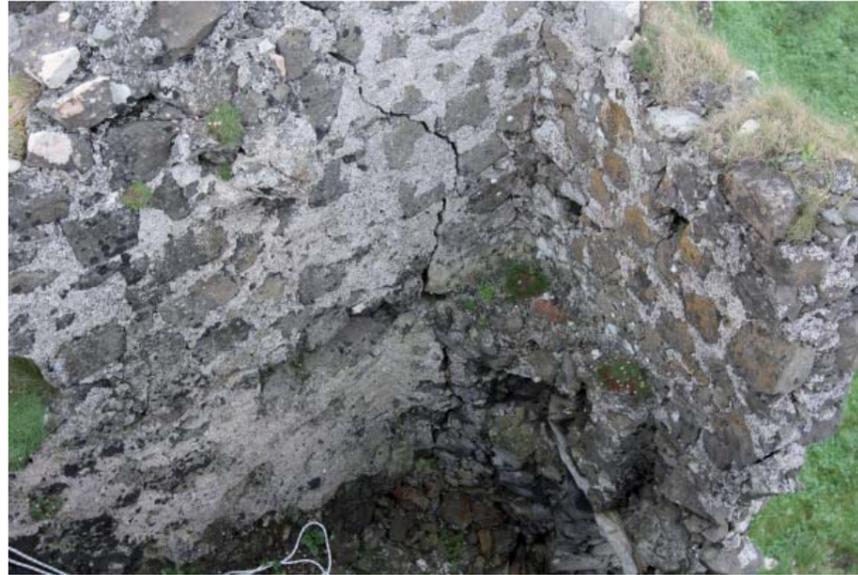
**Illus 20**  
NW corner of Chamber D

As in the W part of the building, the NW corner of the upper chamber is less rounded than the chamber below forming a small scarcement in the corner. The scarcement continues around the inside of the N wall, only truncated by the slot in the masonry above the door (see F04).

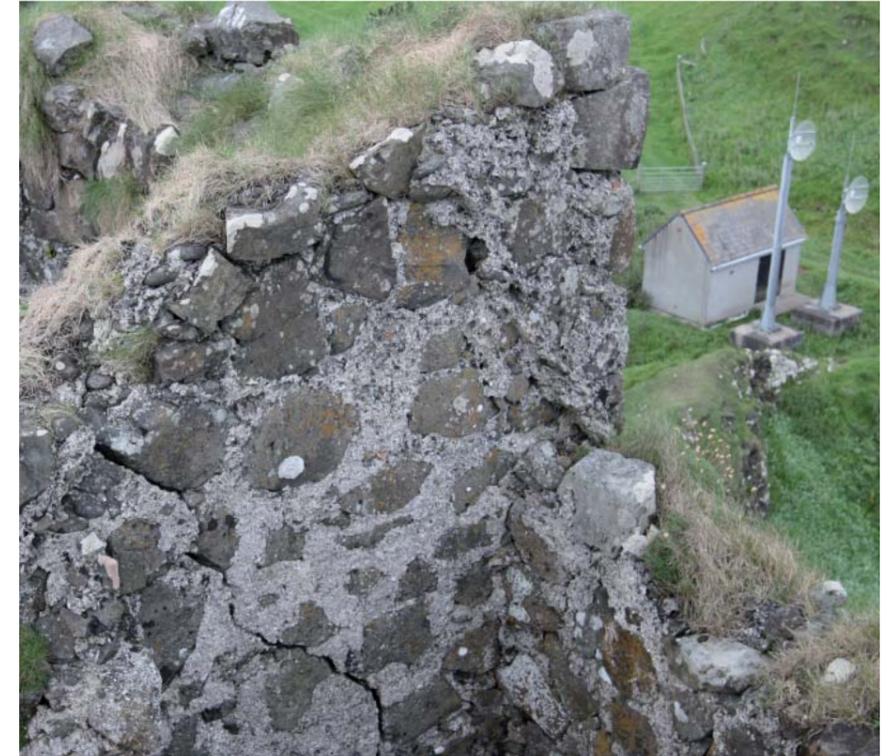
**Illus 21**  
Traces of the pitched roof-line of Chamber D visible on the outer E wall of Chamber C

The two surviving walls of the chamber to the N and W are 1.5 m and 2.4 m high respectively. The N wall survives up to its full height at its W end where it meets the traces of the pitched roof-line of Chamber D visible on the outside of the E wall of Chamber C (Illus 20). The roof-line has a downward pitch of 55 degrees towards the N.

Chamber D was situated on the first floor in the E wing. It measured some 1.2 by 1.6 m, less than 2 m<sup>2</sup> of floor space. The floor of the chamber appears to have been made from four, possibly five floor joists set next to each other. The W ends of the joists were deeply embedded into the E wall of the W wing which could indicate that they were cantilevered with little or no support in the opposite wall. The north wall of the chamber survives to its original height at the NW corner as indicated by the traces of the pitched roof-line in the adjacent wall.

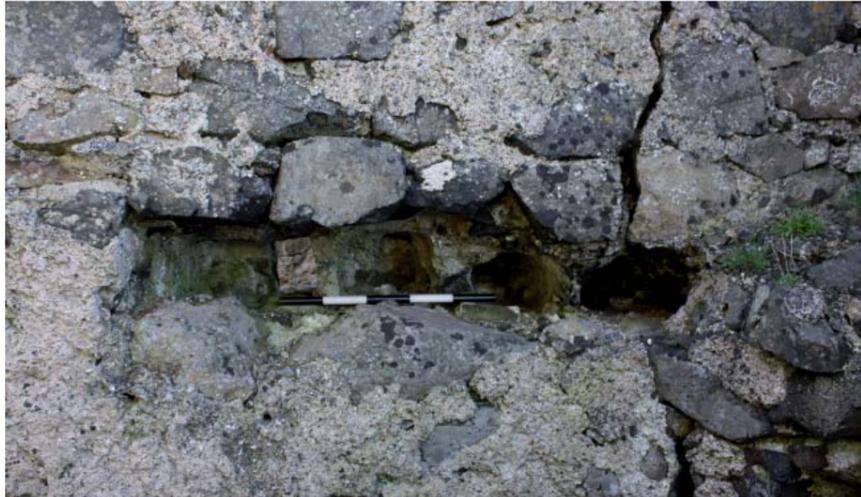
**Illus 22**

F16 is a 1.12 m long, 0.2 m high and 0.6 m to 0.9 m deep slot in the W wall. The slot was formed by the insertion of four wooden beams close to each other into the wall. The beams were so close that the gaps between them were filled with mortar as the wall was built up and over the joists, leaving behind imprints of their shape and dimensions. The slot also contains the imprint of a fifth beam (F03) that continued straight through the wall into Chamber A. It is possible that this beam also was part of the floor support in Chamber D

F17 is the imprint of a rectangular wooden beam, 0.30 m wide by 0.14 m high at the S end of the long beam slot. The socket extends 0.60 m into the wall. The projected imprint of beam F03 lies immediately to the N of F17. There is no mortar surviving between the two slots suggesting that the two beams were placed next to each other.

F18 is the imprint of a rectangular wooden beam, 0.22 m wide by 0.16 m high to the N of F03. The socket extends 0.70 m into the wall. A 0.05 m wide wall of mortar separates the slot from F03 to the S.

F19 is the imprint of a D-shaped wooden beam to the N of F18 that is 0.17 m wide by 0.16 m high and extends 0.77 m into the wall. A 0.08 m wide wall of mortar separates the slot from F18 to the S.

F20 is the imprint of a D-shaped wooden beam at the N end of the long beam slot. It is 0.19 m wide by 0.16 m high and extends 0.90 m into the wall. A 0.03 m wide wall of mortar separates the slot from F19 to the S.

Slot F16, with imprints of floor joists F03, F17-20 in the W wall of Chamber D

The intermittent vertical ridge in the W wall in line with the N side of the presumed corbel might reflect the position of a light wooden S wall resting on floor joist F17 at the S end of the beam slot F16.

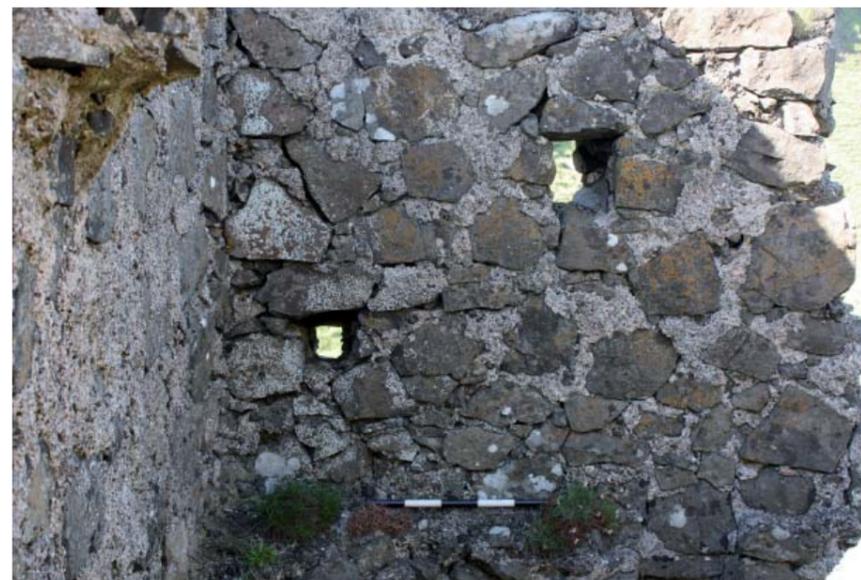
**Illus 23**

F21 is a square opening in the W half of the N wall. It measures 0.17 m by 0.17 m and is located near NW corner and only 0.35 m above the floor of the chamber. The opening slopes downwards towards the outer wall face at a 15 degree angle.

F22 is a rectangular opening in the W half of the N wall. It is 0.16 m wide by 0.24 m high and is located to the E of F21 some 0.80 m above the floor of the chamber.

Openings F21 and F22 in the N wall of Chamber D
