**Hermiston Steading, Edinburgh**

Phase 3: Archaeological Evaluation

**PROJECT SUMMARY SHEET (HSE07)**

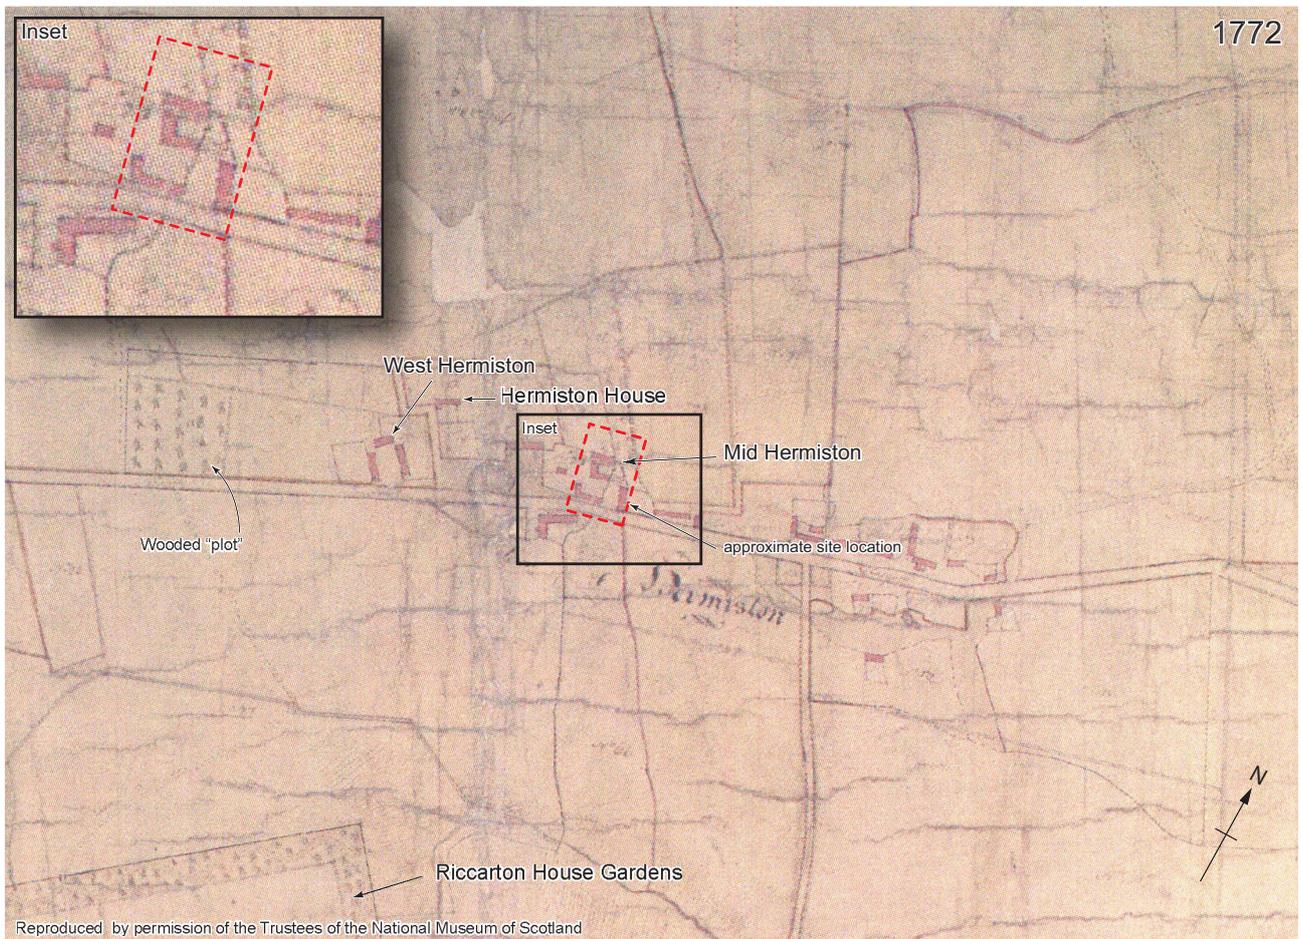
Illus 2

The first detailed plan of the area is an estate plan dated 1772 (Illus 2). This shows, from west to east, a square wooded plot, a 3-sided farm steading (West Hermiston), then a dog-legged road heading north. To the NE of the steading, there is a rectangular building which is probably Hermiston House, and an old farmhouse to the SE. The early Mid Hermiston Steading is SE of this; a group of four separate units, with a track running north between them.

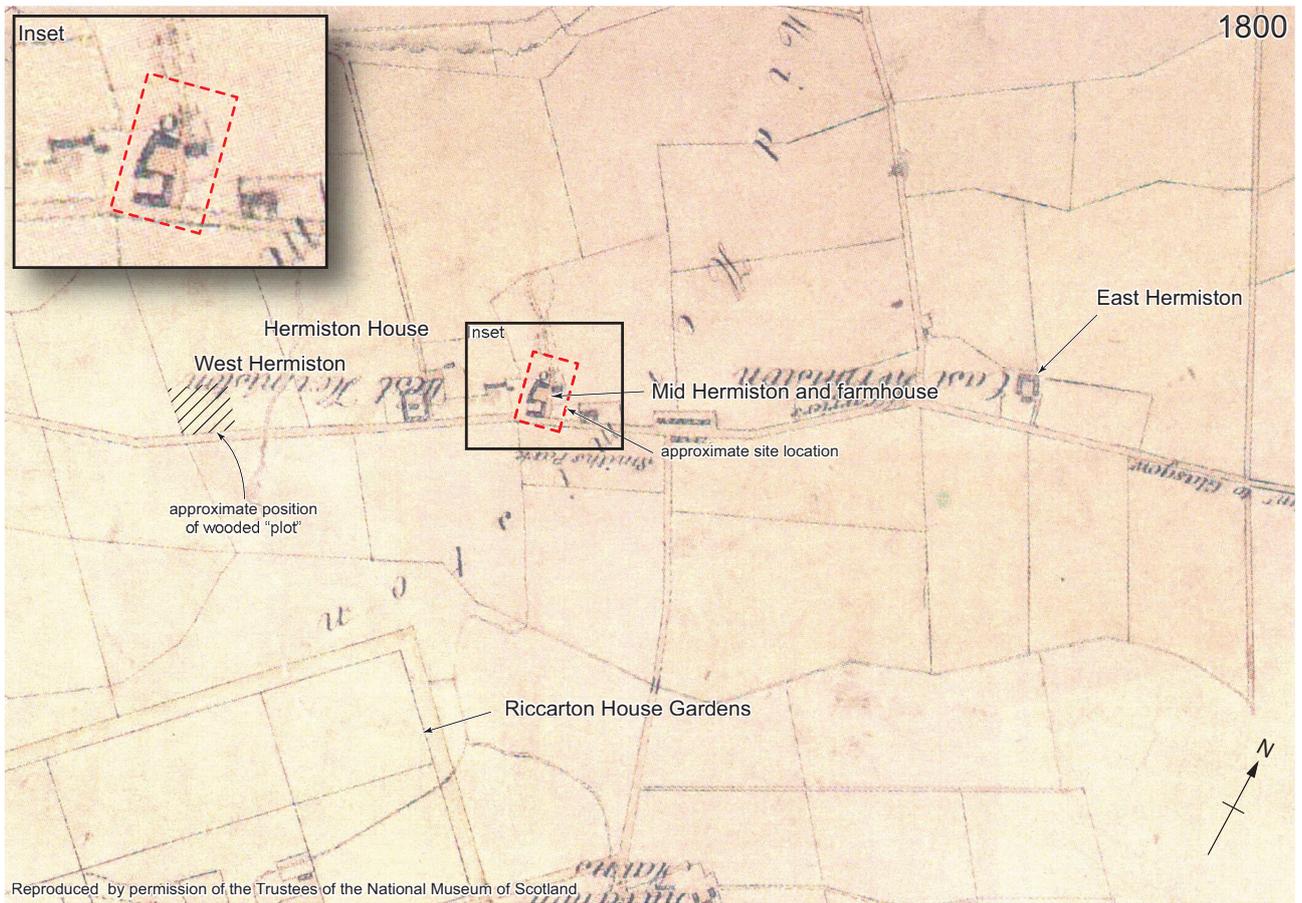
Illus 3

In the late 18<sup>th</sup> century, new forms of farm management resulted in a requirement for more labour and a process of increasing the number of farm workers, constructing new farm buildings and increasing stock was set in motion. Hermiston was consolidated as an agricultural village at this time and its present day structure dates from this period (City of Edinburgh Council 2000; 6). This is particularly apparent in a plan dating to 1800 (Illus 3). The plantation is now gone and West Hermiston steading has been expanded to form a complete quadrangle. Hermiston House and the long building to the SE stay unchanged. Mid Hermiston Steading is clearly recognisable with Hermiston farmhouse to the NE. Older buildings to the E have been reduced in size and a row of buildings constructed along the south side of the main village.

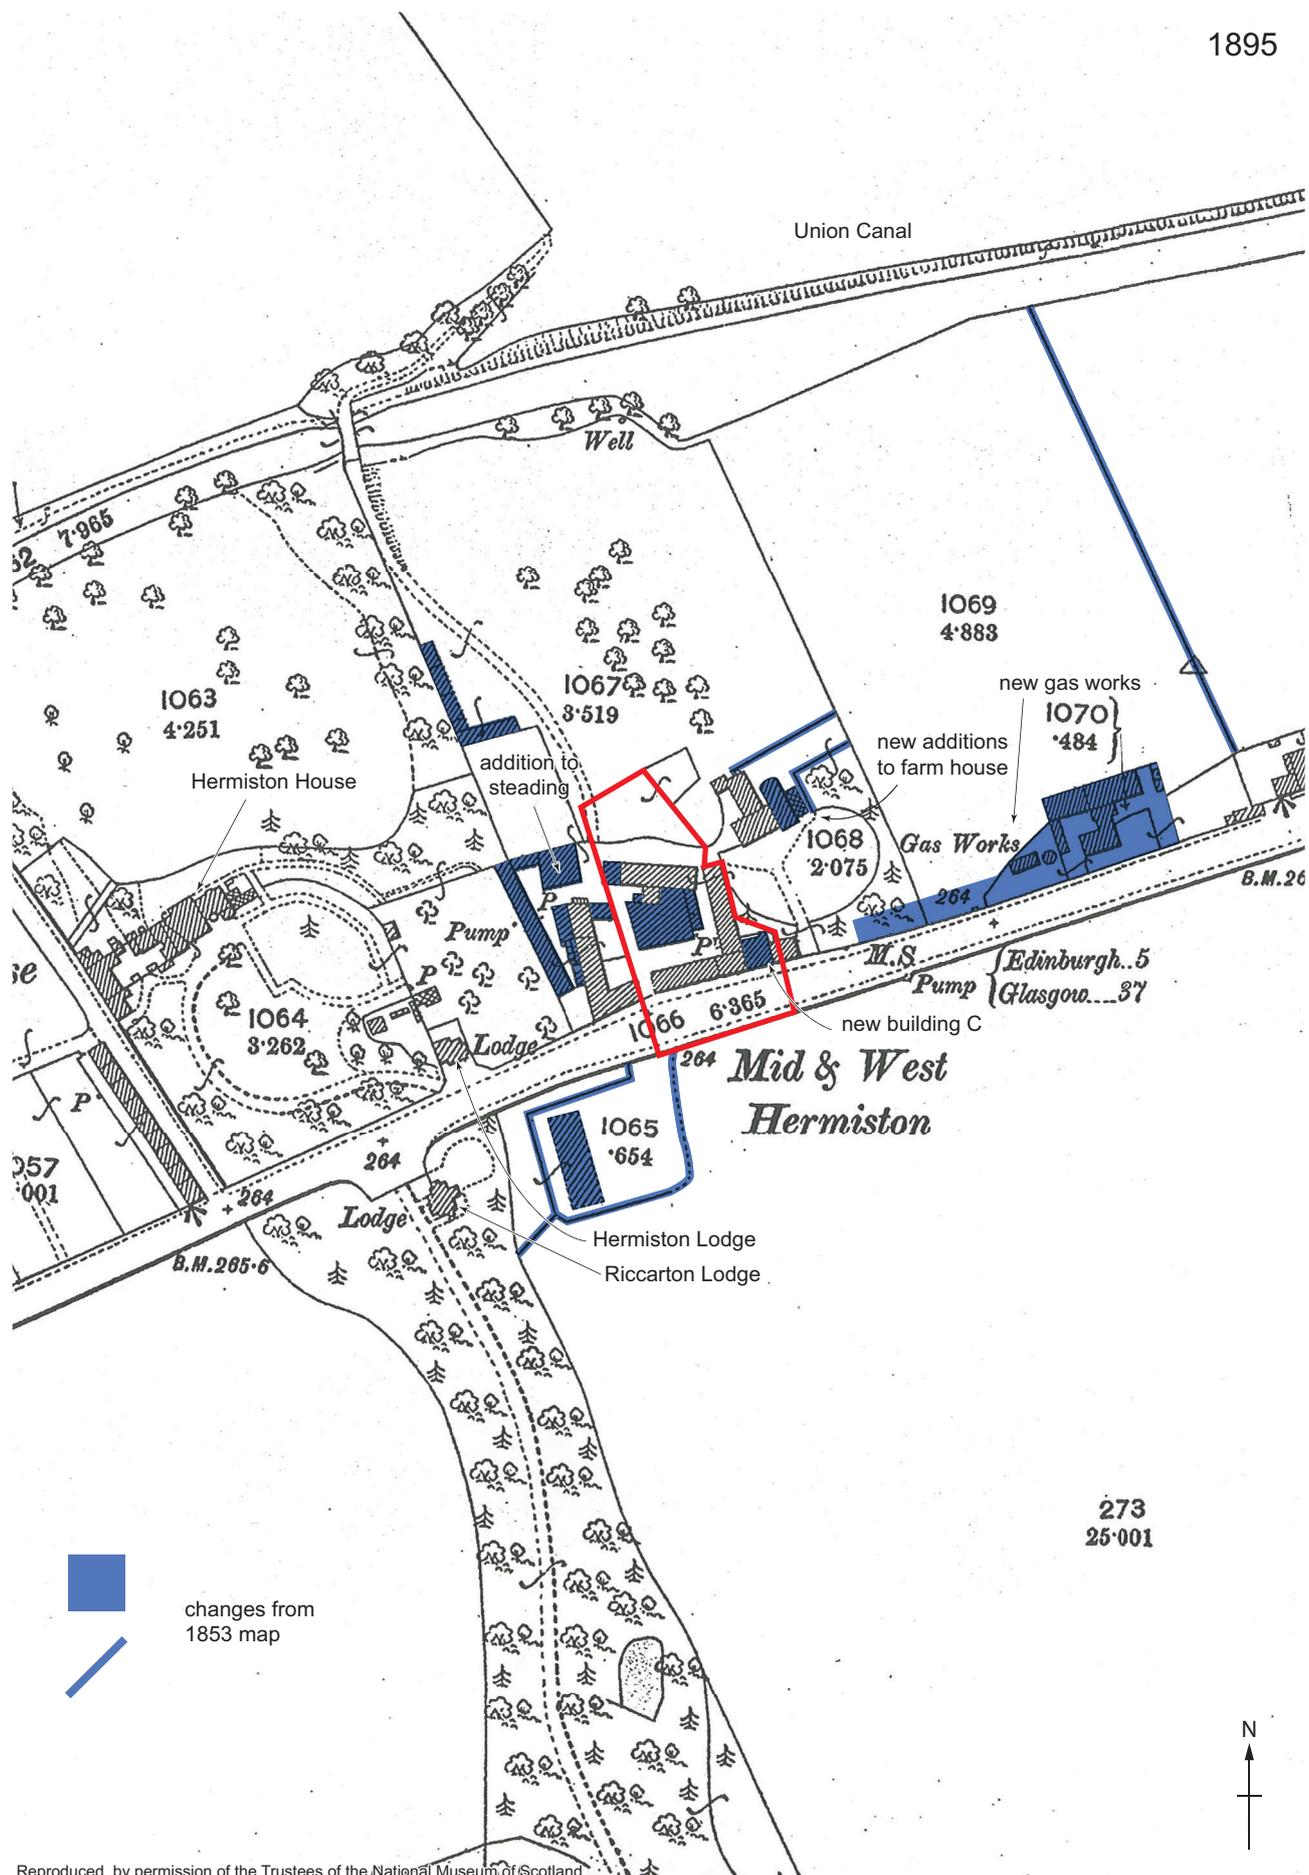
Illus 5

The most comprehensive survey to date was undertaken in 1893 and was published in 1895 (Illus 5). Now referred to as Mid and West Hermiston (West Hermiston had been demolished), the steading had been expanded with new buildings to the NW and in the centre. Hermiston Farm House had also been altered with the addition of the bowed E extension, post 1854. There was also a small gas works and other buildings (some of which survive) in the plot between Hermiston Farm House and Long Hermiston. The smithy had been moved to the E end of the village (featured in a SCRAN image not reproduced here).

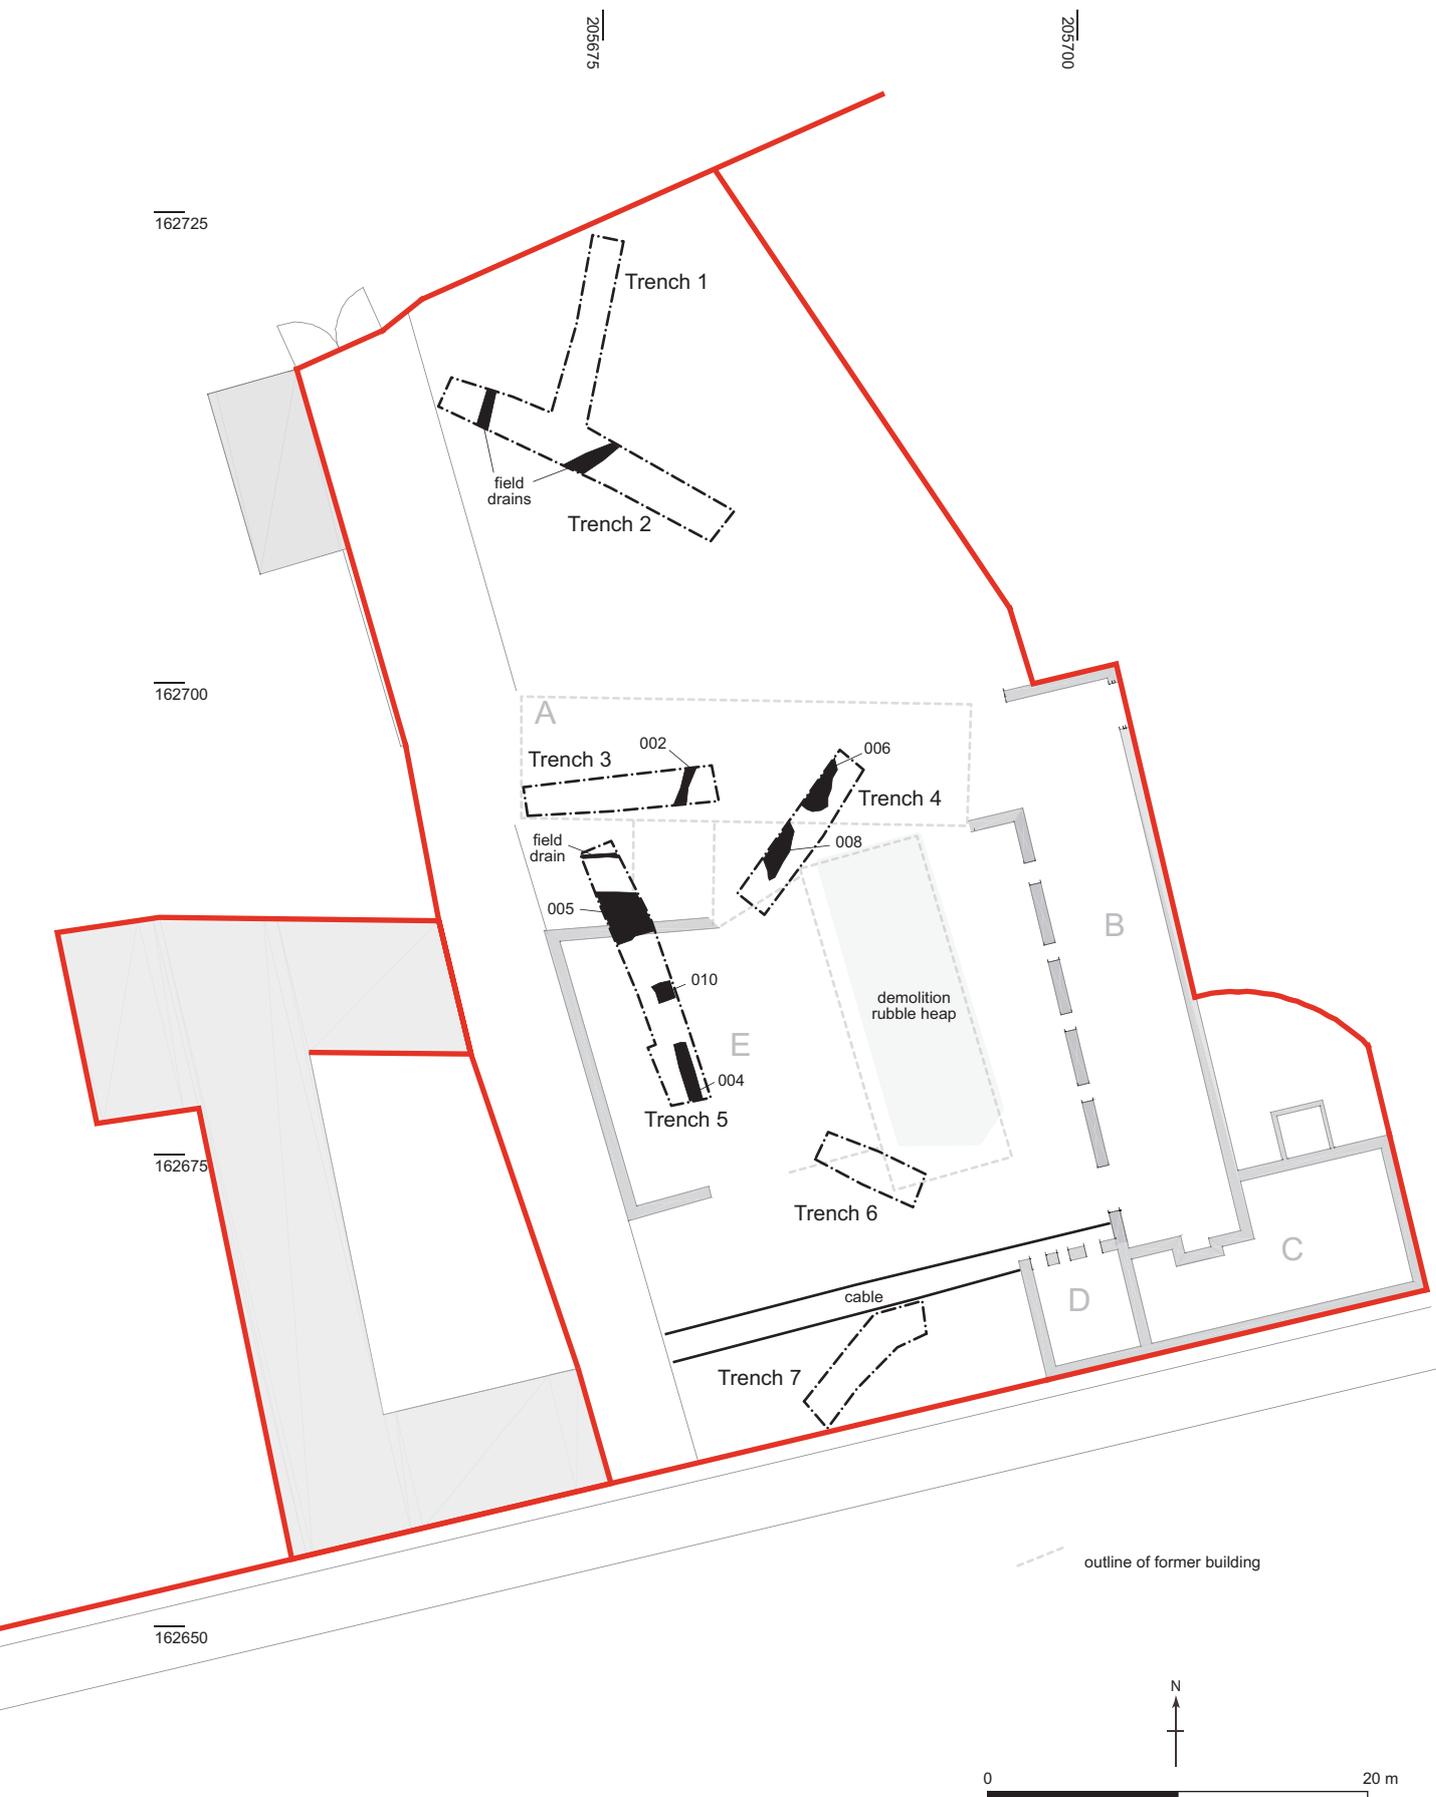
Illus 6

A total of 7 trenches were excavated (Illus 6), ranging from approximately 5 to 18 m in length. Trenches 1 and 2 were located in the northern area of the site in order to see if any archaeological features remained to the north of the steading; map evidence showed that this area was unaffected by building and there was therefore potential for subsurface archaeological remains. Stock piles of demolition material, an underground tank and overhanging mature deciduous vegetation meant that no more trenches could be excavated in this area.

Trenches 3, 4 and 5 were located in the centre of the site within the partially demolished buildings to see if any remains of the structures depicted on maps dating to the 1700s, or indeed any features pre-dating the 1700s, survived within the footprint of the complex. A large demolition rubble heap on the west side of site prevented the placement of trenches in this area.

Trenches 6 and 7 were located at the northern end to see if any subsurface archaeological remains survived in these areas; both trenches were restricted in length in order to avoid a cable which ran east to west towards the southernmost buildings.

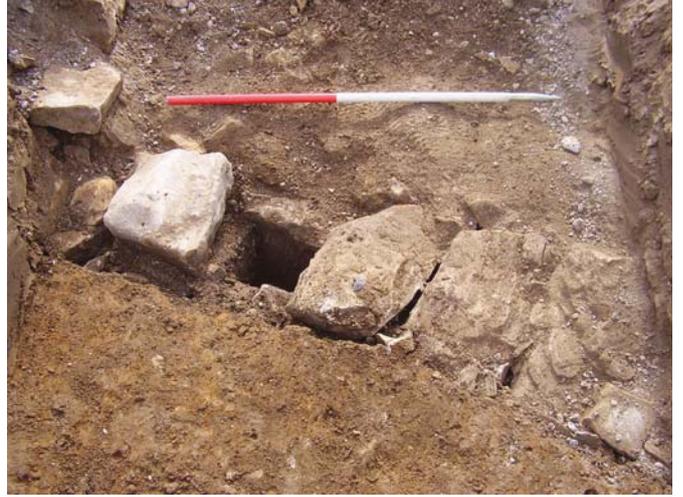
Plate 2

Plate 2: Culvert [002] in Trench 3, Facing E

A stone-lined culvert [002] running north-east to south-west was encountered at the east end of Trench 3 (Illus 6; Plate 2) 0.60 m below the existing ground level, in the area where the northernmost barn was once located. A culvert, on the same alignment and of similar construction was also uncovered in Trench 5. The alignment of the culverts appears to correspond well with the buildings depicted on the 1772 map.

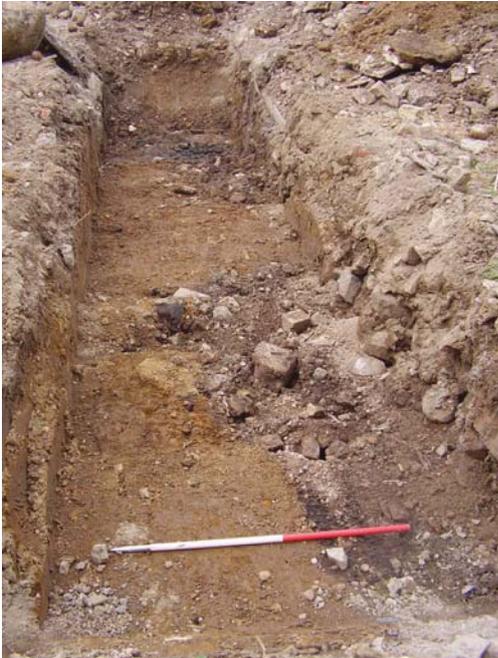
Plate 3

Plate 3: Demolition pits [006] and [007] in Trench 4, Facing W

Two pits, 006 and 008, were uncovered in Trench 4, where the metal grain drier once stood. They were 2.30 m and 3 m long respectively, irregularly shaped and were cut through the natural subsoil. The pits were filled with modern debris including white transfer printed ceramic pottery, iron, wood and red brick fragments.

4	10 m x 1.6 m x 0.80 m	A deposit of demolition rubble 0.50 m deep overlay a 0.30 m thick deposit of mottled orangey brown sandy clay. Demolition pits [006] and [008] containing white ceramic pottery, iron fragments, wood, red brick and rubble, were cut through the natural subsoil.

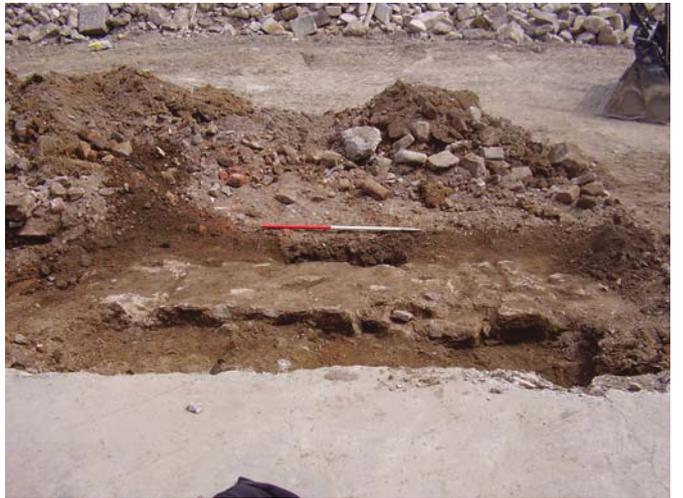
Plate 4

Plate 4: Wall [004] in Trench 5, Facing E

Remains of a sandstone wall, bonded with cement, [010] and aligned east to west, was encountered 8 m from the northern end of Trench 5 directly to the north of the culvert. Similarly, a 0.72 m wide, sandstone wall [004], cut into the natural subsoil, was uncovered at the southern end of Trench 5 within the footprint of the westernmost barn. The wall ran parallel with the upstanding barn wall and was located directly beneath demolition rubble. Map evidence shows that the westernmost barn building was subject to many physical changes in the 19<sup>th</sup> and 20<sup>th</sup> centuries. Several changes occurred in the area between 1854 and 1895 when a large building was added to the central courtyard abutting the barn. Similarly, between 1913 and 1963 considerable changes were made to the southern side of the complex. The central block was significantly altered and largely rebuilt to facilitate the movement of large vehicles and possibly grain bins and silos, and it appears that the wall dates to this period. If the wall was load bearing, as it appears to be on the 1963 map, the thickness of the foundations would be explained. The wall was probably demolished during alteration work later in the 20<sup>th</sup> century when the building was adapted to house very large grain bins. It was primarily overlain with a brick floor surface and latterly with concrete which until recently formed the barn floor.
