Project Code: SCED10
Planning Application No: 10/00746/LBC & 10/00746/FUL
Date of report: 5 April 2010
Client: Watkin Jones and Son Ltd.

ARCHAEOLOGICAL EVALUATION AND HISTORIC BUILDING ASSESSMENT

Sugarhouse Close, 160 Canongate and 41, 49, 53 Holyrood Road, Edinburgh

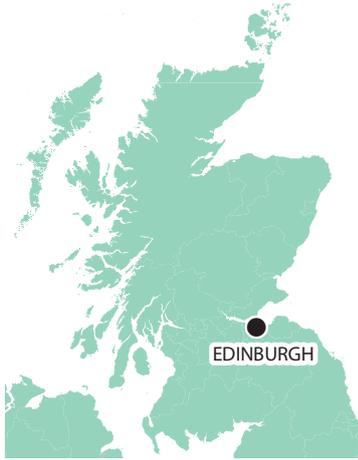
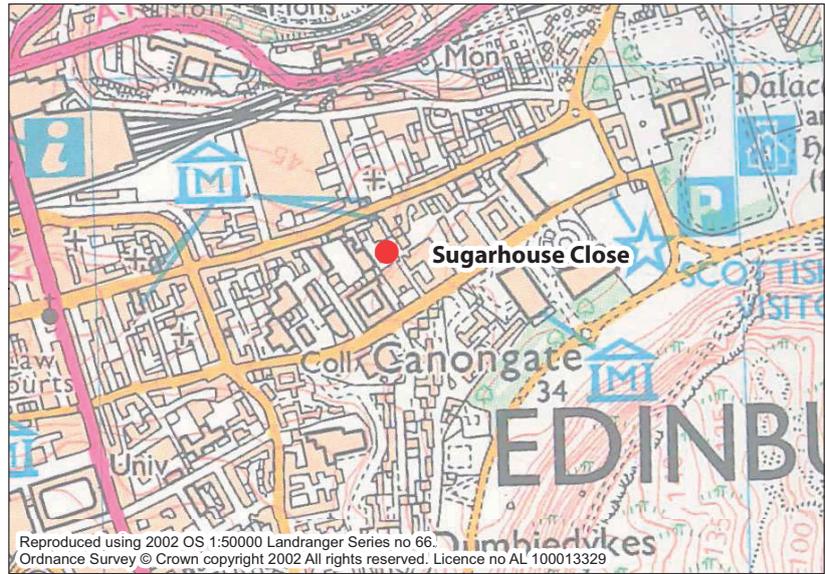
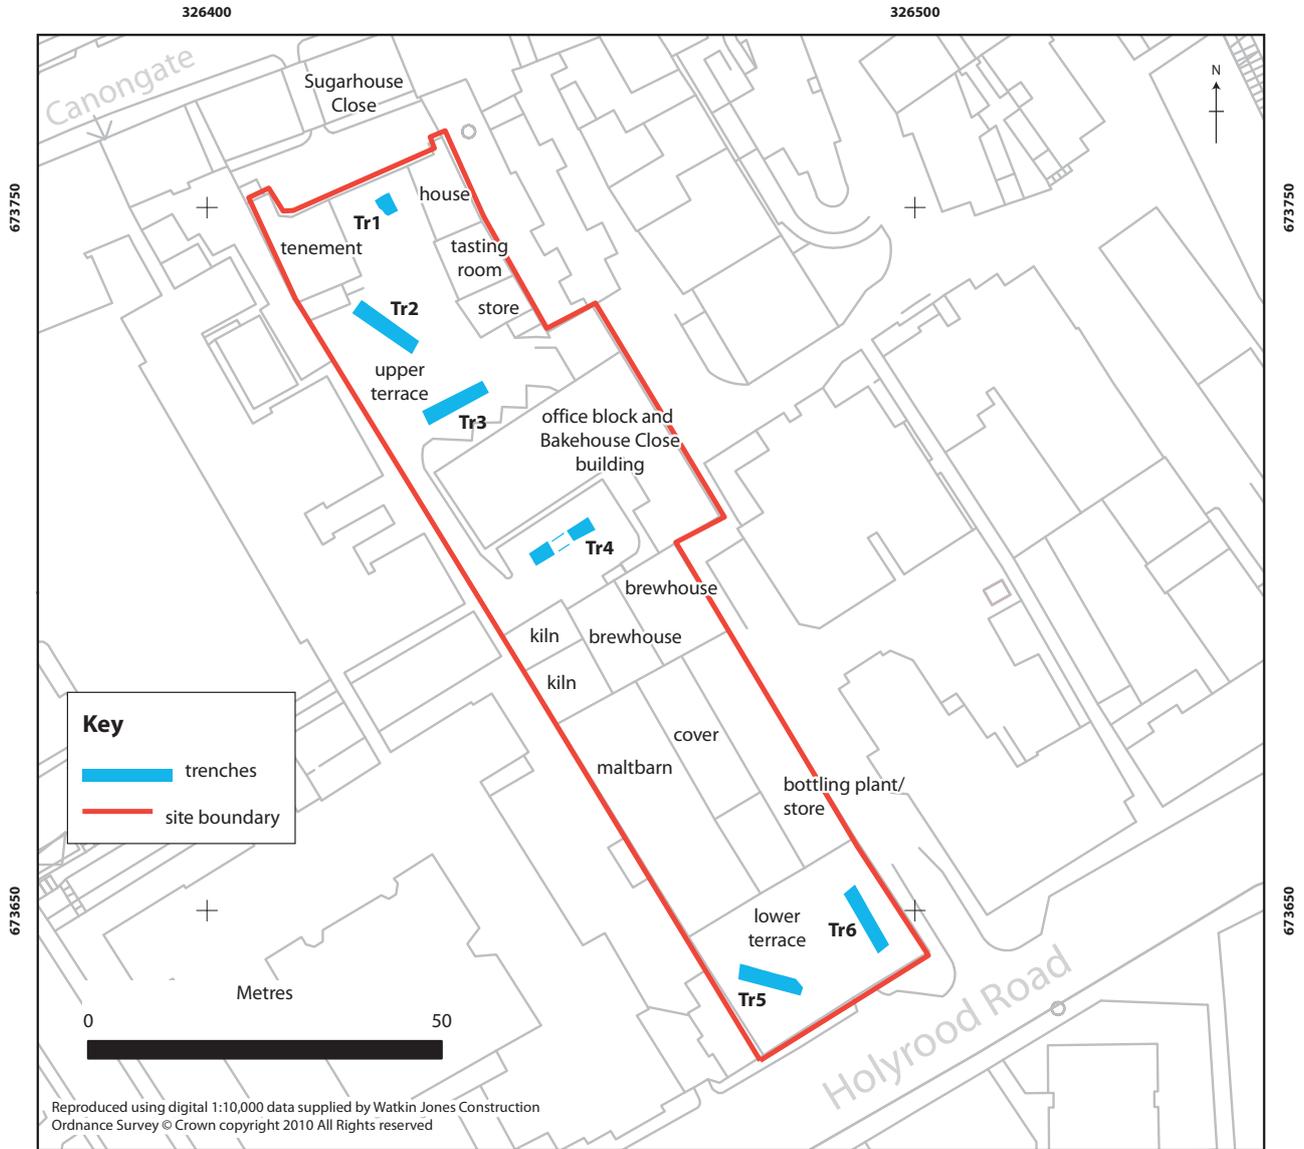
Illus 1
 Location of the proposed development with trench layout

A total of six trenches were excavated, four in the upper yard of the brewery and two in the lower carpark.

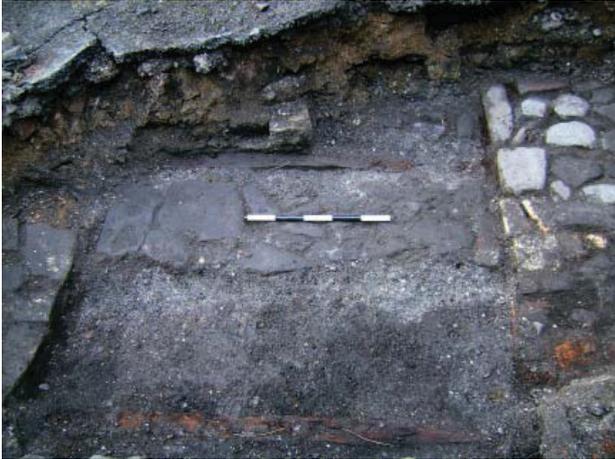
Illus 4
Trench 1, facing W

This 3m long trench was located in the northernmost part of site in an area thought to have a high potential for medieval/post-medieval structural remains. It was the shortest of the trenches due to the presence of known services immediately adjacent.

A cobbled area [01] was uncovered below a thin layer of made ground which underlay the modern tarmac ground surface at a depth of 53.5m OD. This was recorded and partially removed, revealing more setts and cobbled areas [02], [04] at a depth of around 53.2m OD. These were interrupted by a grid-like arrangement of timbers [03] laid into the surfaces. Though they were quite degraded some of these timbers showed evidence of metal bolts. It is suggested that these remains represented either a small set of rails for moving brewery supplies or a machine platform

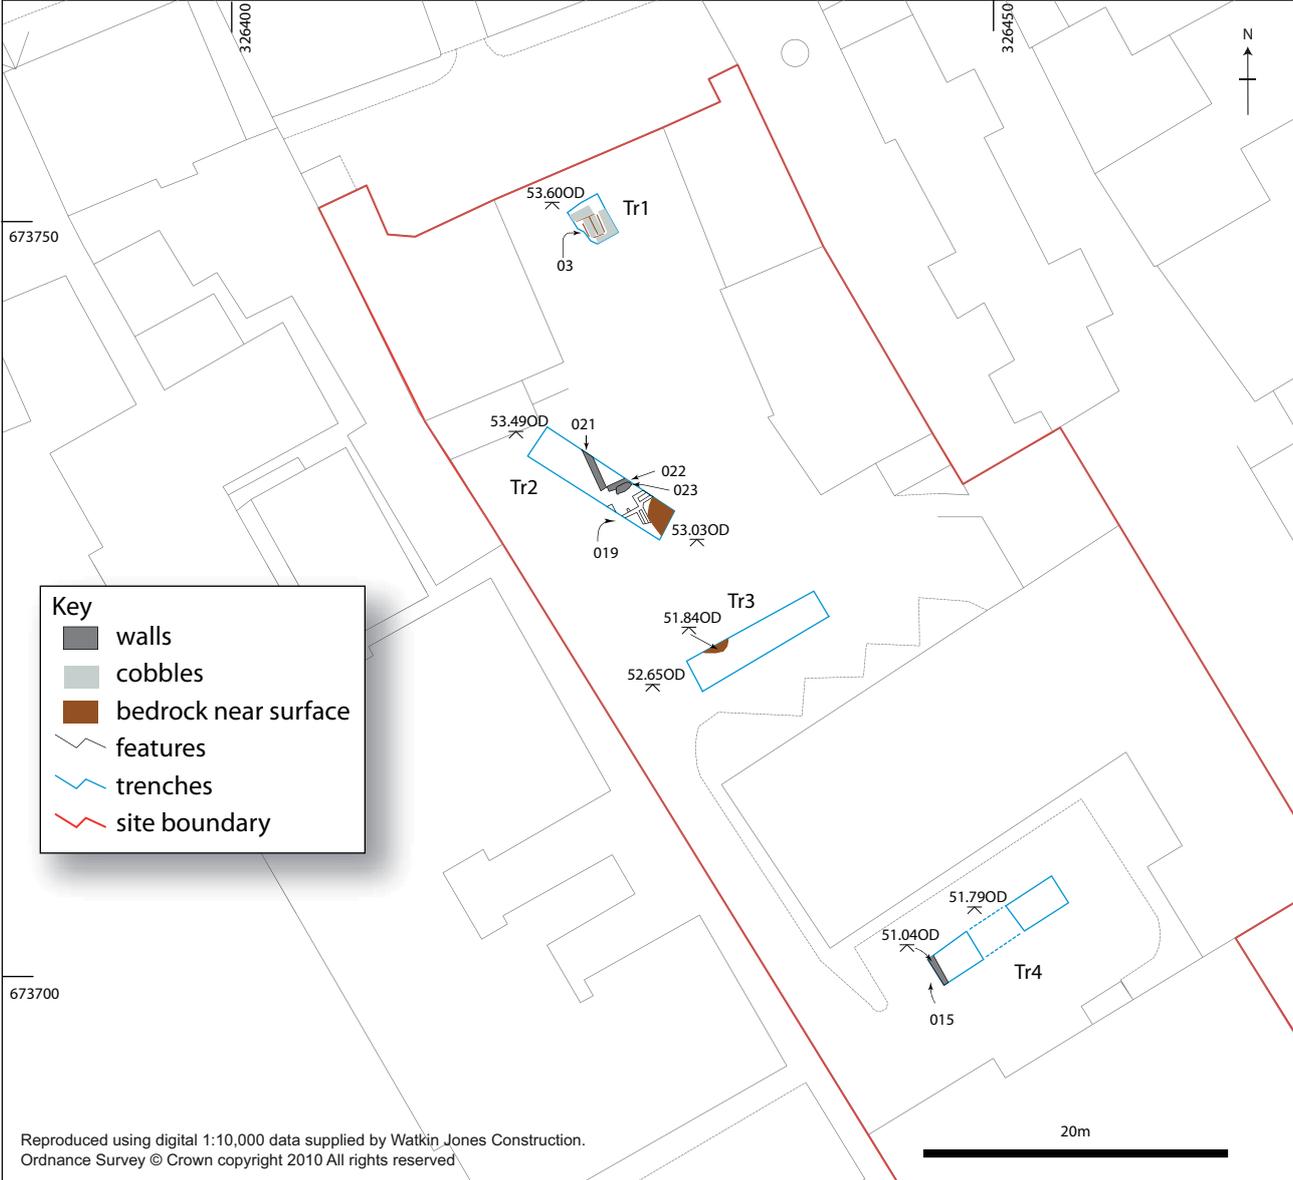
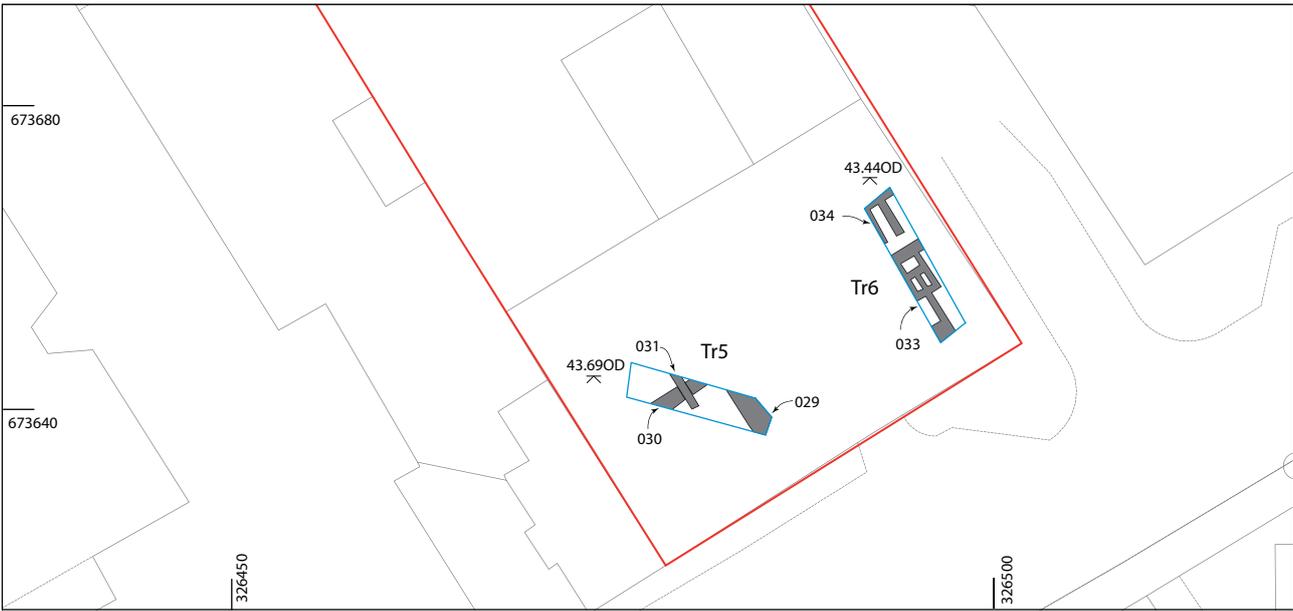
Illus 5
Archaeological features

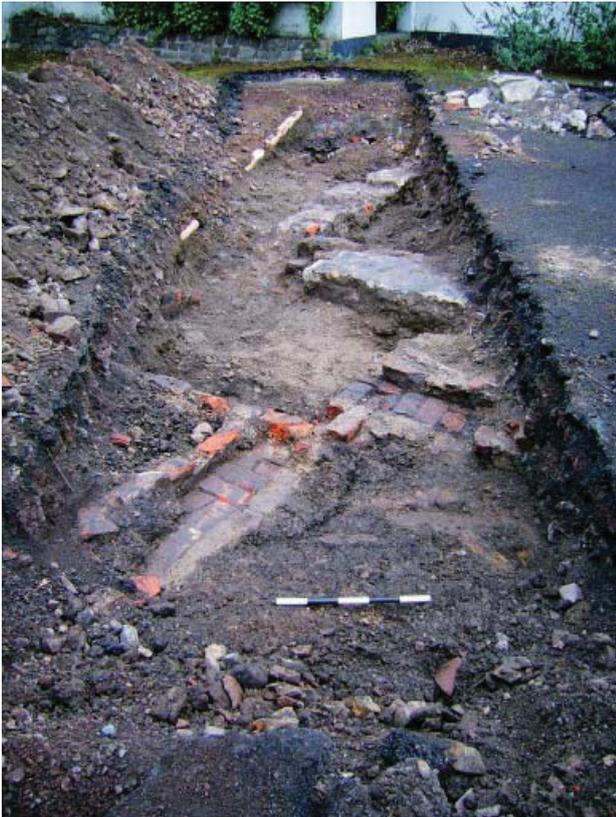
Illus 6

Trench 2 facing NW. The deposit on which the photographic scale is resting is an area of protruding bedrock

This trench was 10m long and aligned NW-SE at the western side of the upper car park. A large sandstone and brick wall [021] aligned NW-SE with an abutting wall [022] running SE-NE from its terminus was recorded at a depth of 52.73m OD. The walls were uncovered directly below the modern ground surface. Excavation at the western edge of the wall showed that it was founded to a depth of at least 2m and due to more recent services within the trench there was insufficient space to excavate further. The wall aligned with a structure shown on the 1st edition Ordnance Survey (1849-53) which had been demolished by the time of the 1867-77 Ordnance Survey Town Plan. However throughout the 19th and 20th centuries there have been several buildings on the same alignment in the same location. It is likely that after the demolition of the first building its plan and perhaps even its foundations were retained for reuse. Fragments of brick incorporated in the upper course of the wall would seem to support this interpretation.

In the same trench a brick structure [019] was uncovered at a depth of 52.44m OD. This was composed of several elements (steps, walls or surfaces) including what appeared to be a drain filled with broken ceramic pipe. The nature of the structure was unclear due to the small area uncovered

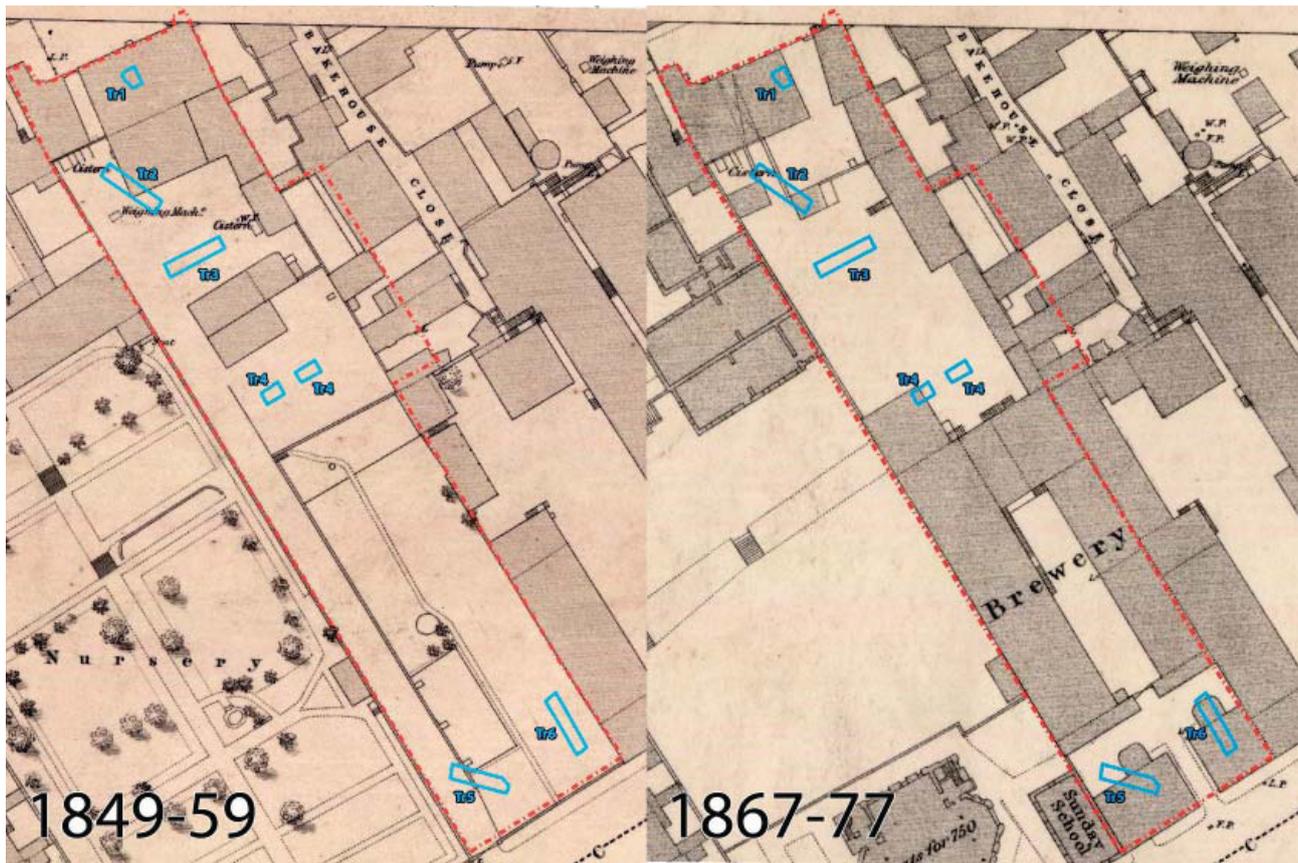
Illus 7

Ordnance Survey maps from 1849-53 and 1867-77 with the proposed development boundary and the trench outlines overlaid
Reproduced by permission of the Trustees of the National Library of Scotland

but it appears to be close to the location of a small structure, a cistern and a weighing machine which are shown on the 1849-53 and 1867-77 Ordnance Survey maps (Illus. 6). A small outcrop of bedrock was uncovered directly adjacent to the brick structure at a depth of 52.6m OD and it appears that outcrops of bedrock in this area can be very close to the surface. Both the wall and the brick structure were overlain by a thick deposit of mortar rich demolition material [020] which continued to a depth of at least 2m at the western face of the wall. Overlying this and between the walls and brick structure was a single large sandstone block [023]. This may be a foundation for a later structure or simply a disturbed block.

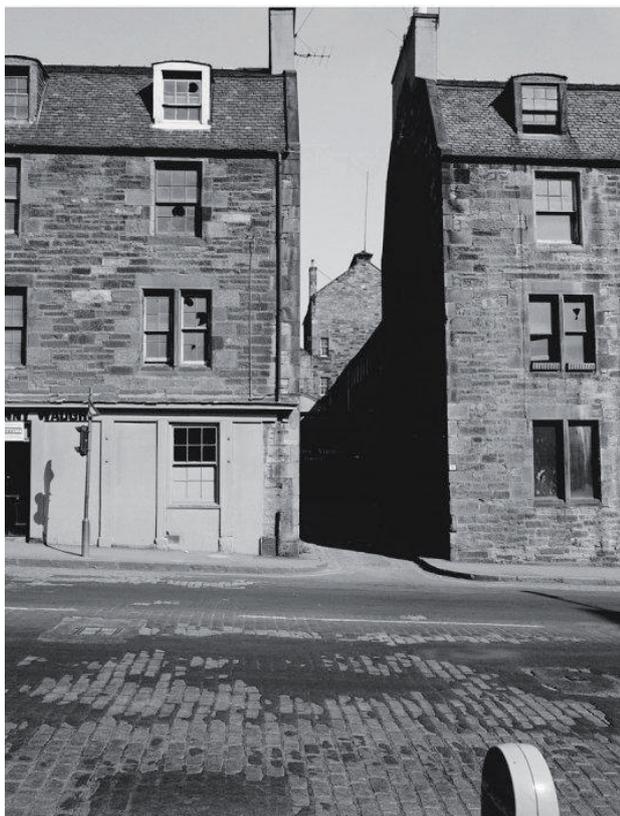
Illus 8

A view of the Clermiston Buildings from Holyrood Road before they were demolished in the 1970's. The front external walls still survive to the first storey while the gap between them now serves as a gateway to the brewery complex

The buildings on the site are enclosed by a number of boundary walls. The sandstone rubble boundary walls at Holyrood Road are the former ground floor fronts of two 1870s tenements, the Clermiston buildings (demolished after 1977), with a double panel swing gate installed between them. The southern part of the eastern boundary wall and Hammerman's Close date from the 1990s, when the adjacent Holyrood Brewery site was redeveloped.

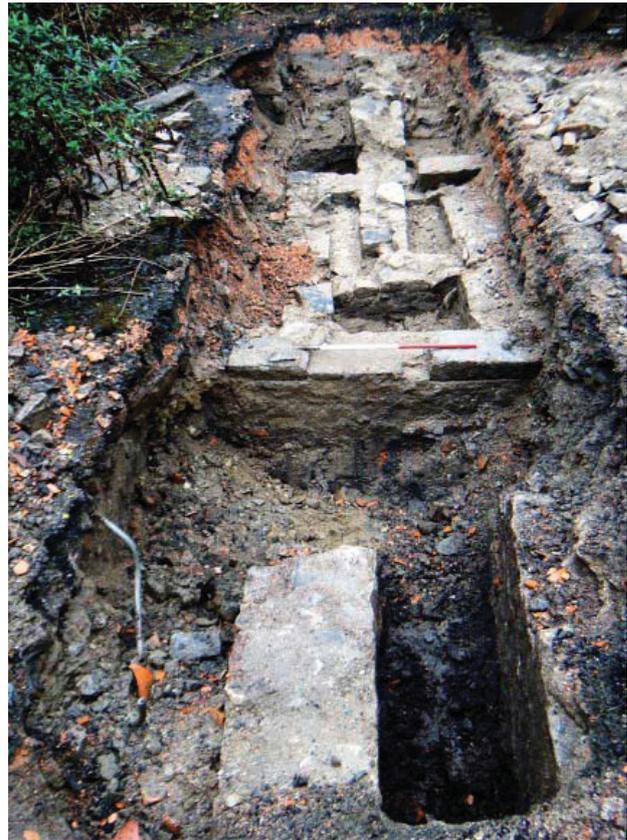
Illus 9
Trench 6 facing S showing the basement of one of the Clermiston Buildings

Trenches 5 and 6 were located in the lower terrace on the site of the former Clermiston Buildings. Both trenches were aligned roughly NW-SE and were 8 m in length. A small area of modern setts with kerbing [028] was uncovered at the northern end of trench 5 and was recorded and removed. Subsequently both trenches revealed extensive remains of large sandstone walls [029], [030], [031], [033], [034] and [037] (see Illus 5). The layout of the walls prevented deep excavations around them in most areas but it was possible to excavate to depths of 2m and 3m in trenches 5 and 6 respectively where it was seen that the walls were becoming rougher and it is likely that the level at which excavation had to be abandoned was close to the maximum depth of the walls (c. 40.5m OD). The deposits [032], [035], [036] between the walls contained extensive dating evidence from the 1970's (including TV guides) which corresponds to the known dates of clearance of the Clermiston Buildings. The walls uncovered were therefore interpreted as the basements of these buildings. It was not possible to uncover any evidence of the stratigraphy which predated the tenements due to their depth.
