Project Code: DKOC10
Planning Ref No: 09/02605/FUL
Date of Report: September 2010
Client: Crichton Lang, Willis & Galloway (CLWG) Architects

ARCHAEOLOGICAL EVALUATION AND HISTORIC BUILDING RECORDING AT DUDDINGSTON MANSE GARDENS

PROJECT SUMMARY SHEET

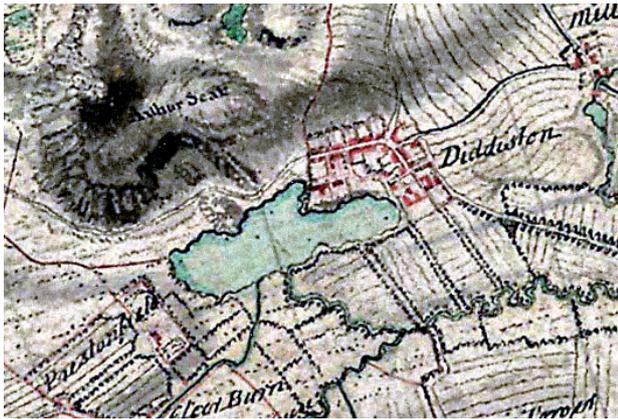
Illus 2

Duddingston as it appears on William's Roy's Military Survey of Scotland 1747-55. The church is clearly visible at the S - W edge of the settlement with another building to its immediate east

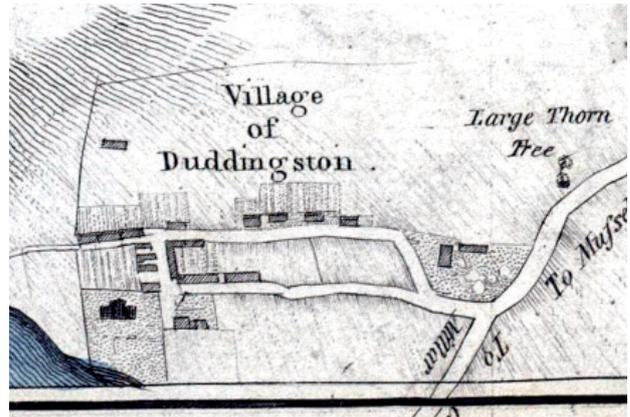
Illus 3

An extract from Scott's map of 1805. In this figure the buildings appear to stand back from the road but this cannot have been the case and it may be that the road has shifted somewhat to the north

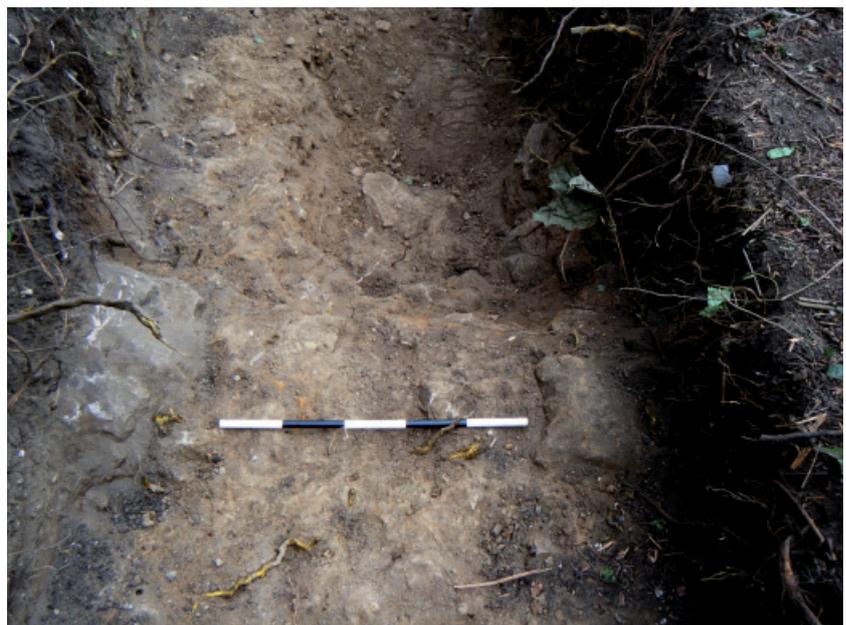
Illus 4

An east-facing shot of the fragmentary wall foundation [009]

Fragmentary remains of a north - south aligned wall tied in to the pre-19th century frontage were found at a depth of 0.18m below the present ground surface (Illus 4). These consisted of a single large *in situ* stone with a few smaller packing stones [009]. The trench was extended up to the frontage around the wall in order to establish a clear relationship between them. The stones were located within a robbed out foundation trench and were aligned with a break visible in the southern face of the northern garden wall of the manse. It was not possible to determine with certainty that they were tied in to the wall but in the opinion of the excavator it was likely that this was the case. This cut continued west across Trench 3 although any other foundation stones which it may have contained appeared to have been removed. The fill of this robbed out foundation trench contained a few small pieces of mortar, charcoal and shattered stone.

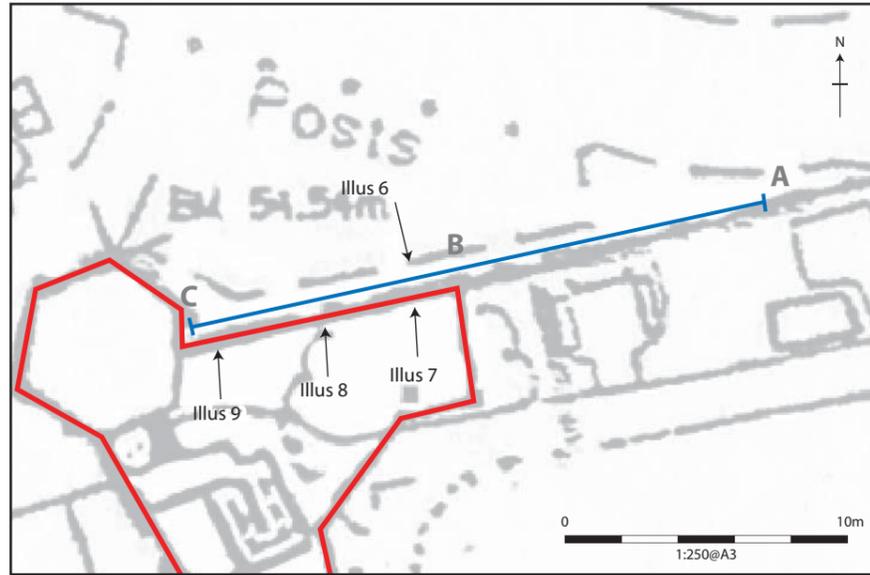
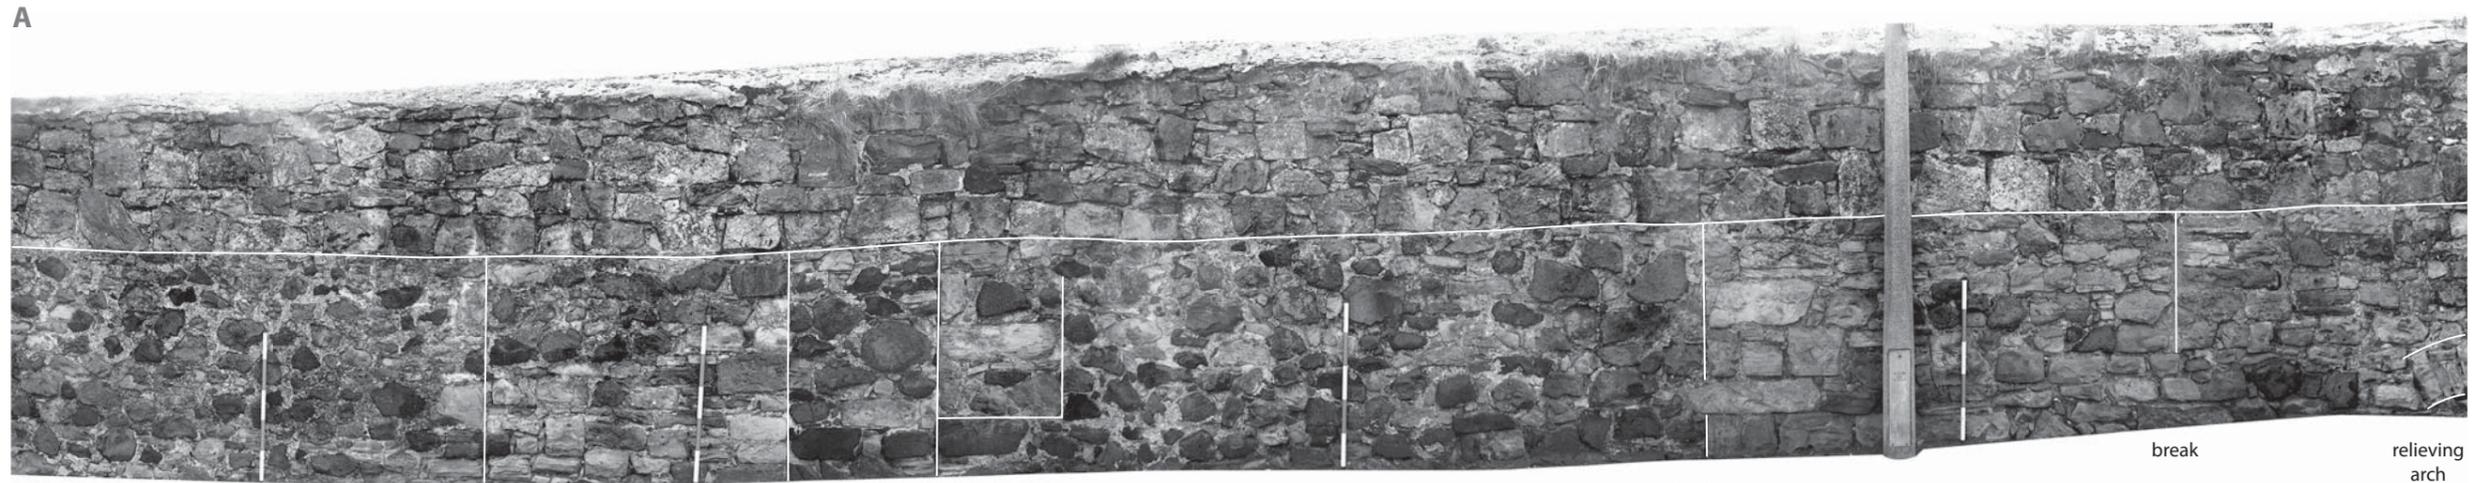
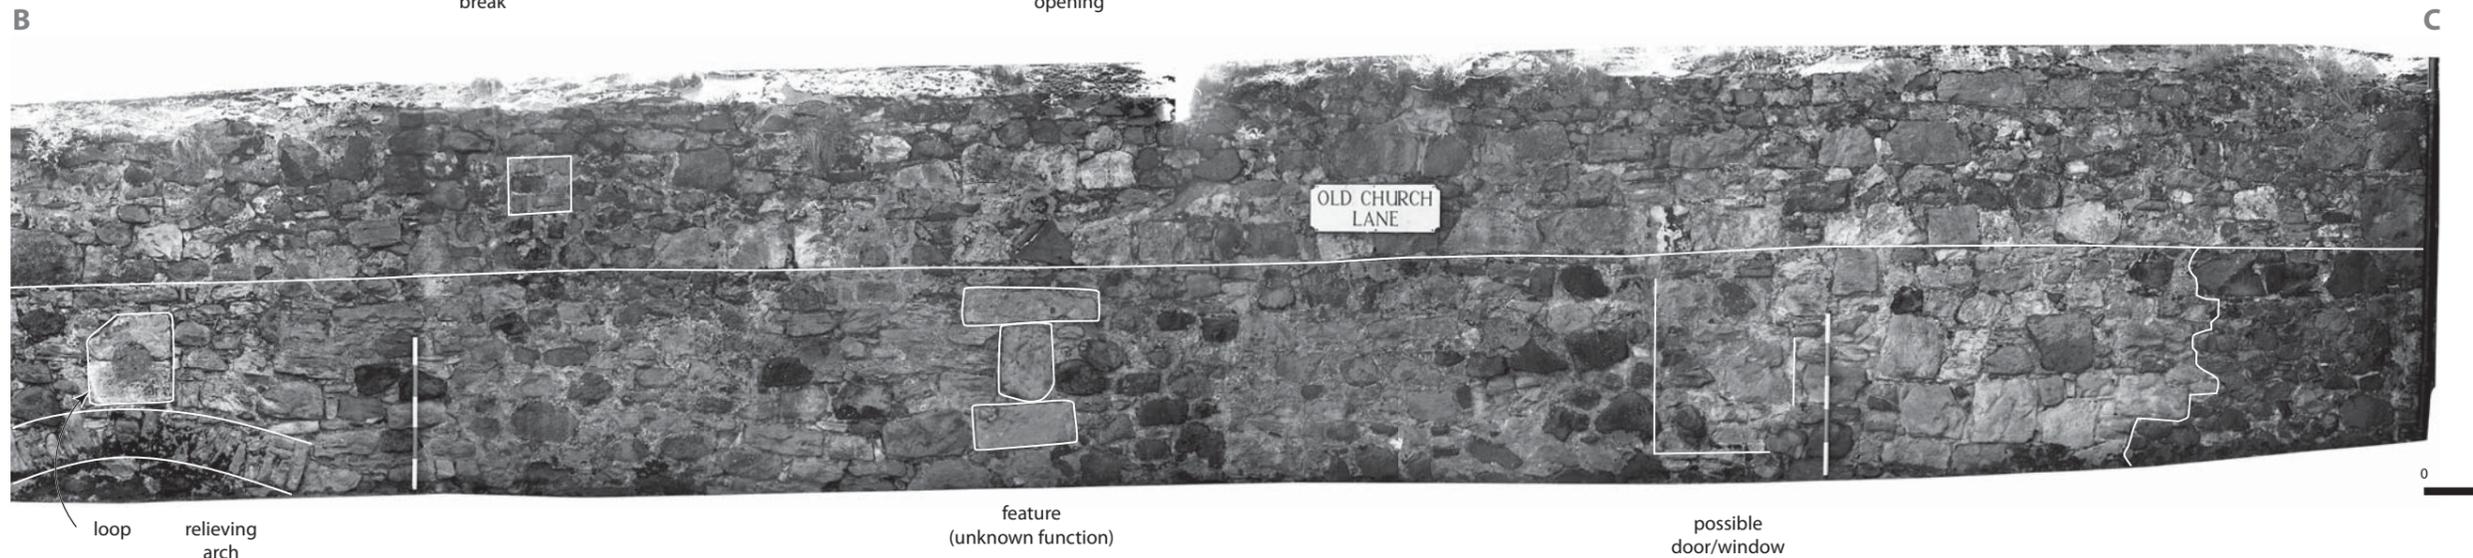
Illus 5
 A photomontage (unrectified) of the north face of the north garden wall of Duddingston Manse. This illustration shows a 20m stretch of the westernmost part of the wall up to the gatehouse

A full photographic record was made of a 20m stretch of the north wall, from the western end where it butts up against the gatehouse (Illus 5–9). A measured sketch was also made noting all visible features. It appears that while the medieval/post-medieval buildings were cleared down to the foundation, their frontage was retained in order to provide a wall for the garden. The wall is rubble-built and of randomly coursed sandstone with a rounded cement or lime mortar coping along the top. This wall appears to have been approximately 1.3m in height along Old Church Lane, but as much as 2m in height above the ground level on the southern side of the wall due to a relative drop in ground levels on either side of the wall.

A number of relict features were visible including a blocked doorway, another possible doorway and a relieving arch, immediately above which was a blocked up gun loop or port hole feature, apparently *in situ* (being composed of two blocks). To either side of the relieving arch at equal distances lay two bricked up windows. The upper courses of the north garden wall (roughly the top metre of the wall) were comparatively recent in date with no relict features.

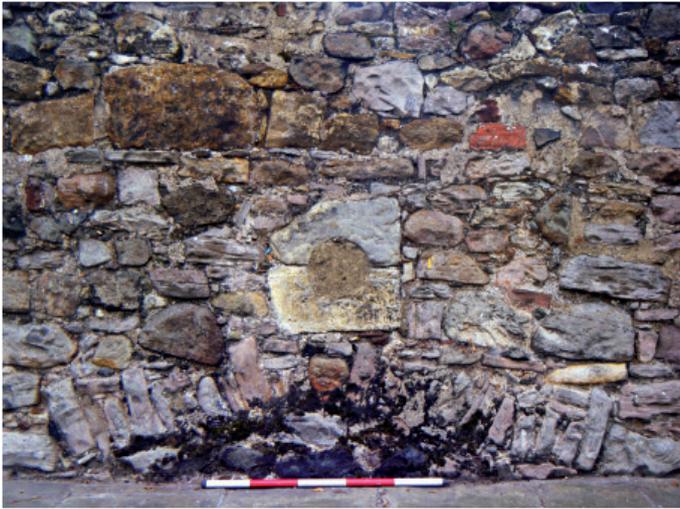
Illus 6

A possible gun loop above a supporting arch in the north face of the north garden wall of Duddingston Manse

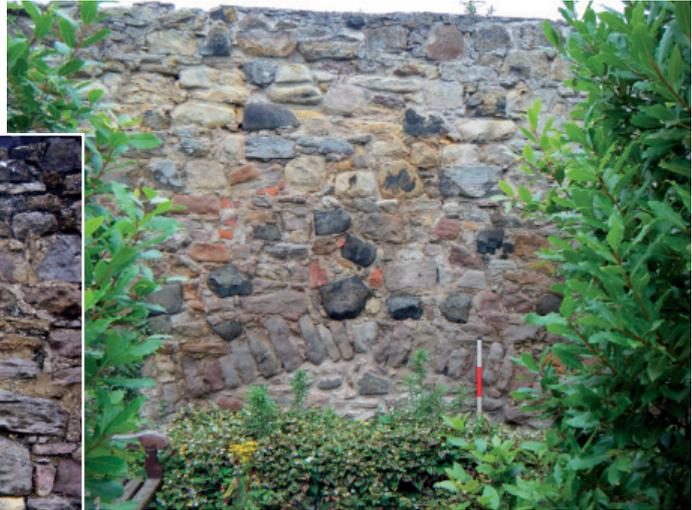
Illus 7

The same feature as it appears in the south face of the north garden wall

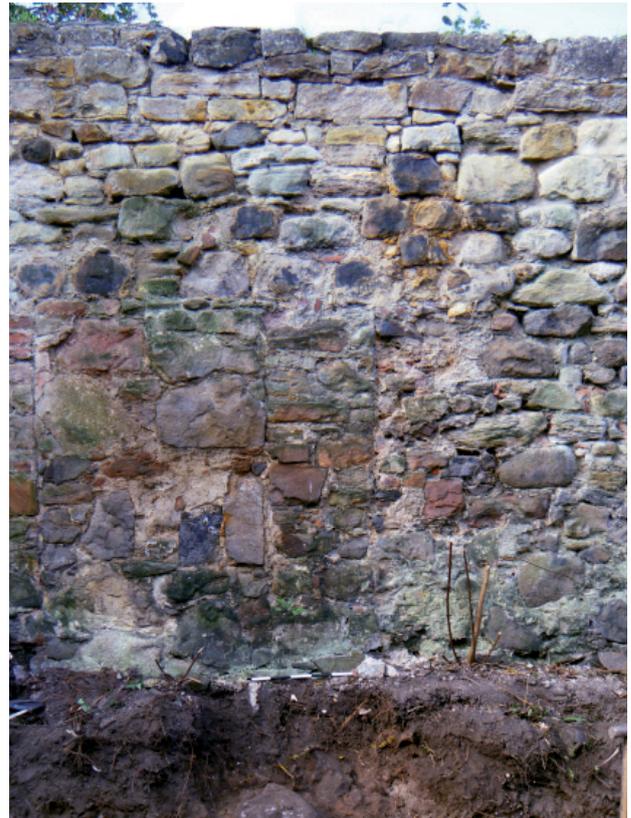
Illus 8

A possible wall stub in the south face of the north garden wall of Duddingston Manse which appears to be aligned with a line of stones [009] found in Trench 3

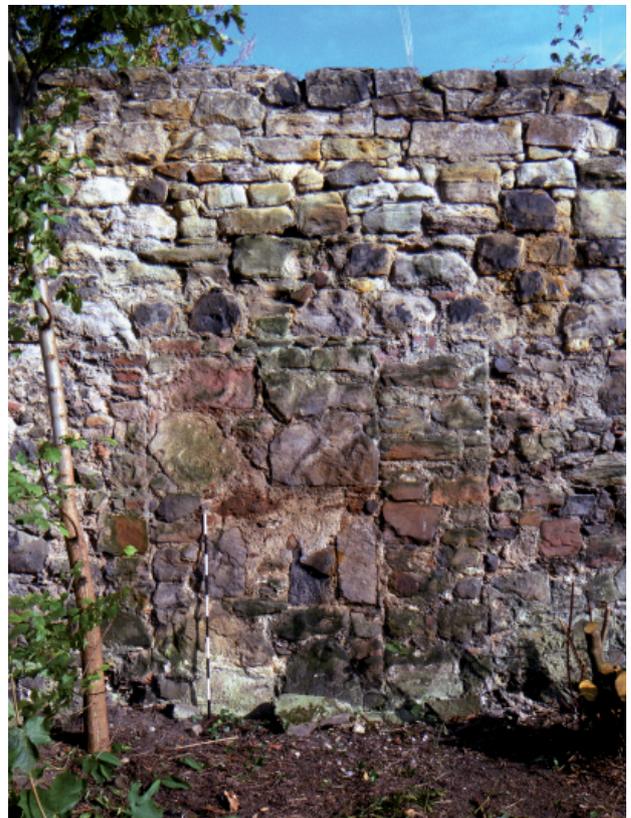
Illus 9

A possible doorway or window at the western end of the south face of the north garden wall of Duddingston Manse
