Project Code: ERSQ10
Planning Ref. No.: 07/04626/FUL
Date of Report: August 2010
Client: Alan Searle

13 EDINBURGH ROAD, SOUTH QUEENSFERRY

Historic Building Recording and Watching Brief

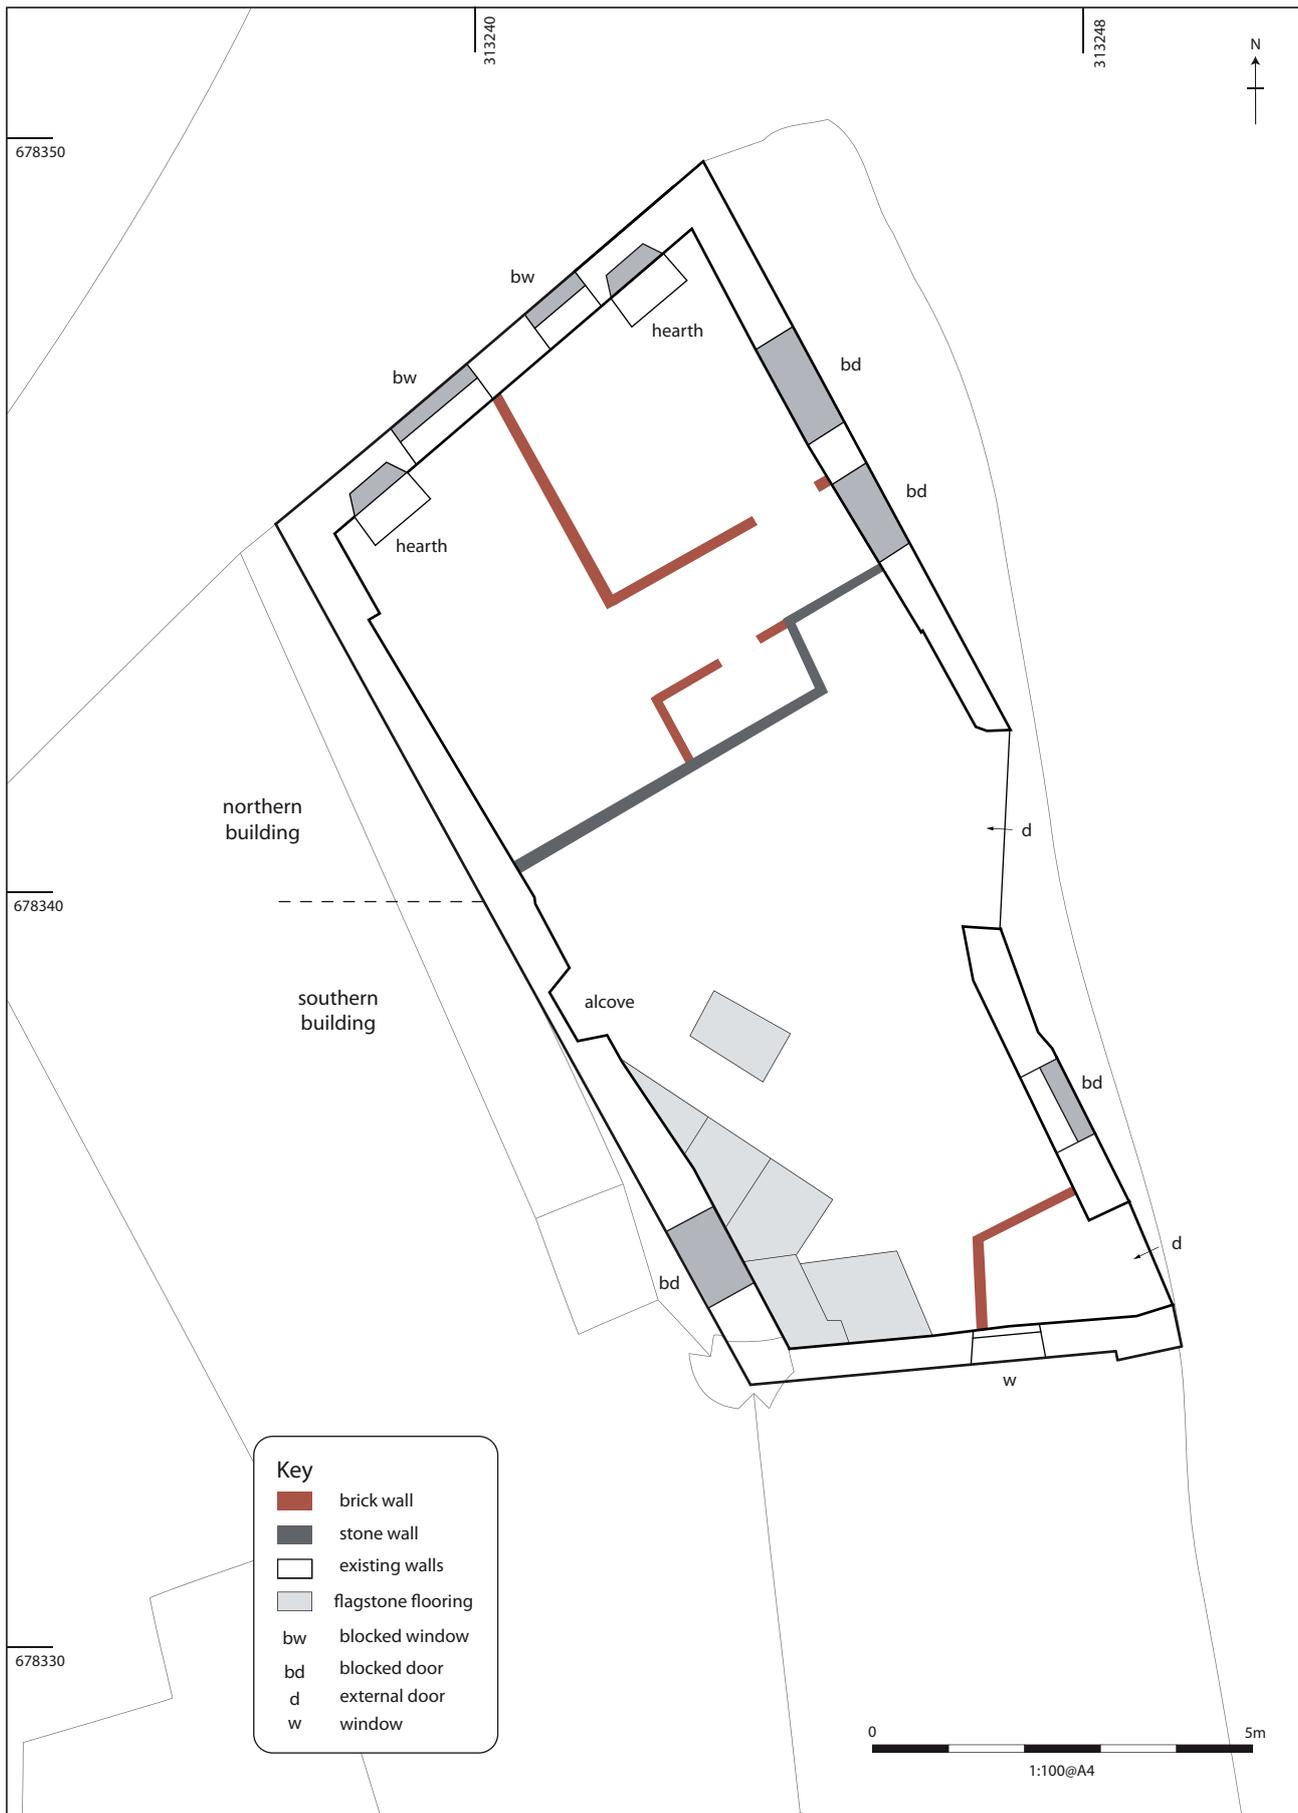
Illus 2
Plan of buildings

The southern building (Illus 2) is sub-rectangular in plan (measuring approximately 9.5 x 5m internally) with external walls between 1m and 1.3m thick. The walls (where likely to be original) stand to approximately 2.8m, and are constructed from irregular stone which

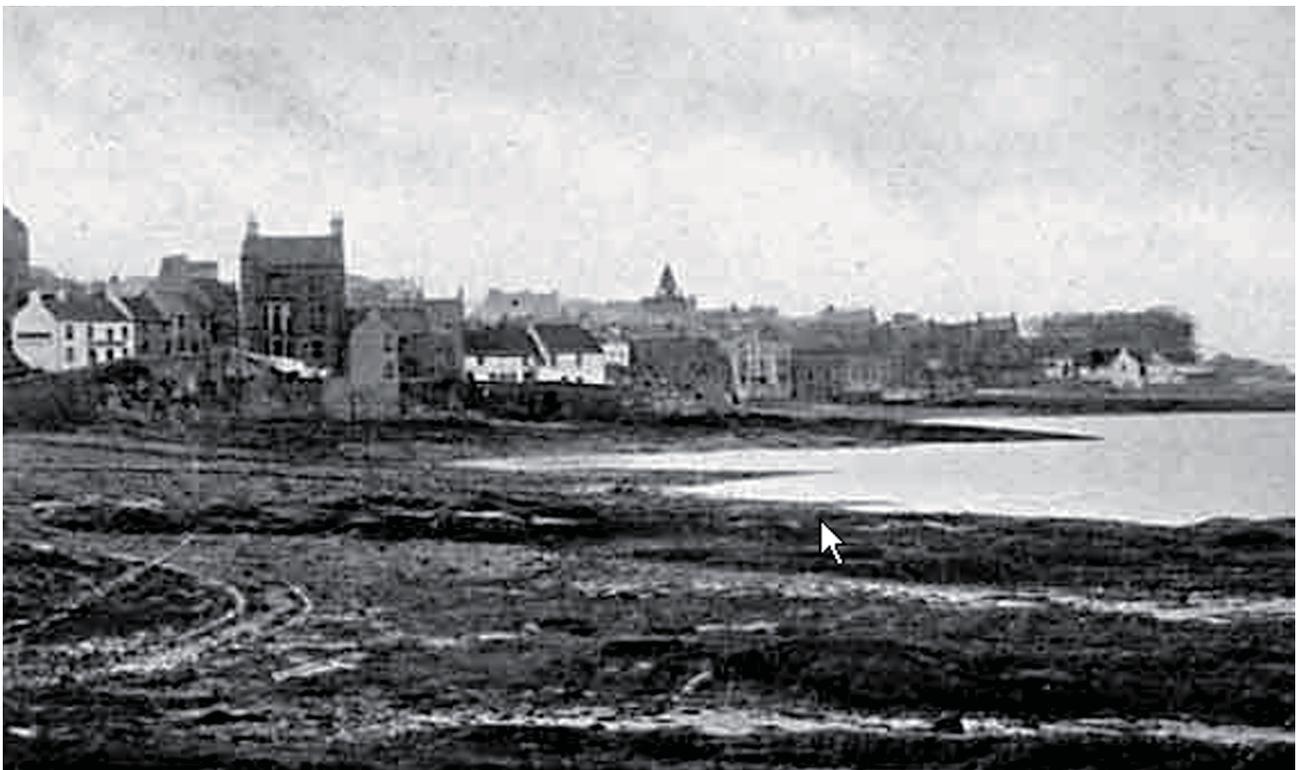
Illus 4
Historic image of South Queensferry
Courtesy of Queensferry History Group

An undated photograph (Illus 4) shows the structures as having formerly had two storeys and a white render. At some point they became derelict, and were joined together for use as an unroofed parking or storage area.

has been rendered to a smooth finish. Historic photographs suggest that this building was previously painted, whitewashed or harled (Illus 4), though no evidence for the exact nature of the finish now remains. The wall heads have been consolidated with stepped concrete. Historic photographs show an upper level of windows on the east side; presumably this level was removed at some point over the last 100 years or so. Holes for timber joists were visible in the internal walls and indicate the former ceiling level. This would have been low, especially toward the south end of the building where the floor was highest (less than 2m).

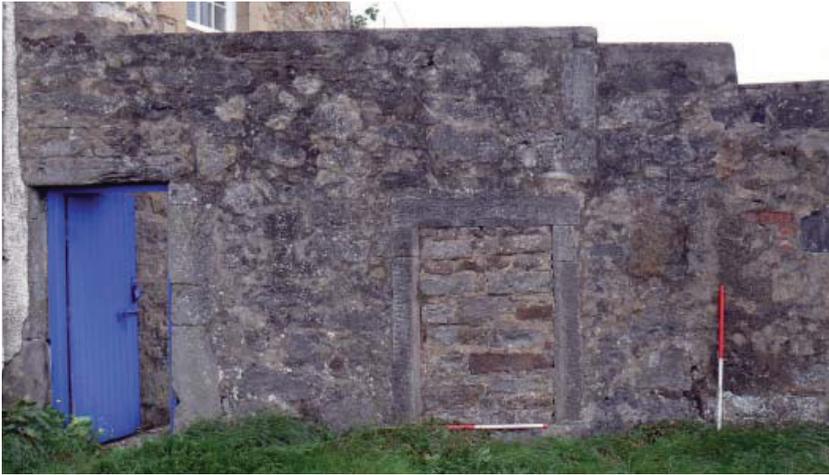
Illus 5
Southern building external shot of east wall

The southern elevation of the south building (contiguous with the northern wall of no. 11 Edinburgh Road) revealed the original pitched roof line in the masonry, reaching 2.2m above the wallhead at its apex. The line confirmed that the walls at the south end of the southern building are likely to reach near to their original height (as can be seen on Illus 5). A blocked window was evident in the shared wall with no. 11 Edinburgh Road (Illus 7)

The eastern wall appears to survive for the southernmost 4–4.5m, north of which it has been replaced with an angled wall that joins with the northern building. There are two openings – a doorway immediately adjacent to the south wall, and a lower blocked door further north. Lintels are of stone externally and wood inside. Possible signs of an upper window can be seen between the two. The upper part of the wall has been heavily consolidated with a mixture of brick, stone and concrete. (Illus 5 & 8)

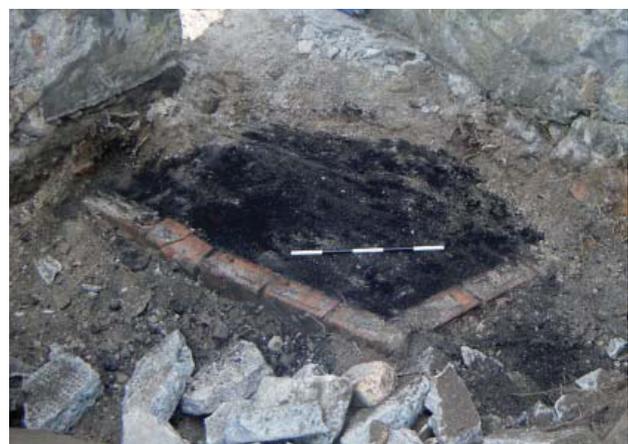
Illus 6
Southern building internal shot of brick/bitumen structure

A concrete floor was removed by the main contractor to reveal several underlying features. In the south-east corner, by the doorway, a low brick structure (measuring 2.1 x 0.9m in plan, Illus 6) was filled with a bituminous deposit, possibly the base of a former step down to the original floor level. This floor consisted of a series of large stone flags in the south-west corner (Illus 2) – further north it had been replaced by a poured concrete surface, which is presumably a later modification. No archaeological deposits were found under these surfaces, and they appeared to have lain directly on bedrock.

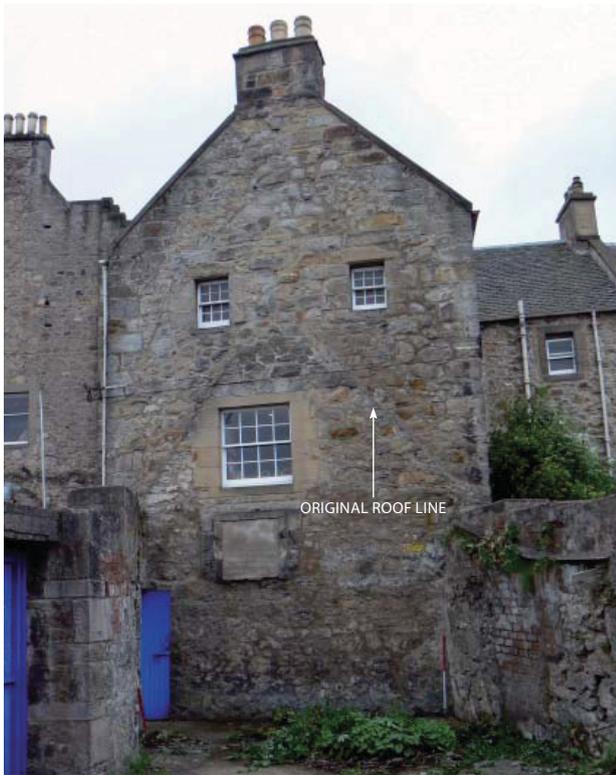
Illus 7
Southern building internal shot of south elevation

below the roof line and indicates that the building at no. 11 predated the recorded structure. The current window immediately above the blocked one must have been inserted after the recorded structure fell into disuse. (Illus 7)

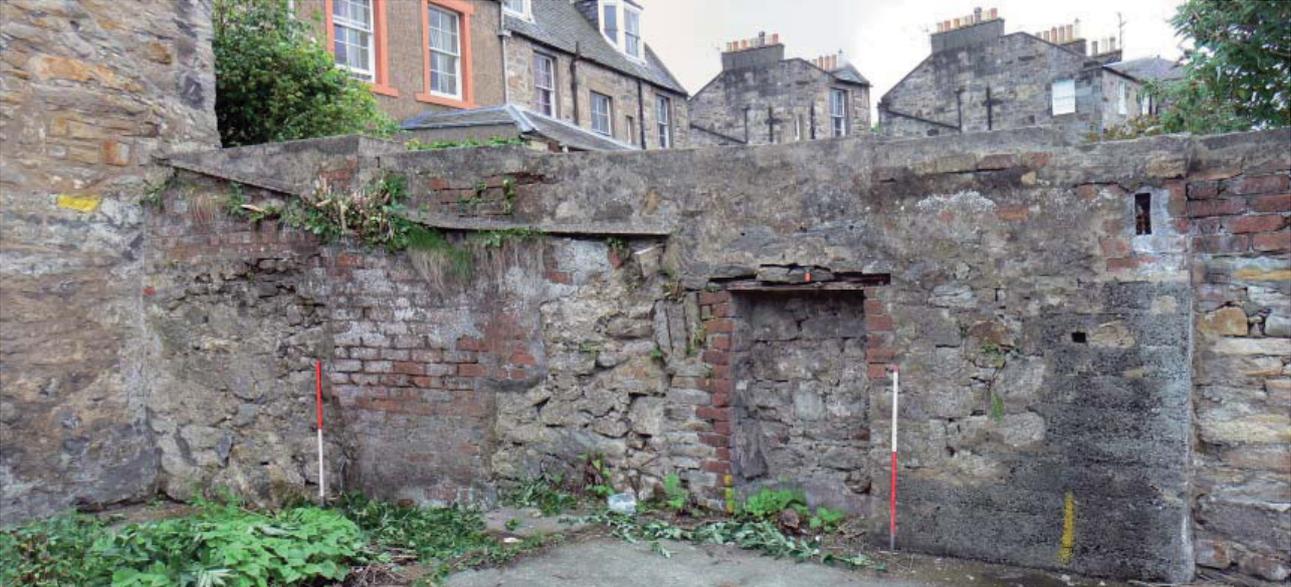
Illus 9
Southern building internal shot of west wall

The western wall runs for 6.8m and again has been heavily consolidated on the interior, primarily with brick. A former opening is visible 1.5m from the southern end, though it is not now possible to identify it as either door or window. A second opening, 1m from the north end does not appear to break

the external face and was presumably an alcove or press. A protruding line of concrete slopes from the wallhead at the south end towards the top of this alcove – this could be related to the consolidation, and may represent a support for a temporary internal roof. (Illus 9)

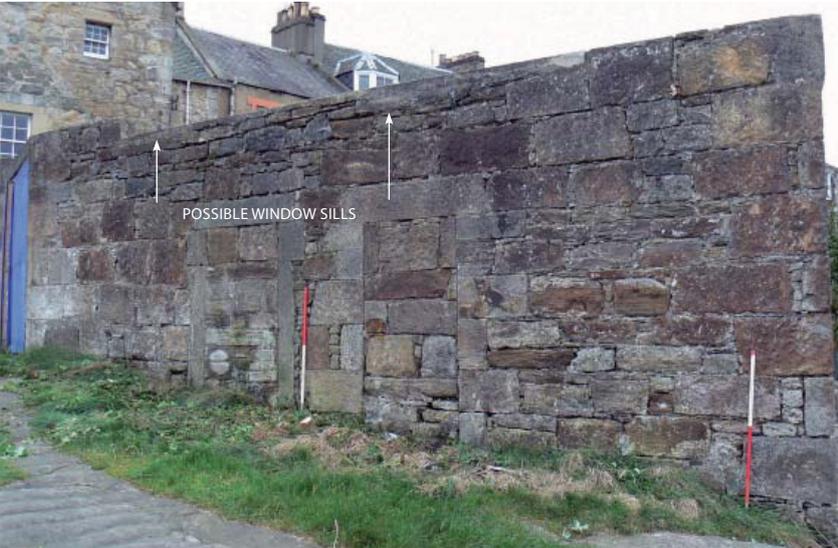
Illus 10
Northern building external shot of east wall

The ground floor of the eastern wall contained two blocked doors (0.9 x 1.9m and 1.25 x 1.85m) both with wooden lintels. The blocking consisted of dressed stone externally, with a layer of brick on the inside of the northern door. The southern door lea into the brick 'corridor'; the other opened into the NE room. Two upper floor windows seen on the historic photograph (Illus 4) could not be clearly distinguished on the exterior although two large horizontal stones may have represented their bottom sills. (Illus 10 & 15)

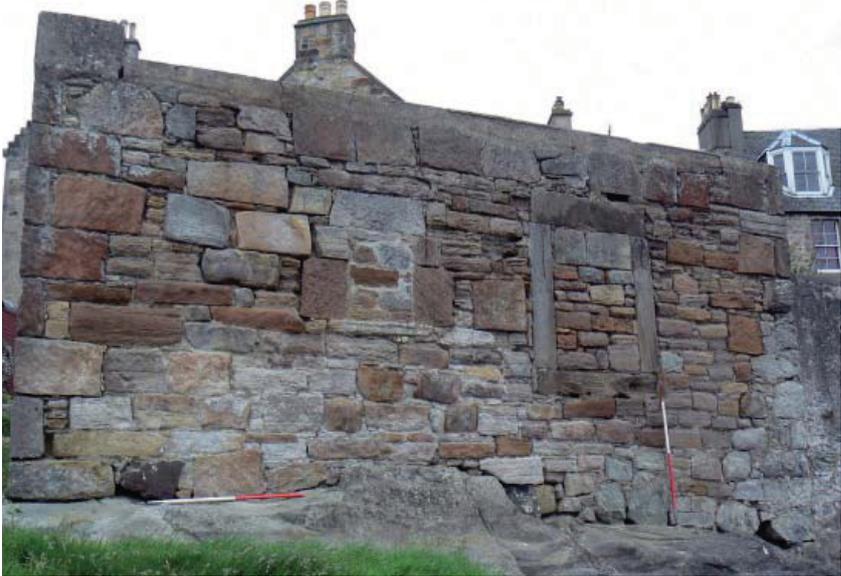
Illus 11
Northern building external shot of north wall

The northern wall of the building was marked by several features. A large ground-floor window (0.9x1.3m) had been blocked with bricks internally with stone on the outside (Illus 11 & 12). A smaller window (0.6x0.7m) further east had been blocked entirely with stone. The interior lintel for the latter is a substantial stone block, while the other is capped by a thin wooden one. Removal of the concrete floor and levelling material revealed two fireplaces with stone sidewalls and plinths, both with bricked up upper sections or flues. The eastern fireplace's flue extended into the smaller window and must be a later insertion. The fireplaces appear to serve the two larger ground floor rooms. The upper parts of the wall had been consolidated with brick and concrete. (Illus 11–13)

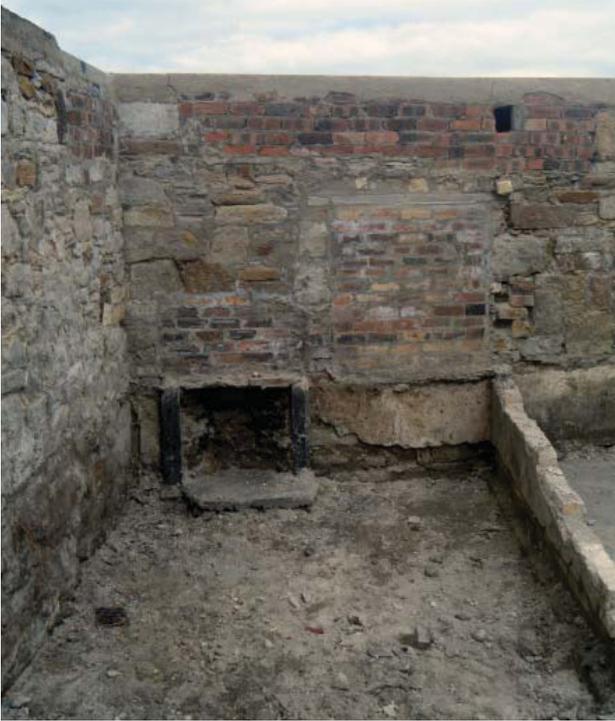
Illus 12

Northern building internal shot of north wall showing hearth and internal dividing wall after excavation

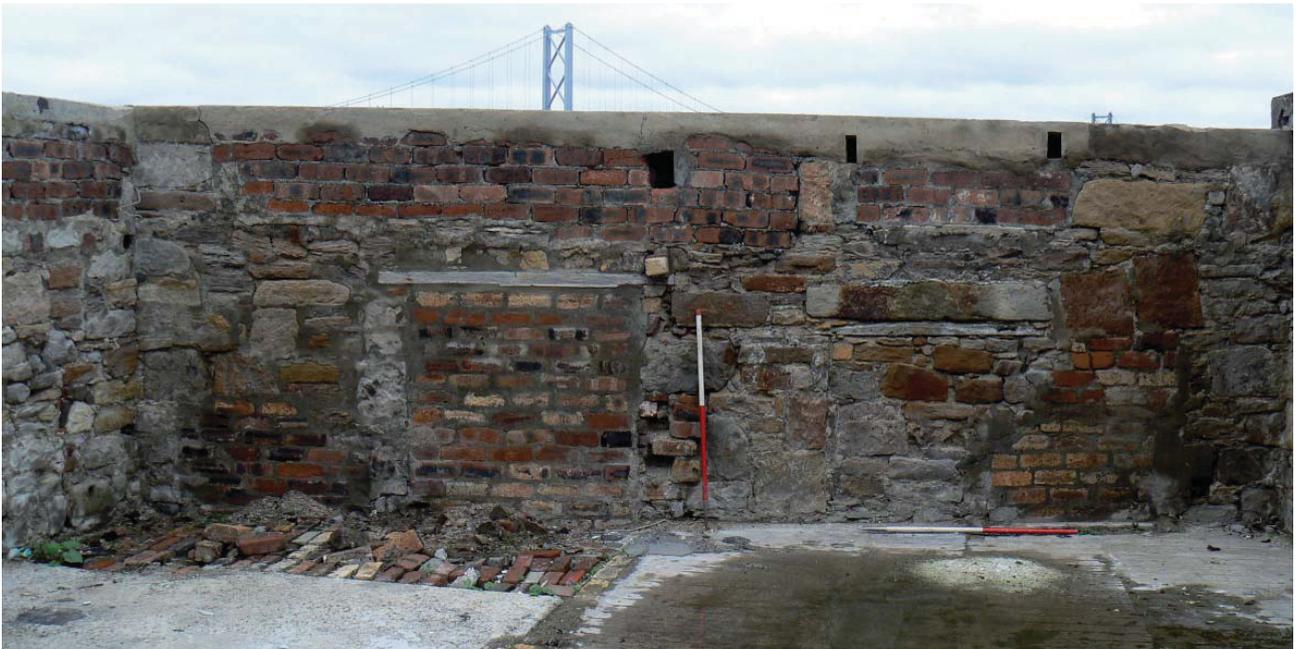
Illus 13

the concrete surface (Illus 13 shows the building prior to excavation). No remains of an original floor were found and presumably this, like the northern building, may have been flagstone. Levelling deposits between the concrete surfaces and bedrock contained no archaeologically significant remains and dated to the modern period. It appears that the interior of the building was originally cut into bedrock.

Northern building internal shot of north wall pre-excavation

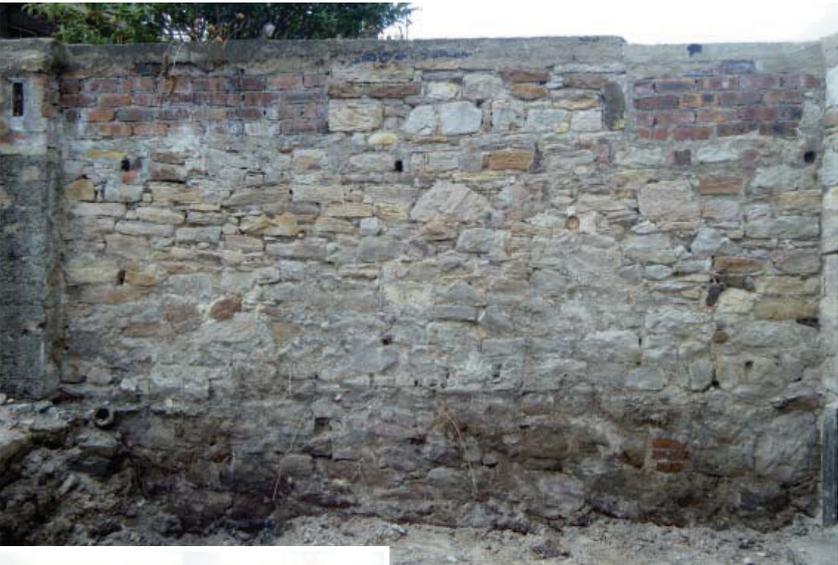
No features were present on the west elevation, excepting a number of joist sockets (presumably for the roof). A clay drainage pipe extended through the wall at the south end. Again, the wallhead has been consolidated with brick and concrete. (Illus 14)

Illus 14
Northern building internal shot of west wall post-
excavation

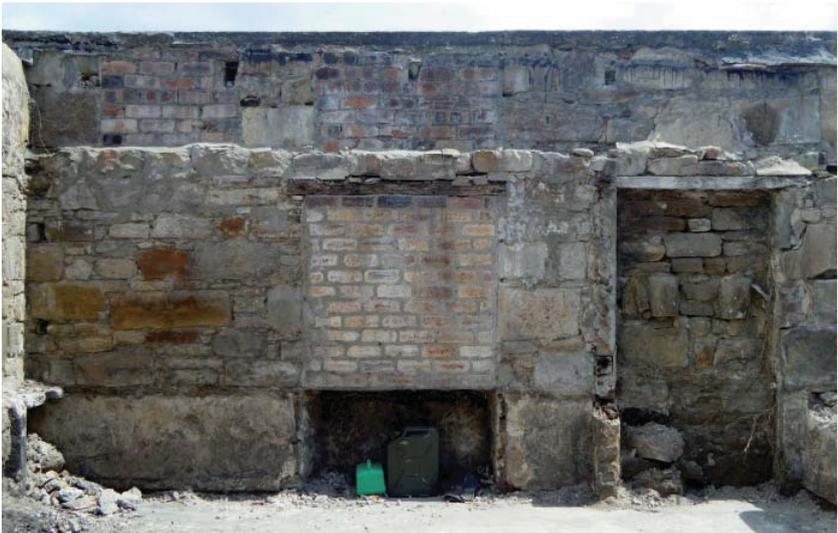
Illus 15
Northern building internal shot of east wall post-excavation

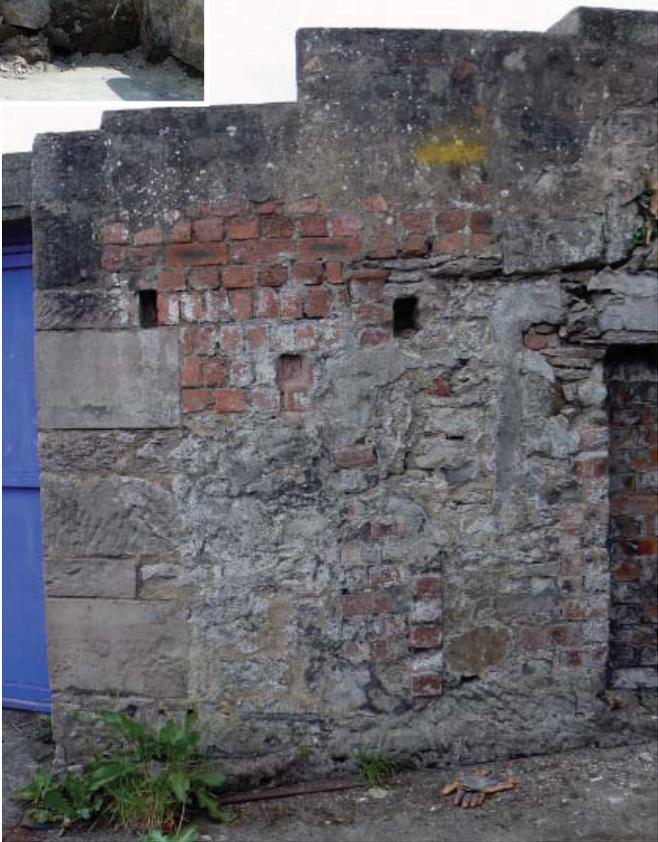
Illus 16
Internal shot showing bedrock

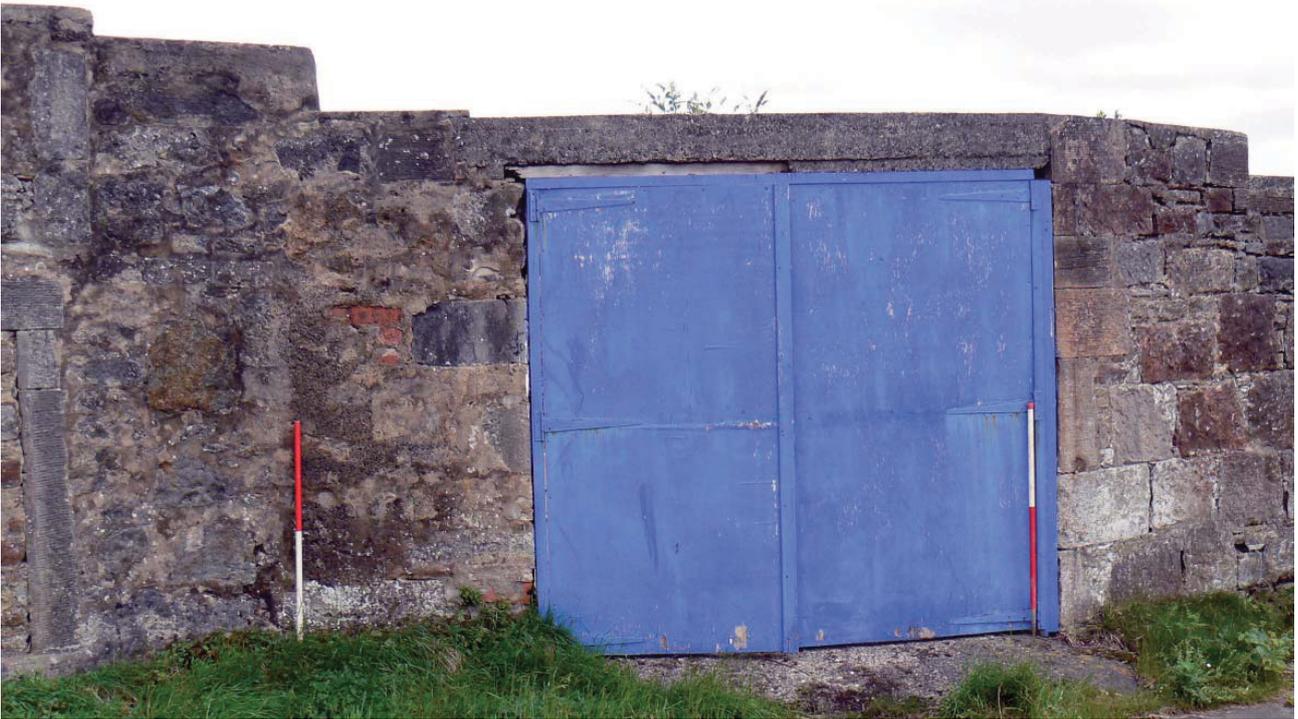
Illus 17

External shot of joining section between north and south buildings

A recent entrance between the two buildings had been created on the east (Illus 17). This consisted of a long concrete lintel supported by substantial dressed stonework around a set of double doors. This section allowed access into the interior and effectively joined the two buildings into one.
