A TOPOGRAPHIC ARCHAEOLOGICAL SURVEY OF FIVE PICTISH FORTS IN THE HIGHLANDS

for Forestry Commission, Scotland

March 2011

HA Job No: PFHS10

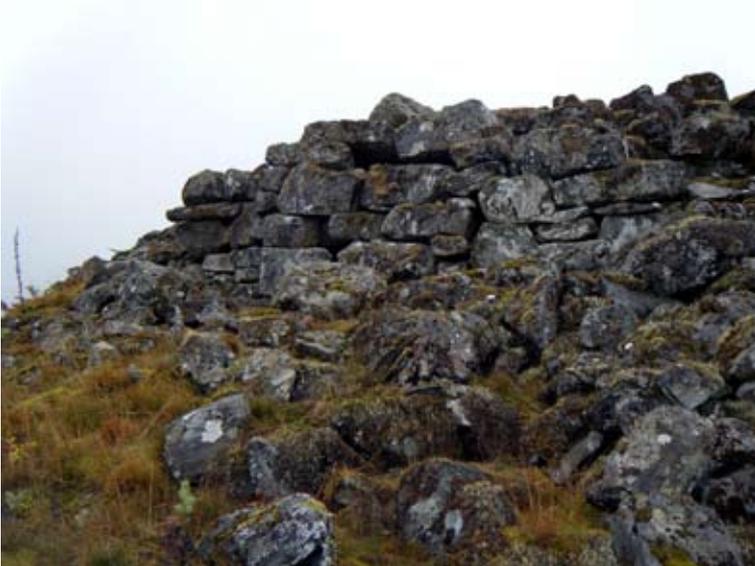
Illus 2

Caisteal Mac Tuathal, external rampart face at south-west corner. Photo taken September 2010

felled. The rampart material is generally spread quite widely as the stones have tumbled down the steep slopes on the outside. However, the ramparts appeared to have remained fairly stable over the last 100 years; a sketch of the best preserved outer rampart section drawn by Christison in the 19th century (Illus 2a) looks almost identical to the remains still visible today (Illus 2).

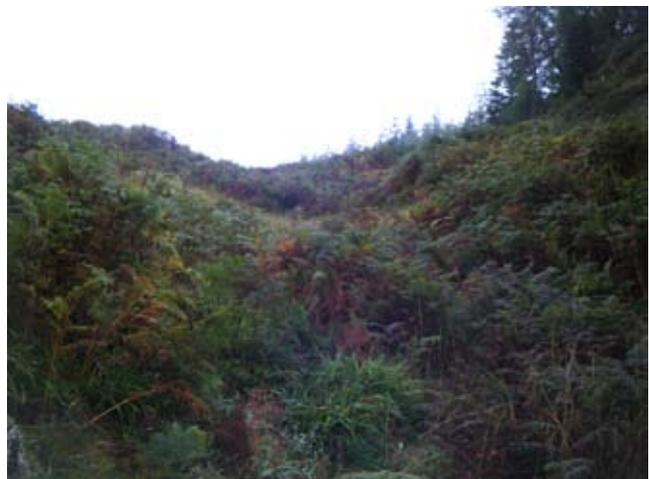
Illus 3

Caisteal Mac Tuathal, defensive ditch to the south of the fort

The approach from higher ground to the south is defended by a ditch situated in a natural depression to the south of the fort (Illus 3). The ditch is some 80m long, up to 10m wide and 1.6m deep. The remains of a low bank could be traced over a distance of some 12m along the inside of the ditch.

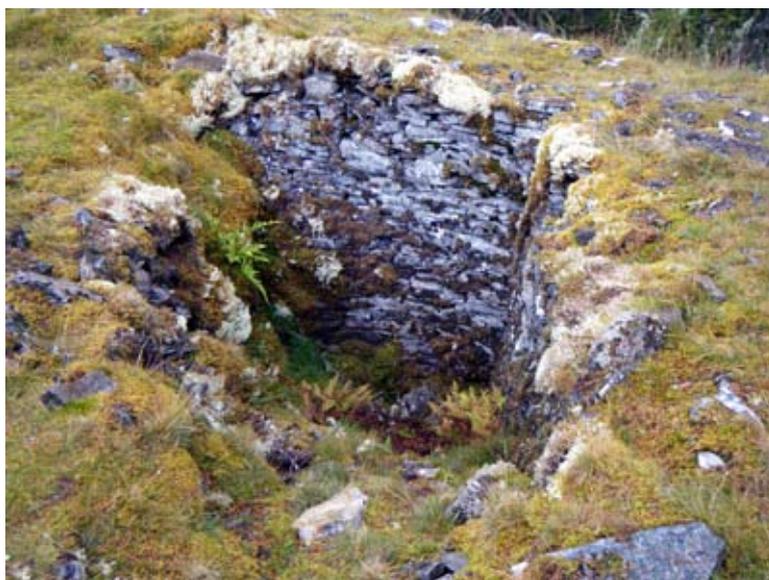
Illus 5

Dun da Lamh, inner rampart face exposed at north-west corner. Note slight change in fabric of upper parts indicating reconstruction

The ramparts are built from small slabs, generally up to 0.5m across and 0.1m thick. Part of the original face of the rampart survive above the rubble around all sides of the fort, but is best preserved towards the west end of the fort. The rampart is up to 7.5m wide, but generally between 4m and 5m. The inner face of the west rampart has been cleared at several locations exposing a height of over 2m. The largest clearance is located at the north-west corner and is up to 2.1m deep. There is a clear change in the build at the upper parts of the rampart at this point suggesting the upper 0.5m has been re-built, most likely to be reconstruction associated with a Victorian investigation (Illus 5).

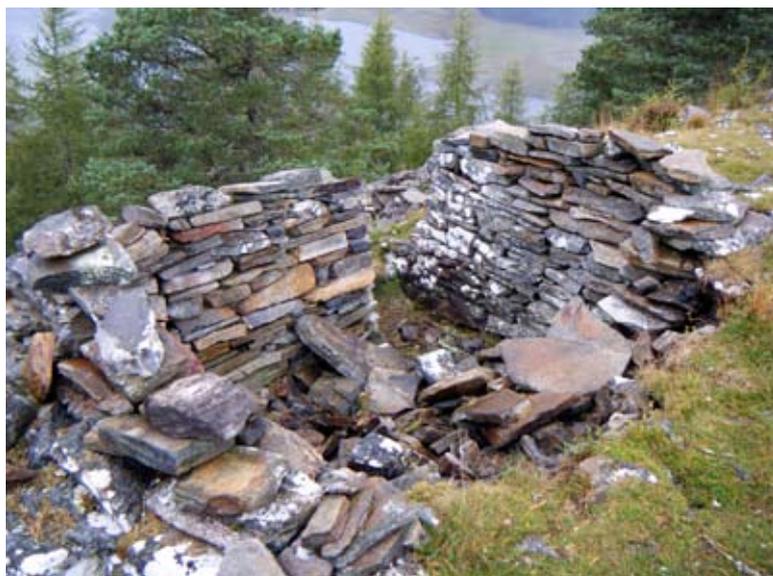
Illus 6

Dun da Lamh, shelter possibly associated with World War II lookout

4 There are a number of features within the fort but most of these appears to post-date the abandonment and collapse of the ramparts. Two small dug-out shelters have been built into the rampart at the south-west corner of the fort. These are likely to be associated with a look out station built by the Home Guard during World War II (Illus 6).

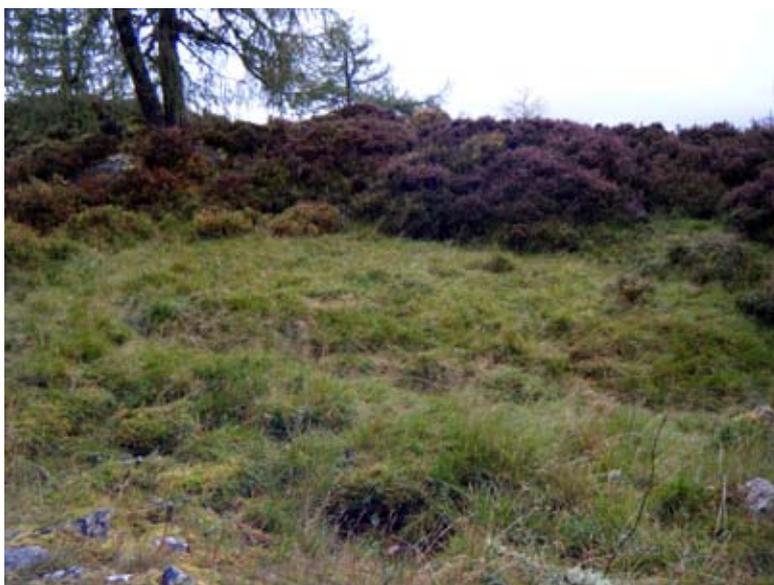
Illus 7

Dun da Lamh, possible hut-platform inside the north rampart

Another site that may be associated with the use of the fort is a semi-circular platform located just inside the north rampart some 30m from the north-east corner (Illus 7). There are faint traces of low banks along the north and west sides of the platform. This could represent the remains of a round-house but the feature is very vague. There are other level areas within the fort that may have been occupied by contemporary buildings but if so these have not left any visible traces above ground.

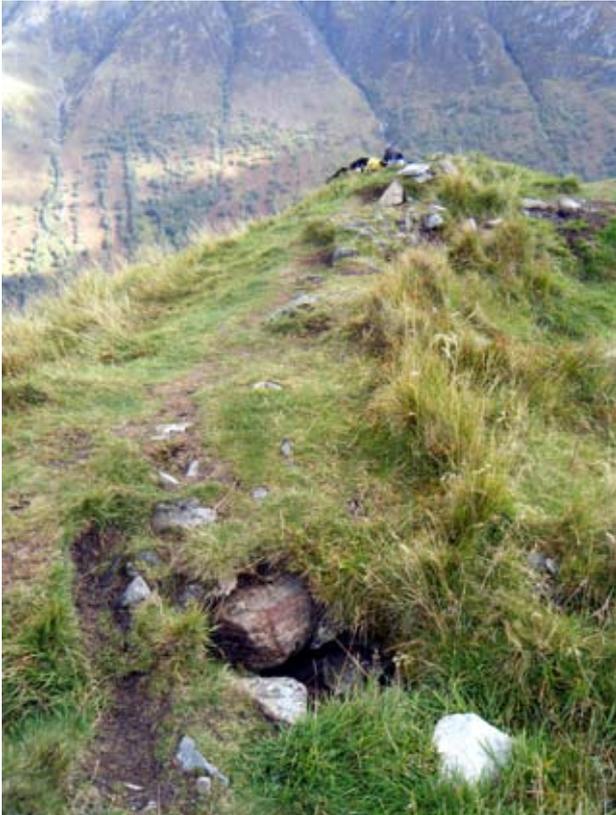
Illus 9

Dun Deadrail, slight erosion on top of north rampart

Despite the fact that the fort seems to have a high number of visitors channelled on to the site along a few narrow paths, there was not many sign of erosion from visitors. Still three small areas were noted along the top of the north rampart where the turf had been partly worn away (Illus 9). This erosion should be monitored although it did not represent serious damage at the time of the survey.

visited the site over a period of some 5 hours. The high number of visitors has caused some limited erosion on the ramparts. This damage needs to be monitored but it doesn't seem to be a serious problem at the moment. The path leading from the West Highland Way seems to be constructed recently and is still in a good condition, the only problem being a short muddy patch at a point where the paved path leads on to the old natural path.

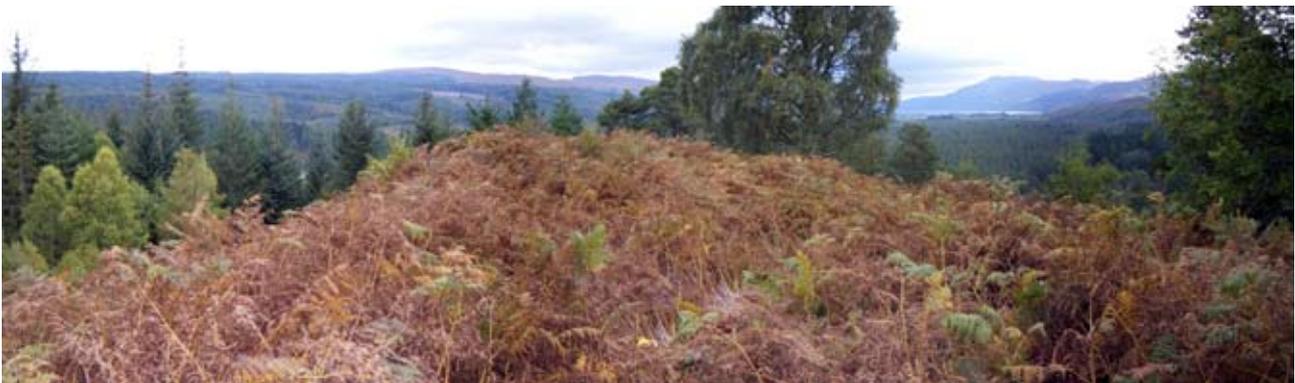
Illus 10

Torr Dhuin, north-facing view of interior

At the time of the survey the entire fort was covered in dense tall bracken that obscured any slighter features of the fort. The fort has been surveyed at a couple of times over the last century. The reports associated with these surveys describe features that are no longer visible due

The forts Caisteal Mac Tuathal and Torr Dhuin are both heavily affected by dense tall bracken which hides the finer details of the fort. In the case of Torr Dhuin old surveys described blocks of vitrified rampart material that now is obscured by the dense bracken. Eradication of bracken on these two forts would greatly improve the appearance of these two forts.

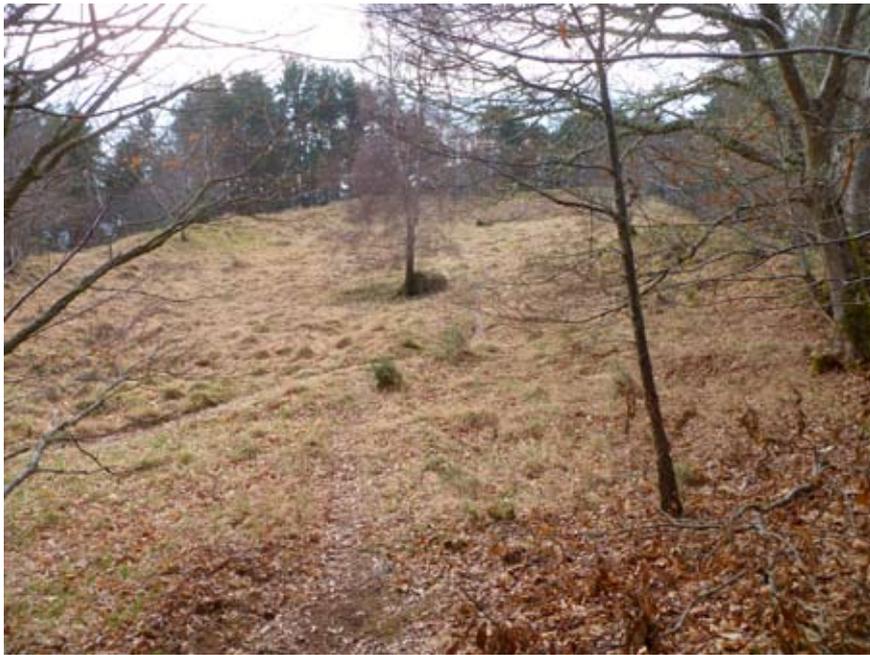
Illus 11

Craig Phadrig, south-west facing view of interior

The fort itself is sub-oval, enclosing an almost rectangular area of approximately 70 x 20m, or a little over 1300m², on a NE-SW alignment (Illus 11). The approaches to the summit are steep, with the easiest access from the north or west. The south-eastern slope remains steep until it reaches valley level. The entrance to the fort lies at the north-eastern end.

The interior of the fort is generally flat (Illus 11), although there appears to be a somewhat higher area at the south-western end. Three possible hollows of between 2 and 4m diameter are visible, though at least two of these may be related to the earlier excavations.

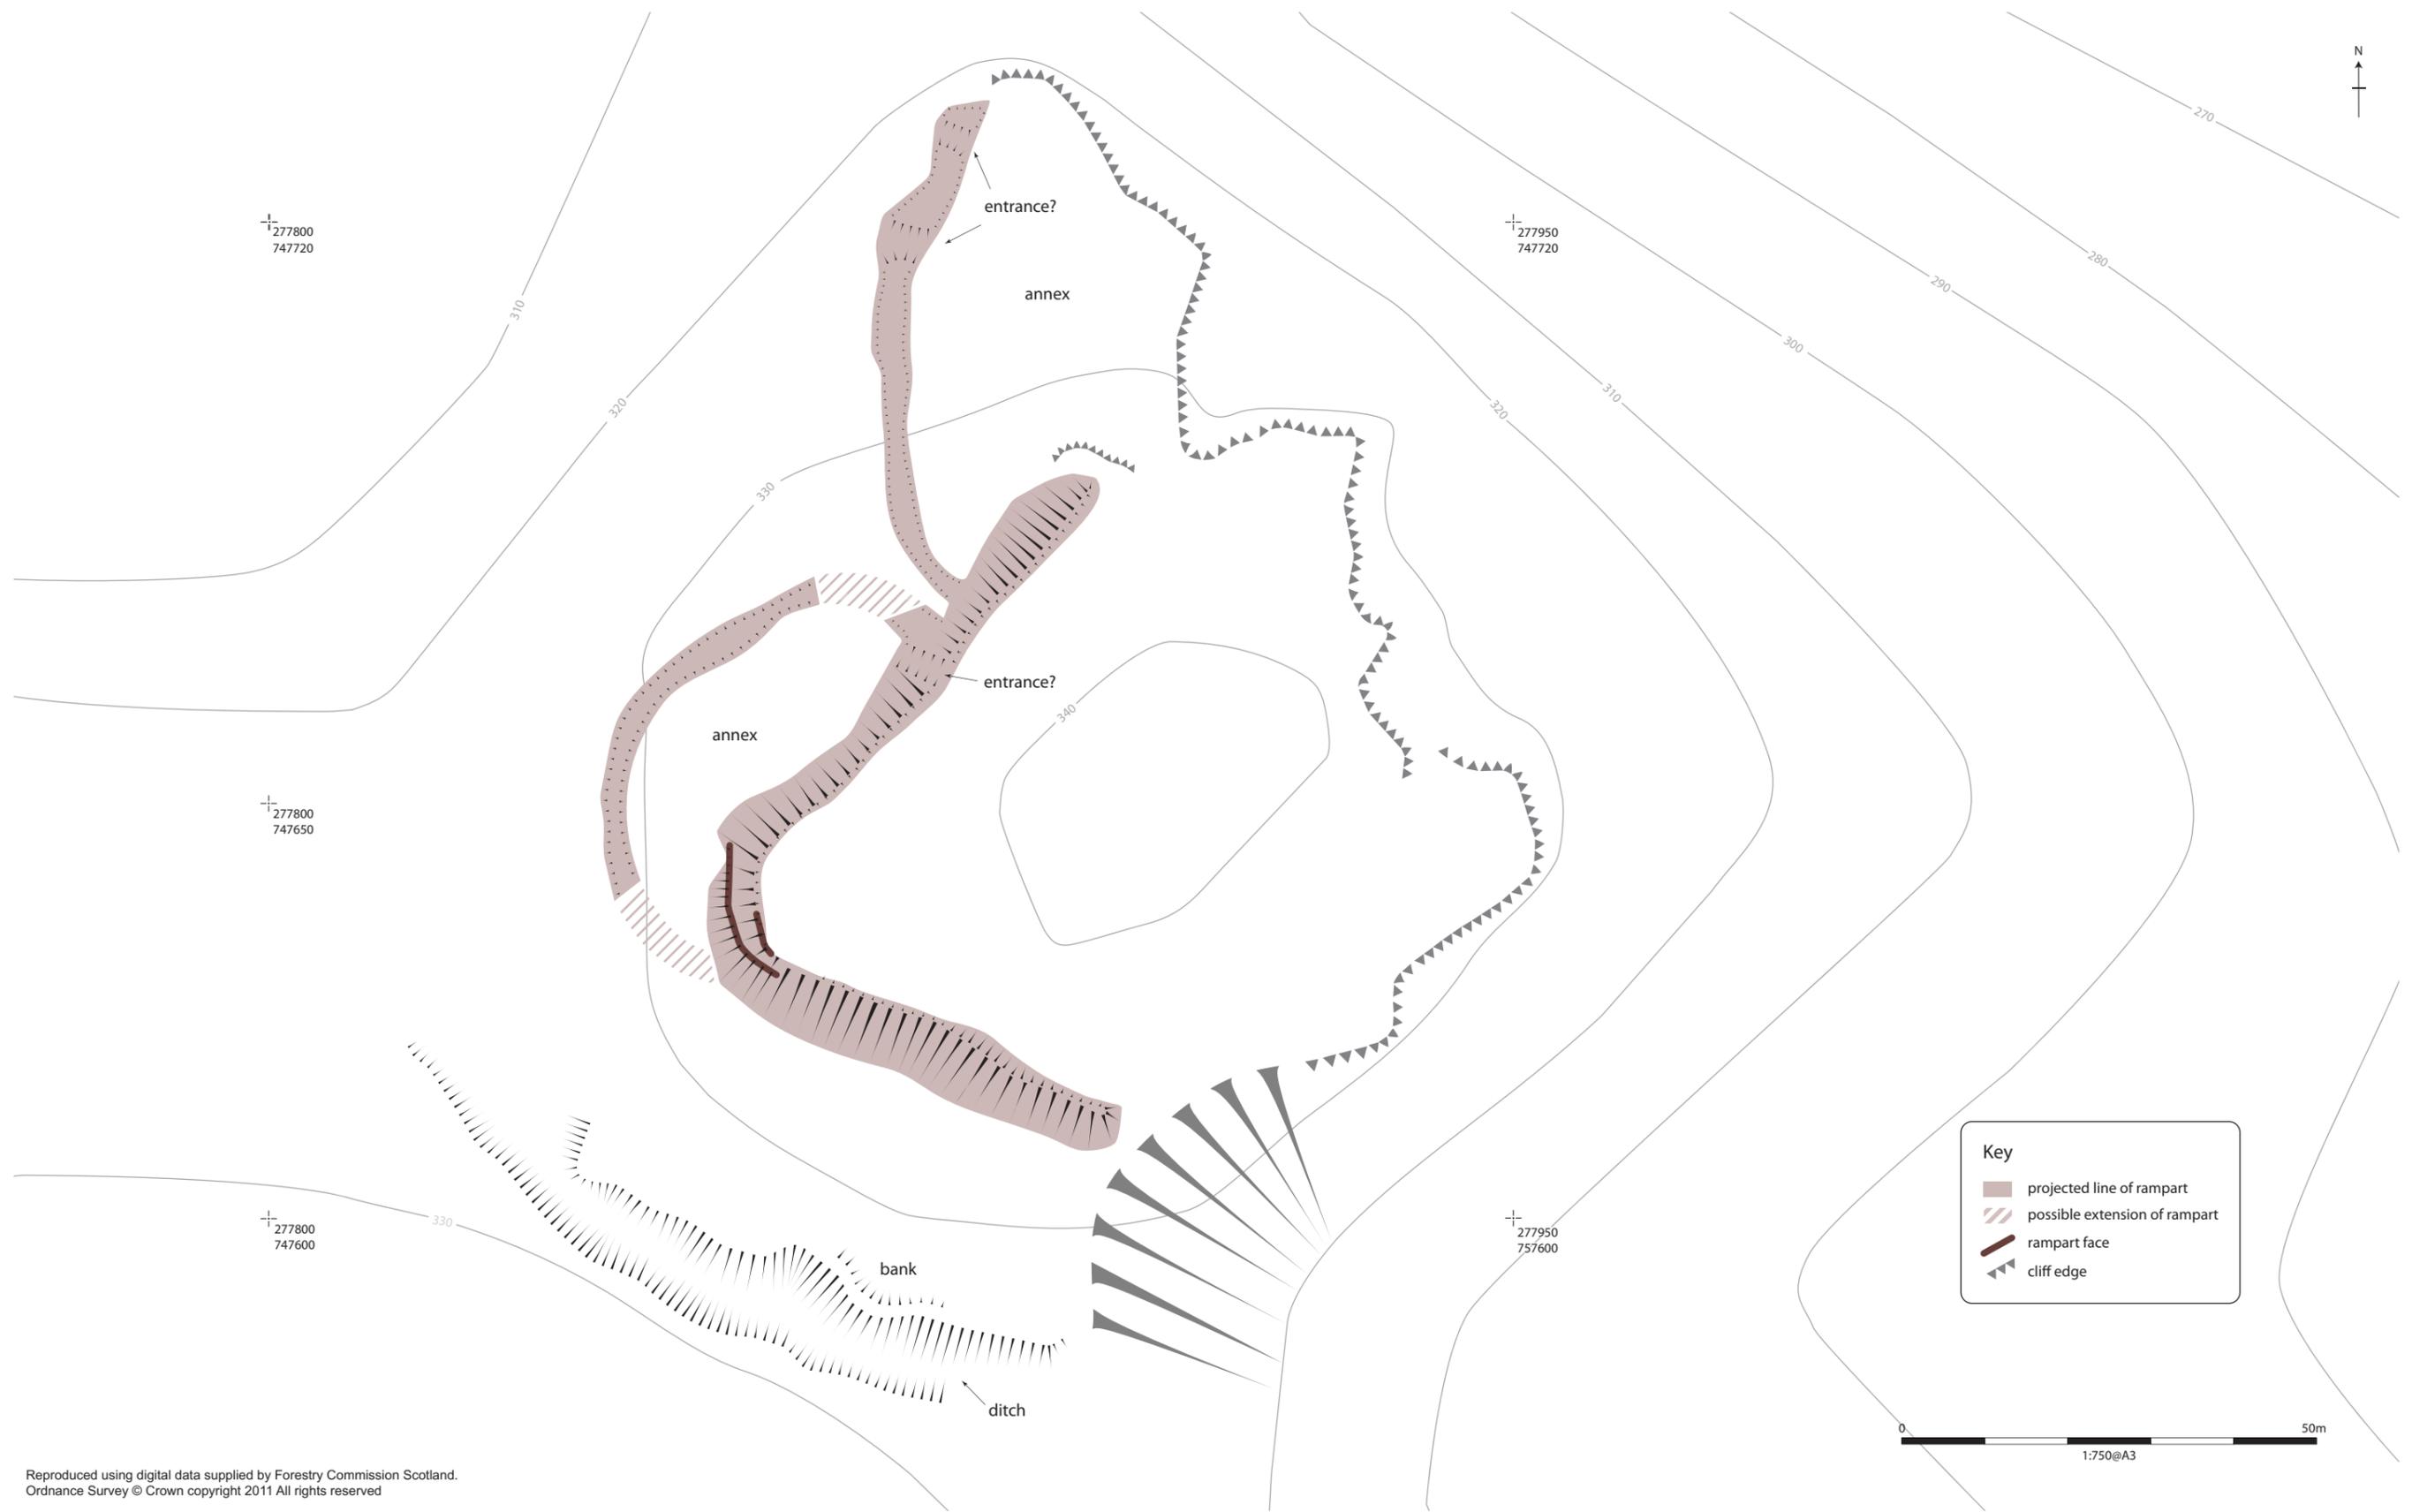
Illus 13
Plan of Caisteal Mac Tuathal at 1:750

extensive views over Strath of Appin and the rivers Lyon and Tay some 250m below to the north and east (Illus 1). The fort is sub-rectangular and measures some 60m by 75m internally, covering an area of 4470m² (Illus 13). It is defended by vertical crags and steep slopes to the north-east and south east and by an L-shaped wall to the south-west and north-west. The wall is between 2.9m and 3.3m wide and is best preserved at the W corner where the outer face still stands to 1.8m (Illus 2). There is no clear entrance but there is a slight gap half way along the north-west side, and another on the edge of the natural slope in the south which could indicate the location of entrances.

There is an annex to the north occupying lower ground and defended to the east by vertical cliffs and to the west by a stone rampart. It measures some 30m by 60m internally and covers an area of 1370m². One of two shallow depressions towards the north end of the rampart may indicate the location of an entrance leading into the annex from the west.

A second annex is located further south on the east side of the main wall. It is defined by a curving rampart up against the southern half of the main western rampart forming a D-shaped area 15m by 40m internally, covering an area of 570m².

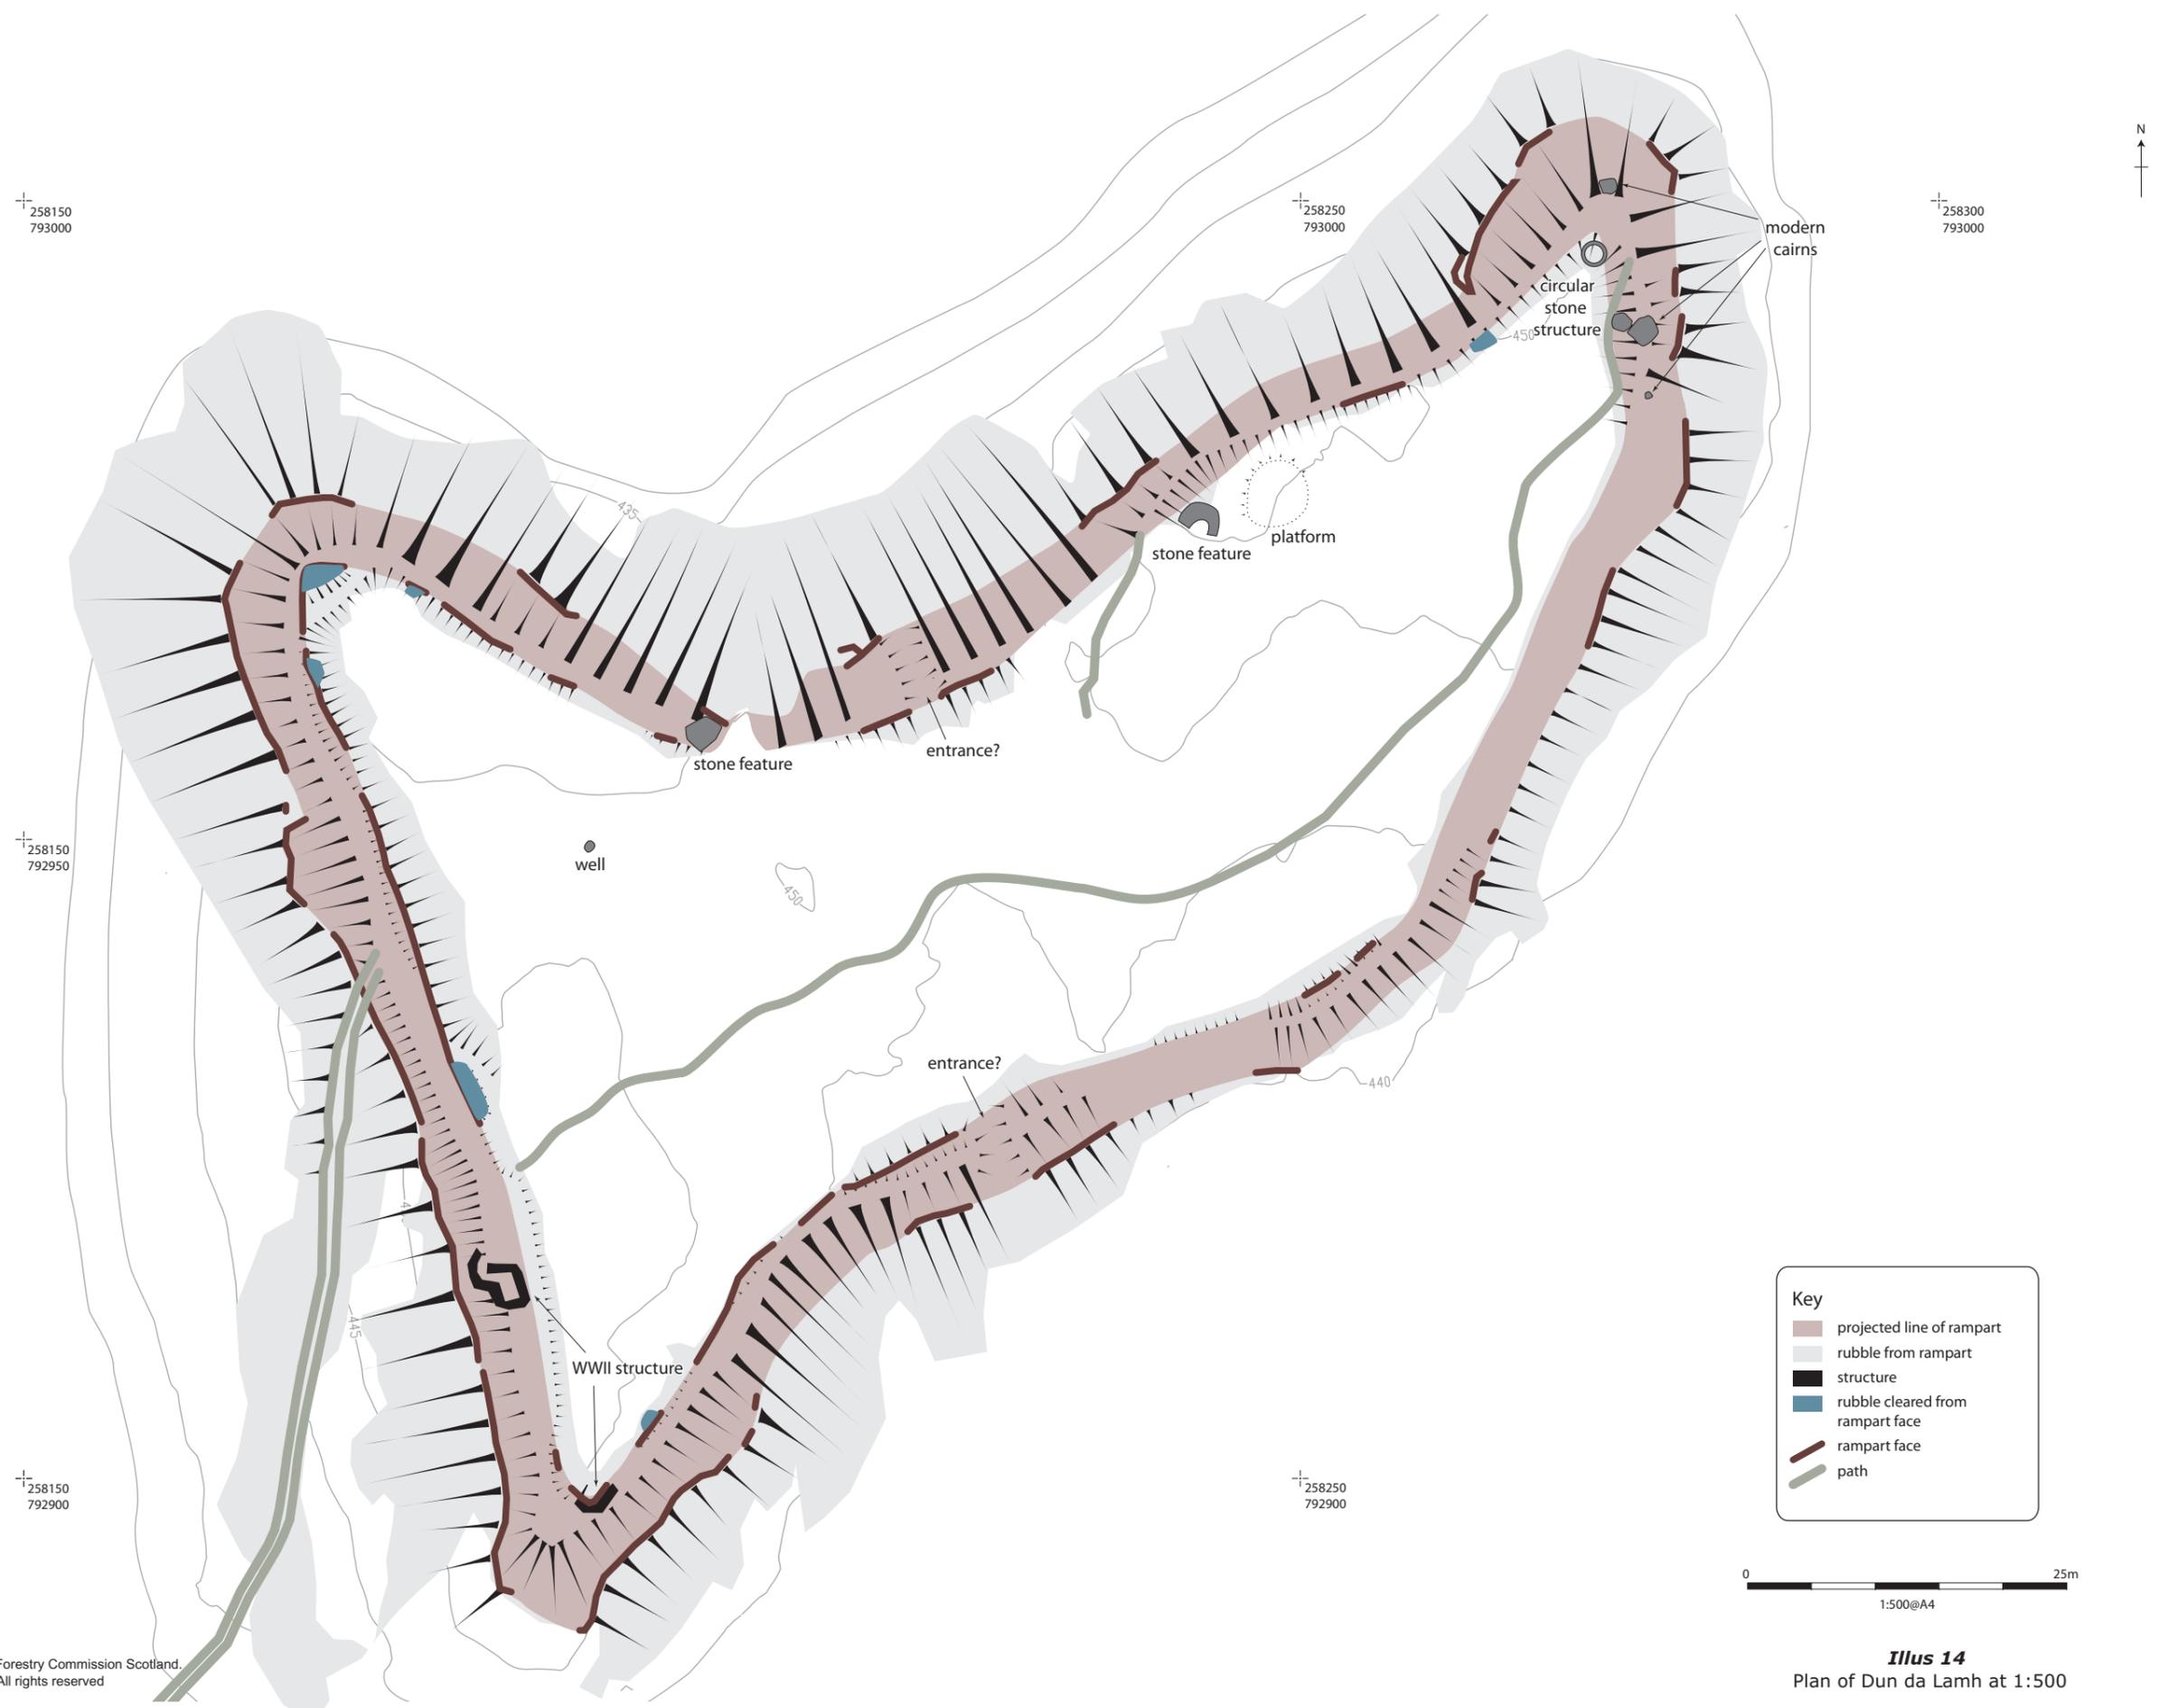
Illus 14
Plan of Dun da Lamh at 1:500

A couple of small stone built features were recorded on or near the ramparts. These appear to be small shelters or possibly shooting butts. A small circular structure has been built on top of the rampart rubble up against a small crag. The interior of the structure was only 1m in diameter internally and defined by low stone banks 0.9m wide. A second semi-circular feature was built up against the foot of a north-east facing rock face. It was defined by collapsed stone walls spread out to 0.7m wide. The interior of the structure measured 1.3m along the rock face by 1.6 m deep. A circular stone feature defined by a ring of stones is situated on top of the rampart rubble at the north-east corner of the fort. The ring is 1.8m in diameter and is made up by a line of stone 0.2m across. Nearby at the north-east corner are four small modern cairns built on top of the rampart. The cairns are 0.9m to 1.5m in diameter and 0.5m to 0.9m high.

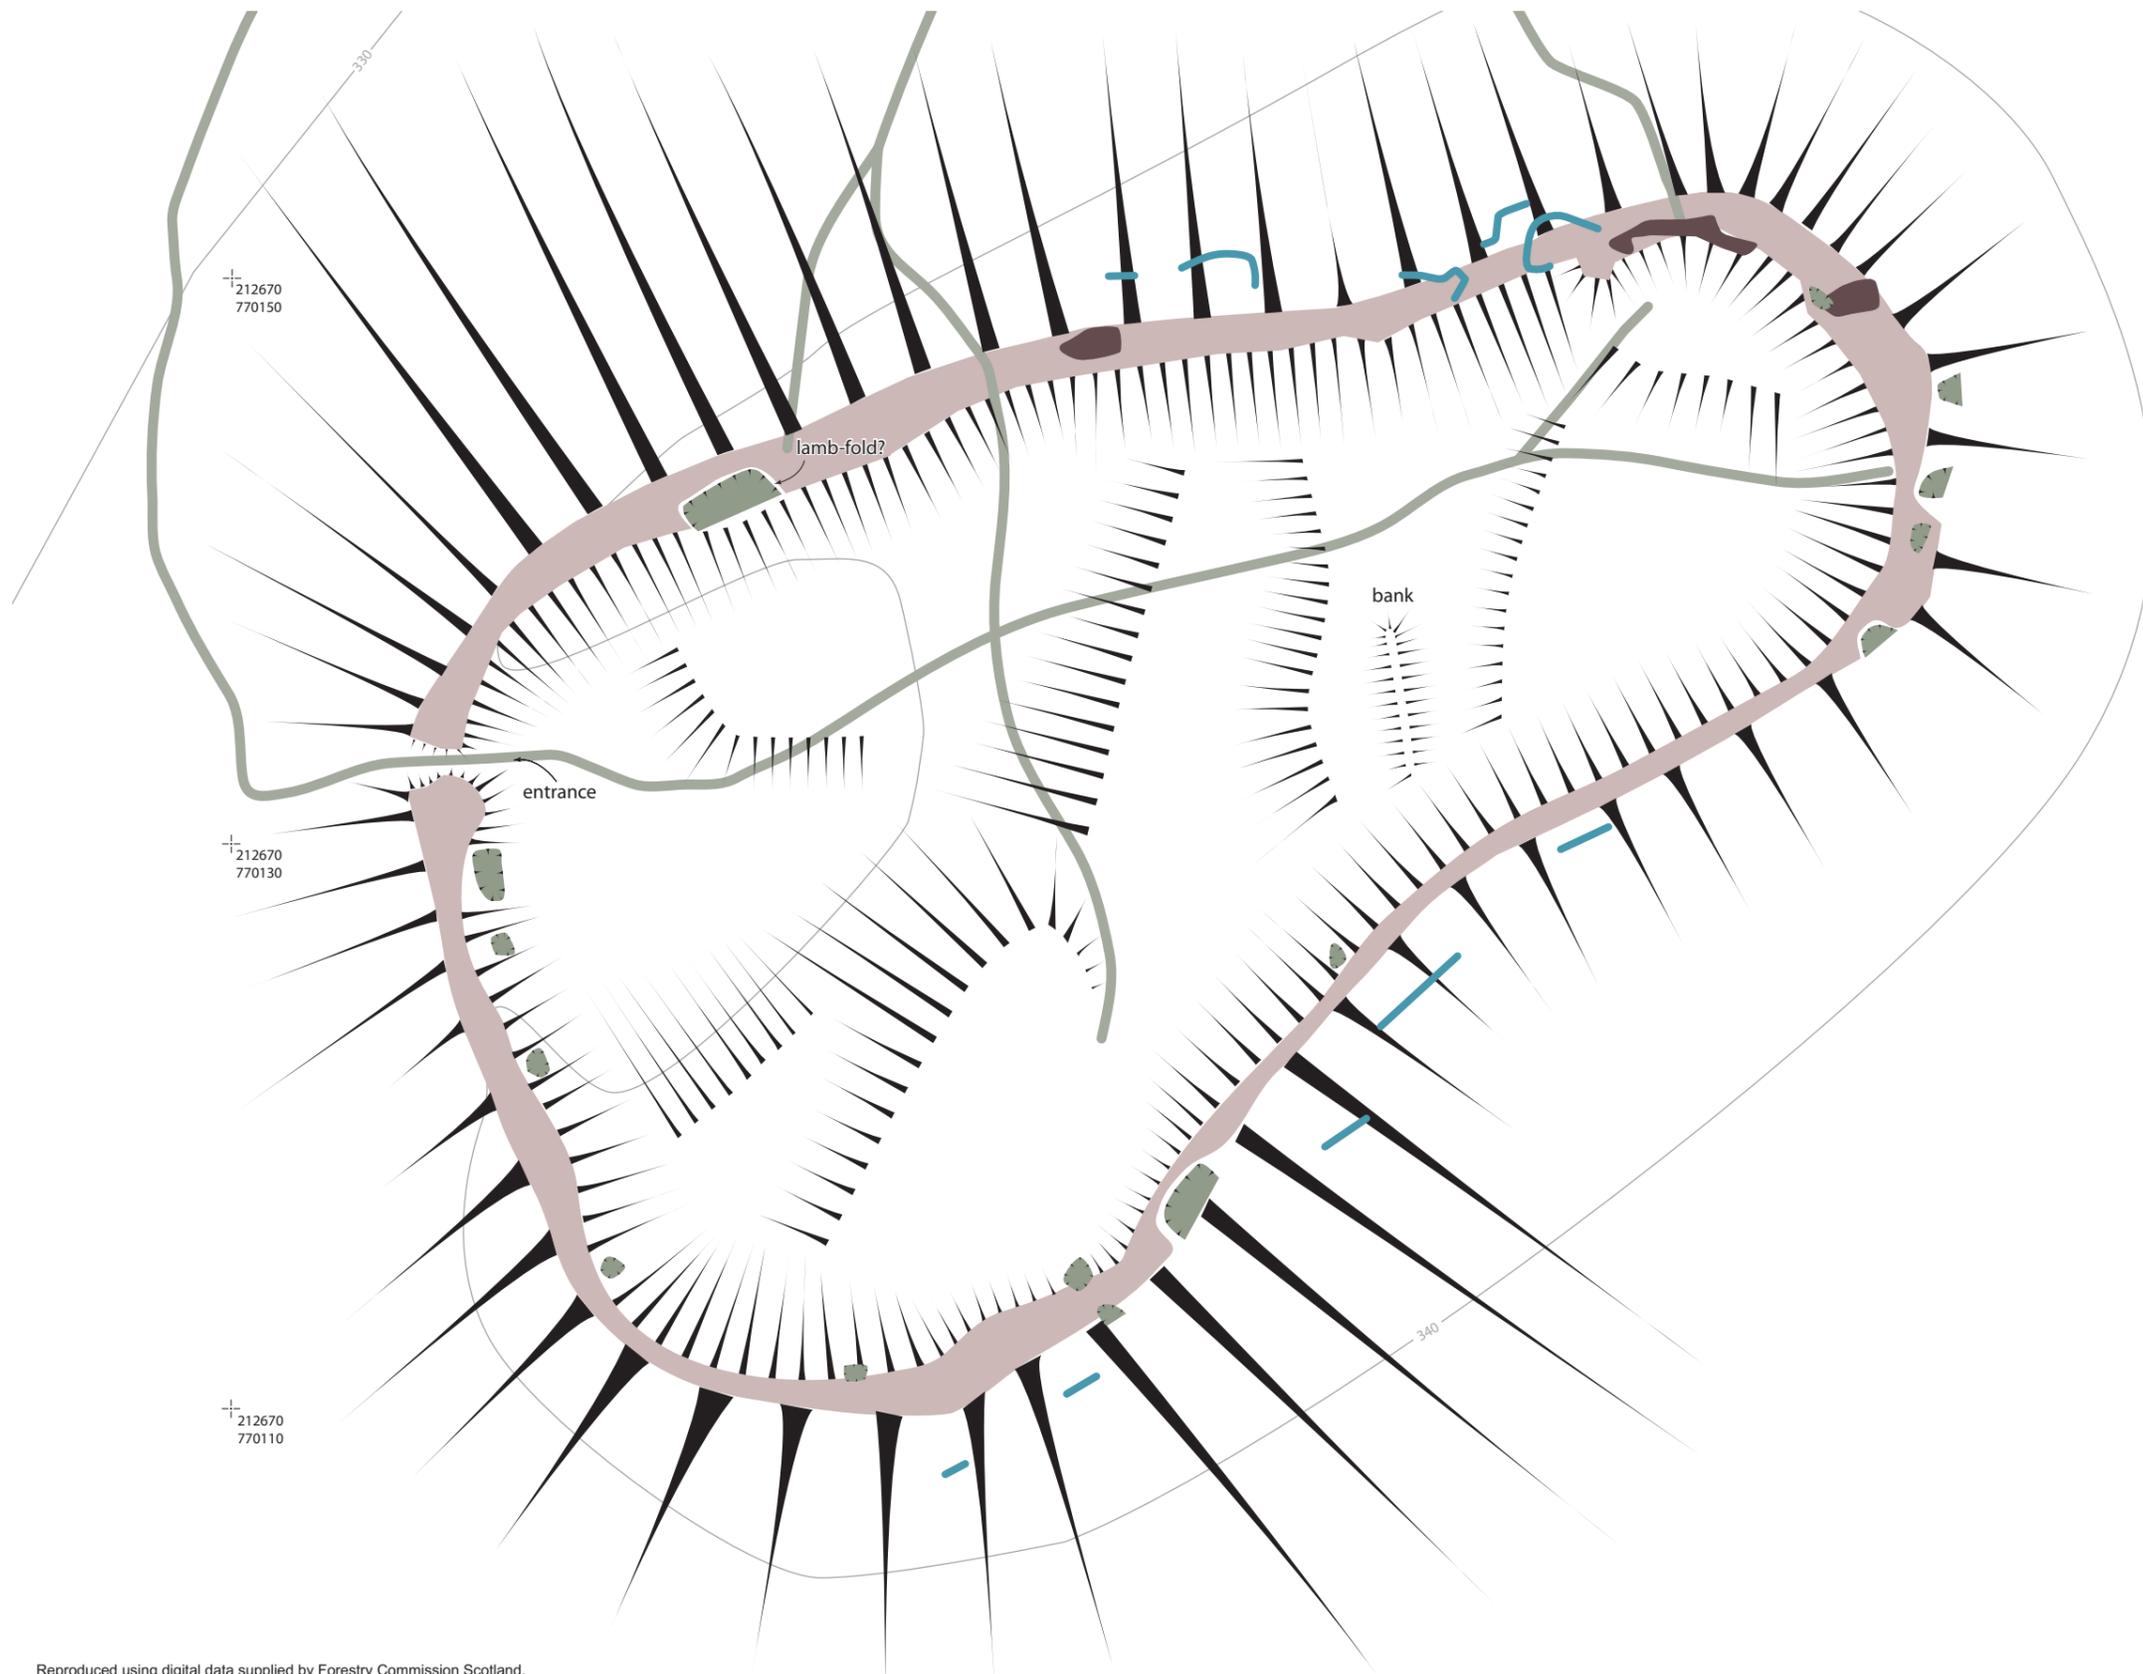
Illus 15
Plan of Dun Deadrail at 1: 250

Several blocks of vitrified masonry were recorded on and around the fort. Most of them were seen on the upper slopes outside the fort to the north and south and they all seemed to be detached blocks; none of them appeared to represent *in situ* masonry. A survey made by The Royal Commission in 1970 indicates additional locations of vitrified rock that is no longer visible.

Several hollows were noted along the ramparts. A large D-shaped hollow on the inside of the north rampart is 1.5m wide by 3.5m long was identified as a lambfold on The Royal Commission plan from 1970. Some of the other larger D-shaped hollows along the outside to the south and east may also be small sheep shelters. However there are a number of other smaller holes that seem to be associated with the original construction of the fort, but the only way to identify the nature and function of these features would be through excavation.

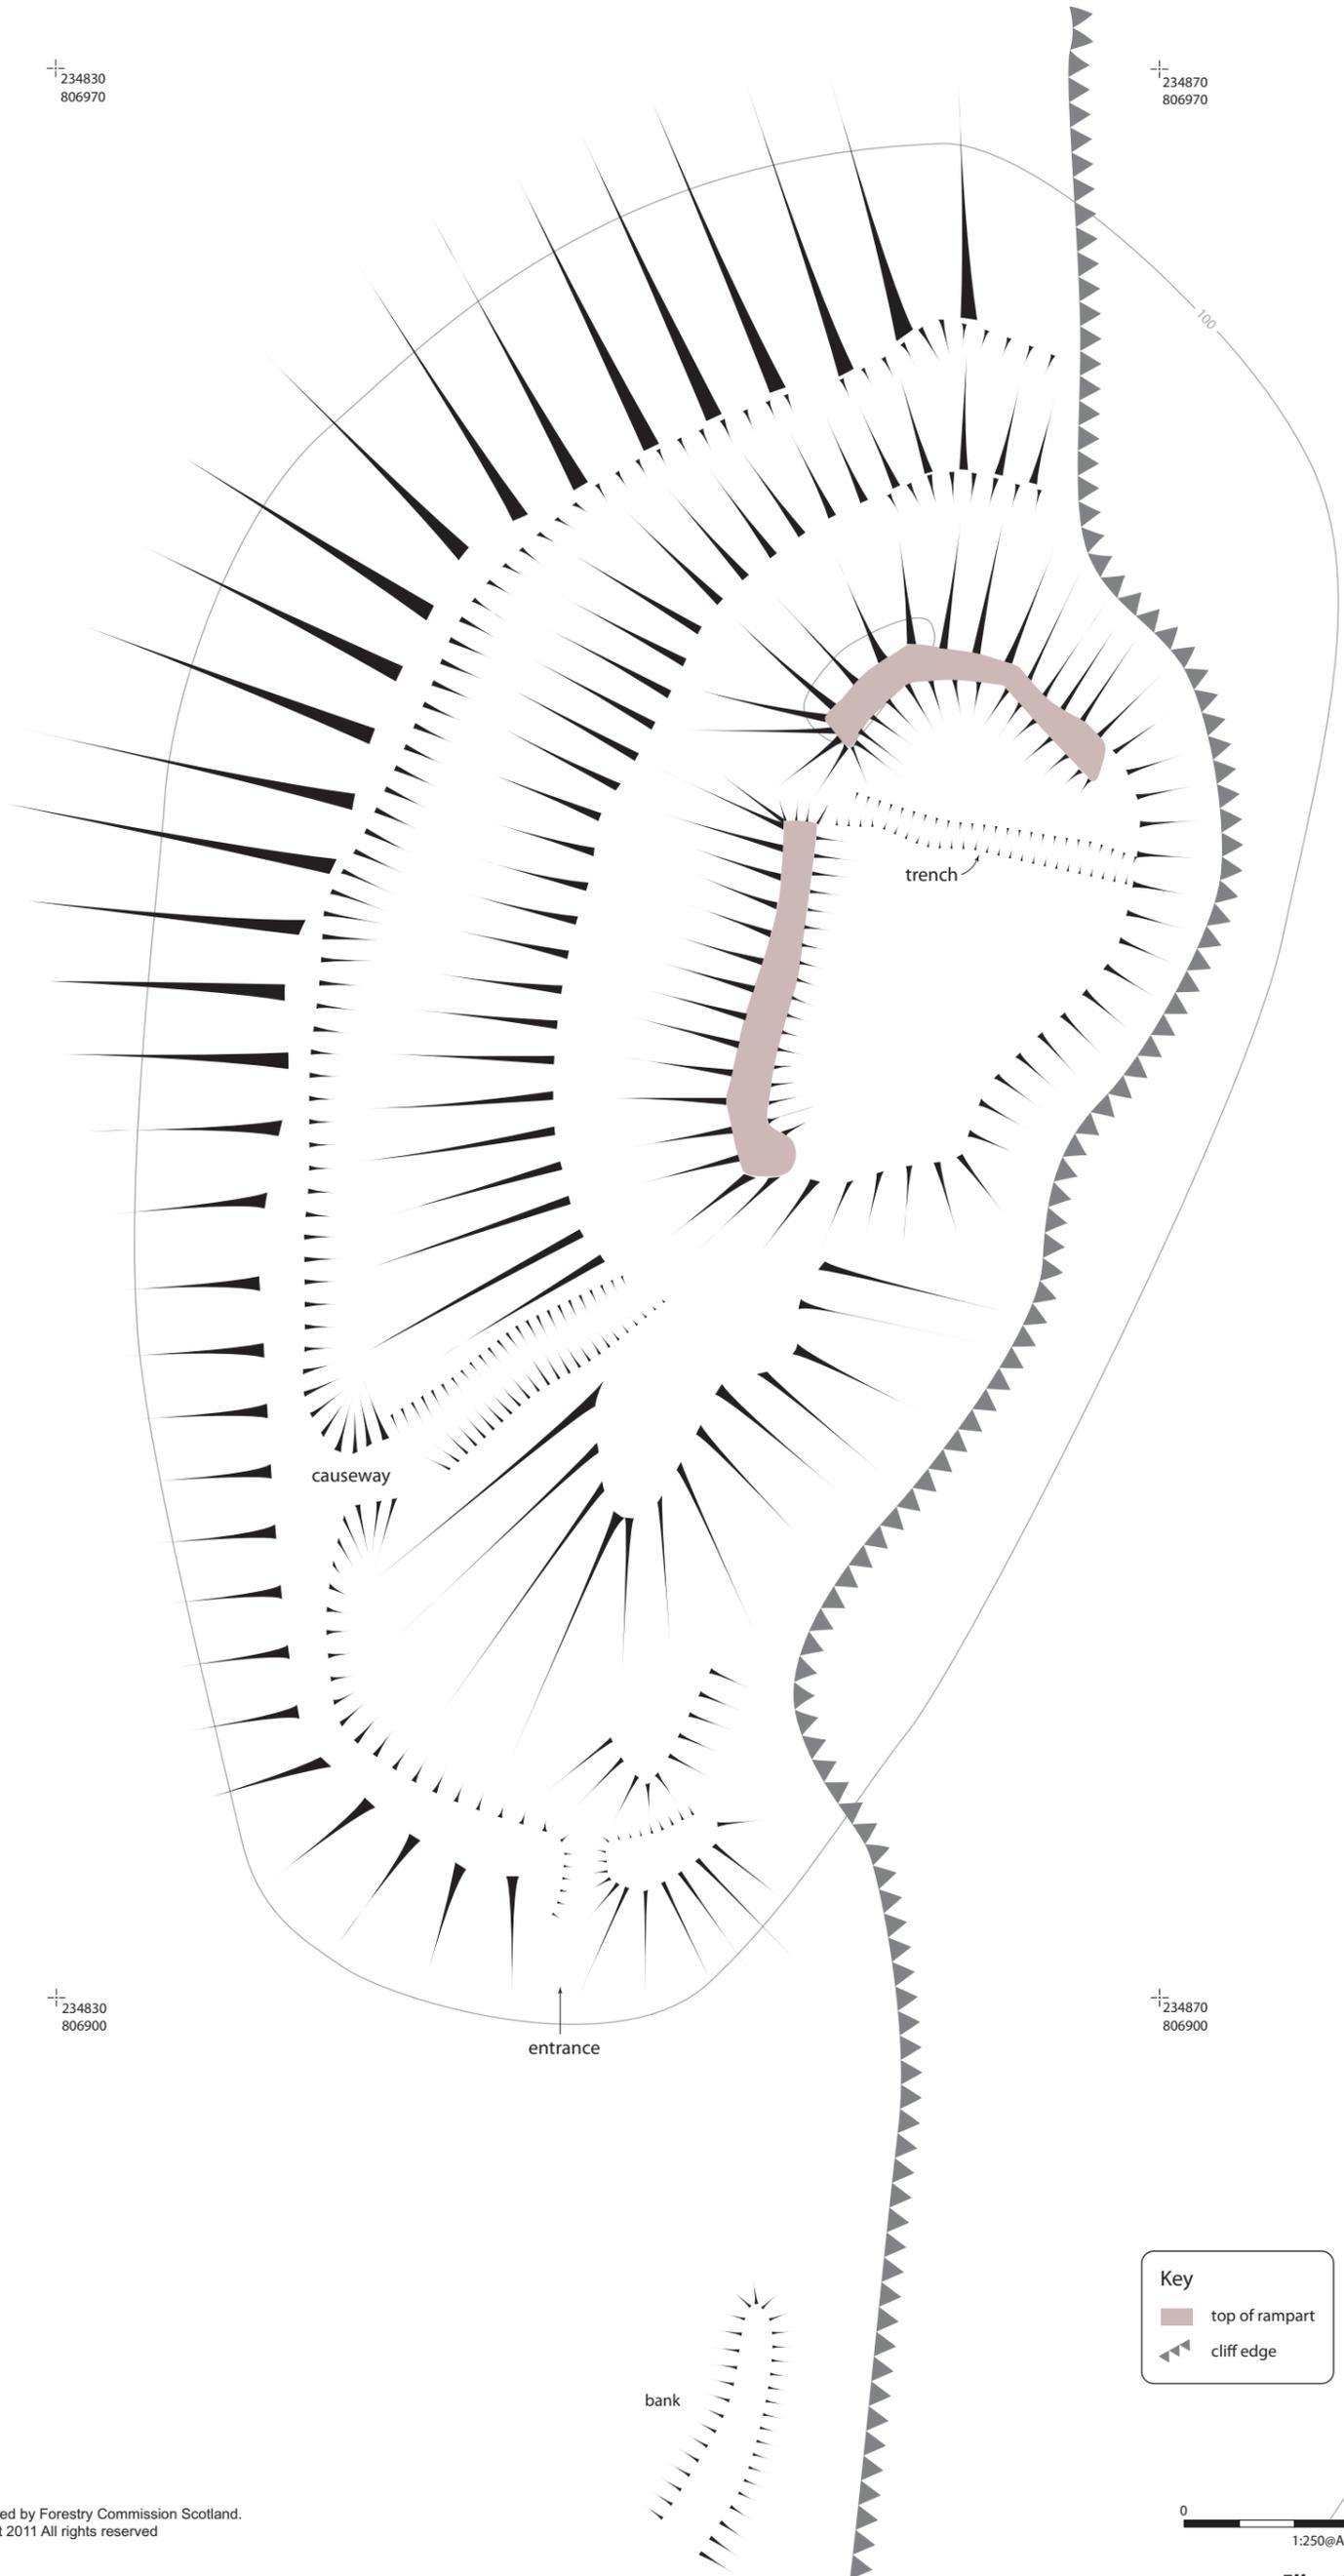
Illus 16
Plan of Torr Dhuin at 1: 250

The fort occupies the top of the small knoll. It is sub-rectangular and measures 19m north to south by 8m to 12m wide, covering an area of some 180m² (Illus 16). The fort is defended to the east by near vertical craggy slopes and on the other sides by a wall and two concentric defences. The inner wall is best preserved as a rounded bank to the north and west, but barely visible to the south and east (Illus 10). A small, but well defined ditch runs east to west across the north half of the fort and cutting through the west wall. The feature is thought to be an old excavation trench cut across the fort to expose a section through the wall and the interior.

Enclosing the summit of the knoll are the remains of a second line of defences now reduced to a terrace with a slight ditch only surviving to the north. The outer defences comprise a ditch up to 5.5m wide and 1.2m deep inside a stony rampart now completely overgrown.
