A TOPOGRAPHIC ARCHAEOLOGICAL SURVEY OF FIVE PICTISH FORTS IN THE HIGHLANDS

for Forestry Commission, Scotland

March 2011

HA Job No: PFHS10

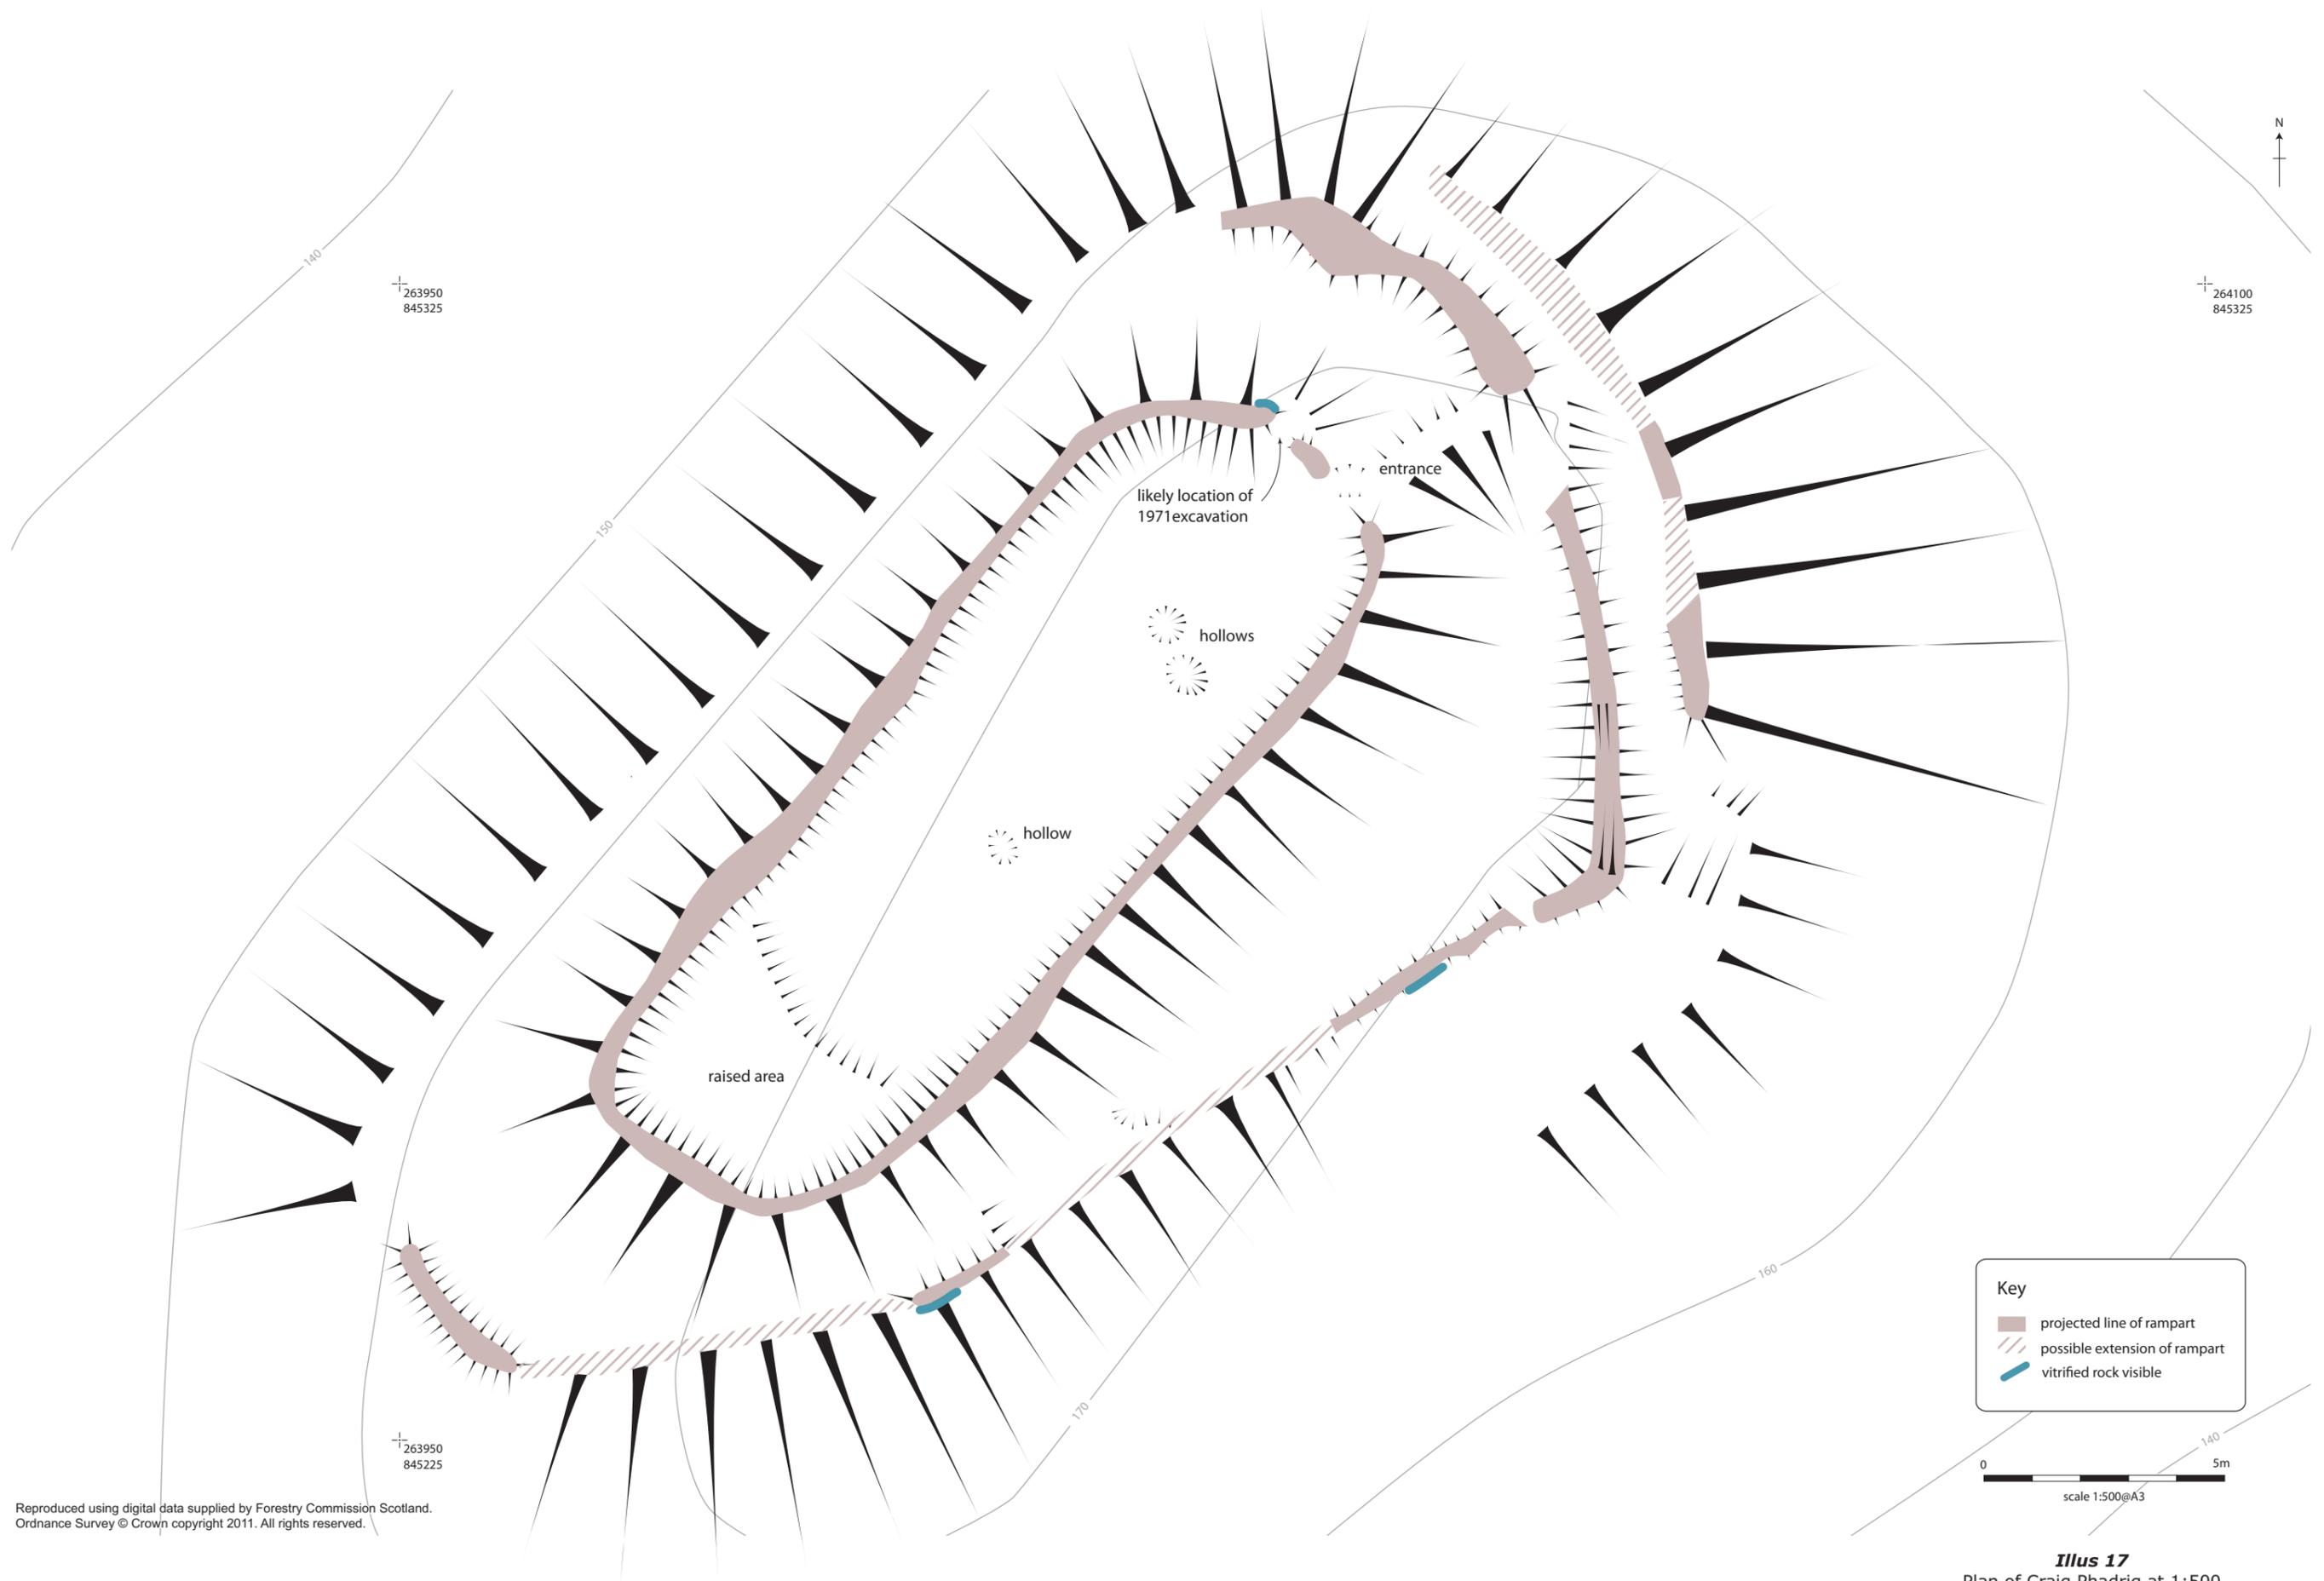
Illus 17
 Plan of Craig Phadrig at 1:500

The enclosure consists of a complete inner rampart, the remains of a second rampart to the south and east, and some further entrance outworks to the north-east. The ramparts appear presently as grassy banks, although some small stretches of vitrified stonework are visible (Illus 11). There are substantial ditches between the ramparts around the entrance.

The inner rampart is between 7 and 10m wide and stands to a height of approximately 0.7m. There are two noticeable breaks, both at the north-eastern end. The likely entrance is between 2.5 and 5m wide, although it has been somewhat obscured by the present path. This gap leads to a raised causeway across the ditch to a corresponding break in the second rampart. Another break just to the north may correspond with the archaeological excavation undertaken in that area in 1971 (Small 1971,
