**Archaeological
Research
Services Ltd**

Kinderlee Mill, Chisworth, Glossop

Desk-Based Assessment and Building Recording

ARS Ltd Report 2006/22
June 2006

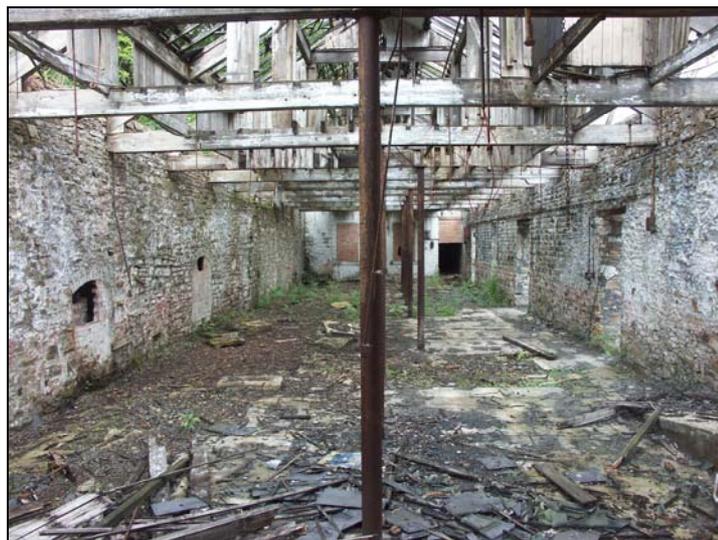
Fig. 3 General shot looking west along the interior of Block A. Remains of beams and partitions can be seen in the ‘attic’ first floor, while the two bricked up furnaces can be seen in the south wall (no scale as it was unsafe to enter Block A).

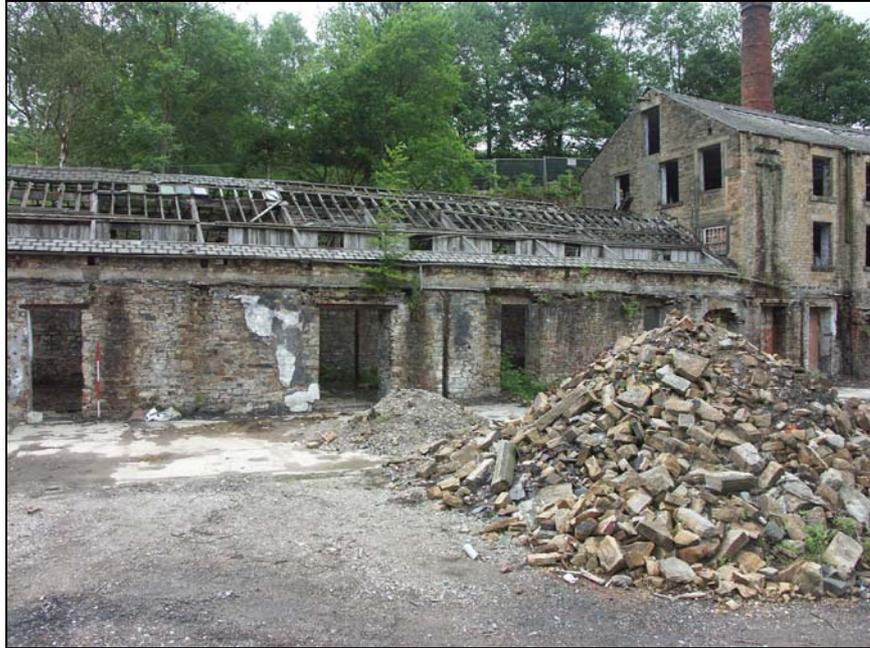
- 6.1.2 Where Block A adjoins Block B, there are two infilled windows and one partially infilled doorway which has been half covered by the construction of Block A. Therefore it is certain that Block A is a later extension onto the eastern end of Block B.

Fig. 4 Western end of Block A showing portion of north façade, and where Block A butts up to Block B (three storey building to the right with chimney) (scale = 2m).

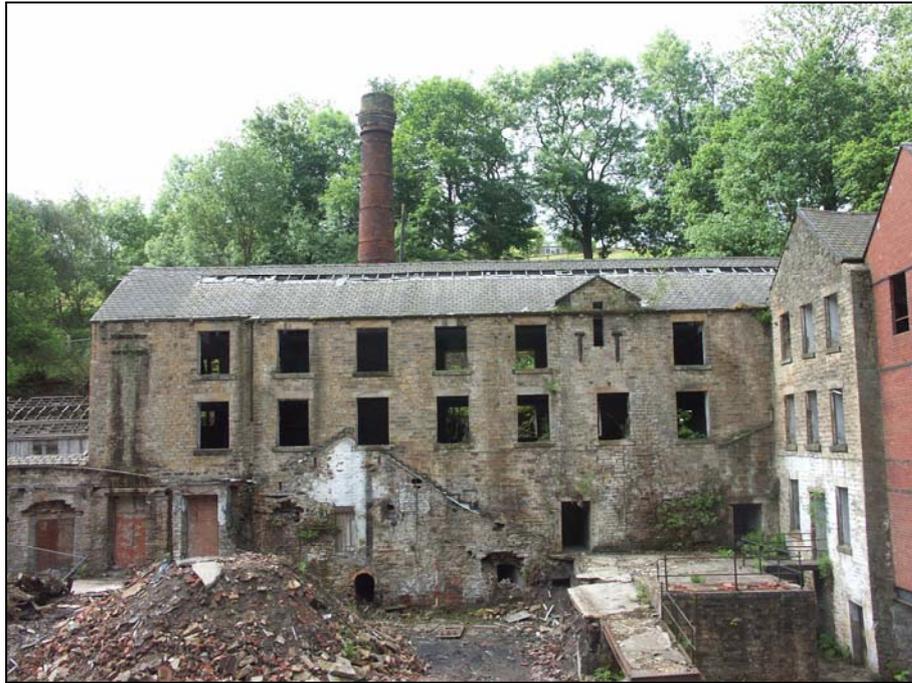
Fig. 5 Northern façade of Block B. The shadow of the furnace extension can be seen on the front of the building – clearly a later addition as it partially covers earlier 2nd floor windows.

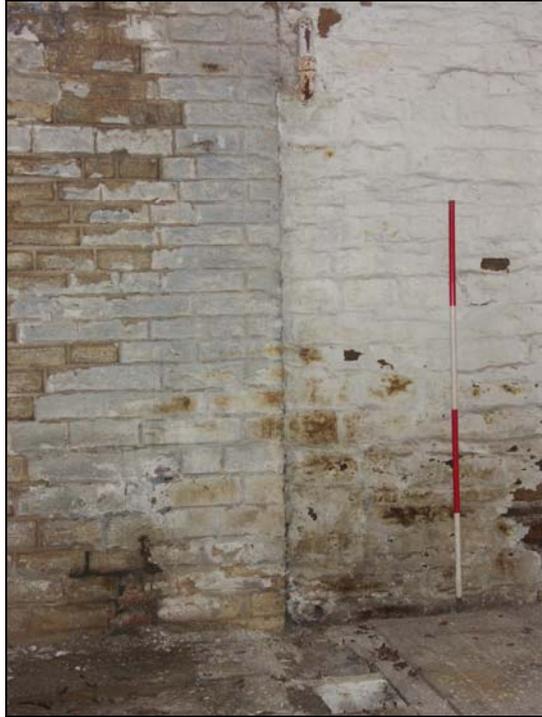
6.2.2 Block B, more than any of the other mill buildings, has undergone much alteration and expansion through its working life. The oldest part of the building has been termed Block B Main and is indicated on the simplified phasing plan below. It is this section of Block B which faces north into the courtyard and houses the furnace and chimney. The remnants of the furnace extension to the northern face of the building can still be seen, along with two of the tunnels into the furnace. Extension One is the block which now forms the south west corner of the courtyard and provided the link to the house to the west (Block F). Although now disguised by the corner of the buildings from the exterior, it is possible to see the masonry join inside where extension one butted up to the original Block B (Fig. 6).

Fig. 6 Block B 3rd Floor – masonry joint between the main section of Block B and extension 1 (scale = 2m).

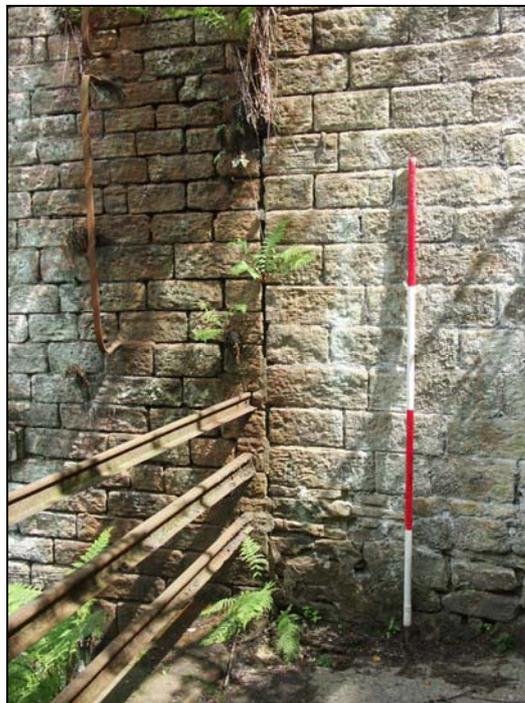
6.2.3 Extension two created an ‘L’ shape building as shown on the plan below. This is again recognisable through the masonry joint where it butts onto extension one, especially visible from the walkway between Blocks B and F.

Fig. 7 Masonry joint between extension one and extension two of Block B taken from walkway linking Blocks B and F (scale = 2m).

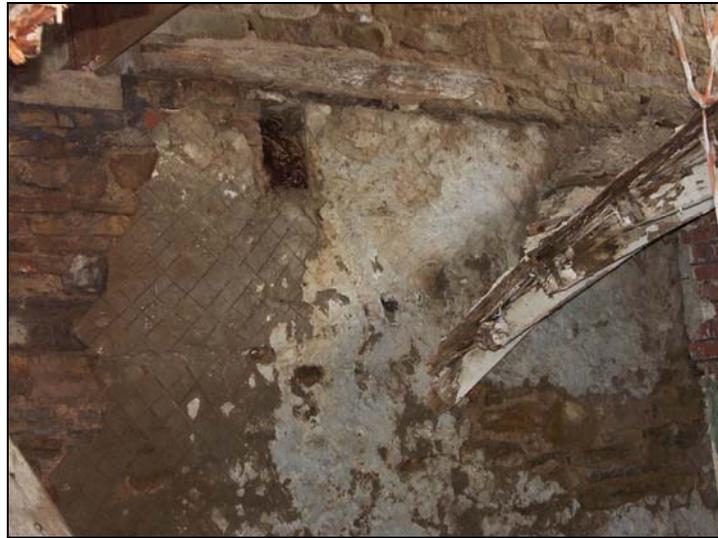
- 6.2.4 Extension three comprises the original piece of building which joined Block B to Block C, now visible from the ropewalk (Block D). Blocked up windows and a masonry join show where this building was inserted into the gap between the two larger buildings.

Fig. 8 Filled-in window in the wall between extension two and extension three this would have been the external side of the window before the construction of extension three

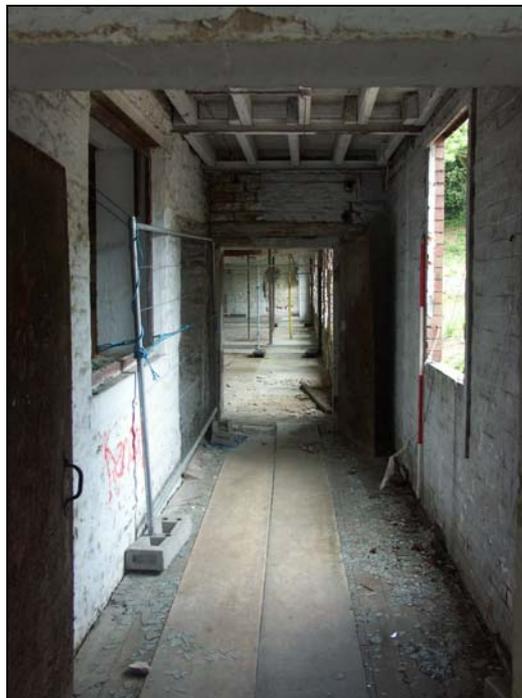
- 6.2.5 The final extension to Block B was the brick façade on the eastern face of extension three. This provided a narrow corridor on the eastern side of all extension three rooms and presumably therefore easier access between Blocks B and C.

Fig. 9 View along the corridor formed by the construction of extension four on the east face of extension three.

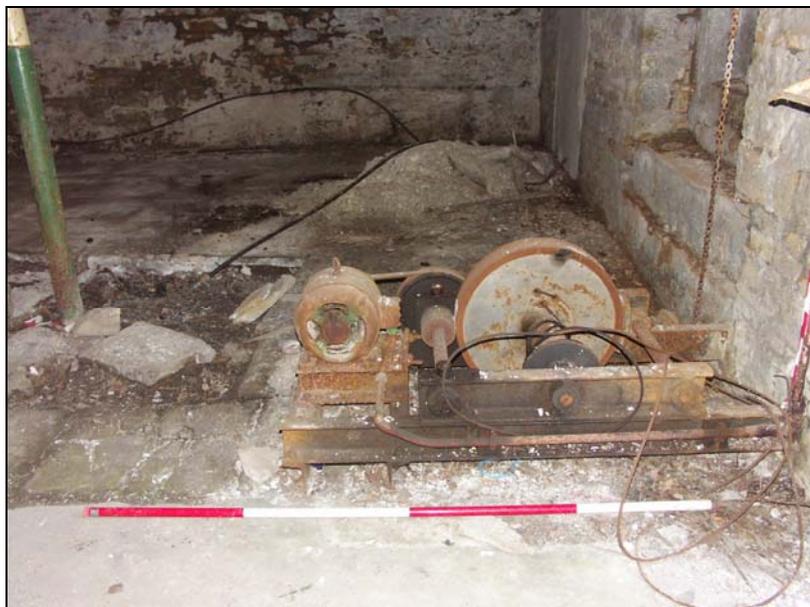
- 6.2.3 As with all the other mill buildings, almost all internal machinery and fittings have been stripped out of Block B. There are a few fittings and evidence of fittings remaining in the building however. In Block B there is a floor mounted winch – presumably fixed in place and unable to be removed.

Fig. 10 Winch mechanism remaining in the extension one of Block B (scale = 2m).

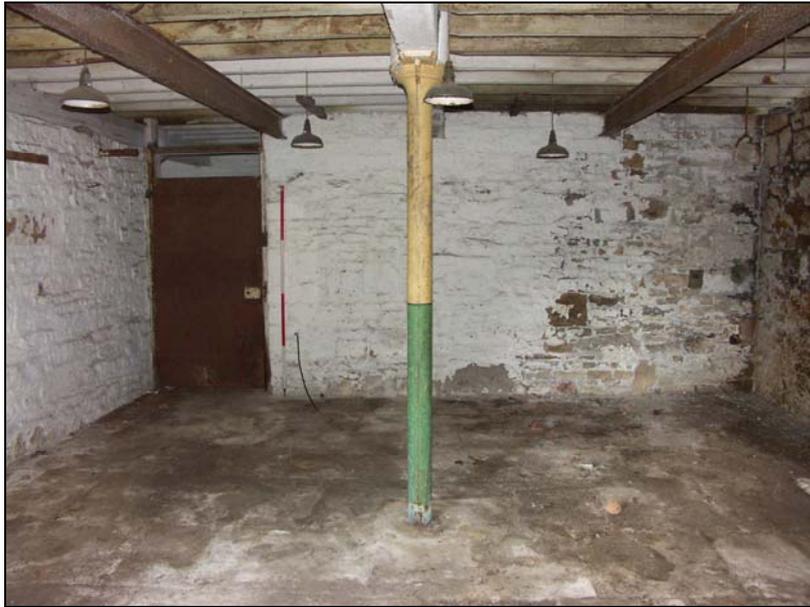
- 6.3.2 Block C has evidence of minor alterations within its fabric. The most evident alterations are a brick chimney which has been added to the eastern façade, and the reconstruction of a portion of the west wall where a pipe has been run through Block C from the overflow millpond and which discharges into the mill brook. The northern end of the first floor contains both a toilet block and an air-raid shelter. The air raid shelter contains reinforced steel joists and a reinforced steel door.

Fig. 11 Interior of the converted air raid shelter facing west (scale = 2m).

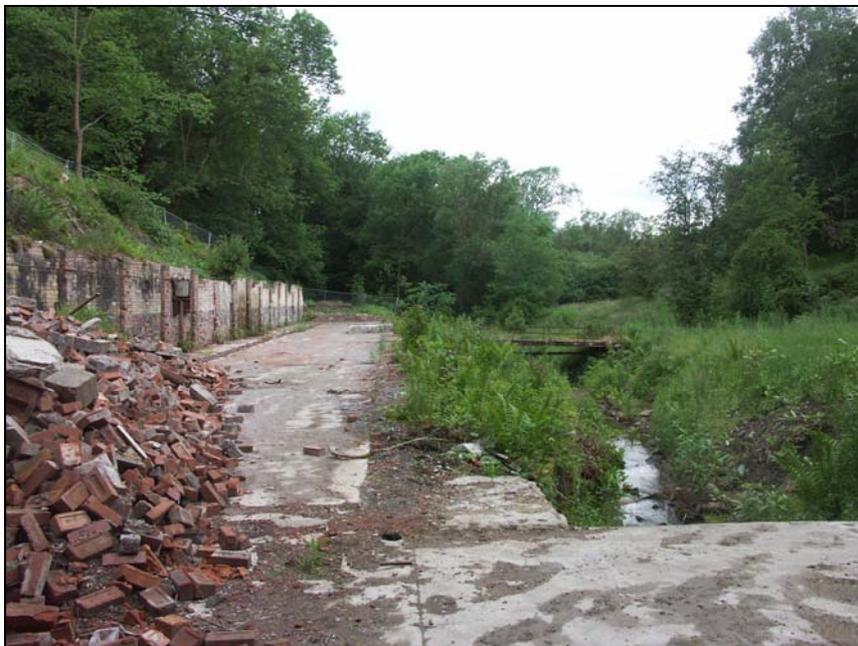
- 6.4.1 Block D consists of the ropewalk to the west of the main mill buildings. The ropewalk was a long covered walkway along which the strands were laid out before being woven into rope. The ropewalk also contains a concrete base – possibly to house some form of machinery associated with the ropewalk, a now demolished block of toilets, and a small footbridge over the mill brook.

Fig. 12 Looking west along the ropewalk with the mill brook flowing to the right of picture.

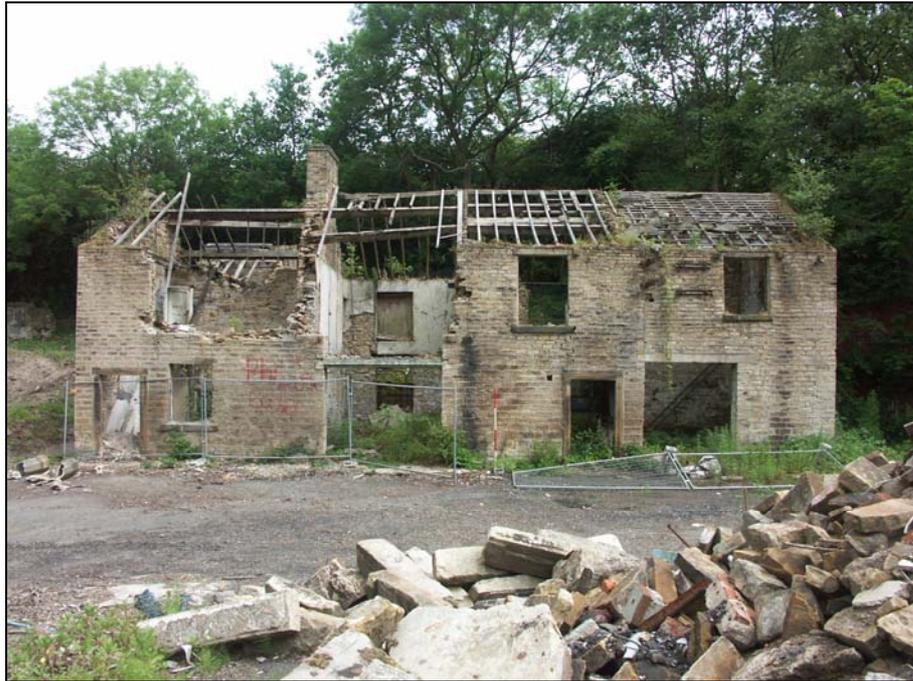
Fig. 13 Southern façade of Block E (scale = 2m).

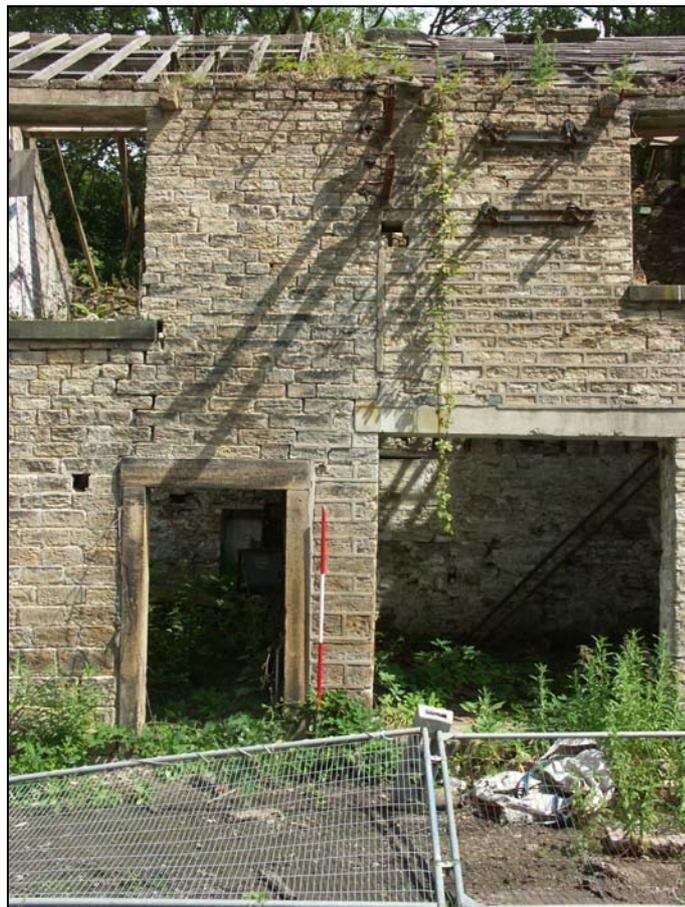
Fig. 14 Close up of join in the masonry between Unit 3 (left) and unit 4 (right) facing north (scale = 2m).

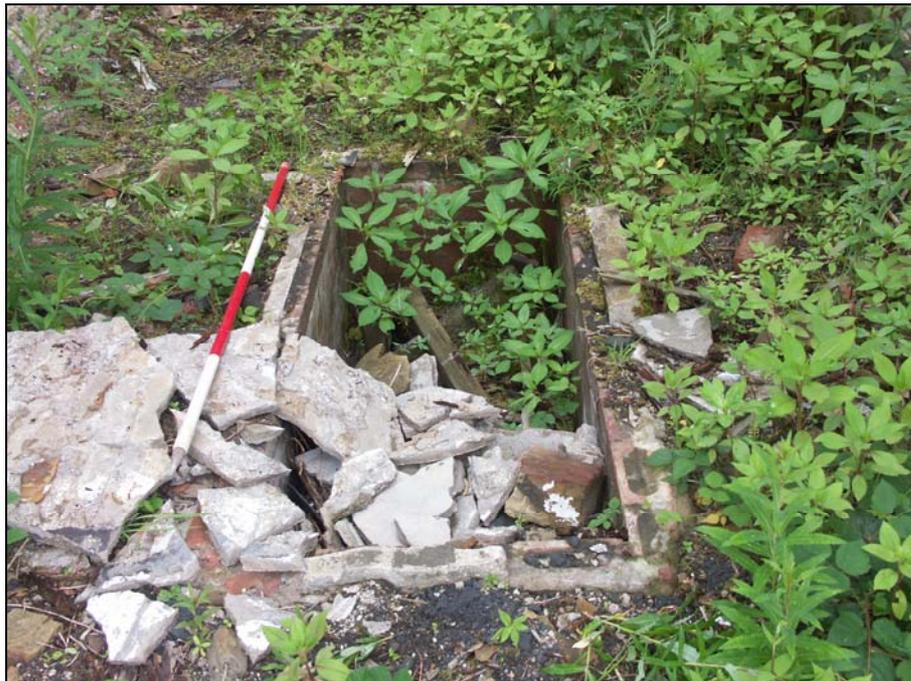
In unit two only the ground floor remains. There are beam mortices in the walls at the level at which there used to be a first floor, though there is no debris as is the case in unit one. This would suggest that the first floor was removed before Block E fell derelict. The entrance to unit two, on the south side, was originally a large double door which came up to the level of the first floor. At a later point this was altered to its present smaller form, perhaps at the same time as the other modifications. In the centre of the ground floor is a small inspection pit which would suggest that this may have been a garage or something similar in its final stage of occupancy.

Fig. 15 Inspection pit in the centre of unit 2 in Block E facing north (scale = 2m).

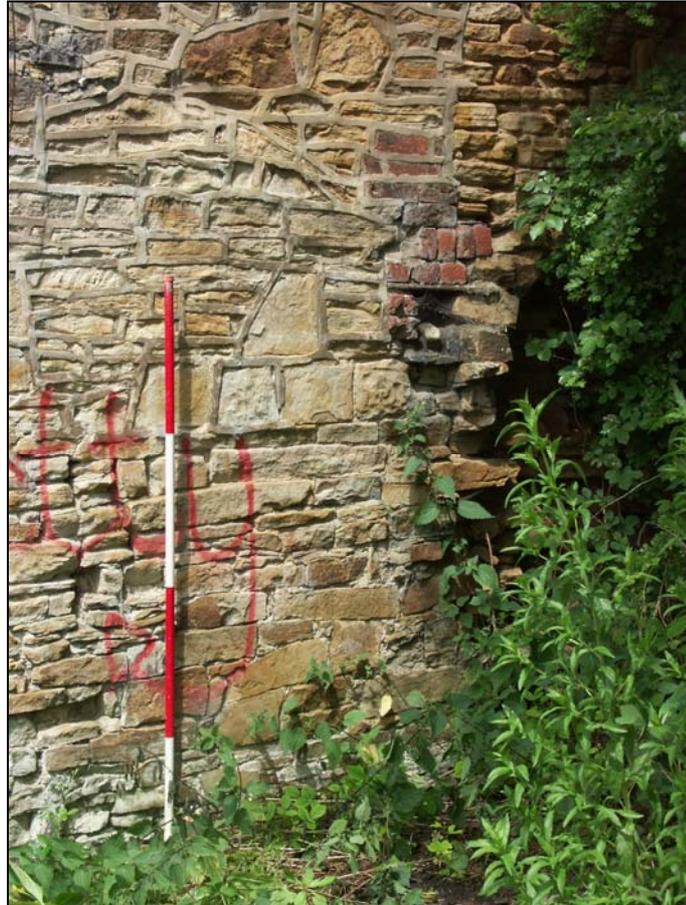
Fig. 16 Haphazard construction with irregular stones in the eastern wall of Block E.

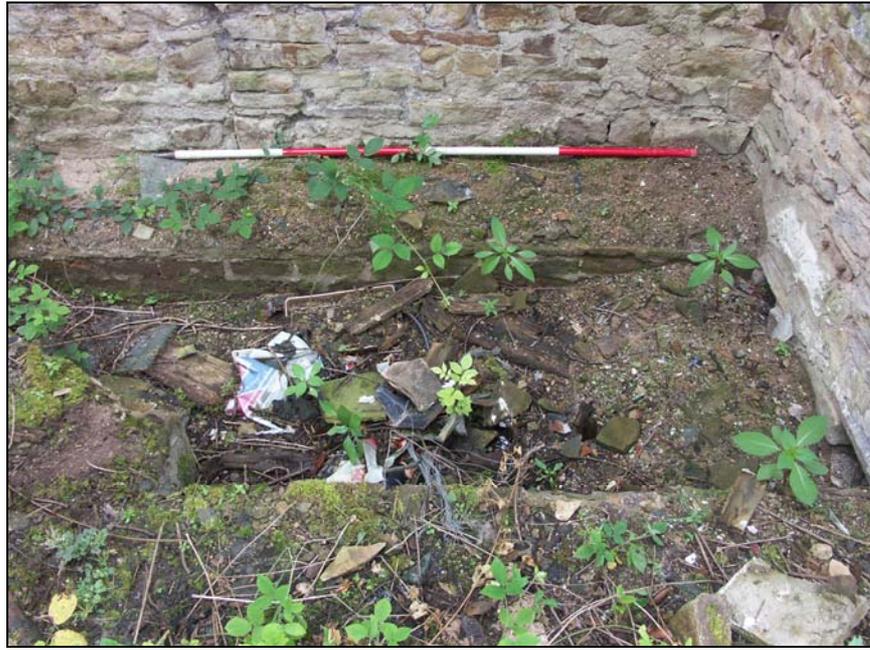
Unit four is a later extension on the eastern end of Block E. As with the rest of the block, there was at one point a first floor in unit four as shown by the debris in the ground floor and beam mortices around the wall. The exterior of the eastern wall facing the entrance to the courtyard appears to have been constructed in a haphazard manner compared to the neat and impressive façade of the block. The interior of unit four features a culvert or drain in the ground floor which appears as a large hole in the south-east corner and narrows as it runs along the eastern wall and turns west along the northern wall.

Fig. 17 Drain/culvert in Block E unit 4 facing east (scale = 2m).

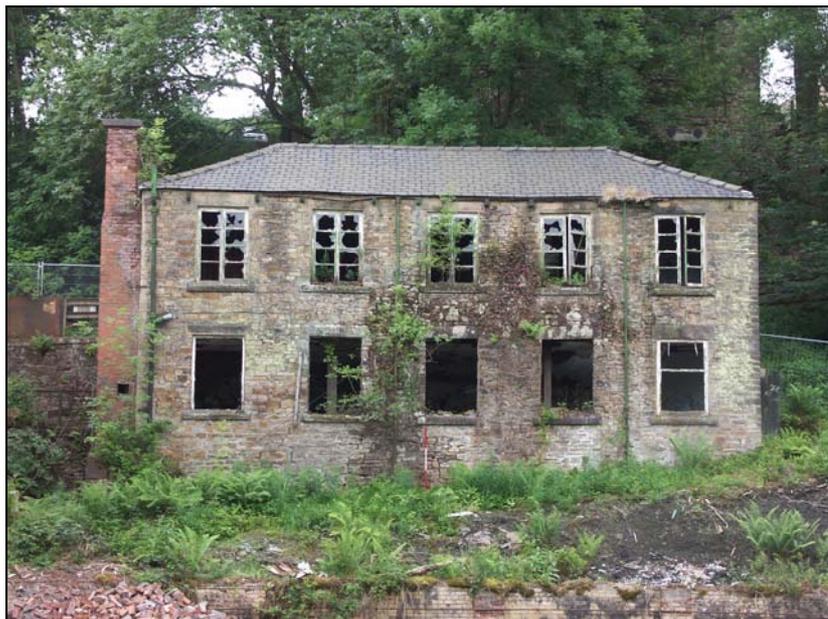
6.6.1 Block F is a small dwelling building to the far west of the mill complex above the ropewalk. Block F is connected to the mill after the construction of Block B extension one. The style of window construction is identical to that of Block C, and though this portion of the mill cannot be accurately dated in comparison to other parts, it seems reasonable to make a tentative suggestion that Blocks F and C were contemporary and Block F was connected to Block B at a later date. The only other later addition to the fabric of Block F is a red brick chimney added to the eastern end in a similar fashion of construction to the chimney added to Block C.

Fig. 18 Northern façade of Block F with a brick chimney added to the end, similar to that added to Block C (scale = 2m).

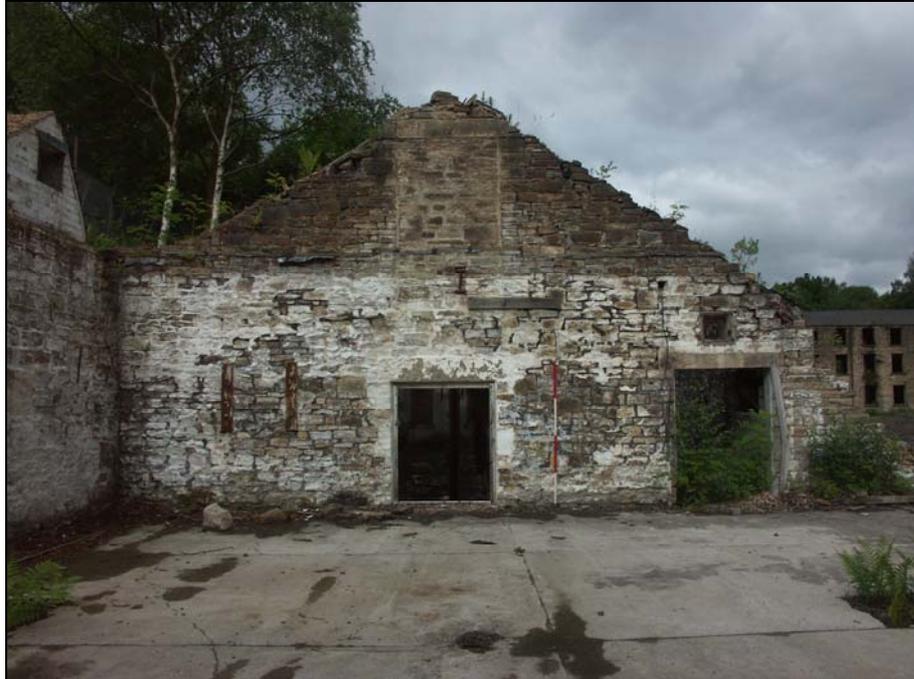
Fig. 19 Eastern façade of Block A showing bricked-in doorway on the first floor (centre) and steel girder set into the infilling (scale = 2m).

- 6.7.5 The remaining south wall of block G abuts onto block A showing that block G was a later addition to the complex. It can also be seen that one of the support beams for Block G is built into a bricked-in doorway on the old first floor of block A.

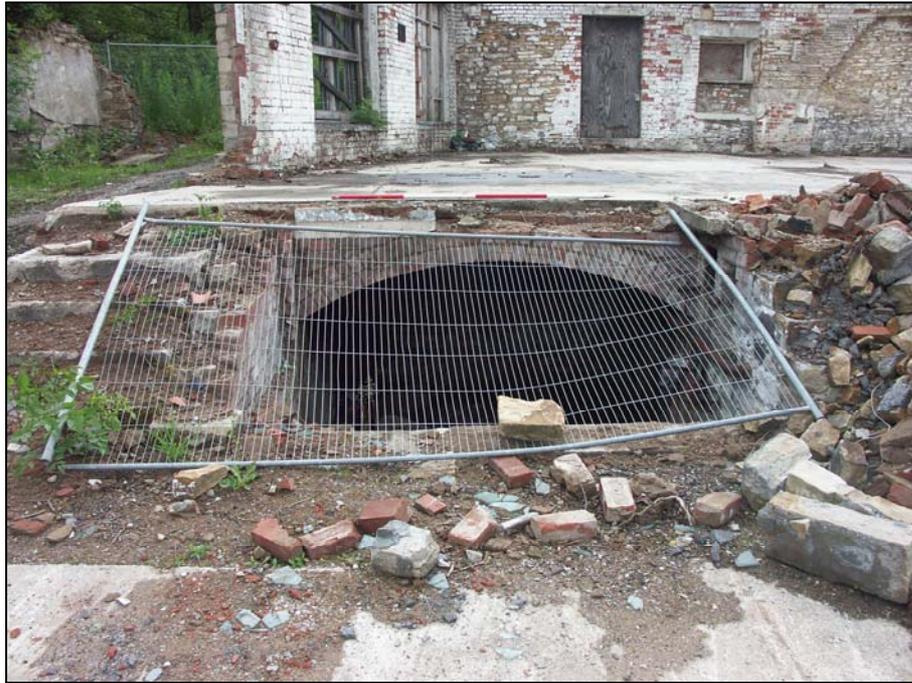
- 6.7.2 Block G is a large open room with no evidence of internal walls. There are bricked-up doors and a central bricked-up fireplace in the east wall with a smaller bricked-up fireplace immediately to its south.
- 6.7.3 The roof in Block G was originally supported on iron girders, such as those which still protrude from the eastern wall of building A. The roof comprised of a series of offset ridges designed to allow rainwater to drain off easily, and incorporated a series of vents into the wall beneath.
- 6.7.4 Along the west and north sides of Block G, where there are no standing walls, there is a flight of four concrete steps which leads up to the floor level. Below this there is a small cellar which is now waterlogged and inaccessible. The cellar measures approximately 4.5 square metres and appears to be approximately 2m deep.

Fig. 20 Entrance to the small cellar beneath Block G facing east (scale = 2m).

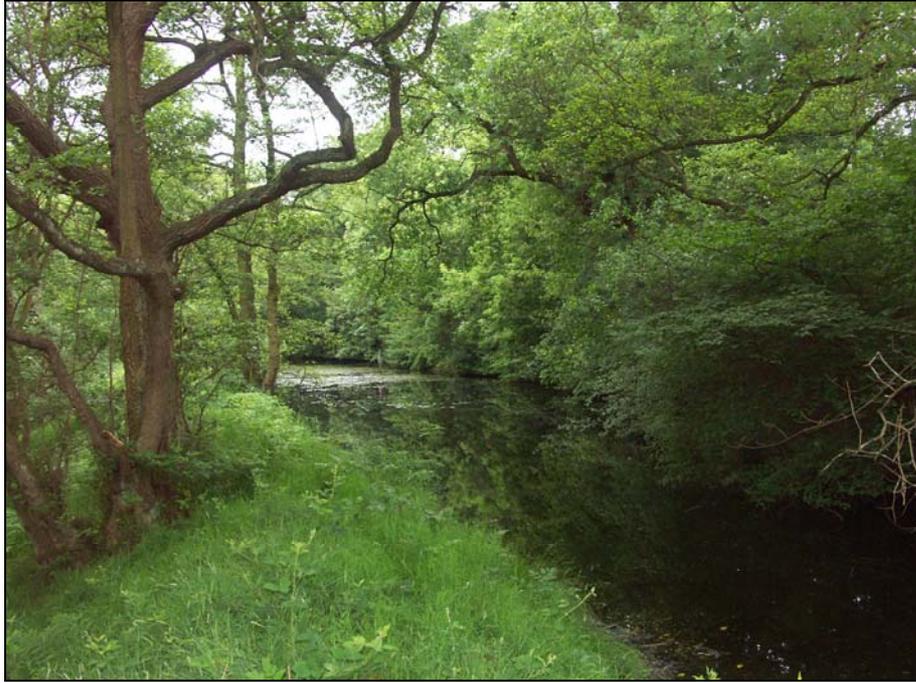
- 6.8.1 To the east of the mill complex, there is a large primary millpond, with a second smaller overflow pond (now dried out) in the mill complex in between Blocks E and C. It is likely that the secondary millpond is a later addition as it is connected with the piping that runs through Block C into the mill brook on the western end of the complex. Alongside the millpond, a mill race runs underground through the courtyard, and discharges at the west end alongside the ropewalk. The mill race is wide and shallow and if it once powered a water wheel would not have been able to provide much force. The mill race clearly respects the shape and construction of Block C and may have also provided the impetus for the first two extensions of Block B, in order to harness the power of a water wheel. If there was a water wheel sat in the base of what became Block B extension three, then it fell out of use at the time of construction of Block C as this appears to be when the two mills were joined and possibly became furnace-powered.

Fig. 21 View across the millpond looking west back towards the mill complex.

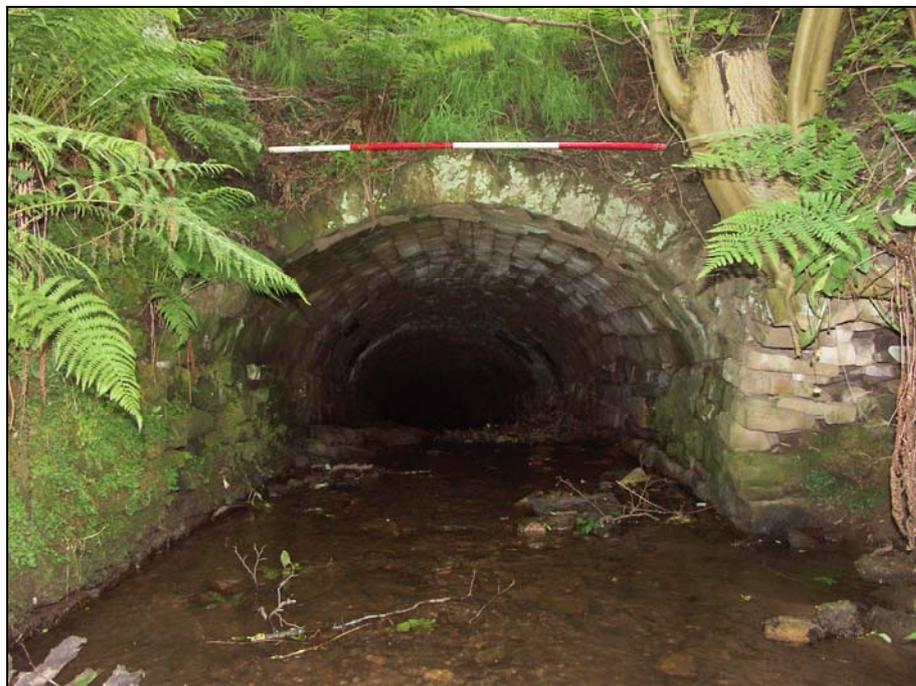
Fig. 22 Looking west along the mill race as it disappears underground towards the mill complex. It emerges at the western end of the complex underneath Block B extension three.

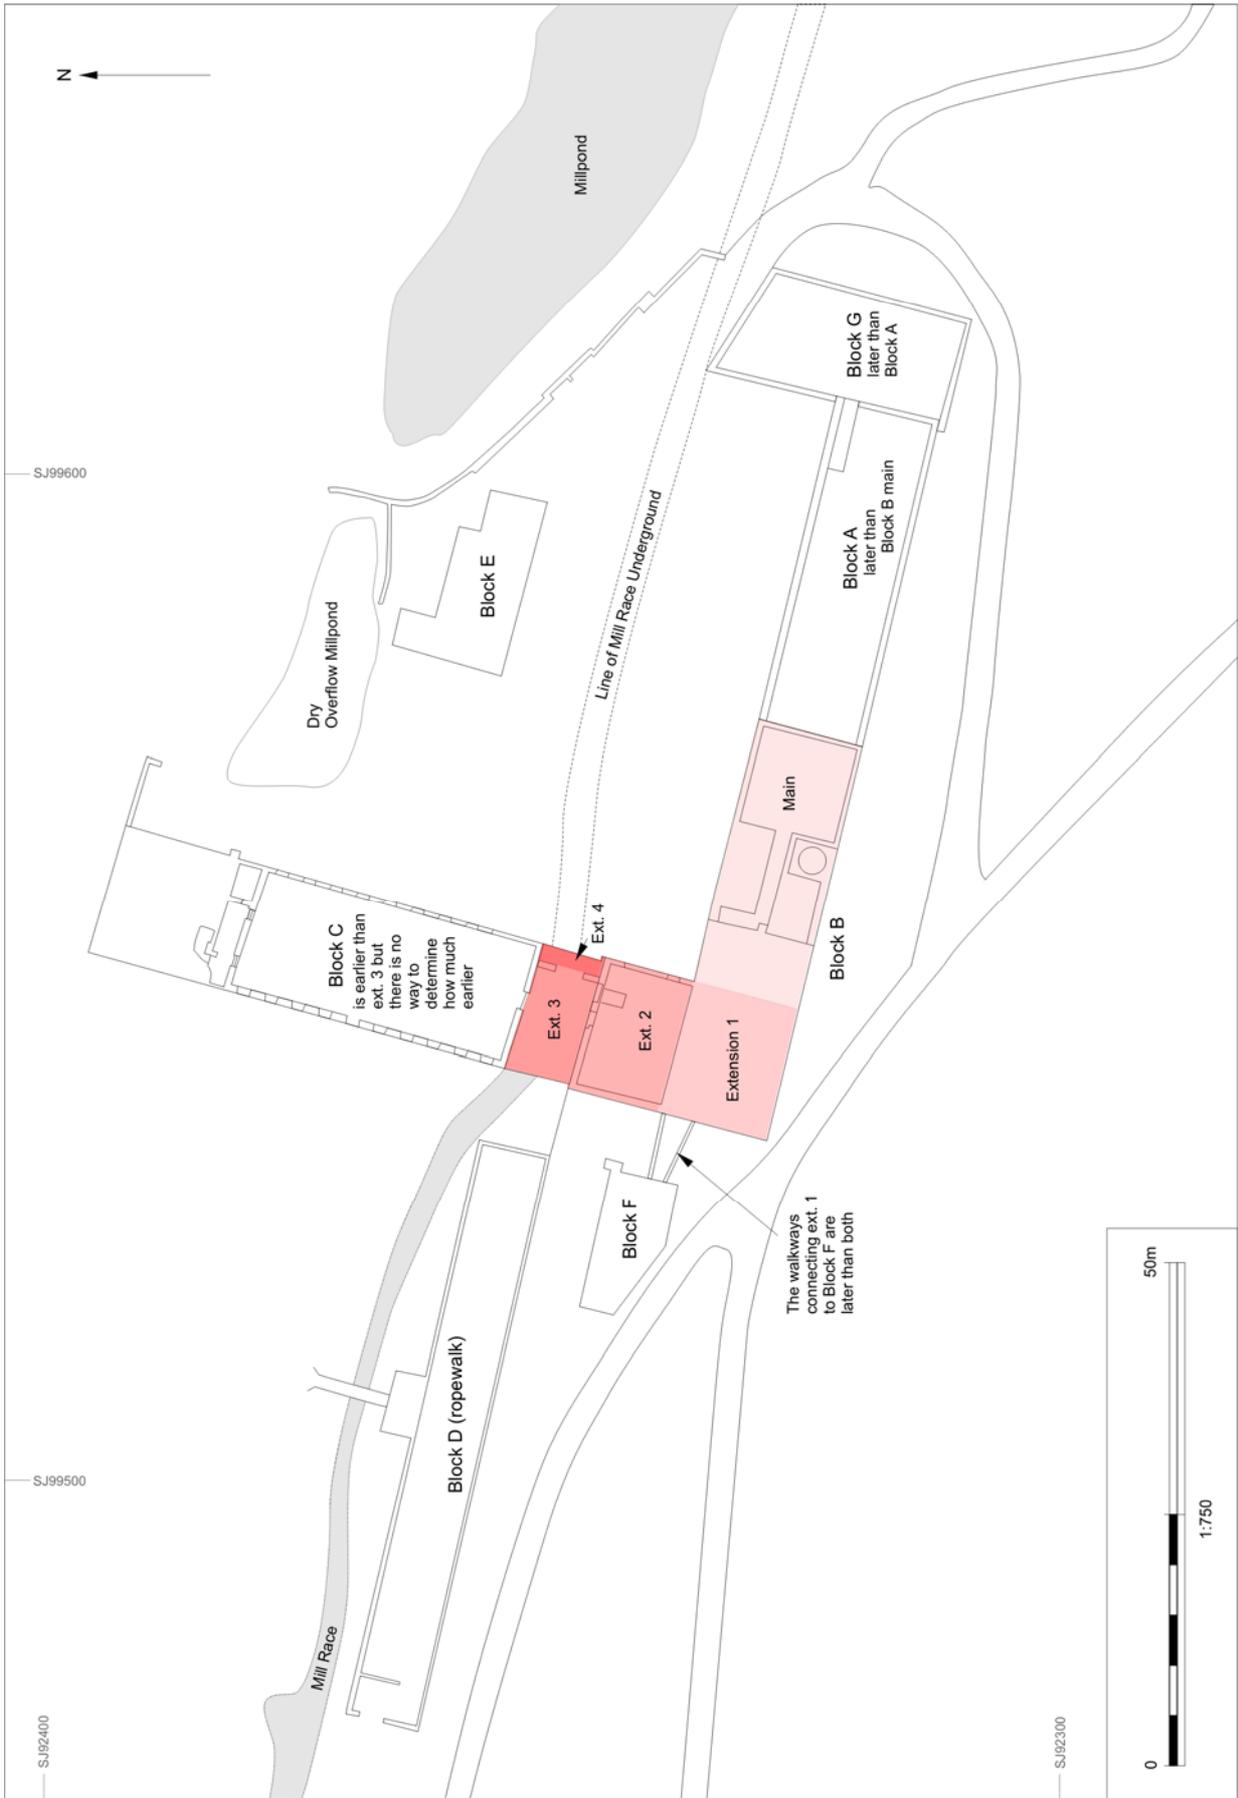
- 7.4 The simplified plan below shows a summary of what can be gleaned about the constructional development of the Kinderlee Mill site prior to the Ordnance Survey maps of the late 19th century.

Fig. 23 Simplified plan of constructional phases in the mill buildings

- 7.3 Block B is more problematic despite the fact that the development of the building can be more clearly gleaned. Block B was originally a much smaller building which was extended until it was joined to Block C. Blocks A and G were also added in that order though it is again impossible to tell whether they were before, contemporary with, or after the western extensions to Block B. The problems in interpretation come when considering the furnace. Block B was clearly constructed to incorporate a furnace as shown by the inclusion of the chimney into the fabric of the structure, and also the furnace workings evident on the first floor. However the actual housing of the furnace which was attached to the northern façade was a later extension as it covers over a number of bricked-up windows.
