Archaeological Evaluation at Iron Sign Farm, Northumberland

ARS Ltd Report No. ARS 54

ARS Ltd Report 2007/54

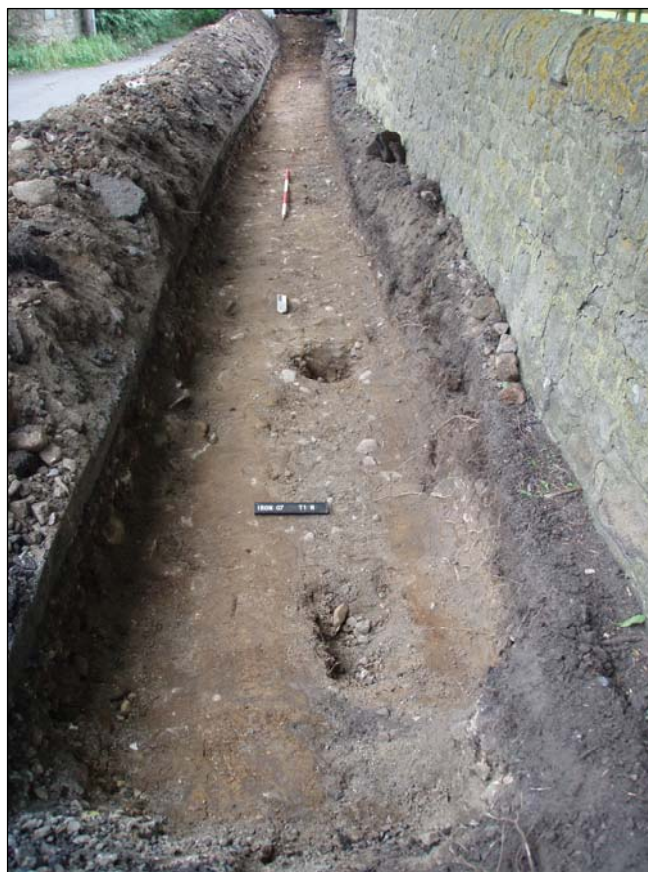
- 4.2.1. Trench One (Figures 5 and 6) was located over the line of Hadrian's Wall Vallum and the Roman Military Way and was oriented north-south. No archaeological features were present within the trench. The stratigraphy (Fig. 7) comprised a layer of tarmac (001) which made up the road surface and measured between 0.28m and 0.32m in depth. Directly below lay redeposited clay with sand (002) which was mixed with modern brick and tile and measured 0.26m in depth across the trench. The undisturbed natural clay with sand (003) lay below and continued beyond the depth of excavation. Cut into the natural clay with sand (003) was a modern British Telecom cable trench (004) which ran the whole length of the trench from north to south and continued beyond the trench edges. It measured 0.25m wide and was cut into the natural layer (003) for a depth of 0.20m.

Fig. 5 North end of Trench One showing the modern telephone cable trench (004) running the length of the trench. Scales = 2 x 2m

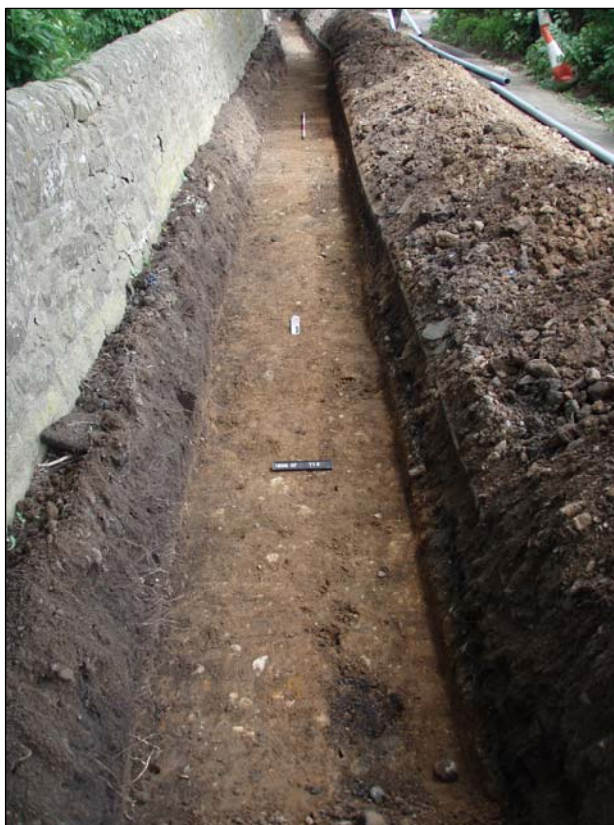
Fig. 6 South end of Trench One showing the modern telephone cable trench (004) running the length of the trench at the east side. Scales = 2 x 2m

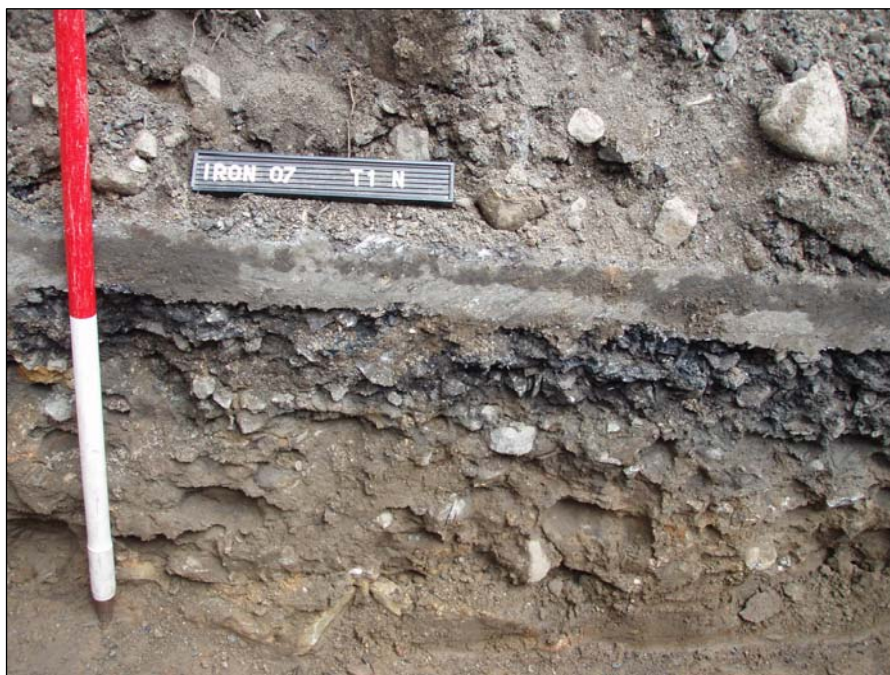
Fig. 7 East facing section of Trench One. Scale = 2m (white section = 0.50m)

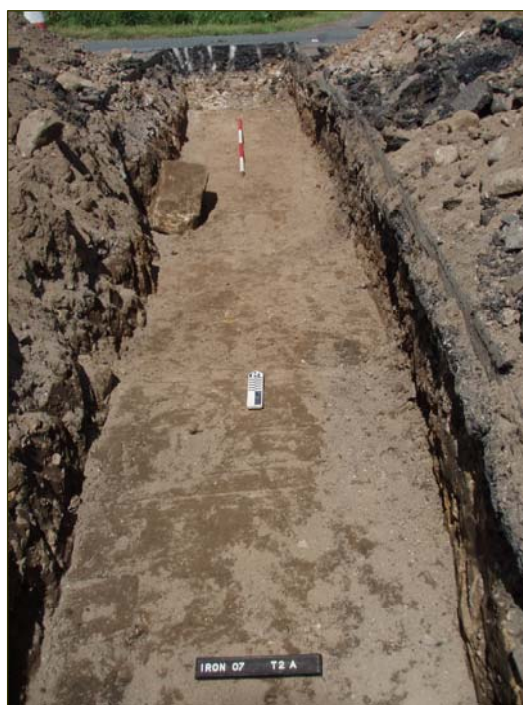
- 4.3.1. Trench Two (Figures 8 to 10) was located across the line of Hadrian's Wall and was oriented north-south. The stratigraphy (Fig. 11 to 13) comprised a layer of tarmac (005) which lay across the whole trench and measured between 0.22m and 0.28m in depth. Directly below was a layer of coarse rubble (006) which measured 0.14m in depth and was present across the whole trench. Below the rubble (006) lay redeposited clay with sand (007) which was mixed with modern debris such as brick and measured between 0.32m and 0.36m in depth across the trench. At the north and south ends of the trench a number of large, dressed sandstone blocks were present. It appeared that the stones at the north end of the trench were reused from the ruined section of Hadrian's Wall to build the foundations of the present road (B6318). The size and shape of the blocks indicates that they were possible taken from the wall but the scattered nature of the blocks and modern debris found associated with them indicated that they had been reused in a modern context. The stones in the southern end of the trench also appeared also to have been reused from Hadrian's Wall due to the size and shape but the associated modern debris again suggested that they were reused in a modern context. Directly below the redeposited natural clay with sand (007) lay the undisturbed natural clay with sand (008) and cut into this at the southern end were the foundations of an old dry-stone boundary wall (009) (Fig. 14) which followed the line of the modern curb. It appeared that the sandstone blocks at this end of the trench were once part of the boundary wall (009) but were truncated, along with the redeposited natural clay with sand (007), when the modern road was constructed. The undisturbed natural clay with sand (008) into which the foundation blocks lay continued beyond the depth of excavation and the modern telephone cable trench that was present in Trench One (004) continued through the full length of Trench Two (010), reaching the British Telecom junction box.

Fig. 8 Trench Two Area A, the modern telephone trench (010) running through the east side of the trench. Scale = 2m

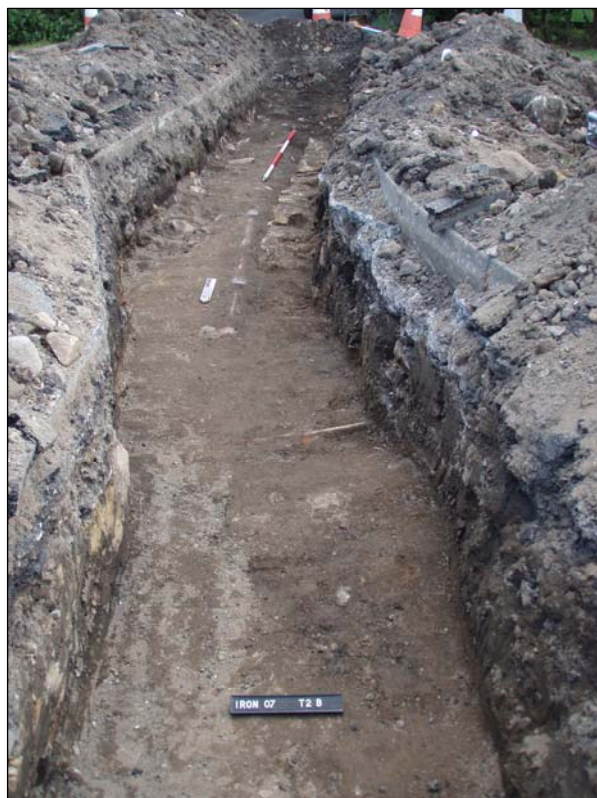
Fig. 9 Trench Two Area B, the modern telephone trench (010) running through the centre of the trench. Scale = 2m

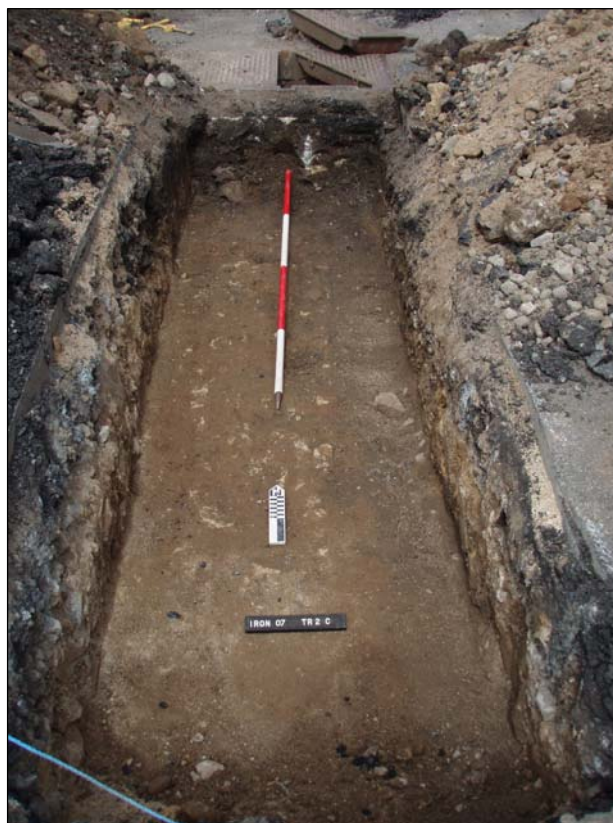
Fig. 10 Trench Two Area C, the modern telephone trench (010) running through the east side of the trench. Scale = 2m

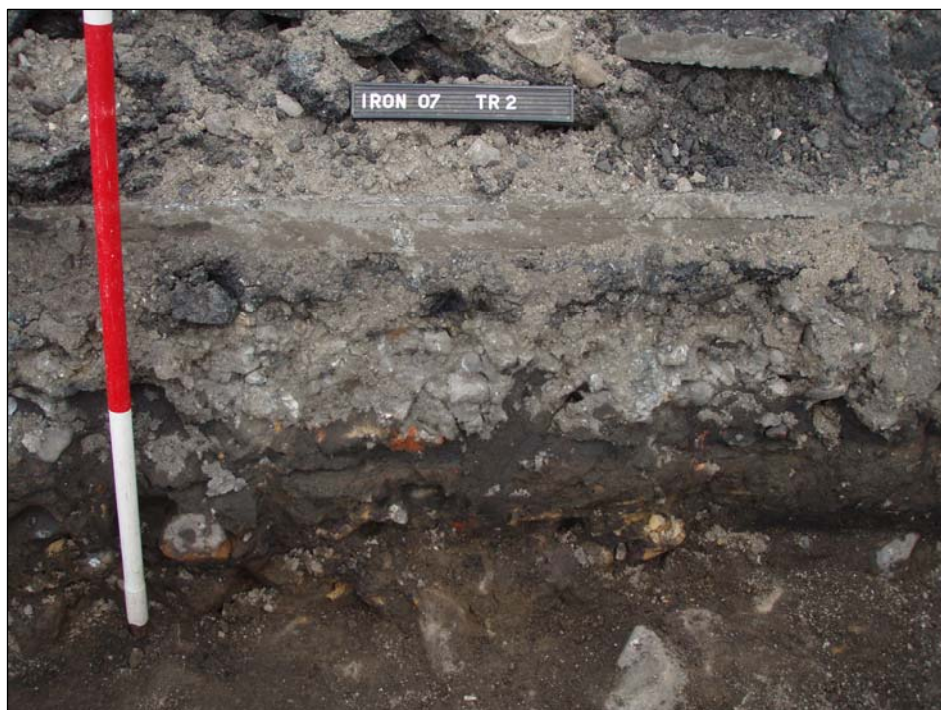
Fig. 12 West facing section in Trench Two. Scale = 2m (red section = 0.50m)

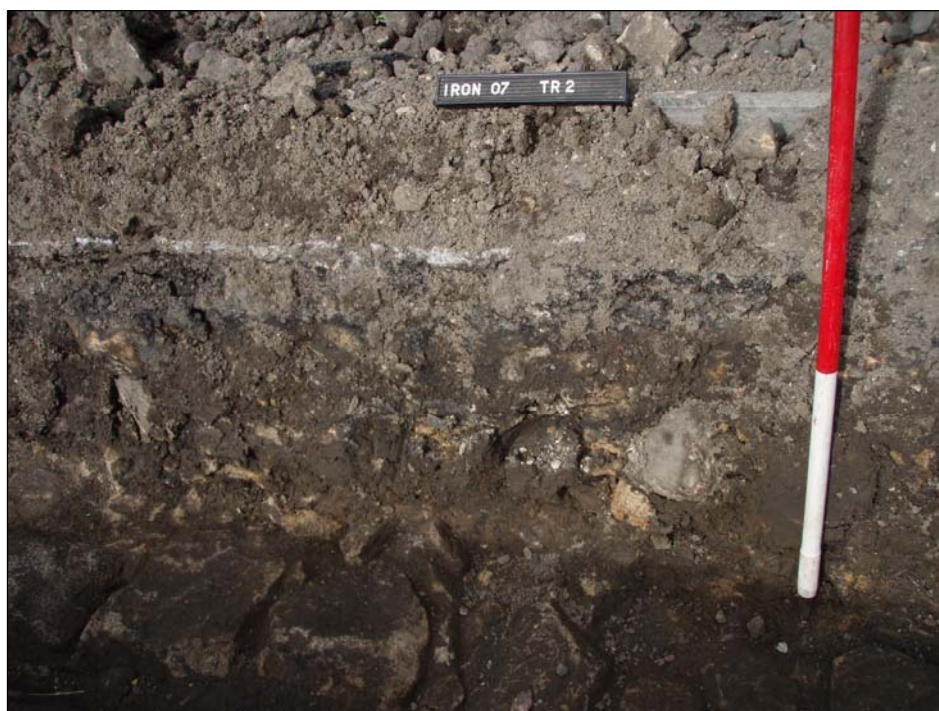
Fig. 13 East facing section in Trench Two above the dry-stone boundary wall (009). Scale = 2m (white section = 0.50m)

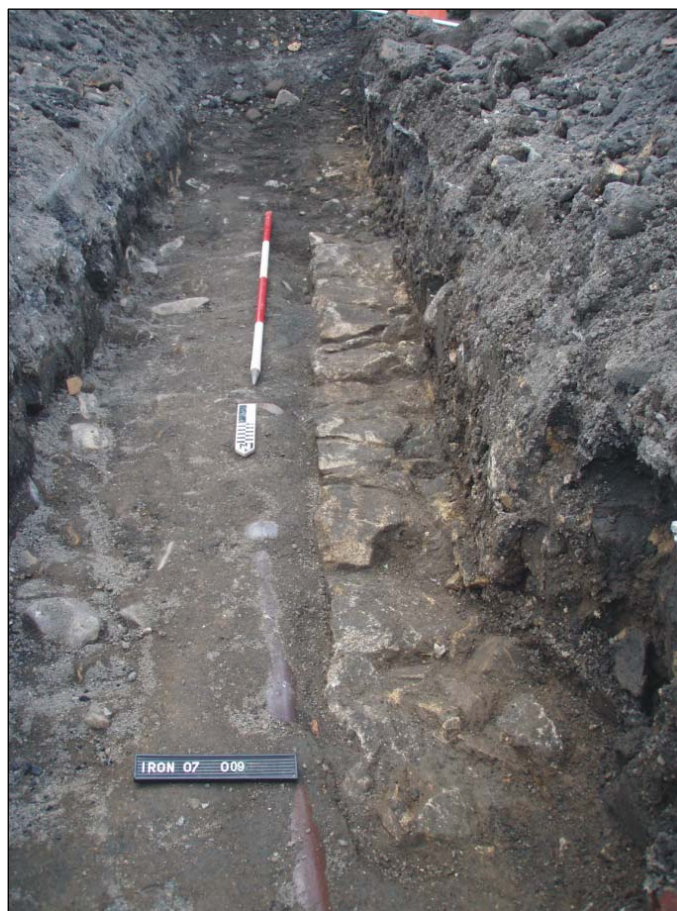
Fig. 14 Old dry-stone boundary wall (009) in the south end of Trench Two. Scale = 2m

- 5.1. There were no surviving *in-situ* archaeological remains dating from the Roman period in Trench One or Two. In Trench Two a number of large, dressed sandstone blocks were found to exist in the levels of made-ground which was likely to have been deposited during the construction of the modern road. These blocks appear to have been taken from the ruined section of Hadrian's Wall in the vicinity and reused for the foundations of the modern road (B6318) in the northern end of the trench. At the southern end of Trench Two a number of blocks appeared to have been reused to build an old dry-stone boundary wall which followed the line of the modern curb. The upper levels of the wall appeared to have been truncated during the construction of the modern road running to the west of Iron Sign Farm and only the lower level of stone remained intact.
