An Archaeological Building Recording of Fulwell Lime Kilns, Mill Garages, Sunderland

Archaeological Research Services Ltd Report No. 2008/71
September 2008

**An Archaeological Building Recording
of Fulwell Lime Kilns, Mill Garages,
Sunderland**

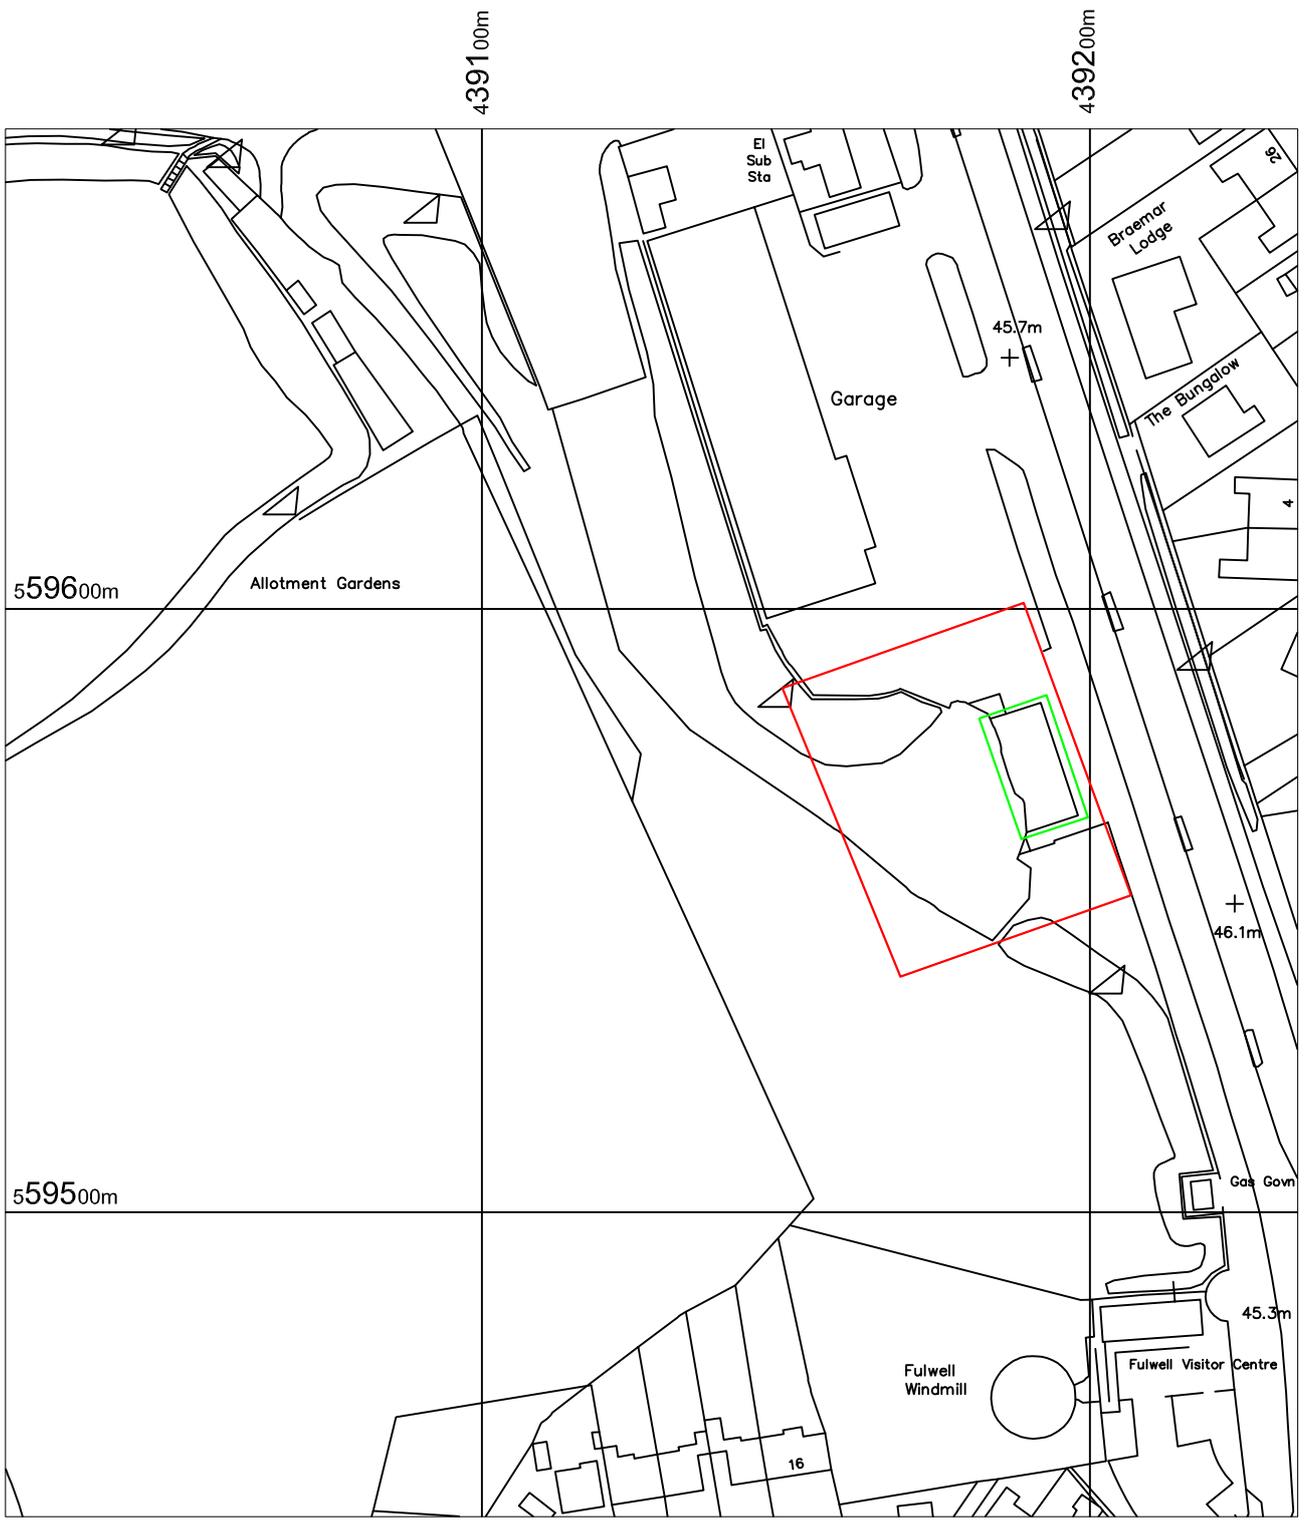
<p>Archaeological Research Services Ltd Baltic Business Centre Saltmeadows Road Gateshead NE8 3DA</p>	<p>Figure 2: Site plan</p>	<p>Key:</p> <ul style="list-style-type: none">

- 1.2.1. Fulwell Lime Kilns are located at the present Mill Garages on Newcastle Road, Fulwell Sunderland, and are centred at NZ 39178 59580 (Fig. 2). Fulwell is a suburb of northern Sunderland. It borders Seaburn, Southwick, Monkwearmouth, and Roker. Fulwell is located near the district border between Sunderland and South Tyneside. The disused quarries at Fulwell are of national geological importance, displaying a large variety of spectacular dolomites from the Late Permian Concretionary Limestone Formation. Semi-natural Magnesian Limestone grassland is the major vegetation type in the area.

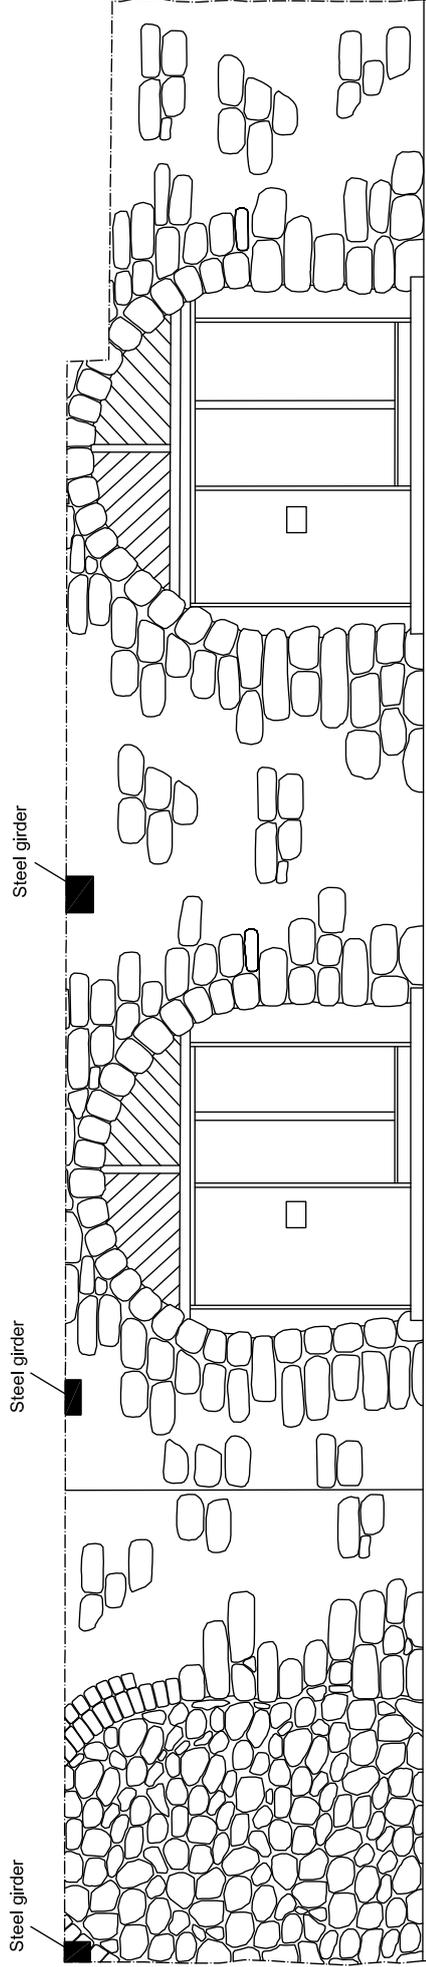
Title:
Figure 3: Elevation within
the showroom

Kiln One
(earliest phase)

Kiln Two
(earliest phase)

5.5.1. There were three steel girders at ceiling level that had been driven into the façade of the kilns (Fig. 30). They are marked on Figure 3. The girders have already caused damage to the kilns and their removal will need to be carried out with care in order to avoid further damage. The masonry and mortar will need to be replaced once the girders are removed.

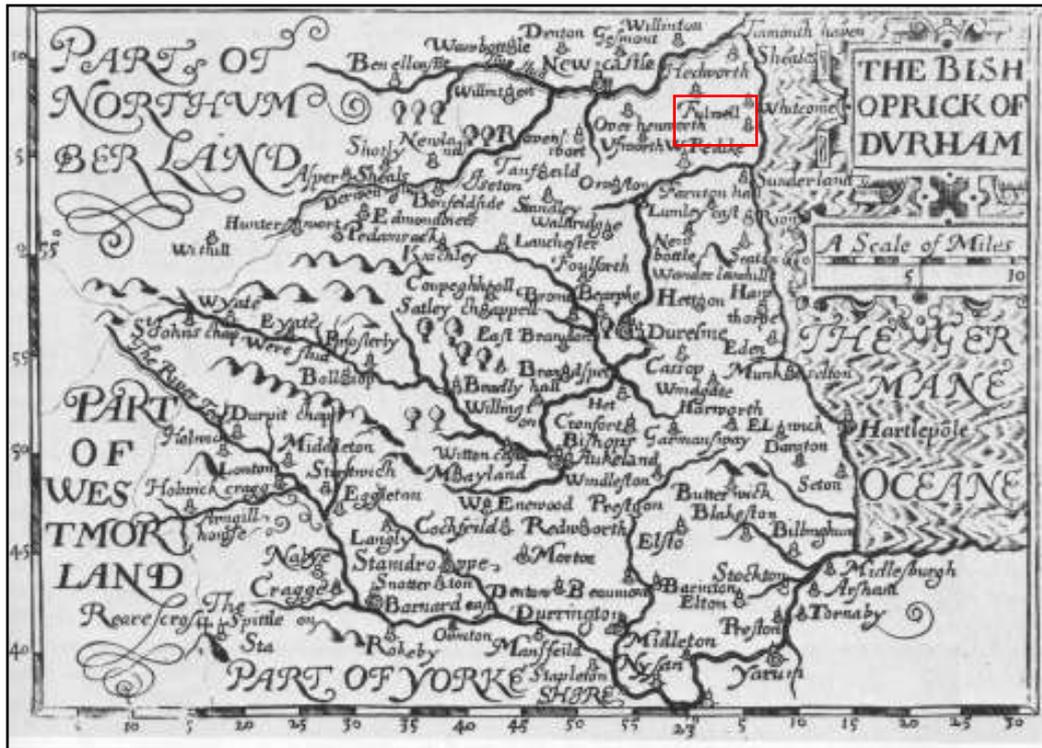
Fig. 6 Bill's 1626 map of County Durham

- 4.2. The earliest maps of the study area that were studied during this work date from the 17th century. Speed's 1610 map of County Durham shows that Fulwell existed at this time but the map is at a scale too small to show the study area in detail. Fulwell can also be seen on Bill's 1626 map of County Durham (Fig. 6).

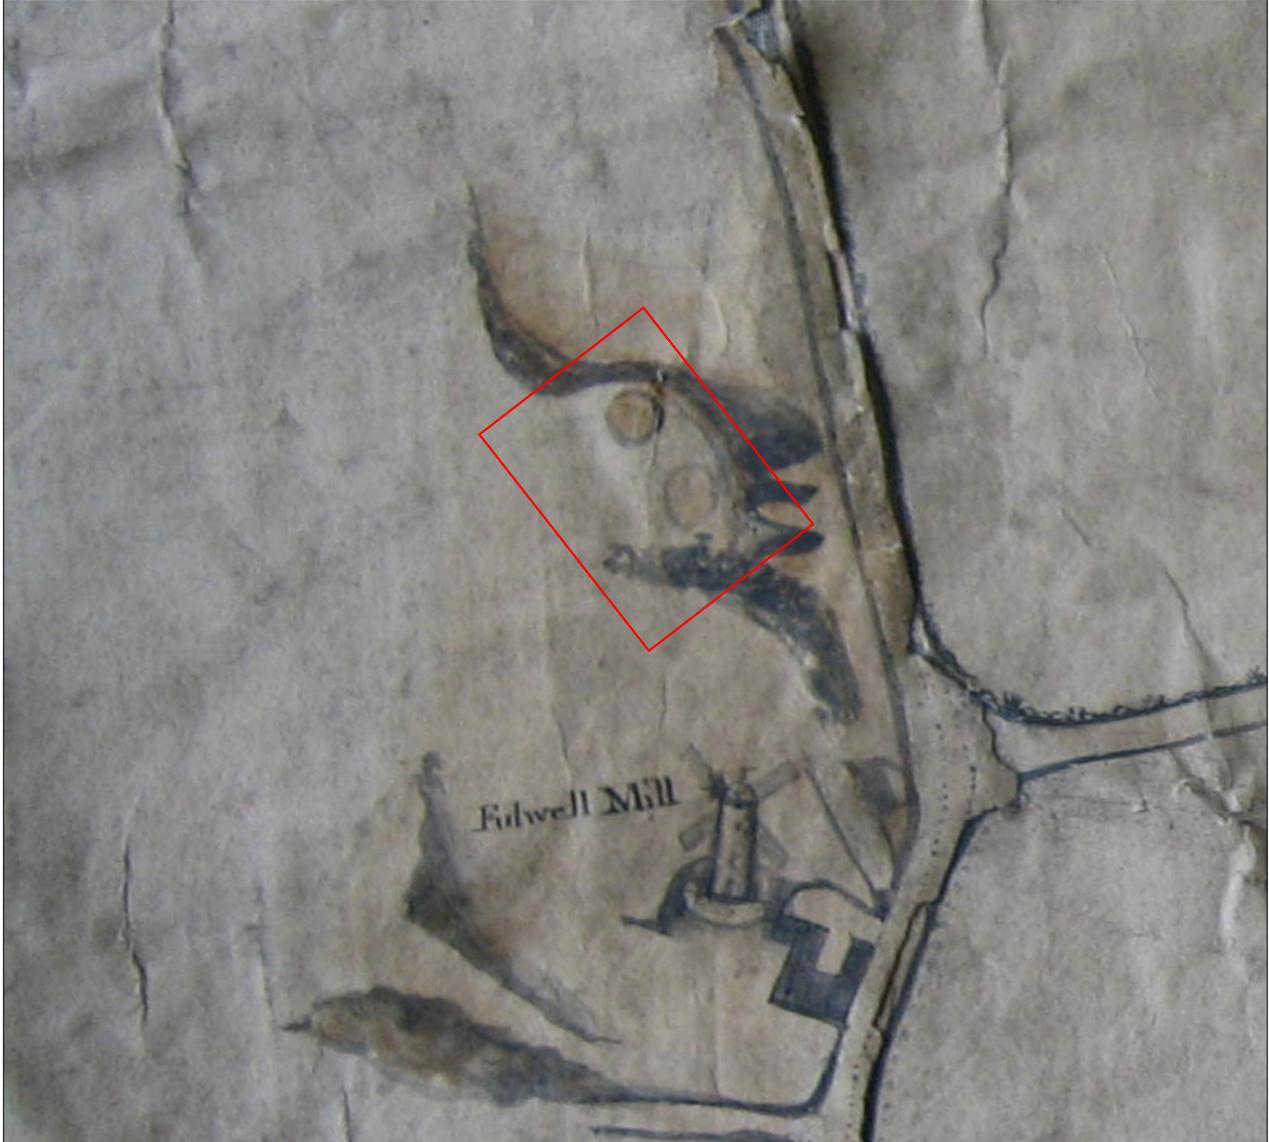
<p>Archaeological Research Services Ltd Baltic Business Centre Saltmeadows Road Gateshead NE8 3DA</p>	<p>Figure 7: Manor Plan of the Parishes Whitburn and Monkwearmouth 1810</p>	<p>Key:</p> <p>

- 4.4. The first map to show any detail of the study area was a plan of Sir William Williamson's estate dated 1810 (Fig. 7). Fulwell Mill is clearly marked and West House can be seen to the immediate southeast. To the north of the mill two lime kilns are illustrated in the side of the hill.

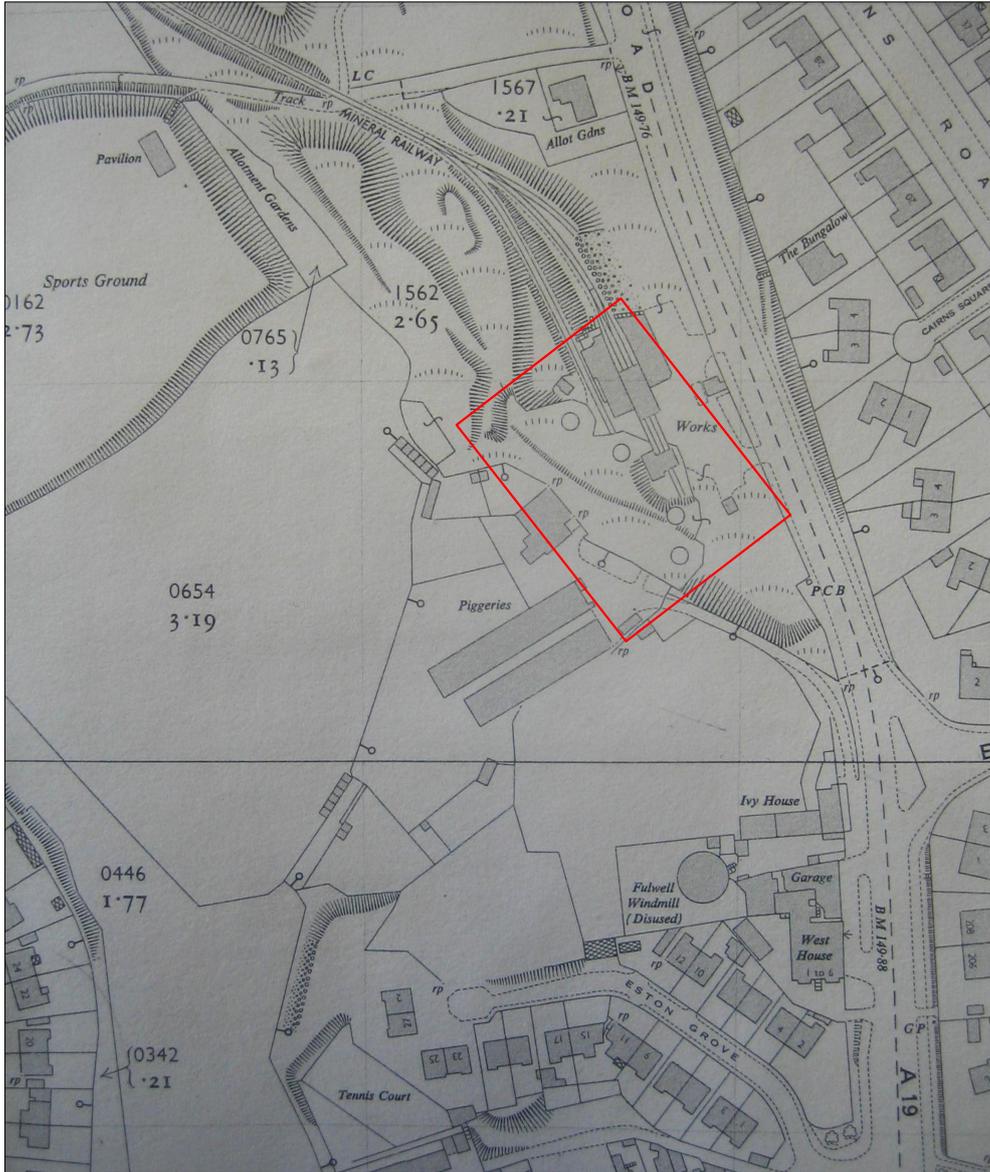
Figure 13:
Revised edition Ordnance
Survey of 1960

- 4.9. The fourth edition Ordnance Survey map of 1939 (Fig. 12) reveals that there have been no changes since the 1919 survey, and the revised edition Ordnance Survey of 1960 (Fig. 13) shows that the lime kilns and the associated wagonways are still present but they were out of use by this date following their closure in 1957. The area to the east of Newcastle Road has also been developed with semi-detached residential housing.

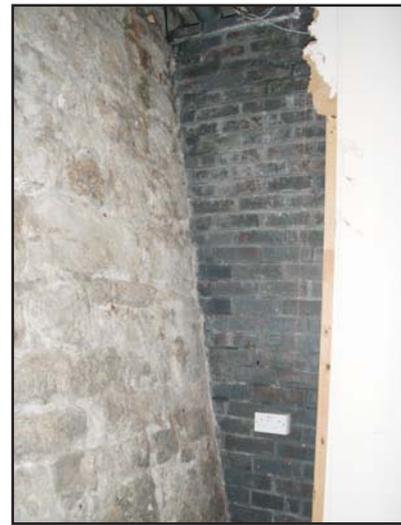
Fig. 31 North west interior wall abutting the kiln facade

- 5.5.2. The north-west brick wall of the showroom rests against the façade of the kilns (Fig. 31) and its removal, if carried out with care should not cause significant damage to the kiln structure. The southeast brick wall of the showroom rests against Kiln Three (Fig. 32) and will also need to be removed with care to avoid damaging the kiln. These walls do not cut into or penetrate the kiln structure and therefore damage should be minimal. The external walls of the modern structure are also built up against the kiln façade and do not appear to penetrate the stone work. Careful removal should cause minimal damage.

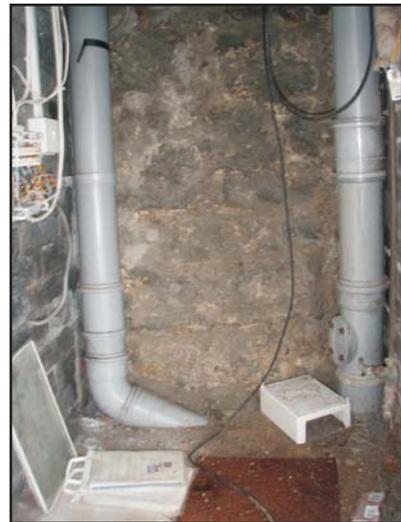
Fig. 33 Kiln facade in ground floor cupboard

- 5.5.3. A section of the stonework was exposed within a ground floor cupboard at the northwest end of the building, revealing that the wall of the showroom only rests against the kiln structure in this section (Fig. 33). A section of the façade was also exposed within the first floor male toilets and revealed the same relationship between the buildings (Fig. 34). The removal of these walls should cause minimal damage to the kilns if removed with care.

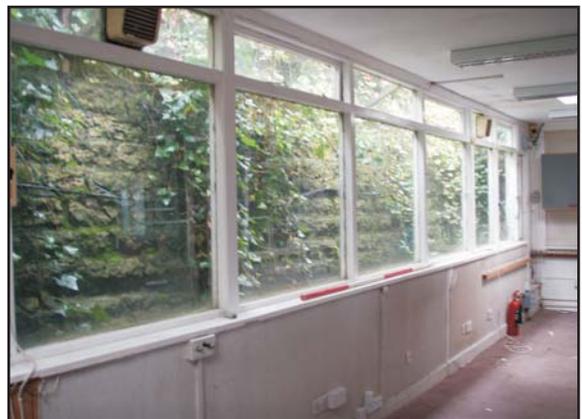
Fig. 35 First floor office

- 5.5.4. The front façade of the lime kilns are not vertical and slope back as the structure rises. They slope back slightly as the structure rises. The showroom was built vertically and therefore the first floor office is set slightly away from the façade of the kiln with fenestration against the façade of the kiln (Fig. 35). The first floor of the building is secured onto the kiln structure by a metal frame which has been bolted onto the kiln façade (Fig. 36). The removal of the frame may cause damage to the mortar of the kilns which will need to be replaced after removal.
