An Archaeological Building Appraisal at The Howard Public House Complex, Sheffield

ARS Ltd Report 2011/1

January 2011

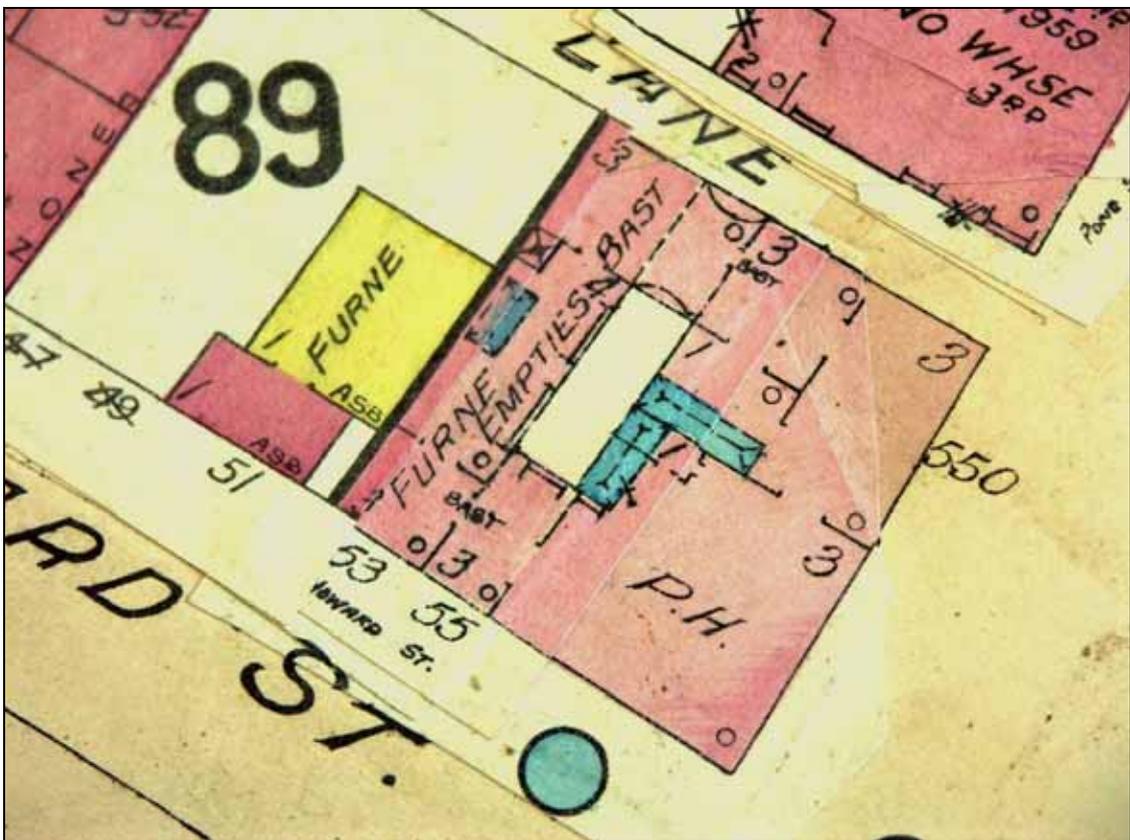
Figure 11: Goad Insurance map 1959

- 5.14 The Goad Insurance map of Sheffield revised in 1959 shows the site with similar layout and internal partitions to the preceding revision, however further details include basements within the complex which are labelled as 'BAST' (Fig. 11). Building E is labelled as 'FURNE EMPTIES' which may indicate that the building might have been vacant or partially devoid of furniture. The adjoining buildings on the north-western side of the streets block appear to had been substantially demolished, including the bakery and oven, and replaced by two new single-storey structures with asbestos roofs.

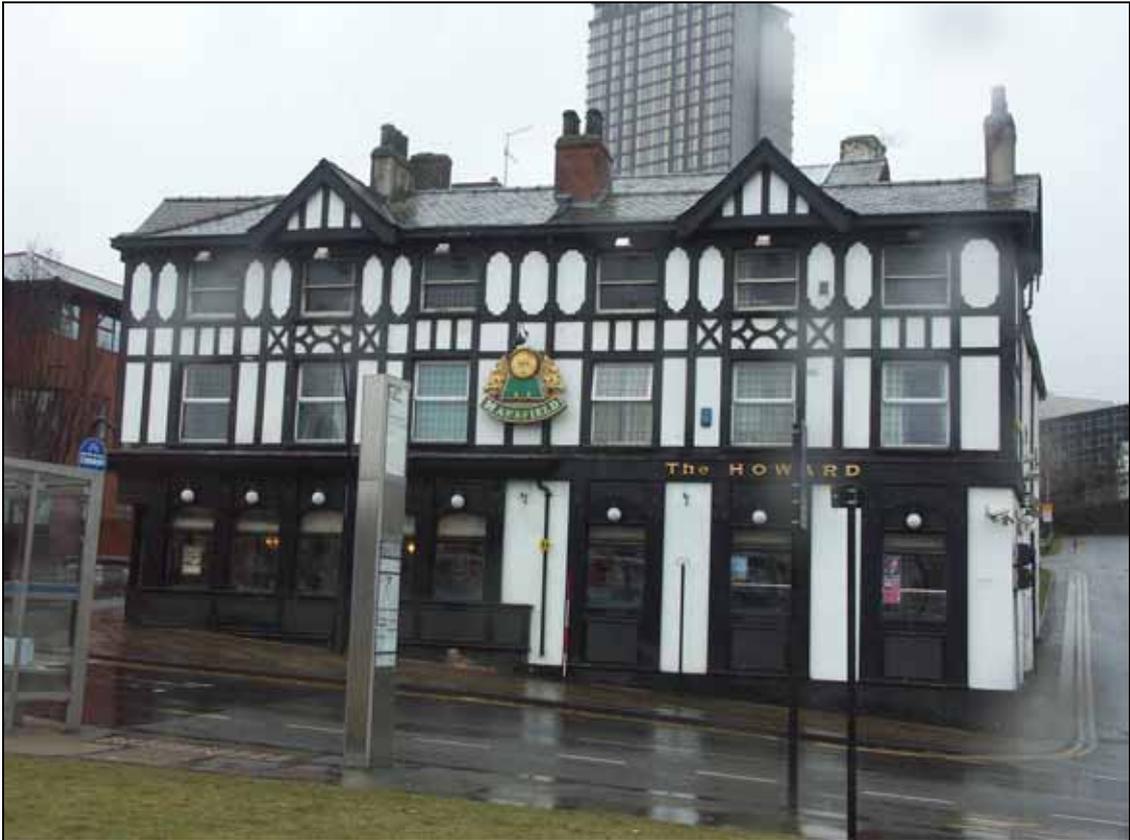
Figure 15: Front elevation of Building A (right) incorporating adjacent Building B (left), looking north-west

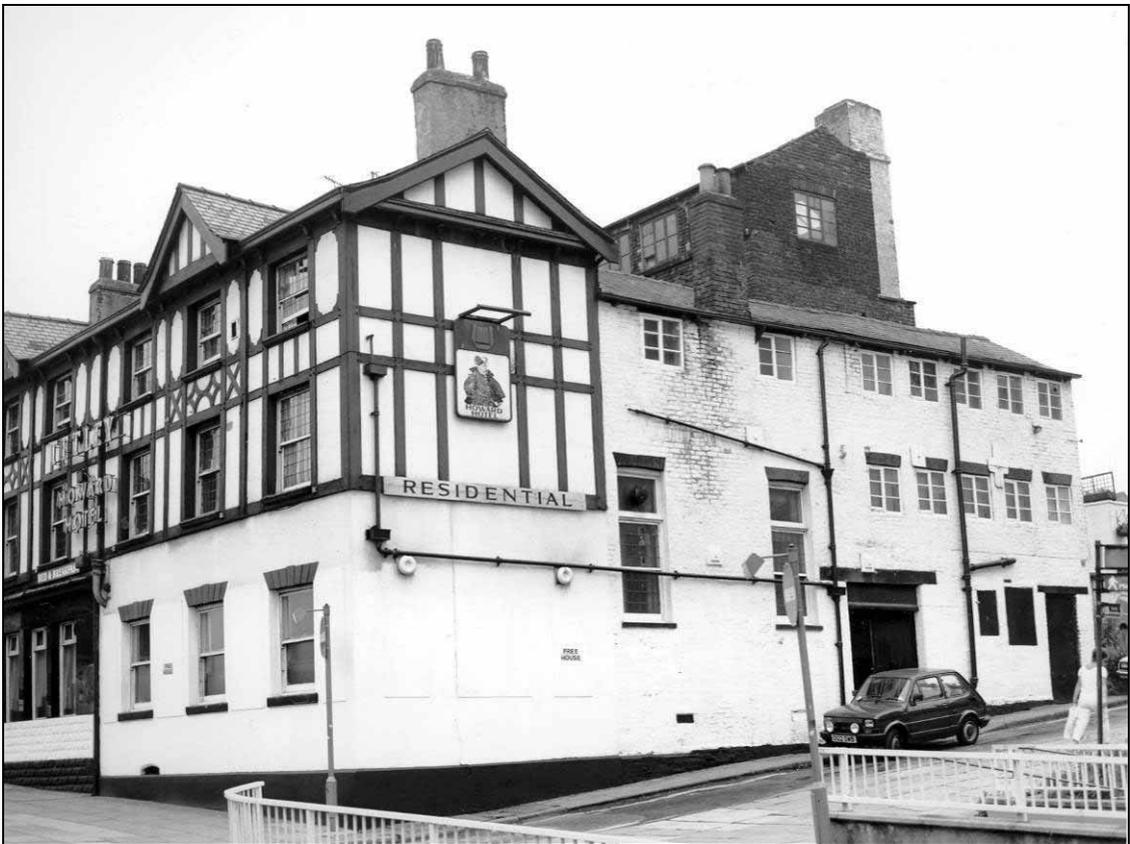
Figure 16: Front and side elevation of Building A photographed in 1988 (copyright Sheffield City Council)

- 6.2 Building A is a three-storey brick-built range with a slated pitched roof and stacks at each gable ends. The roof has projecting eaves and verges. The front elevation consists of three bays with false timber frame, composed of thin planks, on the upper stories which are continuous with the adjoining Building B (Fig. 15). The current appearance has been substantially altered from its original design. The primary window openings can be seen on the ground floor of a photograph taken in 1988 consisting of flat arched heads with wide *voussoirs* and slightly larger key stones (Fig. 16). The actual windows are later Victorian replacements composed of one-over-one sliding sash reinforced with horns. The windows are recessed and placed in behind reveals.

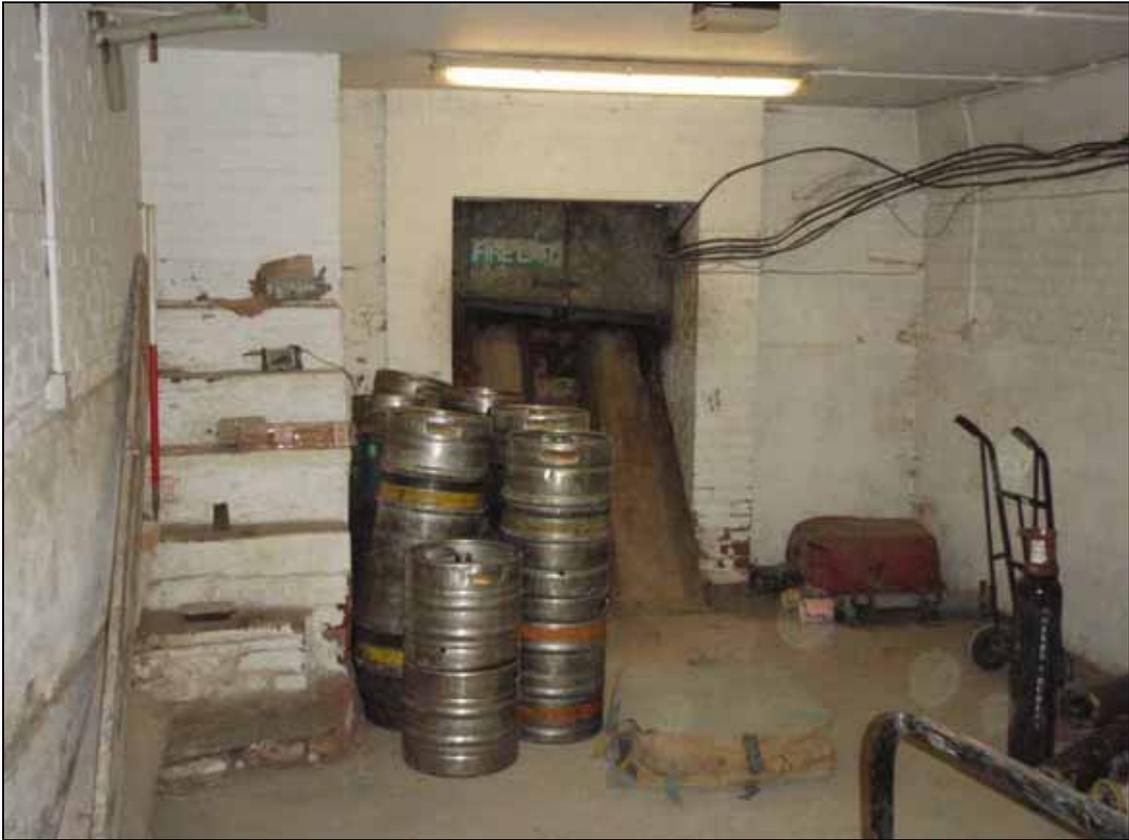
Figure 17: Cellar floor of Building A, looking north-east (scale 1m)

- 6.3 The basement of the present Howard Public House is accessed from a modern staircase in Building D which leads to a series of rooms within the footprint of Buildings A, B, C and E. The basement of Building A has a barrel chute located along Surrey Lane and an obsolete brick straight staircase adjacent to it (Fig. 17). Most of the original fabric has been substantially modified with the insertion of concrete ceiling and floor. The walls are built with bricks including modern repairs.

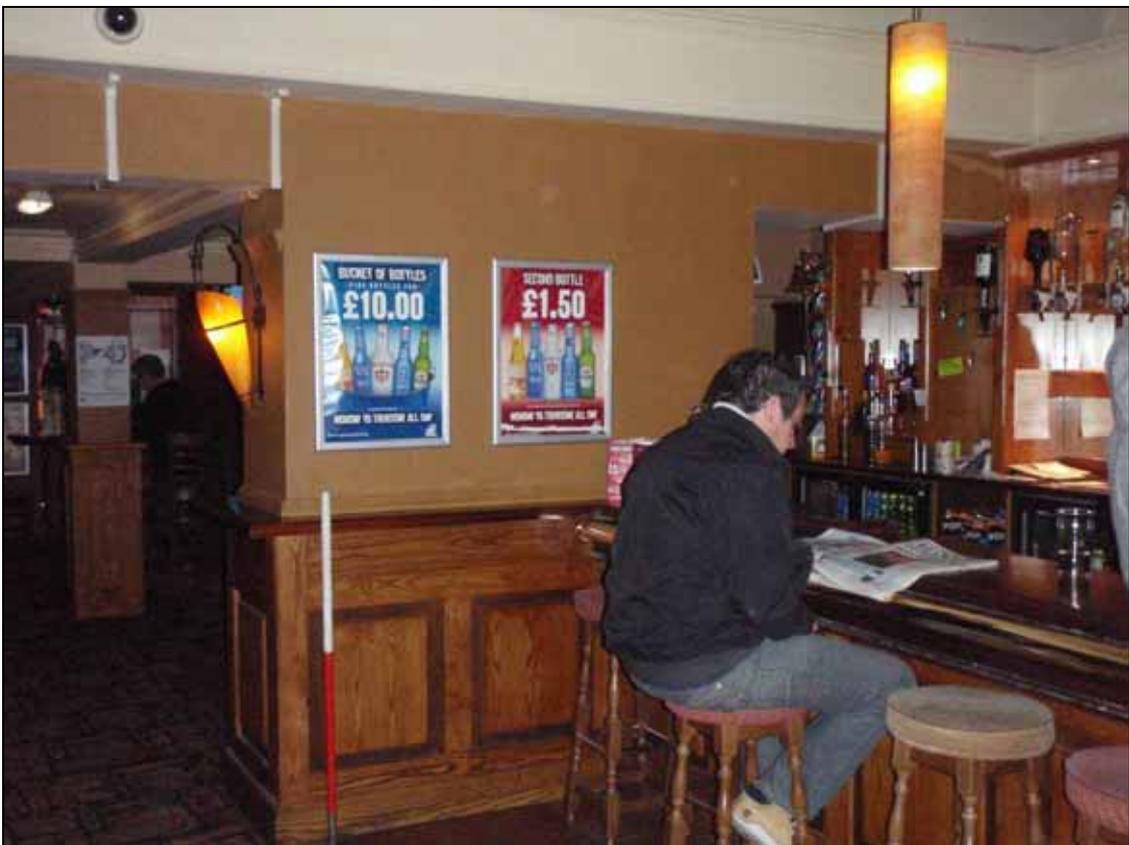
Figure 18: General view of the present pub within Building A, looking south-west (scale 1m)

- 6.4 The ground floor is a large area opened up to the adjacent Buildings B, C and part of F. The original walls dividing the amalgamated buildings have been removed and the upper stories are supported with RSJ girders which in turn are held by stanchions. The entire interior is composed of modern fabrics, such as concrete floors, plaster and plywood (Fig. 18).

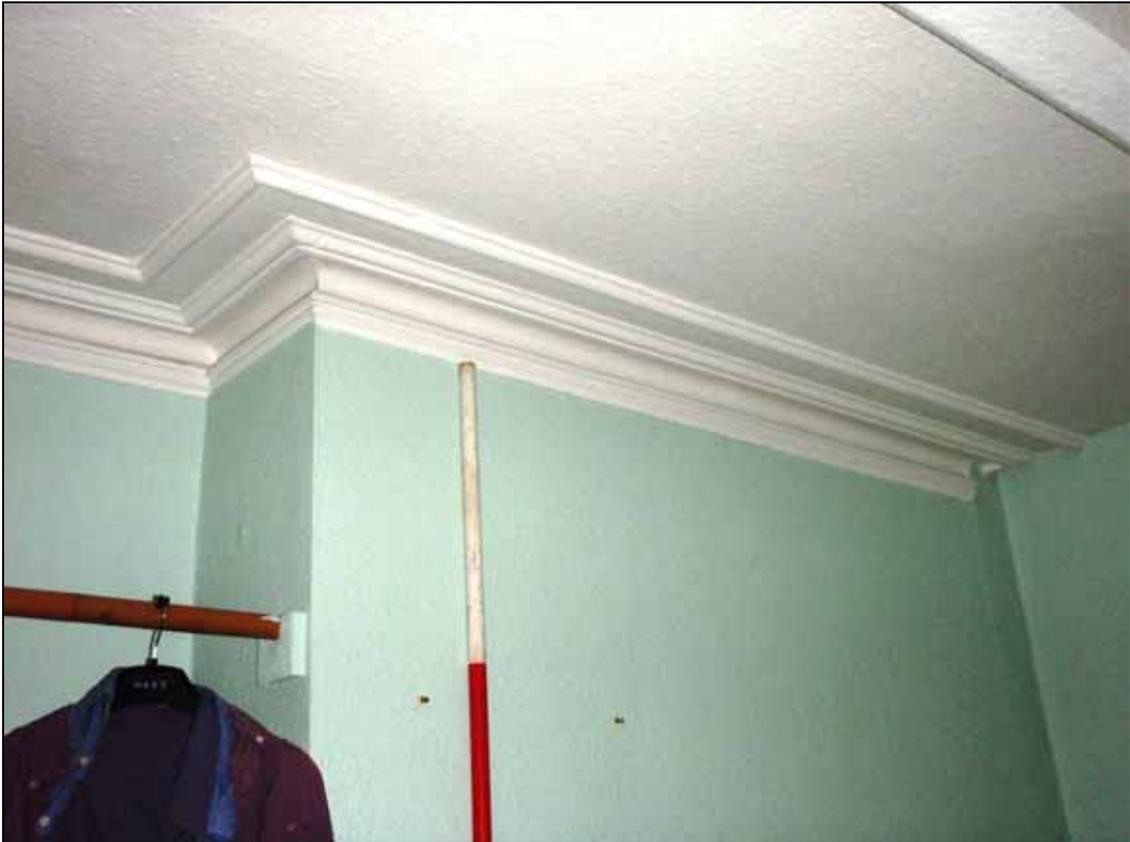
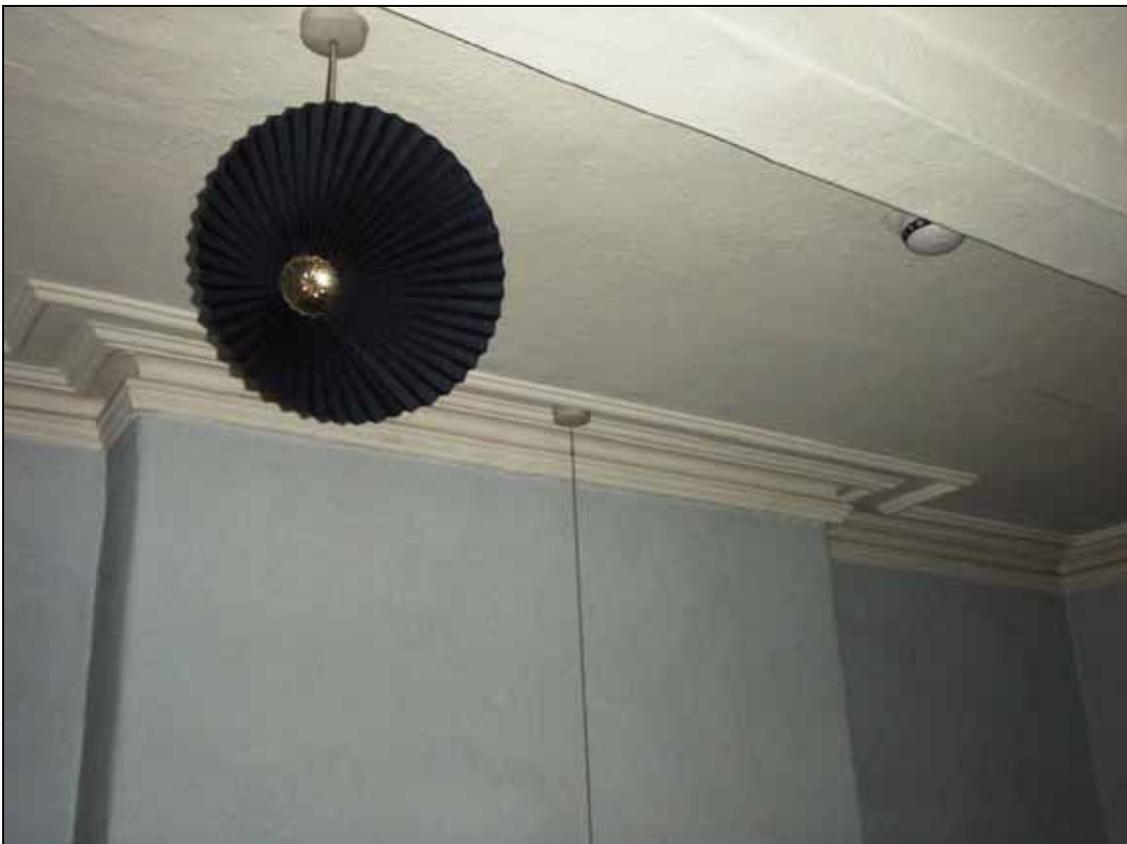
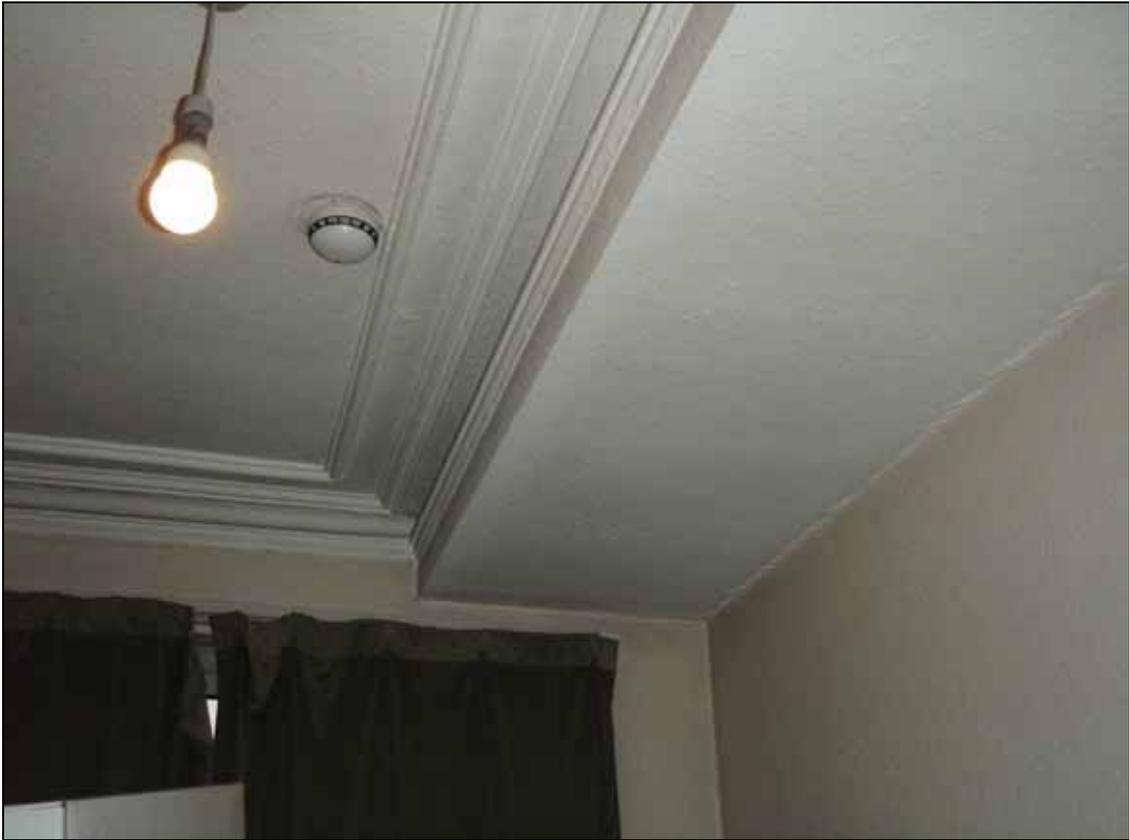
Figure 19: Detail of moulding cornice in the southern room of the first floor of Building A

Figure 20: Decorative cornice in the northern room of the first floor of Building A

Figure 21: Detail of moulding cornice in the first floor of Building A

- 6.5 The first floor consists of two large obsolete bedrooms linked by a passageway. The rooms retain original decorated plaster cornice throughout (Figs 19 – 21). The moulding cornice is in good state of preservation, although there are some small areas slightly damaged. Each room has a chimney breast and their respective fire places are now blocked up with plaster. The windows, doors and skirting boards are later replacement. The floorboards are mainly original and in good condition. The ceiling is made of lath-and-plaster supported by two exposed beams covered with decorative paper.

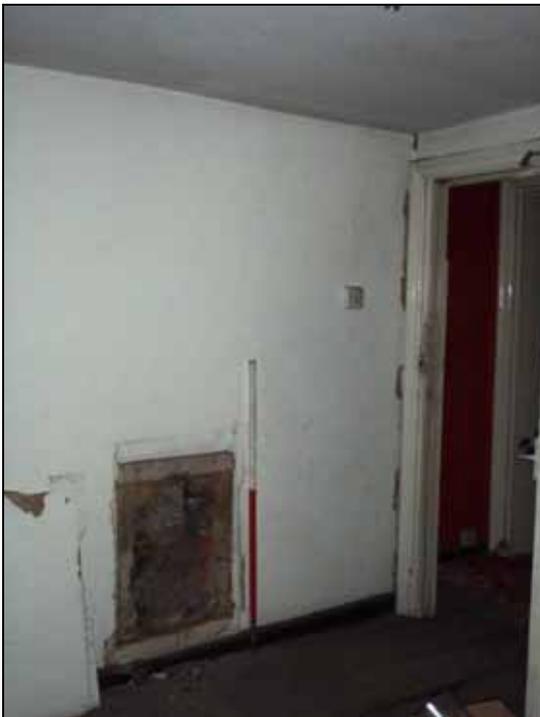
Figure 22: Second floor of Building A

- 6.6 The second floor is comparable to the floor below although all the doorways contain moulding architrave of late 19th century date (Figs 22 and 23).

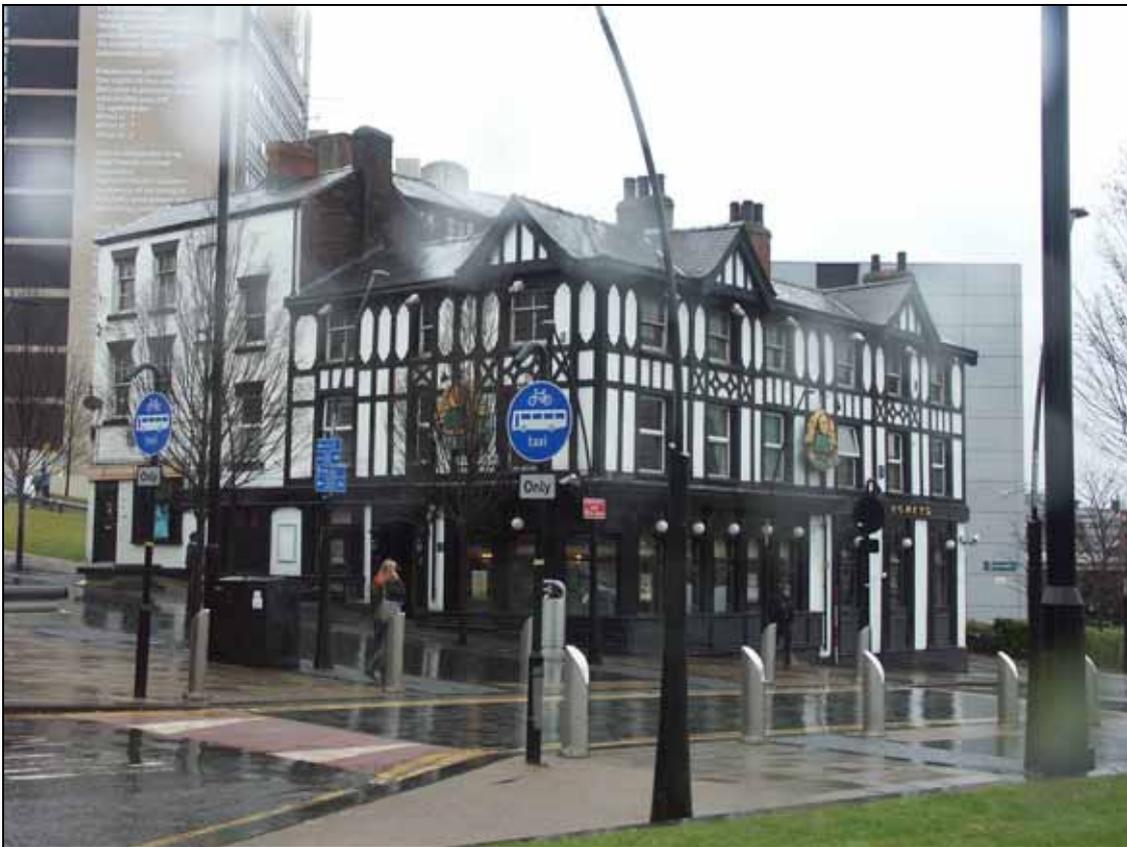
Figure 24: Front elevation of Building B (centre) with adjoining Buildings A (right) and C (left)

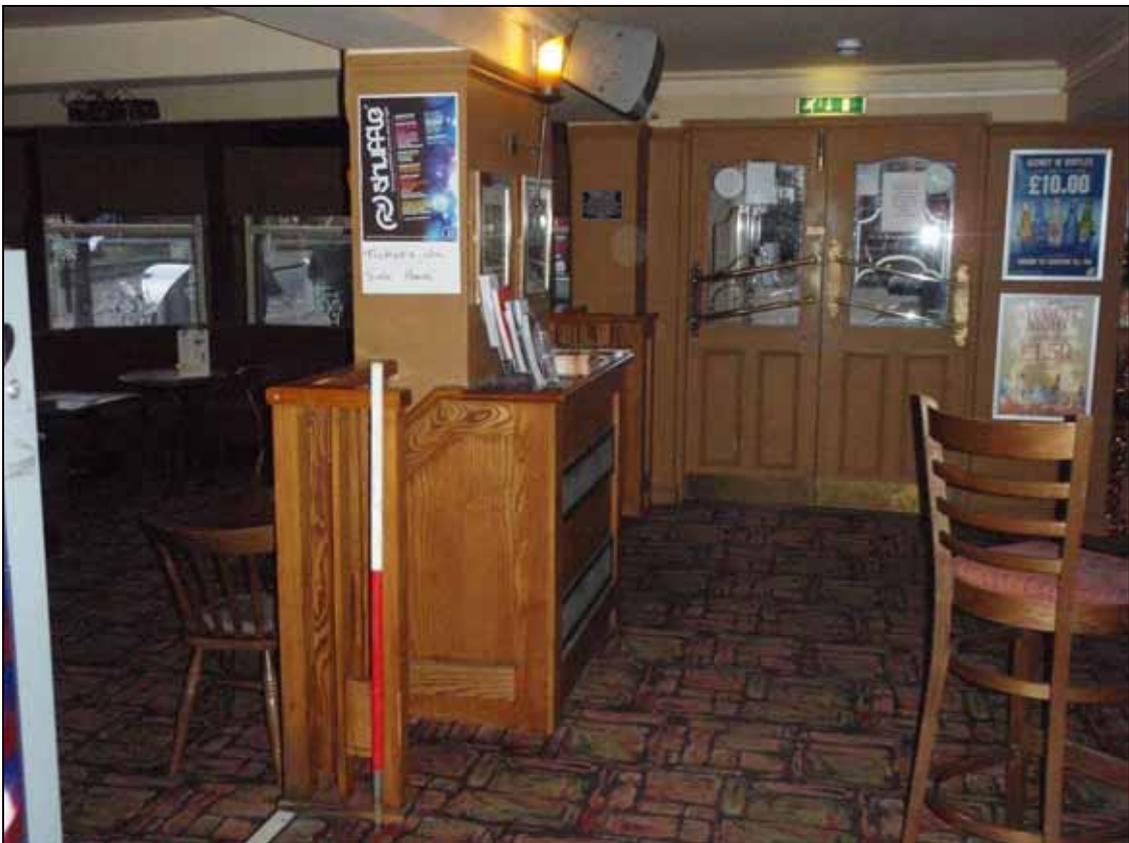
Figure 26: General view of the present pub within Building B, looking south-west (scale 1m)

- 6.9 The ground floor is comparable to Building A (Fig. 26). The floor level is equivalent to Building A but lower than the adjoining Building C to the north-west.

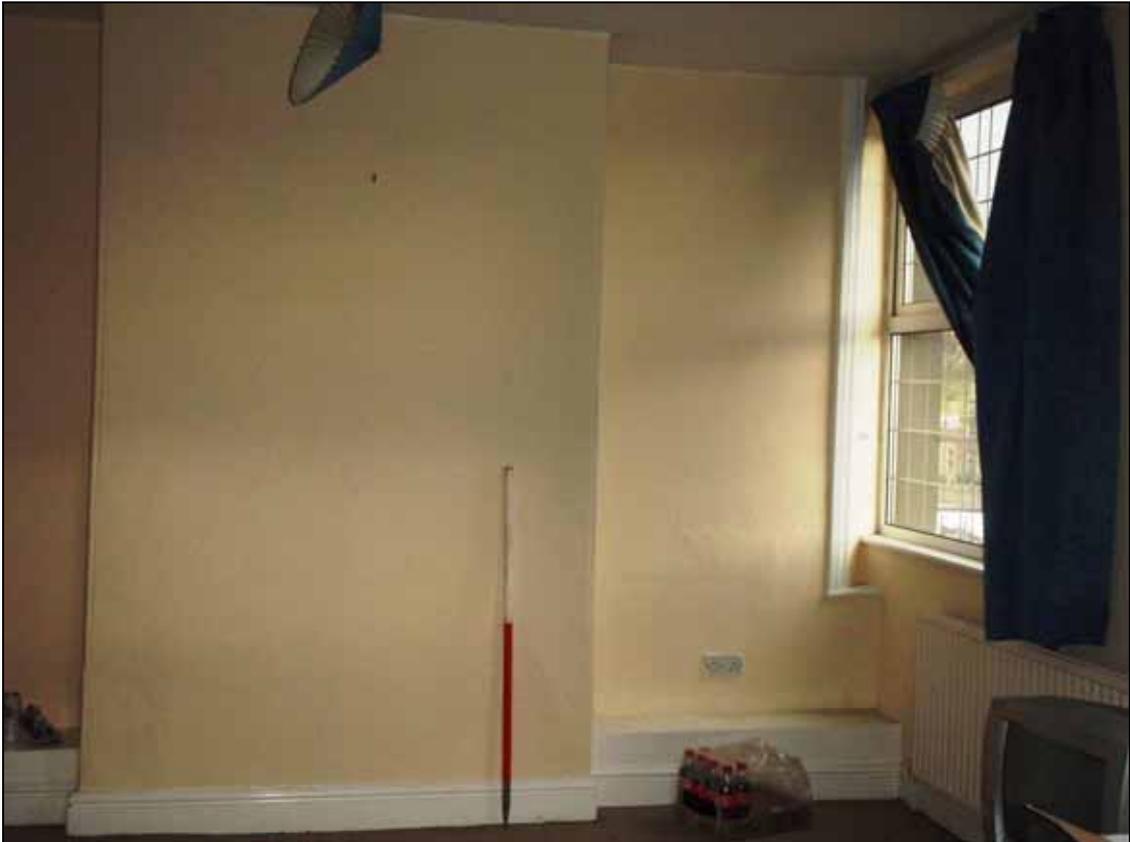
Figure 27: Chimney breast in the first floor of Building B, looking north (scale 1m)

- 6.10 The first floor is similar to the interior of Building A except for the lack of moulded plaster cornice (Fig. 27). The second floor is also similar to the adjoining building with fire places blocked with plasterboard (Fig. 28) and 19th century doorway architraves (Fig. 29).

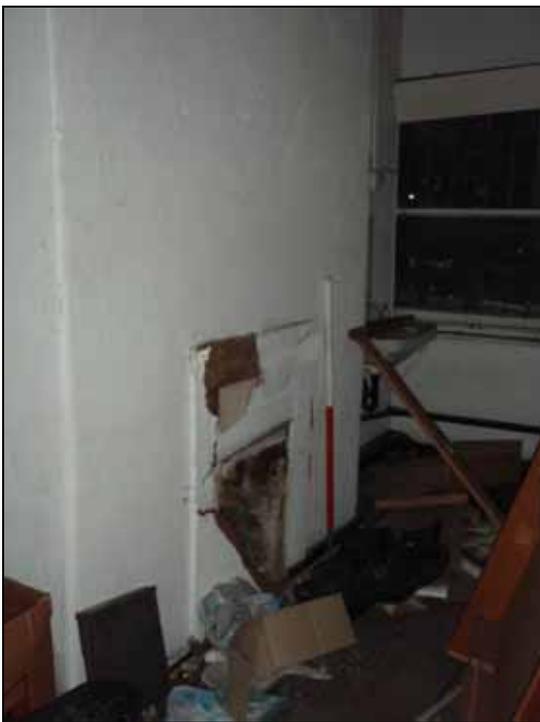
Figure 28: Second floor of Building B

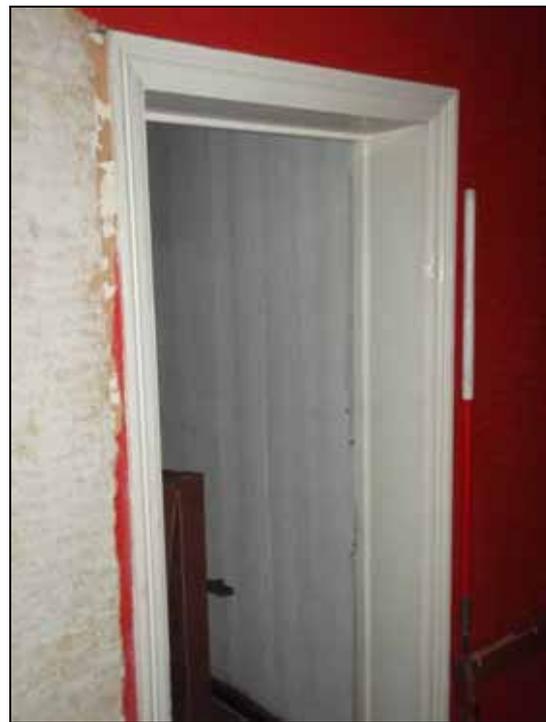
Figure 29: Detail of architrave in Building B

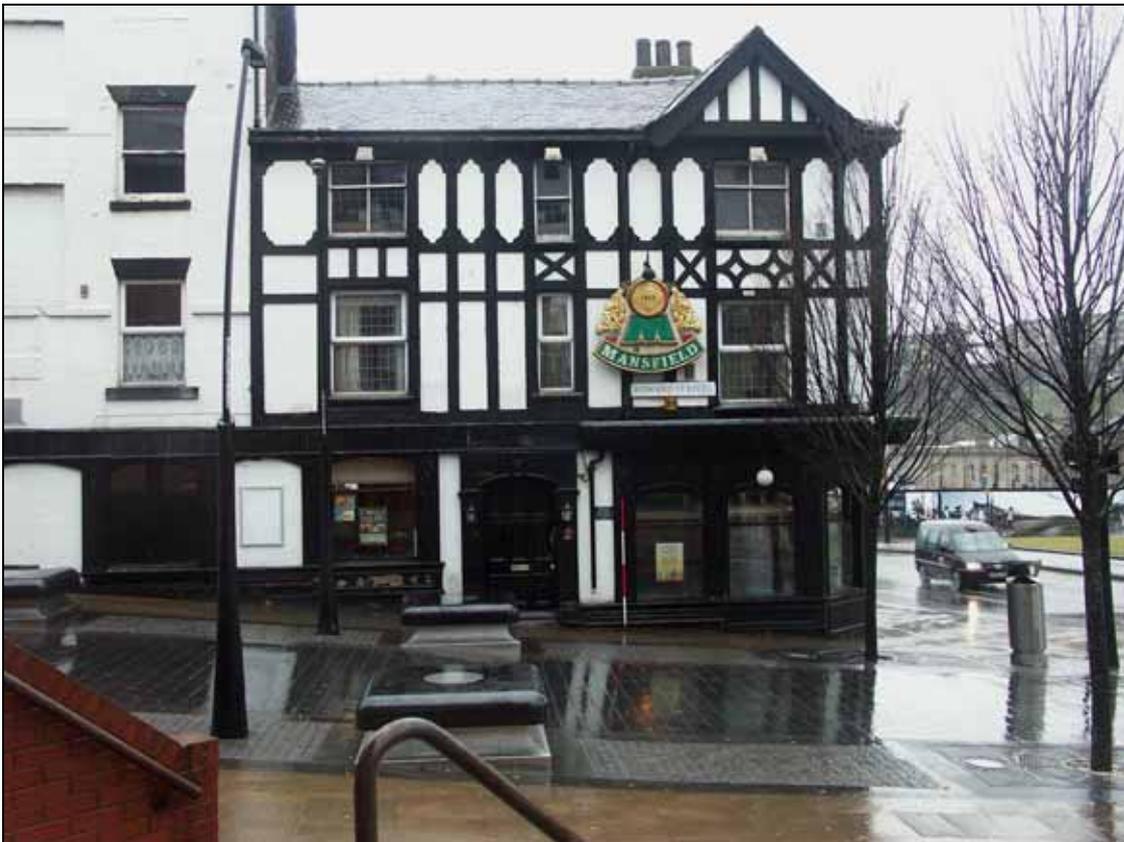
Figure 30: Front elevation of Building C (centre), looking north-east (scale 2m)

- 6.11 Building C is also a three-storey brick-built range with a pitched slated roof with projecting eaves (Fig. 30). The external fabrics have also been altered with the insertion of the continuous false timber frame and later windows. The building itself appears to be an extension of the adjacent Building B.
- 6.12 The basement has an original sandstone wall along Howard Street (Figs 31 and 32).
- 6.13 The ground floor is a continuation of the bar area of pub which bears no significance. The first floor consists of a bedroom containing a chimney breast with the fire place blocked up (Fig. 33). The window, doors and skirting boards are later replacement. The floorboards are mainly original and in good condition. The ceiling is made of lath-and-plaster. The second floor is comparable to the floor below.

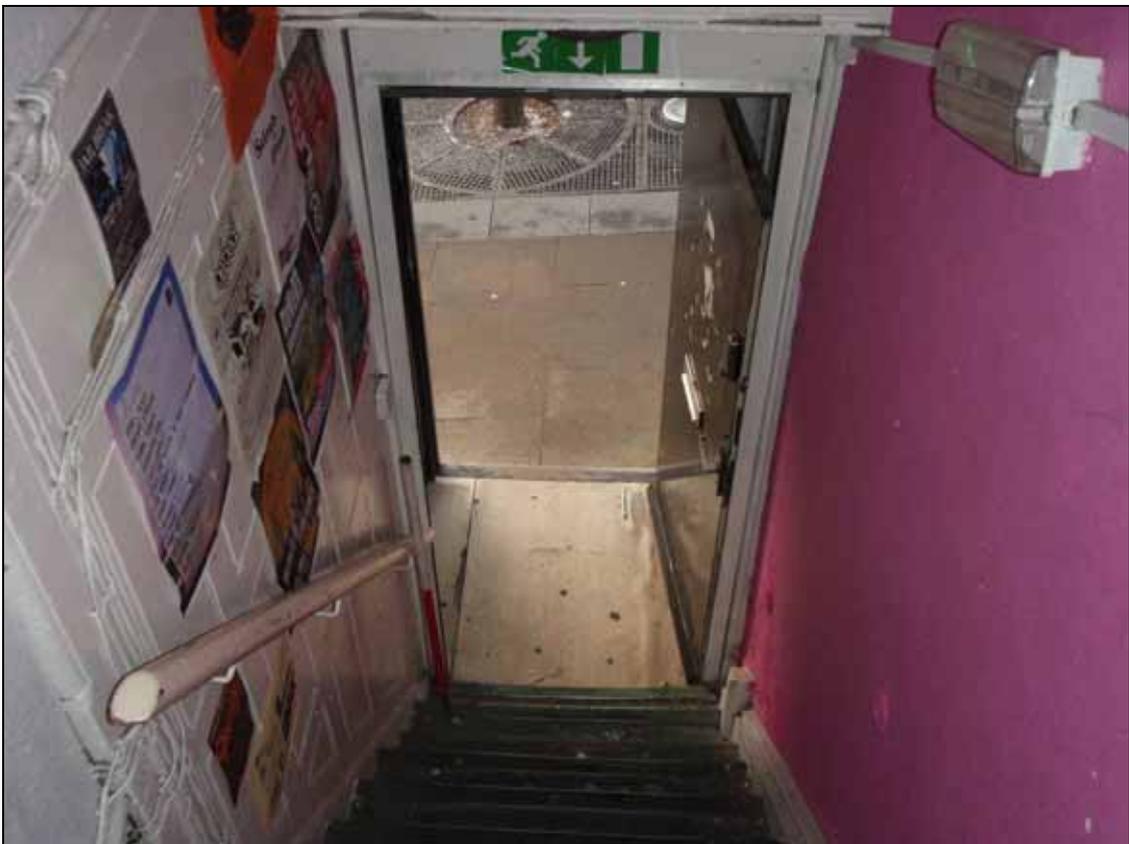
Figure 36: Staircase of Building D, looking west (scale 1m)

- 6.16 There is a small basement adjoining Building C. Most of the original fabrics of the basement have been substantially modified with the insertion of concrete ceiling and floor as well as breeze blocks to create a small boiler room. The lobby on the ground floor contains a quarter-turn timber staircase with winders and close strings (Figs 36 – 38). The staircase has an original timber panelling with short mid rails jointed into long muntins. These are flush but decorated with beaded moulding edges. There is a banister fixed on the panelling wall. However there are scars on the opposite wall indicating that its original location would have been on the brick wall rather than on the present position. Halfway up the lower section of the staircase, an inserted doorway leads to the adjoining record shop within Building E. However, the staircase would have originally enabled access to the upper floors adjoining Building D. The rest of the ground floor is part of the pub and opened up to the adjacent Building C.

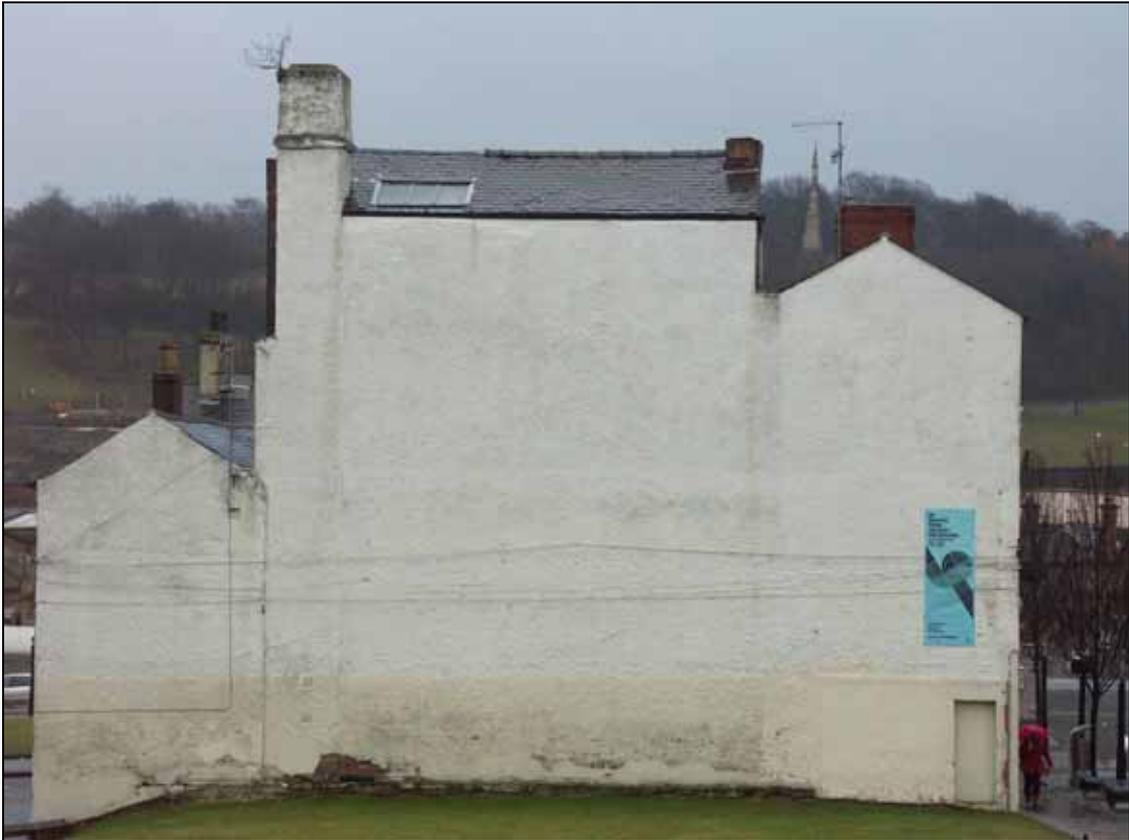
Figure 41: Front elevation of Building E (centre) flanked by Buildings D (right) and F (left)

- 6.18 Building E is a large four-storey brick-built range with rough-cast render and a slated pitched roof (Fig. 41). The roof has plain eaves and close verges. This building appears to have originally been designed as a factory or warehouse. There is a partially truncated chimney stack on the western gable and a larger stack on the north-eastern corner of the building. A damaged area of the rough-cast around the base of the large stack enabled inspection of the brick wall, suggesting that the larger stack appears to be a possible earlier structure, made of different type of bricks, which is neither keyed in with the main front wall of the building, nor aligned in the same horizontal brick course (Fig. 42).

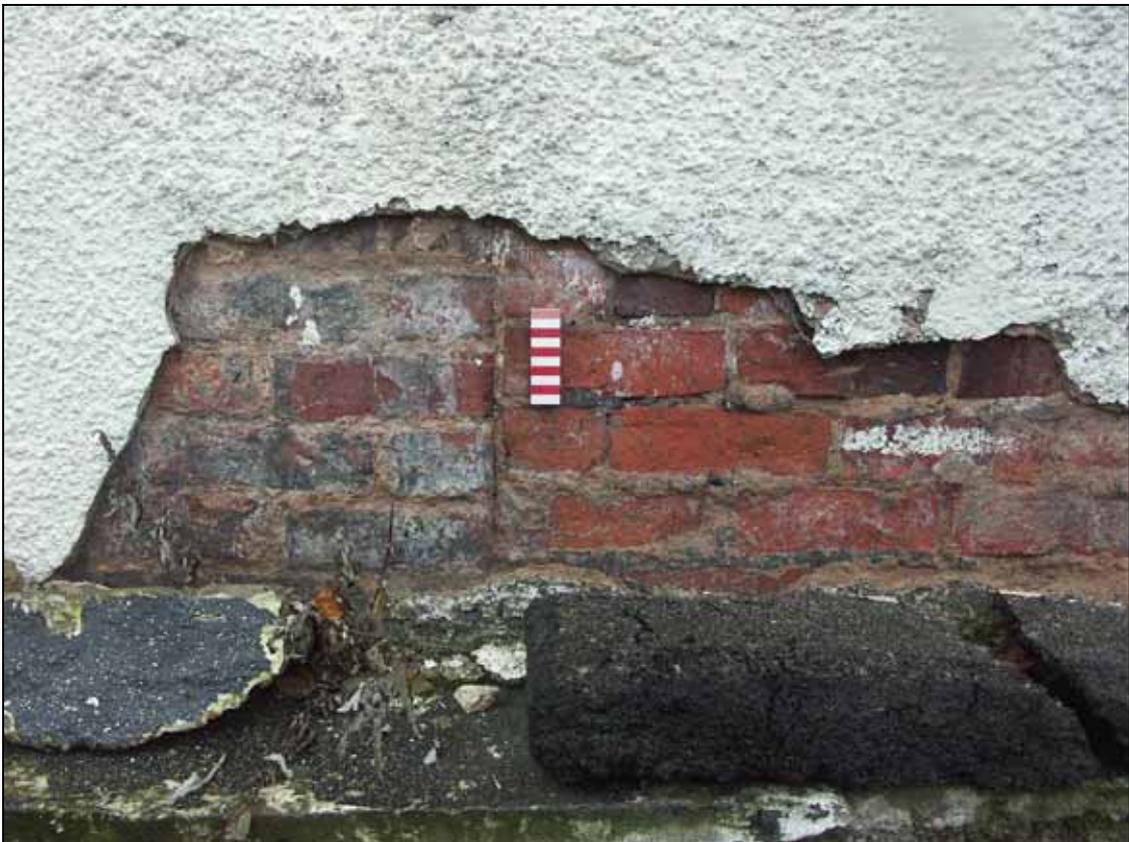
Figure 42: Construction break shown at the base of the chimney stack and main wall of Building E

town trades directories. There is no evidence of former industrial activities within the building except for the character and amount of windows, which are indicative of a factory or warehouse. The large chimney stack does not appear to have been employed in this building and, instead, it might have been associated with an adjacent oven and bake house observed in contemporary cartographic records.

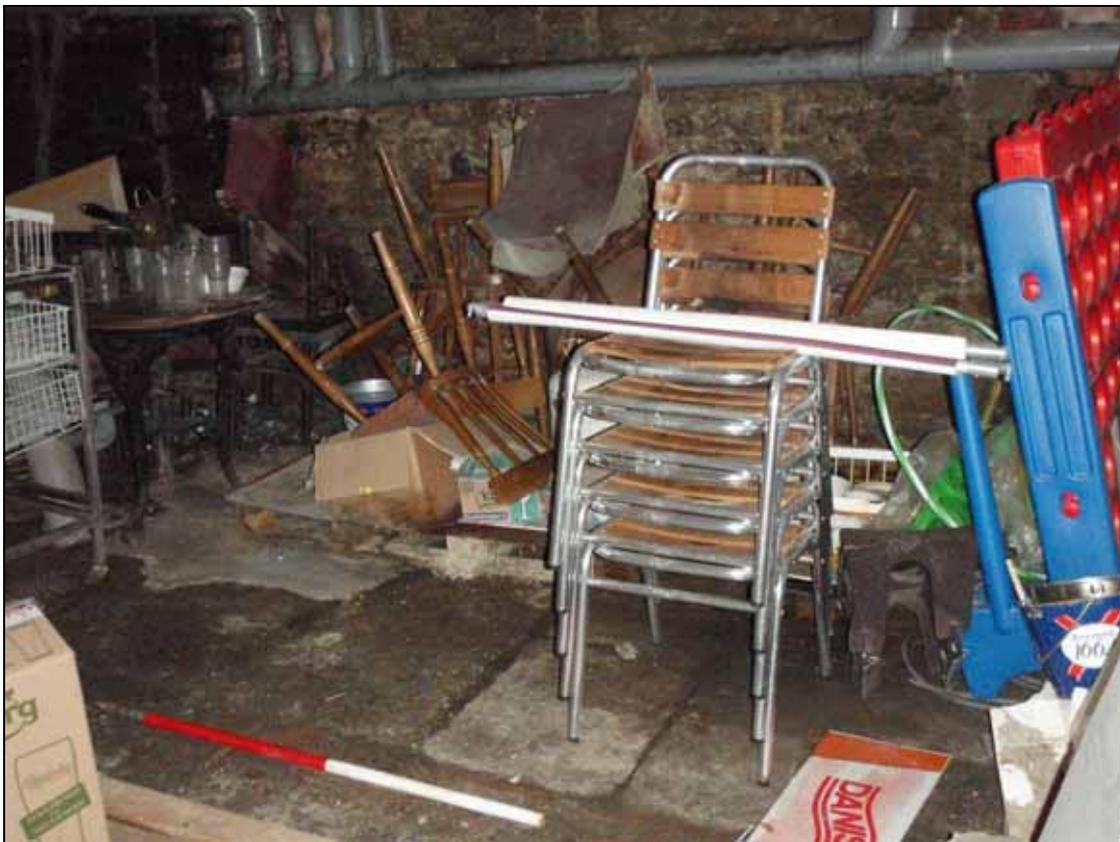
Figure 44: Cellar floor of Building E

- 6.20 There is a cellar room on the western side of the building. The cellar contains original sandstone walls and flagstones (Fig. 44). The ceiling however, is a later repair made of concrete over an RSJ beam.

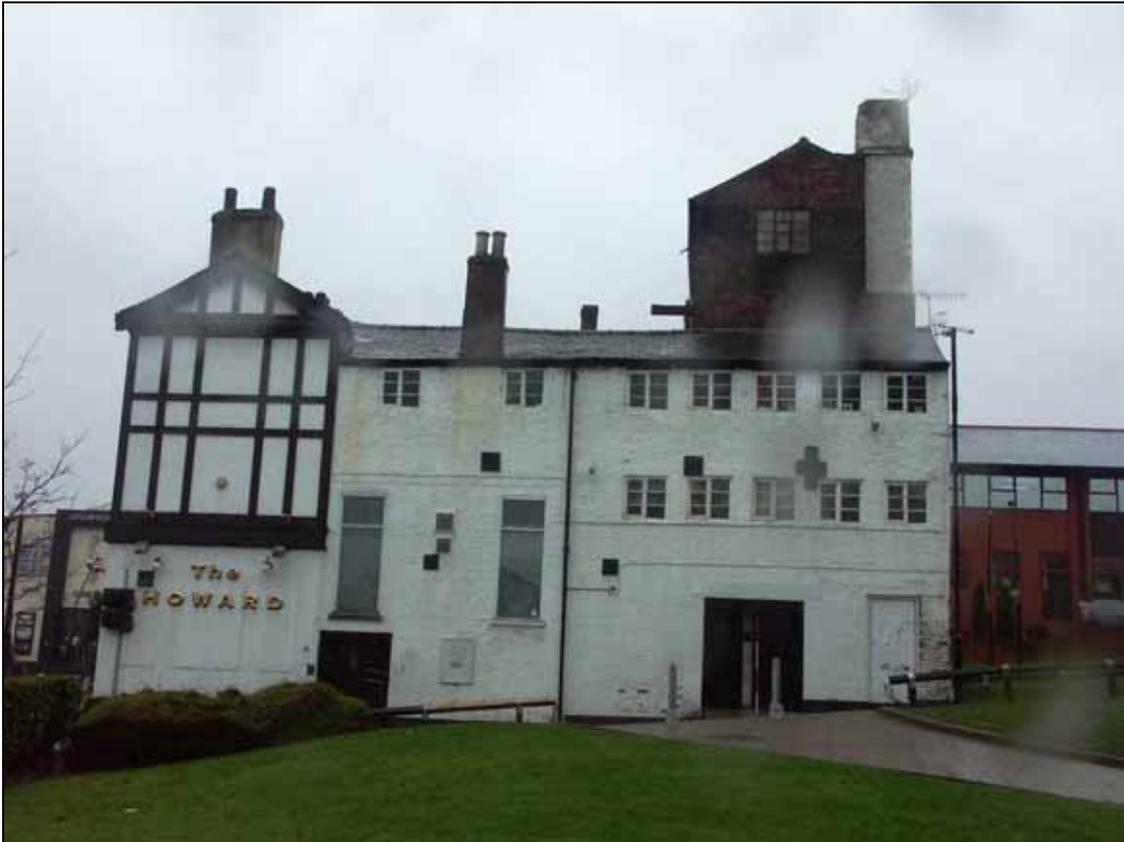
Figure 48: Front elevation of Building F, looking south-west (scale 2m)

- 6.24 Building F is also three stories high, made of bricks and has a slated pitched roof with a stack along the main elevation in Surrey Lane (Fig. 48). The roof has projecting eaves and close verges. This building appears to have originally been designed as a factory or warehouse. The main elevation has been substantially disfigured with the insertion of later openings and blocking of former windows through time. Former secondary openings can be also seen in a photograph dating to 1988 (Fig. 49). It could be discerned that the building might have originally been two adjoining structures of five bays marked by the present casement windows (north-western side) and possibly two bays with a central projecting stack which has been mostly removed except for the top section over the roof (south-eastern side). The rear elevation is only partially visible from the central courtyard between Buildings A and E (Figs 50 and 51). The second floor has a series of different casement windows and a central opening blocked up.

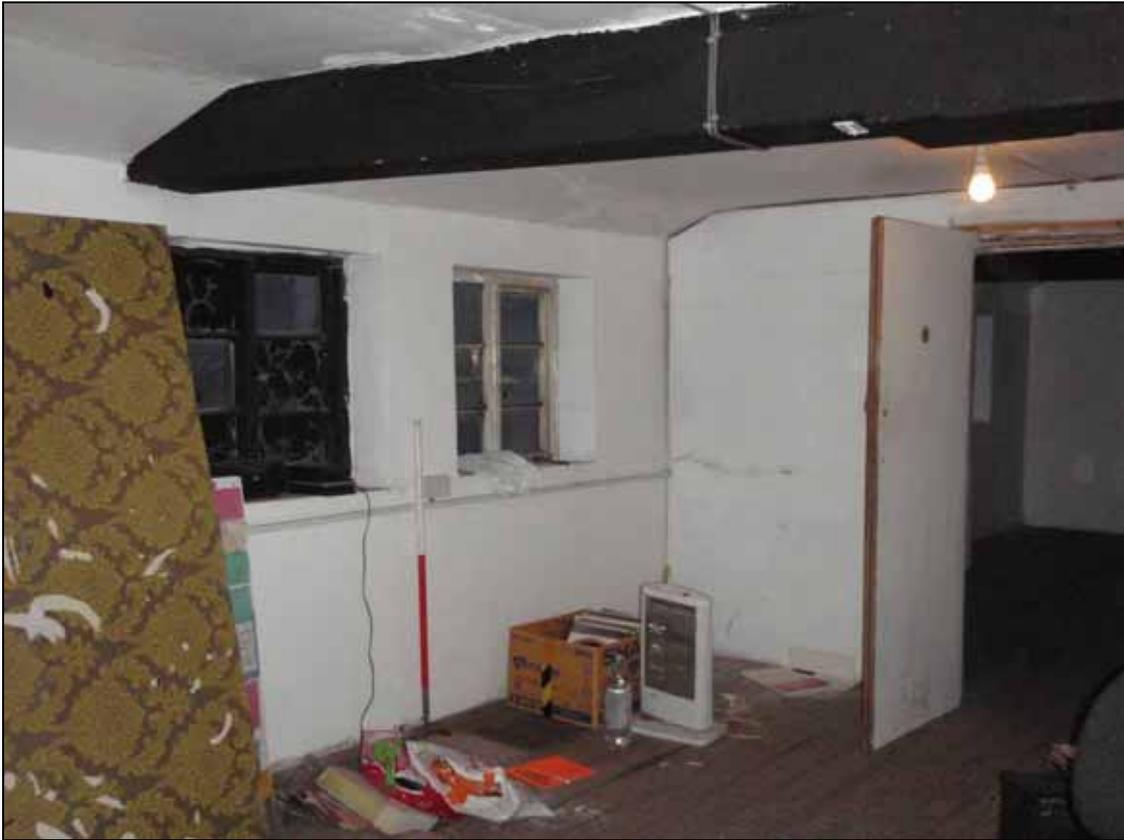
Figure 52: First floor of Building F, looking east (scale 1m)

- 6.25 The ground floor is part of the pub including a kitchen. The fabrics are comparable to the rest of the pub itself, bearing no architectural and/or historical significance. The upper stories are mainly empty and their fabrics consist of wooden floors and lath-and-plaster ceiling. No period doorways or architraves are extant. The second floor has exposed tie beams encased with planks (Fig. 52) and the casement windows are of several types suggesting that they might have been inserted whenever required (Figs 53 and 54).

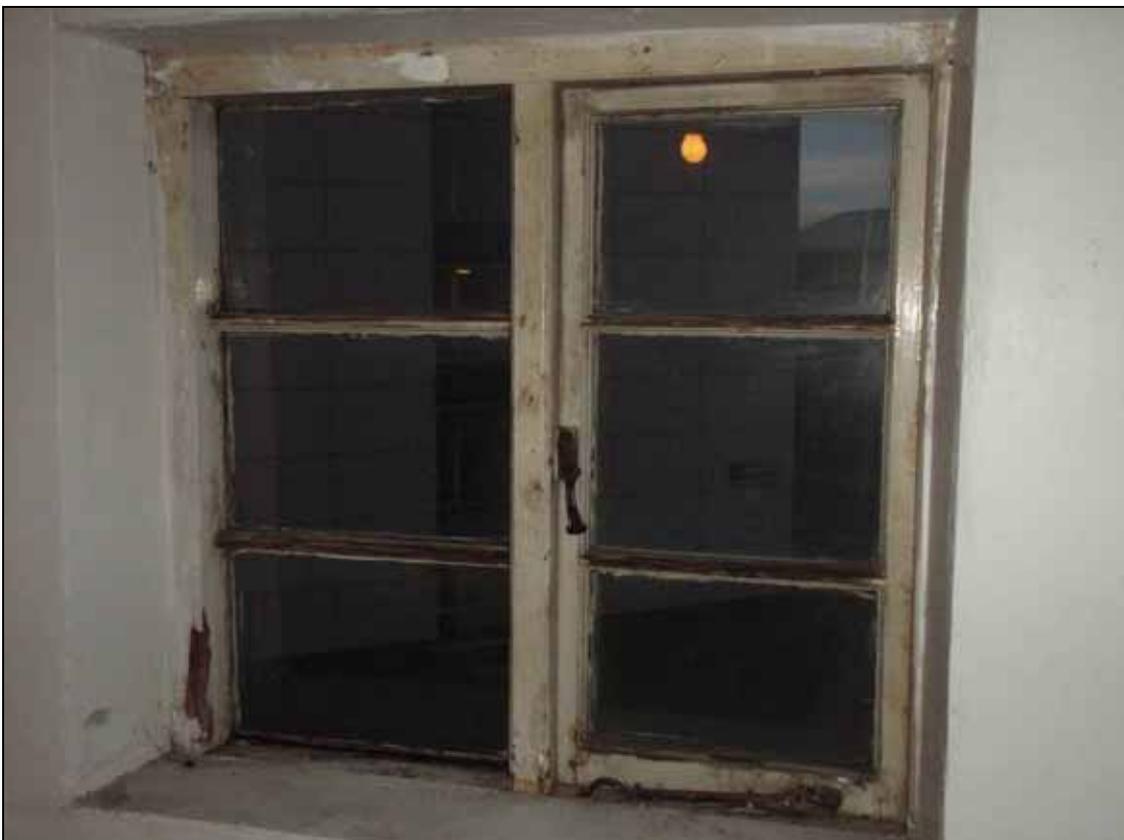
Figure 53: Detail of window of the first floor of Building F

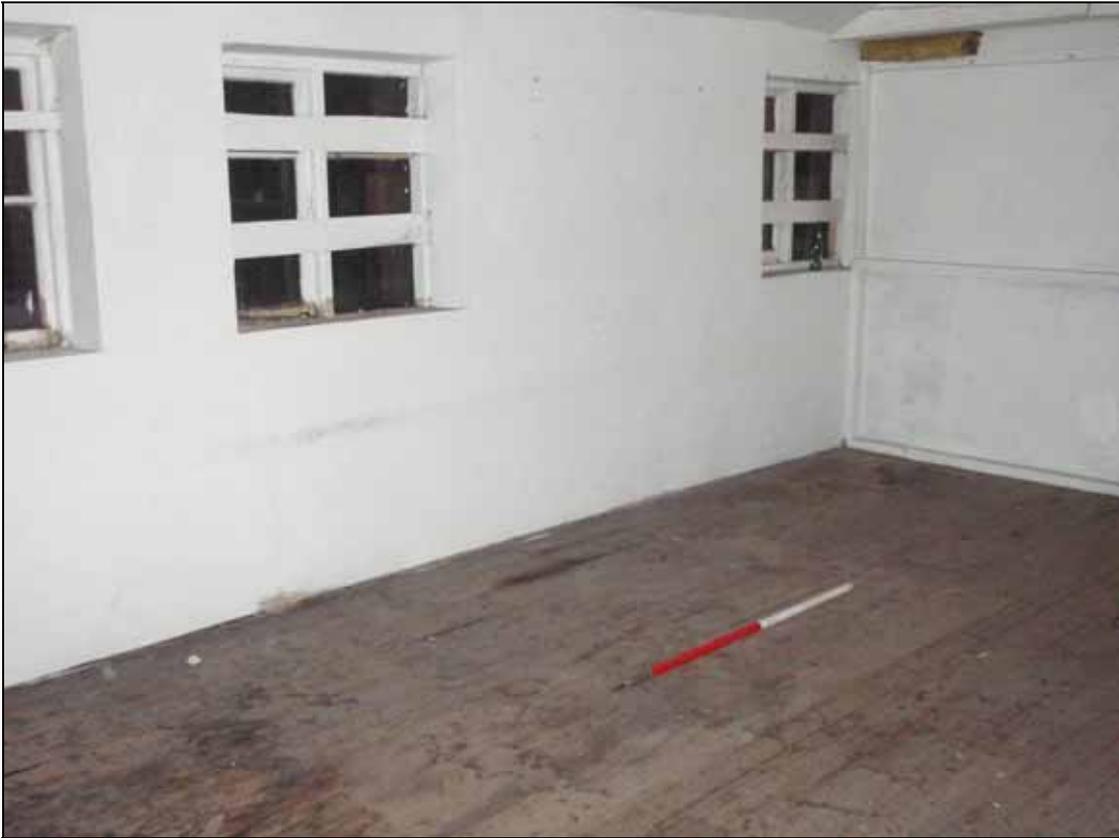
Figure 54: Southern side of Building F (scale 1m)
