An Archaeological Building Appraisal at The Howard Public House Complex, Sheffield

ARS Ltd Report 2011/1

January 2011

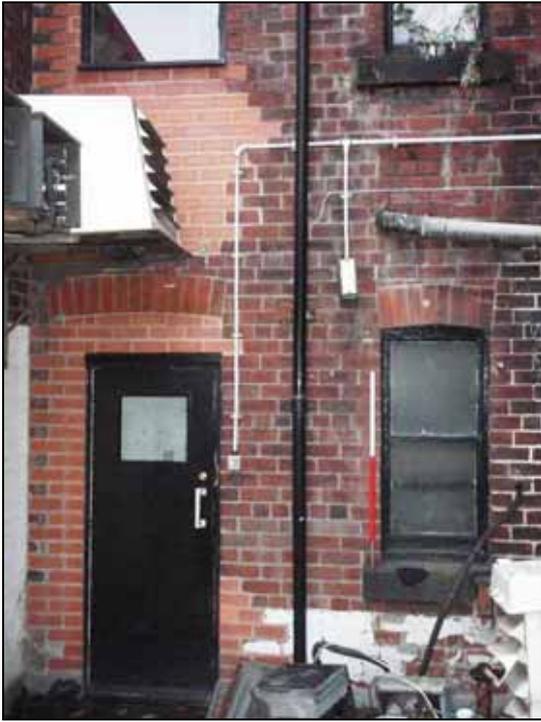
Figure 55: Building G, looking south-west

- 6.26 Building G consist of a series of minor lean-to structures situated at the rear of the preceding buildings and thus situated in the courtyard. The ground floor is merely an infill of the modern pub. The first and second floors contain a straight staircase, and small rooms including bathrooms within a brick structure of no architectural or historic significance (Figs 55 and 56). The staircase has a primary panelling wall covered with plywood (Fig. 57). The panelling is in moderate condition. There is a newel post on top of the staircase which is partially truncated and currently encased with board (Fig. 58).

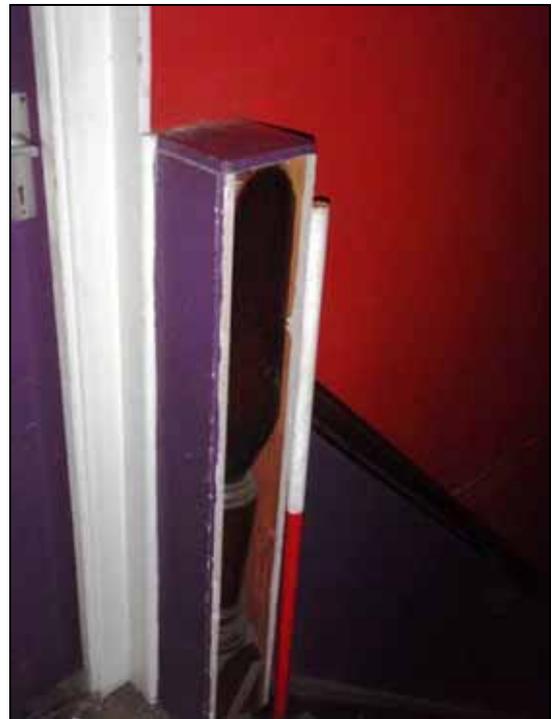
Figure 58: Newel post in Building G
