**PASSMORES HOUSE
THIRD AVENUE, HARLOW
ESSEX**

**ARCHAEOLOGICAL ASSESSMENT
BY TRIAL PITS (PHASE 1)**

Essex County Council

Field Archaeology Unit

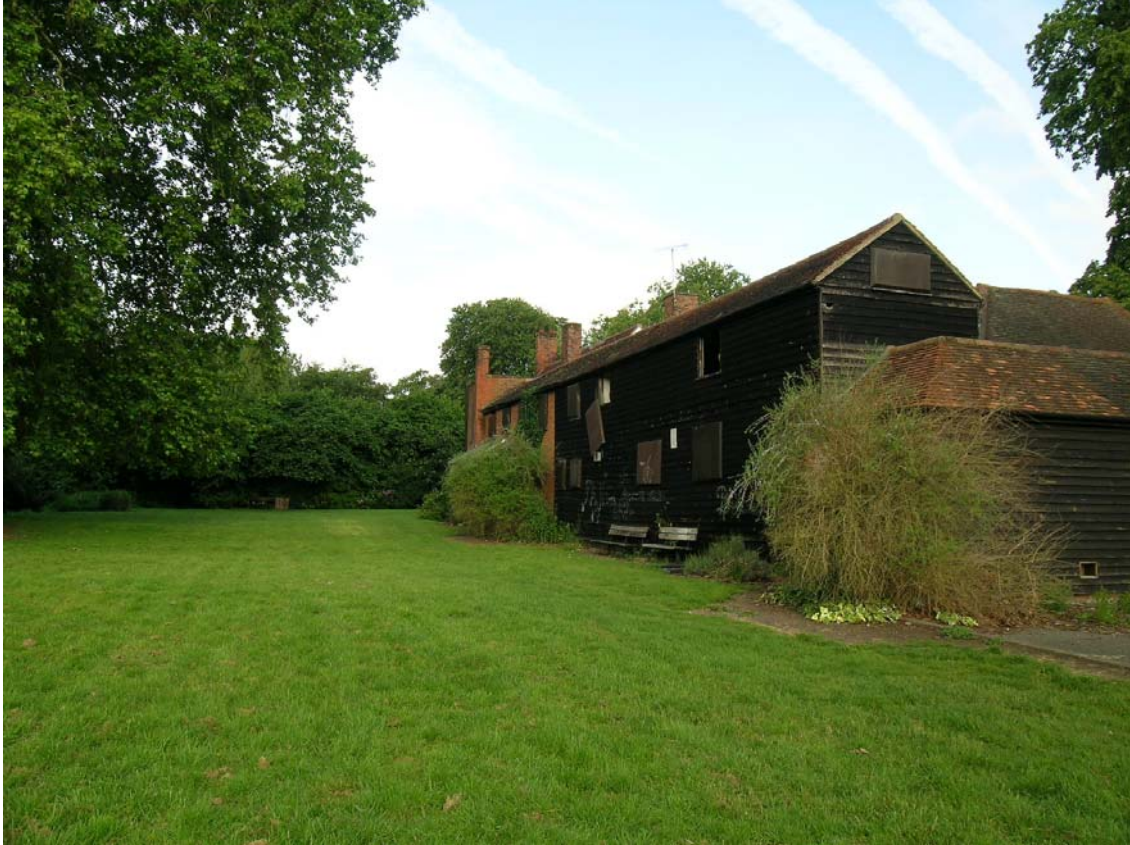
Plate 2. The rear of the house, looking west. In the background is the 18th-century brick house, incorporating elements of an earlier building probably dating to the later 16th century. In the foreground is the timber-clad 19th-century stable block. In very dry weather parchmarks show in the grass behind the 18th-century house, indicating the stone foundations of an earlier, medieval, hall house. The line of the western arm of the medieval moated enclosure is indicated by the trees in the background; the eastern arm of the moat crosses the foreground in line with the end of the stable block.

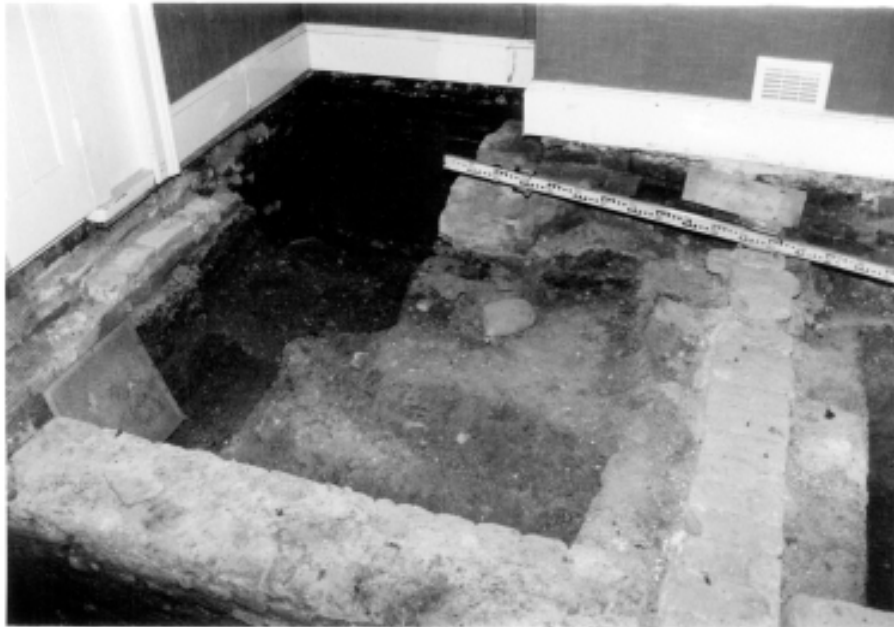
Plate 3. The 1999 excavation, south-west corner. The brick foundation running at an angle across the foreground is a 15th-century addition to a medieval hall house whose foundations survive beneath the grass to the rear of the existing house. The later brick footing on the right supported the floor joists. (Photo: Harlow Museum)

Phase II (15th century). A brick foundation dated to the 15th century abutted the phase I wall and crossed the room north-south (Plates 3 and 4). Brick foundations of the same type were recorded beneath the west and north walls of the room, forming a small chamber measuring 3 x 4m to the north of the medieval hall. The internal floor was formed of silty sandy clay to a depth of 2-3ft (0.6-0.9m) below contemporary ground level.

Phase V (later 16th or later). A further clay floor surface was laid in the west of the room and the base of a brick hearth was recorded beneath the west wall (Plates 3 and 4). The brickwork is dated to the later 16th century or later and would have formed the base of a brick chimney stack, although the upper part of the chimney has since been rebuilt. It is thought that the room, and by extension the entire south range, was built at this date. The hearth and chimney stack suggests the room was a parlour.

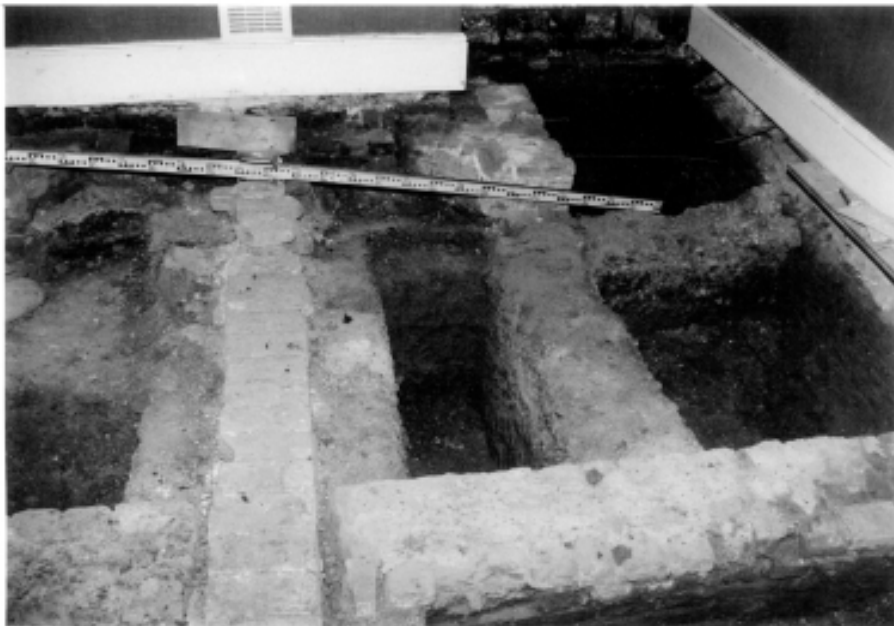
Plate 4. The 1999 excavation, north-west corner (immediately to the north of Plate 3). The 15th-century brick foundation is in the foreground, with the base of a later 16th-century brick fireplace in the background, behind the scale. (Photo: Harlow Museum)

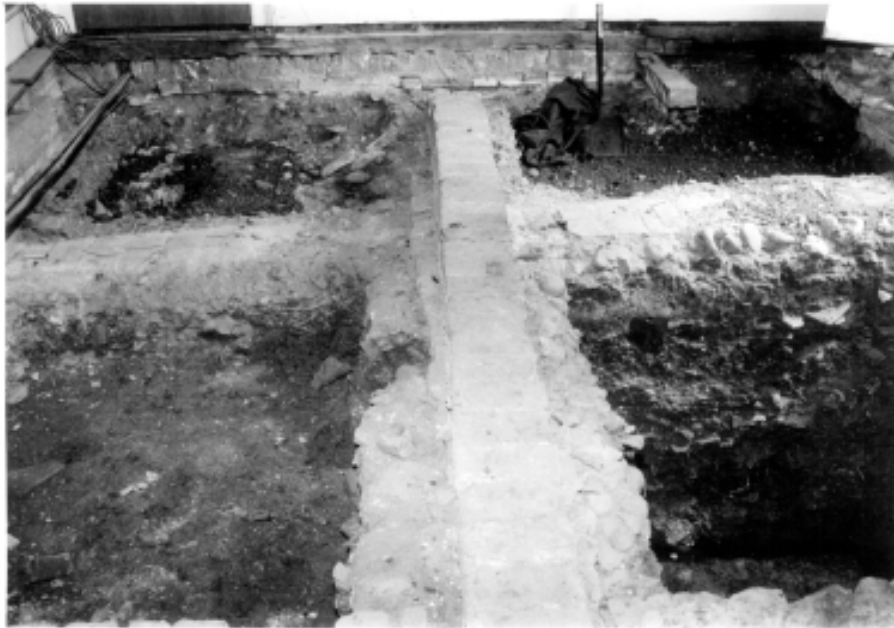
Plate 5. The 1999 excavation, looking east. The area of deep excavation in the right foreground is through the fills of a 15th-century garderobe pit (cess pit for a privy), above which was a 16th-century brick drain running north-south across the area. The later brick footing running up the centre supported the floor-joists. (Photo: Harlow Museum)

Phase III (15th century). A brick-lined garderobe pit (cess pit for a privy), measuring c. 2.0 x 2.5m and over 2.4m deep (Plates 5 and 6) was constructed to the east of the phase II room, abutting the phase 1 wall. It was built of the same bricks as the phase II walls so was presumably contemporary with them although the stratigraphic relationship between the two indicates that the garderobe was a later addition. The pit was not bottomed, but penetrated at least 0.6m into the water table. Its waterlogged lower fill contained a leather shoe and two wooden bowls.

cobbled external surface, above which a brick drain with a peg-tile base ran north-south across the room (Plates 5 and 6).

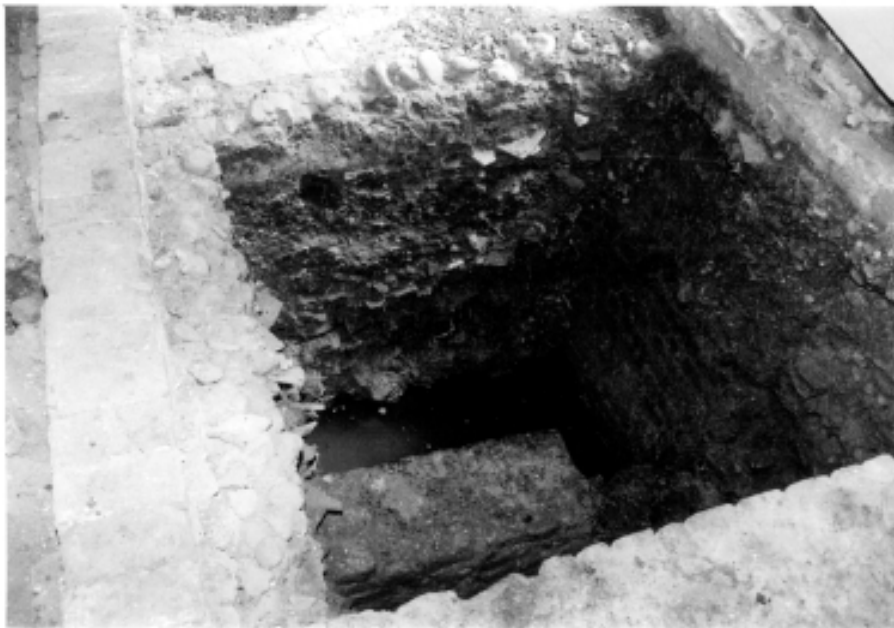
Plate 6. The 1999 excavation, detail of the garderobe shown in Plate 5. (Photo: Harlow Museum)
