WYDDIAL BURY FARM
Wyddial, Herts.

(HN337)

*Historic Building Record &
Archaeological Monitoring Report*

Report no.198

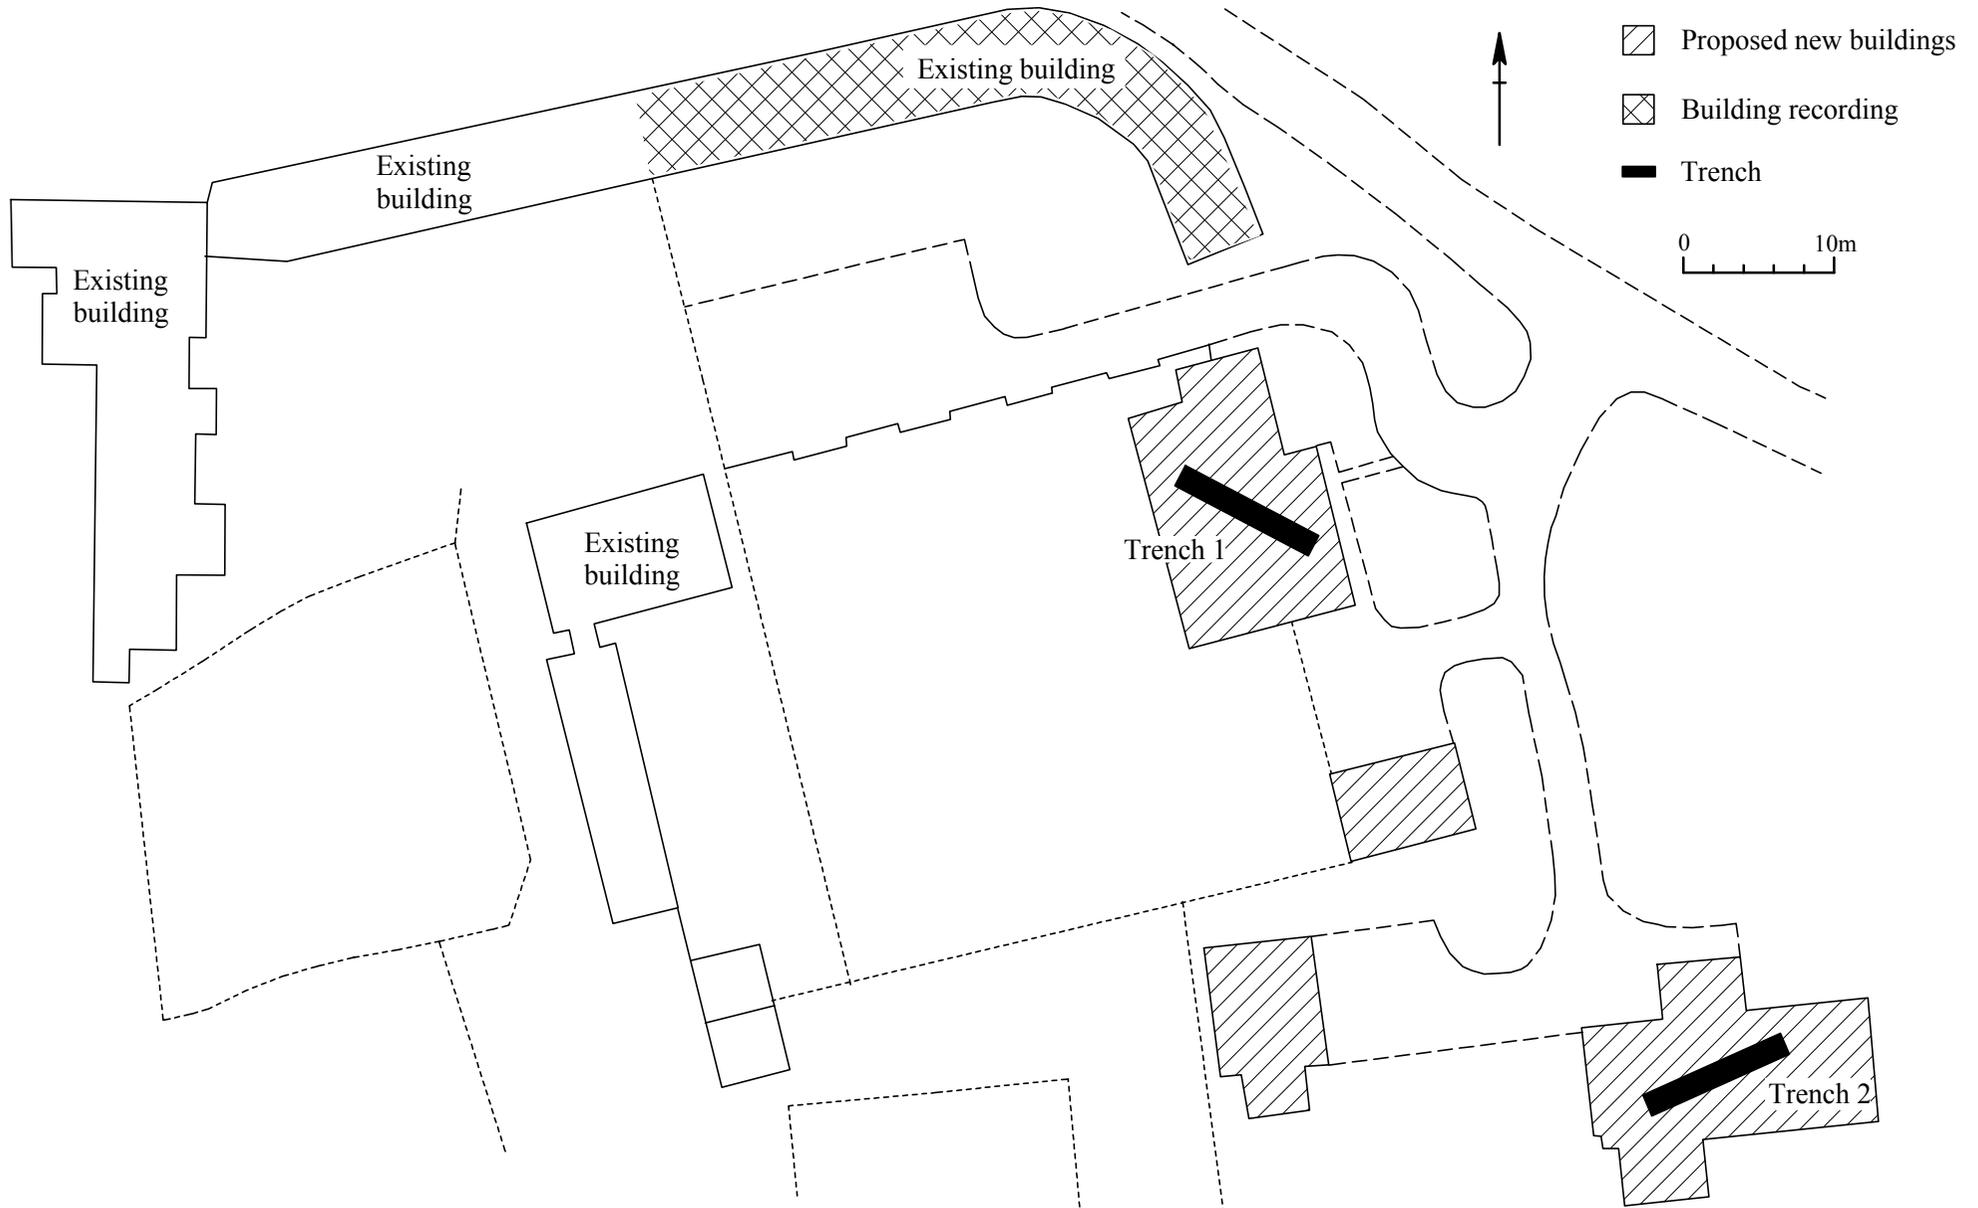
Figure 2

Areas of investigation

1.3 The Project Design (Turner 2002) defined two areas of focus for the archaeological work: building recording of the historic structures and monitoring of the groundworks associated with their conversion; and the archaeological evaluation of the site of the two new dwellings (Fig.2).

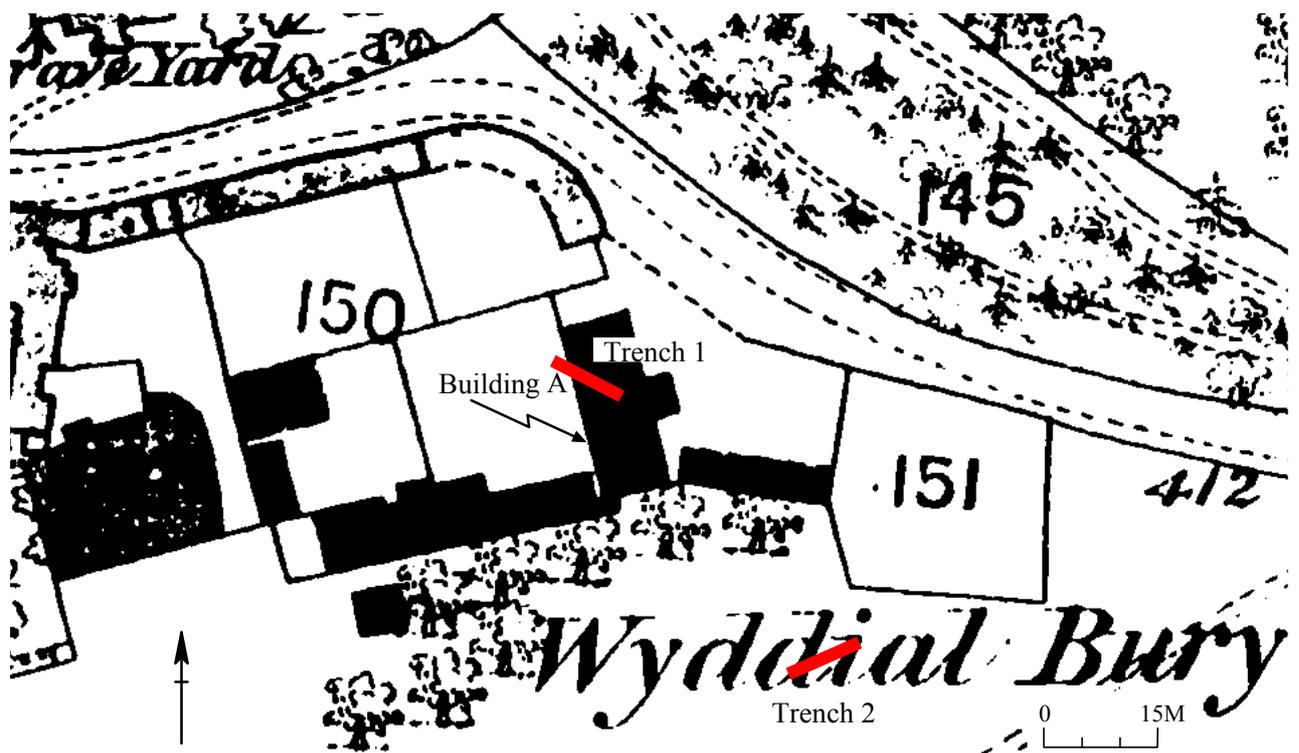
Figure 3a

1877 1st edition OS map, 1877

4.3 The walls [101 & 102] encountered in Trench 1 coincide with out-building 'A', shown on the 19th century plans of the site (Figs. 3a-4a). Wall [101] appears to be a load bearing wall, but the rubble construction of [102] suggests it was subsidiary to the main structure.

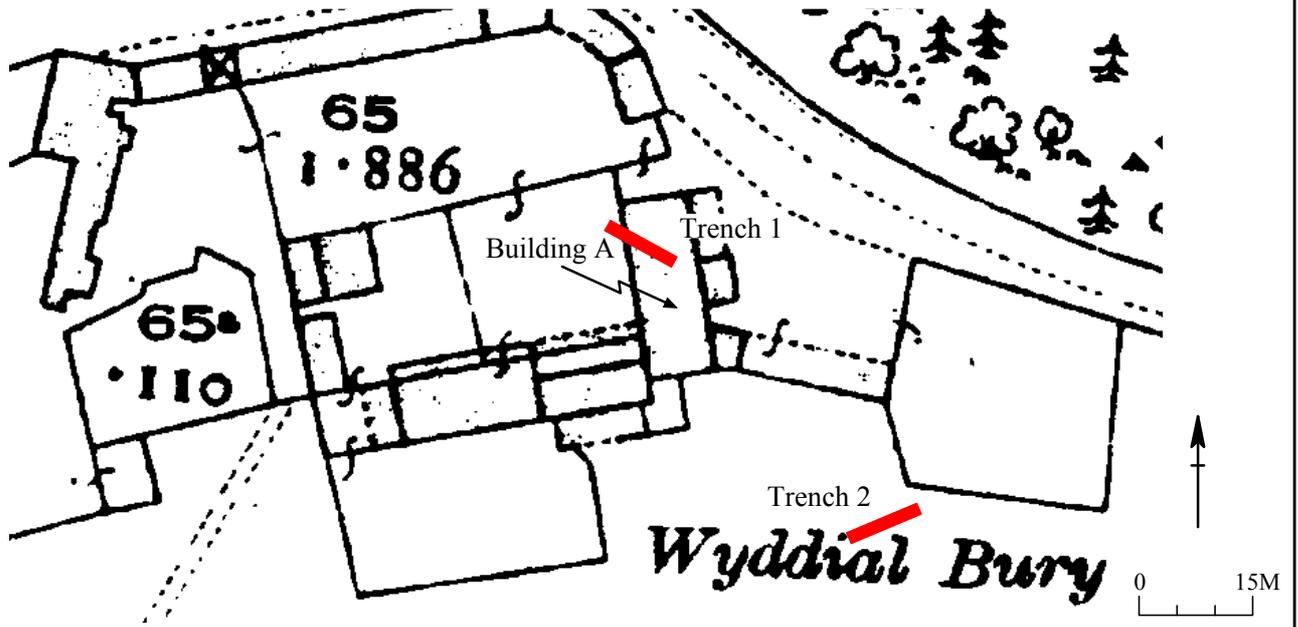
Figure 4a

1921 OS map

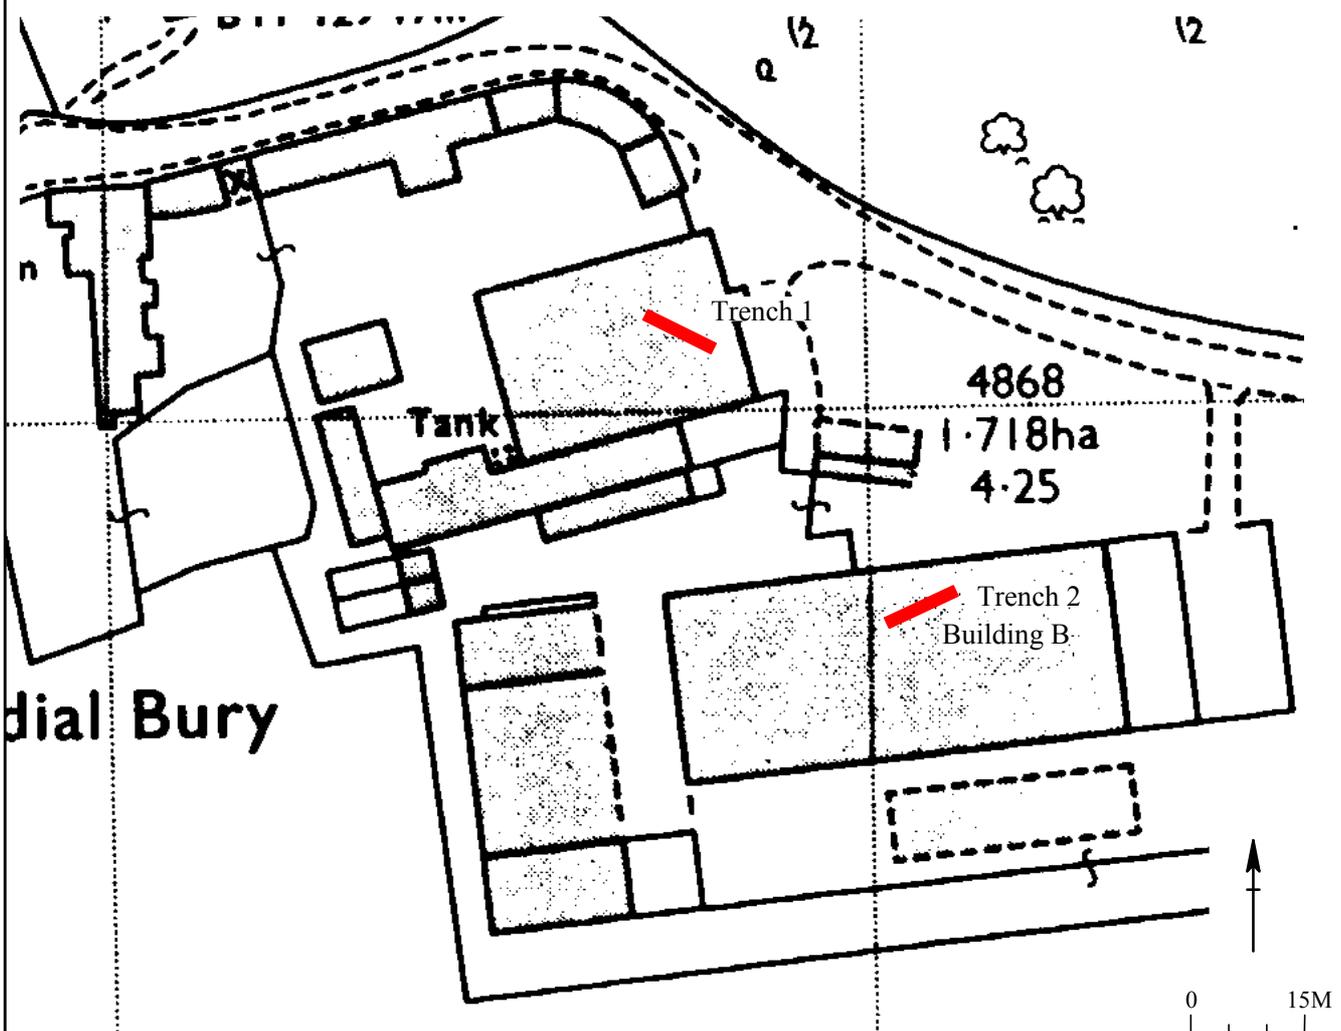
Figure 4b

1976 OS map

4.4 The large concrete stanchion base [204] in Trench 2 was part of a series of stanchions for a modern barn 'B', running E-W, which was built between 1960 and 1976 (Fig.4b).

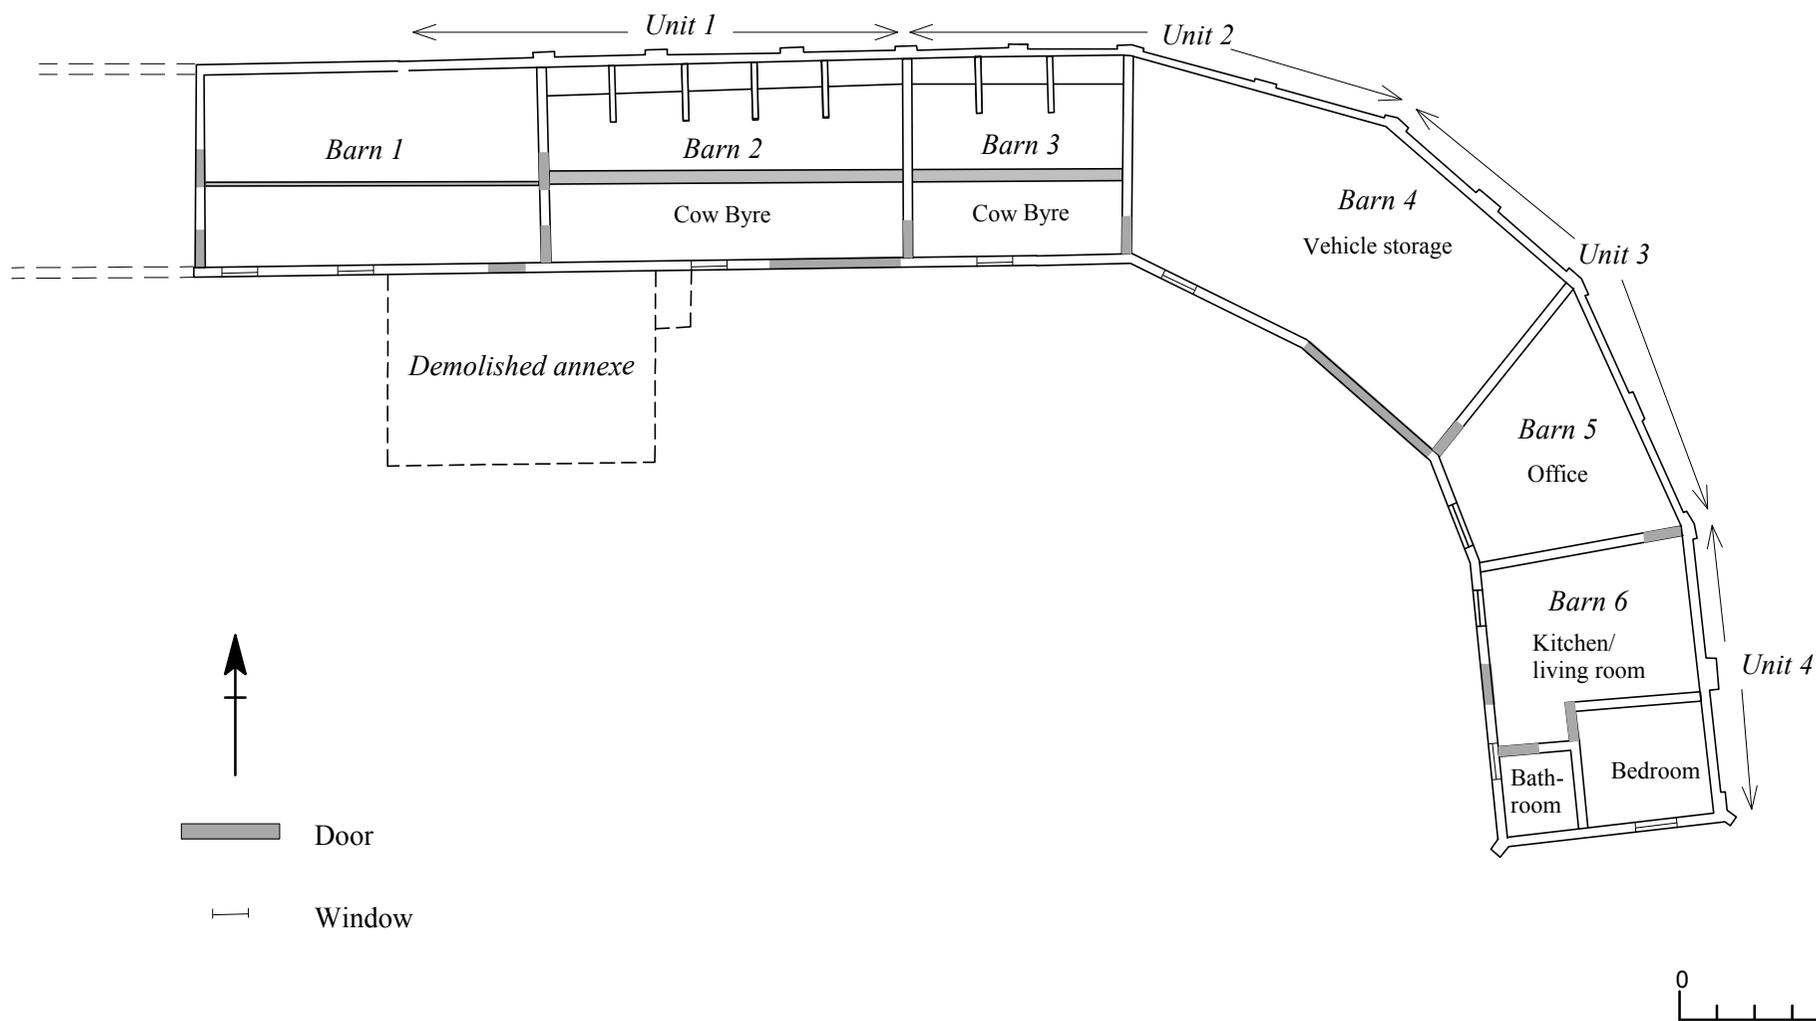
Figure 5

Barn plan

2.1 The barns at Wyddial Bury Farm lie to the east of the farmhouse. They are orientated roughly east to west and are curved to follow the contour of the road (Plate 1a). They were constructed in 1867 of Cambridge White brick on a foundation of locally made, friable red bricks. Some internal and external alteration has been carried out to the south face since their construction. As the western end of the building had already been renovated, the present study concentrates on the remaining six subdivisions which are being converted into four residential units (Fig.5).

2.10 Barn 1 measures approximately 8.80m in length and 5.19m in width (Fig. 5 & Plate 5b). The western wall has a modern door at ground level, leading to the part of the barn that has already been renovated. The barn is linked to those on either side of it by a door set immediately below the roof in both the west and the east walls. The south wall is pierced by a single door at the eastern end, which leads to the remains of a tiled annexe, and one recent and one modern window to the west of it. A single door in the southern end of the east wall connects Barn 1 with Barn 2.

2.11 Barn 2 measures approximately 9.30m in length. Five cow stalls are set into the north wall (Fig. 5 & Plate 6a). Each stall has two feeding troughs on the floor, water bowls on the walls and vertical tying bars. A drainage channel runs down the centre of the barn. The walls have been concreted to half height. Some of the plaster has fallen from the wall above the concrete, revealing that the interior wall was constructed from various, possibly cheaper, types of bricks. The remaining original window is in the south wall of this barn, and to the east of it is a sliding barn door approximately 3.42m wide. A single door in the southern end of the east wall connects Barn 2 with Barn 3.

2.14 Barn 5 is a small wedge-shaped area, measuring approximately 6.80m in width along the north wall and approximately 3.0m in width along the south wall (Fig. 5 & Plate 3a). A single replacement window pierces the south wall. The walls are plastered and painted, as in the other barns, but unlike them this barn has a ceiling. This appears to have functioned as an office in

2.15 Barn 6, which is in total approximately 7.0m in length, has been subdivided to provide living accommodation (Fig. 5 & Plate 6b). The door in the south wall leads into a kitchen cum living area, which measures no more than 4.34m in length. The window to the north of the door in the south wall has a sink below it. To the south of the kitchen is a bathroom, which measures approximately 2.12m by 2.34m. It is lit by the southernmost window in the barns. In the south-east corner of the barn is a bedroom which measures approximately 3.27m by 3.04m. The window in the south gable provides the light for this room.

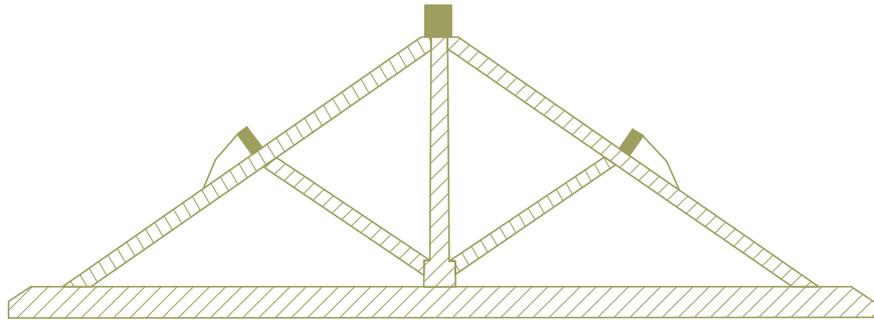
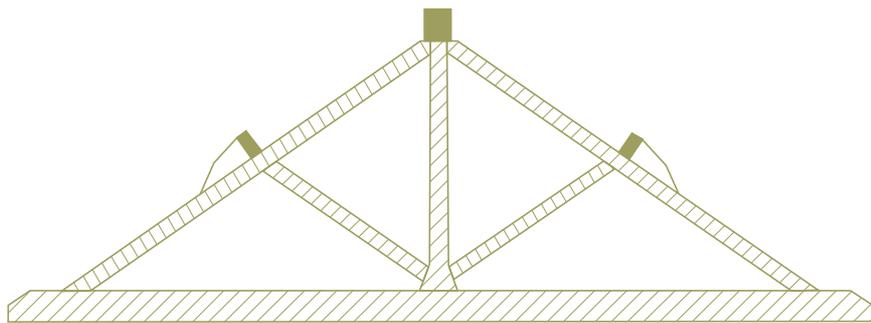
King post with raking struts and squared joggles

King post with raking struts and sloping joggles

2.8 The roof trusses consist of a king post with a squared head, raking struts and cleats supporting the purlins (Fig. 6 & Plate 5a). The first two king posts in Barn 1 have squared joggles supporting the raking struts. All the others have sloping joggles.

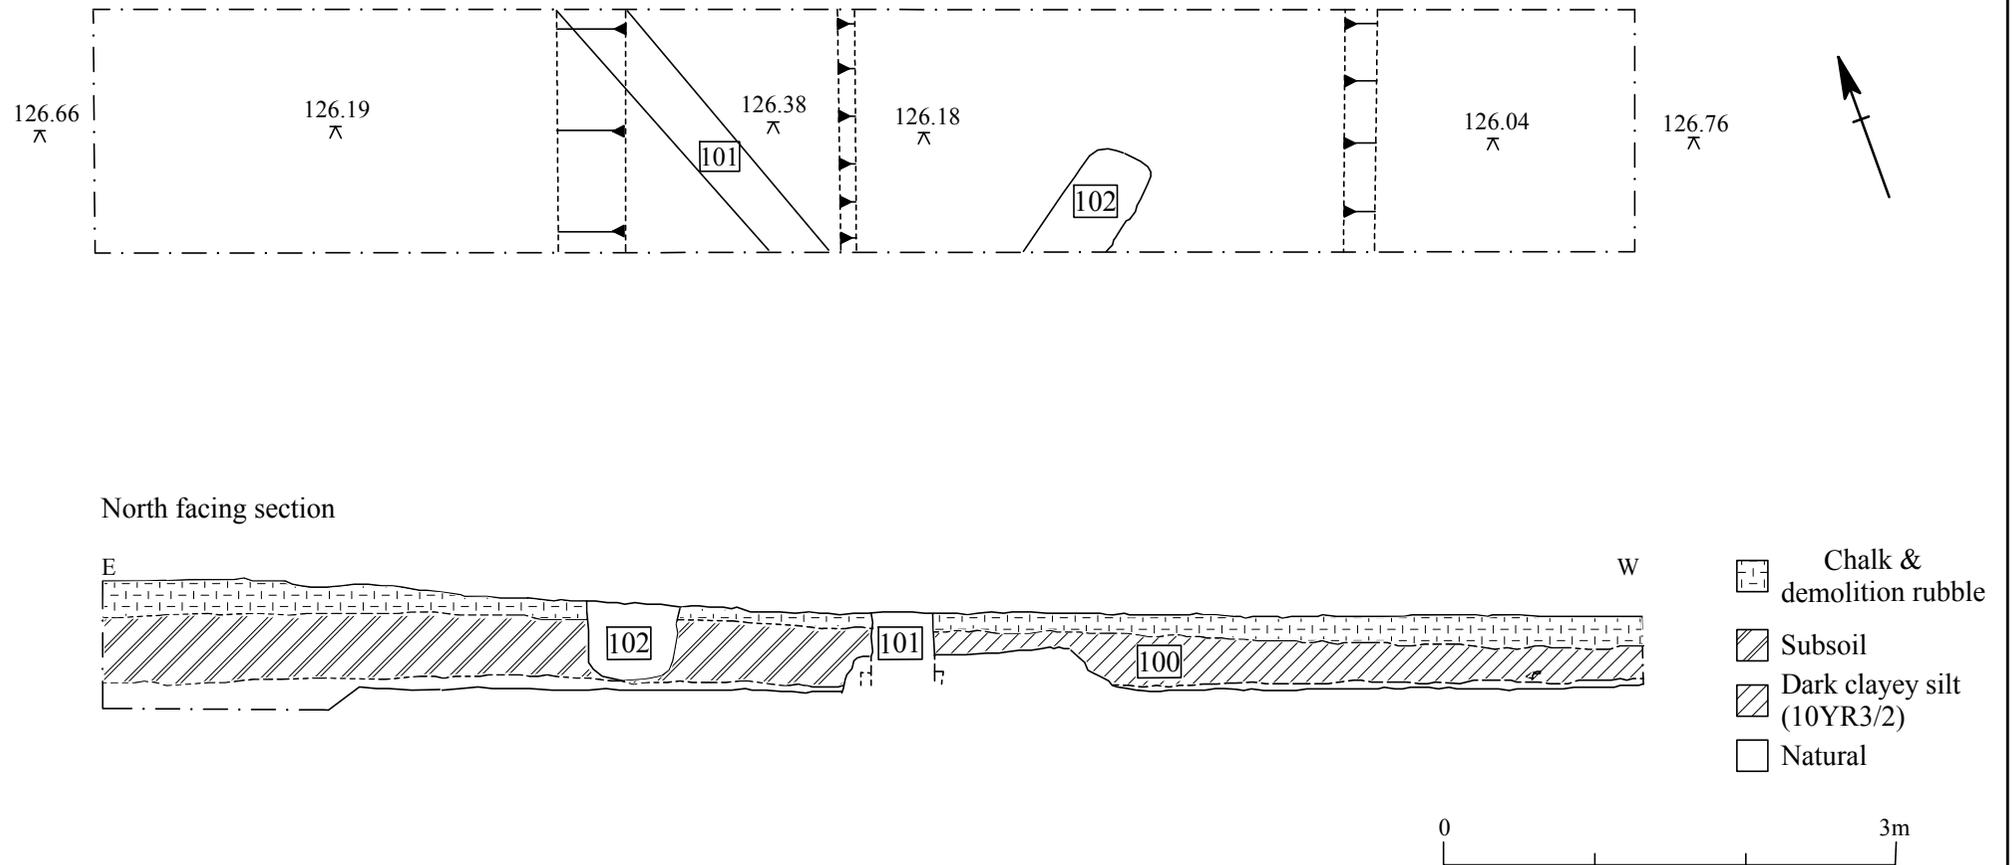
Figure 7

Trench 1: plan & section

- 3.10** This trench was located across the proposed footprint for the dwelling to the south of the existing barns. It was orientated NW-SE and measured 10.20m in length and 1.60m wide (Fig. 7).
- 3.11** The overburden in this trench consisted of a white (10YR 8/1) mixed demolition rubble chalky clay, 0.25 to 0.30m in depth.
- 3.12** Two walls were encountered in this trench, [101] and [102].
- 3.13** The subsoil consisted of a reddish brown (10YR 4/4) clay, 0.20 to 0.25m in depth. The subsoil was only encountered to the east of wall [101].
- 3.14** Beneath the overburden was layer [100] of dark brown (10YR 3/2) silty clay with late post medieval to modern brick rubble inclusions, 0.22 to 0.25m in depth. This layer was only

3.15 Wall [101] ran across the trench on a N-S alignment, it survived to a depth of five courses from surface level. It had a width of 0.38m and was built of modern bricks which measured 0.22m long by 0.11m wide by 0.065m deep.

3.16 Wall [102] ran across the trench on an E-W alignment and survived only in a disturbed state. It consisted of reddish brown brick rubble, with lime mortar. The brick fragments displayed no frog features. Only a 1.20m long stretch of the wall survived, this portion had a depth of 0.50m and a width of 0.50m.

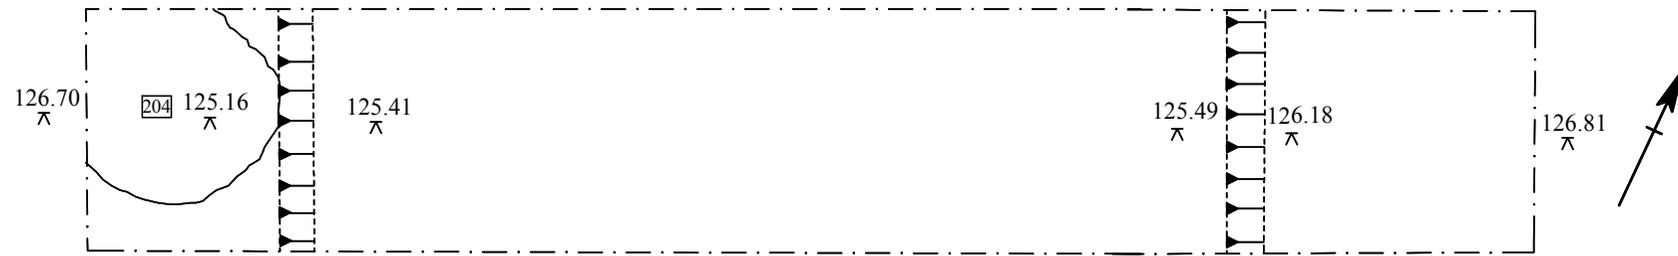
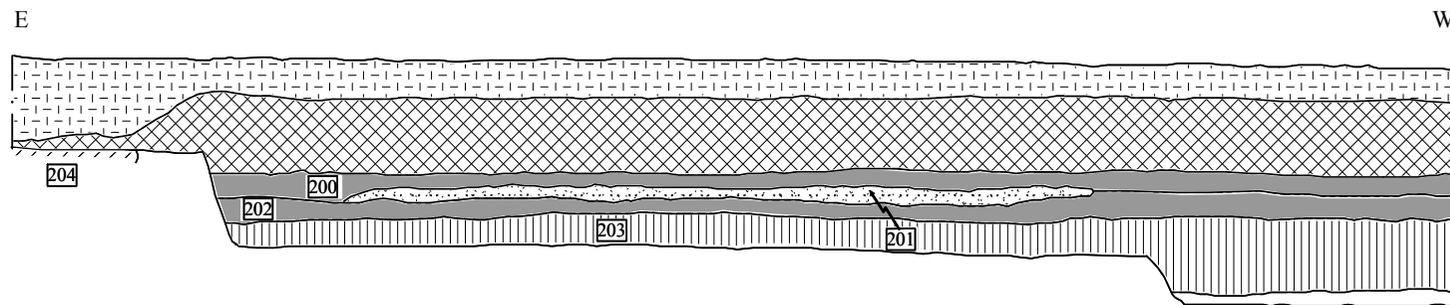
Figure 8

North facing section

Trench 2: plan & section

3.18 This trench was located across the proposed footprint for the dwelling in the south eastern corner of the site. It was orientated NE-SW and measured 9.60m in length and 1.60m wide. (Fig.8).

3.20 A large concrete stanchion base [204], measuring approximately 1.30m in diameter, was observed at the eastern end of the trench. This base sat on layer [200], below the modern aggregate. This feature is part of a 20th century barn clearly marked on the 1976 OS plan of the site and surviving into the 1980s.

3.22 A compacted layer of redeposited chalk was observed under layer [200]. This feature [201] measured 5m in length and 0.10m in depth. This type of compacted chalk layer often represents a foundation base for farm outbuildings. It probably represents a surface for some temporary wooden chicken sheds that were located in this part of the farm.

3.24 Underlying layer [202] was a layer of greenish grey clay (5/ 5 GY). This layer [203] measured 0.50m in depth. Ground water appeared to be rising through the base of this layer. This was initially interpreted as being the location of a former pond although there is no cartographic evidence to support this theory. The organic staining of the layer may drive from animal waste seeping from the former barns.

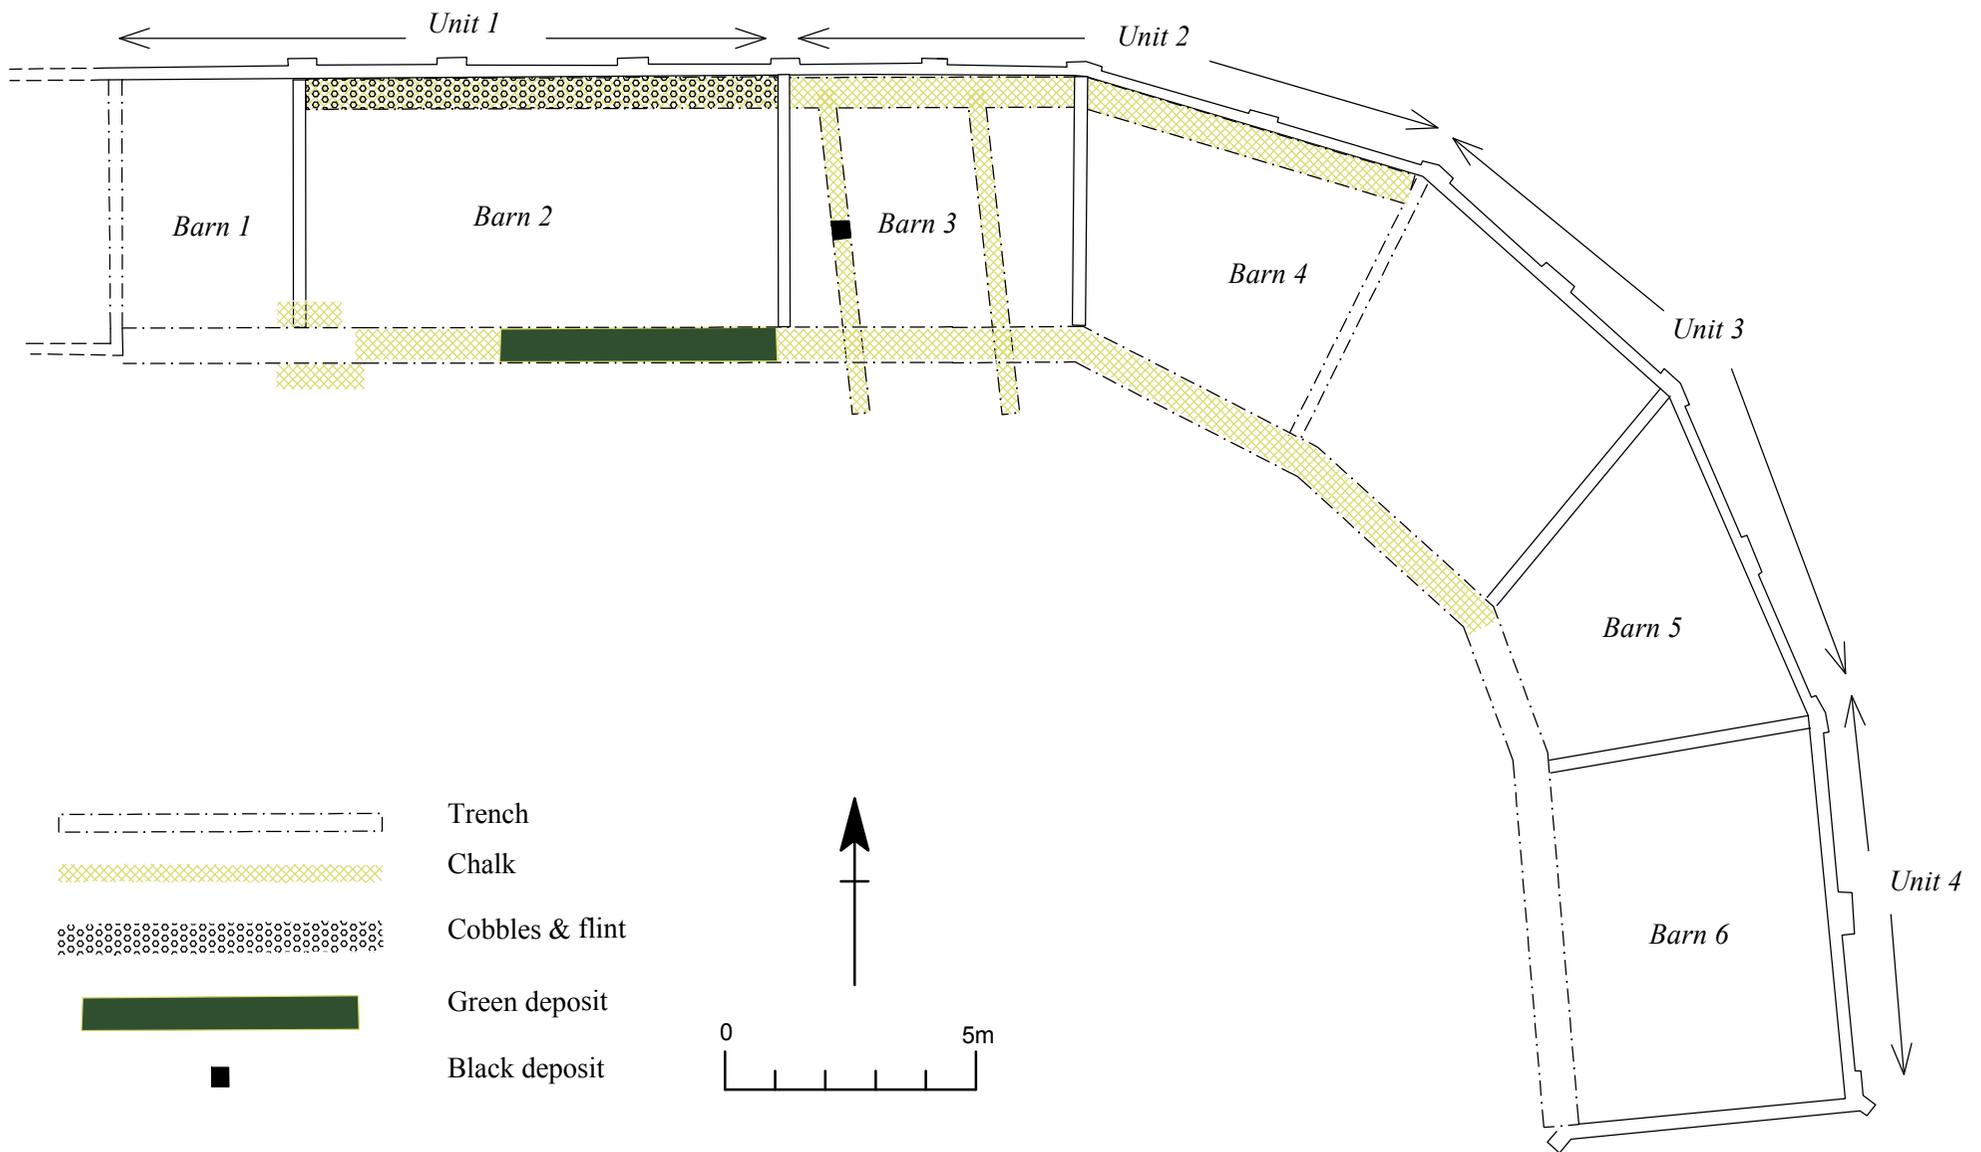
Figure 9

Archaeological features

3.27 The footings trench for the new south wall of the barn measured approximately 0.70m in width and between 1.20m and 1.30m in depth. The only features observed in this trench were a chalk layer and a greenish deposit of indeterminate dimensions (Fig.9).

3.31 Below the concrete was a layer of cobbles and flint which lay on a bed of yellow (2.5Y 8/6) clay heavily mixed with chalk. The combined depth of the concrete and cobble/flint layer was 0.20m, and that of the yellow clay was also 0.20m (Fig.9).

3.34 Two shallow drainage trenches were inspected in Barn 3 (Fig.9). They measured approximately 0.35m in width and between 0.10m and 0.30m in depth. The chalk layer was present throughout the westernmost drainage trench, below which was a black deposit, 0.03m deep and circa 1.40m long. This lay immediately below the drainage channel for the cow byre. Interwoven with this was a brown deposit measuring 0.80m in length and 0.04m in depth. Neither deposit could be identified as they were so wet. The eastern drainage trench was only 0.10m deep and nothing was visible in section.

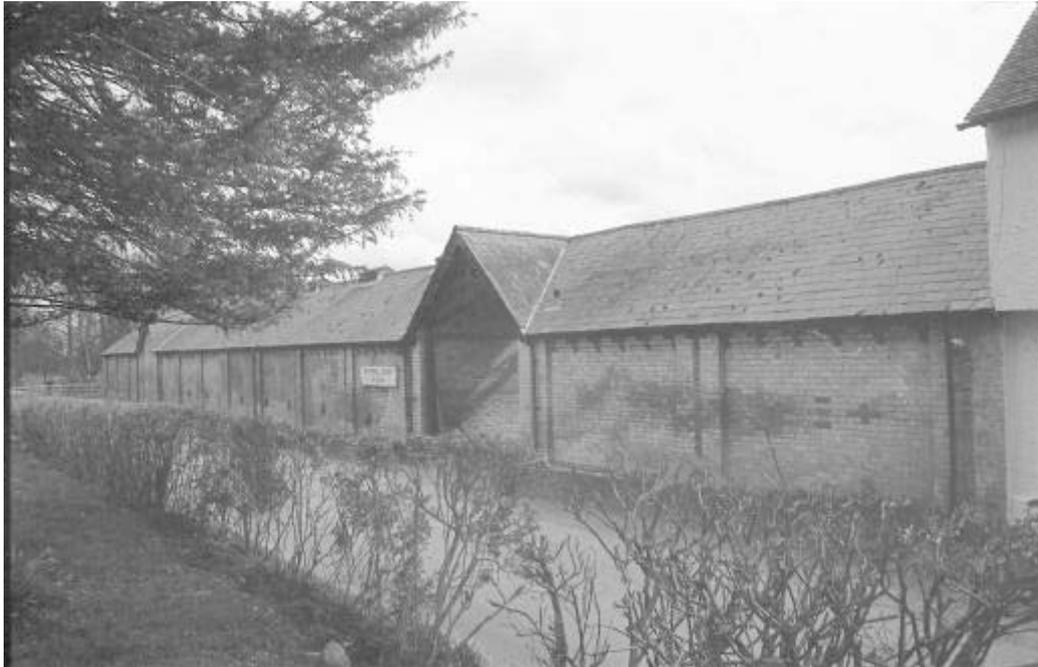
Plate 1a

North elevation

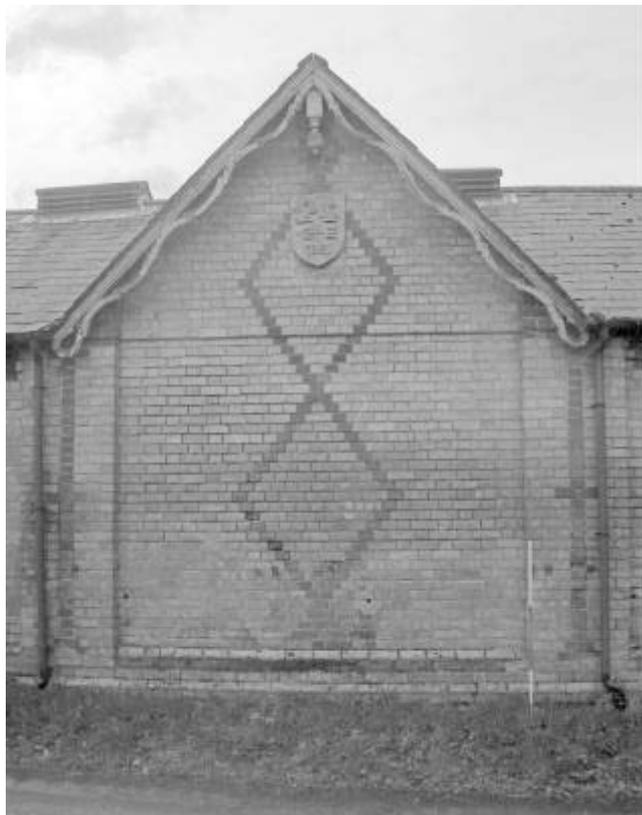
Plate 1b

Gable with coat of arms

2.2 The northern elevation faces the road and the parish church of St. Giles. It is built entirely of Cambridge White bricks in Flemish Bond, with small geometric decorative detail in contrasting red brickwork in every bay. The bays are divided by simple, “pilaster-strip” style buttresses, which are approximately 0.60m wide. The Cambridge White brickwork is relieved by a single vertical line of red bricks. The centrally located gables are decorated with diaper work, also in red brick, and the easternmost gable is further embellished with a coat of arms (Plate 1b). Access to the courtyard is through an arch, which lies at the western end of the range (Plate 2a).

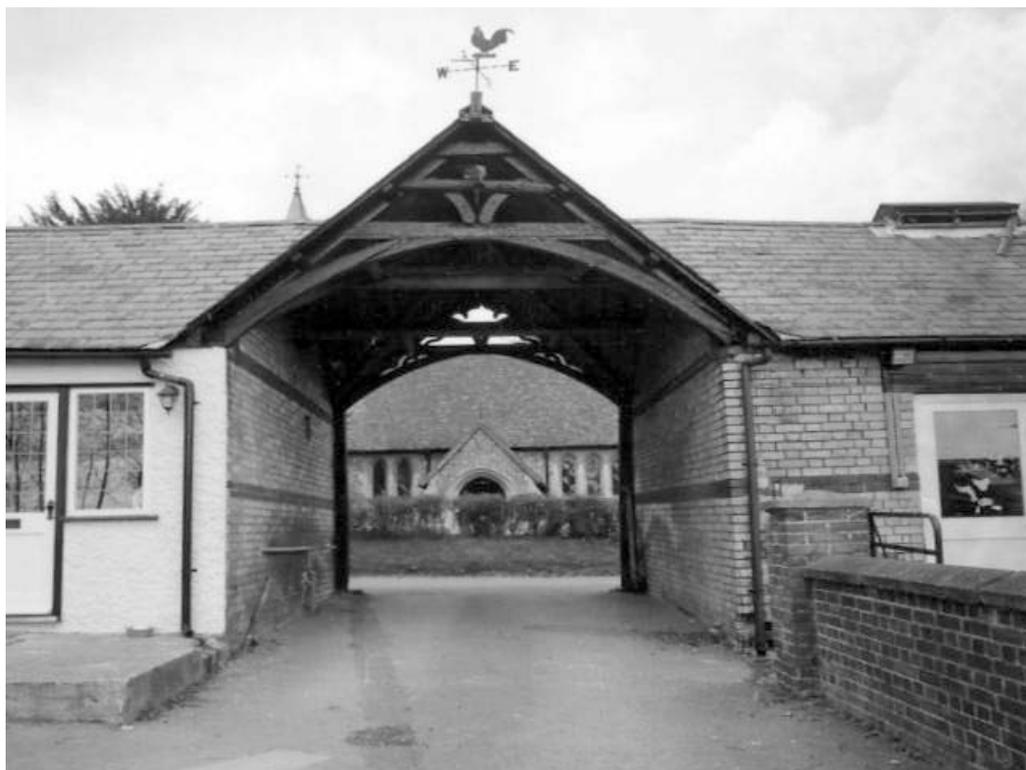
Plate 2a

Entrance arch

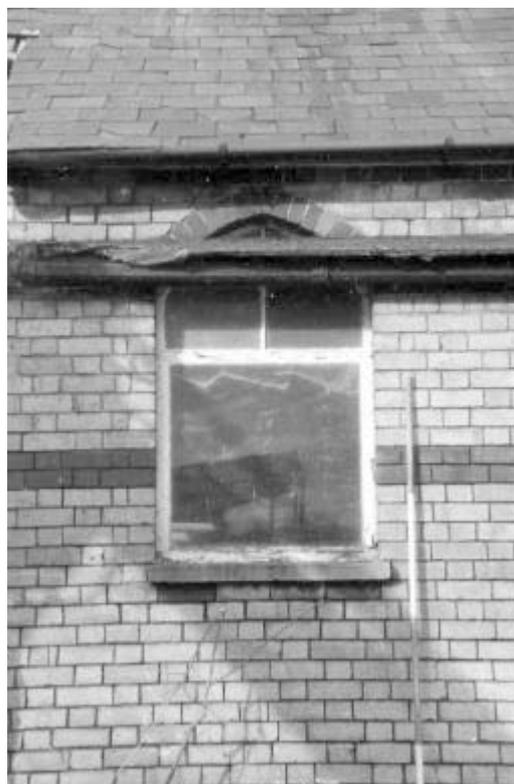
Plate 2b

Original window

2.4 Most of the windows have been replaced, but a single arched window with red brick forming the relieving arch remains in Barn 2 (Plate 2b).

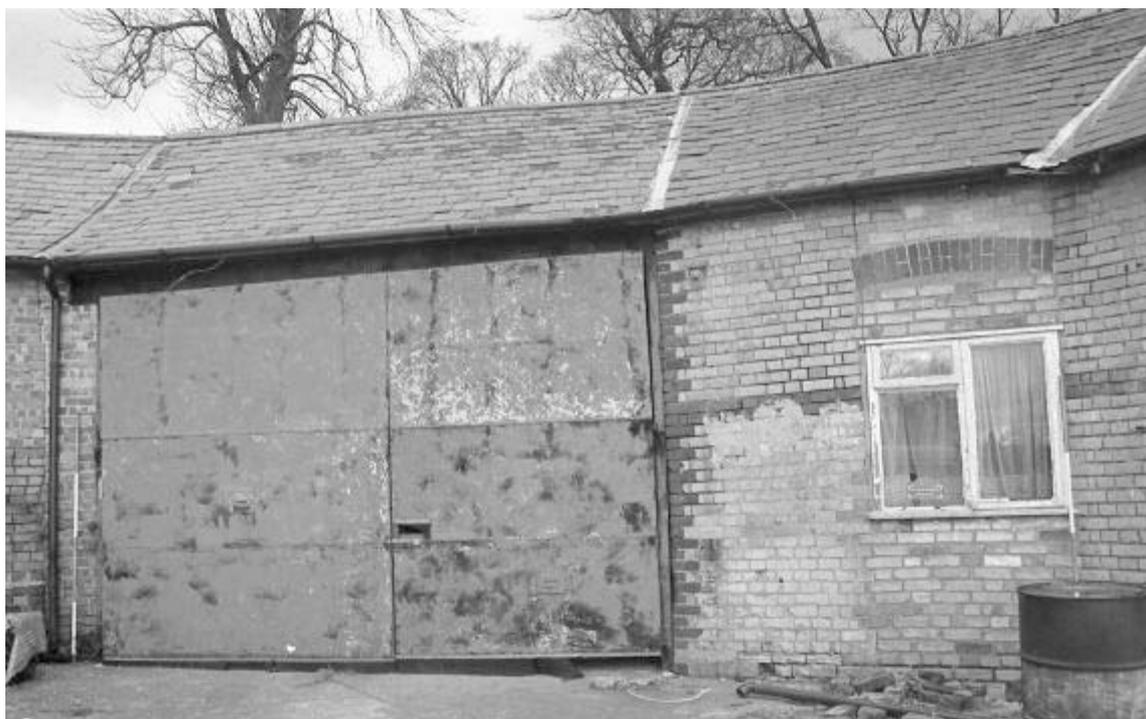
Plate 3a

Barn 5

2.5 A relieving arch made of red brick over the window in Barn 5 may indicate the former presence of a door, which was subsequently replaced by the window (Plate 3a). The north end of the south wall of Barn 5 is unique in that it is finished with brown bricks. The same type of bricks have been used to create the horizontal decorative line north of the window. This would suggest that the south wall of Barn 5 has been rebuilt fairly faithfully to the original, with the exception of the decorative brickwork.

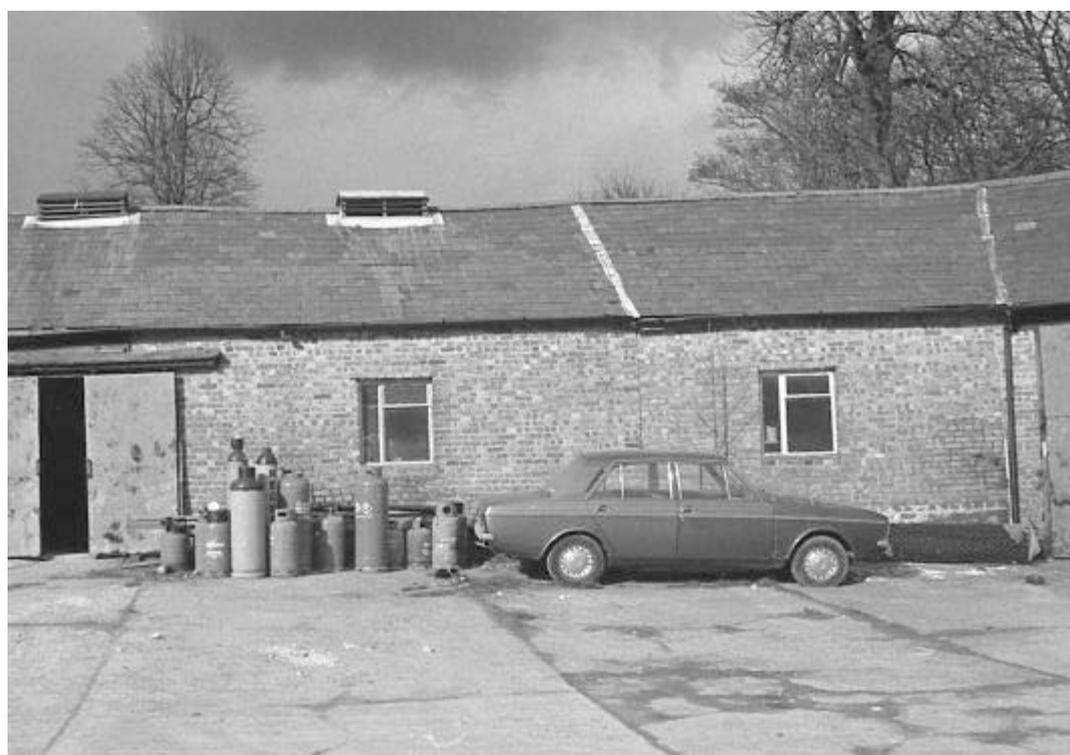
Plate 3b

Barns 3 & 4

2.6 The southern elevation of Barn 3 and the north-western half of the southern elevation of Barn 4 had been rebuilt in Fletton brick (Plate 3b). This appears to have been done at different times as the builds are dissimilar. The south wall of Barn 3 had been rebuilt of polychrome bricks set in a Flemish Bond with very pebbly cement mortar. In contrast, the rebuild of the north-western half of the south wall of Barn 4 is predominantly of the same type of bricks but in a failed Flemish Bond, as the headers are misaligned (Plate 4a). The bottom 0.76m, however, contains a number of different forms of construction. A single course of headers lies below the polychrome brick walling and below this are 6 courses of red brick on the western side, 6 to 7 courses of pinky-red brick on the eastern side, and a column of red headers dividing the two. These lowest courses are mixed headers and stretchers.

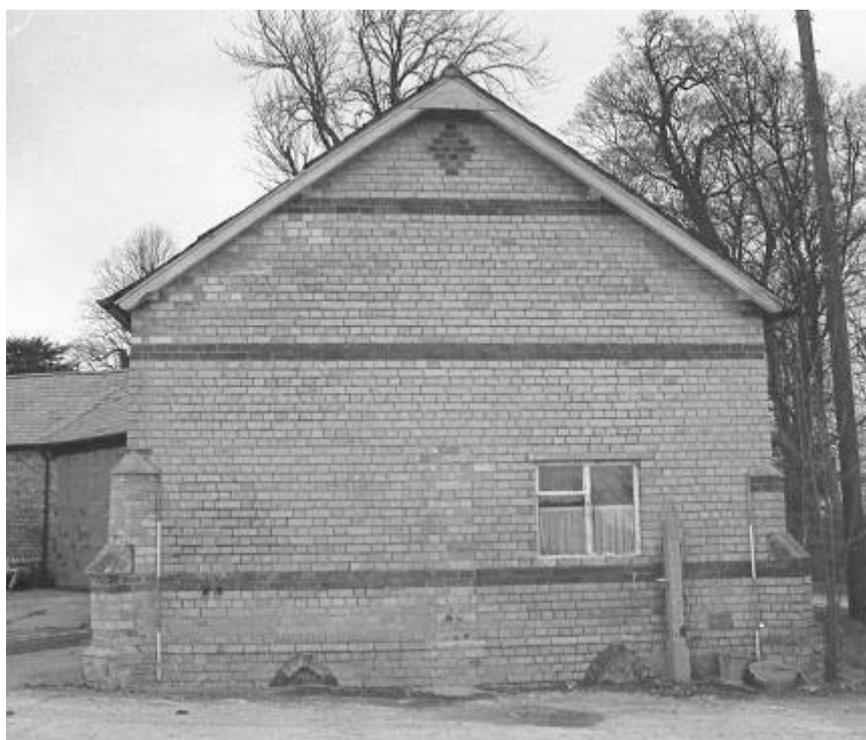
Plate 4b

South gable

2.7 The south wall of Barn 6 has been breached for a modern window, which is offset to the east, and a small buttress at either end (Plate 4b). The wall, which is also of Cambridge Whites, has three decorative lines of red brick, two courses high, and a red brick diamond shaped decorative detail below the apex of the roof. There is a small angled buttress at either end of the wall, and differential weathering to the brickwork suggests that there may have once been a centrally placed buttress.

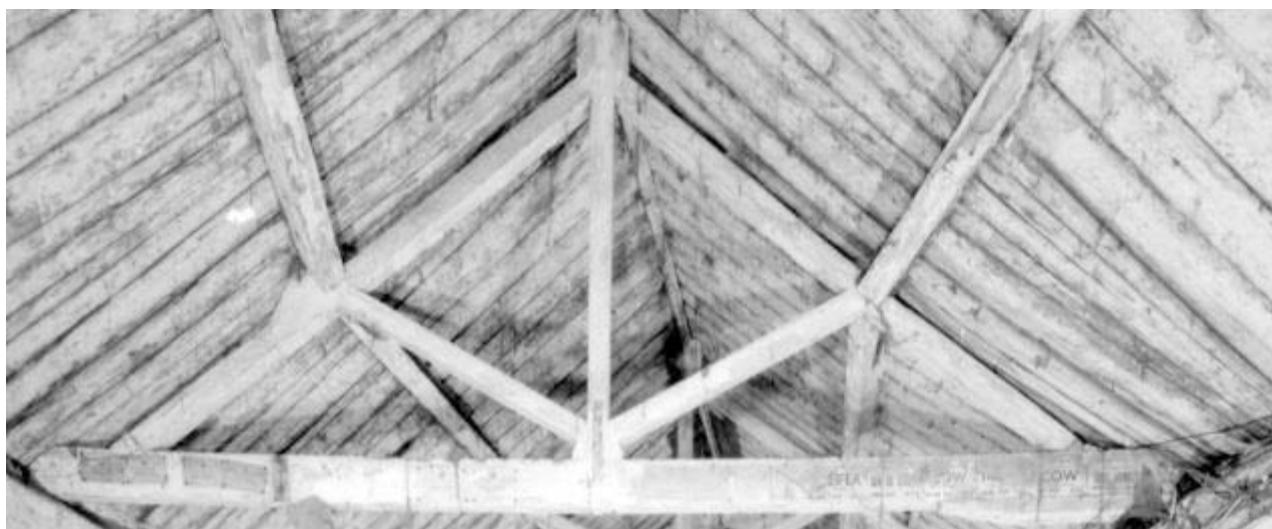
Plate 5a

Roof truss

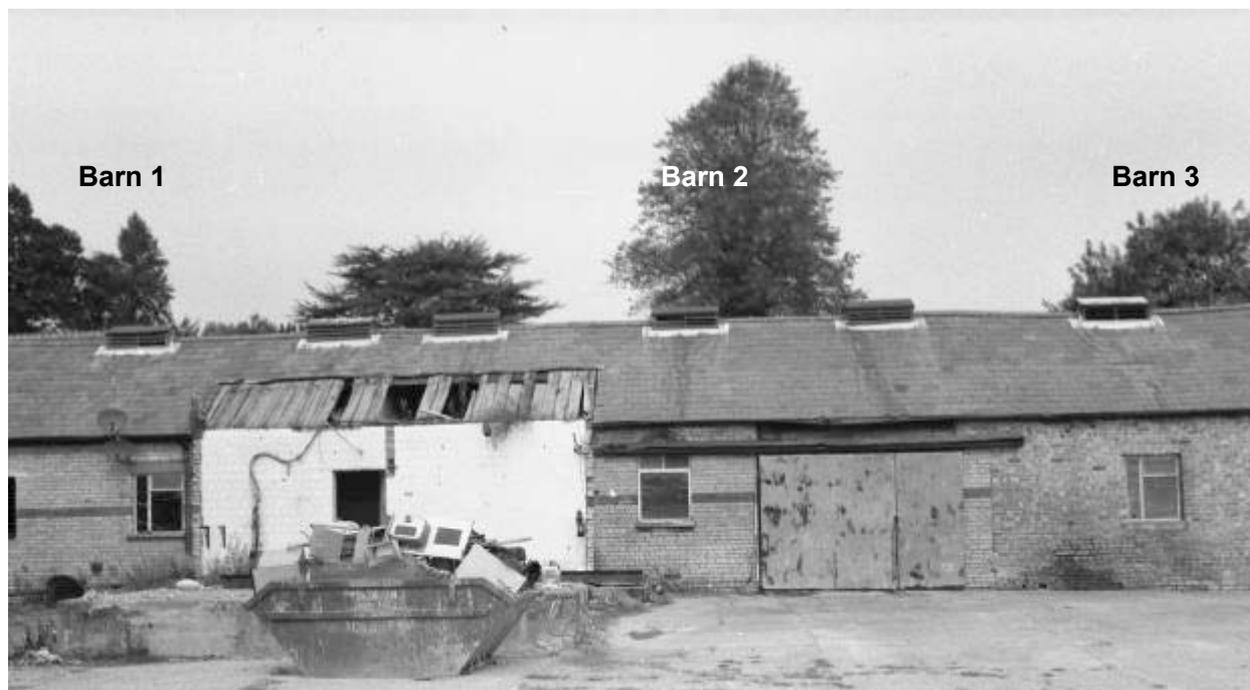
Plate 5b

South elevation
